Engineering Services
14713 Jersey Shore Drive
Houston, TX 77047
Phone 713-433-2155
Fax 713-433-2558
www.structural.net

**CONDITION SURVEY AND EVALUATION OF
THE CONCRETE HYPERBOLIC COOLING
TOWER SUPERSTRUCTURE SHELL IN UNIT
NO. 1 AT AEP'S BIG SANDY POWER PLANT**

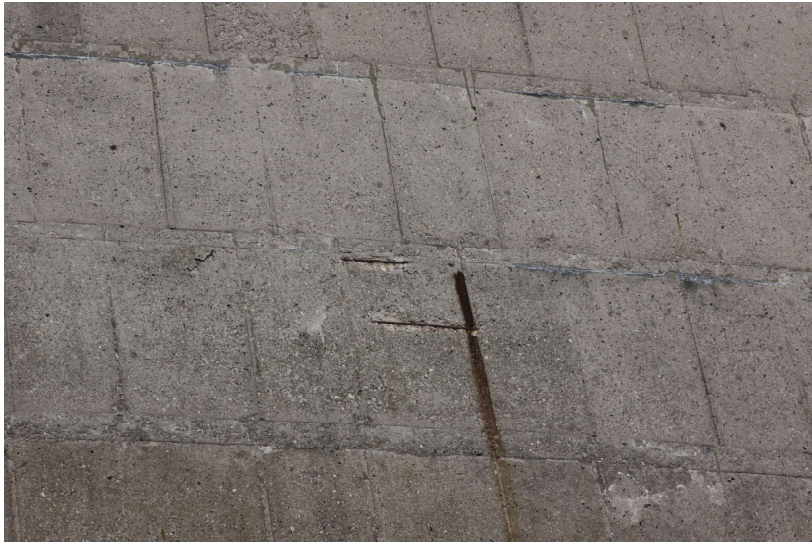
<p>Photo # 2</p>	<p>General photo of horizontal steel reinforcement where the concrete cover has spalled off.</p>

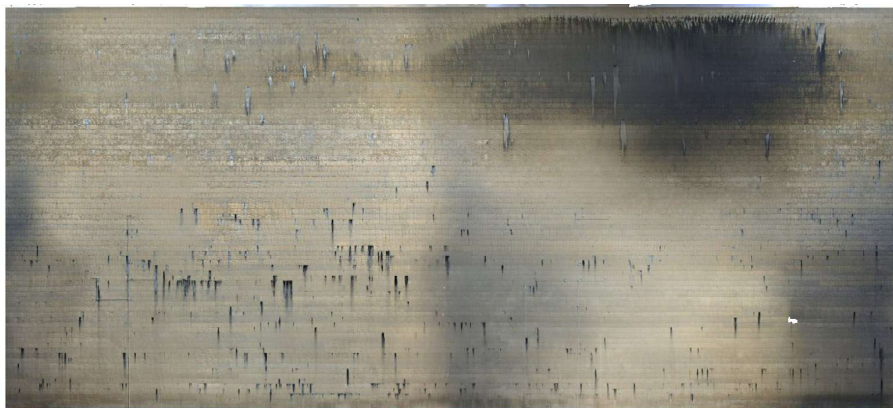
Cylindrical unwrapping N - W - S - E - N (left to right)

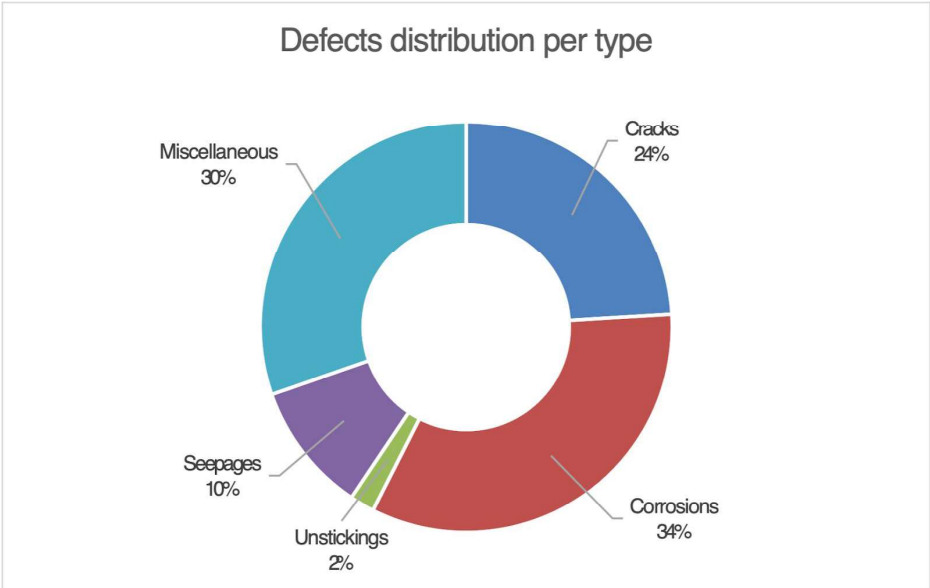
The majority of defects are cracks (1393), miscellaneous defects (1759) and corrosions (1939). Most of the miscellaneous defects are efflorescence with no seepage. When an efflorescence has water seepage, it is classified as a seepage with efflorescence.

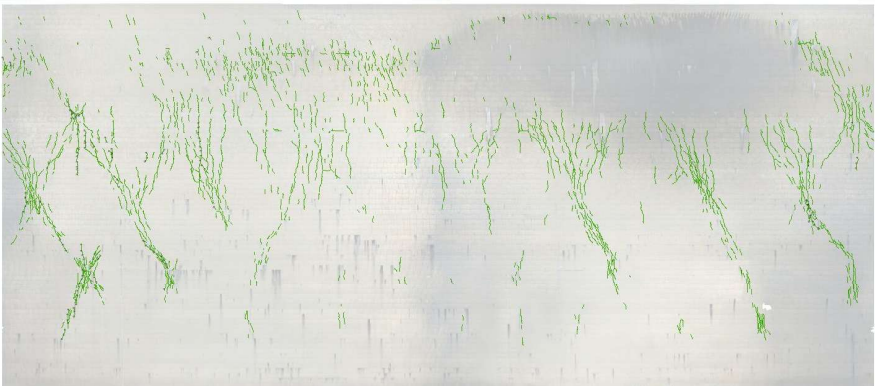
Distribution of cracks N - W - S - E - N

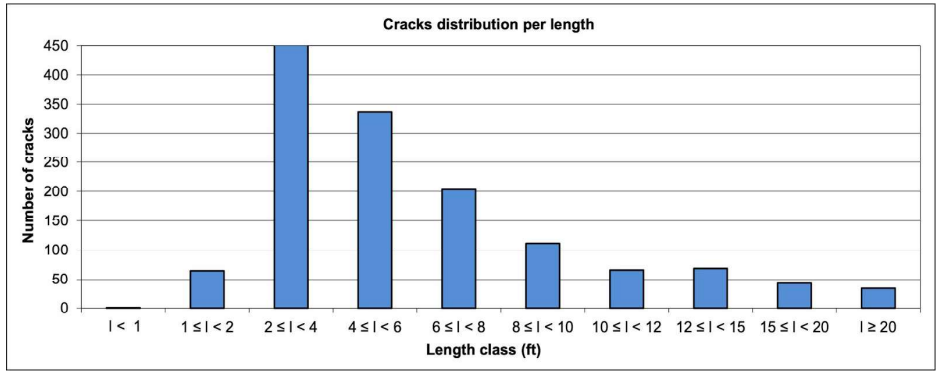
Most of the cracks are between 1 & 10 ft, but we can find 34 cracks with a length of more than 20 ft. A lot of cracks are ready to merge and create a single very long crack.

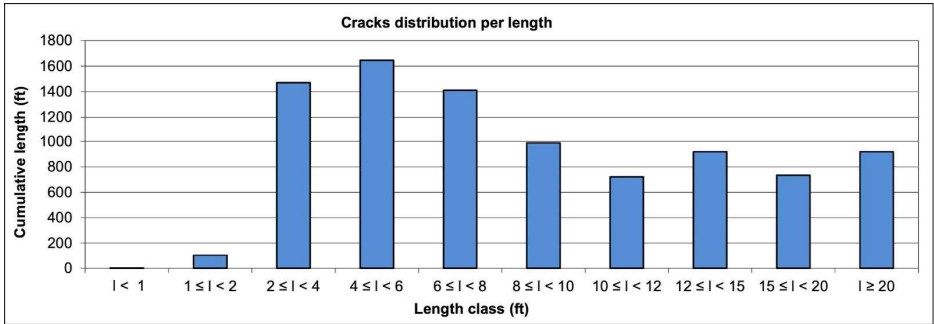
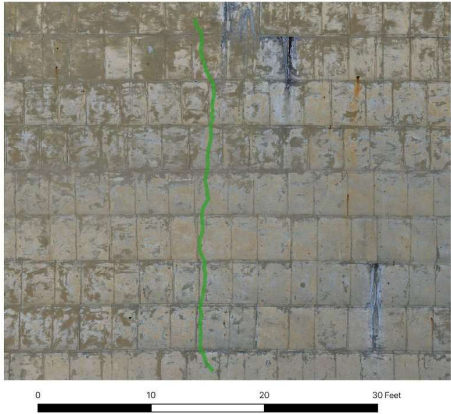
Above, can be seen a closeup of the longest crack, along with its location in relation to the structure.

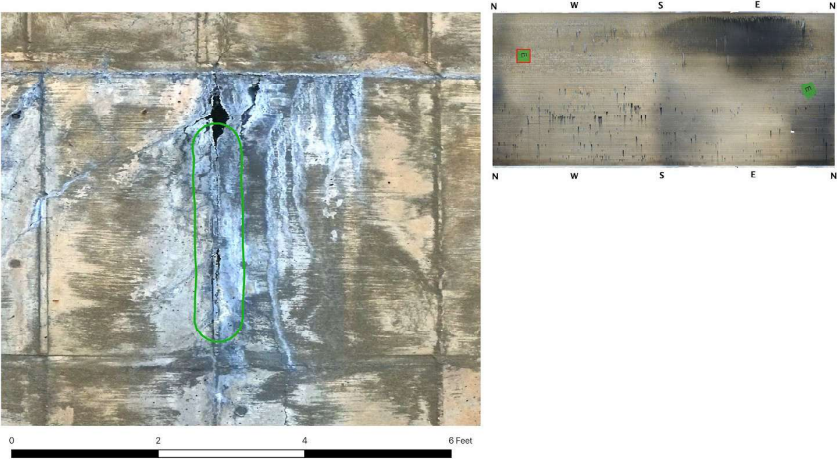
Closeup of widest crack along with georeference

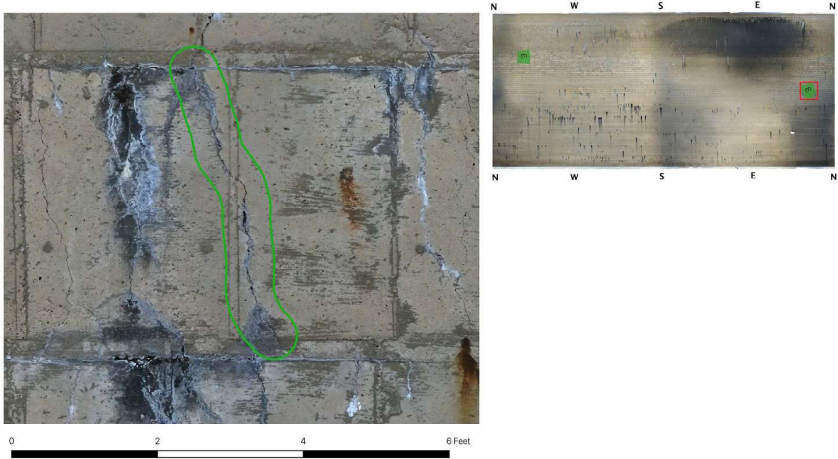
Closeup of second widest crack along with georeference

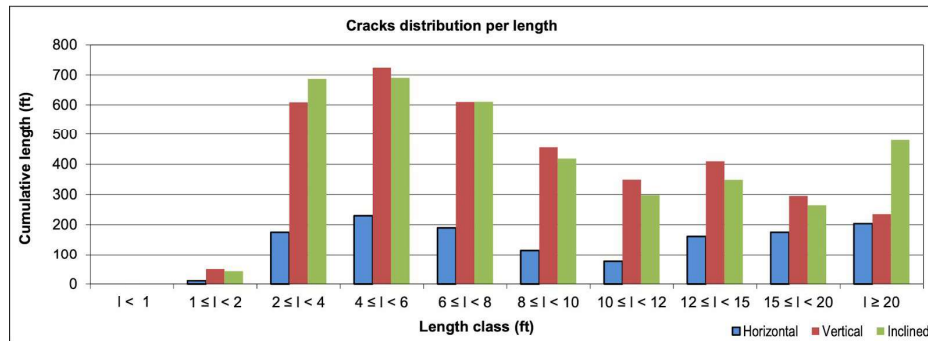
6.3. Seepage and efflorescence

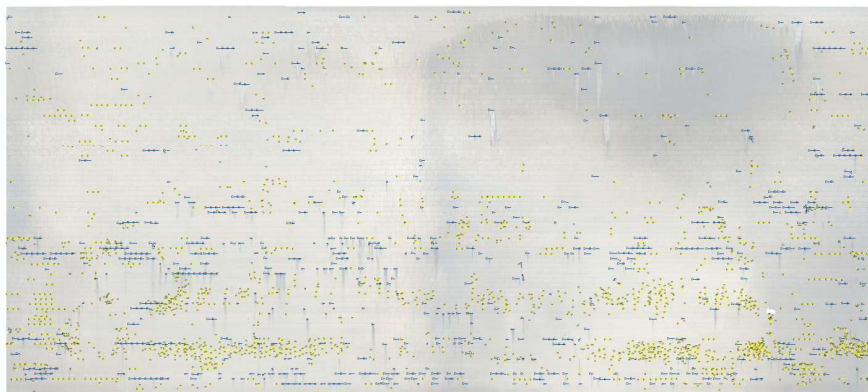
Distribution of seepage and efflorescence N - W - S - E - N (left to right)

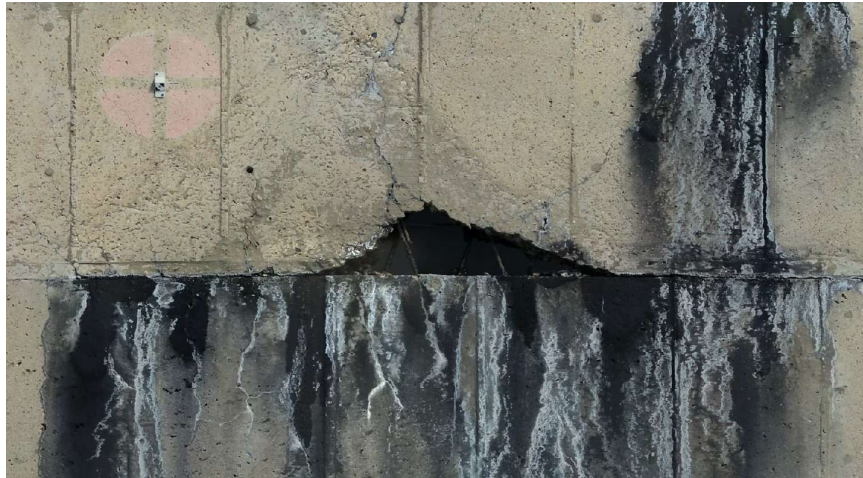
Hole (4 ft width x 1 ft height)

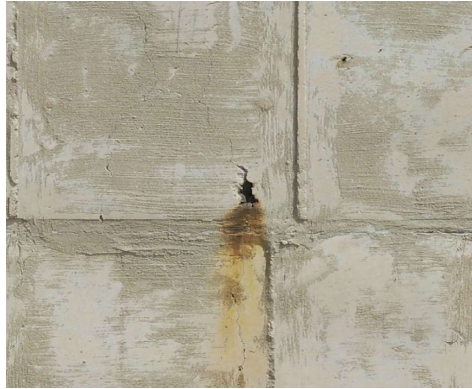
Hole (0.14 ft width x 0.28 ft height)

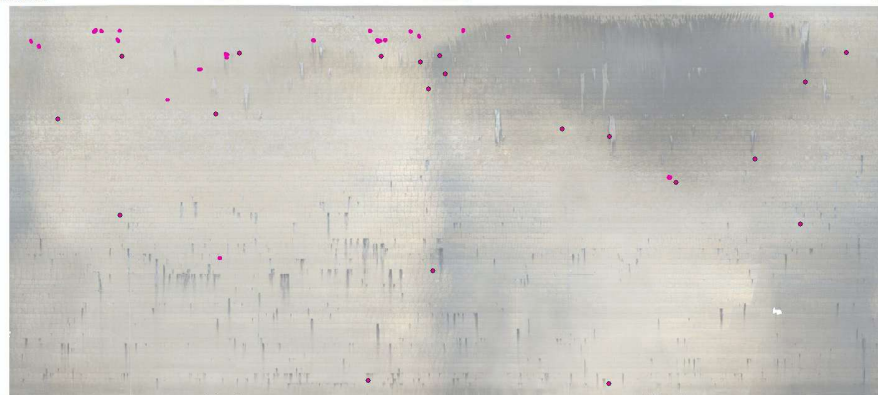
Defects with falling risk N - W - S - E - N

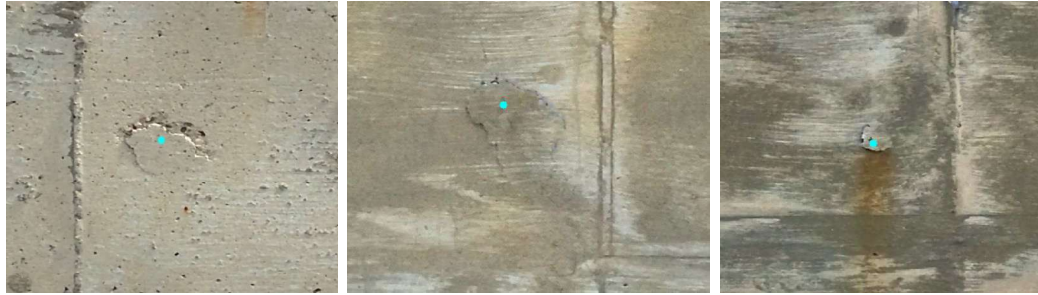
Defects with falling risk

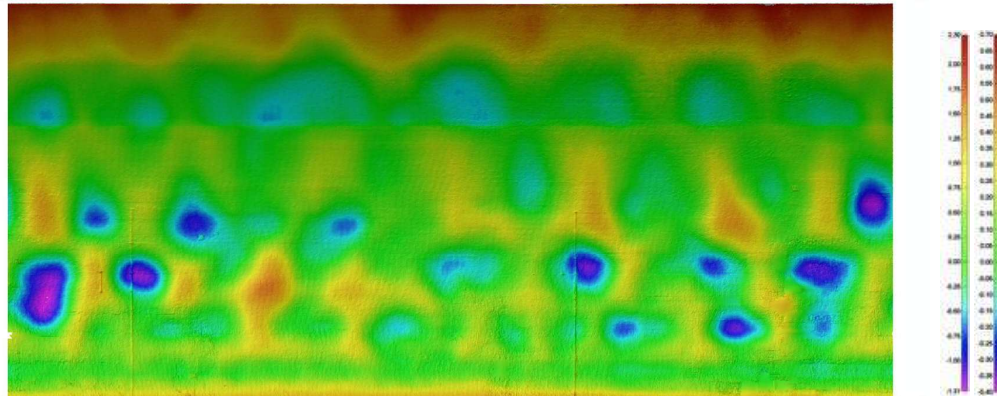
Cylindrical unwrapping of the distortions (scale in foot (left) and meters (right))
N - W - S - E - N

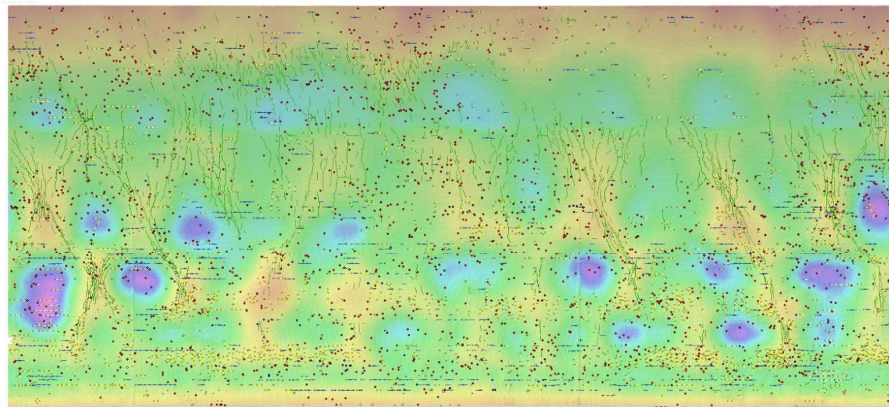
It is now possible to overlay the visual defects of the shell with the geometrical distortions of the shell:

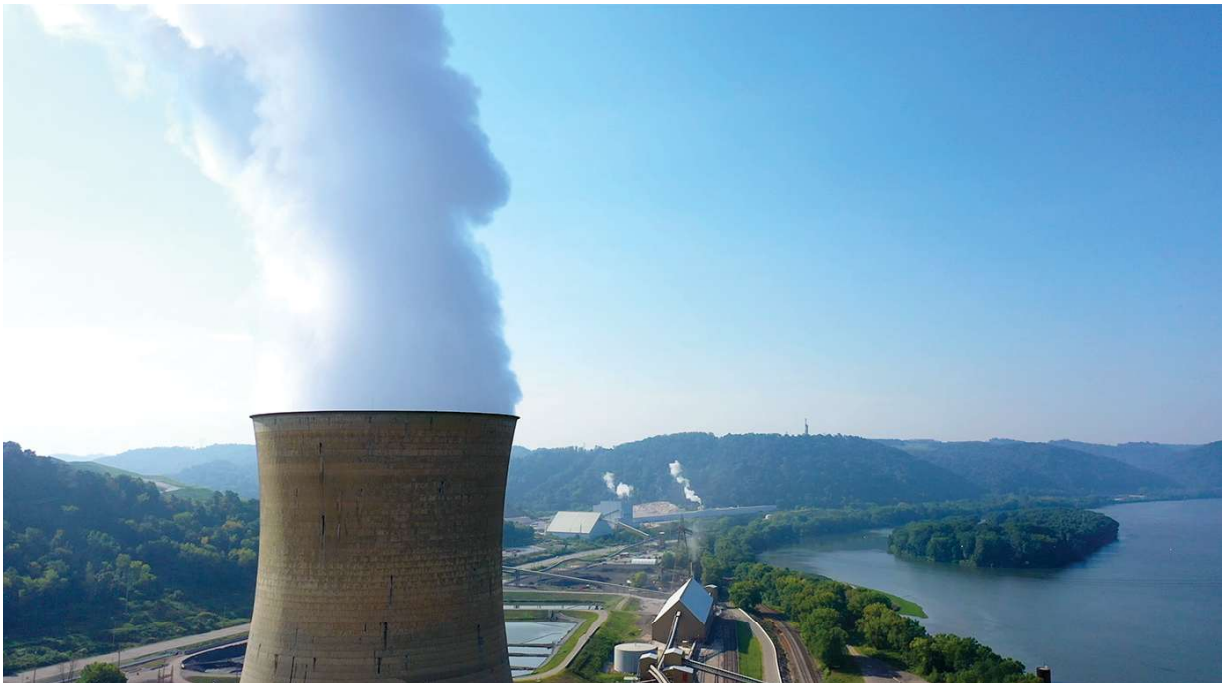
Appendix 2 - Table of defects
