RE: **Case No. 2025-00027**

**Verified Response of Kentucky Power Company to the Commission’s February 12, 2025
Order and Motion to Dismiss**

51 Woodland Way, Grayson

Summary of Voltage Issue Investigation

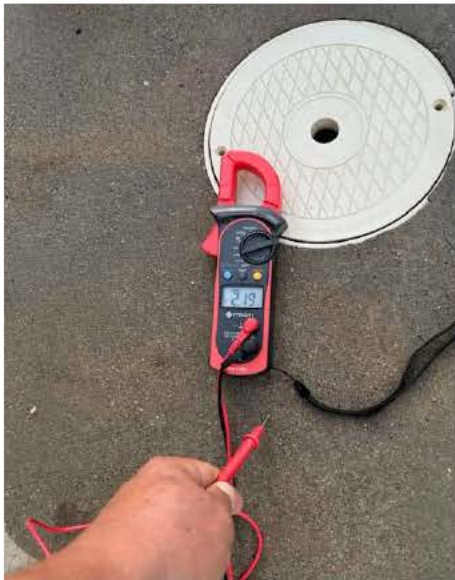
After Kentucky Power departed from the September 3, 2024 visit to the Peterman residence, Mr. Peterson again reported stray voltage in the in-ground pool and provided Kentucky Power with a photograph that purported to show his multi-meter reading 2.19 volts at the pool. However, the metadata on the photograph shows that the photograph was taken in February 2024 and not on September 3, 2024. Nonetheless, Kentucky Power again visited the Peterman residence on September 12, 2024 to perform additional inspections at Mr. Peterson's request, as detailed in the after-action report filed as Exhibit 1.

Customer sent me this picture at 8 pm. I checked the date on the picture and this was taken February of this year.

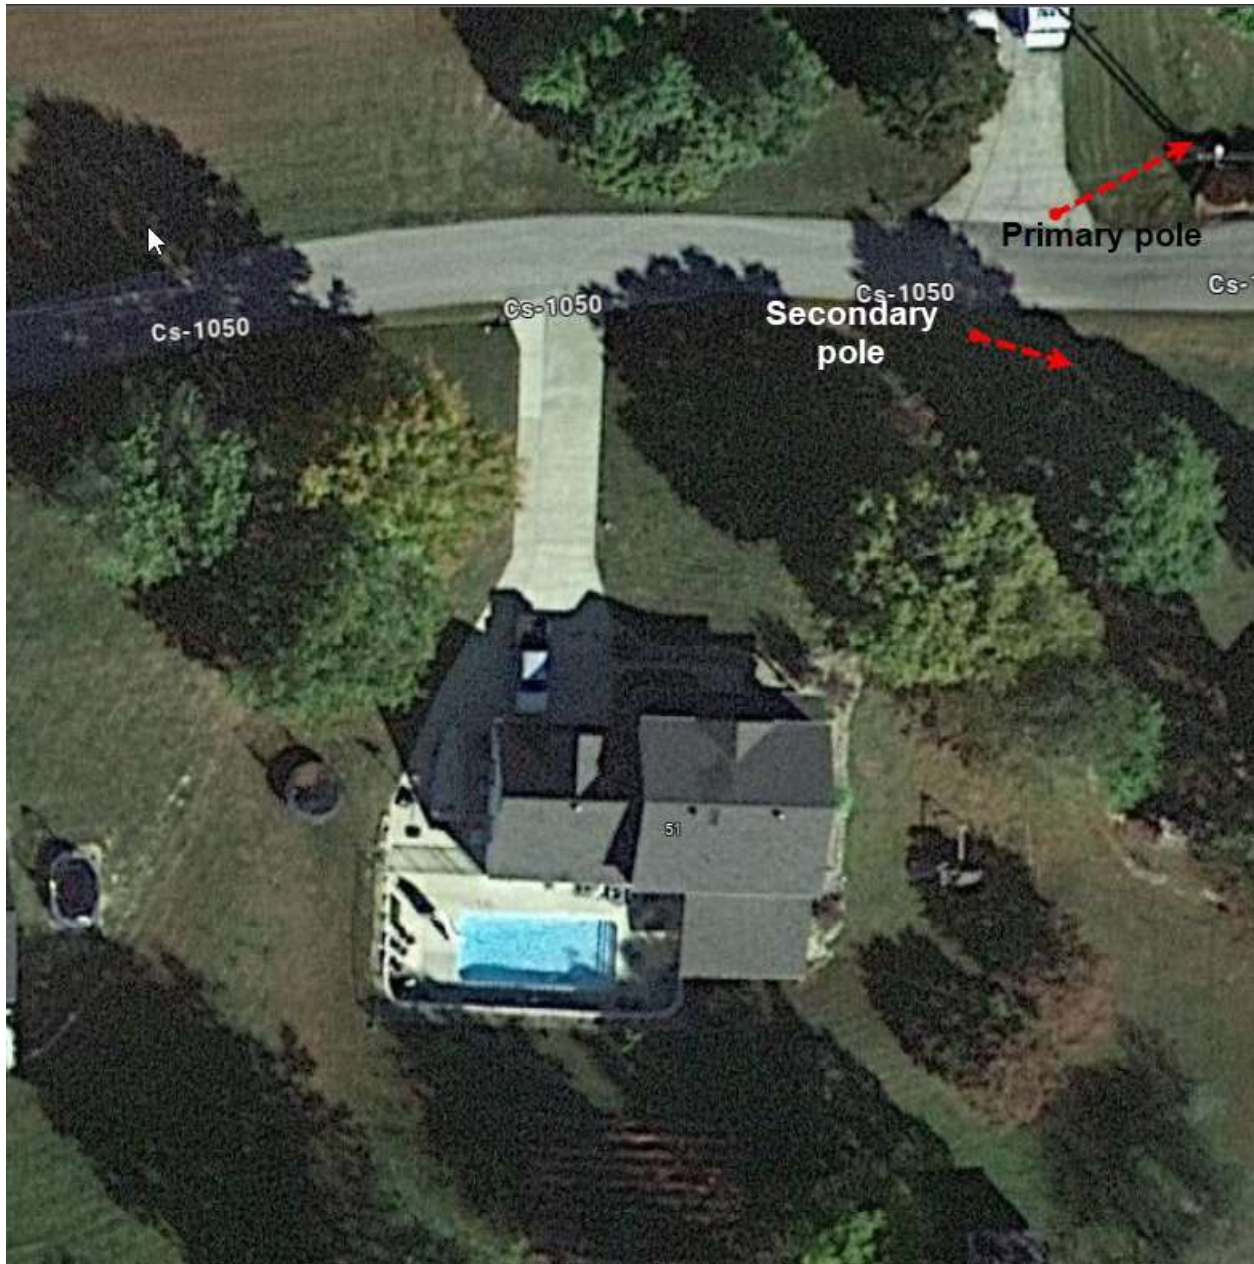
1. Customer's Report:
<ul style="list-style-type: none">The customer reported that the pool continued to show voltage on the same night of our last visit.
2. Testing Conducted:
<ul style="list-style-type: none">We performed additional testing, including:<ul style="list-style-type: none">Ground Wire Assessment: We squeezed the ground wires together on the grounding rod located behind the pool pump and heating/cooling units. The resistance measurements ranged from 500 ohms to 1500 ohms.Circuit Breaker Panel Testing: Travis tested the ground in the circuit breaker (CB) panel and observed loop current present on the ground inside the panel.
3. Voltage Verification:
<ul style="list-style-type: none">Despite thorough testing, we were unable to locate any sources of voltage close to the 2.19 volts noted in the picture provided by the customer.

- Recommend the customer monitor the situation and report any changes.
- Consider scheduling a follow-up visit if voltage issues persist or if additional concerns arise.
