**ASSESSMENT OF
ELECTRIC UTILITIES RESPONSE
TO THE
FEBRUARY 2003 ICE STORM**

**BY
THE KENTUCKY PUBLIC SERVICE COMMISSION
FEBRUARY 6, 2004**

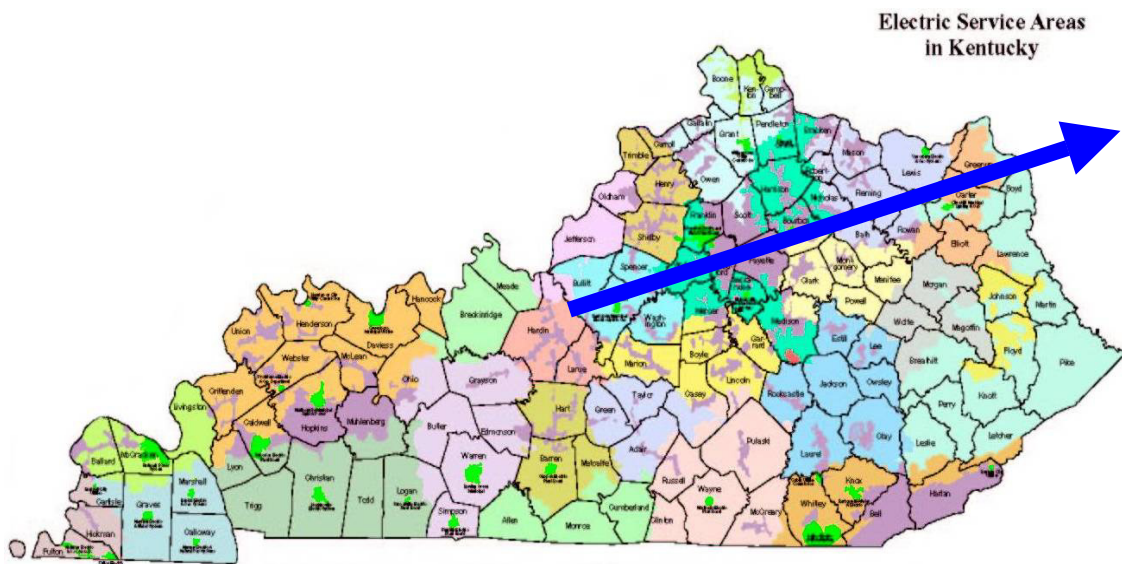
FIGURE 1: February 15 & 16 Ice Storm Track Across Kentucky

The storm’s path crossed central Kentucky during the late night hours of February 15, 2003. Utility damage was experienced along a line beginning in Hardin County running through Lexington to Ashland and Greenup County. At approximately 10:30 PM the ice started layering onto all exposed surfaces in the Lexington area. Radial ice approximately 2 inches thick was deposited along much of the storm track. The storm was one of the most severe to occur in Kentucky in the last century.

Figure 1 indicates the storm’s path across Kentucky during the late night hours of February 15, 2003. At approximately 10:30 PM, ice started layering onto all exposed surfaces in the Lexington area. Radial ice approximately 2 inches thick was deposited along much of the storm track.

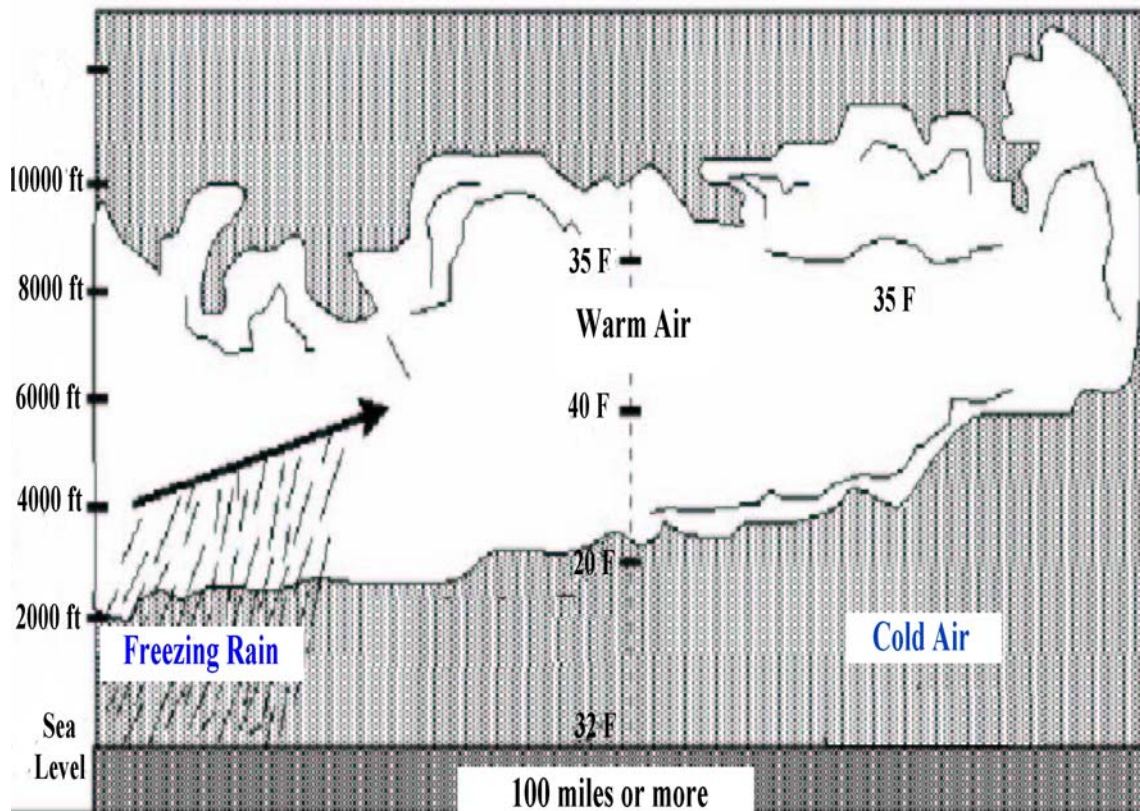
FIGURE 2: Ice-Producing “Inversion Front” (NOAA)

Kentucky quickly discovered that super cooled rain falling on cold surfaces quickly creates extreme conditions. Here is a portion of WLEX-TV Chief Meteorologist Bill Meck's explanation of the 2003 Valentine's weekend storm: "*For a freezing rainstorm, Mother Nature does things backwards. It is warmer in the clouds than down at the ground. This is called an inversion.*" See **FIGURE 2; next page**.

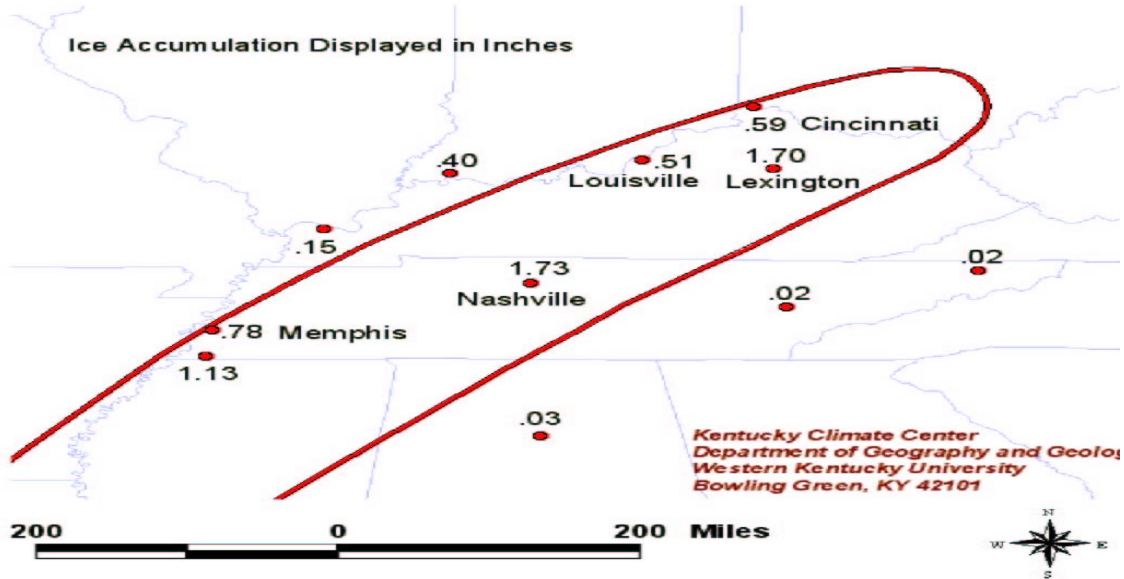
FIGURE 3: Area Affected by the “Great Ice Storm of 1951”

This storm was referred to by many in Kentucky as the “ice storm of the century”. However, it was only slightly more severe than other ice storms that have devastated the state on several occasions over the past century. In 1951 Kentucky experienced an ice storm of a magnitude approaching that of the February 2003 storm.

Following is a pictorial representation of the accumulated ice from the so-called “Great Ice Storm of 1951”. See **FIGURE 3**.

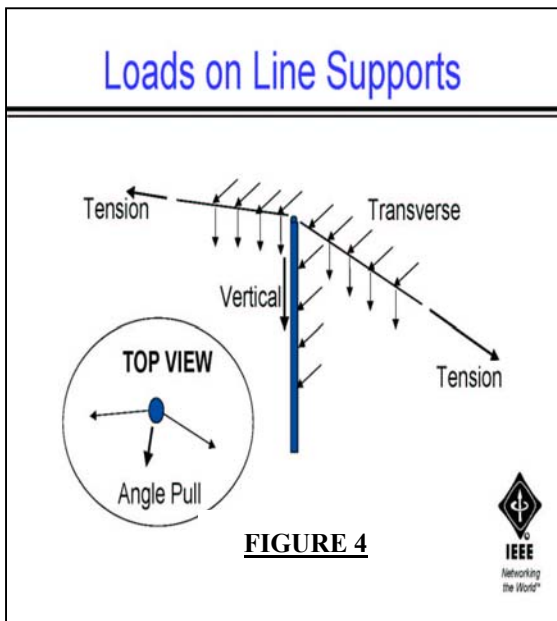
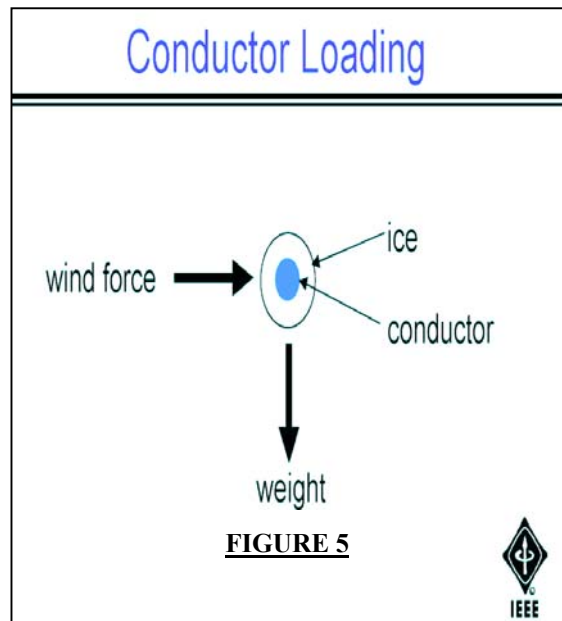
These dramatic load increases are transferred through to the poles, guy wires and anchors causing them to possibly fail. See FIGURES 4 and 5.

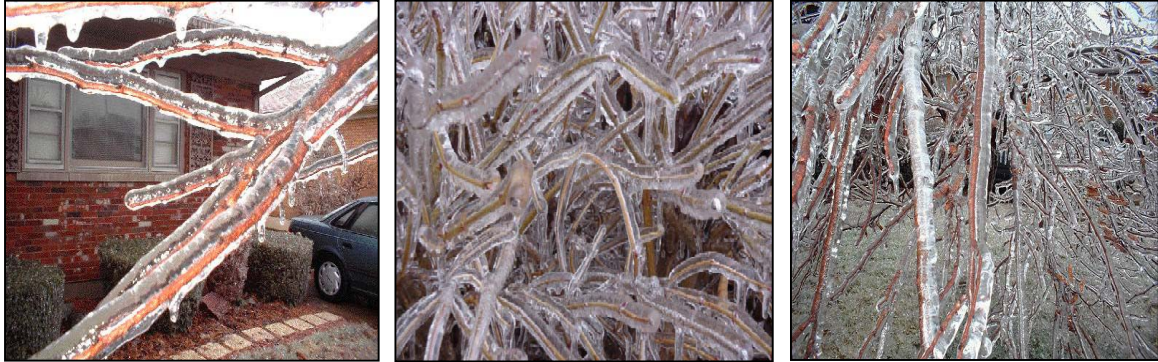
PHOTOS 4, 5 and 6: Ice Loading on Trees and Limbs

The percentage increase in the weight of tree limbs can be even more drastic due to the complexity of limb patterns that allow ice to build up more as a mass than as individual limbs. See **PHOTOS 4, 5 and 6**.

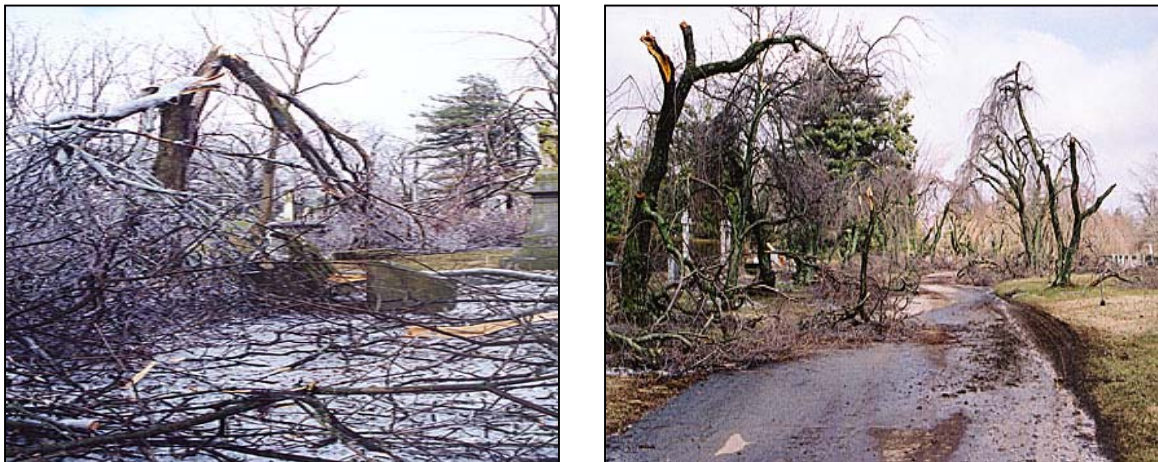
PHOTOS 7 and 8: Trees Damaged by Weight of Ice – Lexington, KY

During ice storms, super cooled rain falls and freezes on contact with surfaces at or below the freezing point. Ice accumulation generally ranges between traces to 1 inch in additional diameter. Accumulations of 1-inch radial ice on trees can increase branch weight by a factor of as much as 30. Accumulations of between 1/4 inch and 1/2 inch can break small branches and faulty limbs, while 1/2 inch to 1-inch thick accumulations can

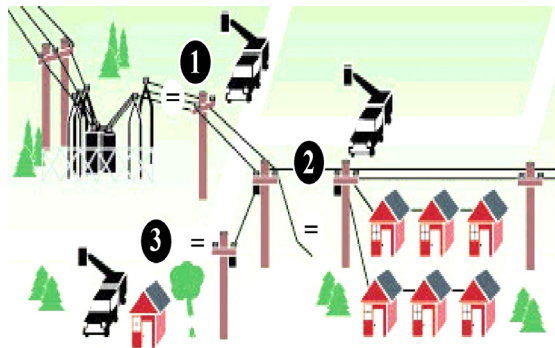
3. Crews will next make repairs to smaller tap lines. Making repairs to this tap line will restore power to individual homes.
4. After tap lines are repaired, crews will focus attention on making repairs to individual service lines that run from a pole to a member's meter. Individual repairs affecting a single member usually come after other problems are addressed because the utility will generally prioritize outages affecting the largest number of members first. This can be frustrating for a member to see his neighbors' power restored while a crew passes by his house, but often a repair that restores power to a single member can take as long as one that brings power back to an entire street or subdivision, which is why outages are often addressed in terms of number of members affected. See (3) in graphic at left.

In any outage, the first priority is to get the greatest number of people back on line as quickly as possible. That's why electric utilities follow a sequence of repairs that restores power to large groups of consumers before tackling smaller groups and individual consumers. This fictitious example details a typical repair sequence.

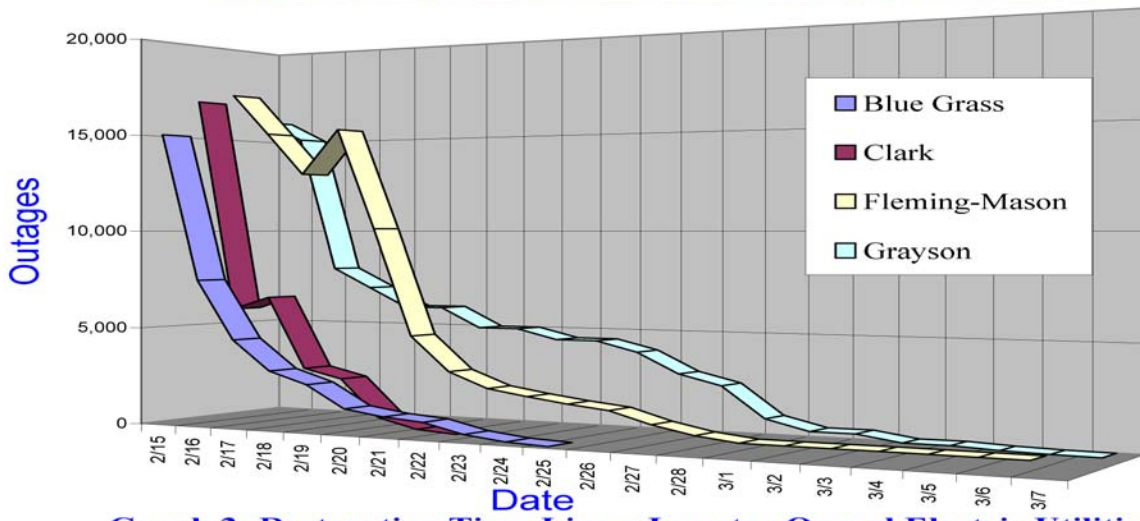
Graph 2: Restoration Time-Line ~ Electric Cooperatives

GRAPHS 2, 3 and 4; page 15 depict the restoration timelines for the utilities most seriously affected by the ice storm. Of note is the increase in number of outages reported on the Alltel timeline during the first week following the storm. **See GRAPH 4; page 16.** This rise in outages, while electric

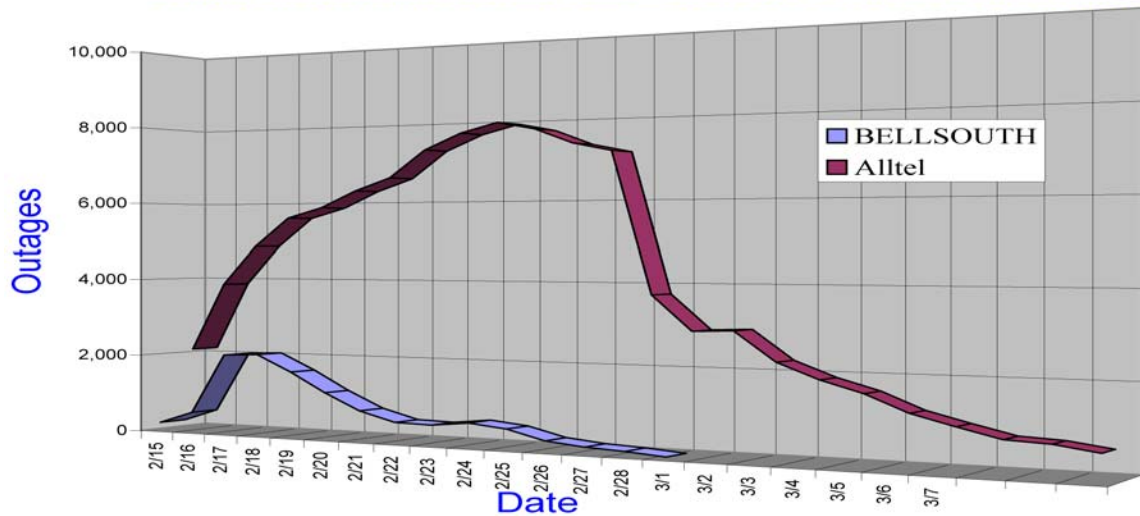
Graph 4: Restoration Time-Line ~ Investor Owned Phone Utilities

outage numbers were decreasing, is attributable to several factors. Primarily, the increases are due to the fact that telephone repair crews usually had to wait until damaged areas were cleared of downed electrical lines in order to insure the safety of their workers making repairs. Secondly, many customers left their homes when it became obvious that electric service might not be restored for days or even weeks in some cases. As more electrical services was restored and customers returned to their homes, more telephone service outages were reported to Alltel. Notifications leveled off approximately 10 days after the storm occurred. Telephone service restorations began to increase a few days afterward. Also noticeable is the brief increase in electric customers out on the Fleming-Mason timeline seen in **GRAPH 2; page 15.** This was attributed to ice melting from lines and limbs causing additional outages as the falling ice initiated contact between the energized and neutral conductors.

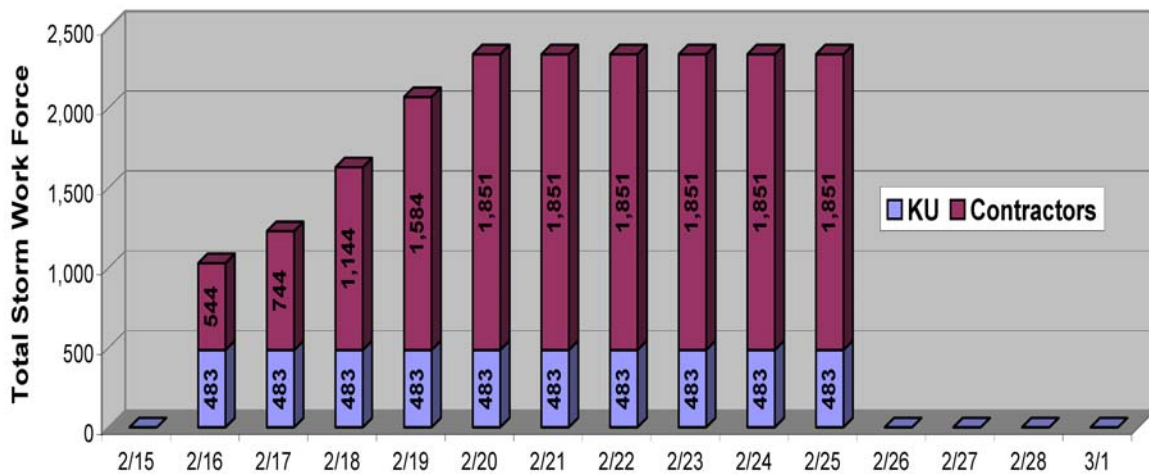
GRAPH 6: KU Work Force Timeline for Storm Restoration

GRAPH 6 shows the number of employees and contractors responding to the restoration work for each day of the storm and subsequent restoration period. KU and LG&E had 483 employees working as linemen, support personnel, tree trimmers, safety supervisors, contract coordinators, communicators, coordinators and logistics to provide restoration of the electrical system. KU is a member of the Edison Institute (EI) Mutual Aid Organization. The Mutual Aid Organization was established so that utilities can assist each other with storm restoration by providing skilled workers familiar with electrical system characteristics to restore structural damage to the utility’s facilities.

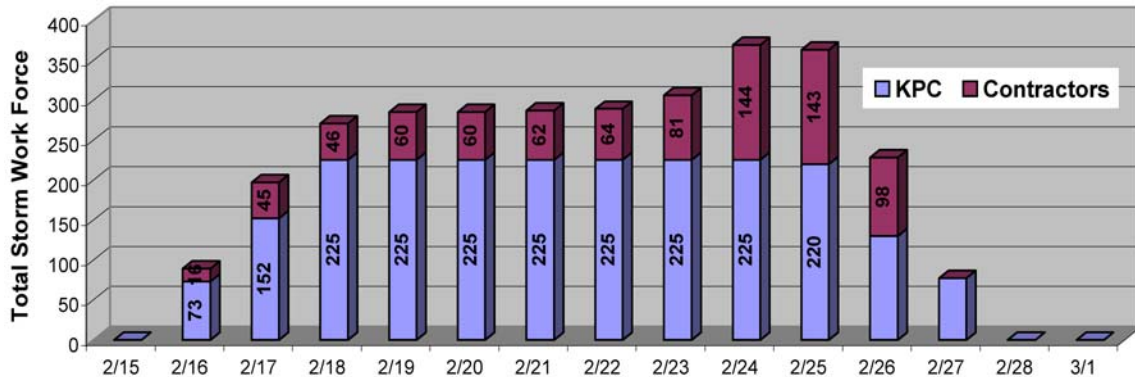
GRAPH 7: KPC Work Force Timeline for Storm Restoration

During the period beginning Sunday, February 16 and Thursday, February 27 KPC replaced 275 poles and 93 transformers. KPC reports that the storm resulted in 1,521,929 consumer-hours of interruption and that its cost incurred for restoration activities was \$6.6 million. The cost per consumer-hour of interruption was \$4.34.

Kentucky Power Company’s restoration efforts were slowed by the duration of the storm and falling ice and rebounding trees as the ice melted. **Graph 8** shows the net number of customers restored to service, as customers were restored others lost service.

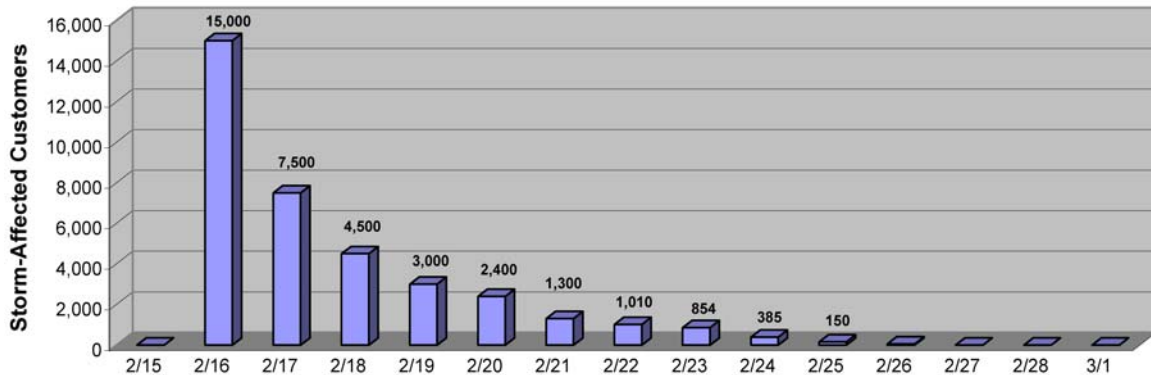
GRAPH 9: Timeline of BGEC Outage Restoration

During the period from Sunday, February 16 to Thursday, February 28, BGEC reported replacing 165 poles and 53 transformers. About one-third of the BGEC system was affected by the storm. BGEC reported that the storm resulted in 849,196 consumer-hours of interruption and that its cost incurred for restoration activities was \$1.64 million, or \$1.93 per consumer-hour of interruption.

BGEC’s restoration efforts were slowed by the duration of the storm, falling ice, and rebounding trees as the ice melted. Much of its system is in rural areas that are not easily accessible by road. The saturated ground made access to its facilities difficult and time consuming.

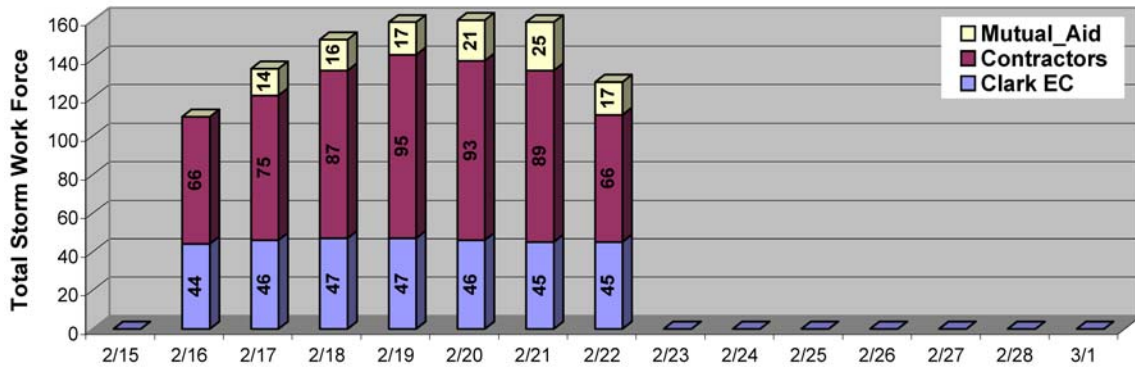
GRAPH 10: Clark Energy Work Force Timeline for Storm Restoration

During the period beginning Sunday, February 16 to Thursday, February 22 Clark replaced 74 poles and about 75 transformers. Clark estimates that the storm resulted in 272,161 consumer-hours of interruption and that its cost incurred for restoration activities was \$713,150, or \$2.62 per consumer-hour of interruption.

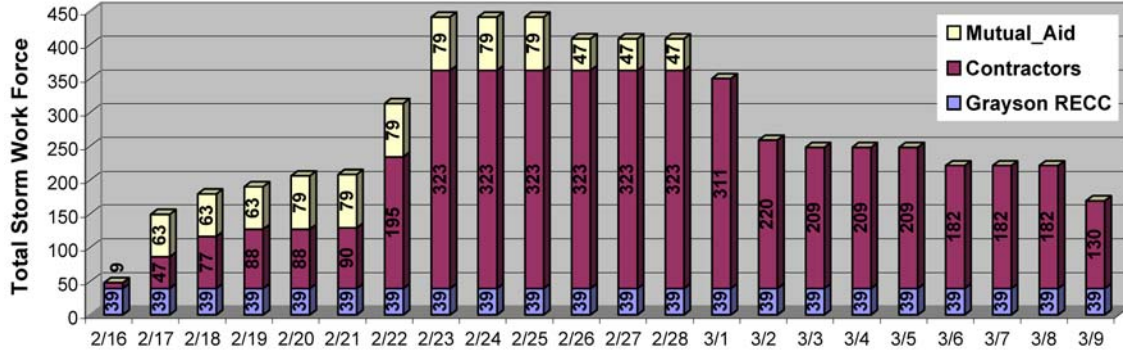
GRAPH 12: Grayson RECC Work Force Timeline for Storm Restoration

During the period from Sunday, February 16, to Thursday, February 22, Grayson replaced over 800 poles.

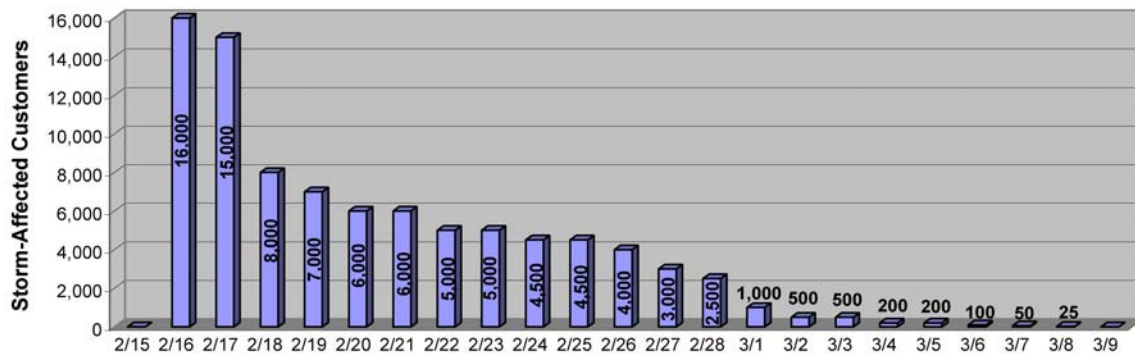
GRAPH 13: Timeline of Grayson RECC Energy Outage Restoration

Grayson’s restoration efforts were slowed by the condition of the roads, the duration of the storm, and falling ice and rebounding trees as the ice melted. Grayson also did not have access to all of the contract labor that it could have used. Grayson reported that it has had no reason in recent years to form relationships with contractors outside of the few that routinely do work for them. Other contractors were obligated to serve the utilities with which they have current contractual relationships. **GRAPH 13** shows the net customers restored to service, as customers were restored others lost service.

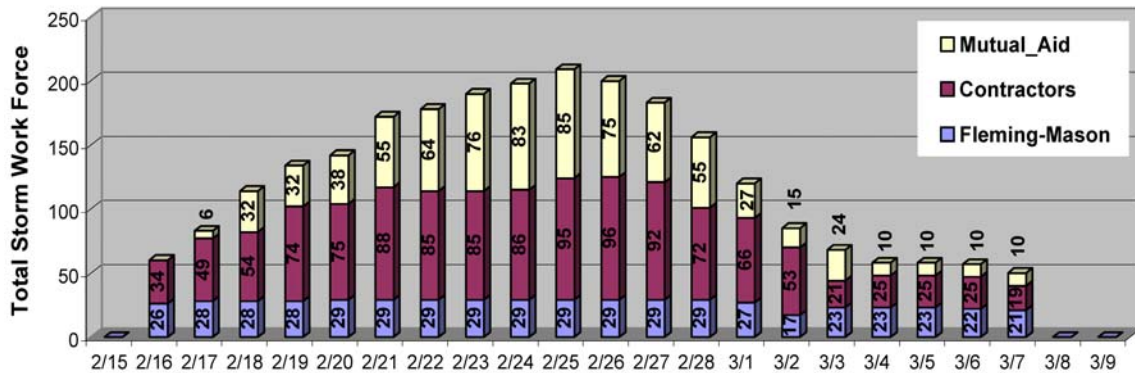
GRAPH 14: Fleming-Mason Energy Work Force Timeline for Storm Restoration

During the period from Sunday, February 16, to March 7, Fleming-Mason replaced 397 poles and 151 transformers. Fleming-Mason estimated that the storm resulted in 1,806,950 consumer-hours of interruption and that its cost incurred for restoration activities was \$ 2,493,591, or \$1.38 per consumer-hour of interruption.

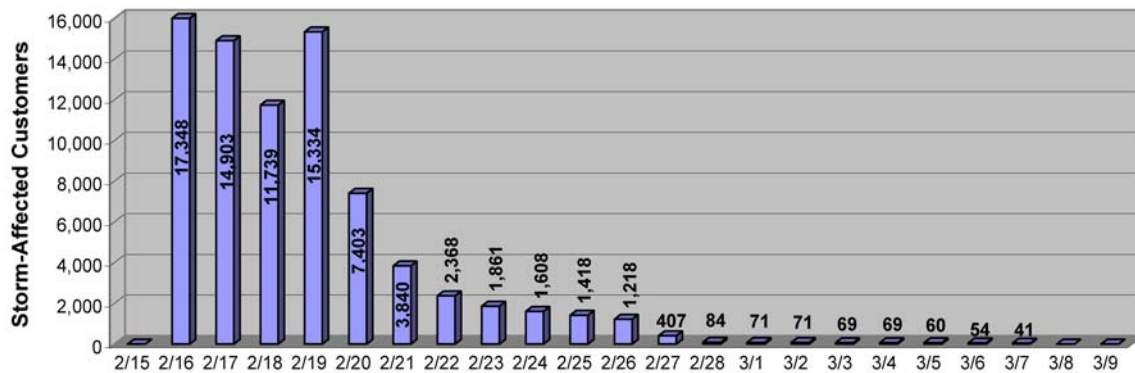
GRAPH 15: Timeline of Fleming-Mason Energy Outage Restoration

Fleming-Mason’s restoration efforts were slowed by the duration of the storm and falling ice and rebounding trees as the ice melted. Fleming-Mason suffered damage in each of the 8 counties it serves. **GRAPH 15** shows the net customers restored to service, as customers were restored others lost service.

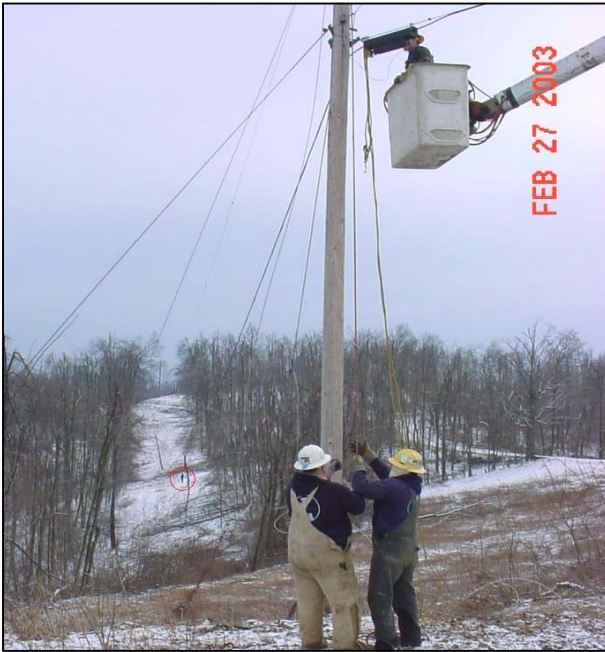
PHOTO 13: Lewis County, KY ~ Pike Contractor and Grayson Crew... Note Lineman in Distant R/W

Rural areas of Lewis, Carter, Fleming, and Greenup counties were some of the last to be restored (**APPENDIX N6 / O6; Fleming-Mason Energy and APPENDIX N7 / O7; Grayson RECC**) due to the remote nature of some of the lines in those areas. **PHOTO 13** shows a repair crew in rural Lewis County following the ice storm. Hours of work in such areas may result in only a few homes being restored. This is typical of many Rural Electric Co-op (“RECC”) and rural areas of Investor Owned Utilities (KU, AEP, etc.) in the state.

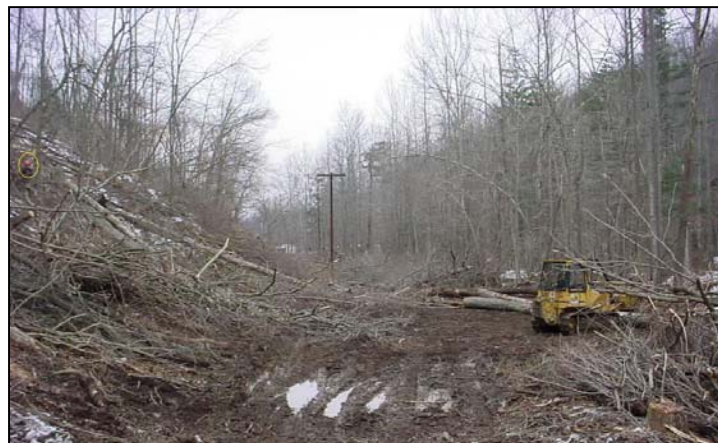
To combat these challenges, crews used a variety of non-conventional methods to gain access to remote work areas. Bulldozers were used to clear R/W’s and pull trucks in and out of fields. Bulldozers also aided some areas in clearing or even establishing new R/W’s. **PHOTO 14** shows an example of this from Lewis County during the days of restoration work following the storm. Other vehicles like 4-wheelers

PHOTO 14: Lewis County, KY ~ Bulldozer Clearing R/W

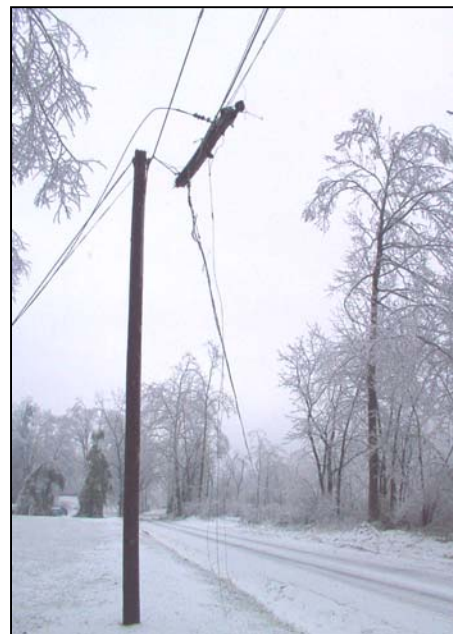
PHOTO 20: Pole Broken at Point of Joint Attachment by possible improper loading

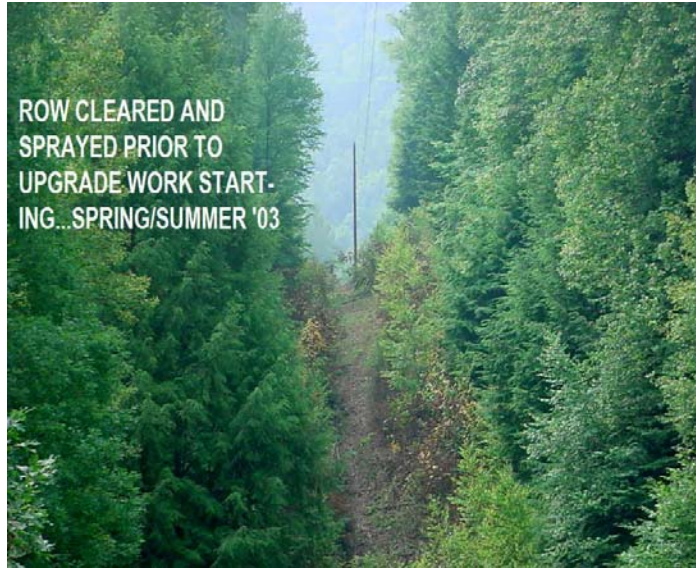
Photo 23: Narrow R/W

Trimmed R/W widths differ throughout the state. There is currently no “standard” cut width mandated by Kentucky law or by NESC codes. Typical best practices place three-phase lines at 40-foot widths and single-phase lines in 30-foot wide R/W's. Some variety in cutting practices is based on company VM policies, geography / terrain, easement widths, line voltages, property owner issues, etc. **PHOTOS 23 and 24** depicts the varied width of

two separate single-phase lines. In **PHOTO 23**, the line crosses a heavily wooded and hilly section. Line clearance in these areas is more time-consuming and costly to the utility. **PHOTO 24** has a line that was trimmed on the upper side to help prevent some of the trees from falling into the line. But even with a 40-foot horizontal clearance, some trees could still fall into the line. It is not practical for any further trim clearance on such a line, yet the potential for damage still exists.

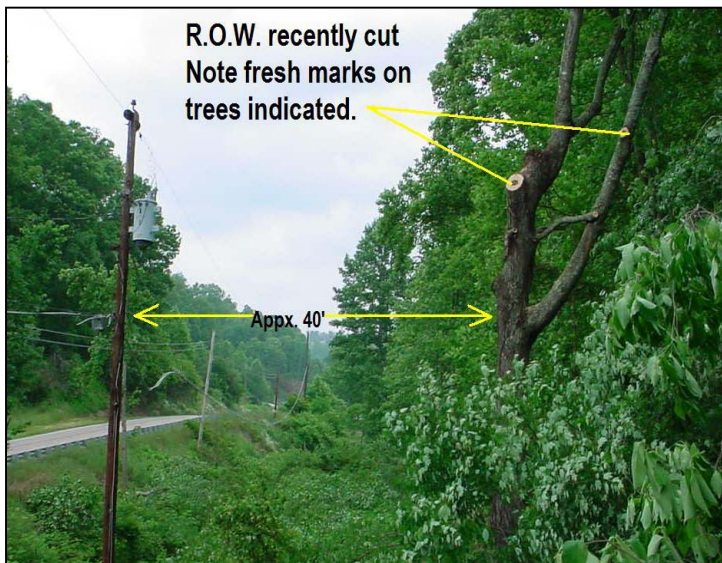
PHOTO 24: Recently Trimmed R/W

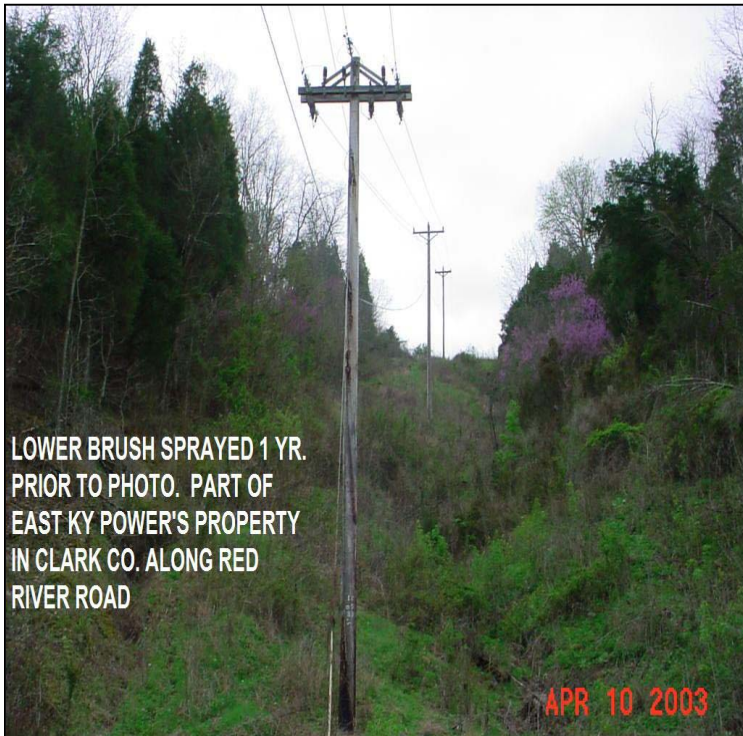
Most VM programs include herbicide spray applications to areas following a trimming. This allows the vegetation's growth to be limited, thus lessening the need for future trimming. An additional benefit of spraying is a more accessible R/W for maintenance and repair purposes. **PHOTO 25** shows R/W that was recently trimmed and sprayed. Underbrush and smaller vegetation is minimized with properly applied sprays and chemical treatments. Spray treatments are somewhat limited in their use due to environmental concerns and precautions. Rural areas away from streams and creeks are the most likely places to have the full benefit of herbicide treatments.

PHOTO 25: Benefits of Herbicide Treatment

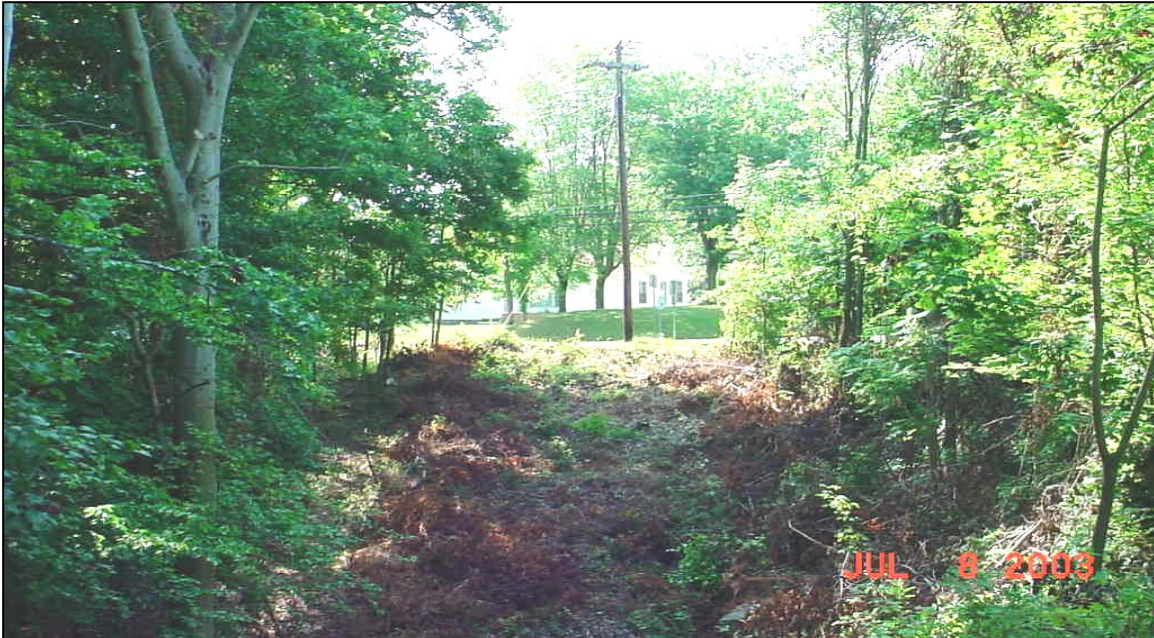
R/W accessibility can benefit a utility in a number of ways. Quicker restoration times, more thorough line inspections, and more efficient future R/W trims are all potential improvements garnered from maintaining cleared ground R/W's where possible. Trimming practices also enhance the future accessibility of clear R/W's. By not throwing cut brush in the R/W, tree trimmers allow a more accessible and workable R/W. Some utilities include this provision in their VM plans. For example, *"All brush and wood will be left at the side of the right-of-way or chipped..."*. **PHOTO 26**

shows a R/W where there has been some effort made to remove the cut limbs and brush. Bush-hogging the ground under a R/W is also a common practice to maintain accessibility where applicable. While some of these practices take extra time and effort initially, those areas that have incorporated such plans into their VM programs reap the benefits of later cost savings and fewer outage hours.

PHOTO 26: Bush-Hogged R/W

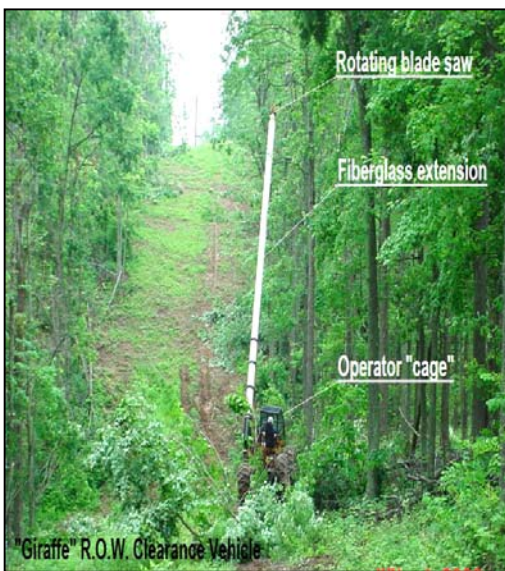
The main tools of the trade are bucket trucks, pruning tools, saws, etc. There is a variety of other equipment available that helps provide accessibility to electric lines needing trimming. See **PHOTOS 27 and 28**. Trucks with robotic arms and helicopters with spinning saw blades are examples of equipment often used to cut areas with limited accessibility. These types of units can be used in remote areas if R/W accessibility allows. Hourly rates for such units are costly, yet will usually be less expensive than climbing, or manual cut crews.

PHOTO 27: “Jarraff” R/W Trimmer

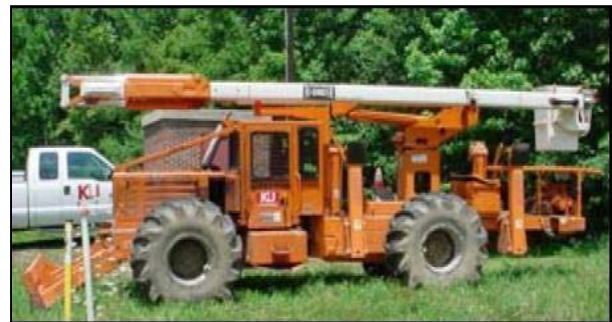
PHOTO 28: “A-Tab” All Wheel Drive

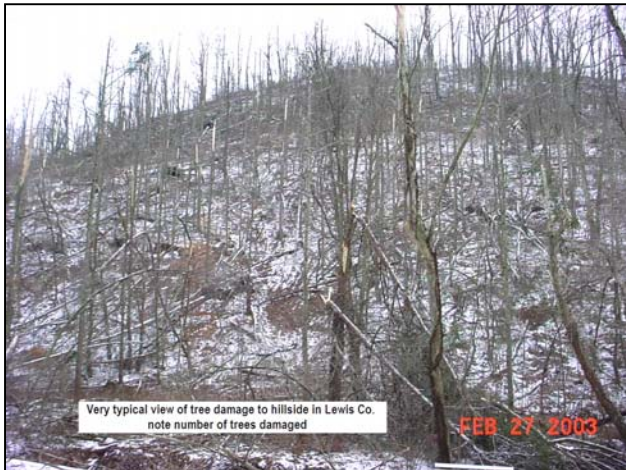
PHOTO 30: Lewis County, KY

Geographically, the Northeastern and Central counties of Kentucky saw the most build-up of ice during the days of February 15-16. A total of 51 counties were declared disaster areas as a result of the ice storm’s damage. Utility line damage was widespread but particularly bad in Lewis, Carter, Greenup, and Fayette counties. **PHOTOS 30 and 31** provide some example of tree damage in Lewis and Fayette counties.

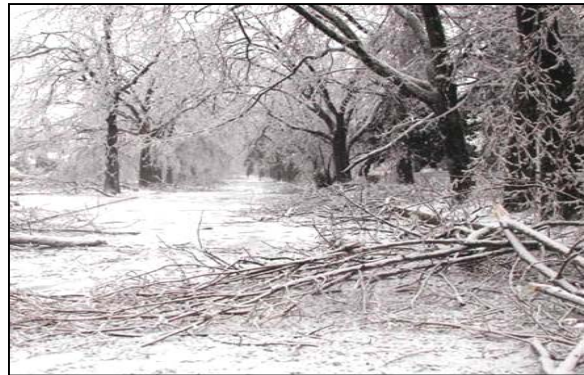
PHOTO 31: Fayette County, KY

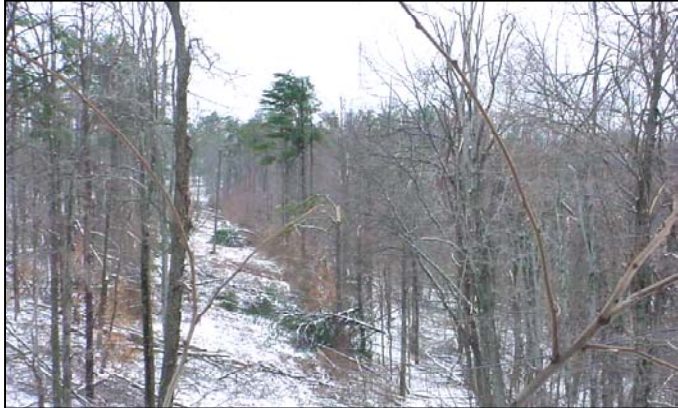
PHOTO 32: Normally Adequate R/W Wasn't Enough to Ward Off Devastation Inflicted by this Ice Storm

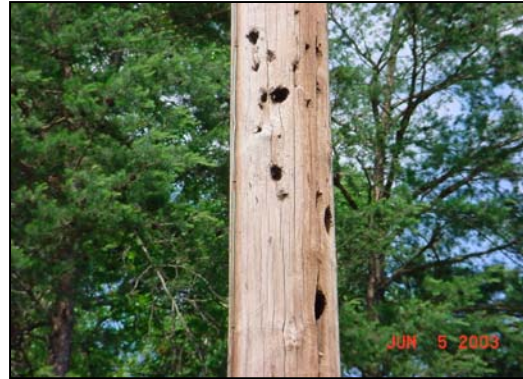
PHOTO 33: Wood Pecker Holes Limit the Strength and Shorten the Life of Wood Poles

4. A below-ground-line pole inspection and treatment program should be ongoing at the industry recommended interval.
5. A program to replace all excessively aged and/or damaged conductors is highly recommended.

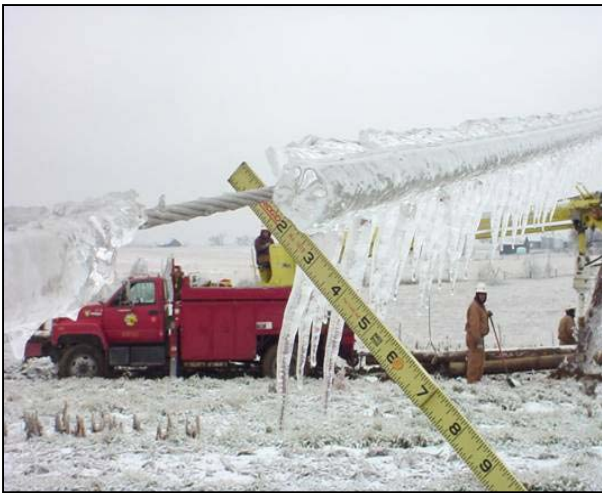
PHOTO 34: Ice Accumulation on #2ACSR Wire Near Lexington, KY

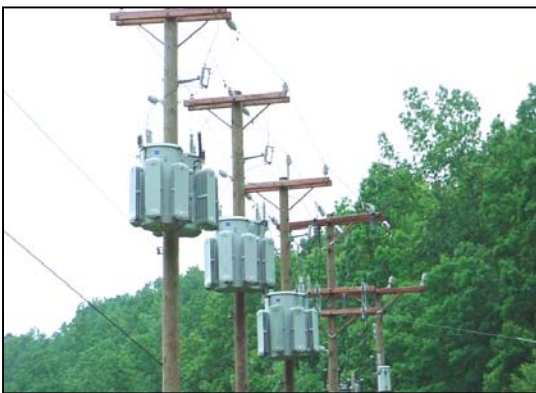
Pole-mounted electrical equipment generally consists of metal tanks filled with oil. Examples of these devices include transformers, reclosers, capacitors, regulators, switchgear, etc. See **PHOTOS 35 and 36**. Each type of apparatus has its own maintenance schedule and operating criteria. Line reclosers and/or sectionalizing devices are often temporarily removed from service in order to perform maintenance. Other pieces of equipment such as transformers are merely visually inspected on a regular basis.

PHOTO 35: 34.5 x 12.4 kV Transformers

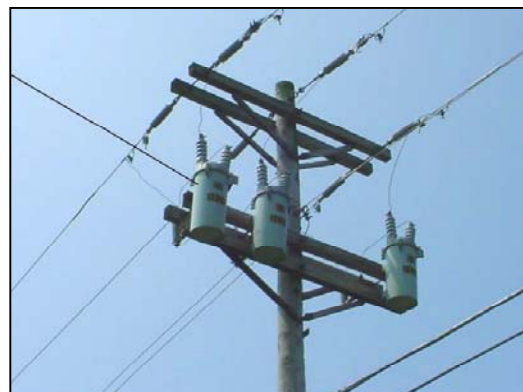
PHOTO 36: Reclosers

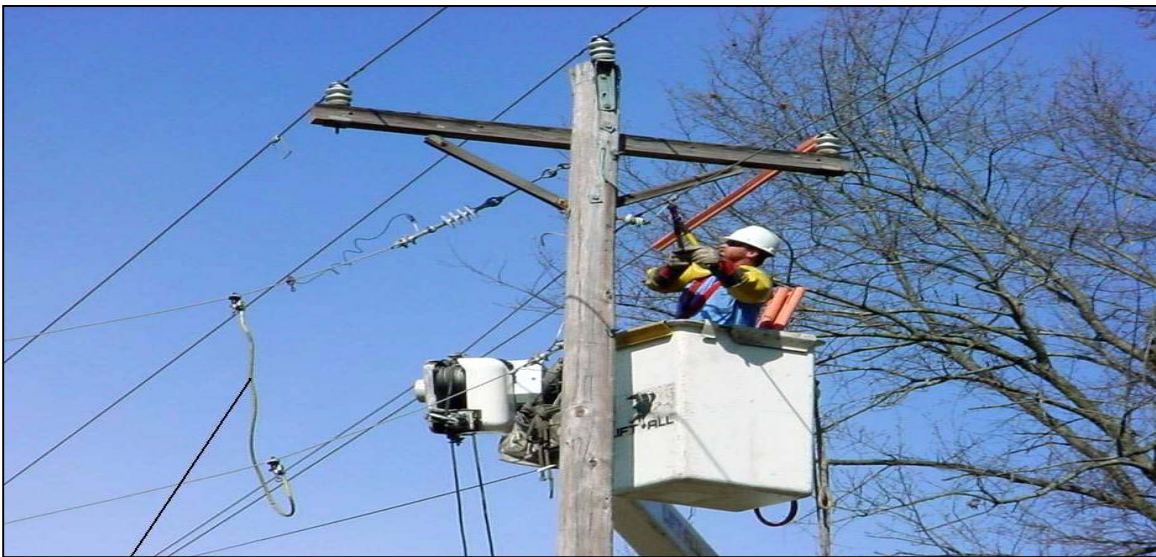
PHOTO 37: Three-Phase Distribution Pole and Hardware (insulators, cross-arm & braces, insulators & brackets, conductors, bolts, etc.)

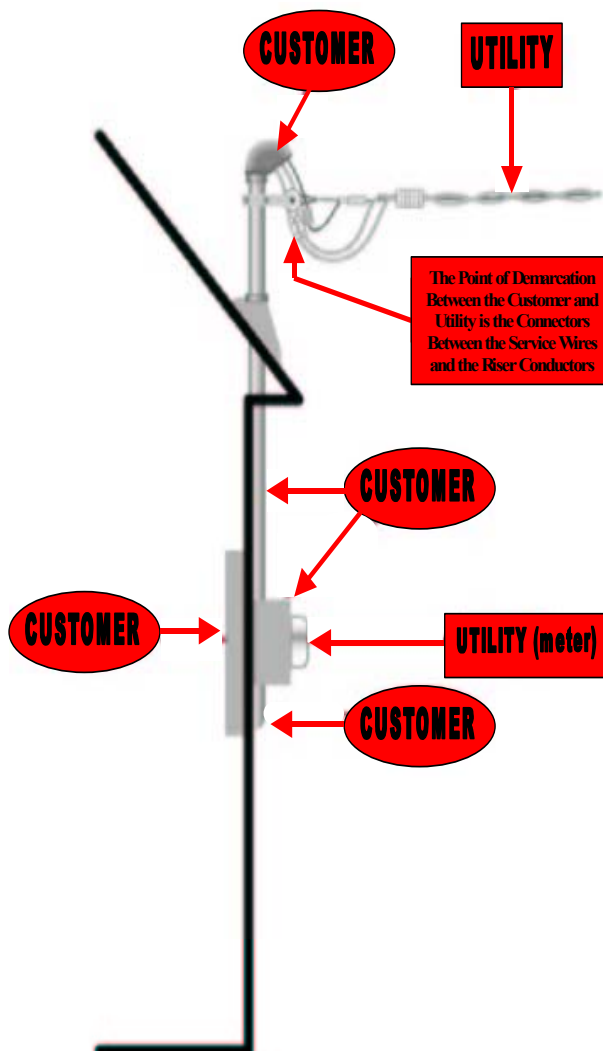
FIGURE 10: This sketch depicts a typical home or building electrical entrance indicating the ownership and responsible parties for various portions of the electrical service, meter and base. Misunderstanding in regard to the repair process and procedures led to timely and expensive undertakings by many homeowners. The customer equipment, wiring and installation must meet the National Electrical Code (“NEC”) while the electric and telephone utility equipment, wiring and installation must meet the National Electrical Safety Code (“NESC”).
