COMMONWEALTH OF KENTUCKY  
BEFORE THE PUBLIC SERVICE COMMISSION

KENTUCKY POWER COMPANY	)	
_____	)	CASE NO.
	)	2010-00317
ALLEGED FAILURE TO COMPLY WITH	)	
KRS 278.042	)

**INCIDENT INVESTIGATION**  
**STAFF REPORT COMPILED – 10/29/2009**  
 Incident Location: Hueysville, Kentucky (Floyd County)  
 Incident Date: June 15, 2009  
 PSC Investigator: Jeff Moore  
 Utility: AEP/Kentucky Power  
 Injured: William Wolf

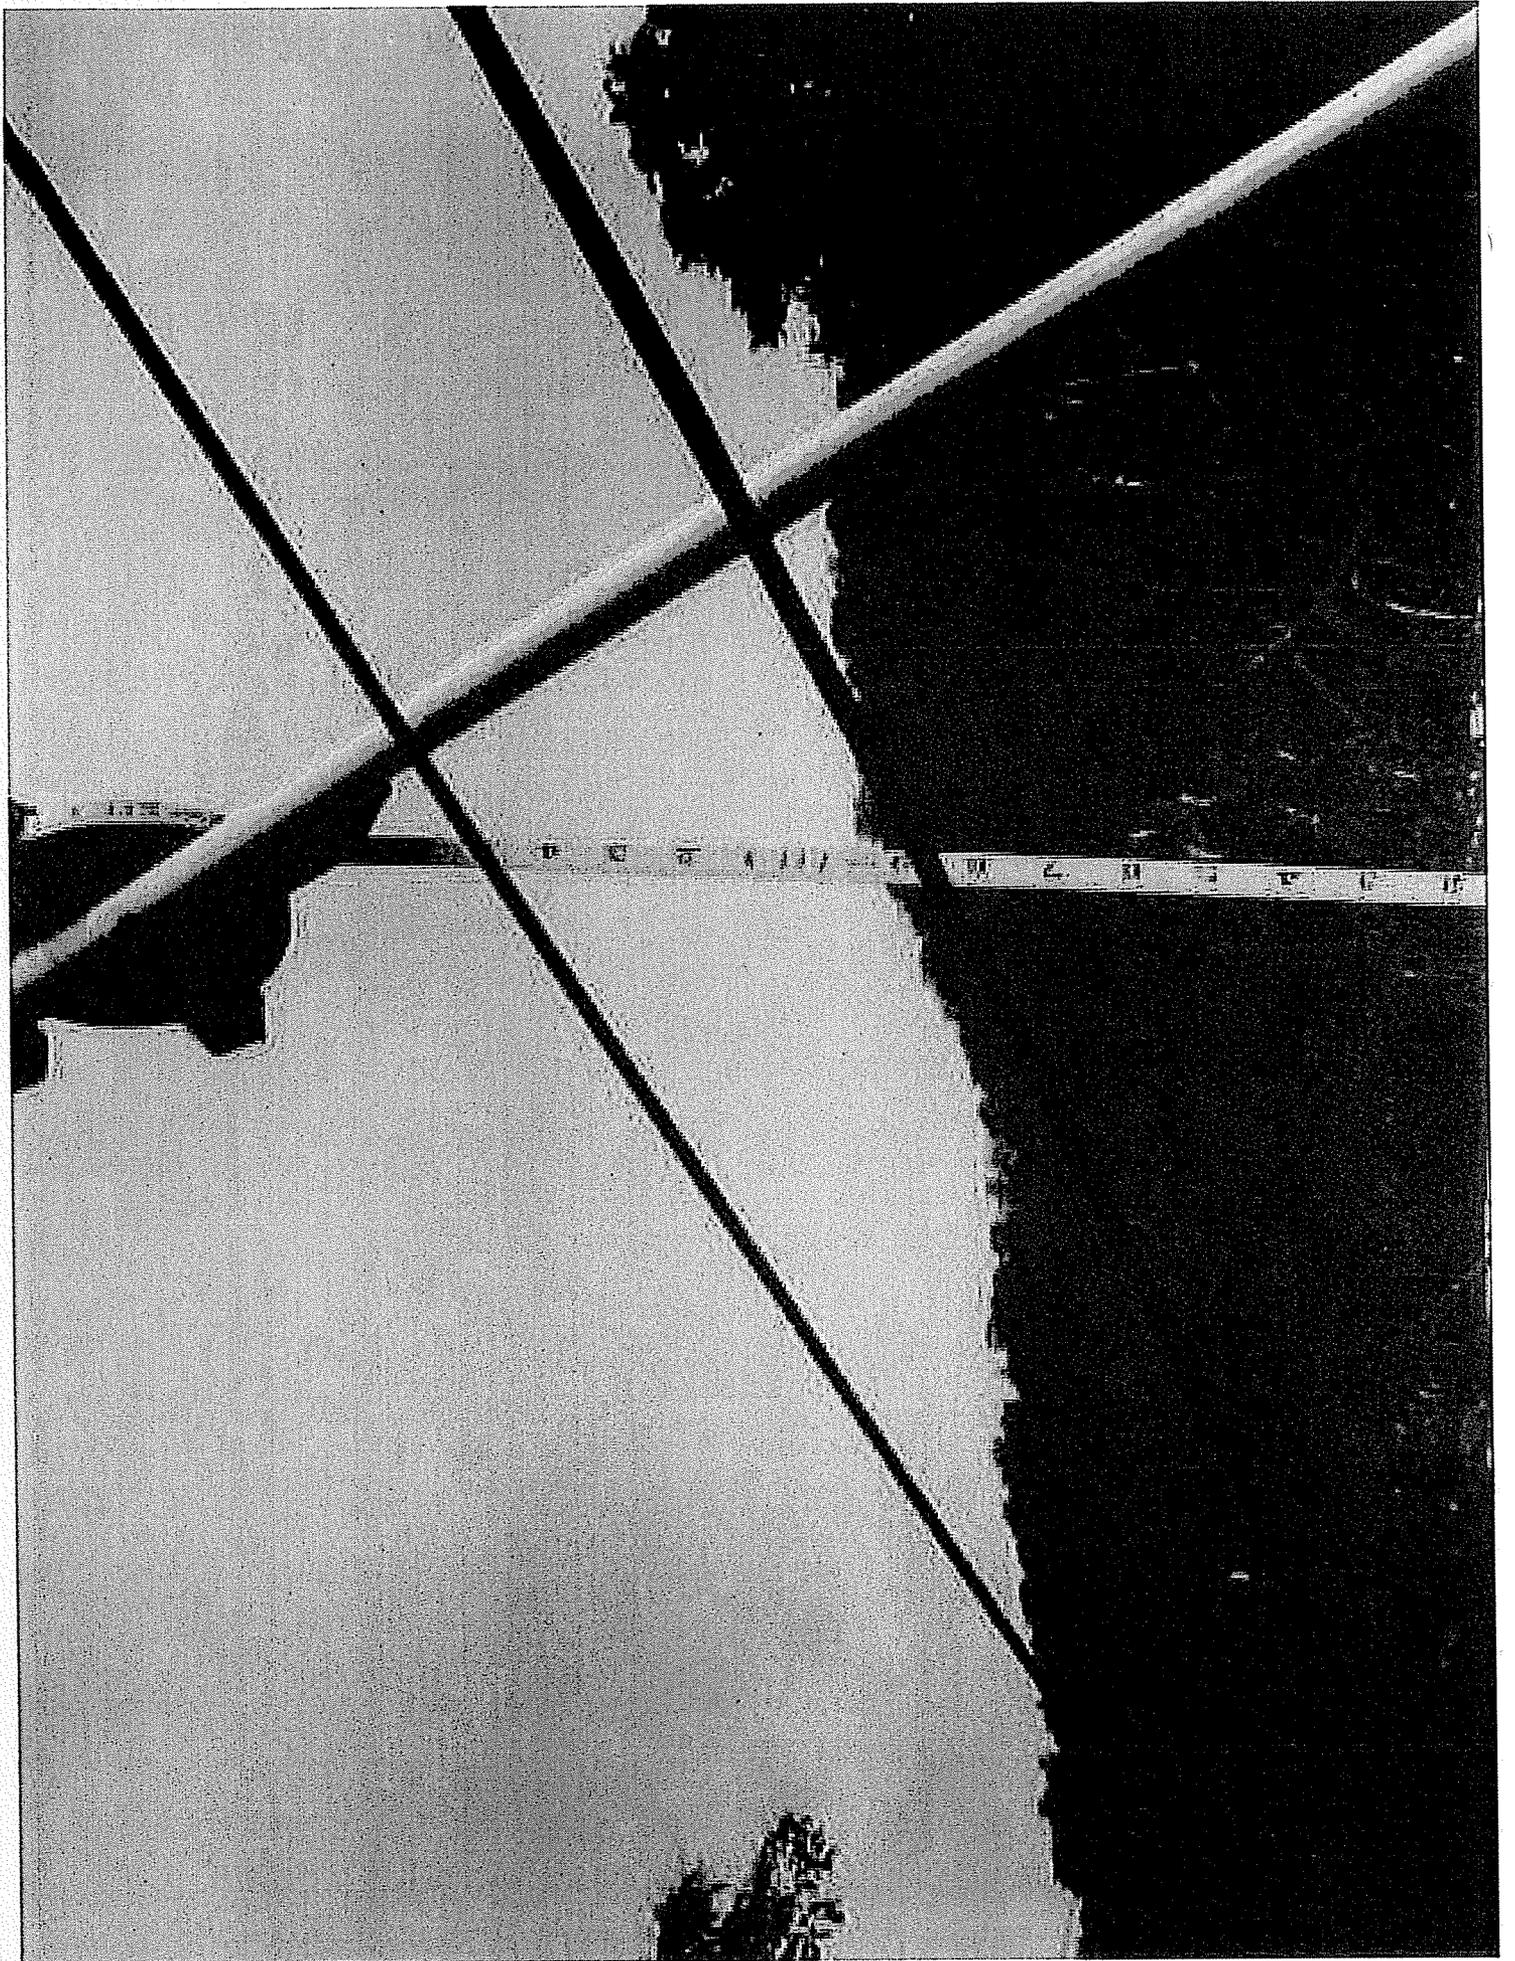
Attachment B

Attachment #1 reflects measurement of the phone cable, KYPCo's lowest point was 6'

Utility Photographs (phone drop)

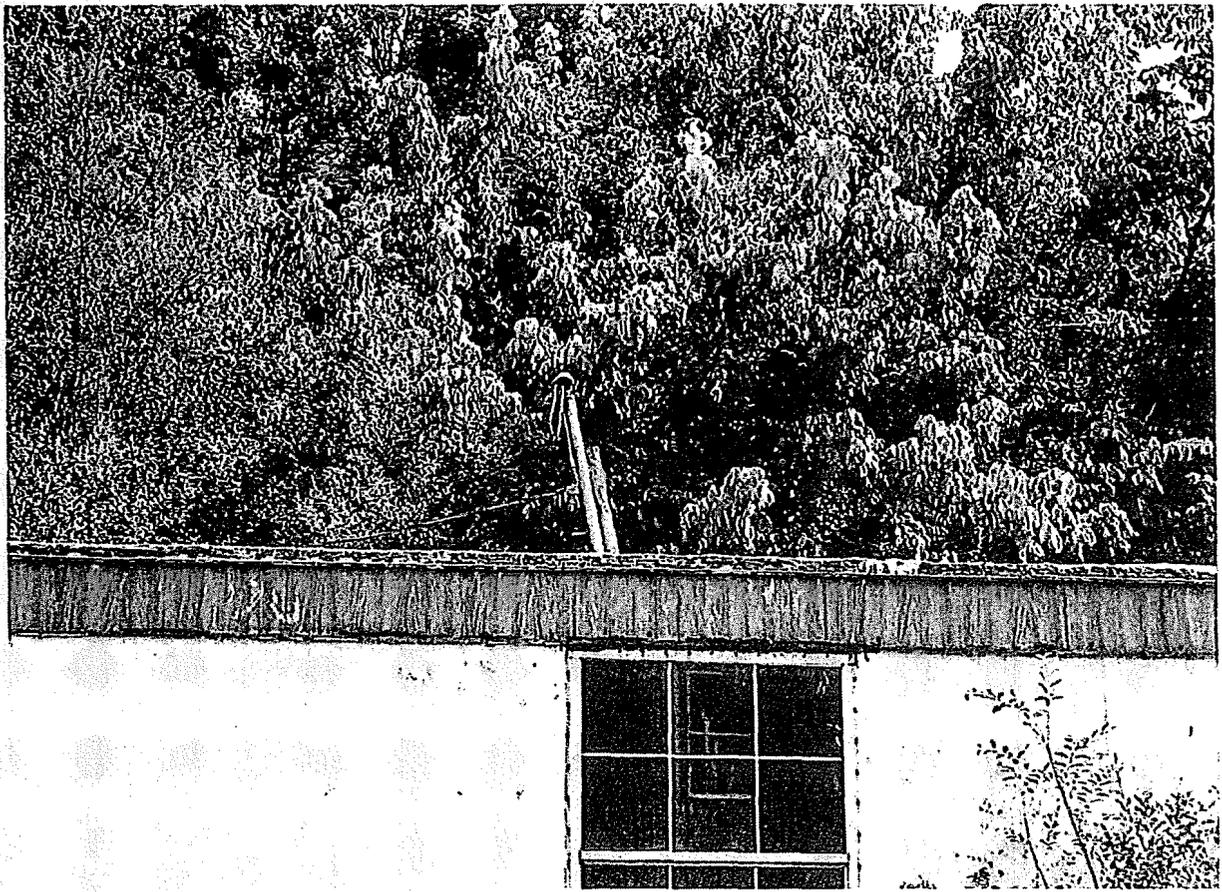
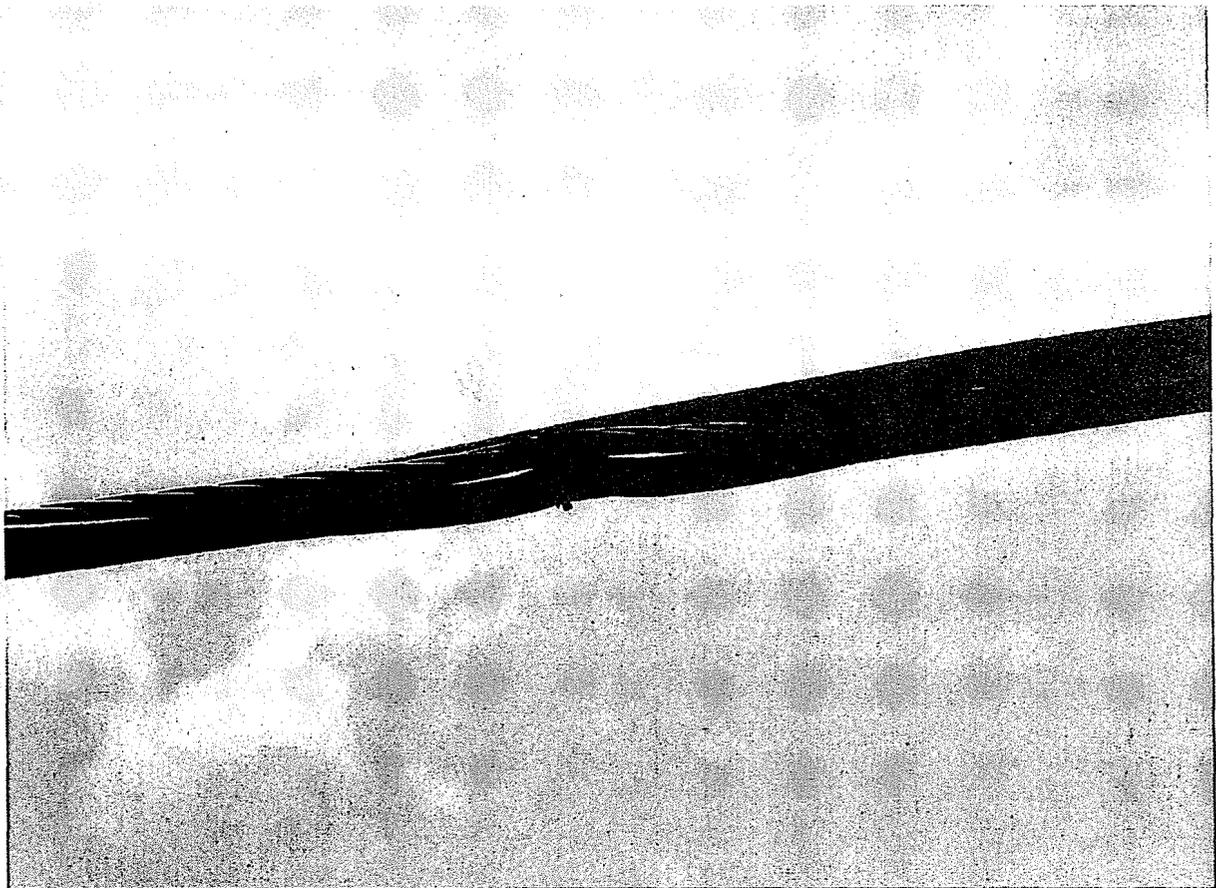
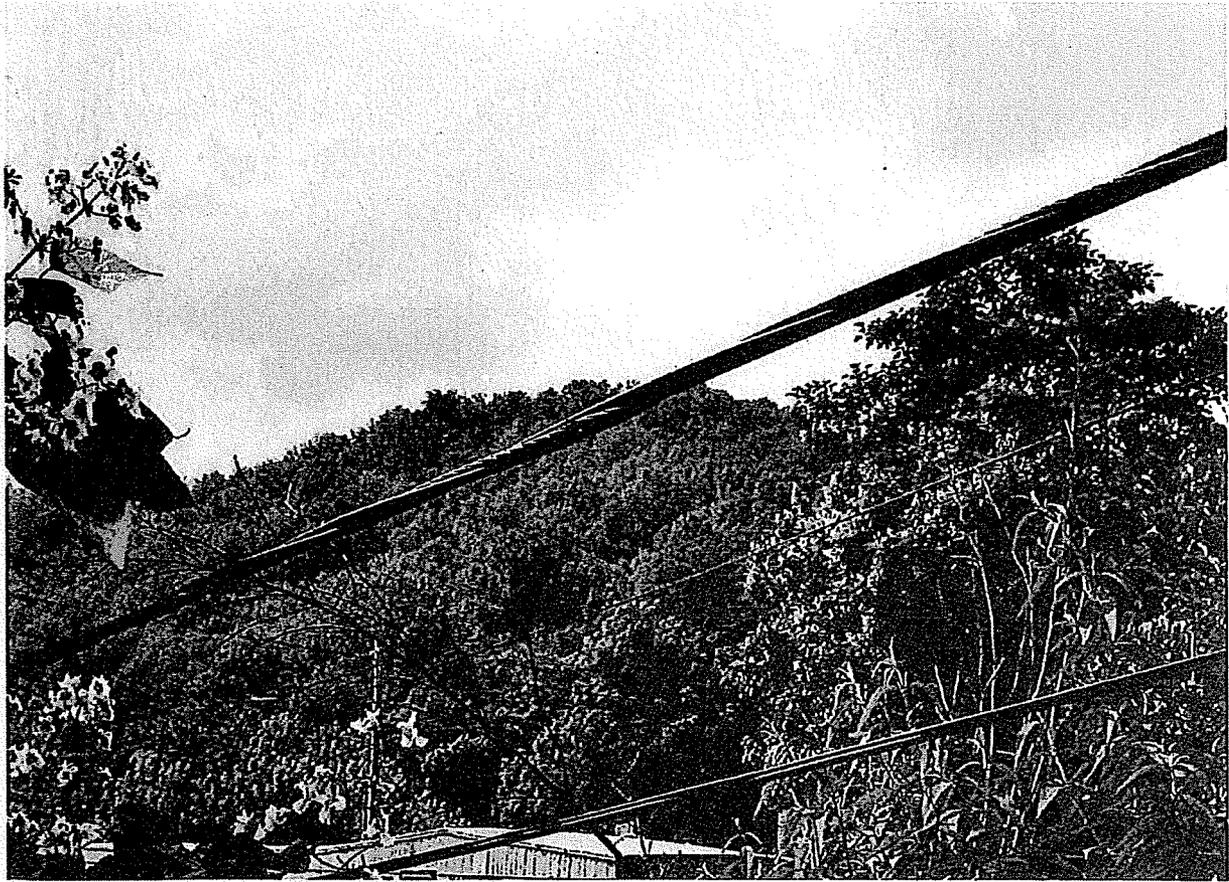
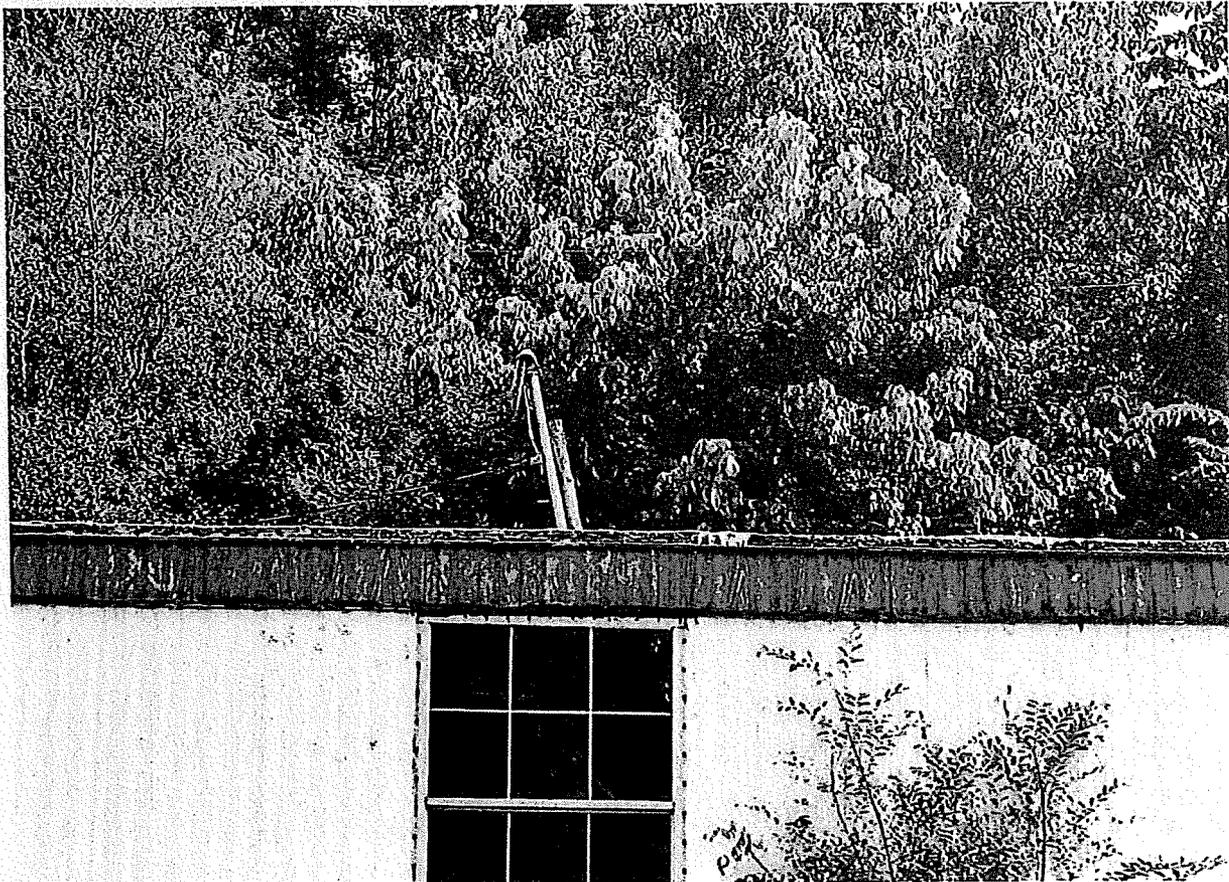
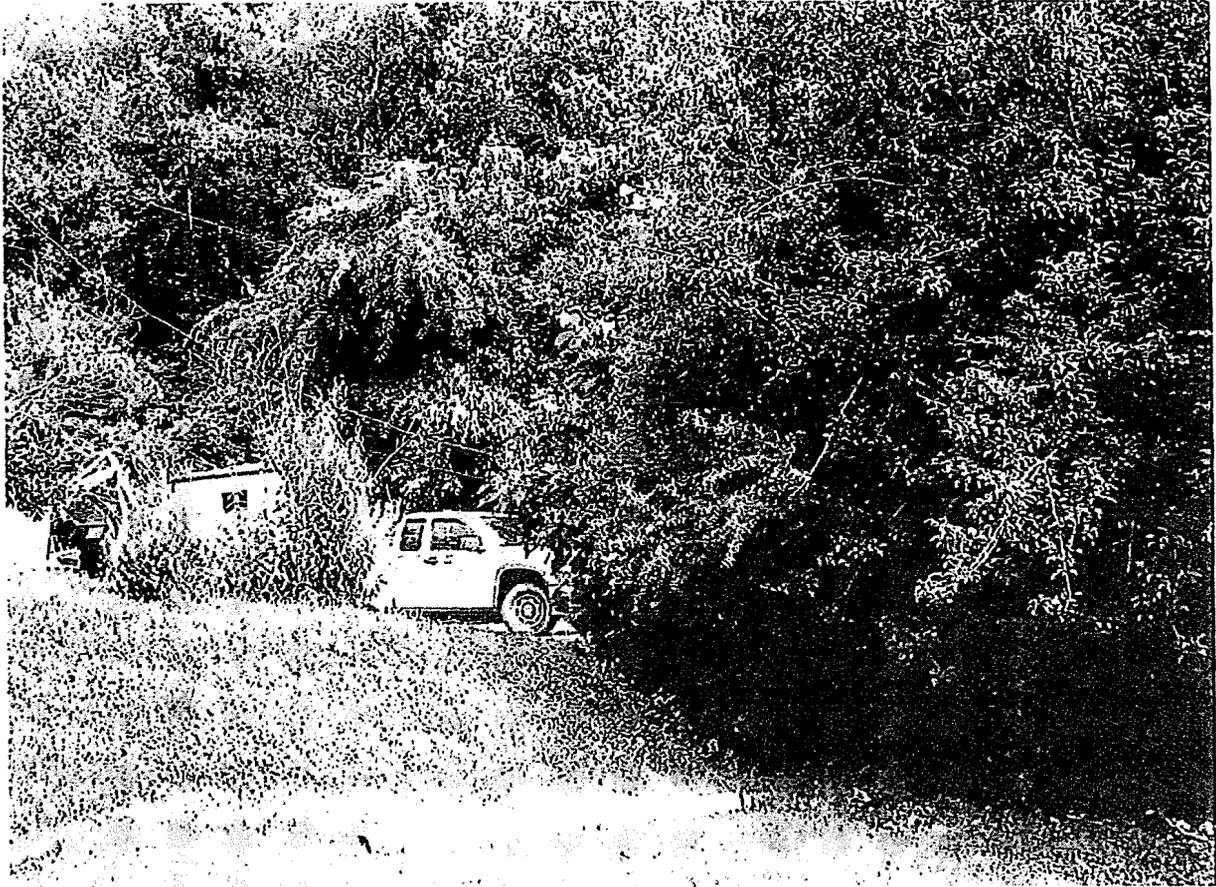
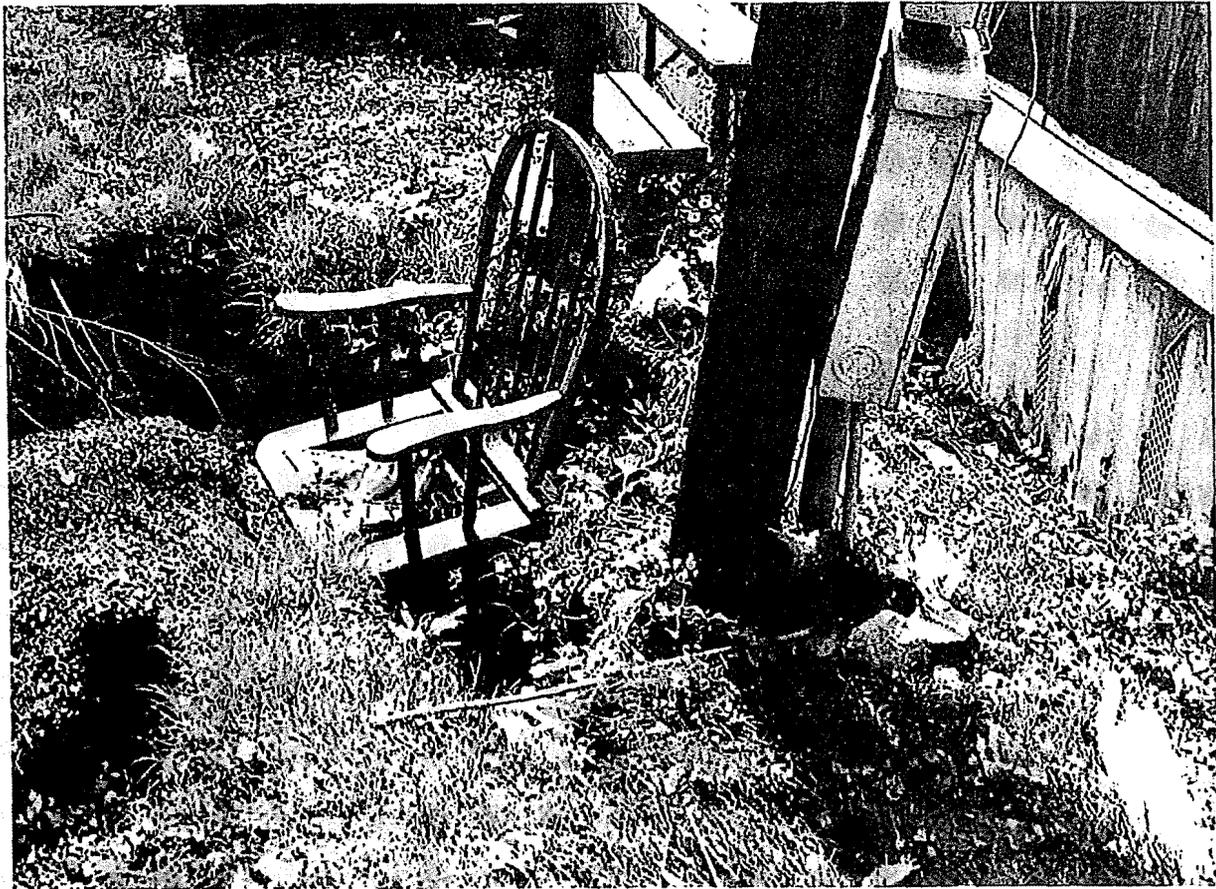
Attachment C

During the incident site visit I was informed by the Manager of the Pikeville District that the Distribution Service Supervisor had returned and re-installed the original service so he could take photographs of the service on the original distribution and service pole. See attachment C; (service drop at incident site).

Utility Photographs (service drop at incident site)
