COMMONWEALTH OF KENTUCKY BEFORE THE PUBLIC SERVICE COMMISSION

n the Matter of:		
BECKNELL-COGHILL, INC.)	
)	CASE NO. 2021-00159
ALLEGED VIOLATION OF UNDERGROUND FACILITY DAMAGE PREVENTION ACT))

OPENING ORDER

PIPELINE DAMAGE INVESTIGATION REPORT

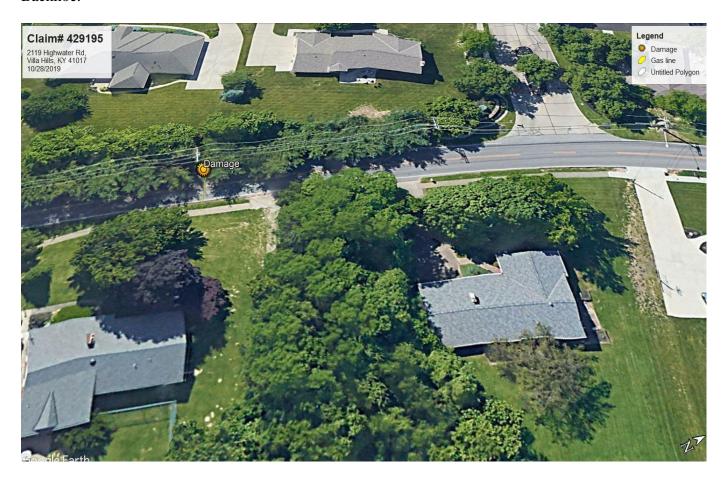
On Monday, October 28, 2019, I was notified by Duke Energy about damage at 2119 Highwater Rd, Villa Hills, KY 41017. Duke Energy's Underground Facilities were damaged at the above stated location by a Backhoe.

I arrived on site and spoke with Duke Energy. The service was marked correctly and the damage was close to the gas shutoff valve.

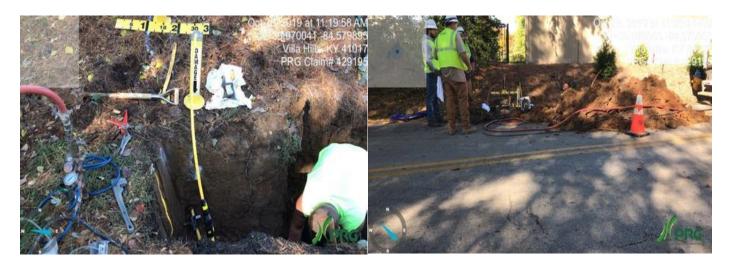
ROOT CAUSE

Failure to properly expose and protect underground facilities

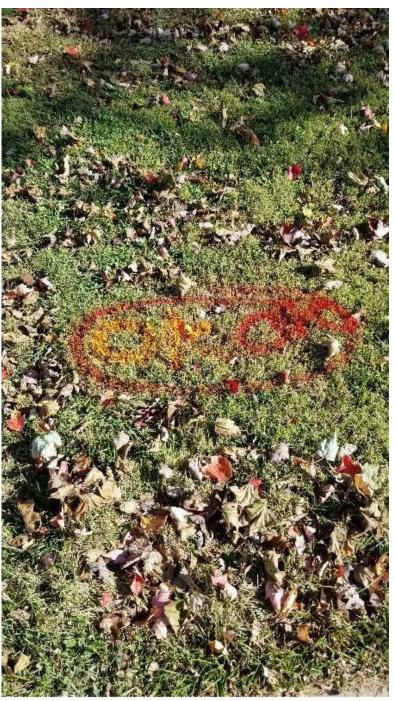
429195 - Locate Pre-Dig1.jpg

Property of United States Infrastructure Corporation Photo created on 10/23/2019 15:28:01 PM EDT

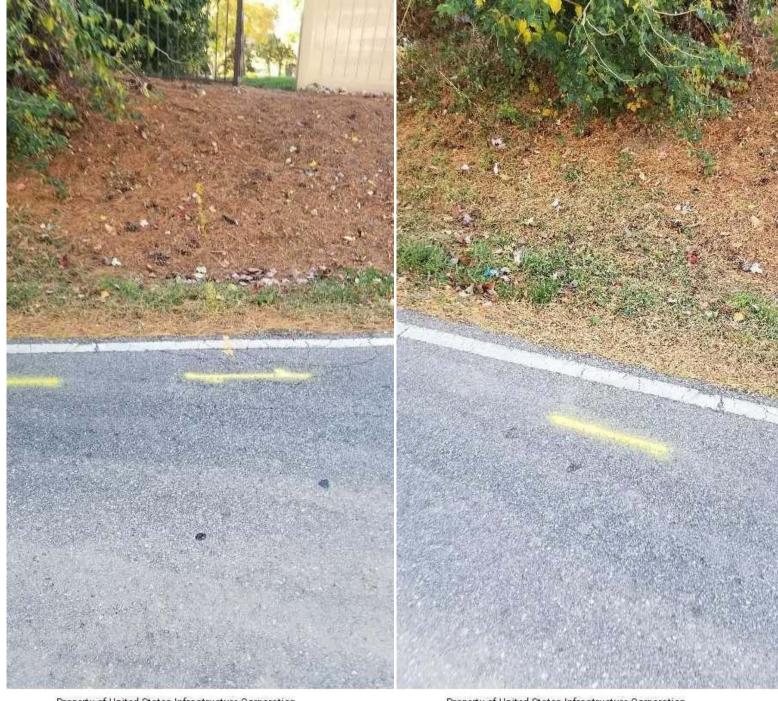
429195 - Locate Pre-Dig2.jpg

Property of United States Infrastructure Corporation Photo created on 10/23/2019 15:28:16 PM EDT
