LOUISVILLE GAS AND ELECTRIC COMPANY)
_____) CASE NO. 2006-00353
ALLEGED FAILURE TO COMPLY WITH)
KRS 278.042)

Electric Utility Personal Injury Accident Report

INCIDENT INVESTIGATION ~ Staff Report

KPSC External / INVESTIGATION REPORT

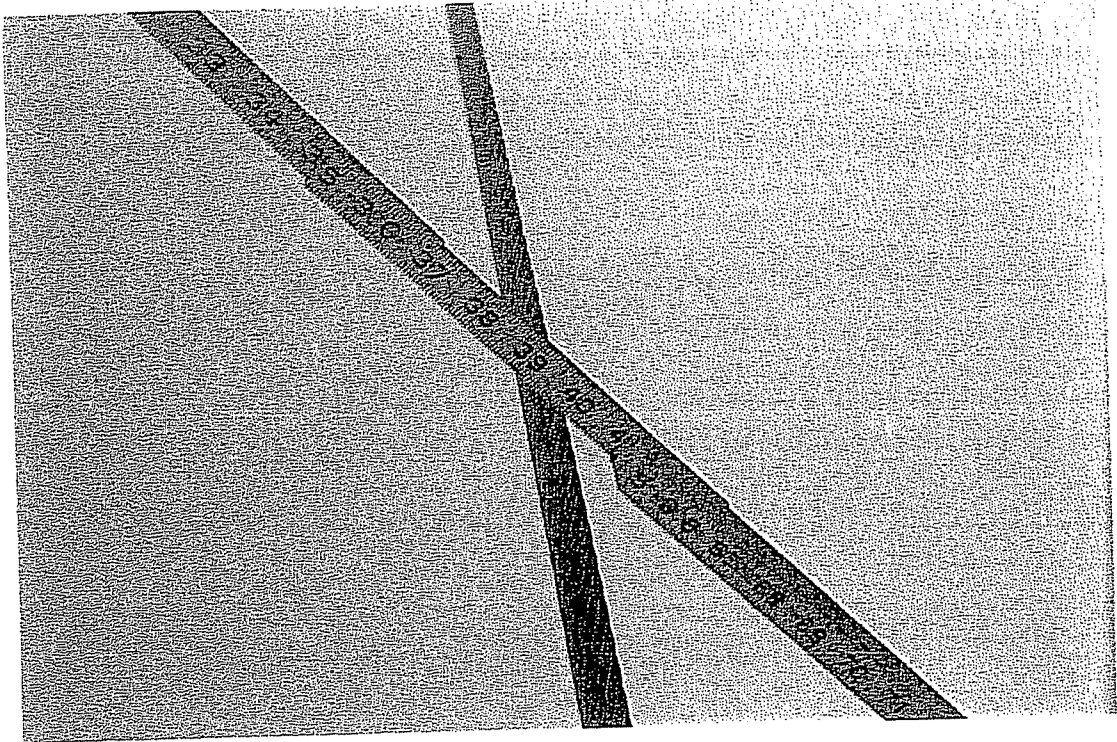
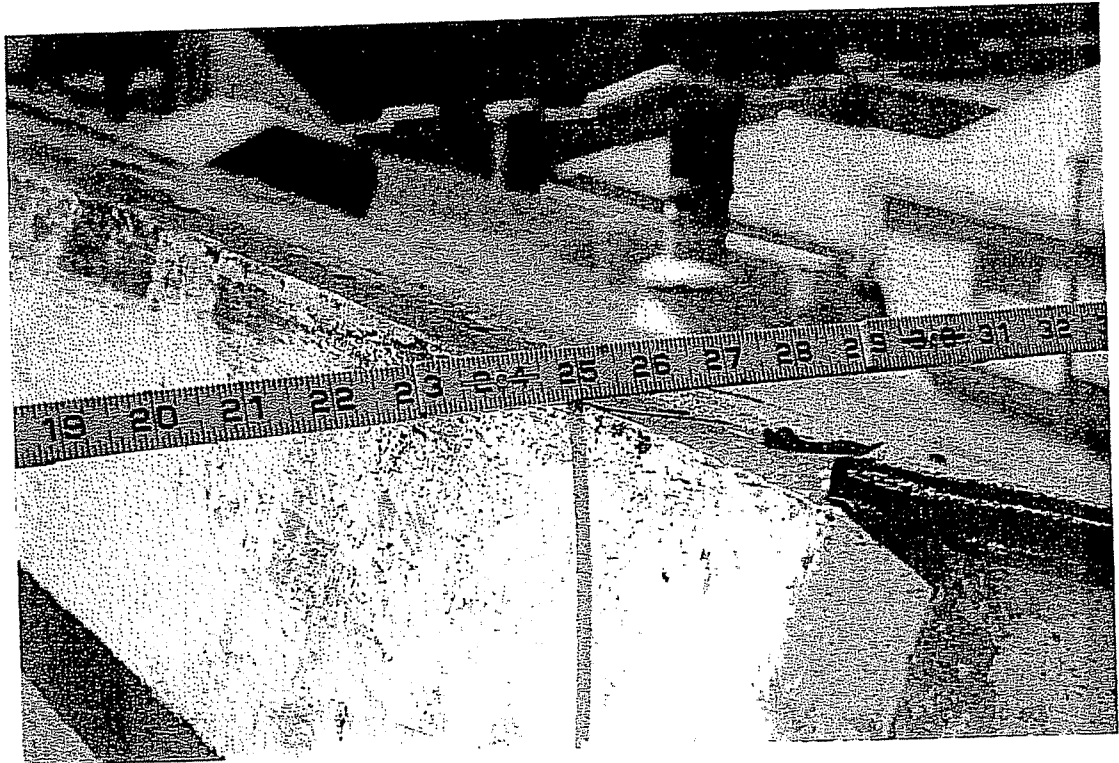
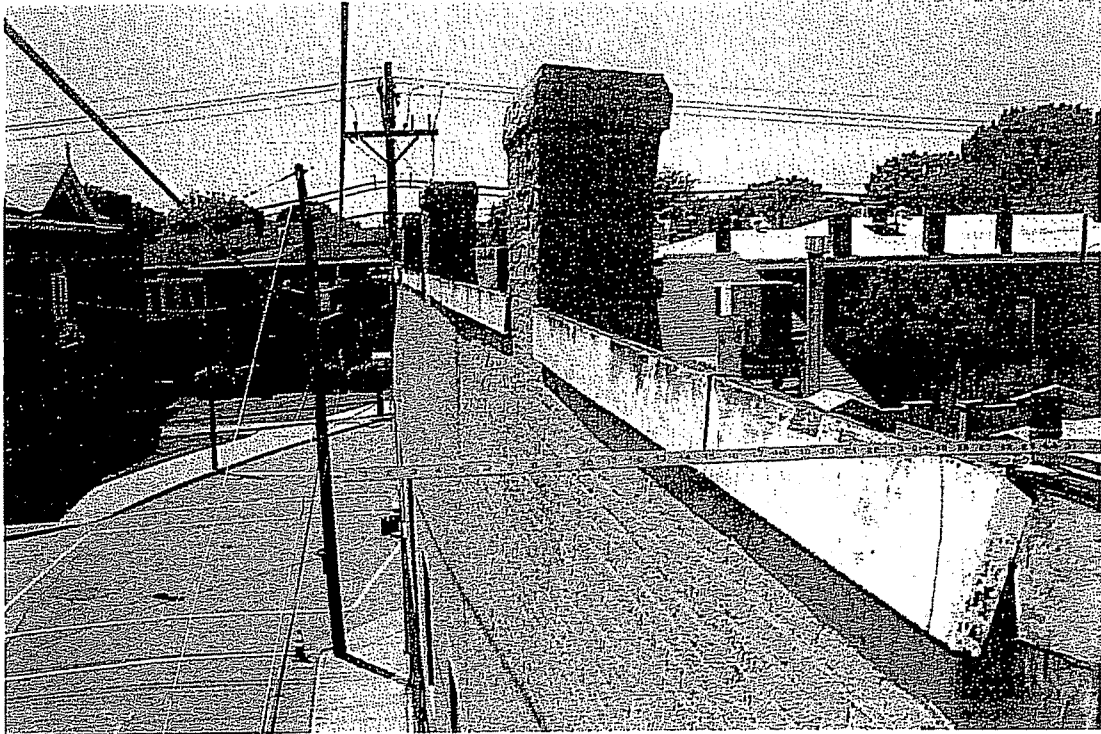
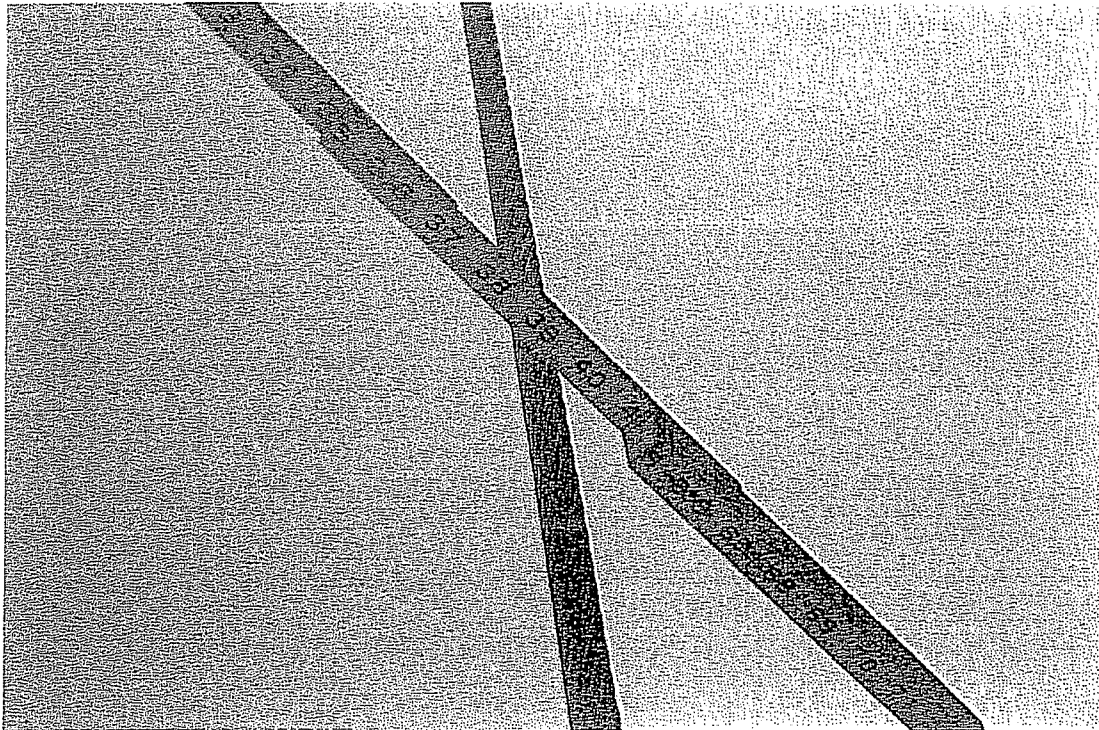
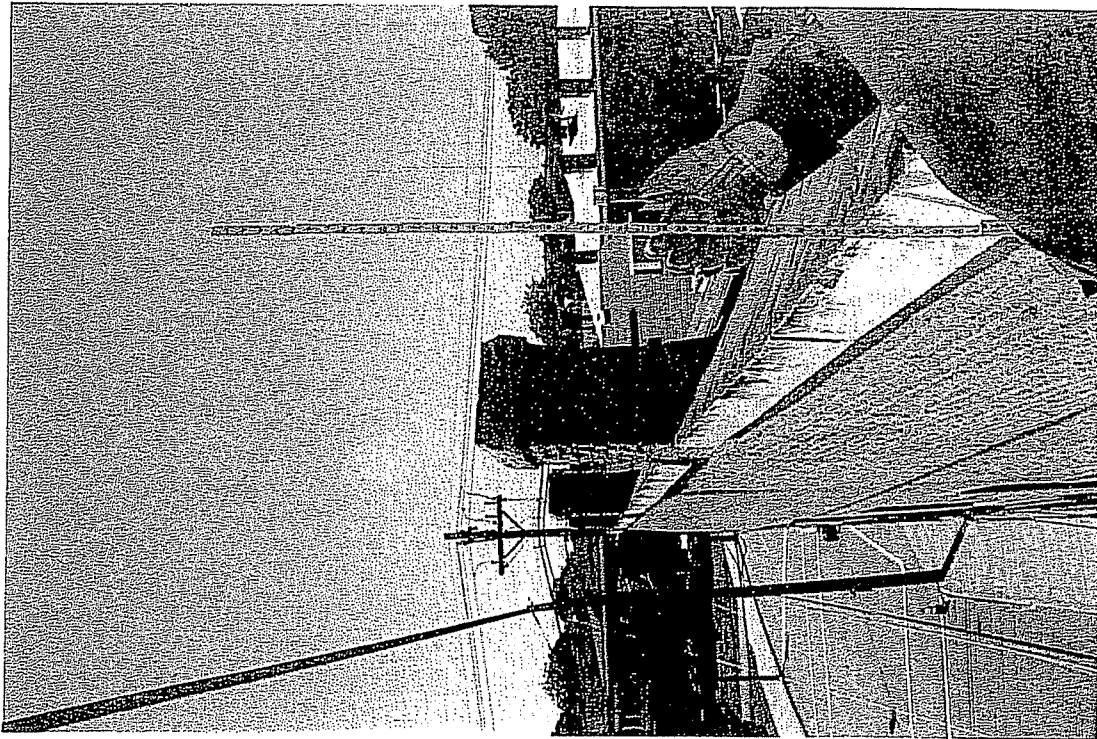
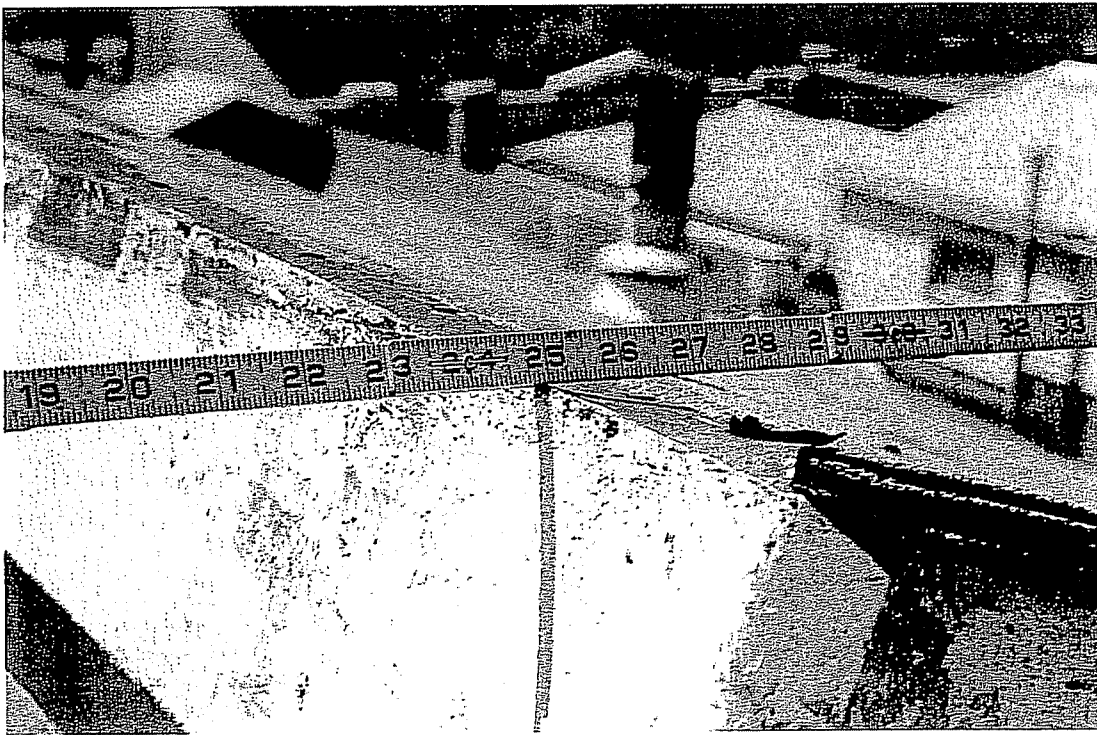
Utility Photographs of Accident Site

Mr. Durbin appeared to have been lying on his stomach and reaching over the edge of the roof while using an aluminum pole with a paint roller attached at the end. While either raising or lowering the pole and roller, Mr. Durbin contacted the A-phase of the 3-phase 4 kV system with the aluminum pole. Mr. Kevin Broyles, a co-worker of Mr. Durbin, stated to the LMPD Investigator that he heard the pole and roller fall and hit the sidewalk; he indicated he was not a witness to the contact. When Mr. Broyles climbed the ladder to see what was wrong, he found Mr. Durbin unconscious.

Burn mark on phase to earth –	33ft 10in
Burn mark on phase to south roof edge (horz) –	2ft 2in
Burn mark on phase to south roof edge (vert) –	2ft 9in
Burn mark on phase to south roof edge (diagonal) –	3ft 8in
Burn mark on phase to east roof edge –	2ft 3in
Height of building (south roof edge to earth) –	30ft 11in

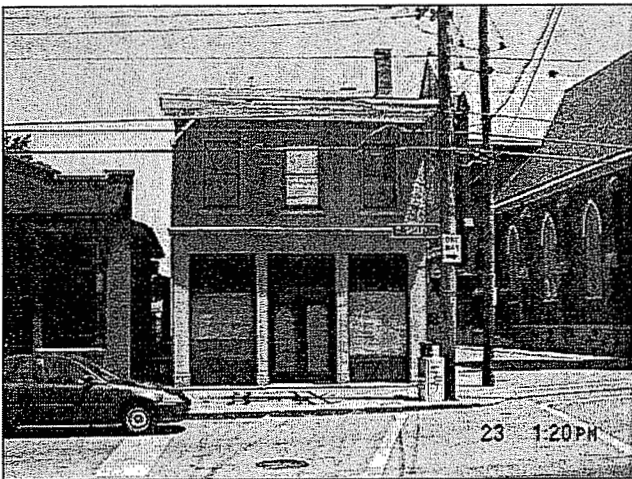
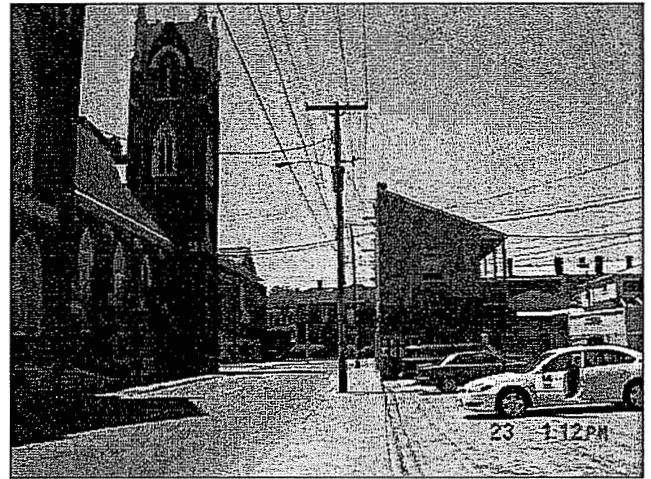
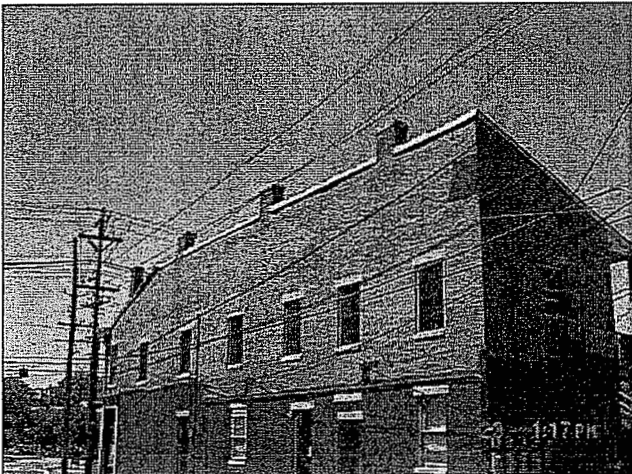
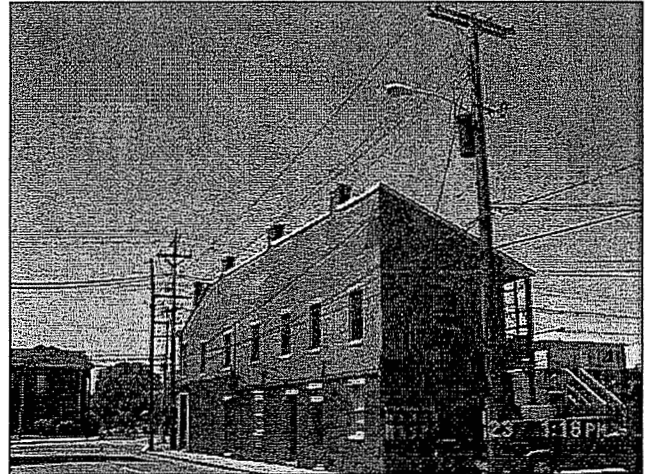
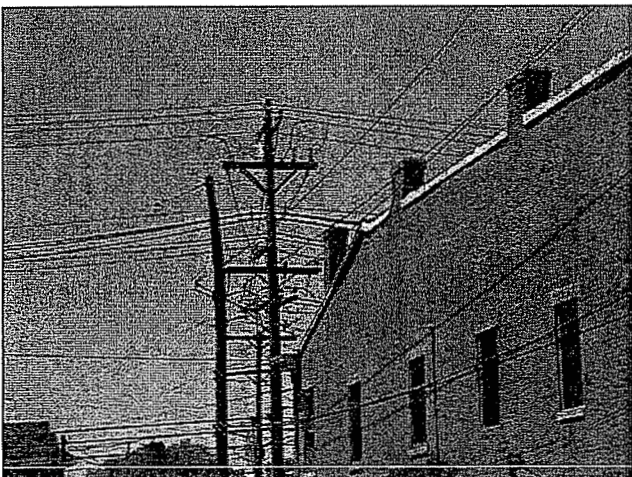
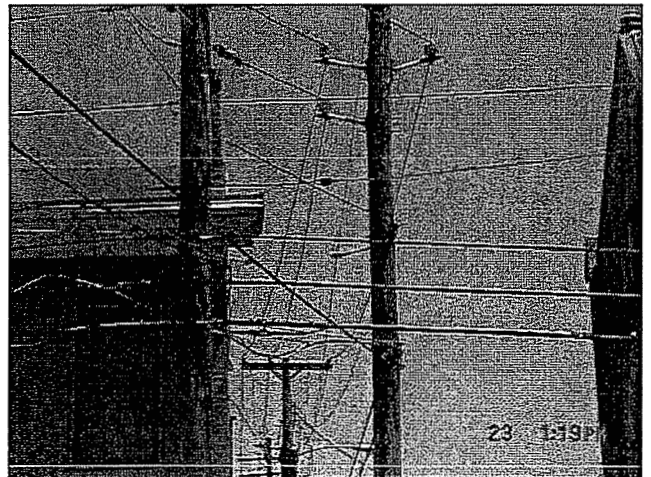
PSC Photographs of Accident Site

Line/Equipment Measurements/Clearances					
Line Clearances At Point of Accident:	Measured	Minimum Allowed by NESC	Applicable NESC Edition ¹ 2002	Voltage	Construct Date
Vertical: A Phase to Elevation	33'-10"	18'- 6"	2002 Edition	2.4 kv	Unknown
Horizontal: Phase to Structure	2'-2"	7'- 6"	2002 Edition	2.4 kv	Unknown
Date of Measurement:	May 23, 2006				
Temp & Weather:	55° Calm and Sunny				
Measurements Made By:	Name		Company		
	Keith McBride		LG&E		
Investigated By:	Name		Company		
	Jeff Moore		Public Service Commission		
Signed:
