COMMONWEALTH OF KENTUCKY
BEFORE THE PUBLIC SERVICE COMMISSION

INTER-COUNTY ENERGY)
COOPERATIVE CORPORATION)
_____) CASE NO. 2011-00280
)
ALLEGED FAILURE TO COMPLY WITH)
KRS 278.042)

INCIDENT INVESTIGATION ~ Staff Report

Re: Bluegrass Ag Distributors public contact accident 4/6/2011

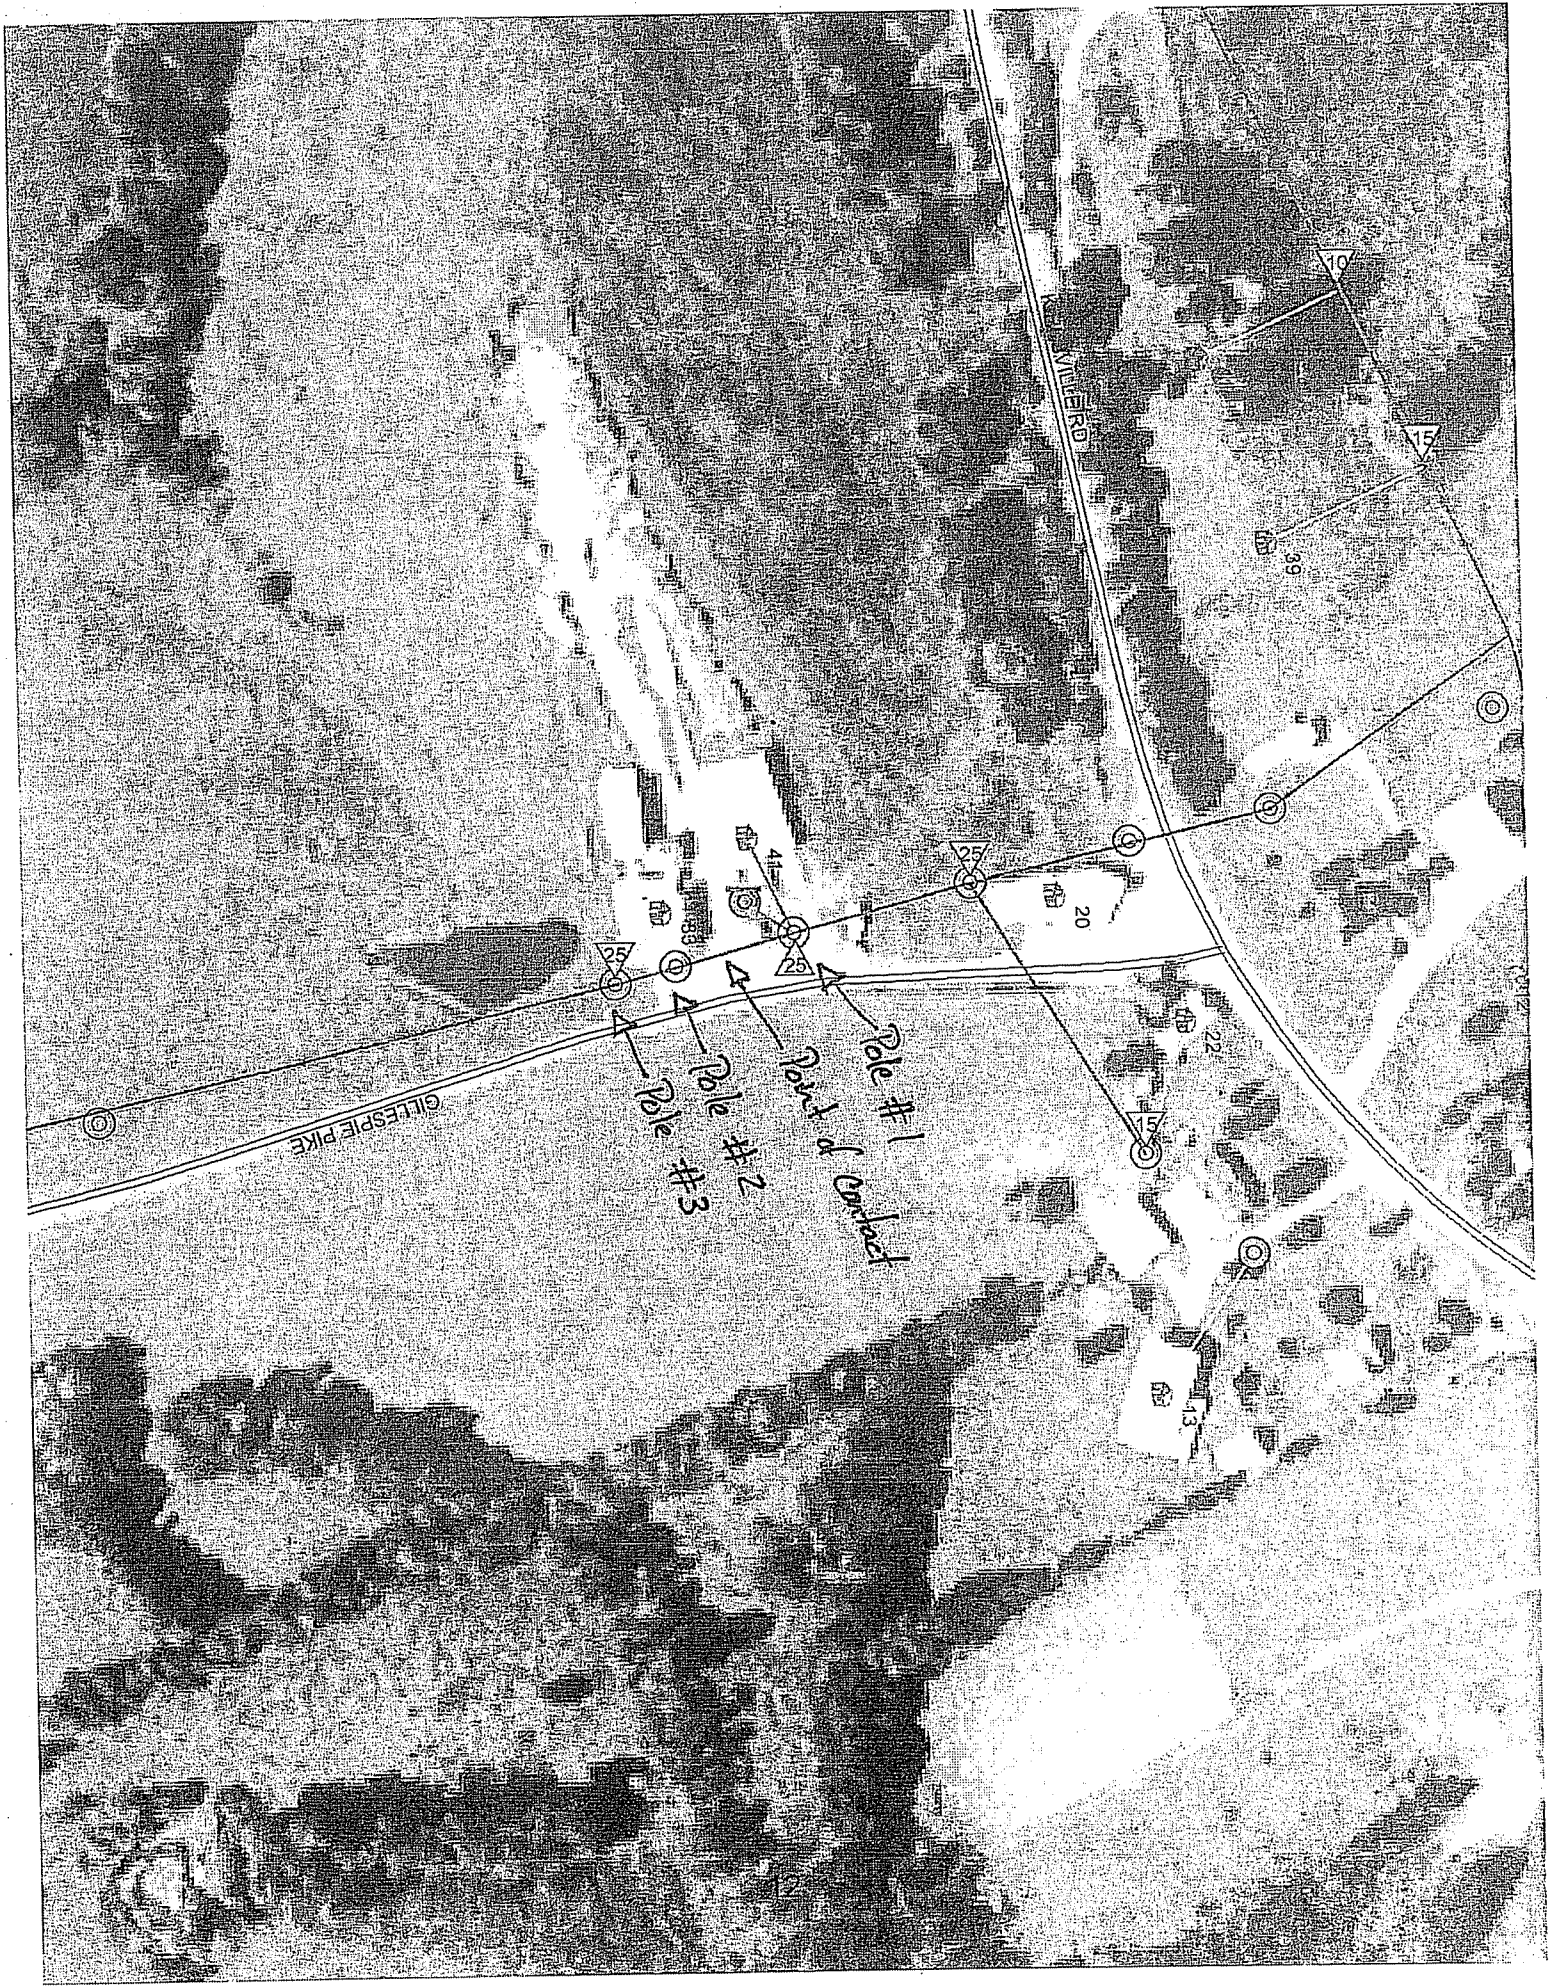
Pole #1
Point of Contact
Pole #2
Pole #3

Re-closer 188, which previously fed these homes on Gillespie Pike from Nina Ridge, is still in service. It feeds to the location on attachment #2 marked as "Pole #1". This pole has a 25 kva transformer that feeds another building on the Bluegrass Ag property. Beyond this pole, there is also a 25 kv suspension

On attachment #2, the distance between pole #1 and pole #3 is 179 feet. This conductor is now de-energized, grounded and serves as a support cable between the two feeds. This spans the entrance to the grain bin area where the contact accident occurred. The nearest energized primary conductor is now 65 feet, 10 inches away. This conductor is located on a non-loading side of the grain bin. When referencing figure 234-4 (b) of the NESC, we are outside of the 15 foot slope envelope and greater than 18.5 feet vertical distance to the primary.

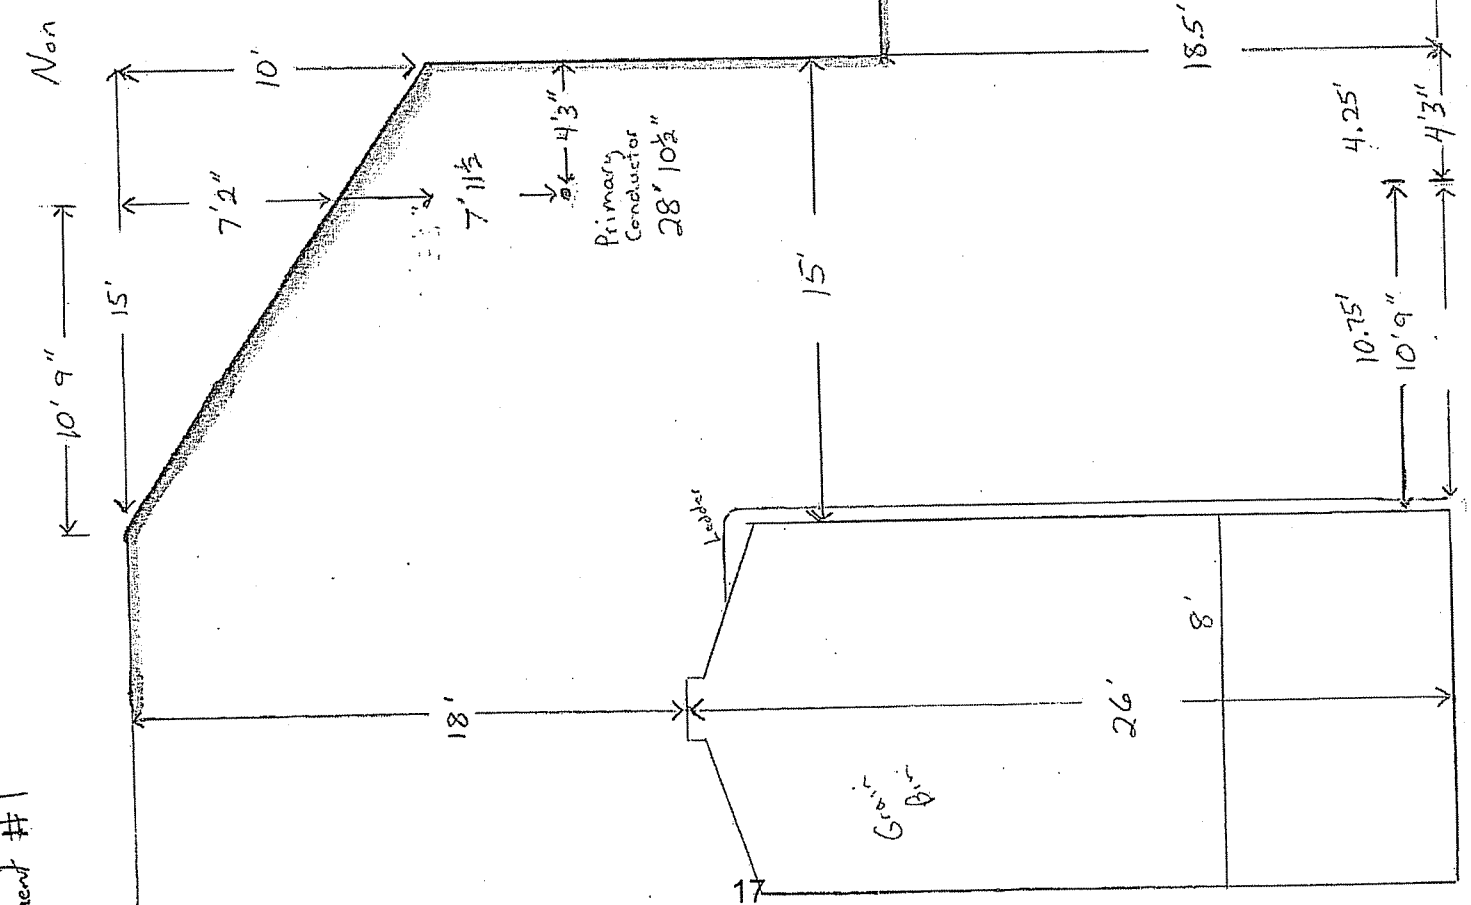
Attachment #1

Non loading side clearance envelope

1" = 6'
Assuming 6' radius of Grain Bin

Clearance Zone for non-loading side of Grain Bin

Approximate values used.

At 10.75' out from a point 44' above ground at the non-loading edge of the grain bin from the ground, the clearance envelope is at 36' 10" high. Our primary conductor was measured at 28' 10.5". Thus, our primary was 7' 11.5" vertically intrusive to the clearance envelope and 4' 3" horizontally intrusive to the clearance envelope.

After meeting you at the accident location on May 5th and reviewing the NESC 2007 Edition, we have learned that our clearance for primary conductors on the non-loading side of a grain bin was inside the clearance envelope that the code requires. Please see the attached diagram explaining our previous clearances (attachment #1). In order to meet NESC code requirements under figure 234-4 (b), the primary at this location should have been 8 feet higher or 4.5 feet farther away from the grain bin. Since that time we have made changes to the primary line at this location to meet the required clearances under 234F2a(c), as this line is now de-energized.

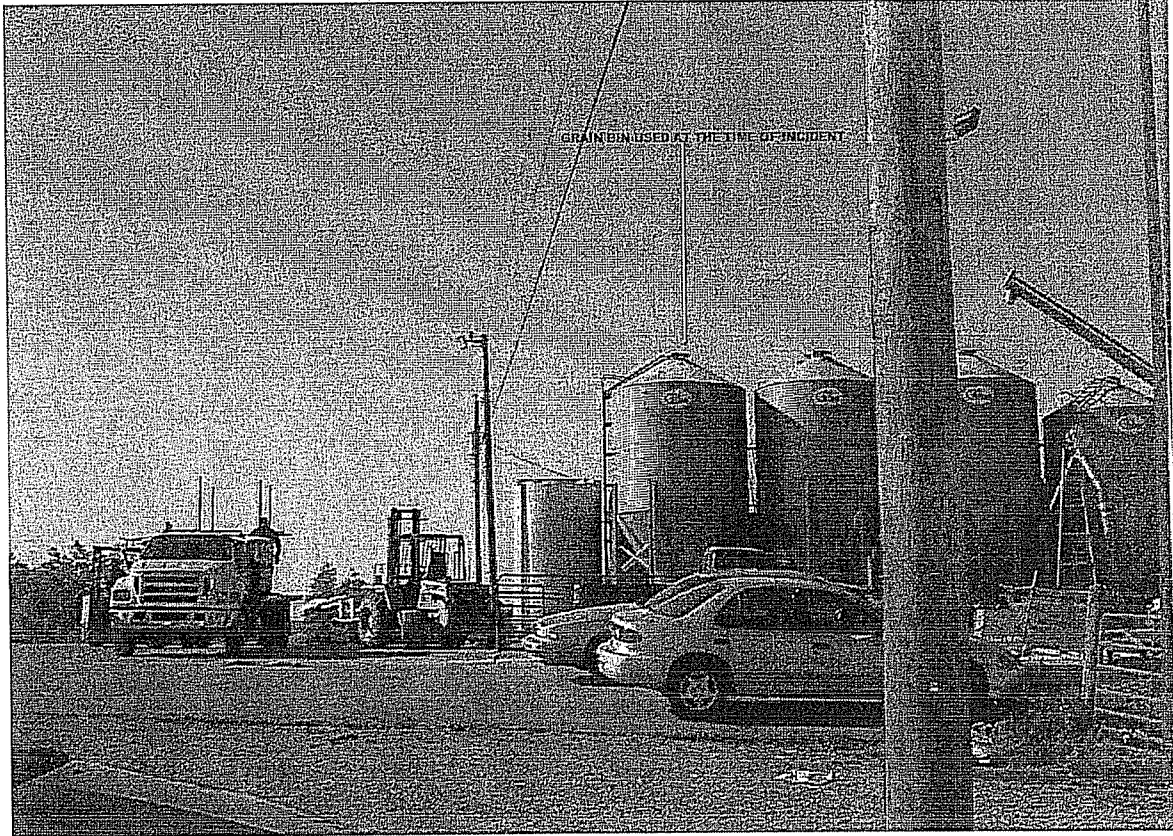
GRAIN STORAGE AT THE TIME OF INCIDENT

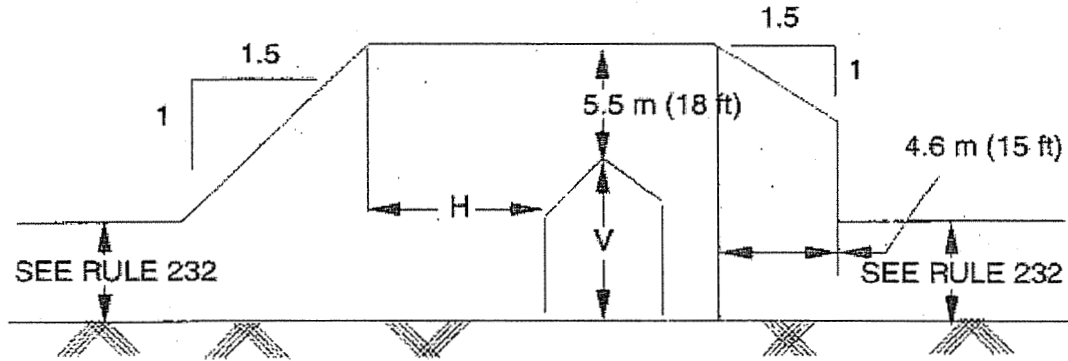
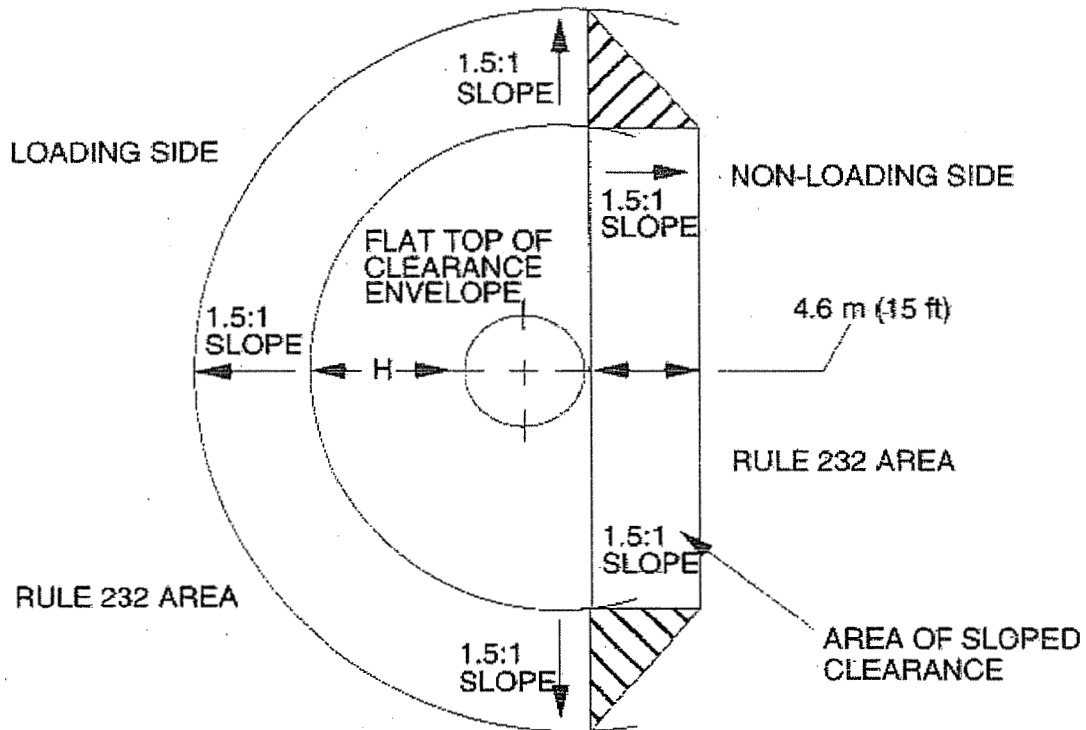
Fig 234-4(b): Clearance Envelope for Grain Bins Filled by Portable Augers, Conveyors, or Elevators

a. The clearance of wires, conductors, cables, and rigid live parts from grain bins that are expected to be loaded by the use of a portable auger, conveyor, or elevator shall be not less than the values illustrated in Fig 234-4b.

V = HEIGHT OF HIGHEST FILLING OR PROBING PORT ON GRAIN BIN

$$H = V + 5.5 \text{ m (18 ft)}$$
