COMMONWEALTH OF KENTUCKY
BEFORE THE PUBLIC SERVICE COMMISSION

DUKE ENERGY KENTUCKY, INC.)	
_____)	
ALLEGED FAILURE TO COMPLY)	CASE NO. 2016-00349
WITH KRS 278.042)

ORDER

Commission Staff completed an Accident Investigation Staff Report (“Staff Report”), attached hereto as the Appendix, on November 23, 2015. The Staff Report alleges that on April 3, 2015, a three-person substation repair crew responded to a fault on Circuit 45 at the Duke Energy Northern Kentucky University Substation located on the campus of Northern Kentucky University, Highland Heights, Kentucky. Two Duke Kentucky transmission electricians, Senior Maintenance Electrician Nathan Trapp (“Trapp”) and Maintenance Electrician Kyle Leninger (“Leninger”) (collectively, “Injured Employees”), sustained burn injuries while performing repairs on a four-cubicle 13.2-kiloVolt (“kV”) switchgear. The Injured Employees were reportedly attempting to remove a fiberboard barrier from an adjacent energized Circuit 44 switchgear cubicle to use as a replacement for a burned fiberboard barrier in the de-energized and grounded Circuit 45 switchgear cubicle they were tasked to repair. The Injured Employees incorrectly assumed the Circ

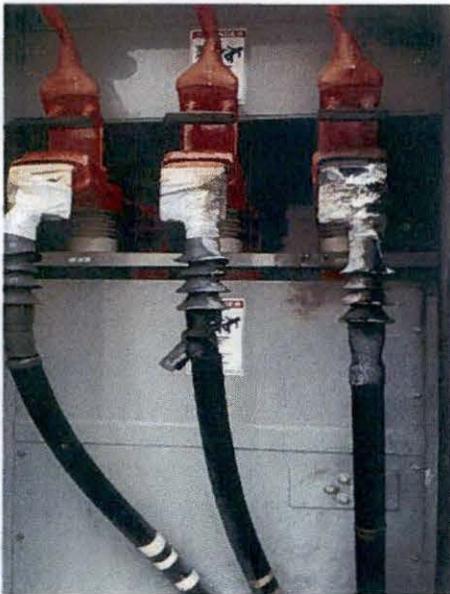
Photo 1. KU Substation initial cable fault on Cir. 45

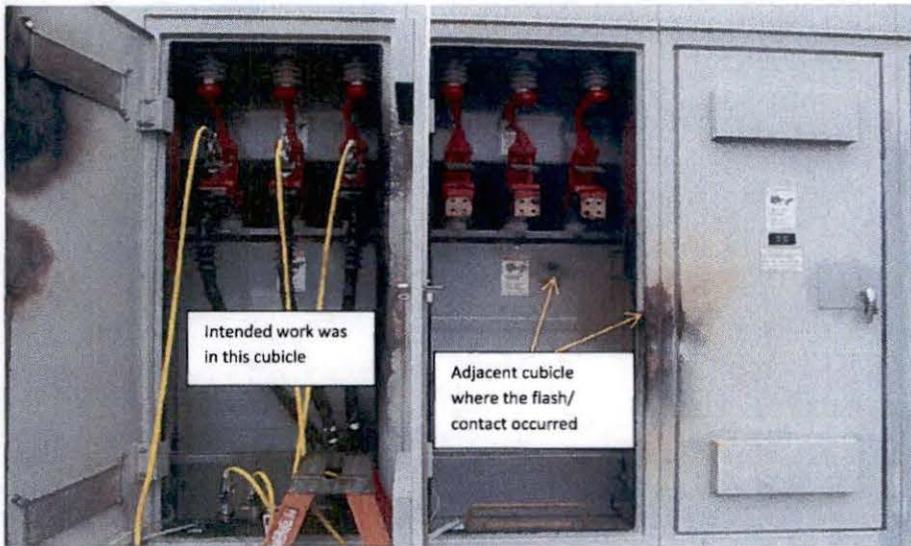
Photo 2. KU Substation Circuits Cir. 45, Cir. 44 and Cir. 43.

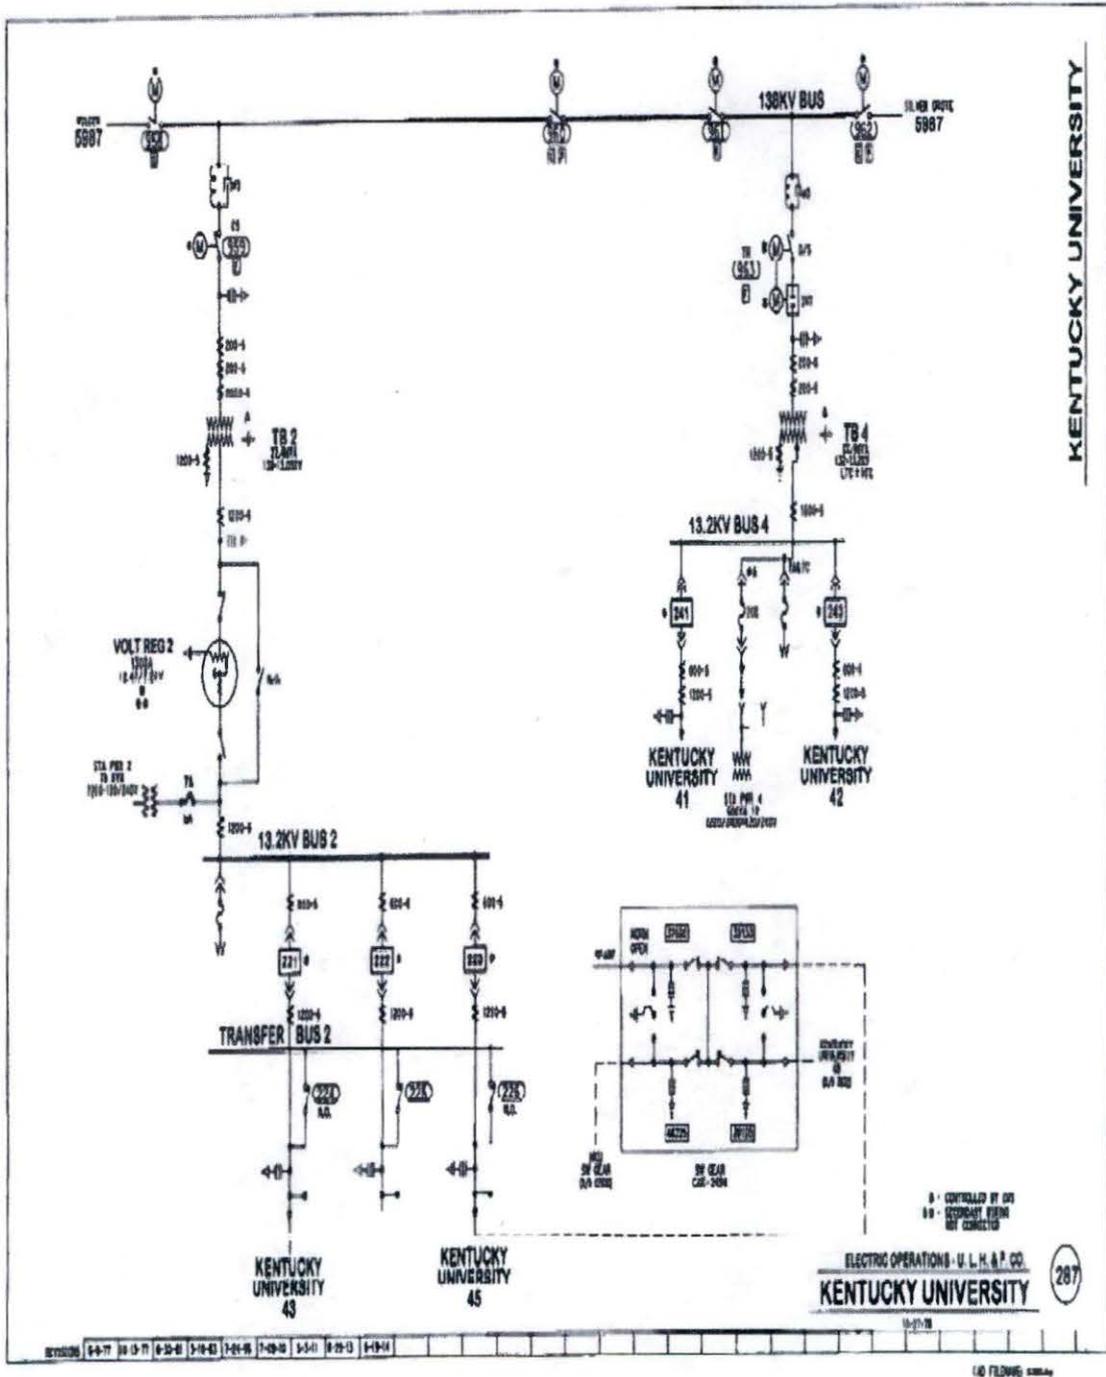
Figure 1. The single line diagram of KU substation showing Cir. 43 and Cir. 45

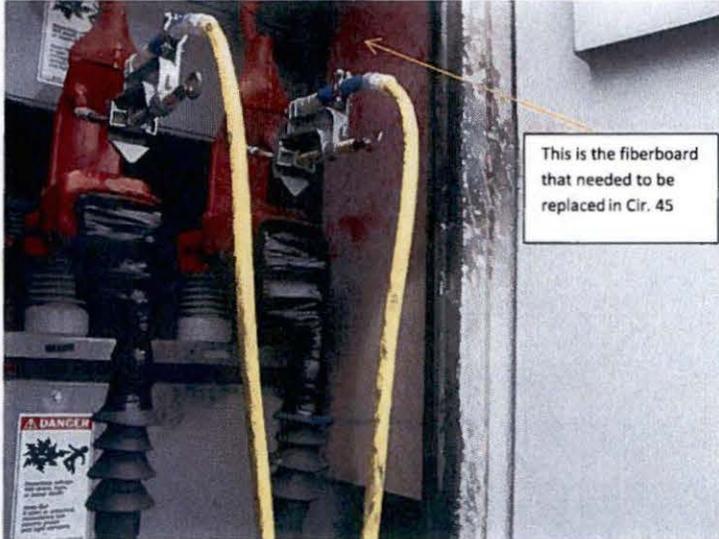
Photo 3. Inside cubicle KU45 shows, taped spades, grounds and fiberboard that needed to be replaced.

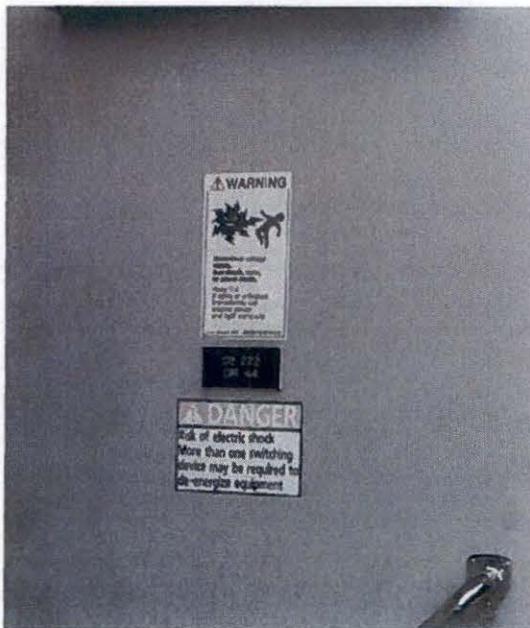
While cable repairs were ongoing, the Maintenance Electrician A and Trainee C&M from Substation Maintenance retrieved parts from their Transmission C&M Supervisor at Queensgate (except the fiberboard barrier) and proceeded to the site. Substation Maintenance worked on Cir. 45: bolted the connections, taped bare parts and cleaned the cubicle for Cir. 45. The fiberboard barrier still needed to be replaced. The Transmission C&M Supervisor called the Maintenance Electrician A to check progress on the job. During this conversation, the Transmission C&M Supervisor emphasized the need to test the adjacent cubicle for voltage before removing the fiberboard barrier from Cir. 44, see Photo 4, pg. 12 shows labeling on Cir. 44 cubicle.

Photo 4. This is the labeling outside of cubicle KU 44/CB222.

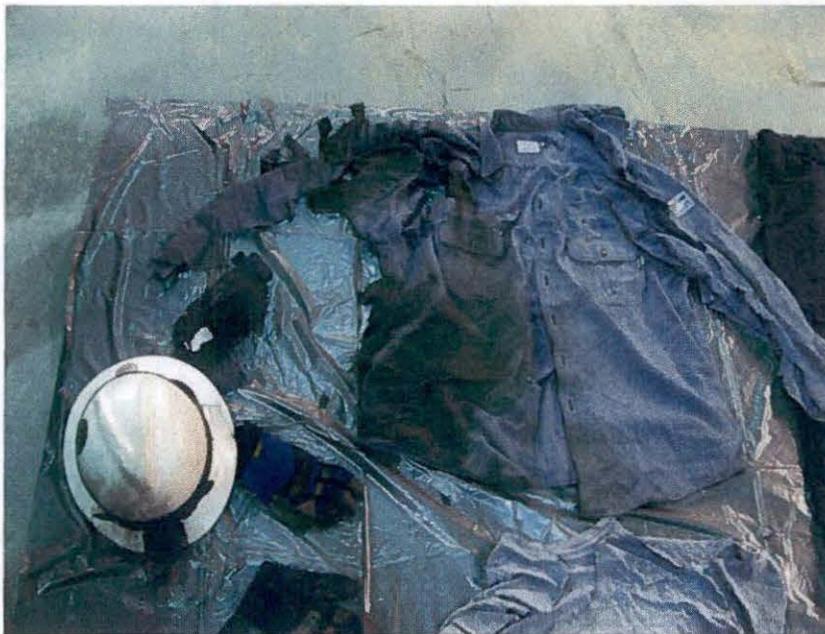
Photo 7. Maintenance Electrician A's clothes. Note burns to right side of body.

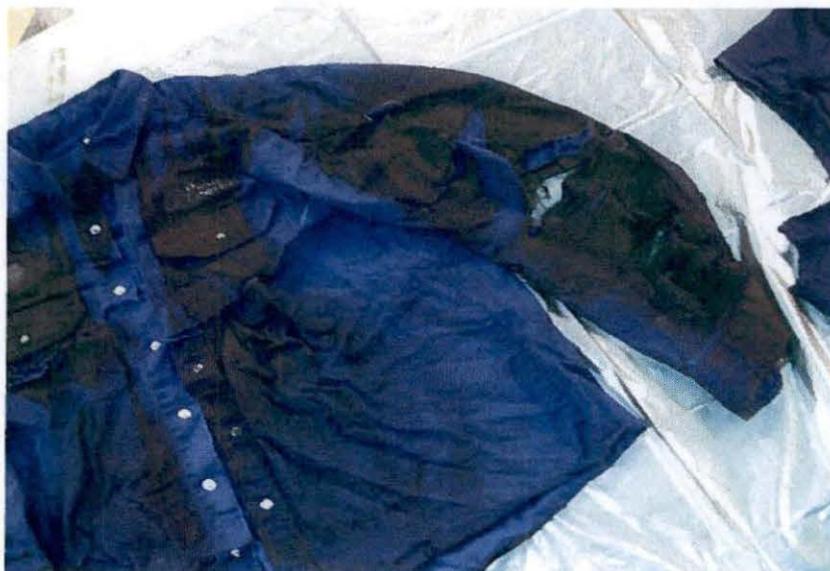
Photo 8. Senior Maintenance Electrician's clothes. Note burns and tears to left side of body.
