COMMONWEALTH OF KENTUCKY
BEFORE THE PUBLIC SERVICE COMMISSION

MAXIMUM PLUMBING INC.)	
)	
_____)	CASE NO.
)	2021-00361
ALLEGED VIOLATION OF UNDERGROUND)	
FACILITY DAMAGE PREVENTION ACT)

PIPELINE DAMAGE INVESTIGATION REPORT

Damage Investigation Findings

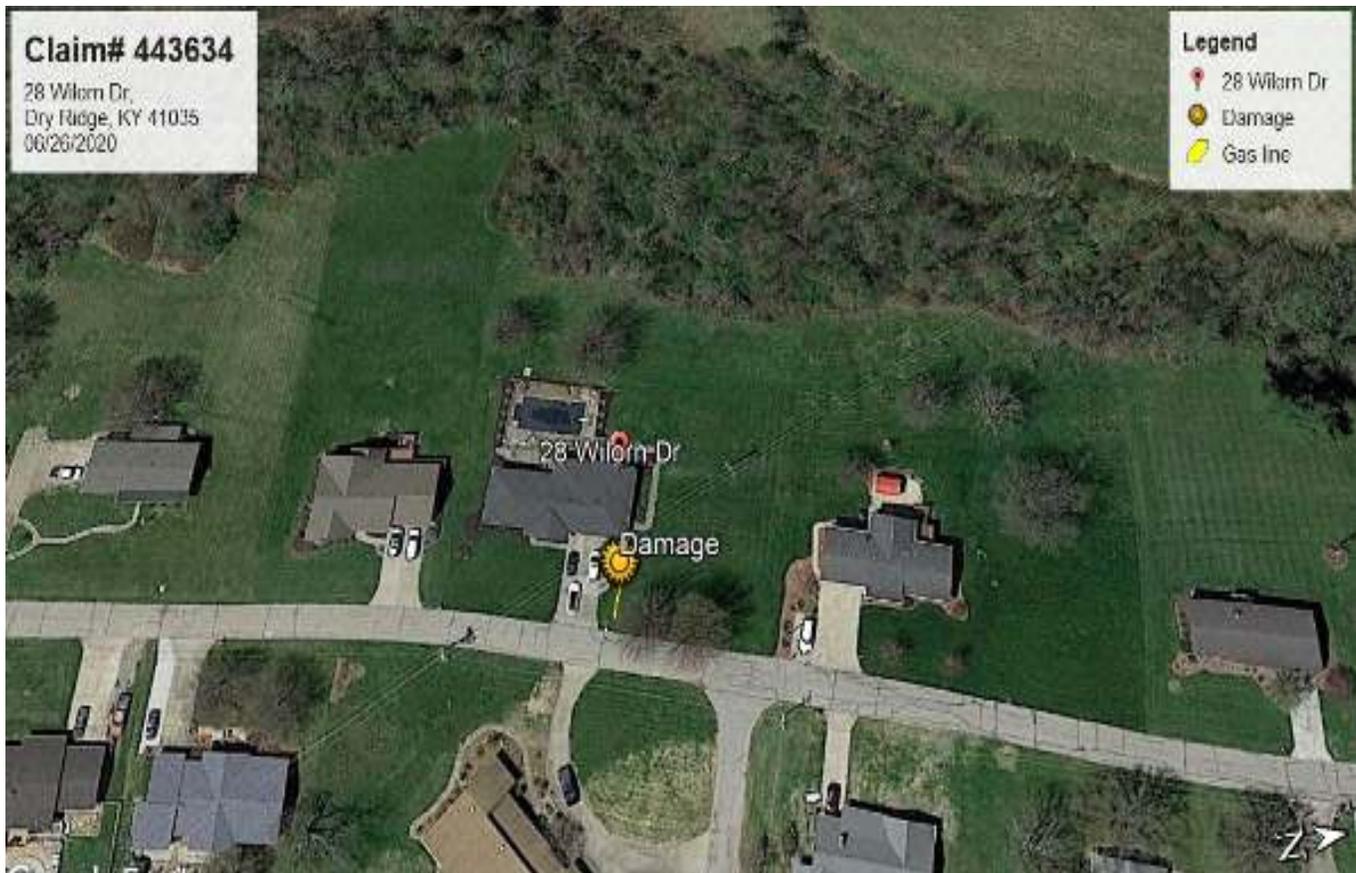
On Friday, June 26, 2020, I was notified by Duke Energy about damage at 28 Wilorn Dr, Dry Ridge, KY 41035. Duke Energy's Underground Facilities were damaged at the above stated location by a Backhoe.

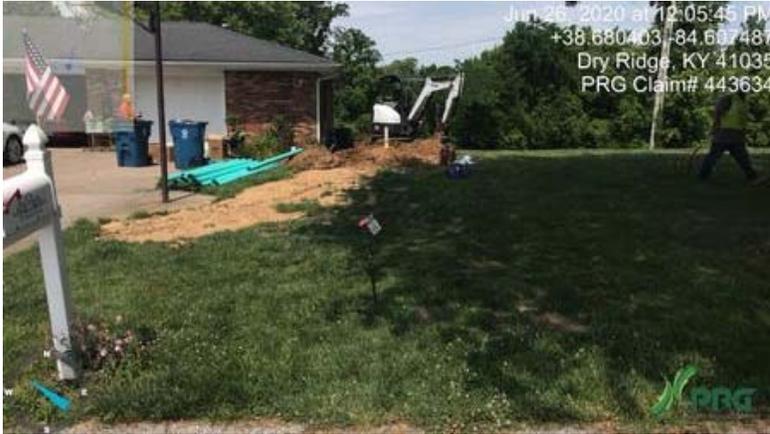
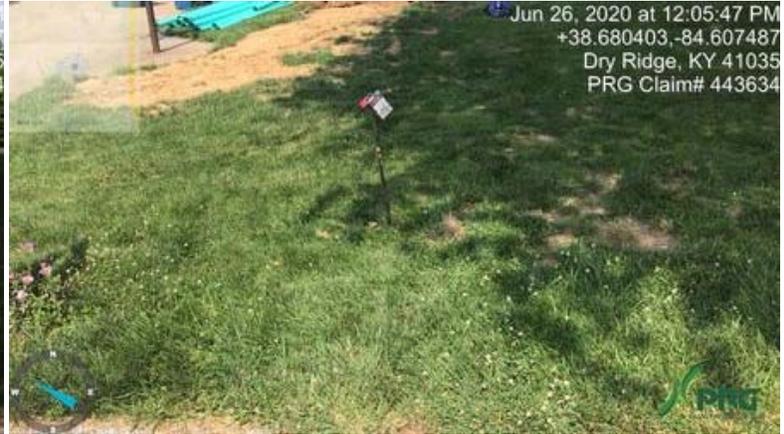
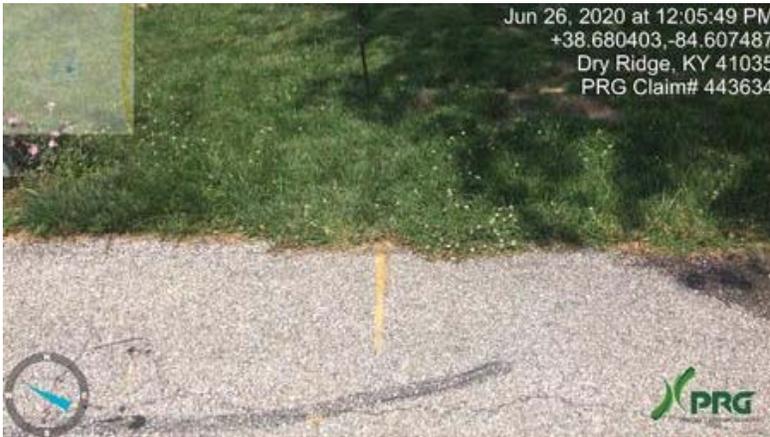
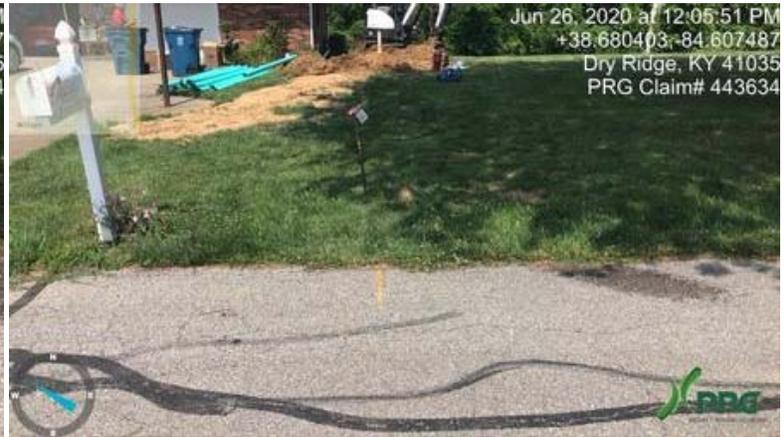
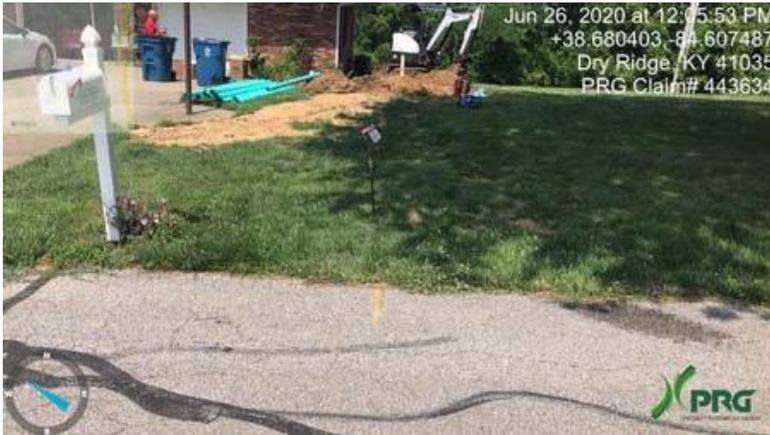
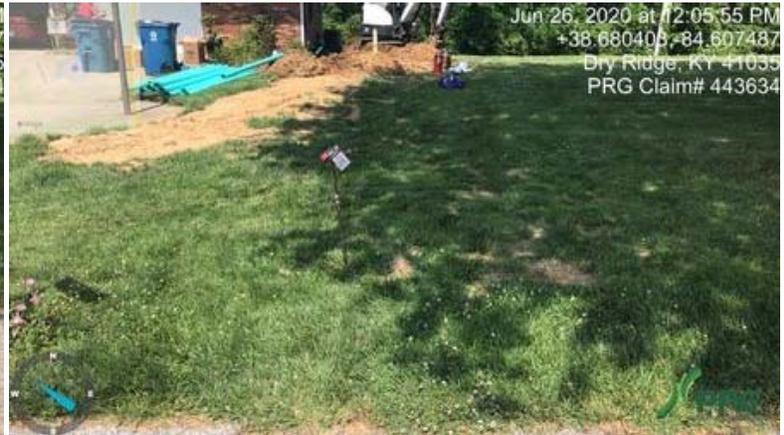
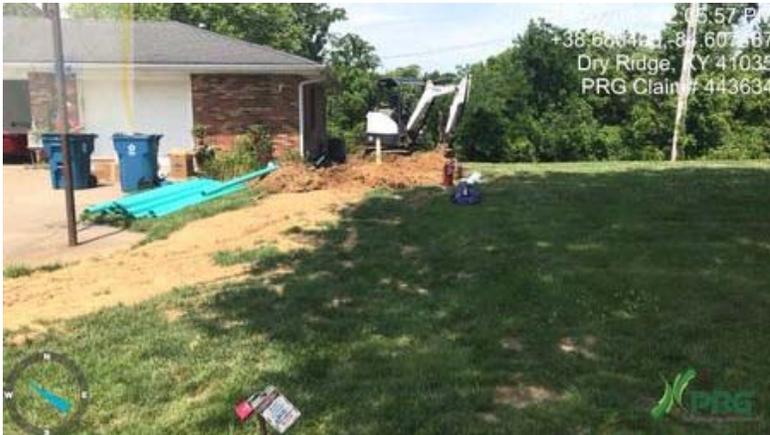
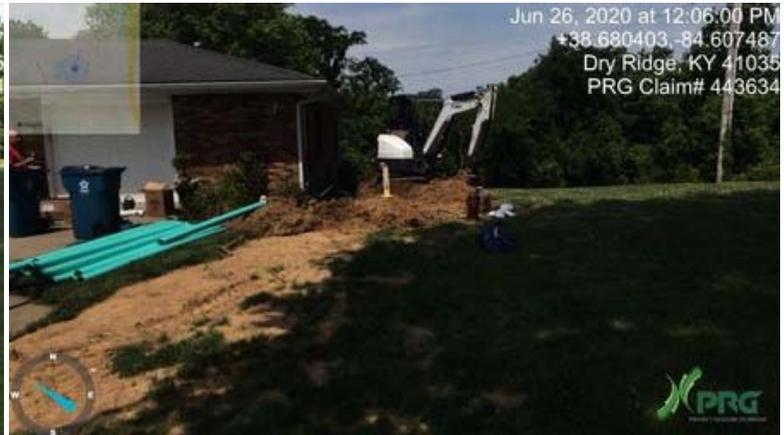
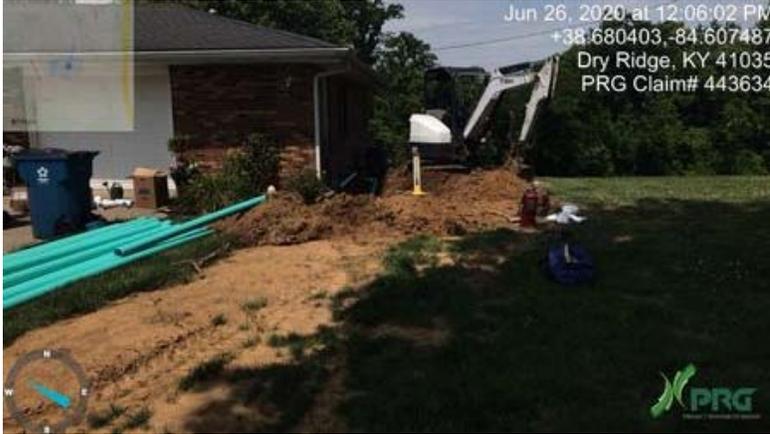
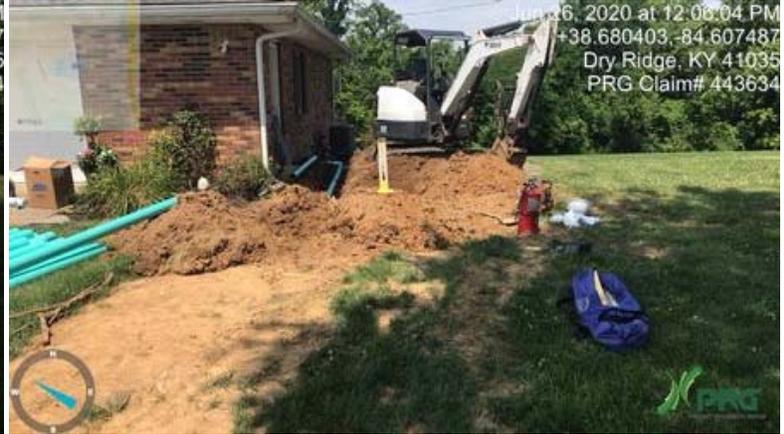
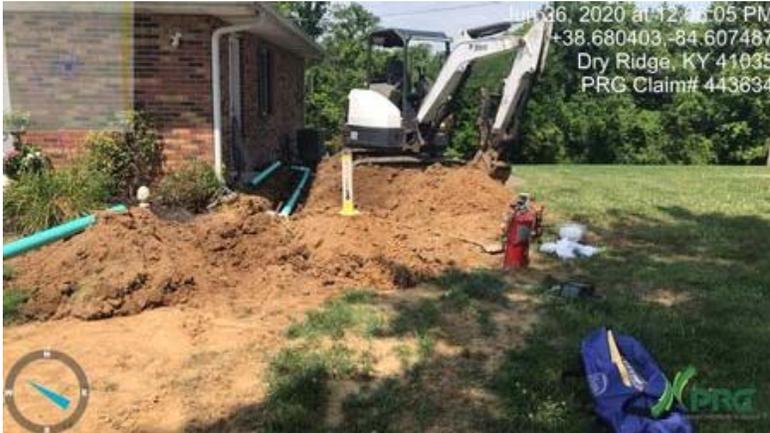
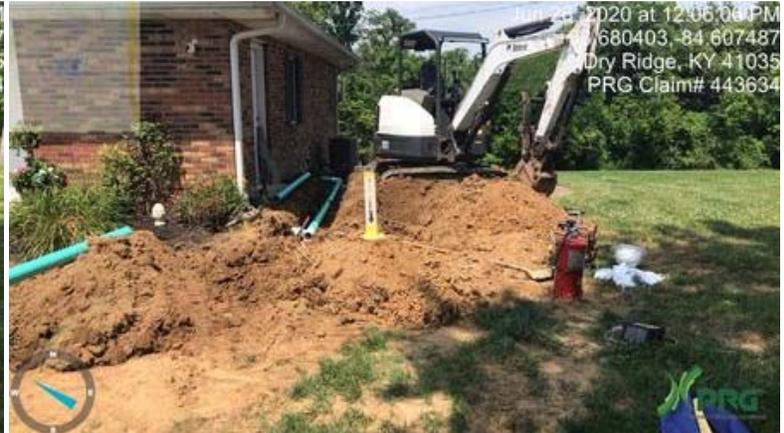
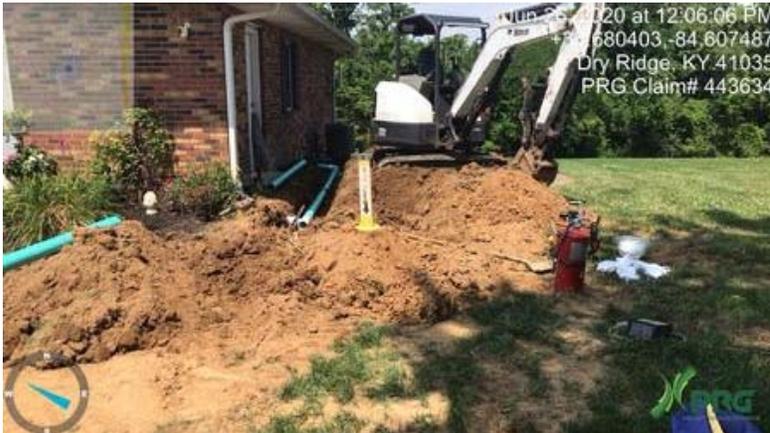
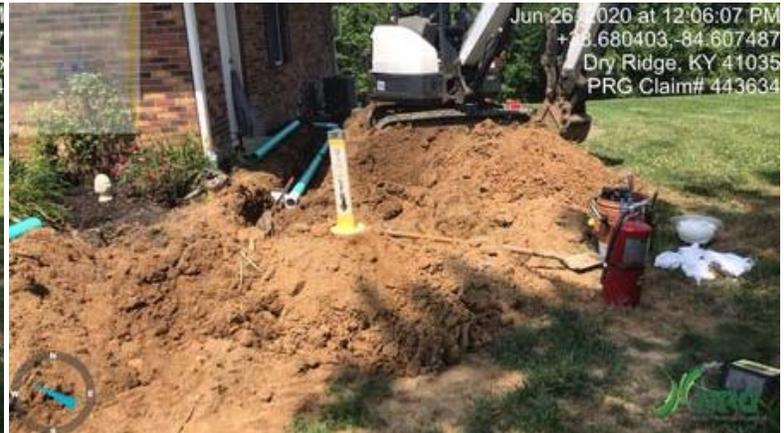
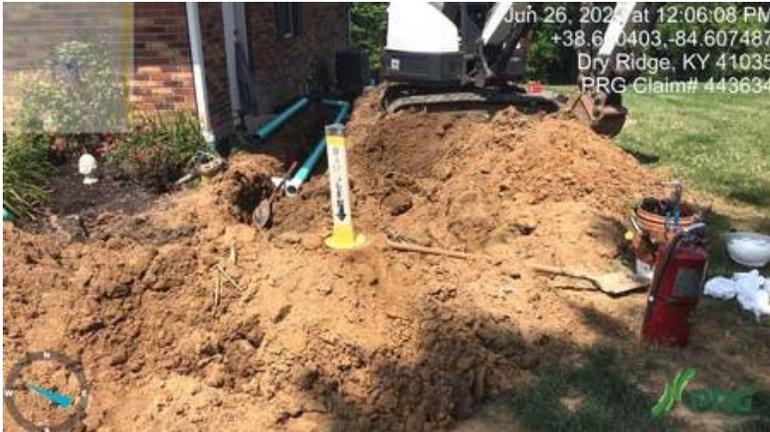
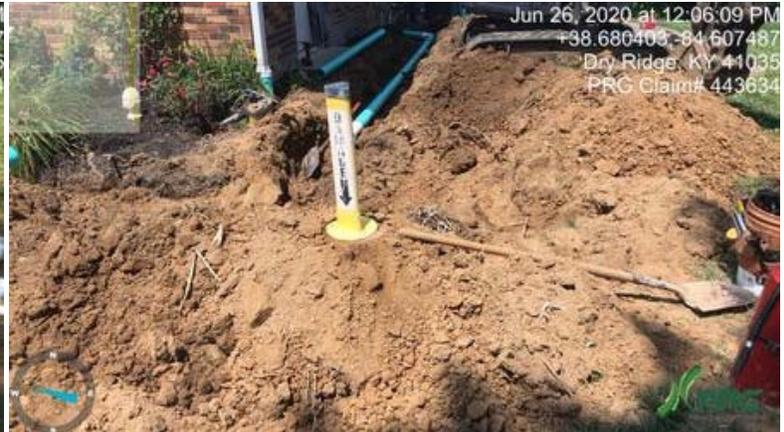
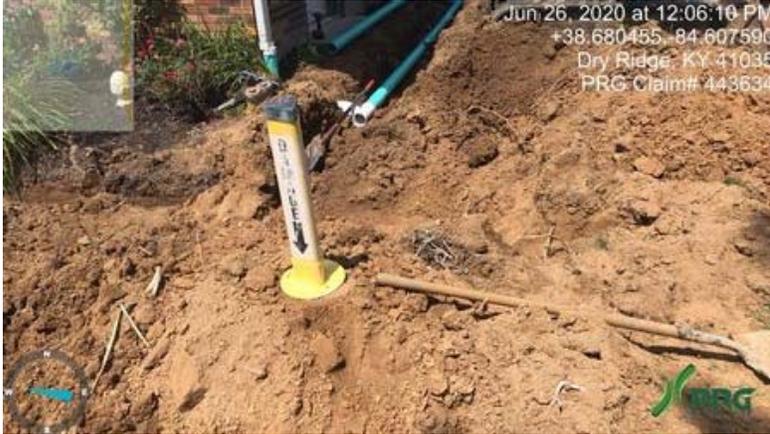
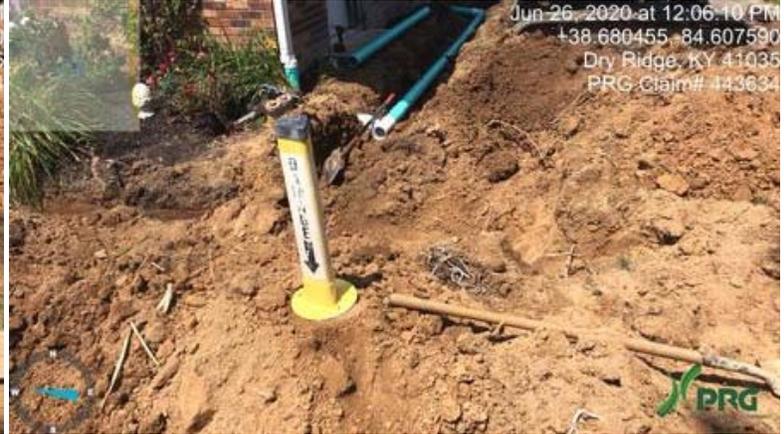
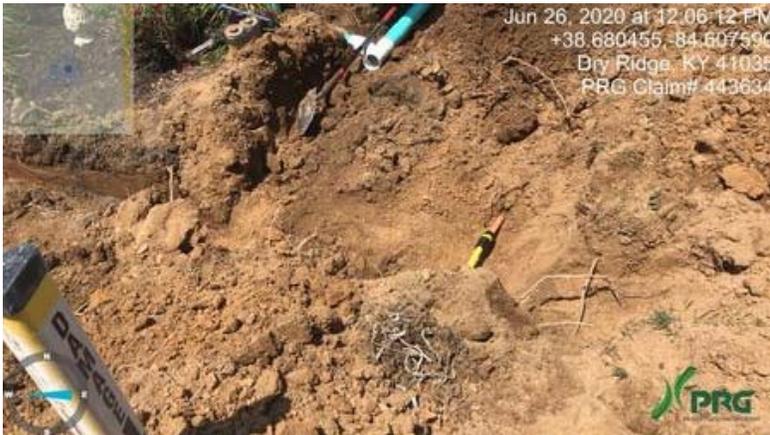
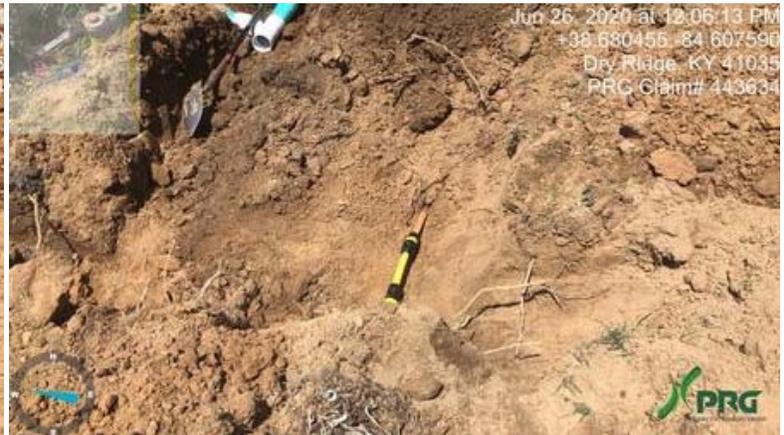
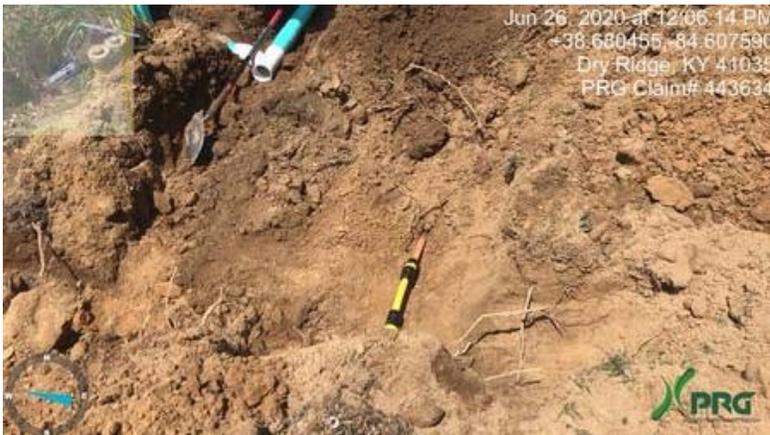
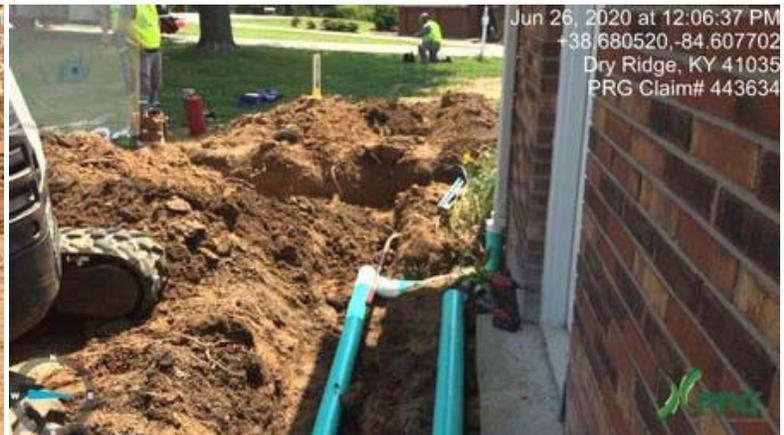
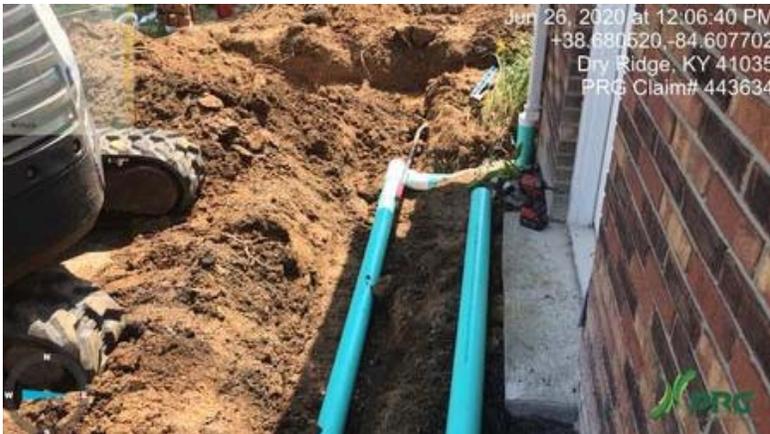
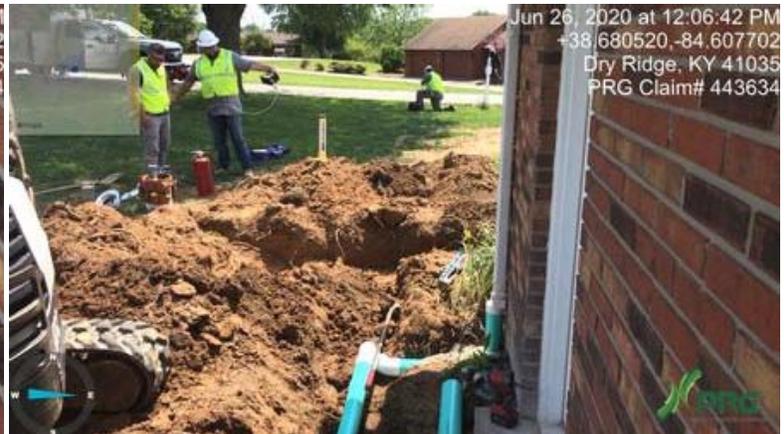
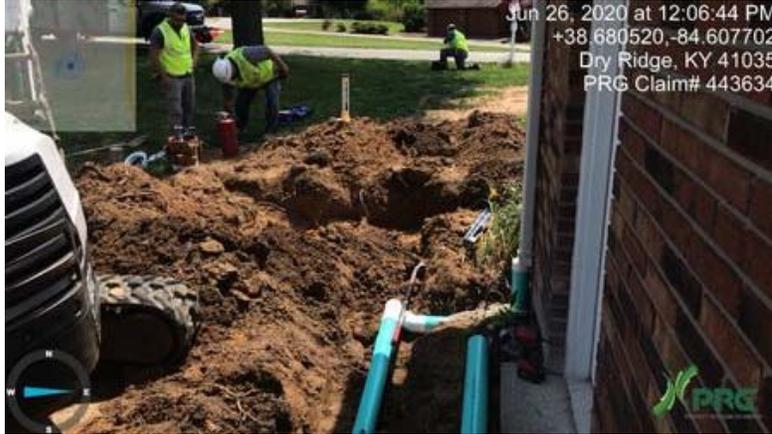
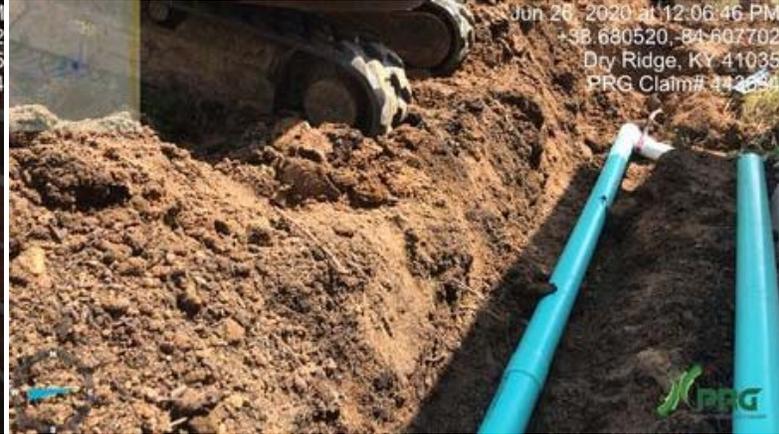
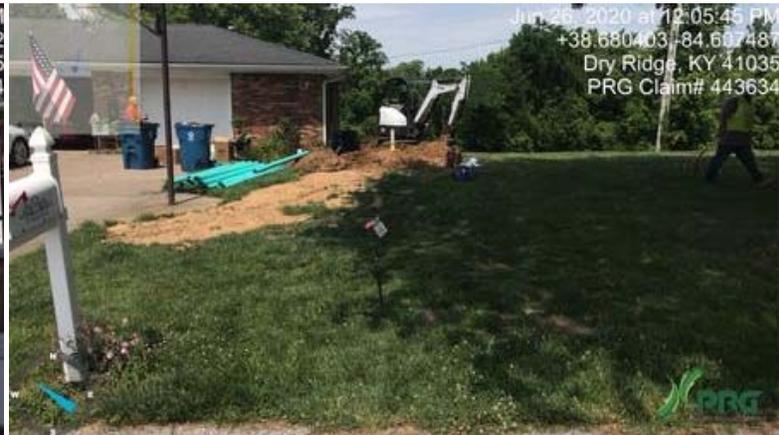
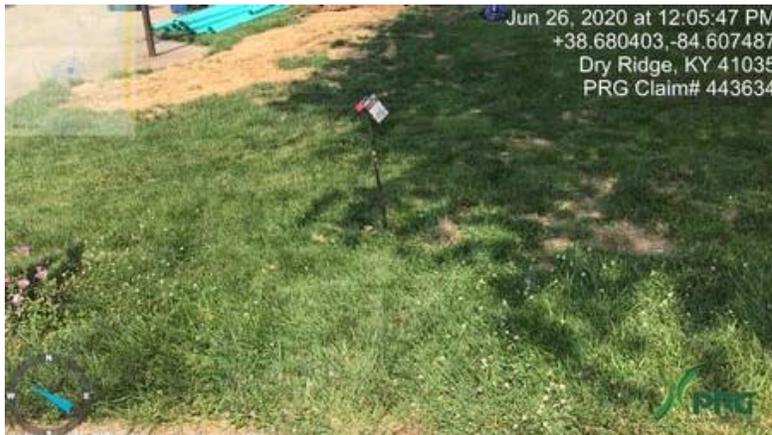
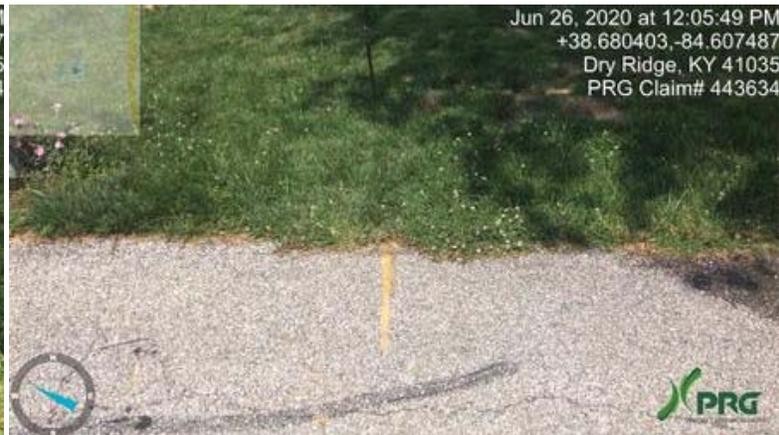
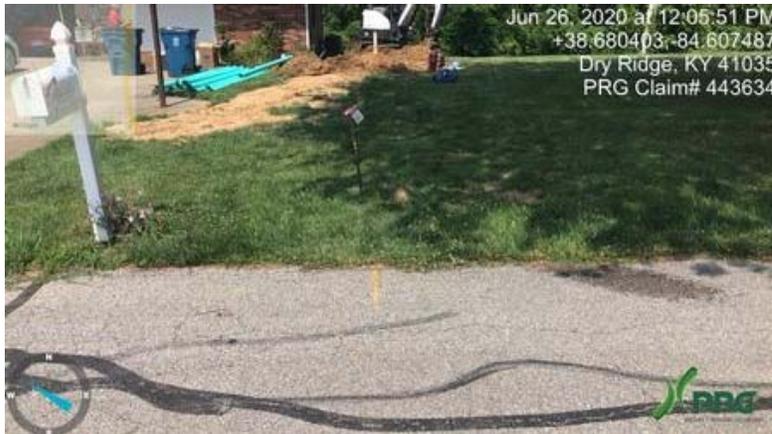
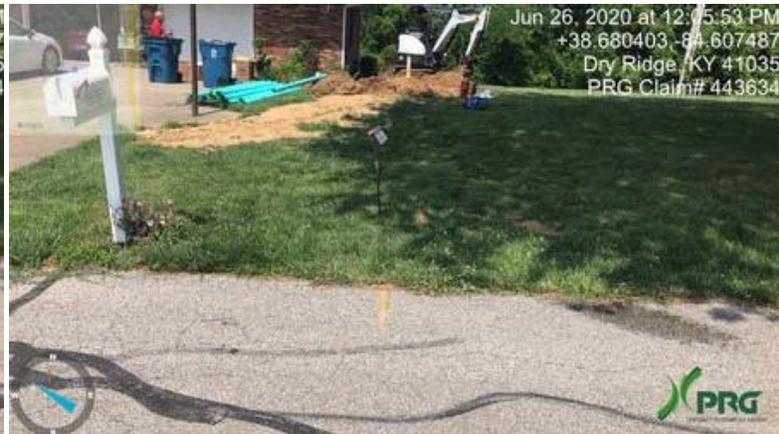
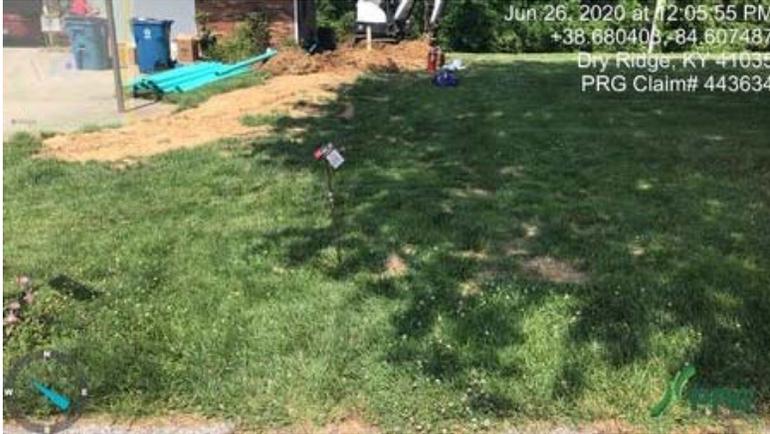
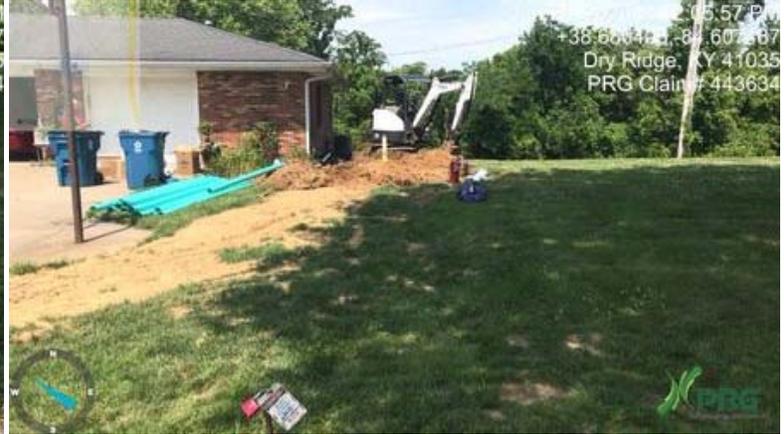
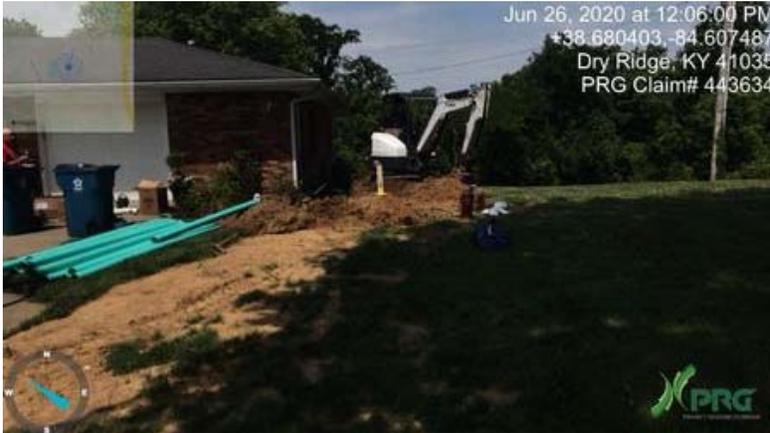
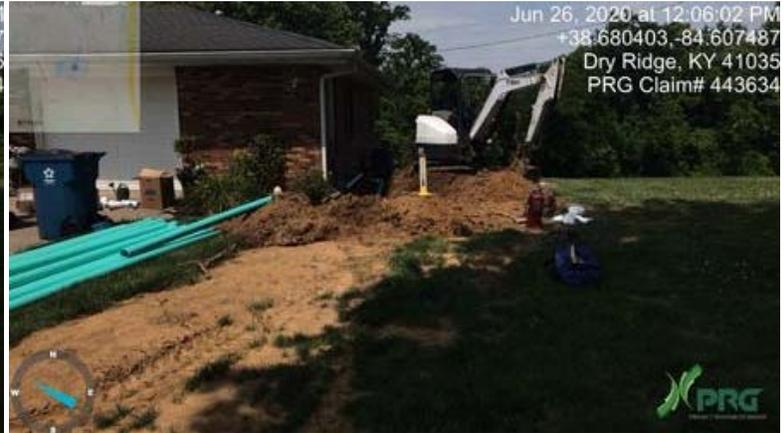
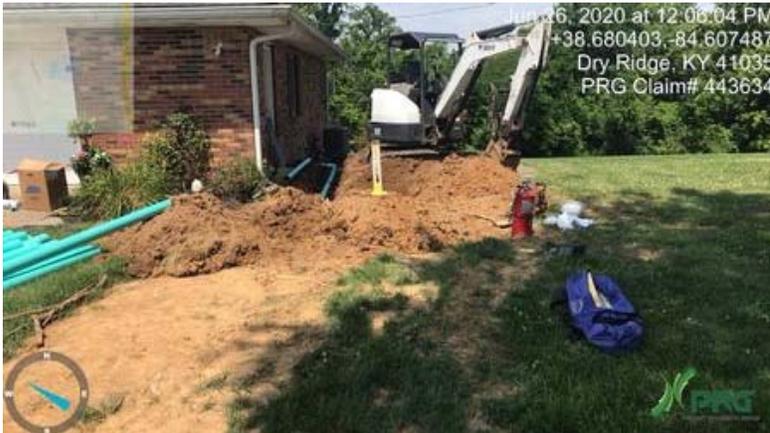
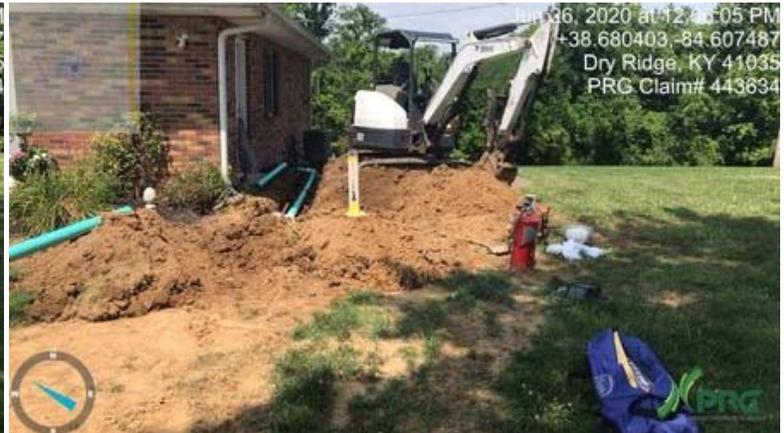
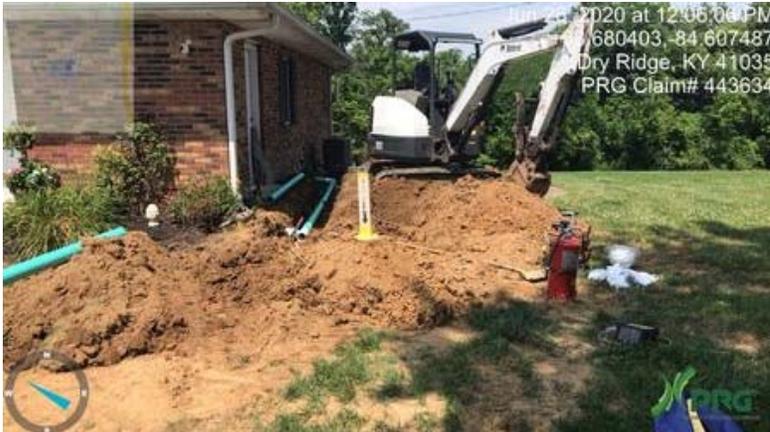
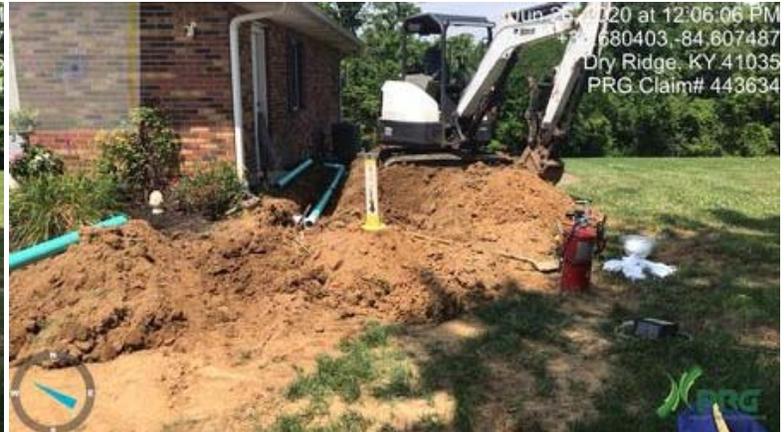
On Friday, June 26, 2020, Duke Energy suffered damage to its facilities at the above stated location as a direct result of a sewer installation/repair by Maximum Plumbing. In light of these circumstances, it has been determined that Maximum Plumbing will be held liable for this damage and the associated costs to Duke Energy.

ROOT CAUSE

Excavation on expired locate ticket

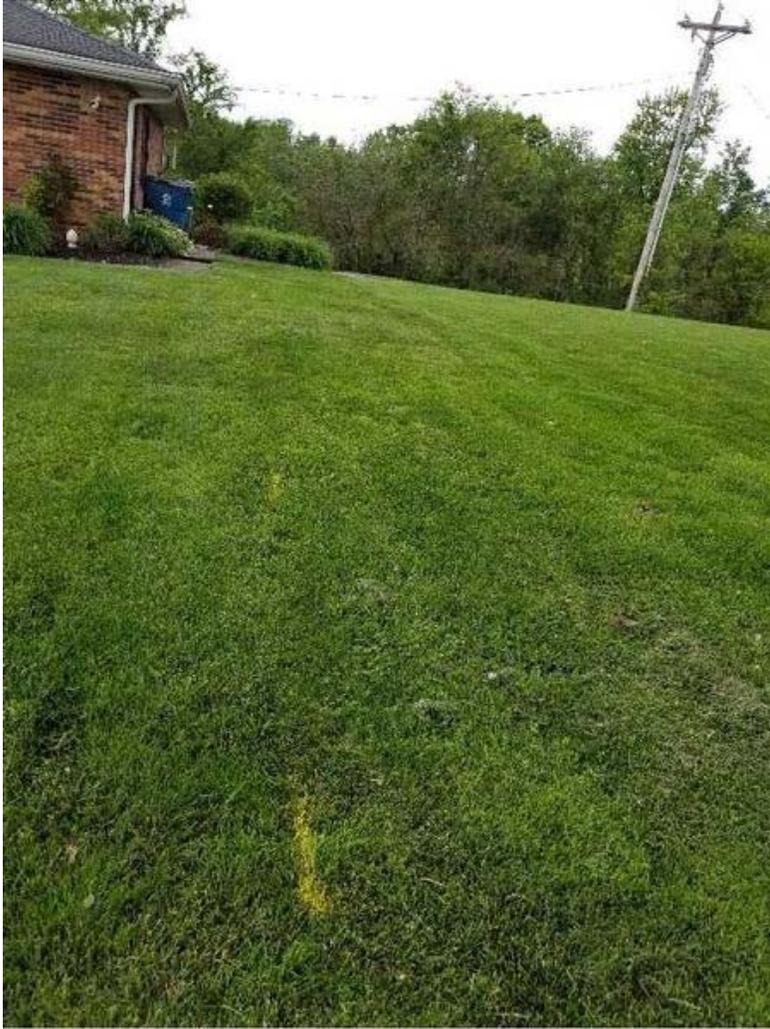
443634 - Locate Pre-Dig27.jpg

Property of United States Infrastructure Corporation
Photo created on 05/27/2020 16:10:03 PM EDT

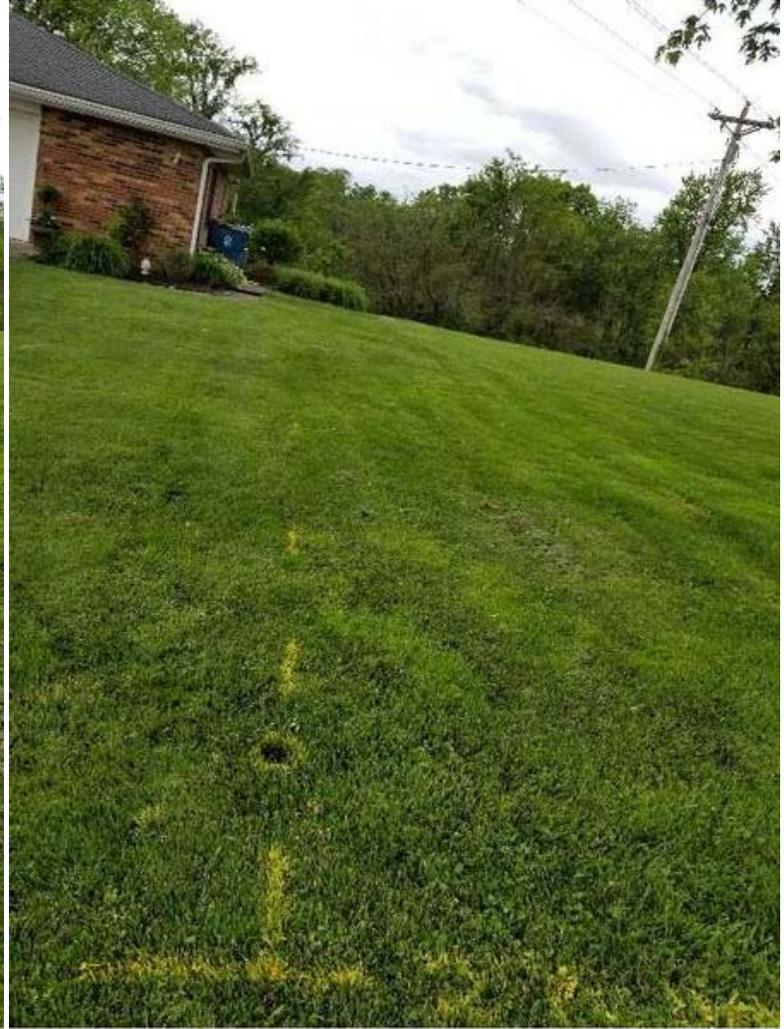
443634 - Locate Pre-Dig28.jpg

Property of United States Infrastructure Corporation
Photo created on 05/27/2020 16:10:05 PM EDT
