COMMONWEALTH OF KENTUCKY BEFORE THE PUBLIC SERVICE COMMISSION

In the Matter of:		
LUXURY GARDEN CENTER INC.)	
)	CASE NO. 2025-00088
ALLEGED VIOLATION OF UNDERGROUND FACILITY DAMAGE PREVENTION ACT)

INITIATING ORDER FOR ALLEGED 811 VIOLATION OF THE KENTUCKY UNDERGROUND FACILITY DAMAGE PREVENTION ACT

PIPELINE DAMAGE INVESTIGATION REPORT

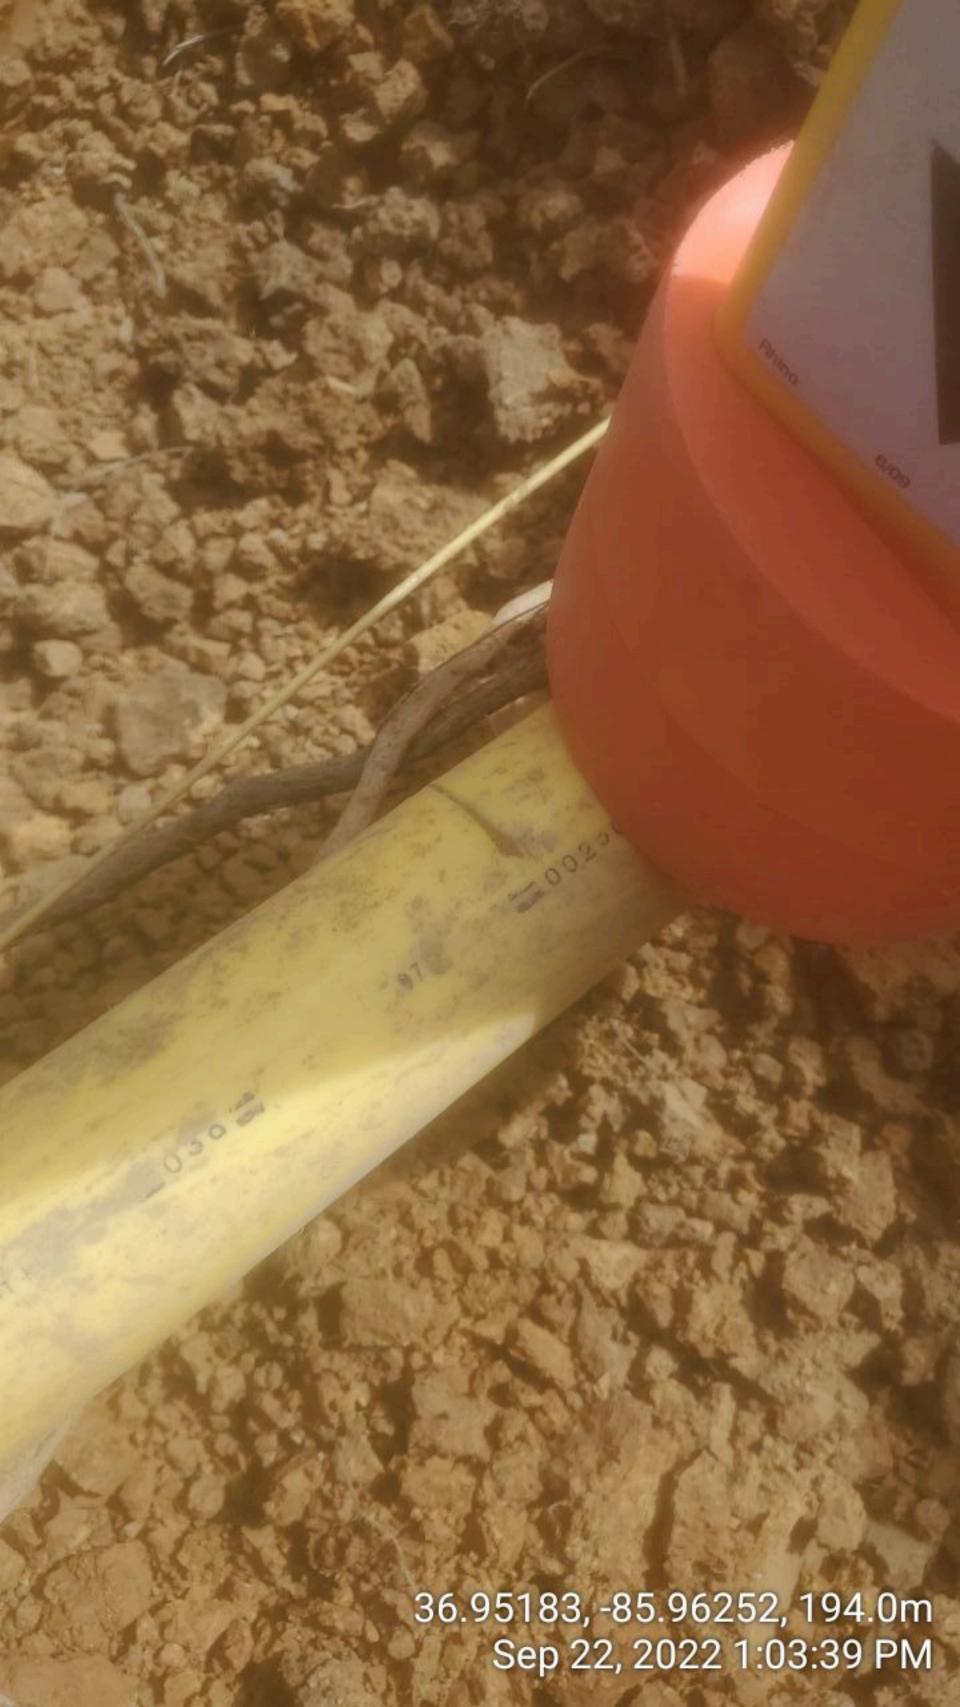
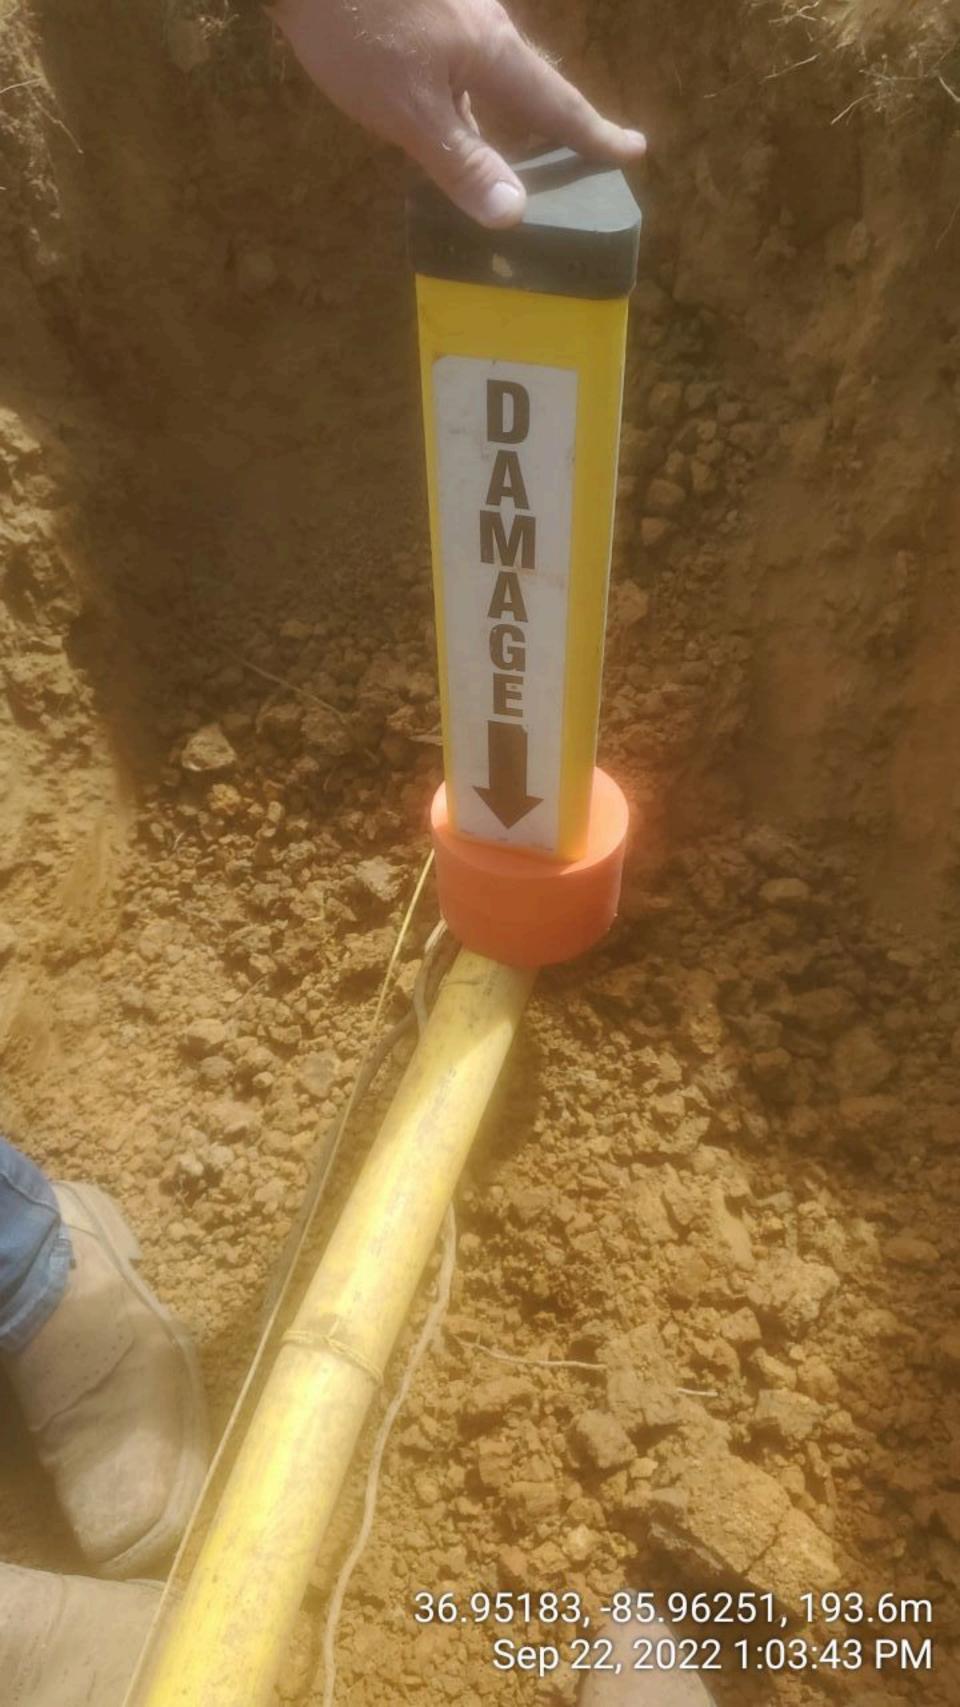
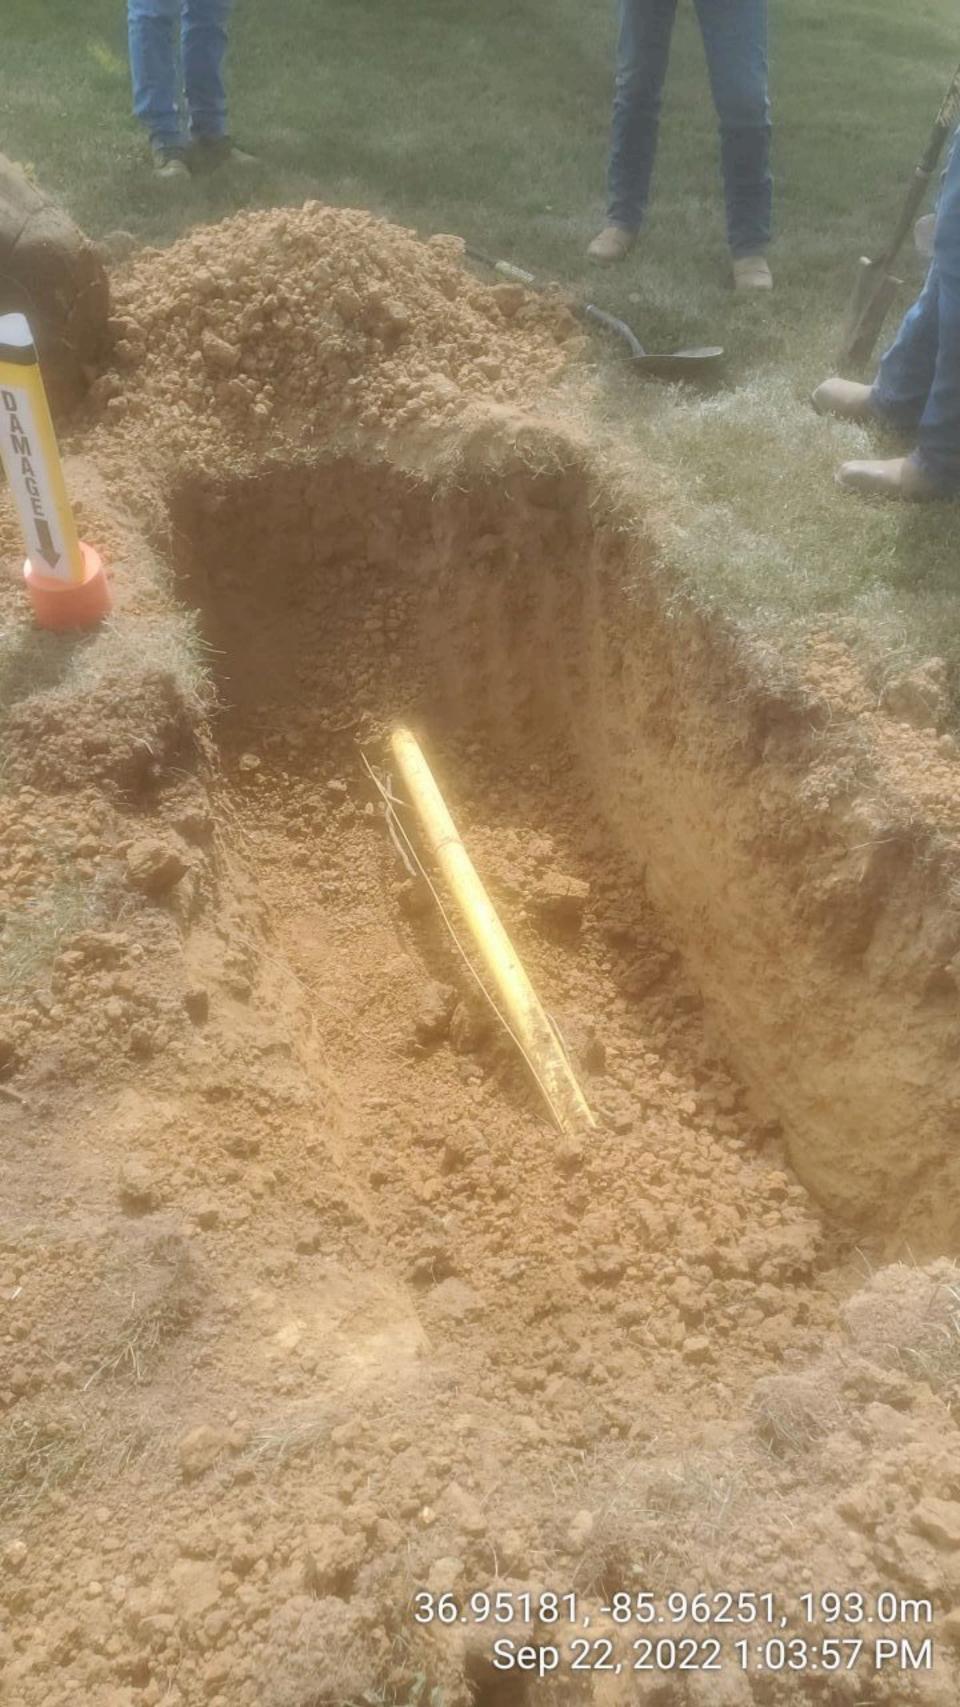
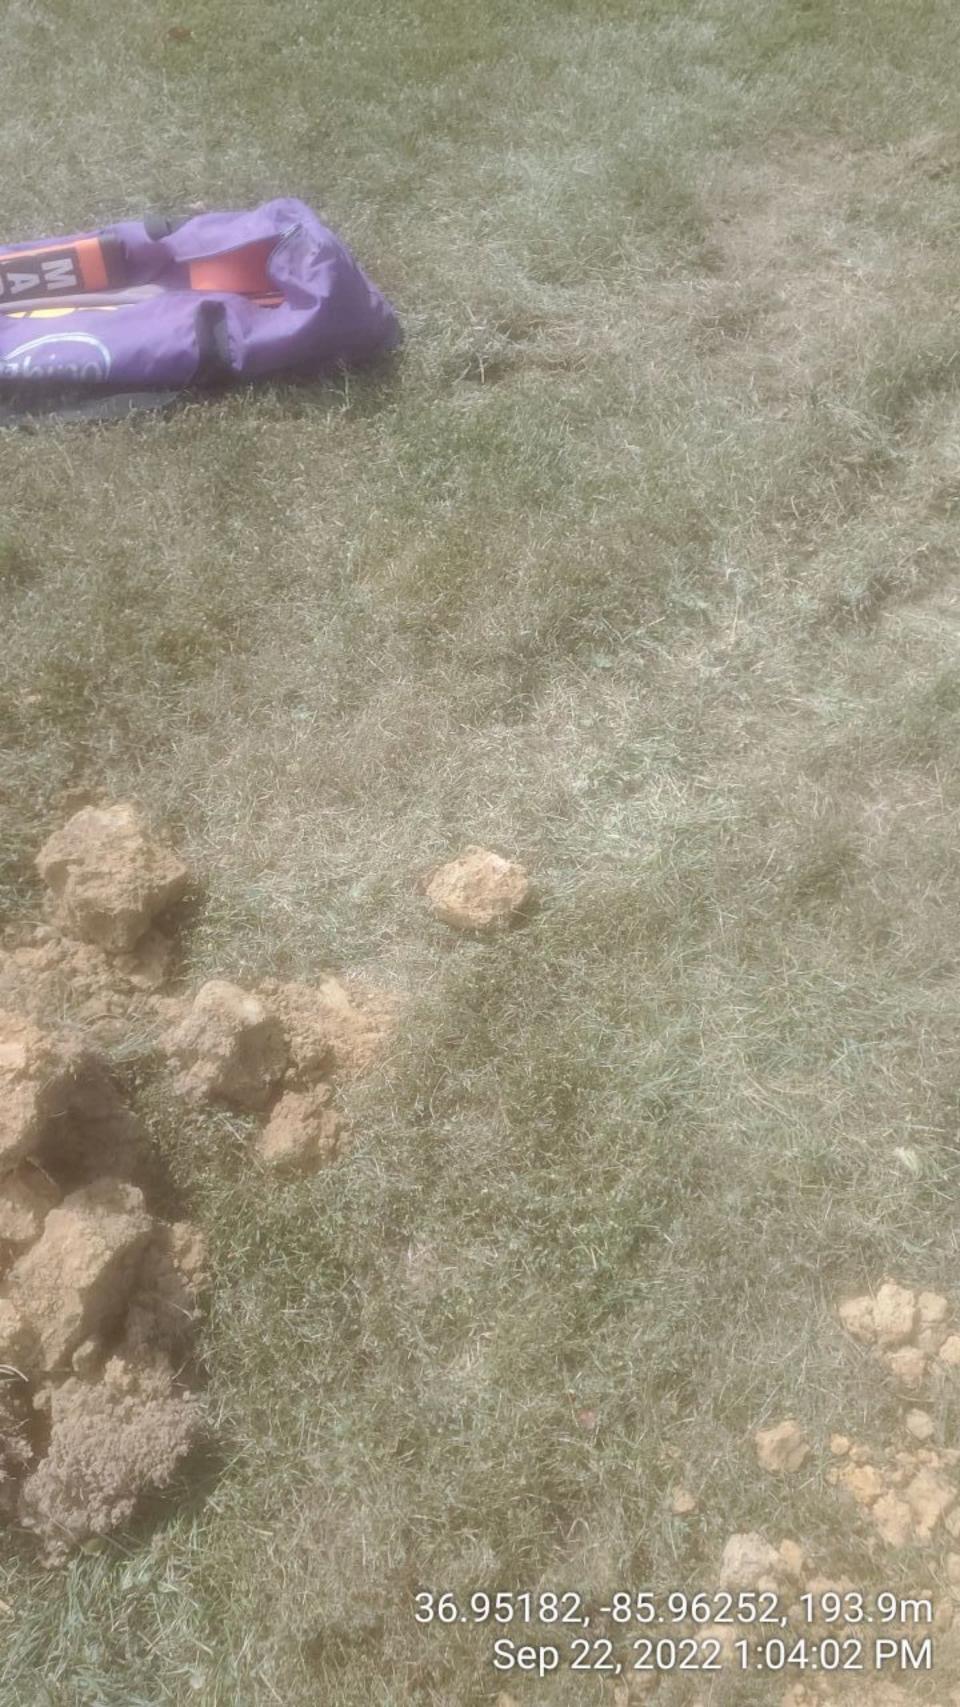
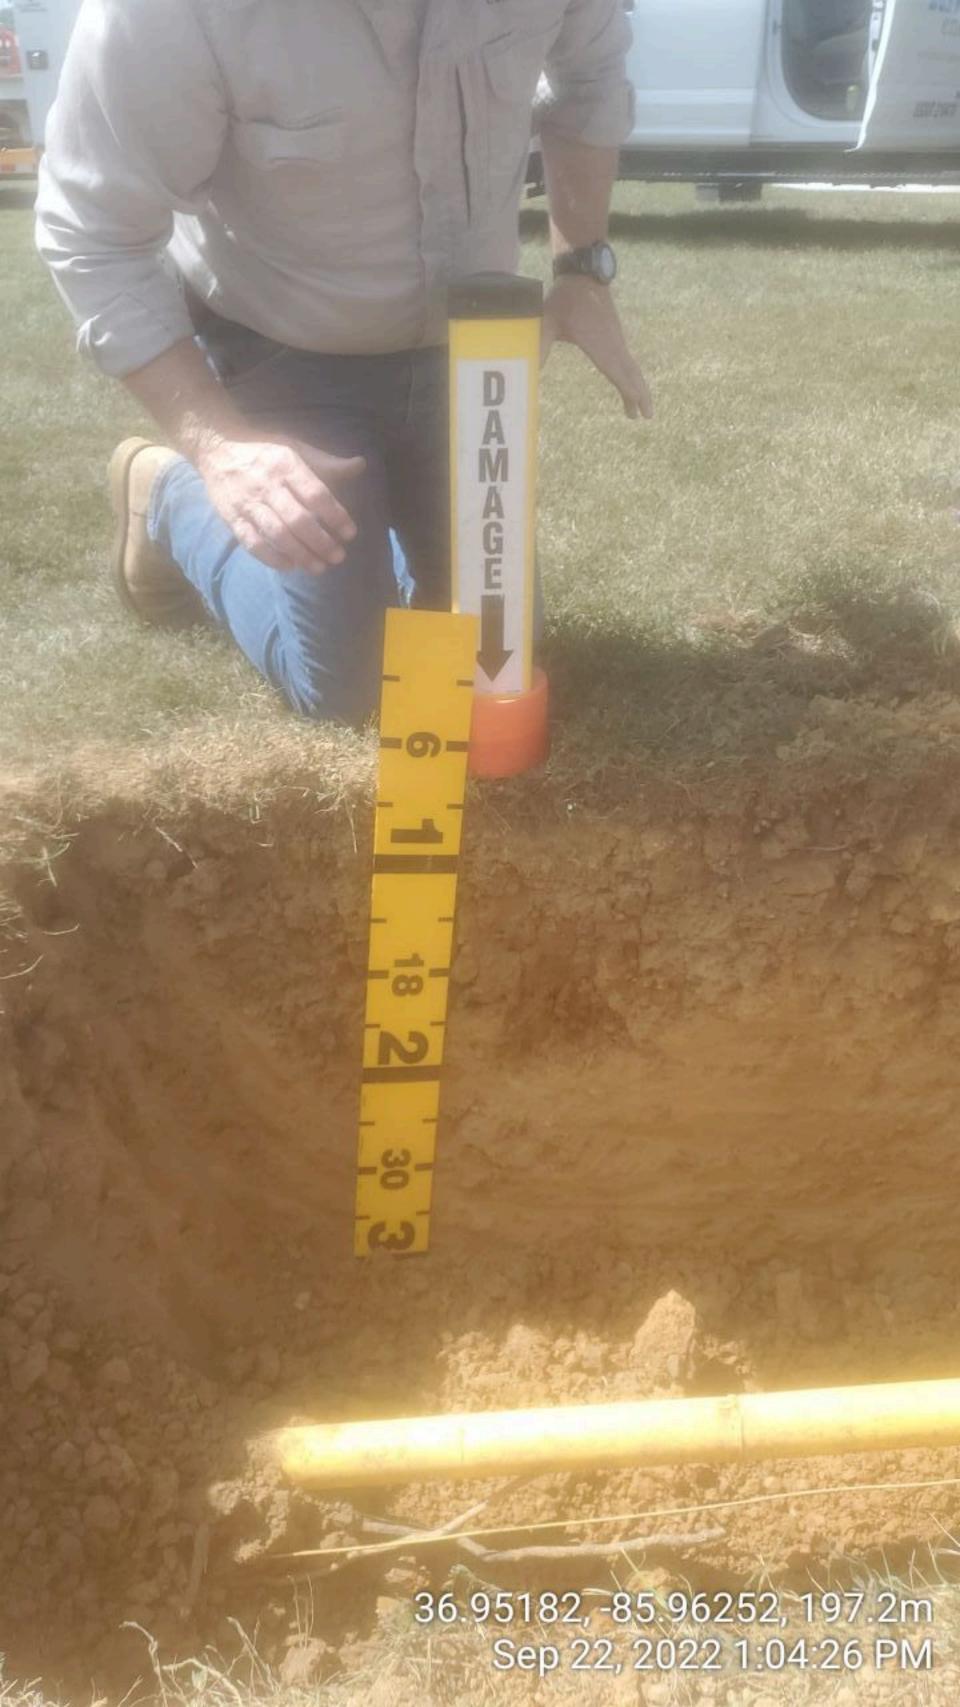
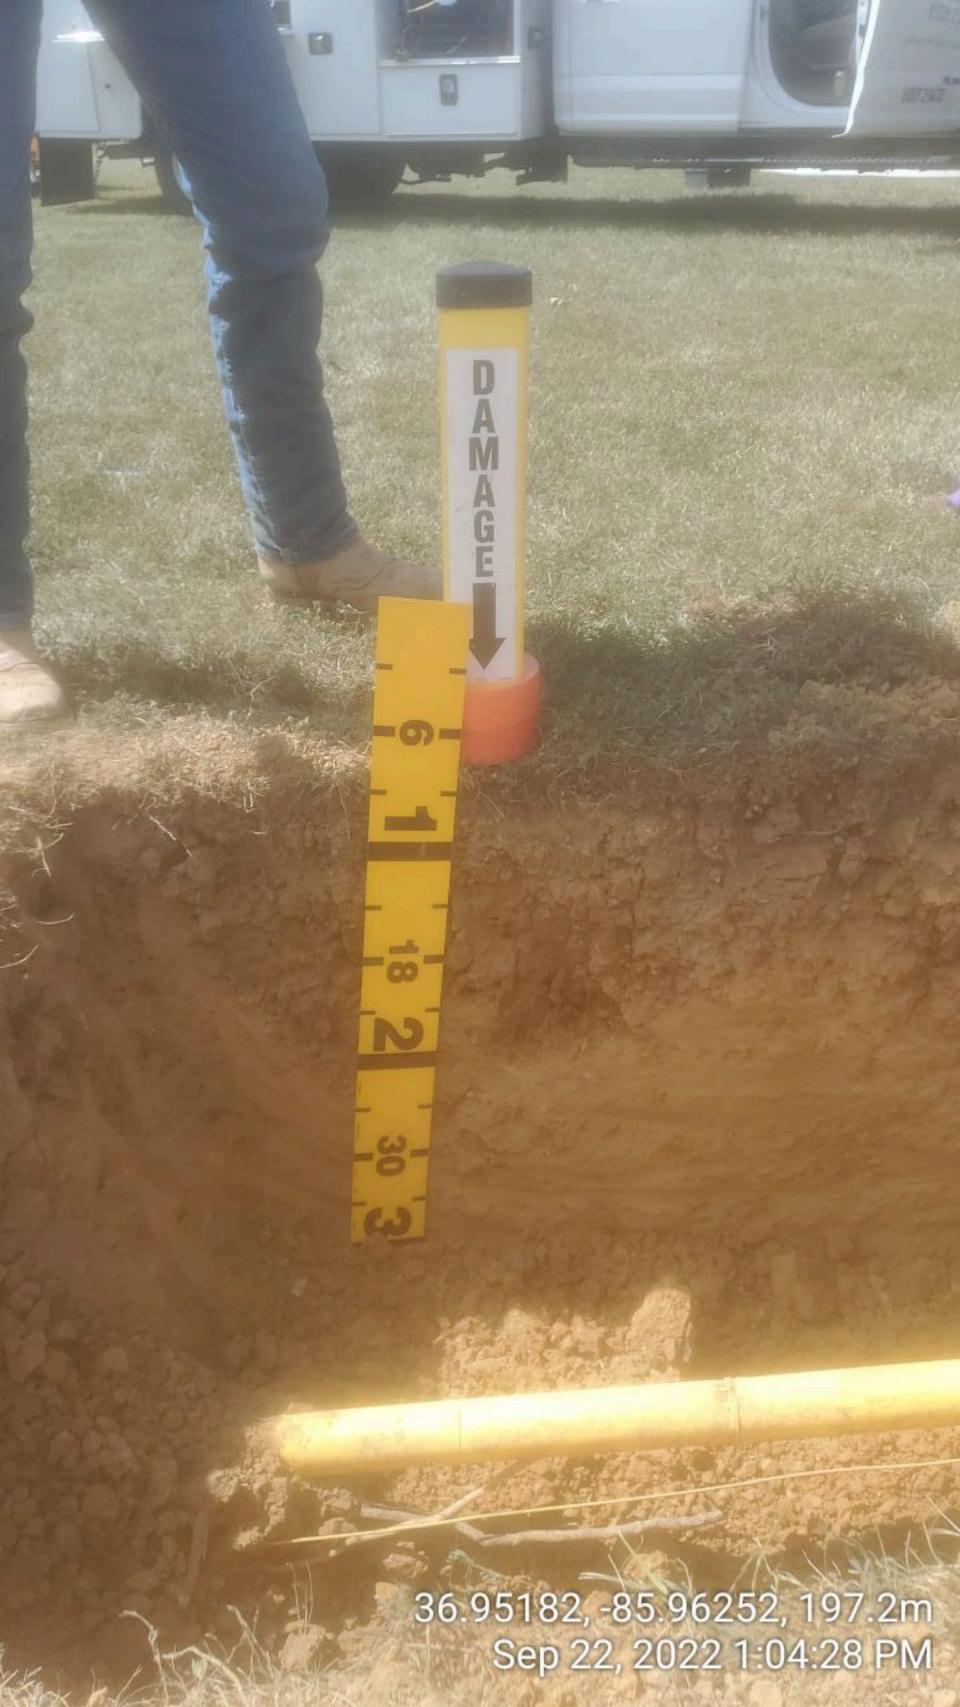
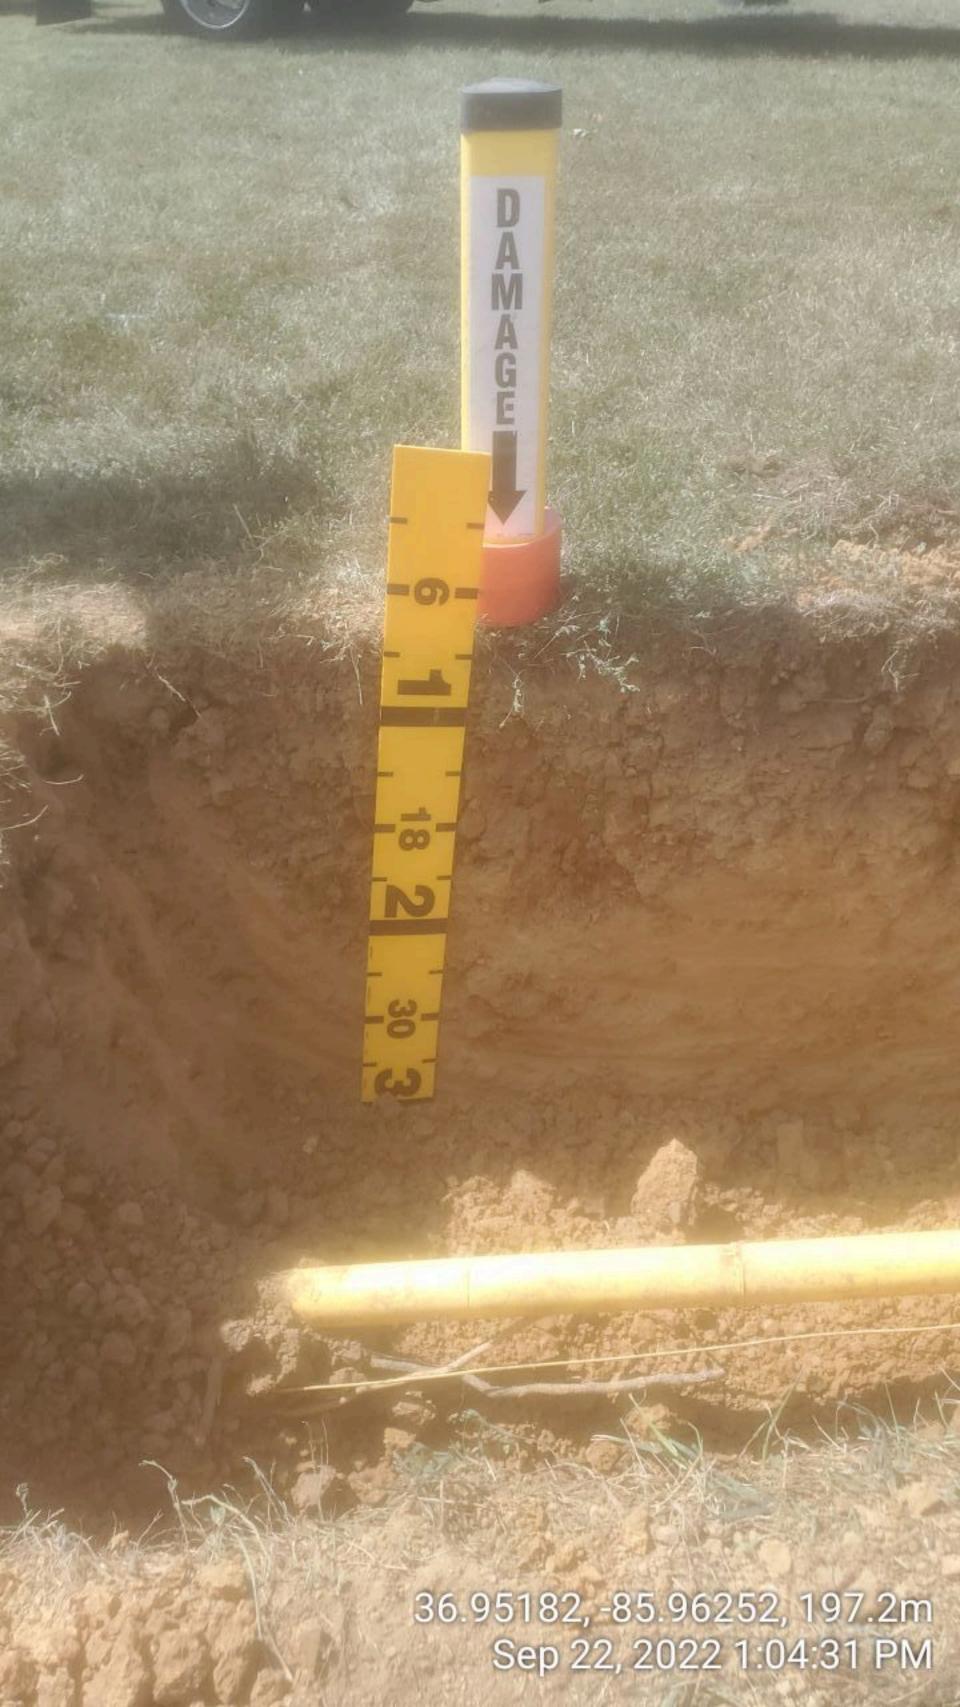
- <u>Leak Found Report, Third Party Damage Form & DR:</u> Outlined in the DR Summary and Attachment
 1.
- Seven Photographs: Depicting the incident location.
- Invoice: Indicating the Operator billed the Excavator \$1,030.25 for the damage repair.

Full details such as the Luxury Garden Center damaged a 2" PE main with a mechanical auger while planting trees. Locate 2209201706 was valid but excavation started before the line was marked.

2" PE main repaired. 4 customers off.

Luxury Garden Center was billed for the repairs. Tanner from Luxury Lawn and Landscapes was educated on calling 811 and waiting for a positive response to dig.
