**THIELSCH ENGINEERING, INC.
195 FRANCES AVENUE
CRANSTON, RHODE ISLAND 02910**

MARCH 2012
INSPECTION OF
BOILER HEADERS
UNIT NO. 2
MITCHELL GENERATING STATION
AMERICAN ELECTRIC POWER
MOUNDSVILLE, WEST VIRGINIA

September 7, 2012

Report No. 14151

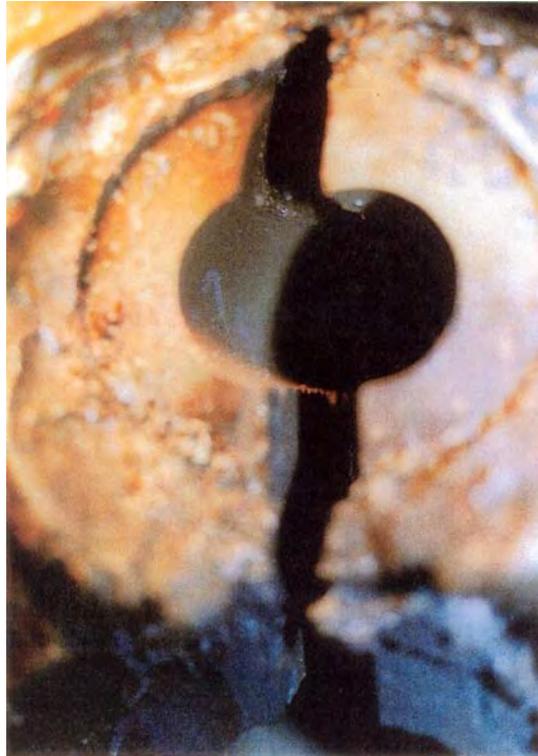
The header shown below is a case in point. The inspection of this header, located at a midwestern utility, revealed ligament cracking in multiple tube rows. The most severe cracking was located in tube holes that overlapped the circumferential girth welds. (The girth welds had been counterbored and flat-topped during original fabrication.) The subsequent metallurgical evaluation confirmed that the girth welds, which had been completed using low-carbon filler material, were subject to advanced creep deterioration (even though the header base material showed no evidence of creep deterioration).

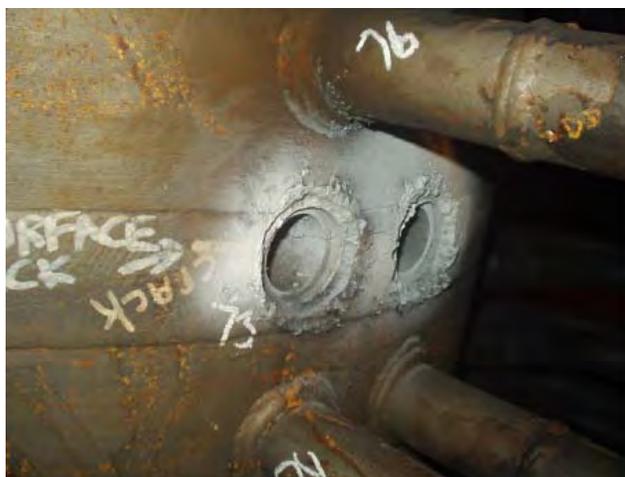
The header shown below is another case in point. This header, located in the southeastern United States, began leaking after 28 years of high-temperature service. The subsequent investigation confirmed that in the area where the leak occurred, the tube holes substantially overlapped a circumferential girth weld. (Again, the girth weld had been completed using low-carbon filler material. In addition, it had been counterbored.) The investigation confirmed that in this area, the header was subject to cracking of the header-to-tube stub welds. It was also subject to ligament cracking that extended through the available cross-sectional thickness. No additional cracking was revealed at any of the other 250 header-to-tube stub welds.

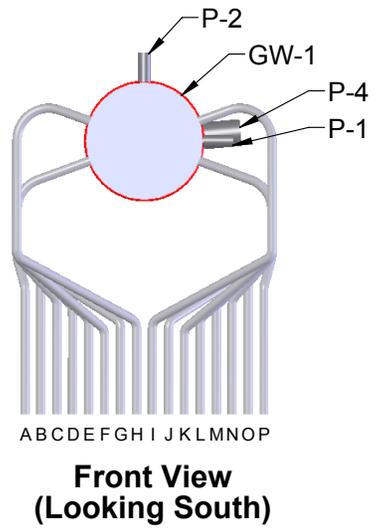
Fig. 1. Sketch of the Platen Superheater Inlet header

The visual examination of the Platen Superheater Inlet header did not reveal any evidence of cracking, distortion, or other deterioration. No evidence of sagging or bowing was noted along the header.

The diameter measurements performed on the Platen Superheater Inlet header fell within the permissible manufacturing tolerances. There was no evidence of general swelling such as would be produced by creep deterioration. (This conclusion is

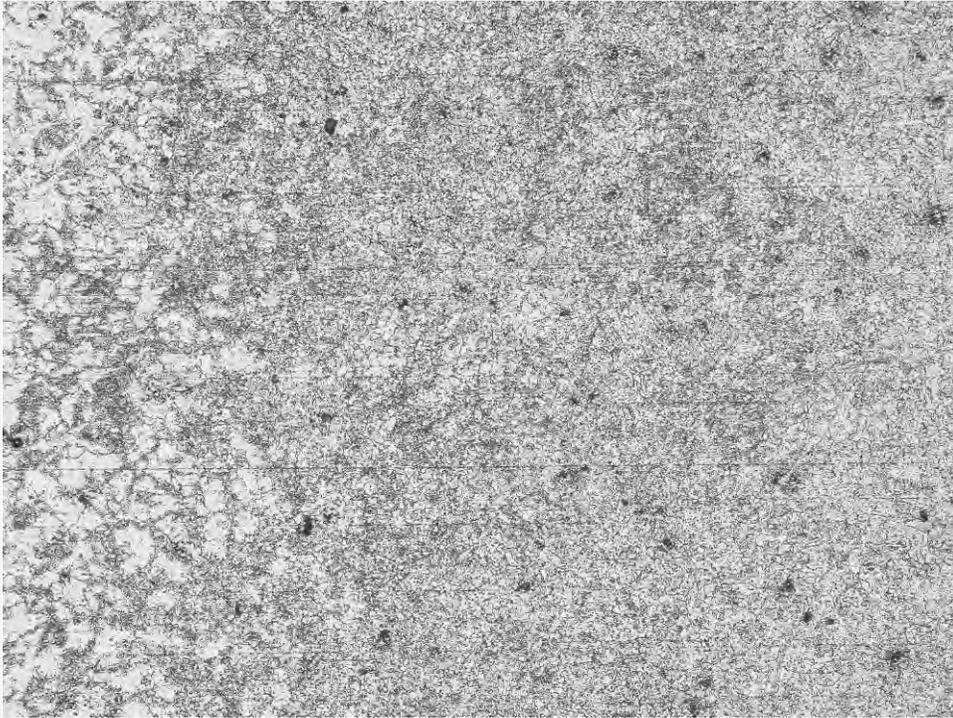
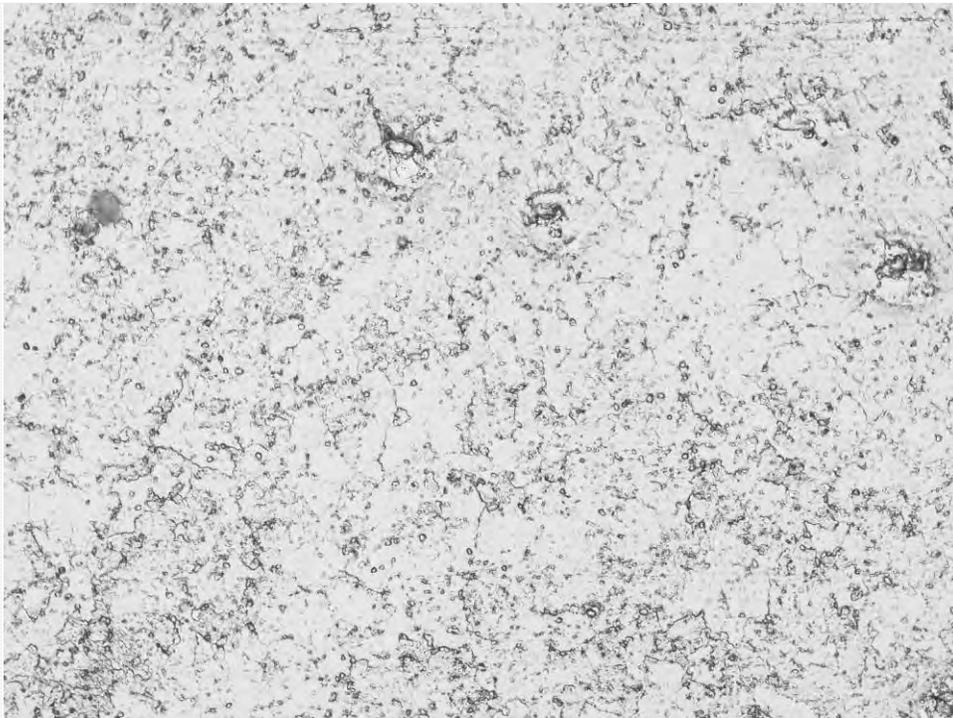
Fig. 8. Replica No. PSIH-R4.

All of the replica foils removed from the Platen Superheater Inlet header (PSIH) exhibited similar microstructures. Specifically, the microstructure exhibited by the welds consisted of bainite and limited amount of ferrite martensite. The microstructure exhibited by the heat-affected zones consisted of spheroidized pearlite and ferrite. The microstructure exhibited by the base material also consisted of ferrite in a matrix of spheroidized pearlite. Even though the material specified for the header is ASME SA-335 P11, the microstructure observed in these replica foils are typical of ASME SA-204 Grade A steel plate. The microstructures observed in these replica foils are typical for low-alloy C - 1/2 Mo steel pipe produces in accordance with ASME SA-204 Grade A plate, and filler material of the equivalent chemical composition that has been subjected to high-temperature service for extended period of time.

The base material did exhibit some microstructural transformations as a result of high-temperature service for an extended period of time. This included partial decomposition of bainite and spheroidization of pearlite. It also included carbide precipitation and agglomeration at the grain boundaries. These microstructural transformations are not unexpected for carbon and low-alloy steel materials and subsequent to prolonged high-temperature service.

As noted previously, bainite decomposition and spheroidization of pearlite, along with carbide precipitation and agglomeration, are the early precursors to creep deterioration. Despite this, none of the replica foils removed from the Platen Superheater Inlet header and the tubes exhibited evidence of creep deterioration.

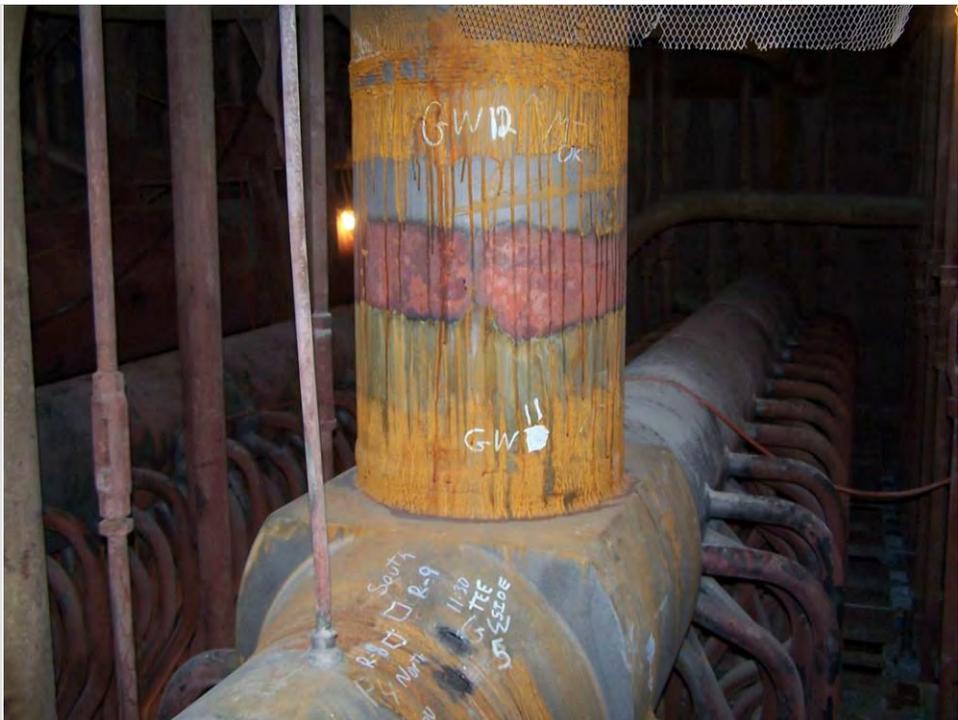
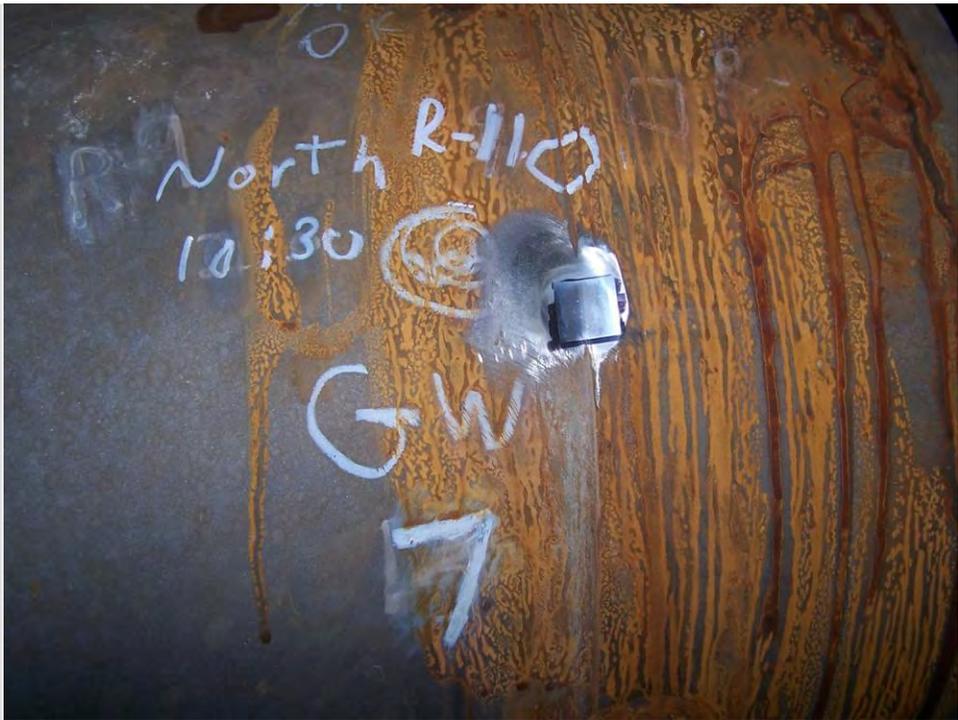
Fig. 17. Photographs of the inspection locations on the Platen Superheater Outlet header.

The visual examination of the Platen Superheater Outlet header did not reveal any indications of cracking, distortion, or other deterioration. No evidence of sagging or bowing was noted along the header.

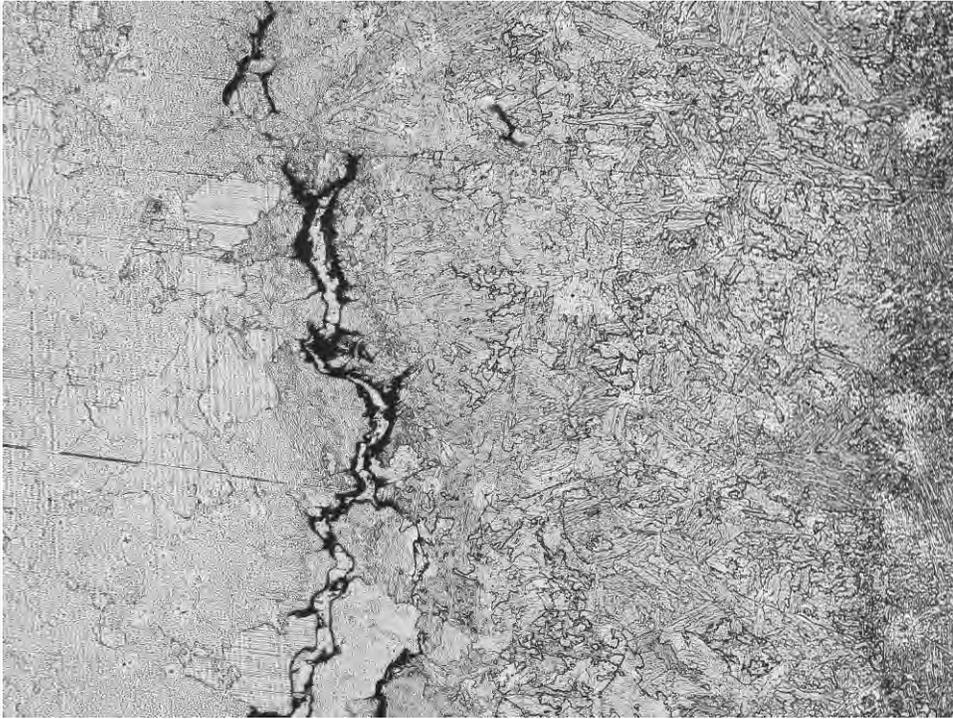
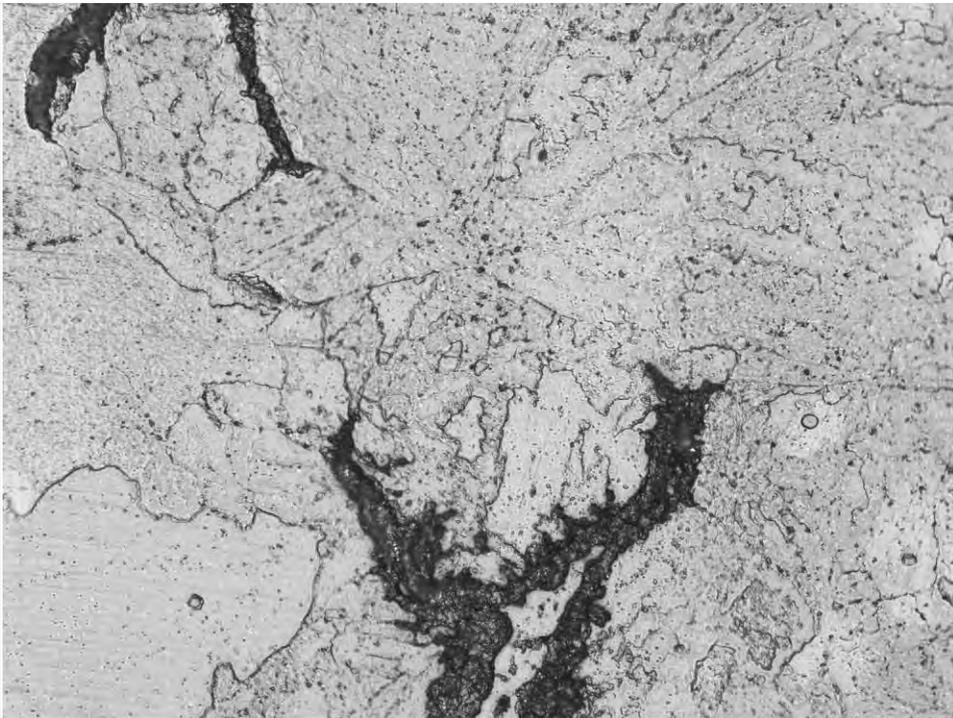
Fig. 26. Replica No. PSOH-R8.

The replica foils, except for replica PSOH-R8, removed from the Platen Superheater Outlet header exhibited similar microstructures. Specifically, the microstructure exhibited by the welds consisted of bainite with limited amount of ferrite. The microstructure exhibited by the heat-affected zones consisted of tempered bainite, carbides, and ferrite. The microstructure exhibited by the base material also consisted of ferrite and partially decomposed pearlite and bainite. The microstructure exhibited by replica PSOH-R8 revealed void formation, void linkage, and cracking in the heat-affected zone of the girth weld. Repair or replacement of the girth weld with creep cracking damage should be planned for the next outage. The microstructures observed in these replica foils are typical for 1-1/4 Cr - 1/2 Mo low-alloy pipe, produced in accordance with ASME Specification SA-335, Grade P11 and filler material of the equivalent chemical composition. There was no evidence of microstructural anomalies relating to the original manufacture of the pipe or the subsequent fabrication of the Platen Superheater Outlet header.

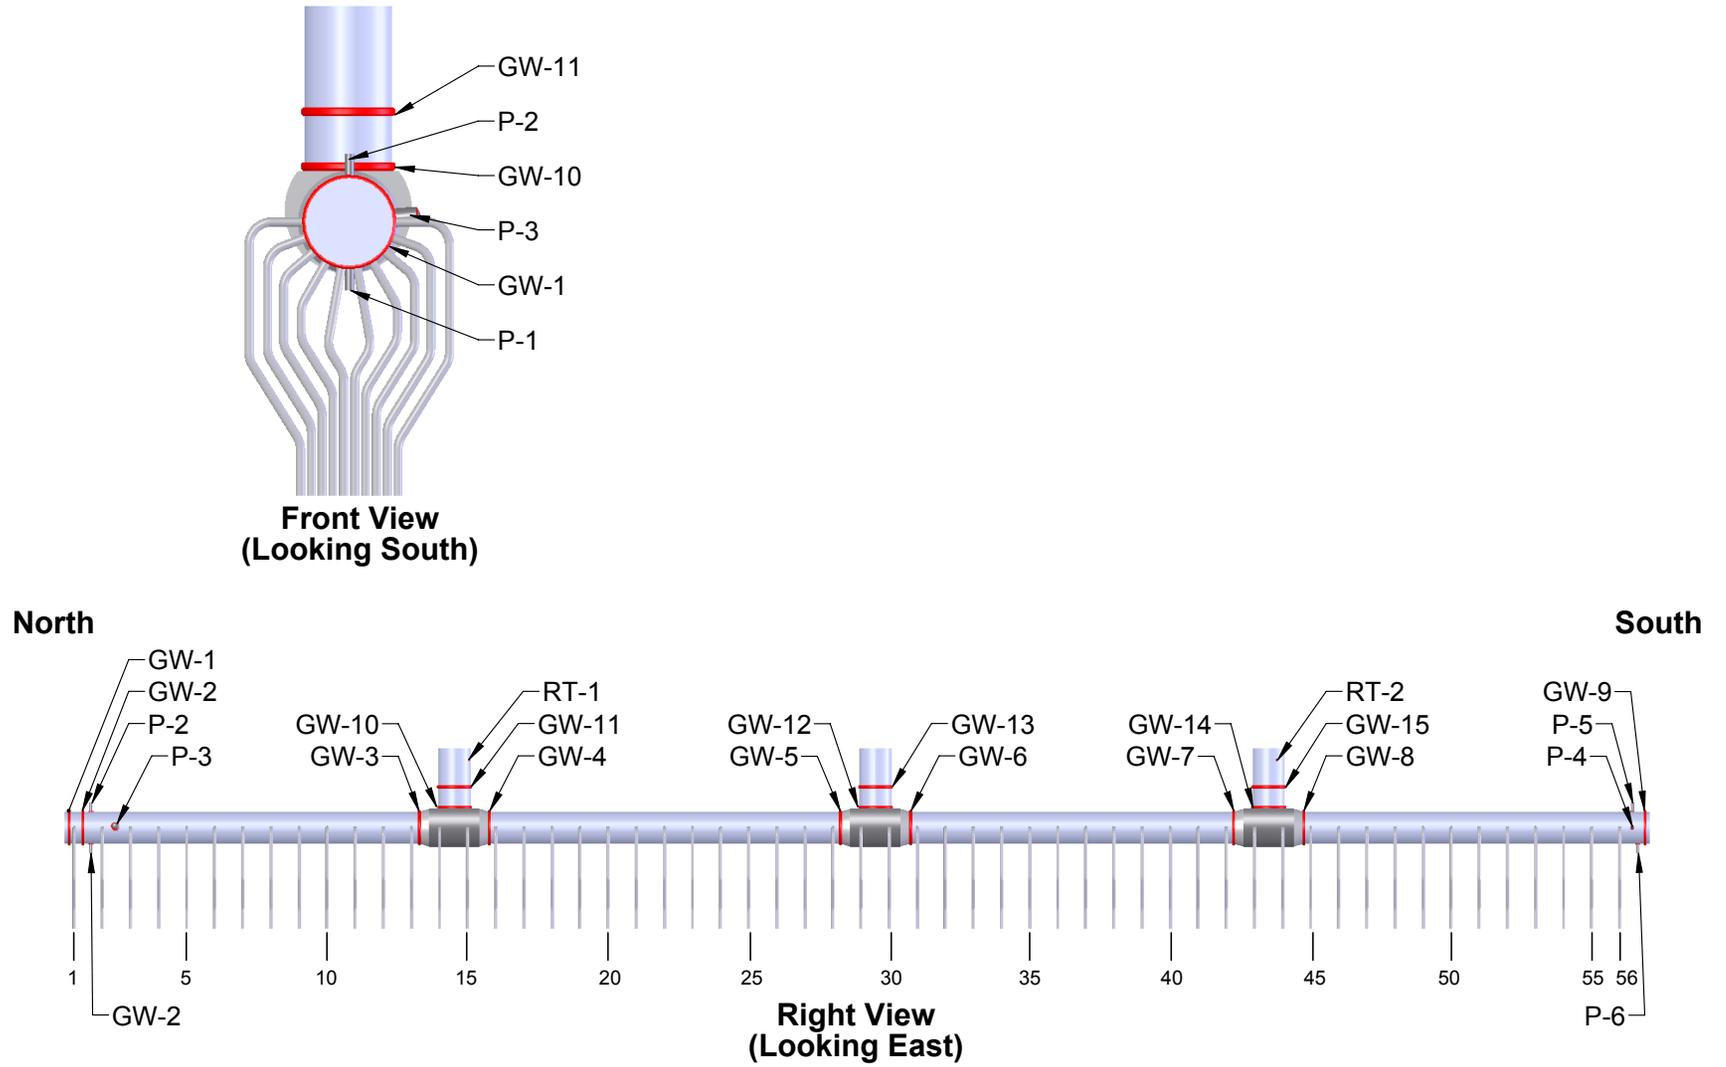
Fig. 30. Sketch of the Finishing Superheater Inlet header

The visual examination of the Finishing Superheater Inlet header did not reveal any indications of cracking, distortion, or other deterioration. No evidence of sagging or bowing was noted along the header.

The diameter measurements performed on the Finishing Superheater Inlet header fell within the permissible manufacturing tolerances. There was no evidence of general swelling such as would be produced by creep deterioration. (This conclusion is further corroborated by the results of the metallurgical evaluation, which did not reveal any evidence of creep deterioration in the header.)

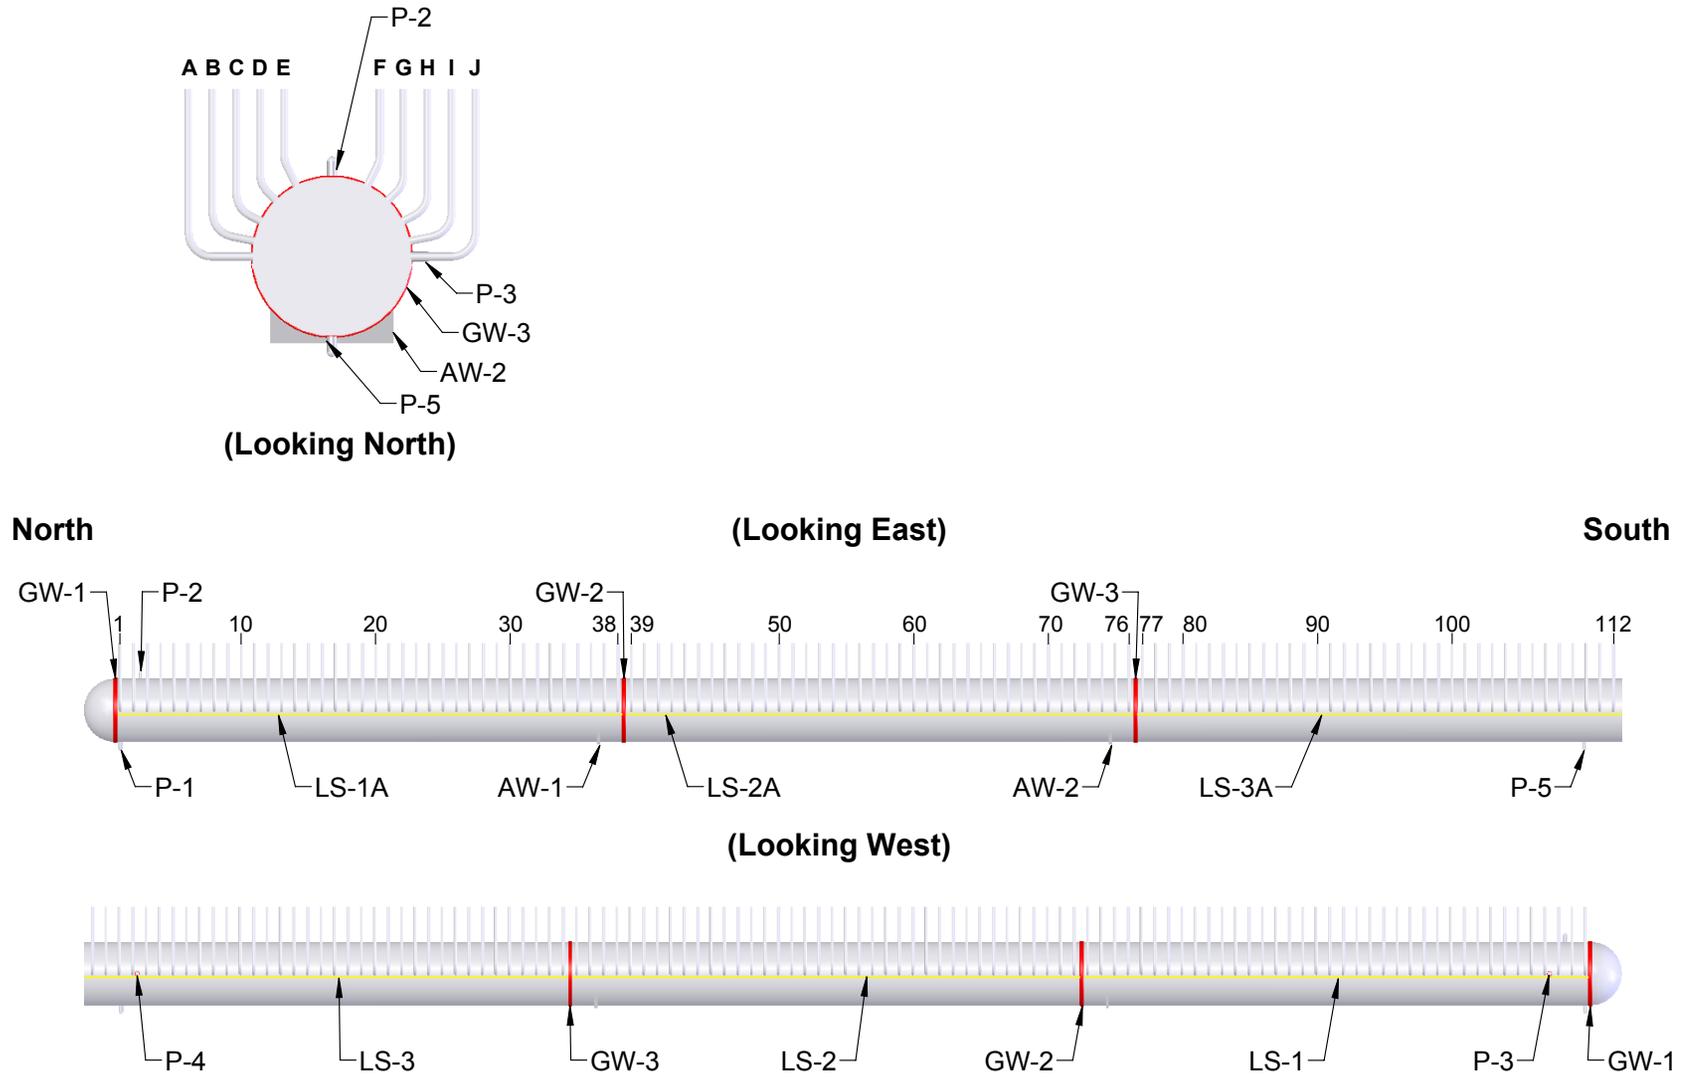
Fig. 90. Sketches of the High-Pressure Reheat Outlet header

Component	Examination Type	Results	Recommendations	Remaining Useful Life
High-Pressure Reheat Outlet Header	VT, Dim, MT, UTT, UTPA, Rep, HD, OS	<p>Multiple fatigue-type indications were evaluated and repair welded by plant personnel during the outage.</p> <p>Several weld defects identified and evaluated as acceptable.</p> <p>Heavy internal oxide scale growth on terminal tubes. Evaluated as nearing end of operational life.</p> <p>Operating in Class 1 creep range.</p>	<p>Remove tube sample for laboratory analysis within the next 12 months.</p> <p>Reinspect weld repairs after one year of continued operation (in 2013).</p> <p>Perform a similar inspection after three years of additional service (in 2015).</p>	<p>Header material has consumed less than 20% of useful life.</p> <p>Most tubes revealed an estimated remaining useful life of >102,000 hours.</p> <p>Lowest remaining useful life of -37,089 hours was observed.</p>

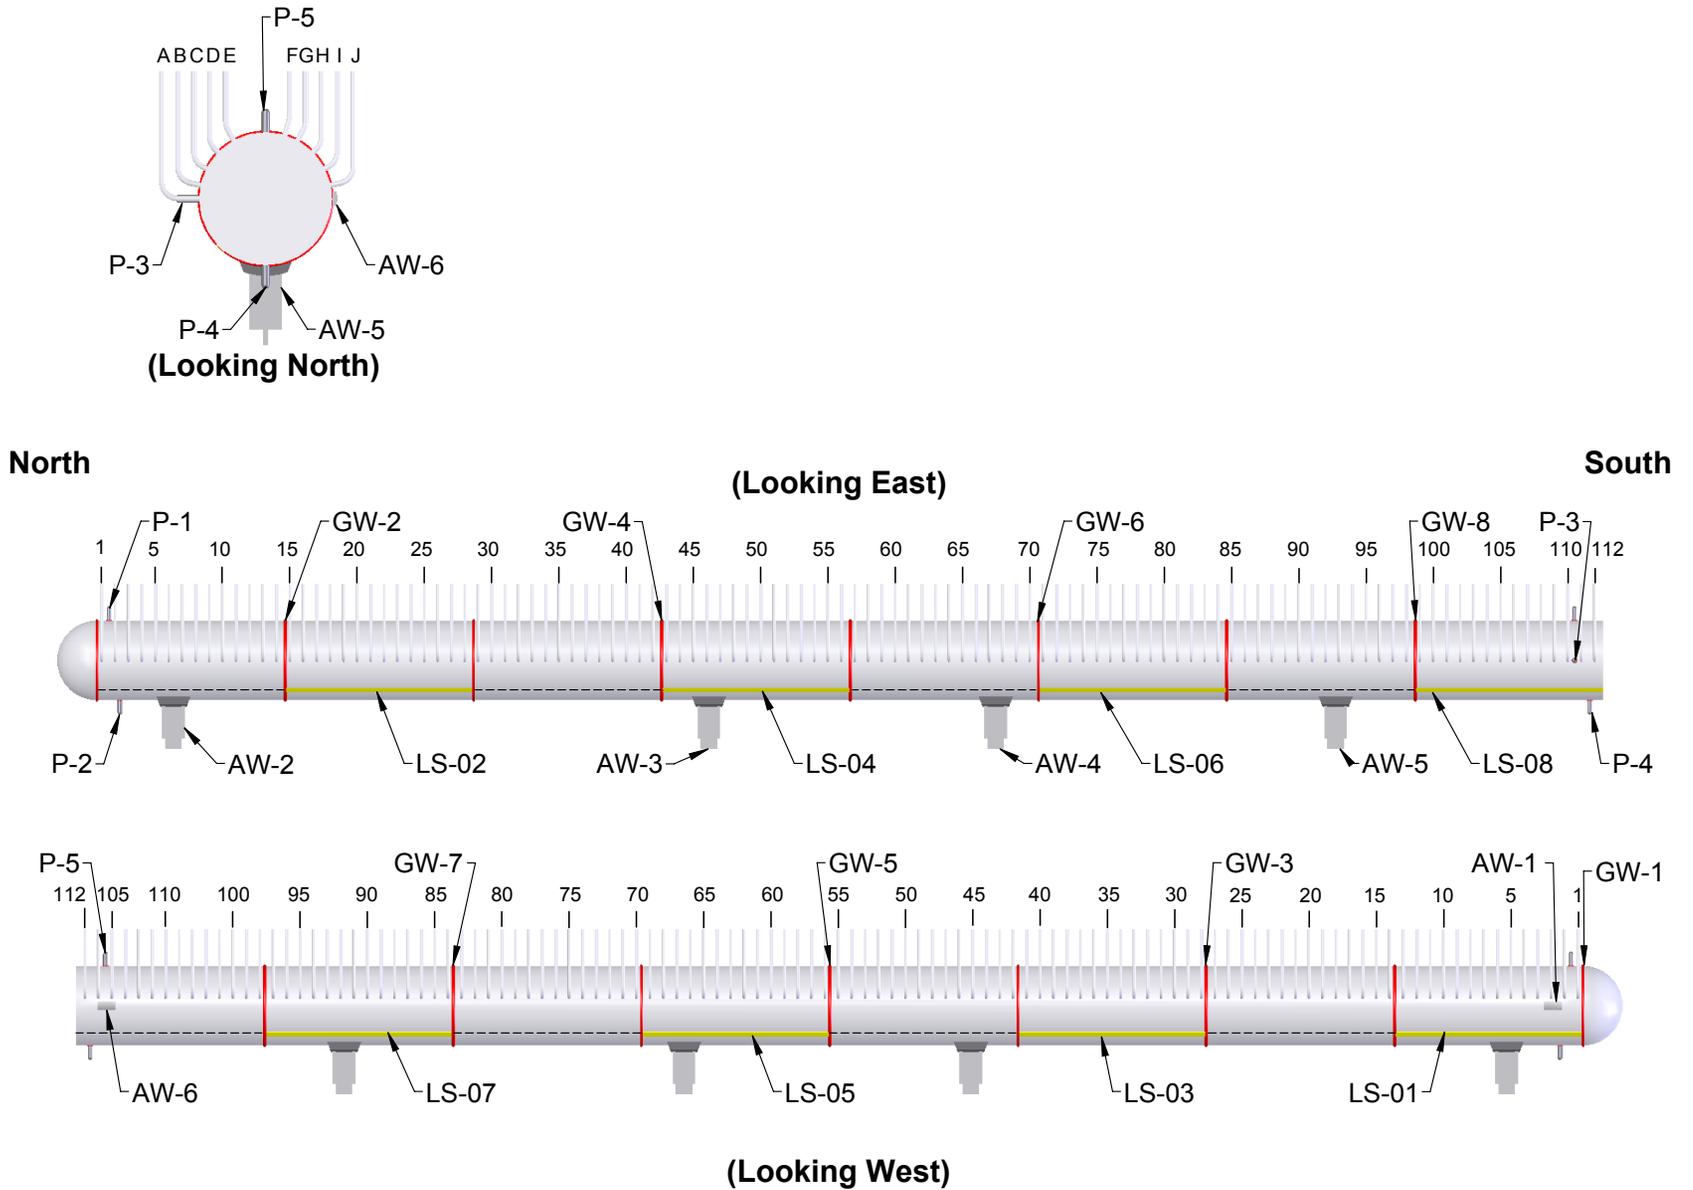
Fig. 112. Sketch of the Low-Pressure Reheat Outlet header

Low-Pressure Reheat Outlet Header	VT, Dim, MT, UTT, UTPA, Rep, HD, OS	<p>Significant cracking identified at attachment welds.</p> <p>Several sub-surface indications within girth welds. Evaluated as acceptable.</p> <p>Operating in Class 1 creep range.</p>	<p>Repair the attachment welds within next 24 months.</p> <p>Monitor the sub-surface indications during future inspections.</p> <p>Reinspect after three years of continued service (2015).</p>	<p>Header materials have consumed less than 20% of remaining useful life.</p> <p>All tubes revealed an estimated remaining useful life of >200,000 hours.</p>

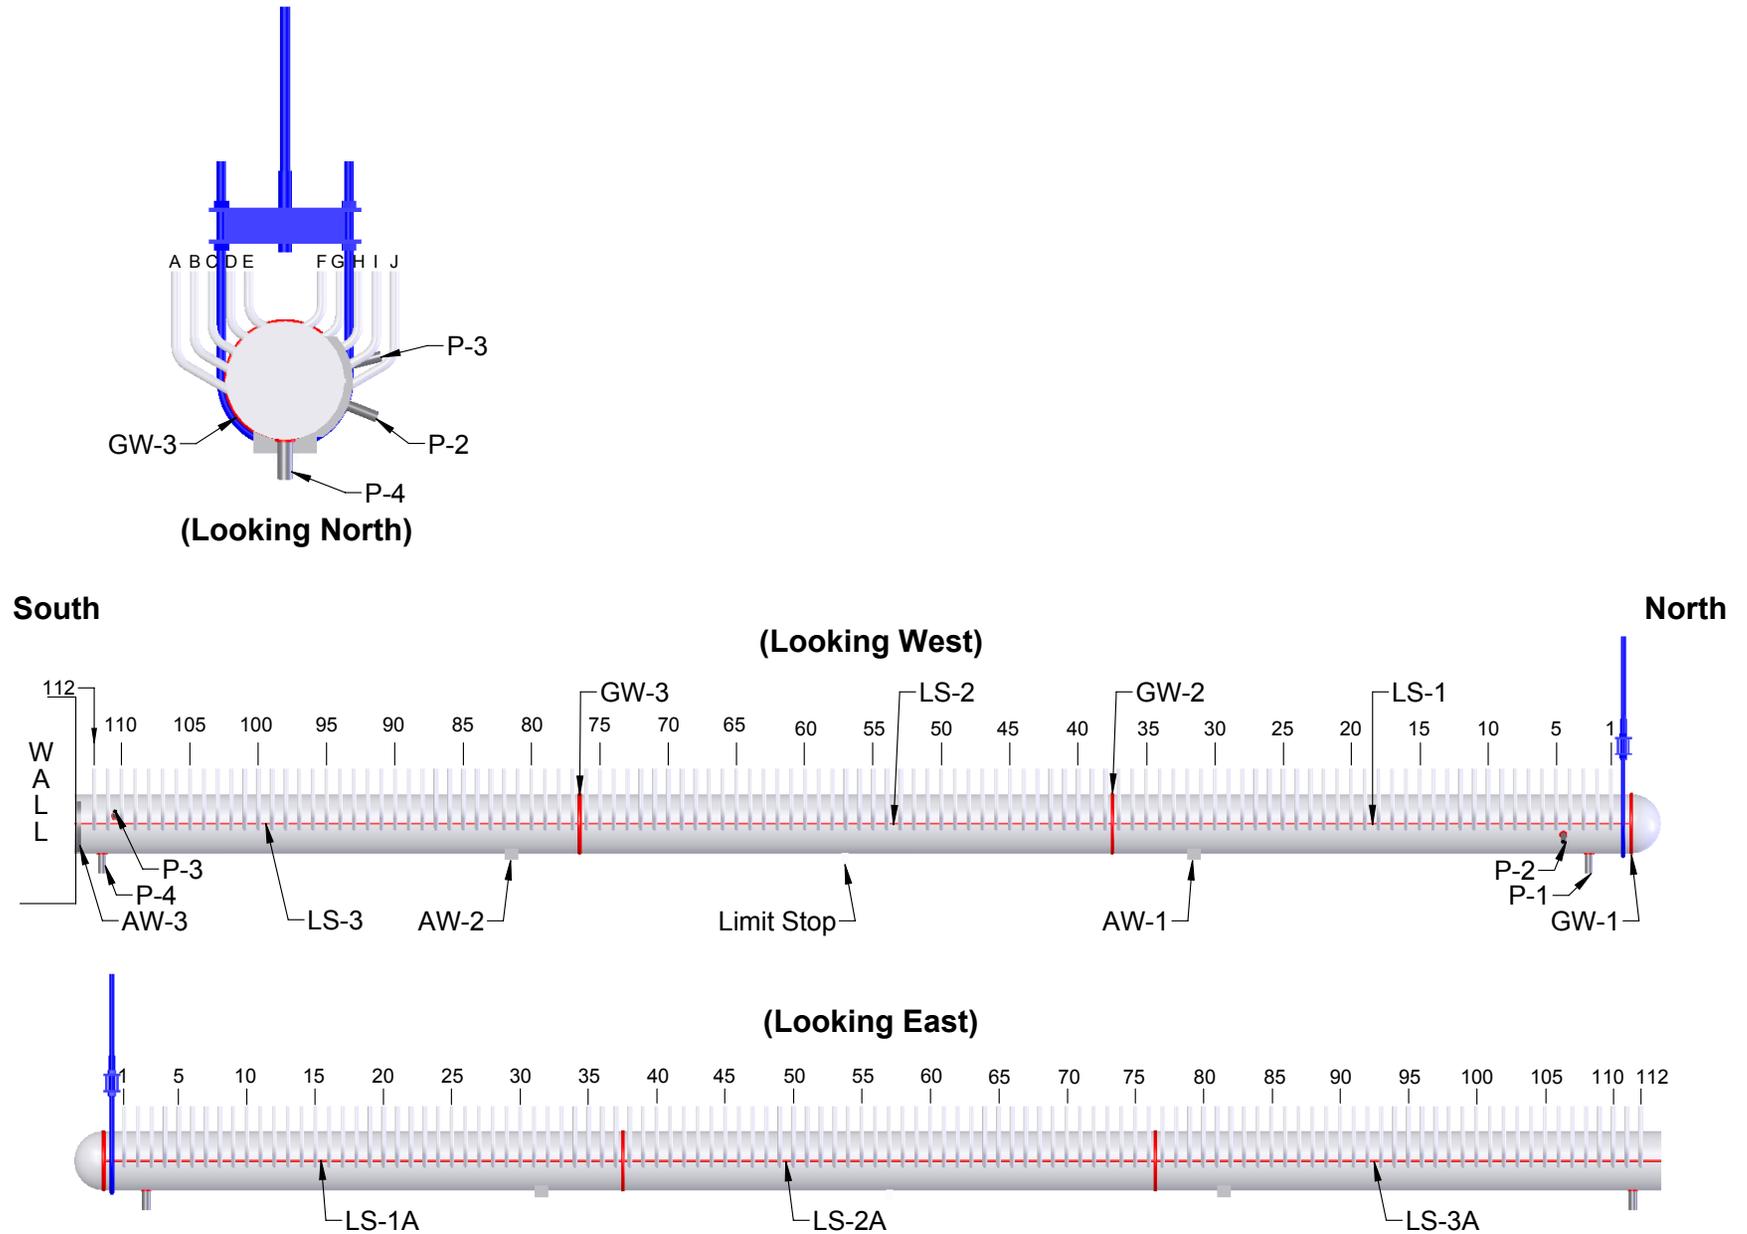
Fig. 123. Sketches of the High-Pressure (1st) Reheat Inlet header

Component	Examination Type	Results	Recommendations	Remaining Useful Life
High-Pressure (1st) Reheat Inlet Header	VT, Dim, MT, UTT, UTPA, Rep, HD	Surface and subsurface indications revealed on seam welds. Indications repaired by plant personnel during outage. No evidence of pipe swelling or wall thinning was noted. Operating in Class 1 creep range.	Reinspect the weld repairs after one year of continued operation (2013). Perform a similar inspection after three years of additional service (2015).	Header material has consumed less than 20% of remaining useful life.
High-Pressure (2nd) Reheat Inlet Header	VT, Dim, MT, UTT, UTPA, Rep, HD	No recordable surface or subsurface indications. No evidence of pipe swelling or wall thinning was noted. Operating in Class 1 creep range.	Perform a similar inspection after three to five years of additional service (2015 to 2017).	Header material has consumed less than 20% of remaining useful life.

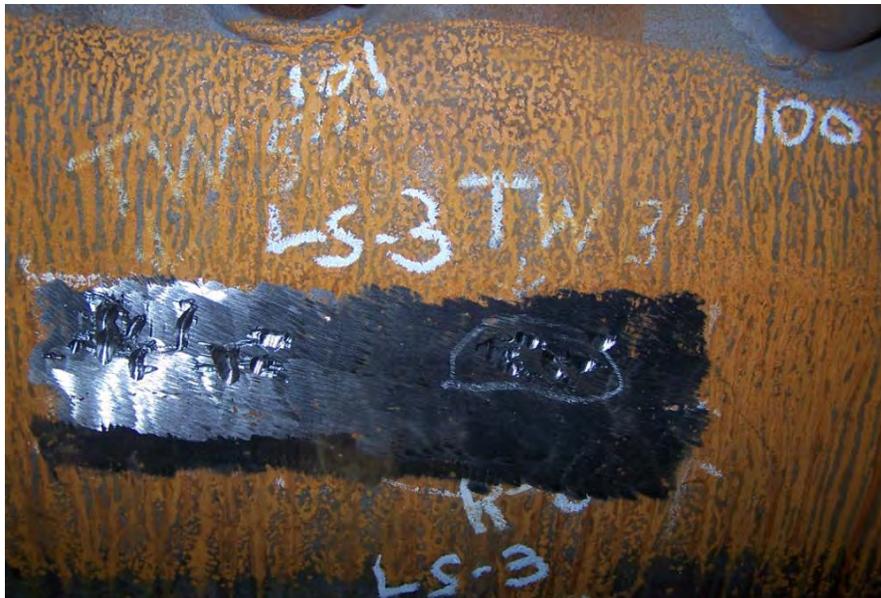
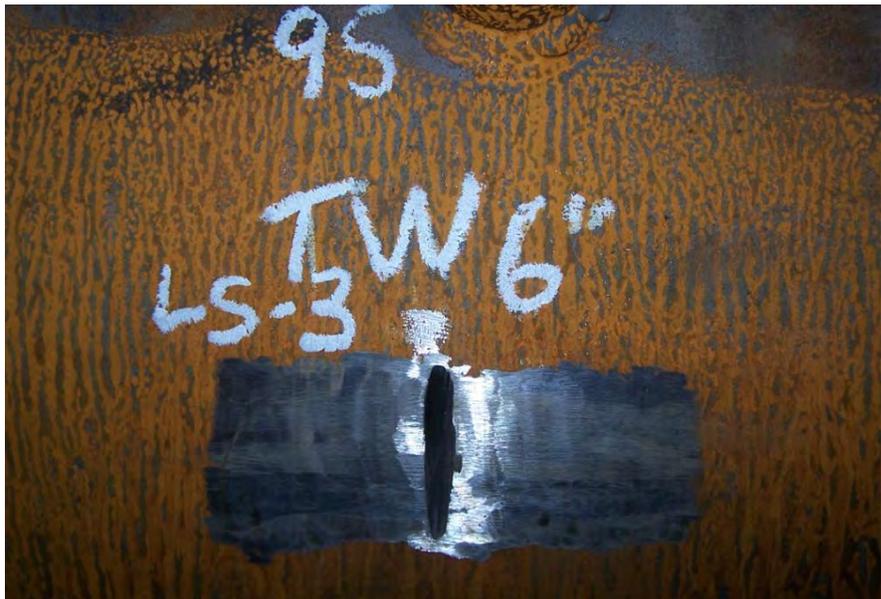
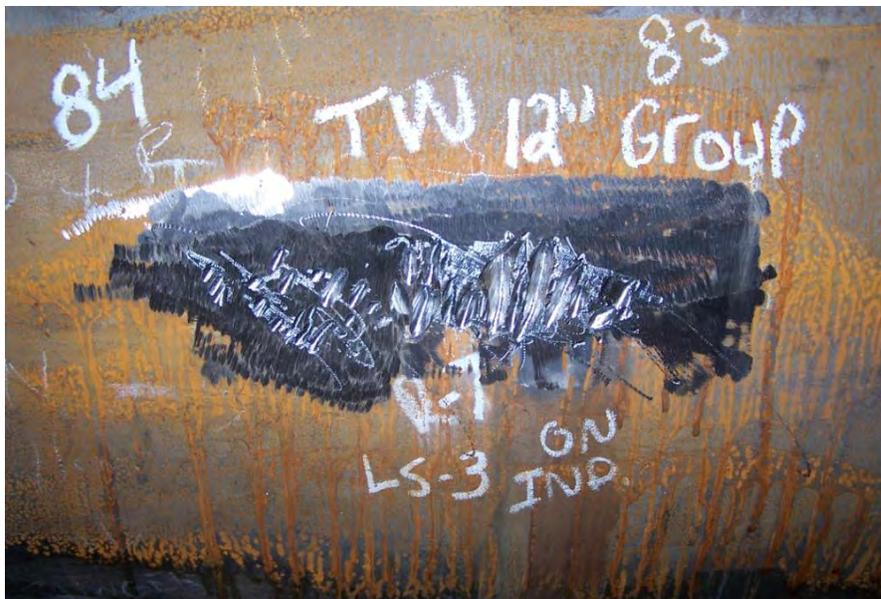
Fig. 126.

Photographs of indications in seam weld No. LS-3 on the High-Pressure (1st) Reheat Inlet header.

Photographs of repaired indications in seam weld No. LS-3 on the 1st High-Pressure Reheat Inlet header.

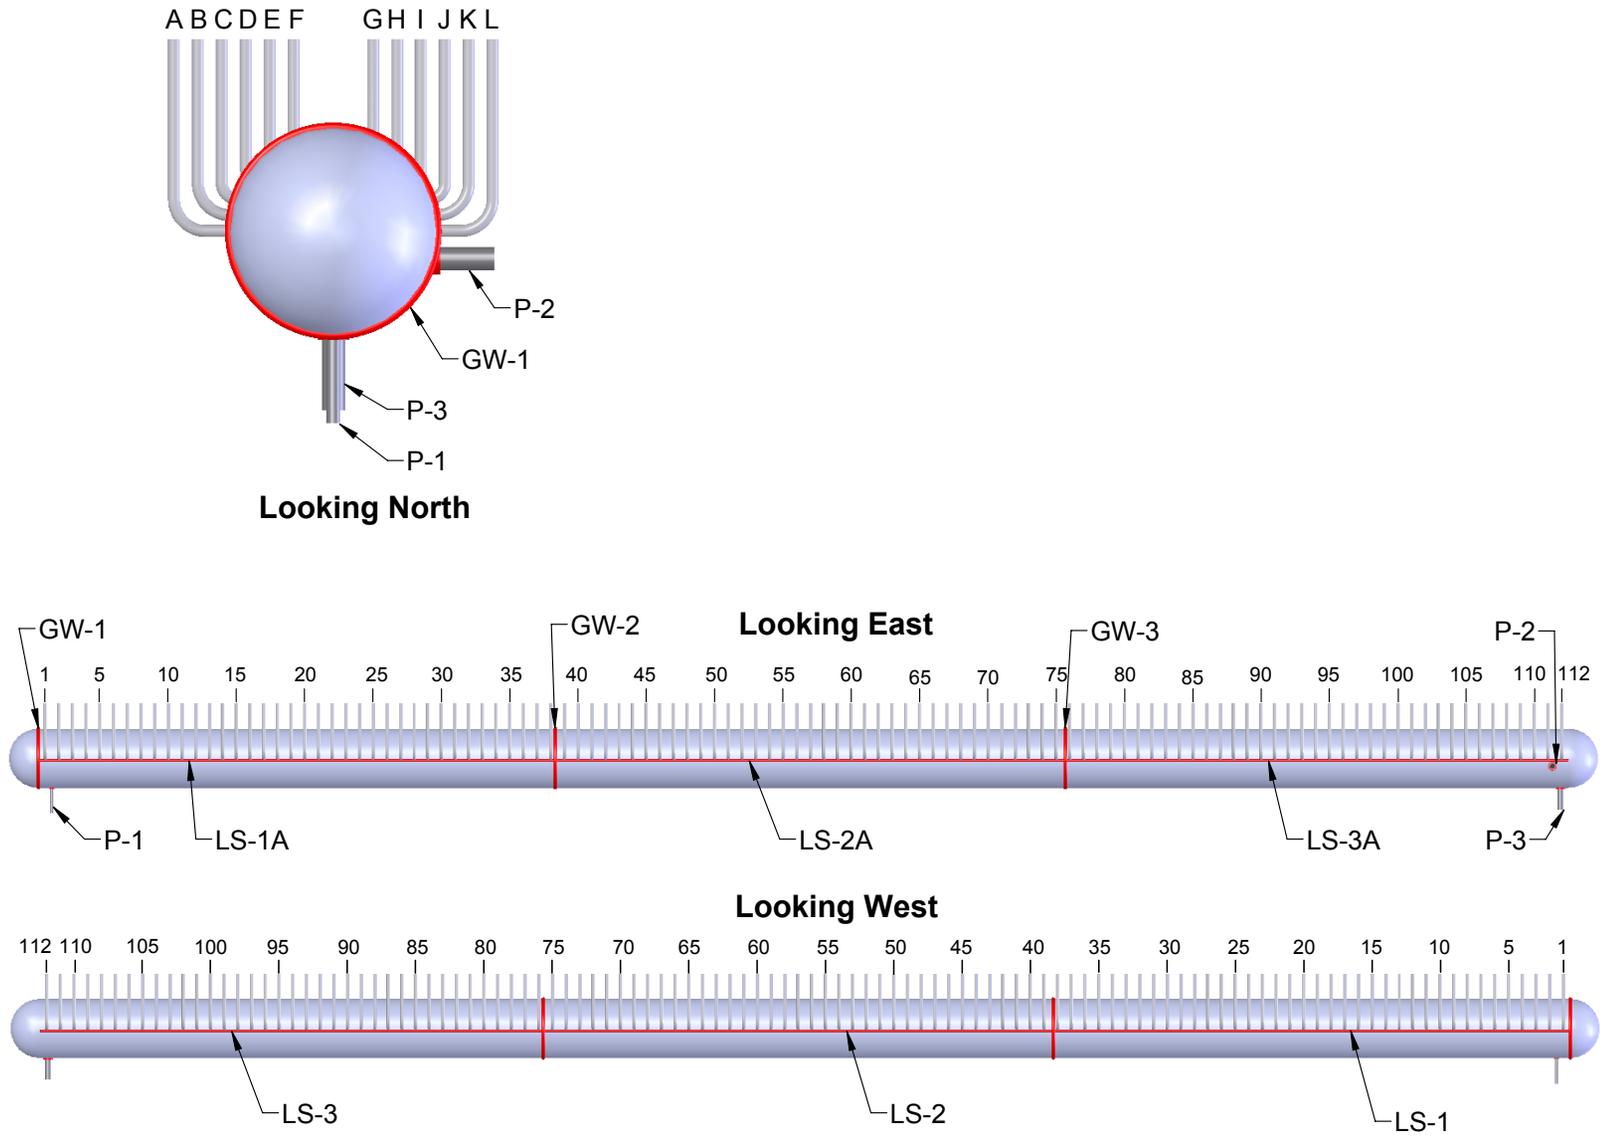
Fig. 135. Sketches of the Low-Pressure (2nd) Reheat Inlet header

- No recordable surface or subsurface indications were identified.
- No pipe swelling or wall thinning noted.

- Operating in Class 1 creep range.
- The header material has consumed less than 20% of its remaining useful life.
- The Low-Pressure (2nd) Reheat Inlet header is considered suitable for continued service under the intended operating conditions.
- Perform a similar inspection after three to five years of continued operation (2015 to 2017).

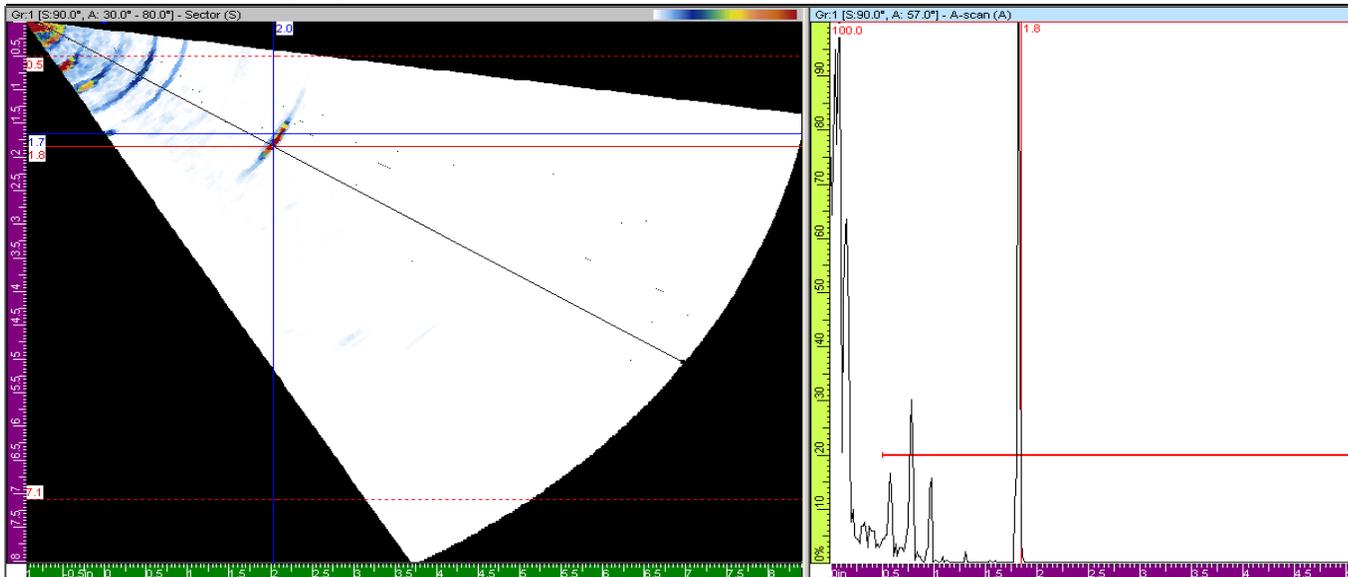
Above image of 1-1/2" long subsurface indication located at the 12:00 o'clock position/indication is approximately 0.100" in the through thickness dimension/inclusion from original manufacturing.
Range of indication depth is between 1.7" to 1.8" from the outside surface.

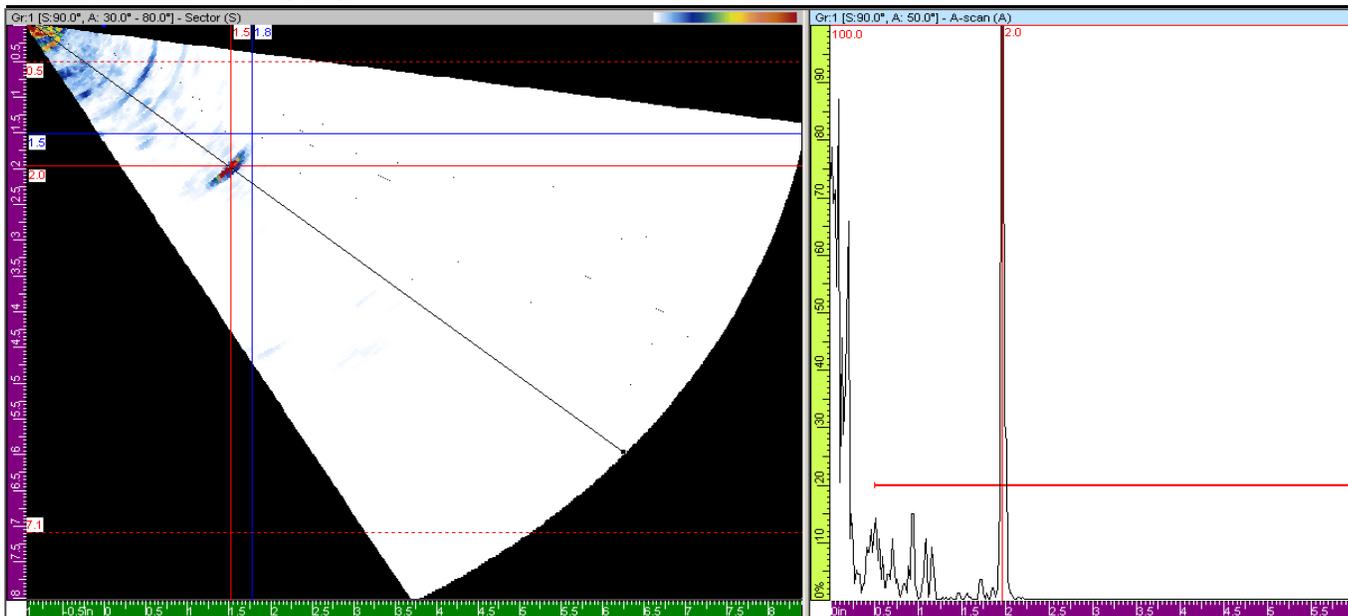
Above image of 2-1/2" long subsurface indication located directly above the E tube row adjacent GW-3.
Indication is approximately 0.500" in the through thickness dimension/inclusion from original.
Manufacturing/range of indication depth is between 1.5" to 2.0" from the outside surface.

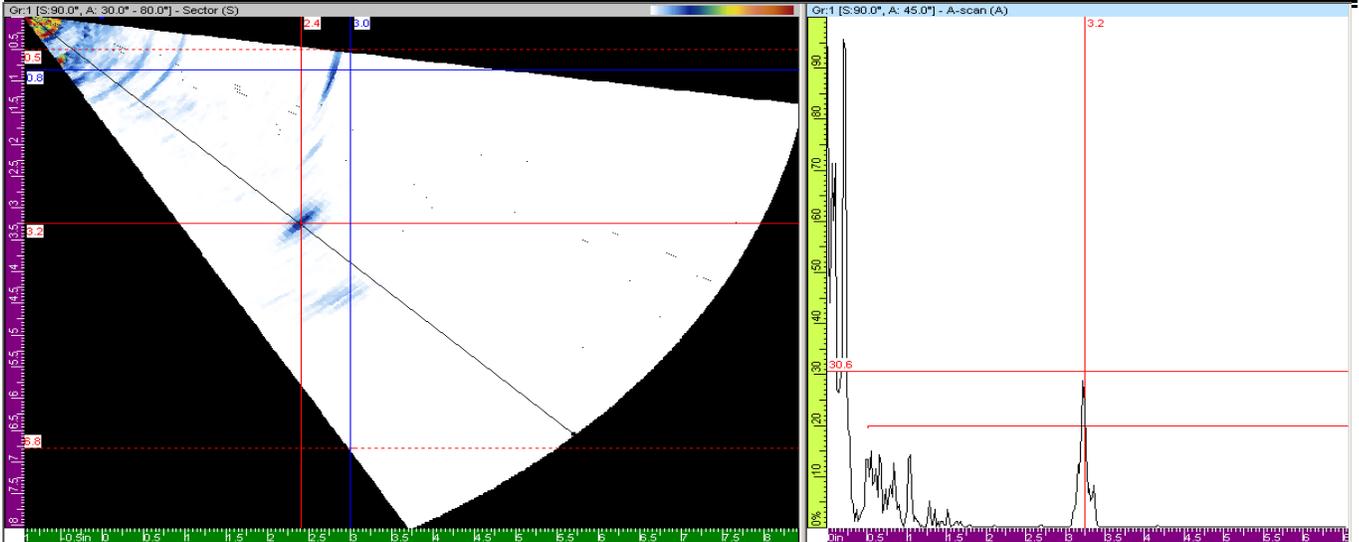
(FIGURE 1)

Image of transverse indication located between tube rows 9 and 10/very low amplitude/width of weld in length/small area of lack of fusion in an area which from the surface condition was a past repair area

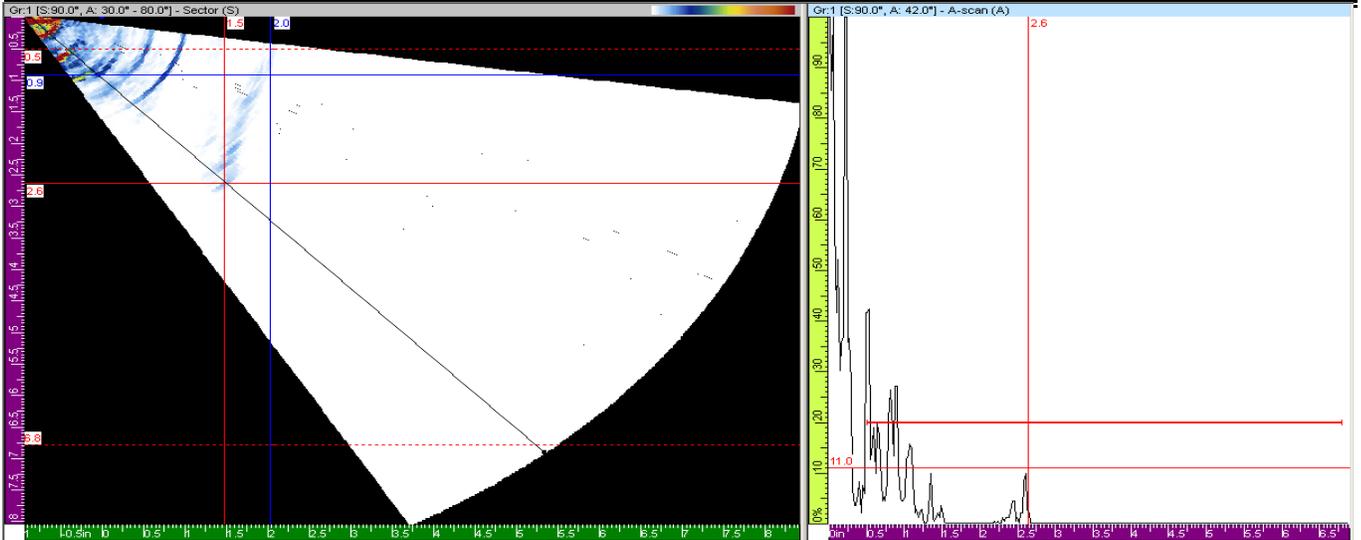
(FIGURE 3)

Above image of approximately 2" long area of lack of fusion between tube rows 33 and 34.
Indication is very low in amplitude/original fabrication indication.

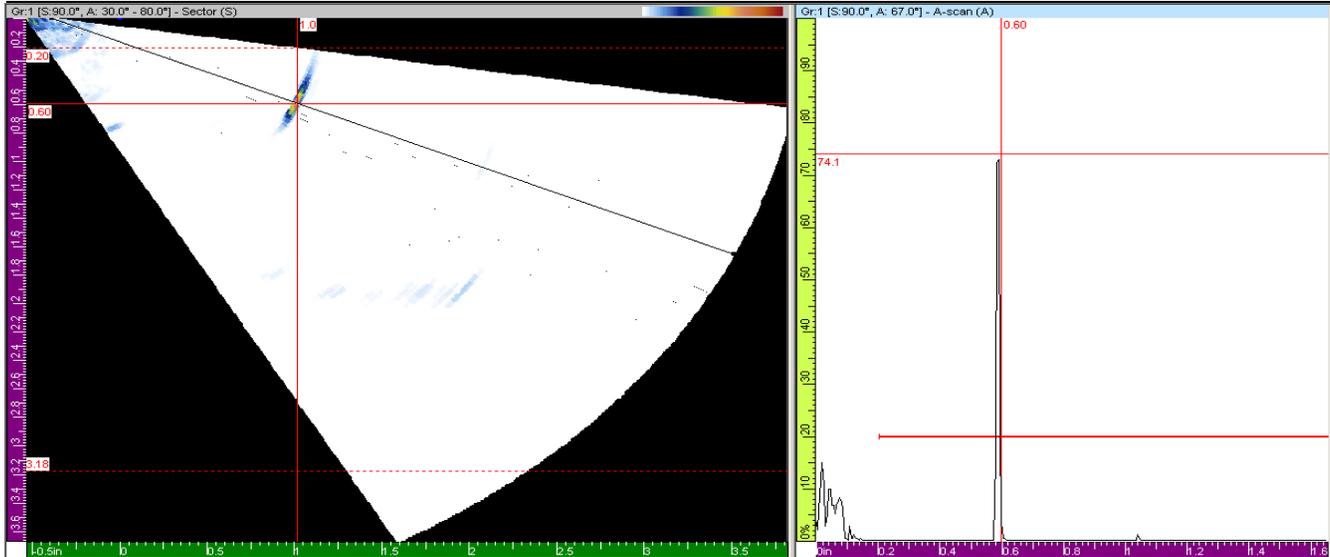
Figure 1

Located at the 7:00 o'clock position / Less than 1/2" in length and was 0.600" deep from the outside surface/Indication inclusion from original fabrication.
