**THIELSCH ENGINEERING, INC.
195 FRANCES AVENUE
CRANSTON, RHODE ISLAND 02910**

MARCH 2012
INSPECTION OF
BOILER HEADERS
UNIT NO. 2
MITCHELL GENERATING STATION
AMERICAN ELECTRIC POWER
MOUNDSVILLE, WEST VIRGINIA

September 7, 2012

Report No. 14151

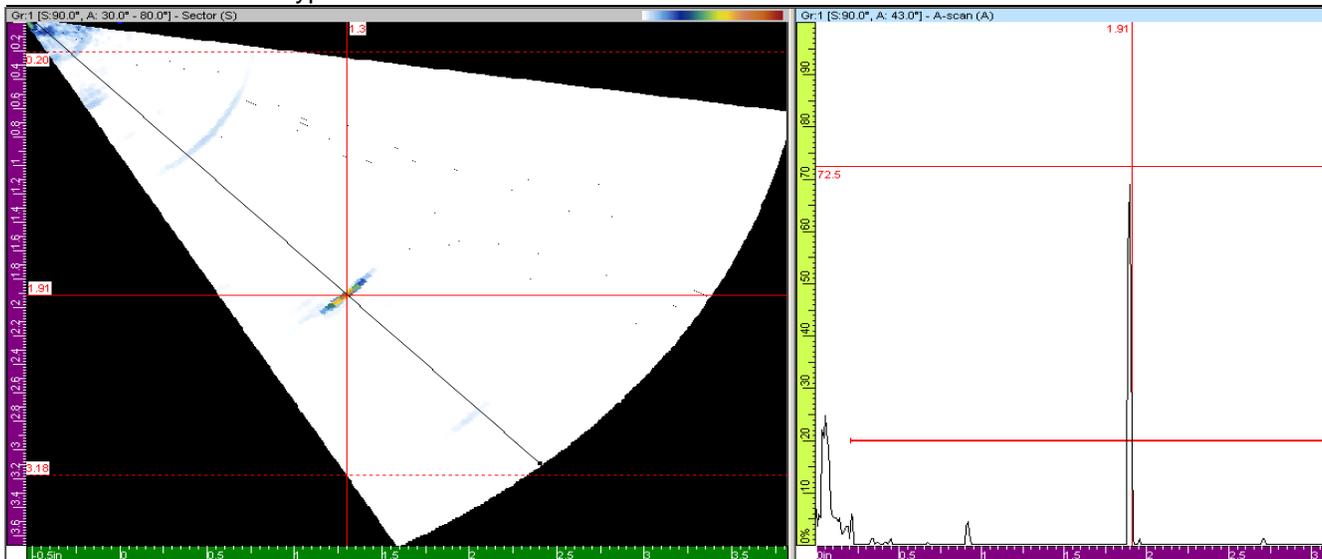
Figure 3

Typical root signal found on all seams inspected/root geometry/visually verified by internal examination.

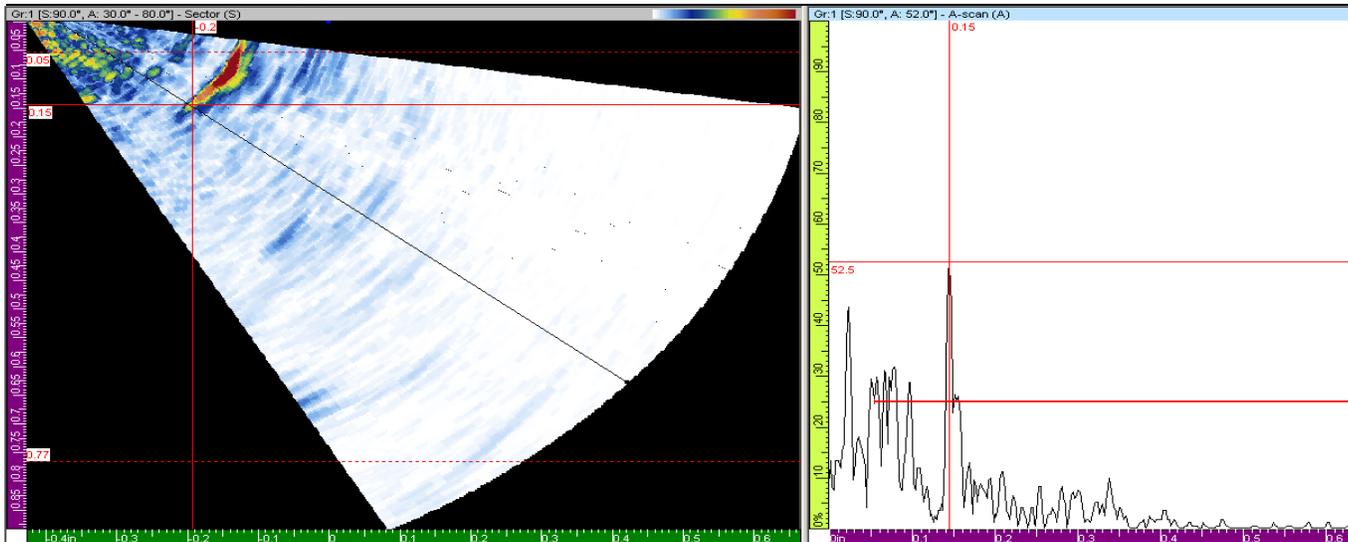
(FIGURE 1)

Above image of transverse indications detected by magnetic particle inspection/linear phased-array used to determine the depth of indications from outside surface/area imaged above was between tube rows 100 and 101 having a maximum depth of approximately 0.150 inches.

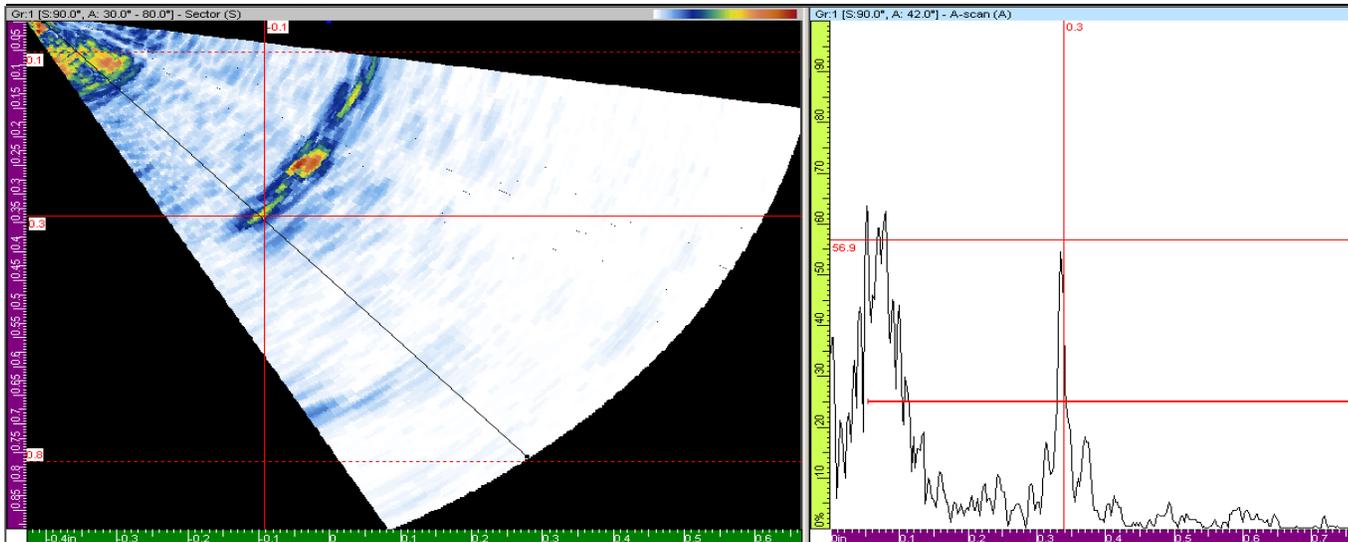
(FIGURE 3)

Above image of transverse indications detected by magnetic particle inspection/linear phased-array used to determine the depth of indications from outside surface/area imaged above was adjacent tube row 83 having a maximum depth of approximately 0.350 inches.

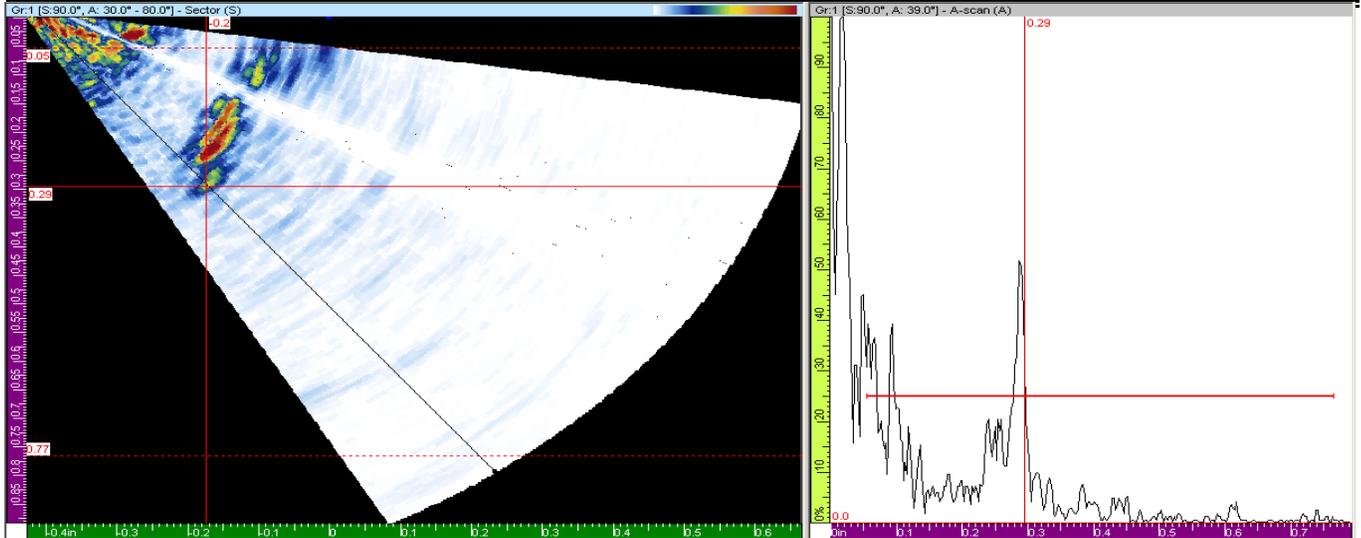
(FIGURE 5)

Above image of transverse indications detected by magnetic particle inspection/linear phased-array used to determine the depth of indications from outside surface/area imaged above was between tube rows 14 and 15 having a maximum depth of approximately 0.250 inches.
