**THIELSCH ENGINEERING, INC.
195 FRANCES AVENUE
CRANSTON, RHODE ISLAND 02910**

APRIL 2011
INSPECTION OF
BOILER HEADERS
UNIT NO. 1
MITCHELL GENERATING STATION
AMERICAN ELECTRIC POWER
MOUNDSVILLE, WEST VIRGINIA

Report No. 13795

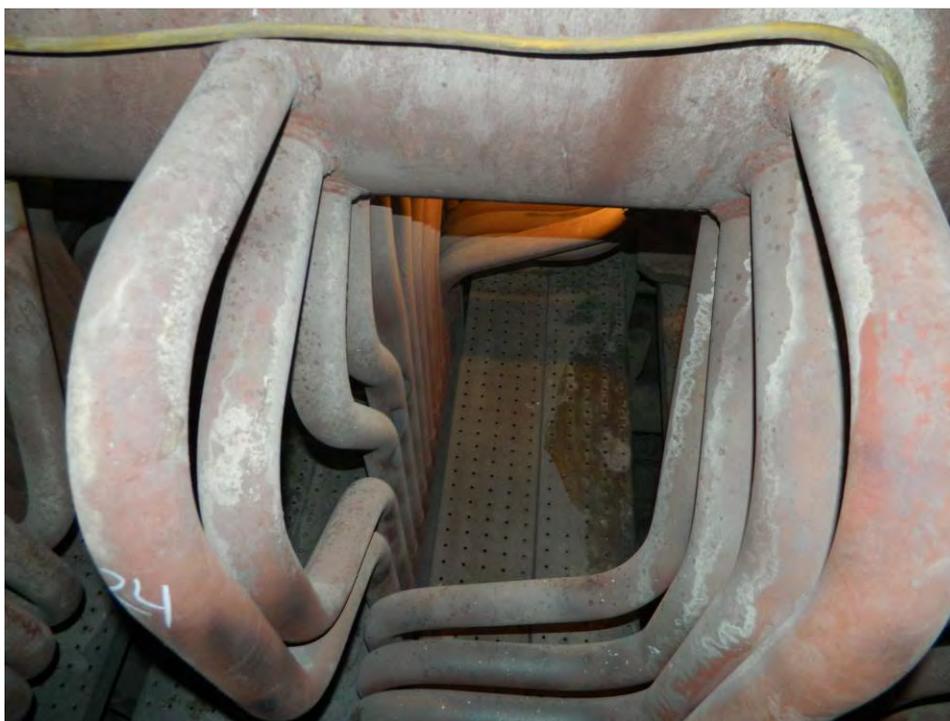
Fig. 16. Photographs of the Platen Superheater Outlet header tubing.

The visual examination of the Platen Superheater Outlet header did not reveal any indications of cracking, distortion, or other deterioration. No evidence of sagging or bowing was noted along the header.
