CLOSURE OF INVESTIGATION OF)	CASE NO.
SEPTEMBER 13, 2018 INCIDENT – KENTUCKY)	2019-00130
UTILITIES COMPANY)

Electric Utility Public Injury Accident Report

KPSC INVESTIGATION REPORT

KPSC Photographs of Accident Site

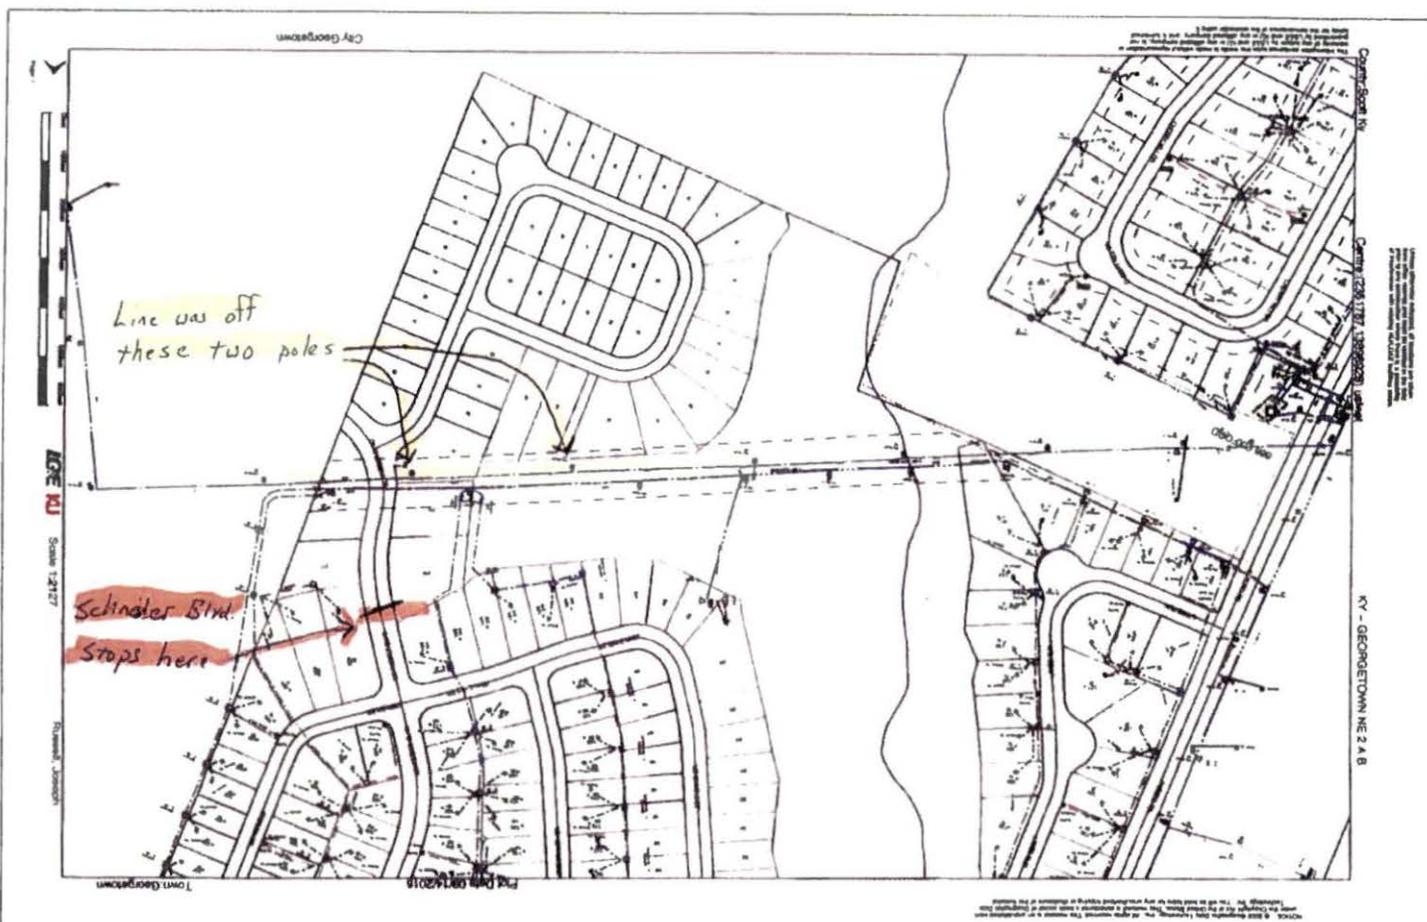
Trouble Info

Note	Date	User	User Name
Completed as Assist.	2018/09/13 11:32:13	5044_Glen_Ferrell	5044_Glen_Ferrell
opened fuse to repair broken crossarm	2018/09/13 15:53:34	Matthew_Shipley...	Matthew_Shipley-DCC DSO

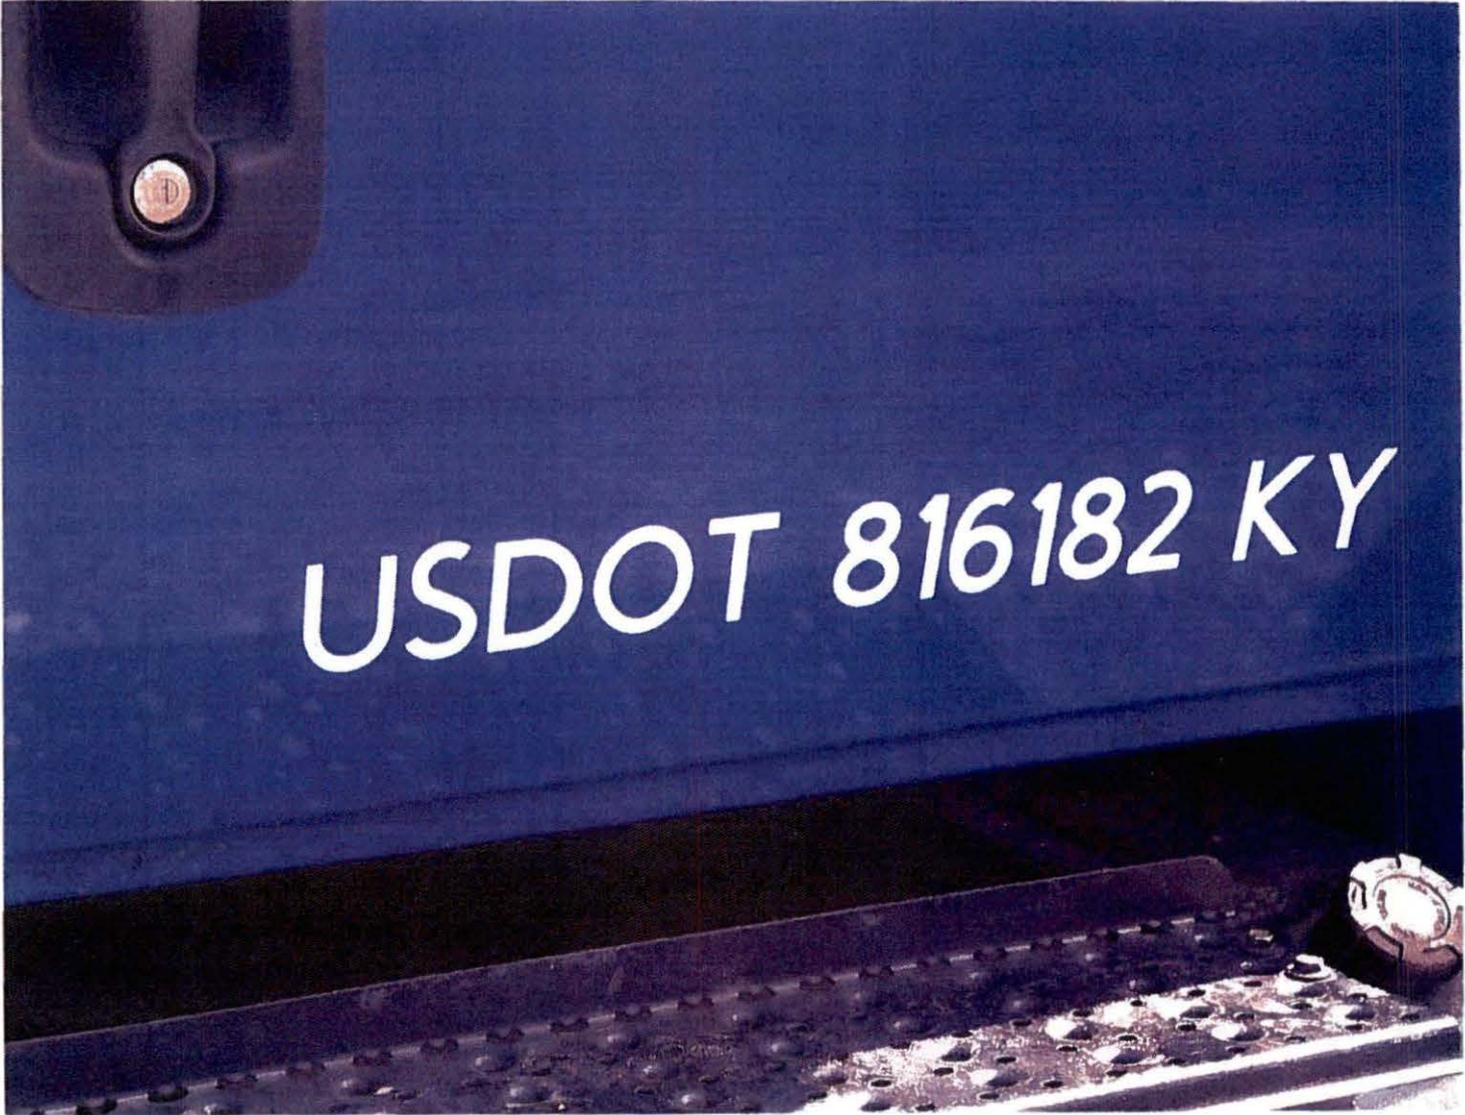
USDOT 816182 KY

A close-up photograph of a blue vehicle body. The text "USDOT 816182 KY" is printed in white, bold, sans-serif font. Below the text is a metal grate with a diamond pattern. A circular metal fastener is visible in the upper left corner, and another circular metal fastener is visible in the lower right corner.

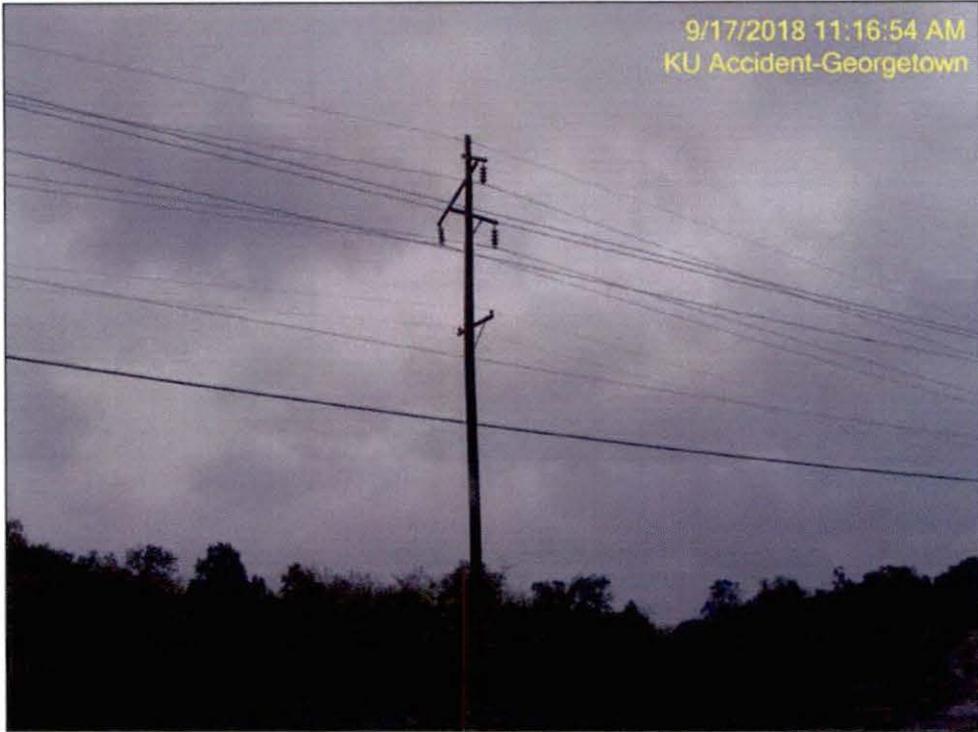
#1

Inspection of the wire found that the ends of the two cross-arms supporting the span had broken off and fallen. The cross-arm on the east pole appeared to have been hit by lightning as there was significant burning on the cross-arm between the pole and the insulator. The conductor was still in the air and was measured at 63 inches to earth. The conductor never touched the ground and therefore did not create a substantial ground fault to operate the 30 Amp fuse.

- Within 30 days of the date of this letter, KU shall inspect the condition of all cross arms on the 7,200-volt circuit involved in the September 13, 2018 incident.
- Within 60 days of the date of this letter, KU shall replace all cross arms on the 7,200-volt circuit that display damage or deterioration.
- Within 90 days of the date of this letter, KU shall file with the Commission a report of the results of its inspection of the cross arms and of any corrective action taken.

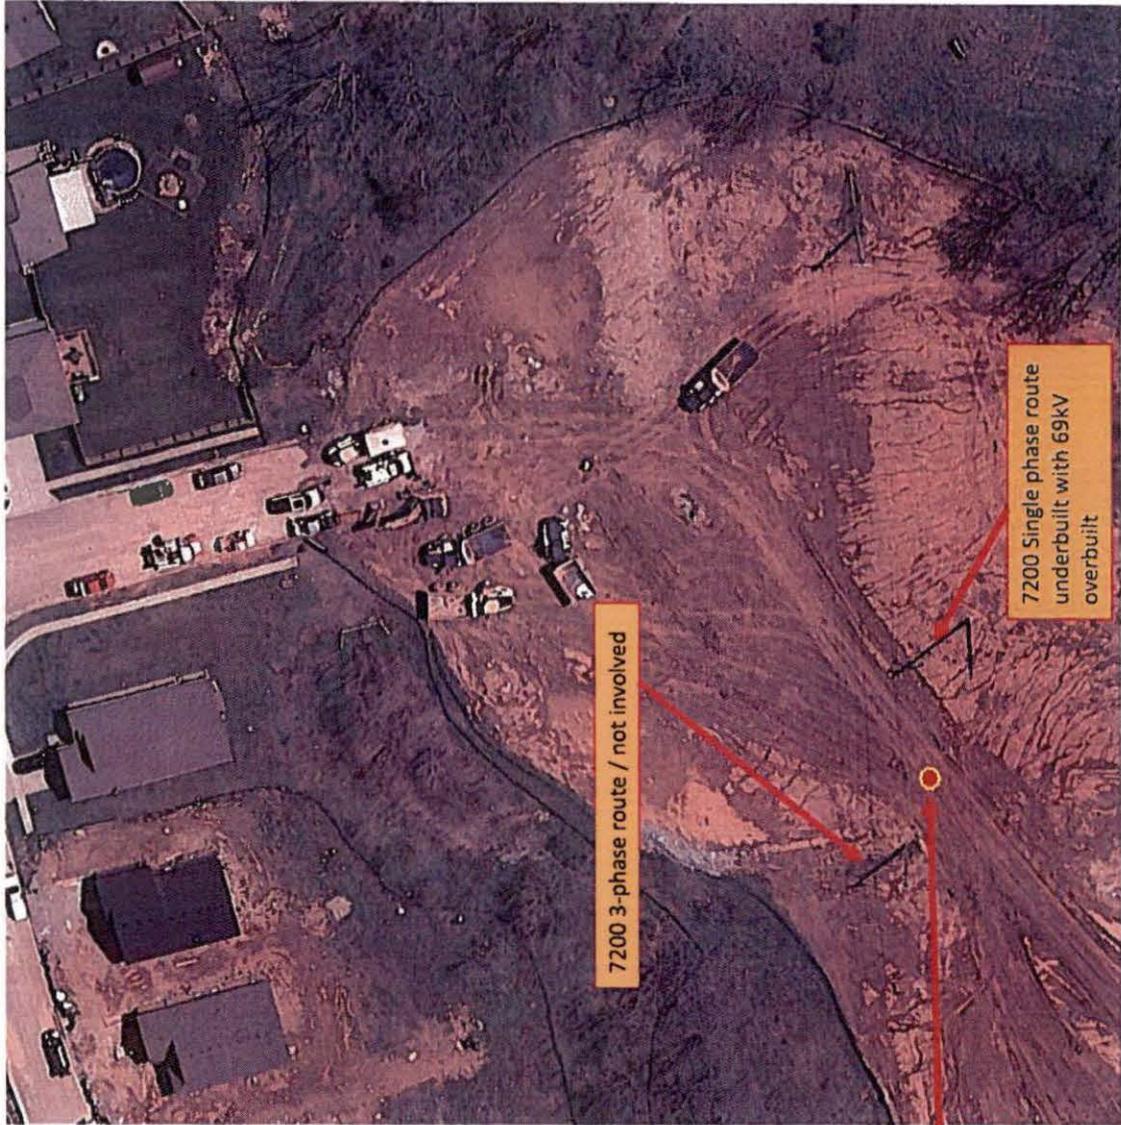
The incident occurred at the end of Schneider Blvd., Georgetown, KY. This is an undeveloped area. Below is a snap pic of the area.

7200 3-phase route / not involved

7200 Single phase route underbuilt with 69kV overbuilt

Contact point

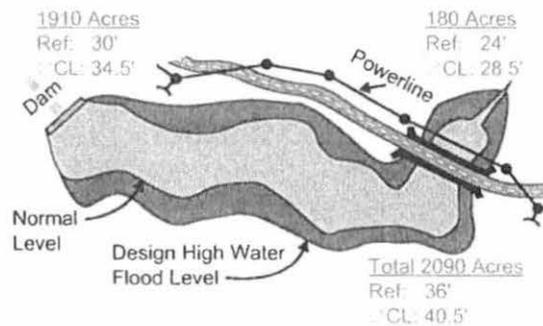
If the line is placed on the 180 acre side and the bridge height above design high water is less than 36 ft, but more than 24 ft, the required line clearance is reduced from that required by a lake of over 2000 acres by the difference between the bridge clearance and 36 ft. If the bridge height above design high water is less than 24 ft, the required clearance remains at that required for a 20 to 200 acre lake. See following figure.

Power line on small lake side of bridge
