Subject: Case 2012-00362: City of Tompkinsville
From: Joseph Orazen (jorazen@yahoo.com)
To: jason.brangers@ky.gov;
Cc: shmartin1@bellsouth.net; reed@reedmoorelaw.com; jarmscityclerk@yahoo.com; mcphersonc93@yahoo.com;
Date: Tuesday, March 5, 2013 11:15 AM

To:
Jason Brangers
Manager, Pipeline Safety Branch
Kentucky Public Service Commission

**LEAKAGE CONTROL REPORT
FIELD SURVEY**

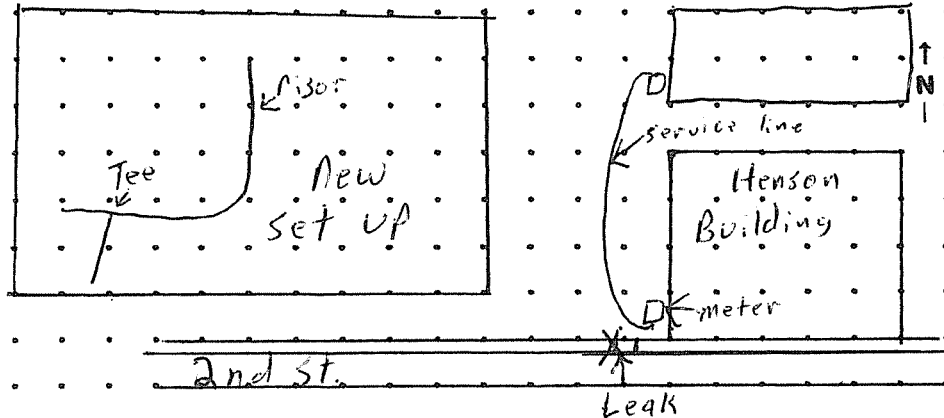
Remarks We found a tap on the risor here leaking. We replaced the risor at the Henson Building, feed off of the ^{new} plastic service line & ran it back to the secondary service.

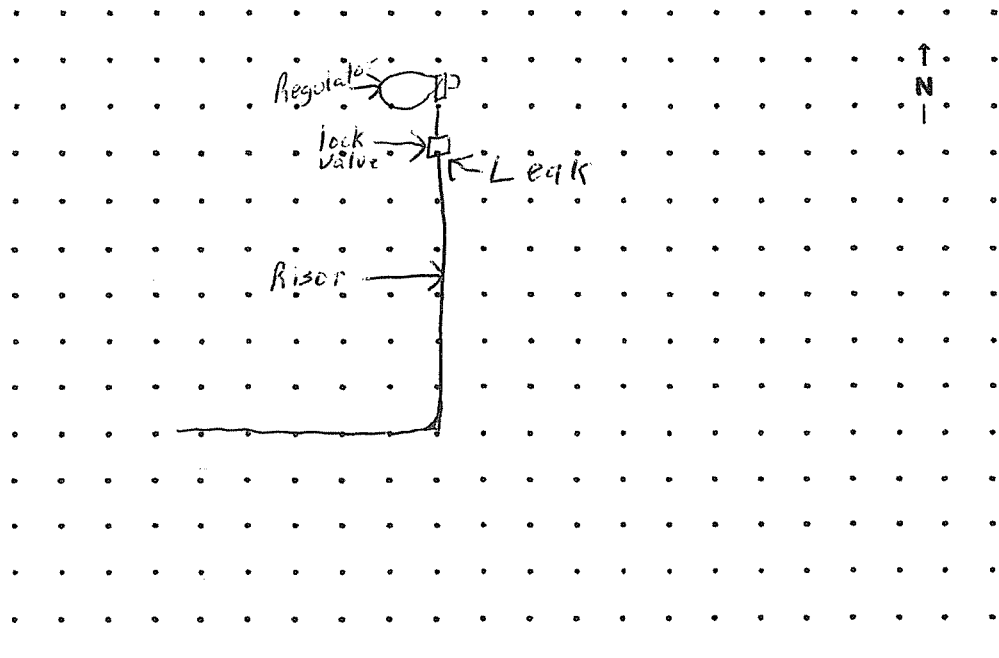
Remarks Found a leak at the bottom of the lock valve. We broke down the meter set and backed off the lock valve enough to redope the inlet side of the and retightened it. We put everything back together and retested for leaks

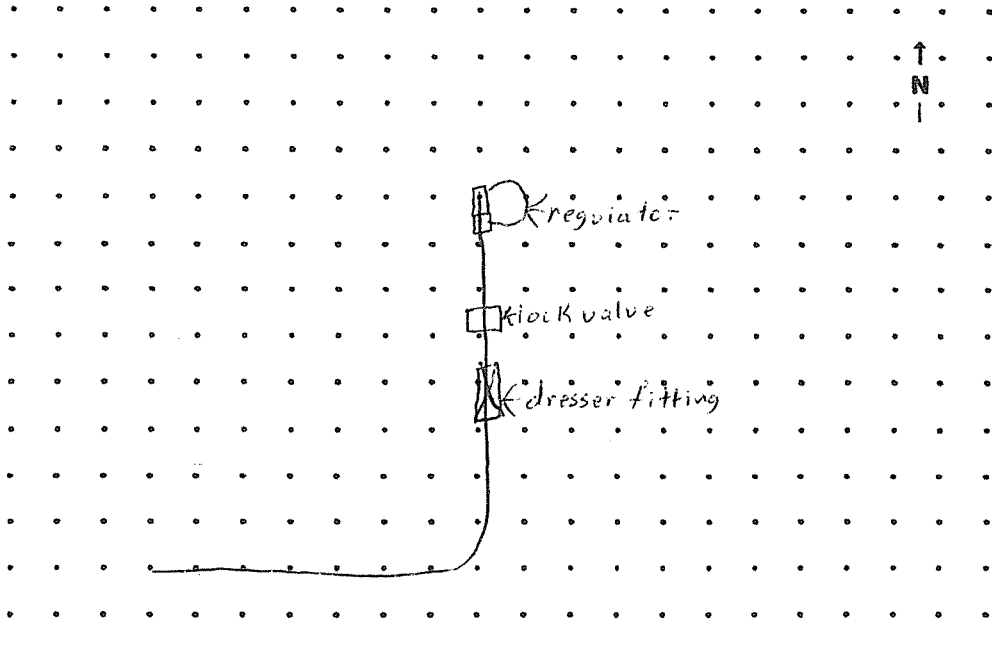
Remarks We dug up the riser and replaced it to remove the dresser fitting. We then rebuilt the meter set.

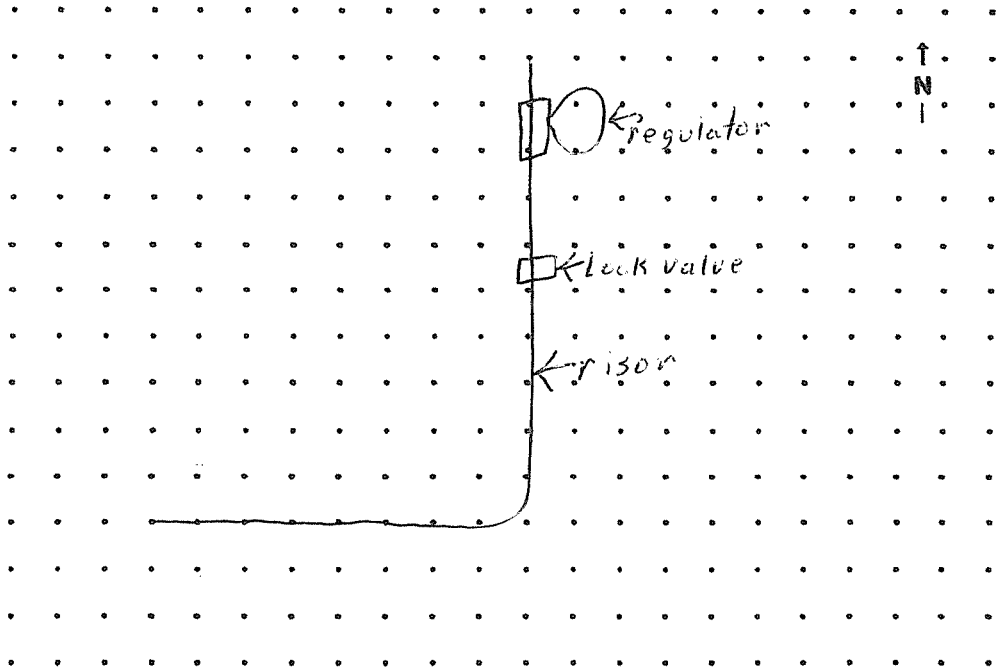
Remarks A leak was found at the bottom of the regulator.
We broke down the meter set, redoped the regulator and
rebuilt the meter set. We then tested for leaks.

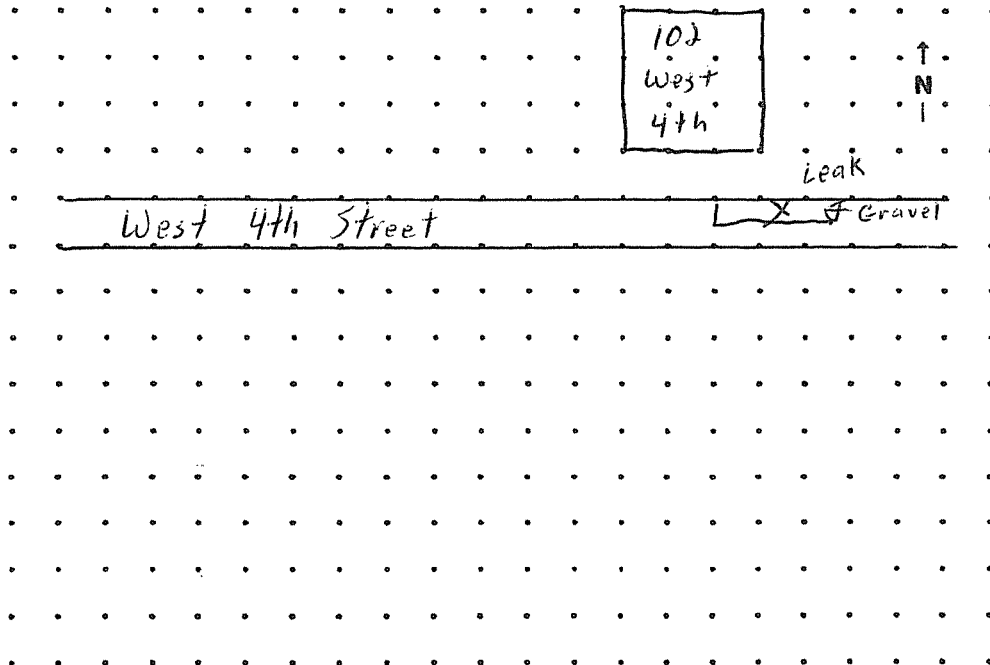
Remarks A leak was detected in the ground here. The leak expanded for a long way down the street. More information on the next report.

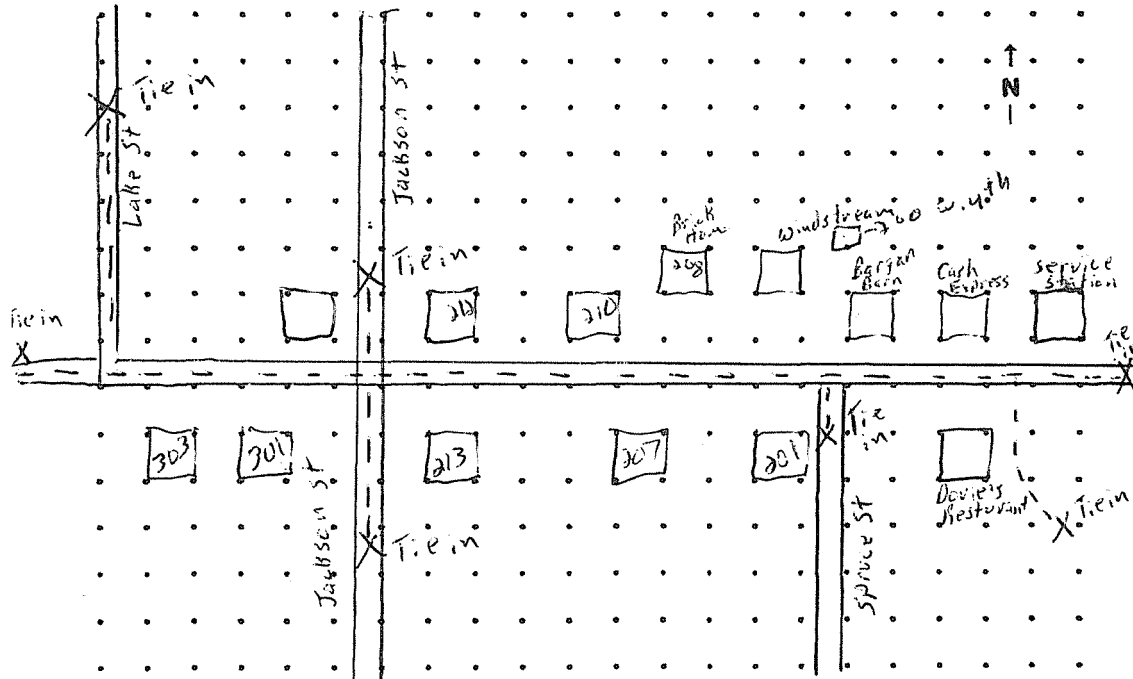
Remarks
 The leak here on 4th Street extended so far that we couldn't pinpoint the leak. The pipe was also in bad shape. We tied in at Main St. and put in new 3" PE all the way to Lake St & ran new services to each customer on the line.

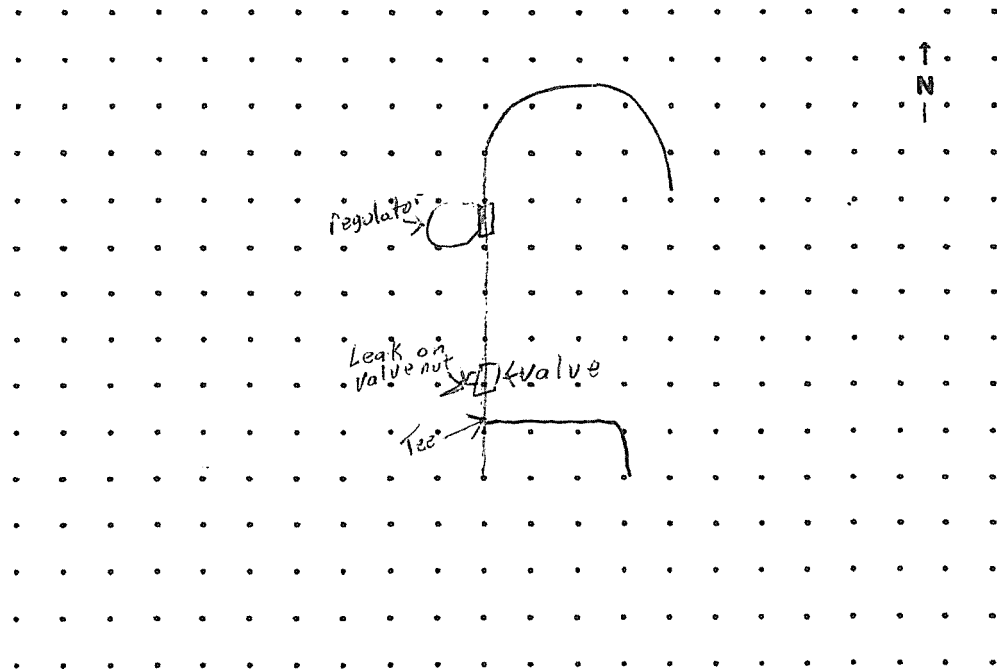
Remarks On this service, the valve was locked off
it was leaking on the nut. When we checked
it, the nut was very loose. The fix was as
simple as tightening the valve nut.

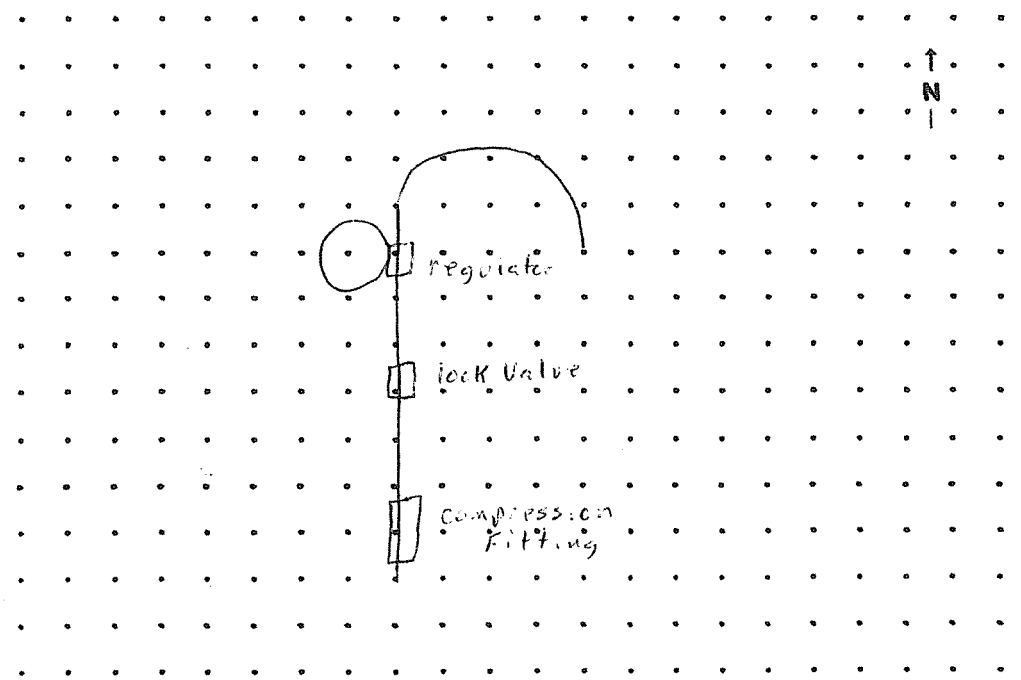
Remarks The service here had repair fitting on the base of the riser covering a spot that had pitted out. We replaced the riser & rebuilt the entire meter set.

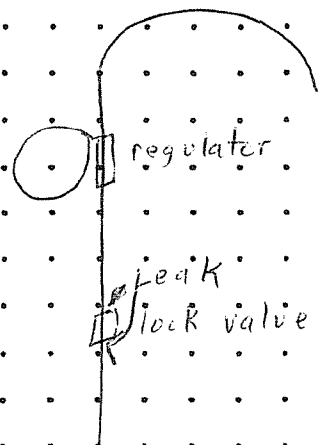
Remarks The leak was on the ~~st~~ inlet side of the lock valve. It didn't look to be in very good shape. We decided it would be best to replace the lock valve + rebuild the meter loop back.

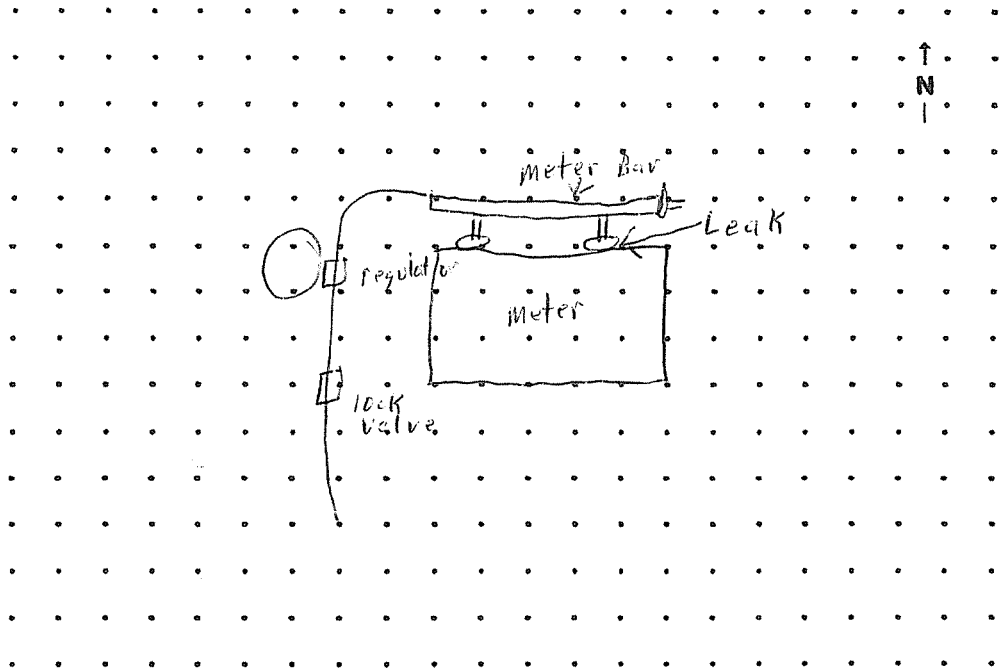
Remarks The leak here was on the outlet side spud nut of the meter bar. We simply tightened the nut to fix it. We also discovered a leak on the inlet side of the regulator that is on the next report.

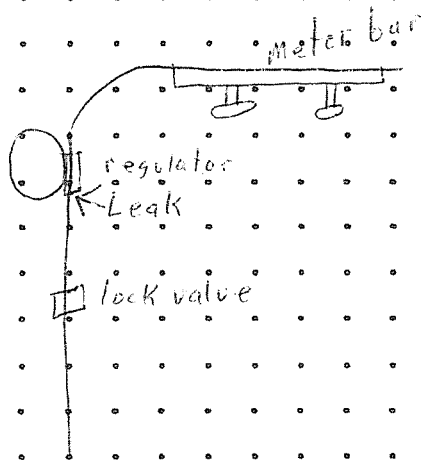
Remarks We had a leak on the inlet side of the regulator. We broke down the service & replaced the regulator. We then rebuilt the meter set, tested for leaks & turned the gas back on.

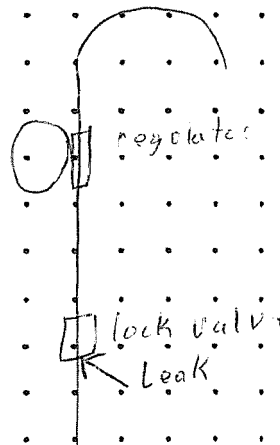
Remarks The lock valve on the service was leaking.
We broke down the service and backed off the lock valve,
We redoped it & threaded it back. We then rebuilt
the service & tested for leaks.

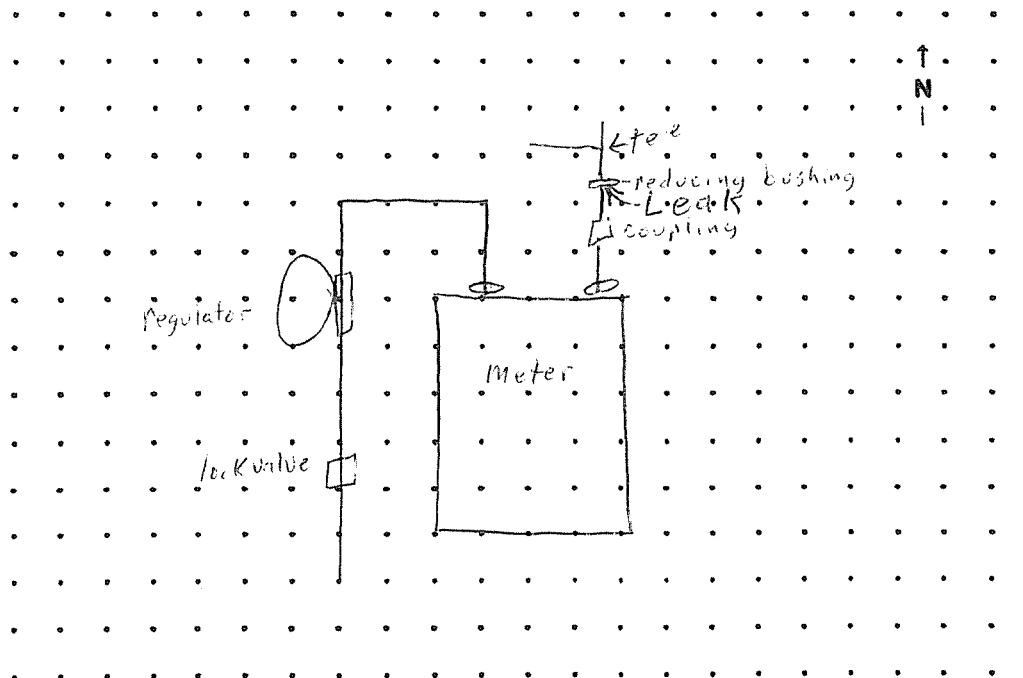
Remarks We found a leak on the customers side of the service meter on the 1/4 x 2" reducer. We immediately notified the customer & showed him the problem. We went back to check it & found that the leak had been repaired.

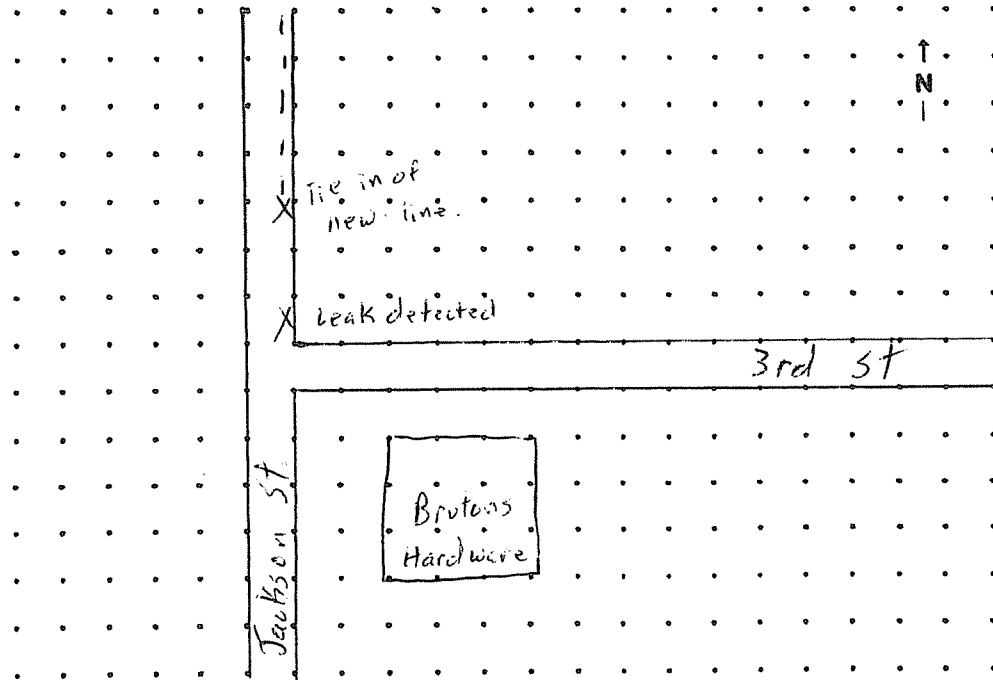
Remarks We detected a leak here. We tied in the new line on 4th St., and it appears it Migrated from that section. We are continuing to monitor the area.

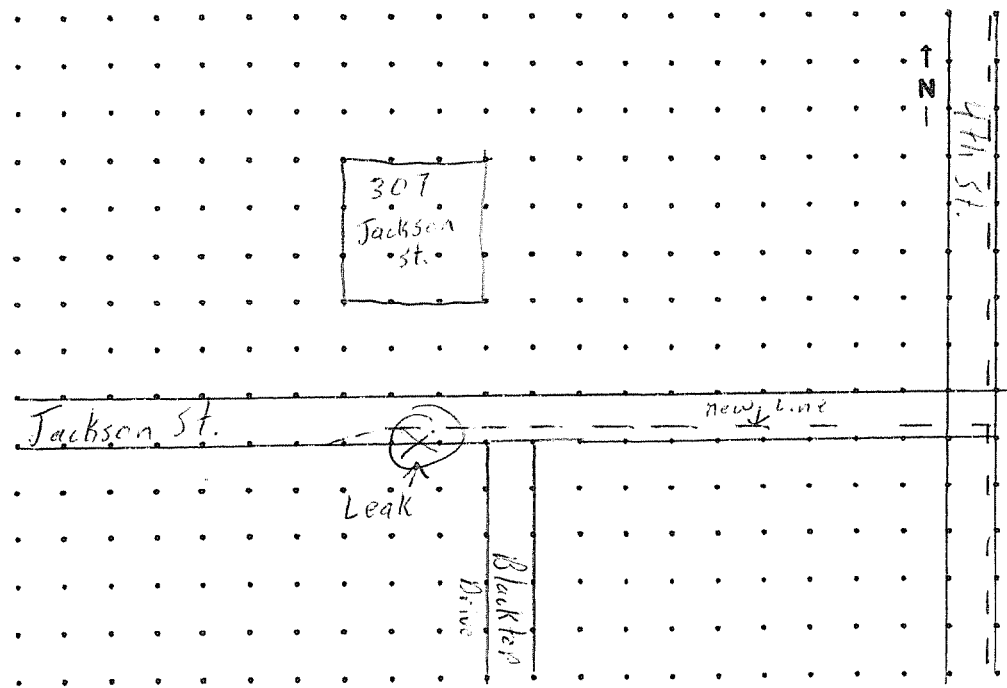
Remarks We picked up a portion of Jackson St. with the new line we laid on 4th St. We dug down where the leak was detected & found that the line was laying on rock & had a hole rubbed in it. We temporarily put a repair clamp on it. When we tied Jackson St. in off of 4th St., we went past the leak & found where the original line ~~was~~ was up off the rock & made the tie in.

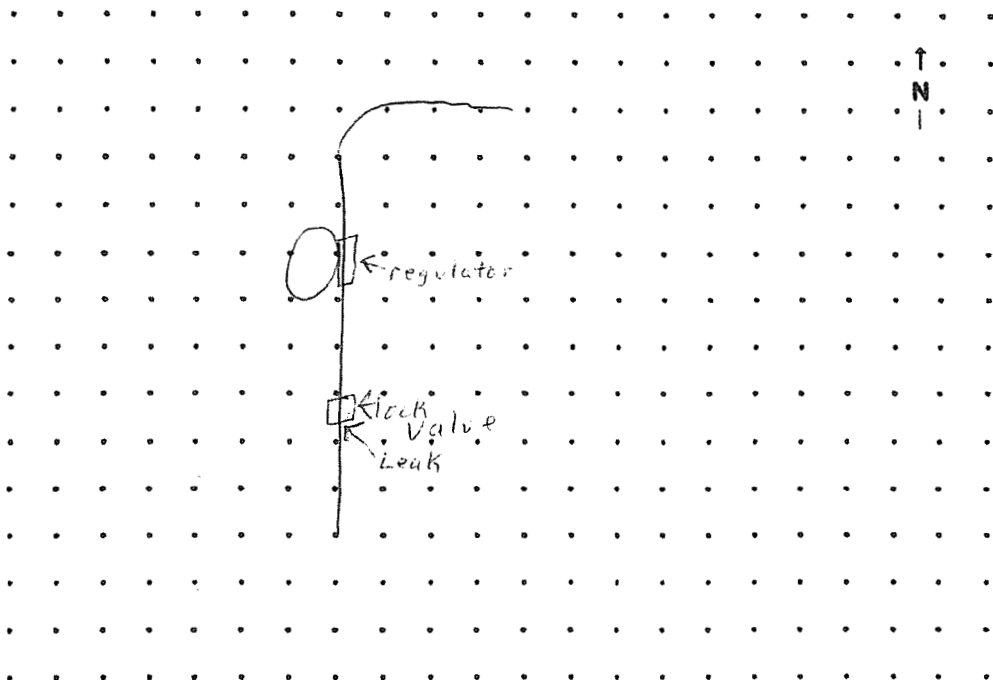
Remarks Here, we replaced the lock valve because it was leaking through. We broke down the meter set, replaced the lock valve, & rebuilt the meter set. We then tested for leaks & returned services.

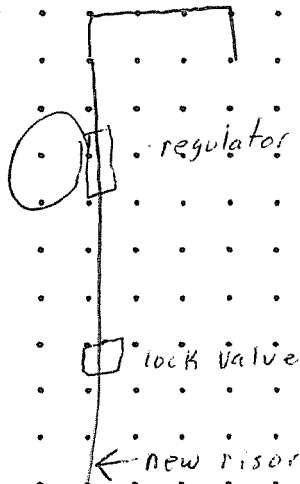
Remarks We had a leak in the ground on the service. We replaced the riser & rebuilt the meter set. We tested the service for leaks & relit the customer.

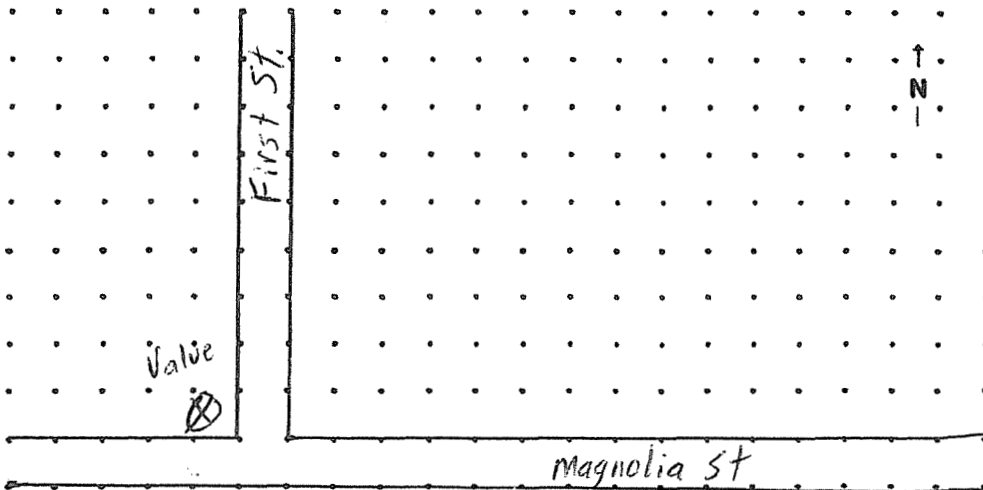
Remarks Valve hadn't been greased & worked for a good while. We greased & worked it, & it seems to have solved the problem

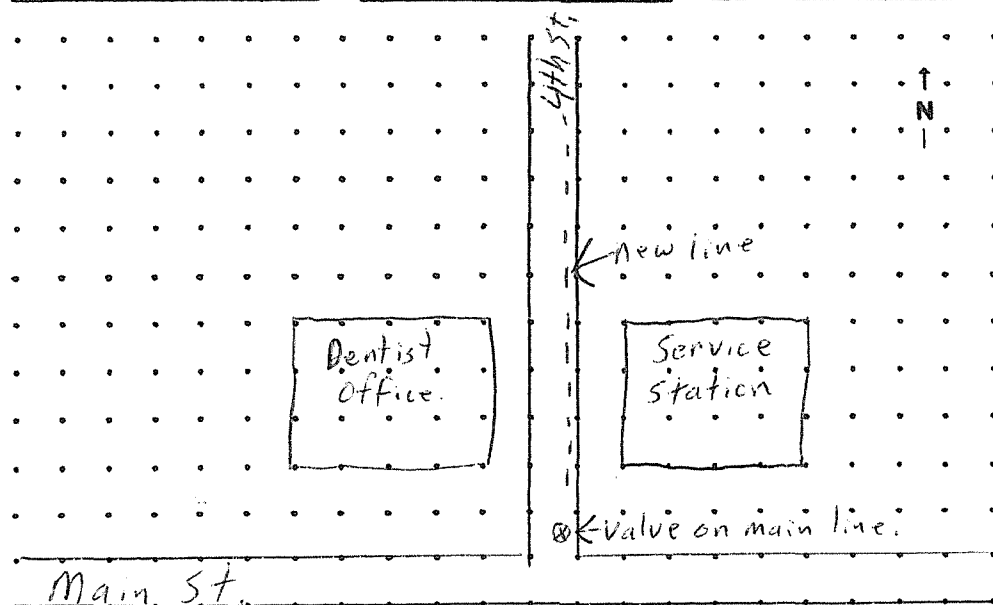
Remarks We greased & worked the valve, as well as replacing the line on 4th St to Lake St.

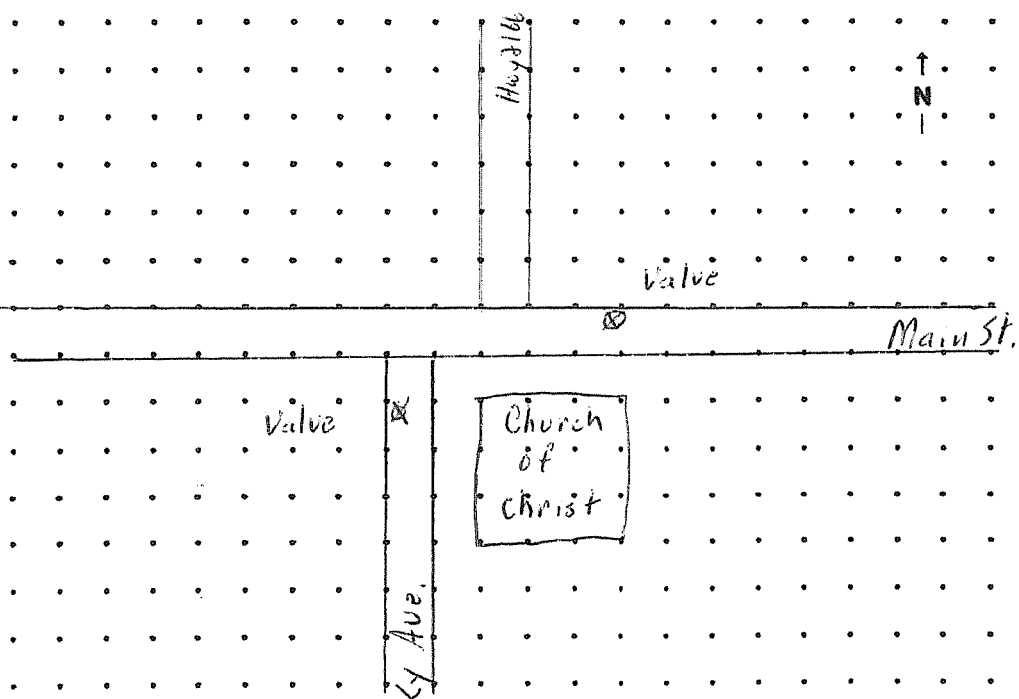
Remarks The valve on Main St. was greased & worked.
We also replaced the valve on KY Avenue due to
a leak on it. After working the valve on
Main St, we have detected no gas present.
Monitoring will continue.

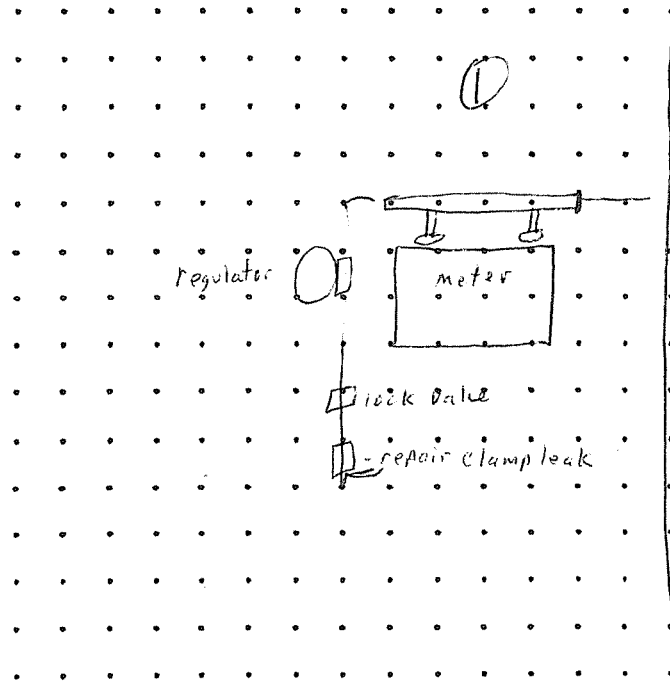
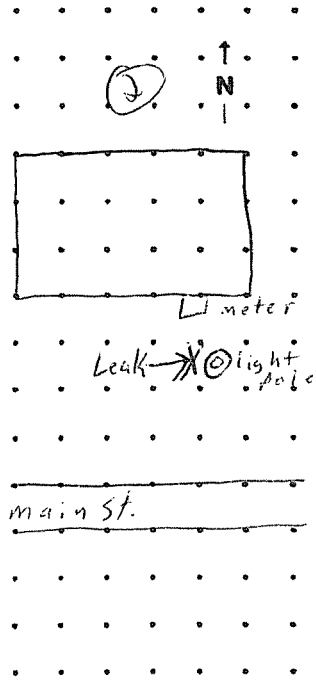
Remarks We had 2 leaks at this service. One in the ground by the water meter & One on a repair clamp on the riser. We dug out the riser & found a bad spot on the service as well. We replaced the bad section as well as the riser. We rebuilt the meter set & tested for leaks.

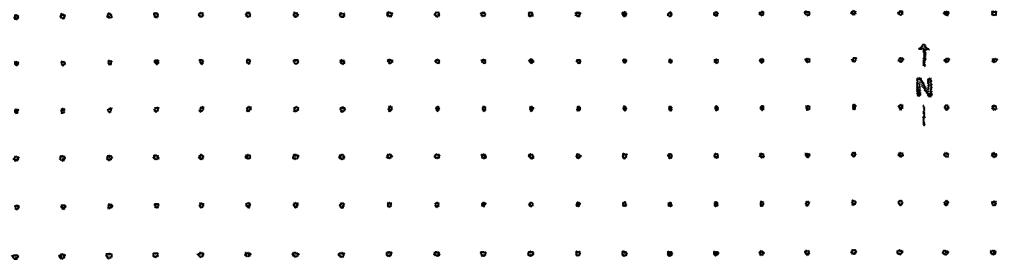
Main Street Man hole

Remarks We picked up a trace of gas here in the manhole for the sewer system. We immediately vented the man hole. The gas disapated fairly quickly. The man hole isn't far from the leak that was found on the 2" valve at the intersection of Hwy 166 + Main St. After making repairs there, the problem has been resolved. We are continuing monitoring.

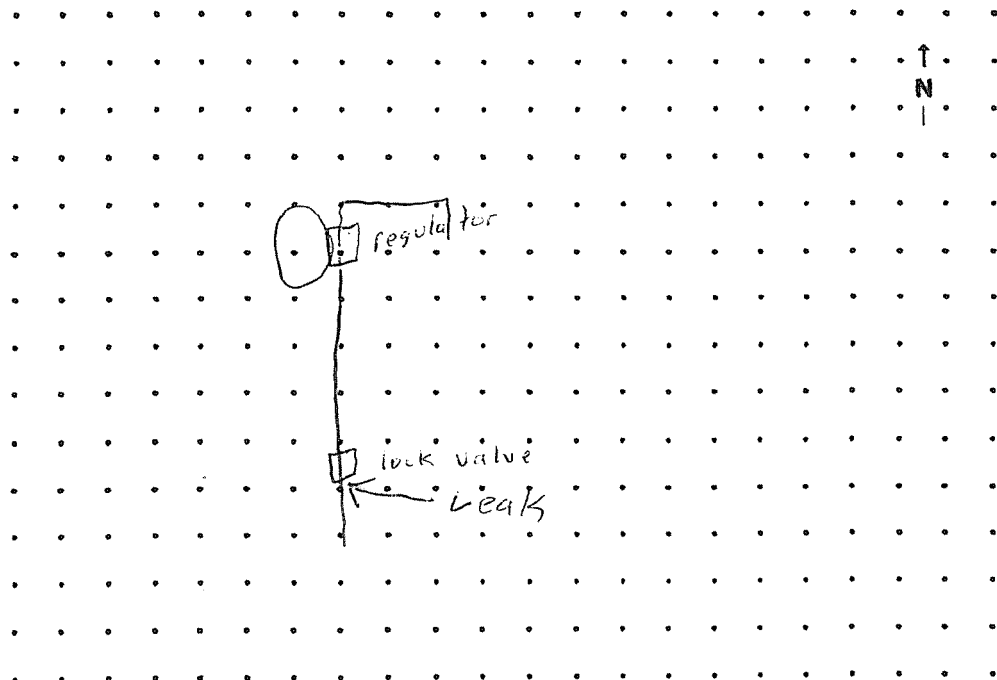
Remarks The lock valve on the service was leaking on the Inlet side. We redoped the lock valve & rebuilt the meter set. We tested for leaks & resolved the problem.

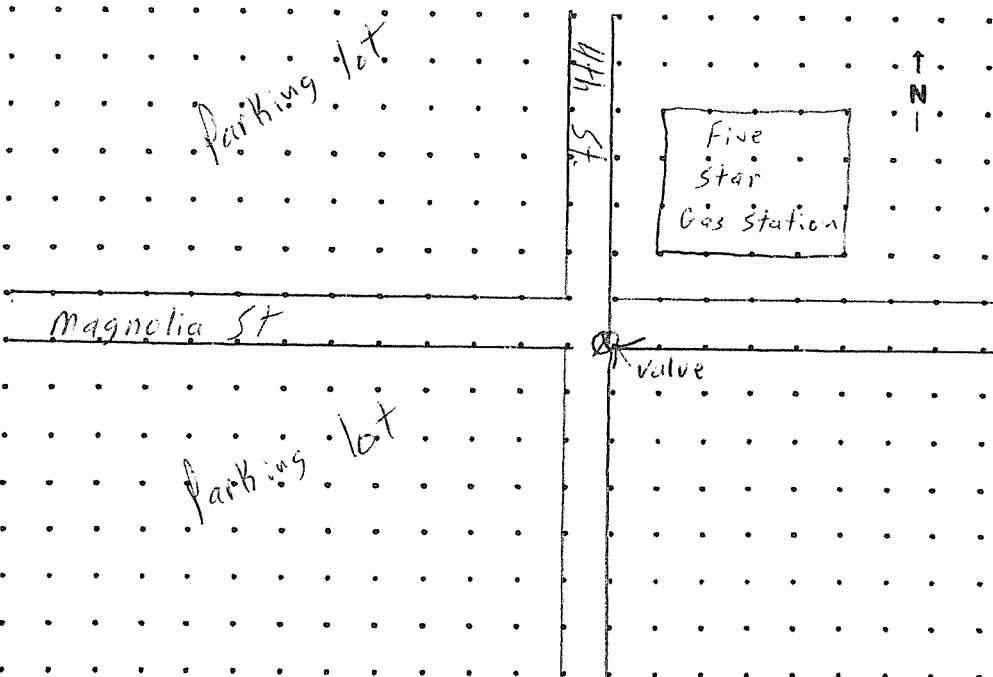
Gas traces were detected in the valve box, possibly on the valve. We greased & worked the valve, & so far it seems to have resolved the problem. It appears that several main line valves here in town have not been greased or worked for a long time. We went through the system & worked every valve that we knew of.

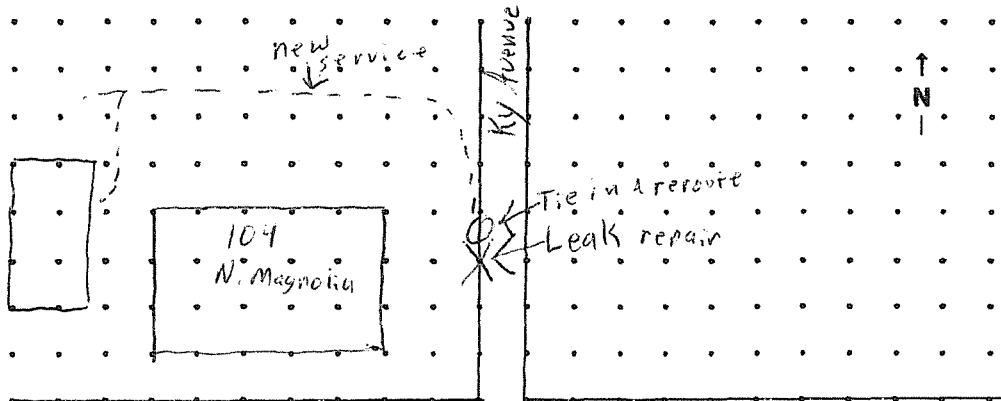
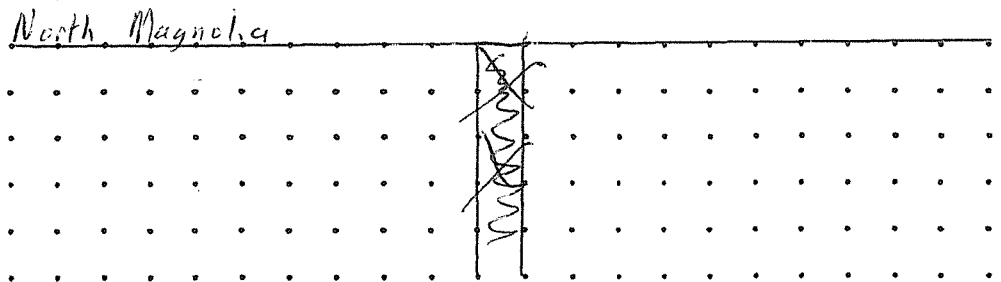
Remarks 104 N. Magnolia was scheduled to be tore down to build an addition on to the service station at the corner of 4th and Magnolia. We dug out the leak location & found a place on the main leaking. We repaired it using a repair clamp. We then tied into the old service & rerouted it to allow for demolition.

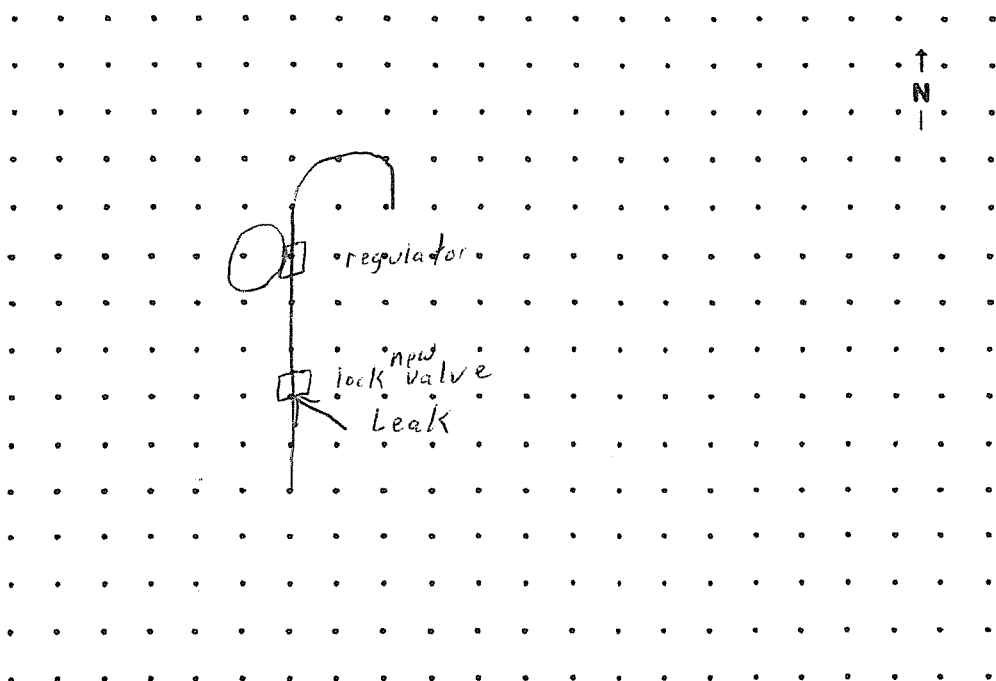
The lock valve was leaking on the inlet side of the service. It was in bad condition, so we replaced it. We then rebuilt the service using new parts, tested for leaks, & relit the customer

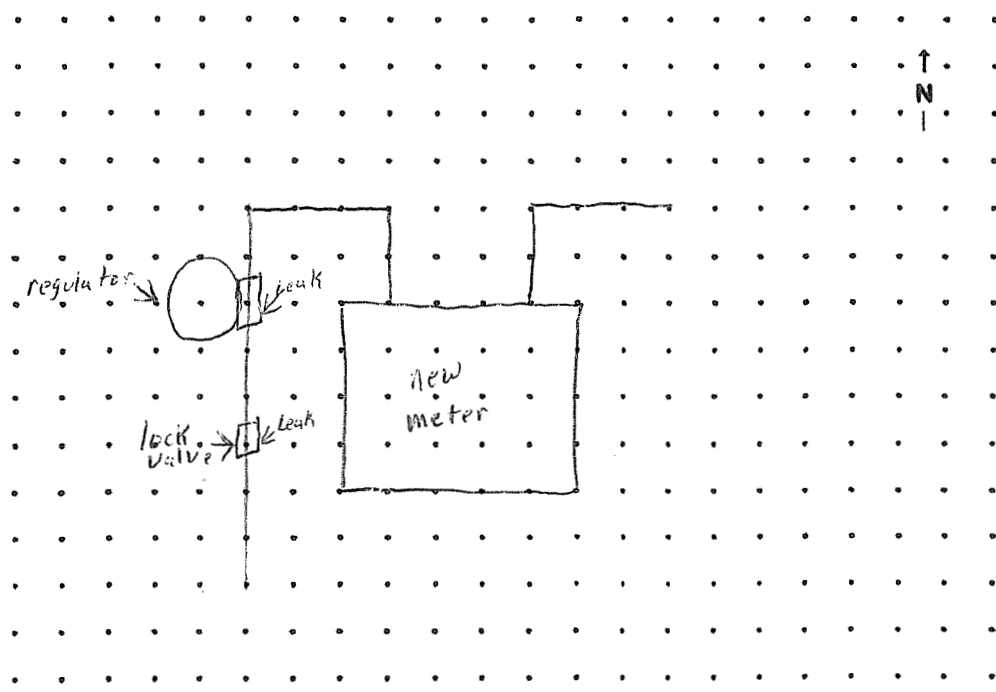
Remarks We had a leak on the lock valve & on the regulator at the service. We replaced the riser due to corrosion & rebuilt the meter set using new parts. We then tested for leaks & relit. the customer

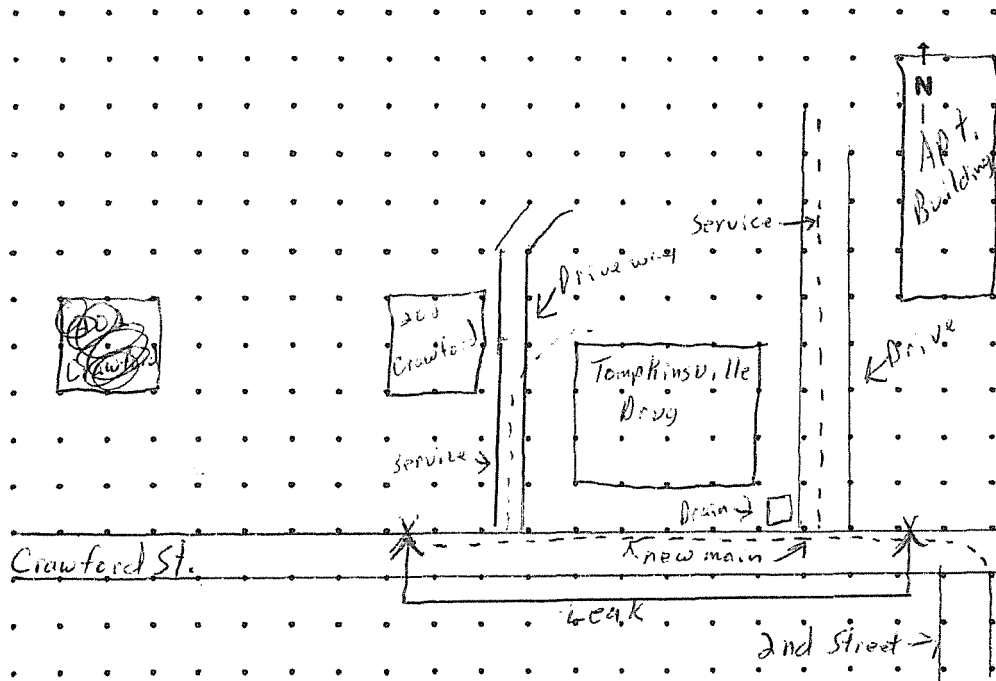
Remarks The leak here extended a good distance. We dug down in several places & the pipe was in bad shape. We found one place that had been hacked with a backhoe or trucker bucket & damaged. It wasn't leaking, but was mashed & pulled up. We replaced the entire section with 2" PE & tied in all services.

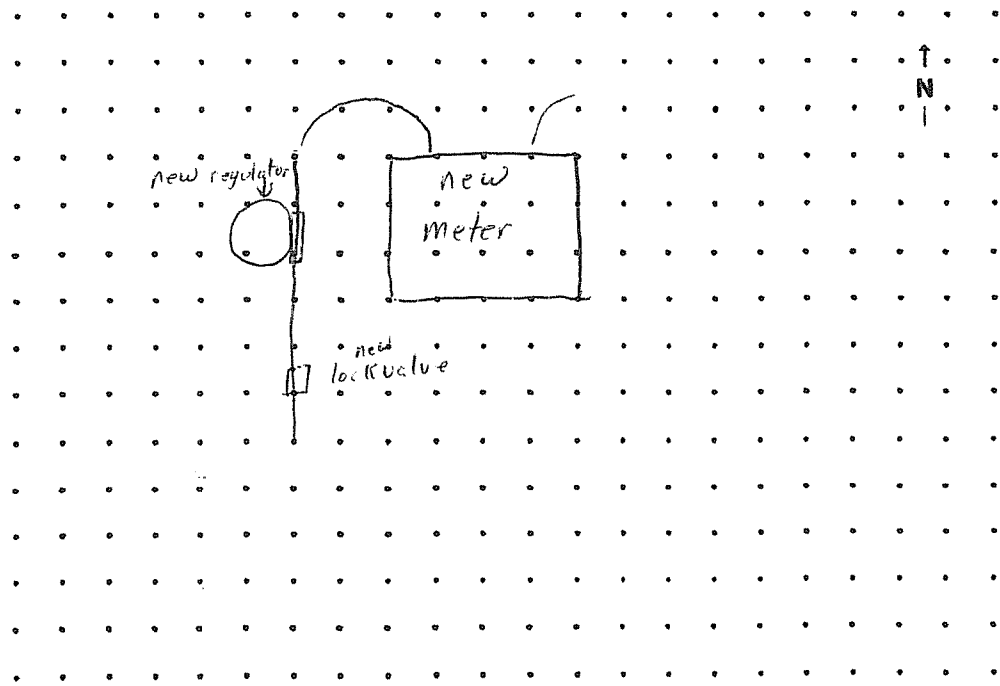
Remarks There was a leak on the lock valve at this service. We replaced the lock valve + installed a new regulator + meter. We replumbed + tested for leaks.

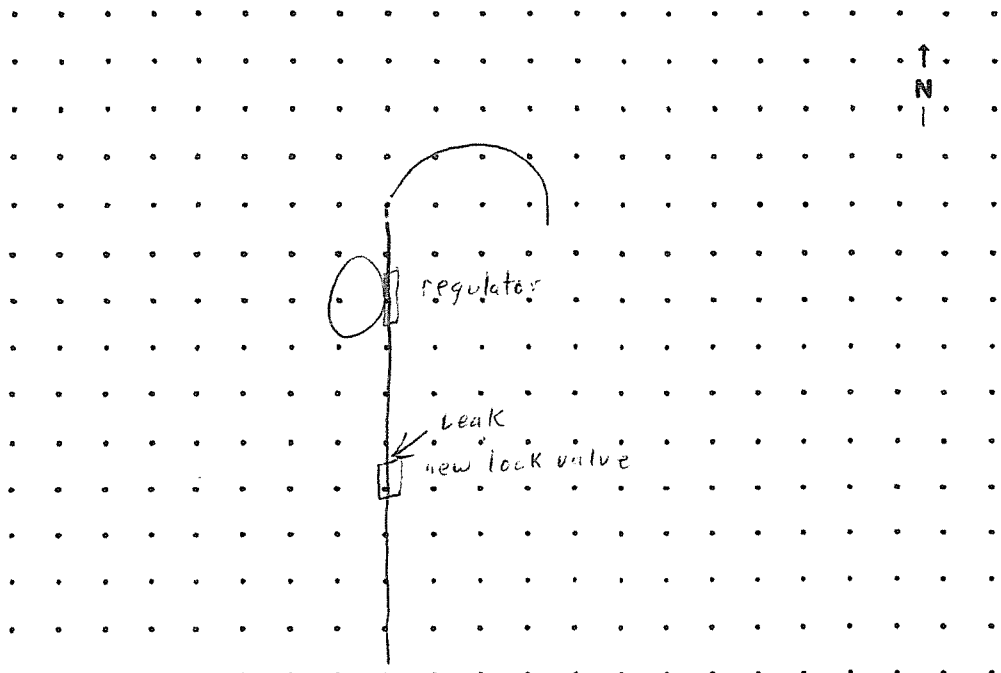
Remarks We had a leak on the lock valve at this address.
We replaced the faulty lock valve & replumbed the meter
back. We then tested the set for leaks & relit the
customer.

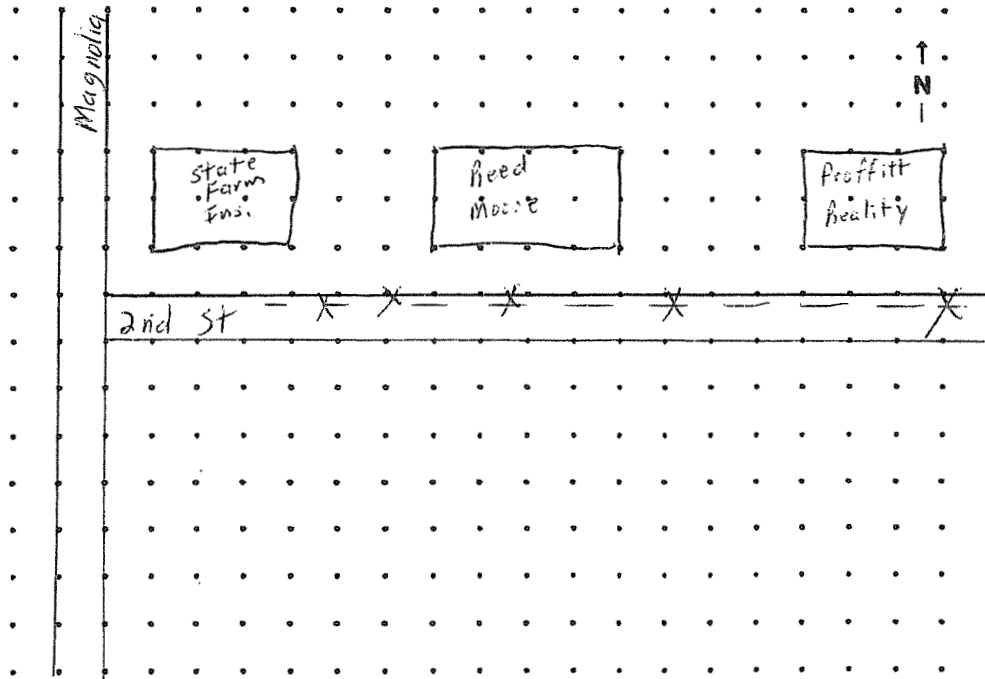
Remarks We had gas present in a wide area here. Proffitt Reality building had gas present inside the building. The were asked to leave for the day until we could repair the problem. We started digging up the main & found 5 separate leaks in a 200' section of the main. We put repair clamps on the bad places to temporarily fix it. We plan to put in new line as soon as possible to discontinue use of the bad line.

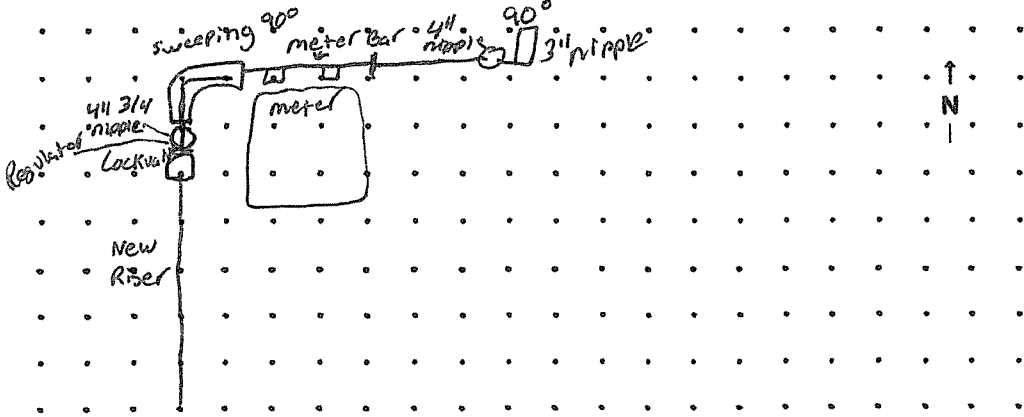
Remarks
Installed New Riser, Lock Valve, 4" by 3/4" nipple
Sweeping 90° - New meter Box - meter - 4" nipple
3" nipple and 90° basically rebuilt whole meter set.

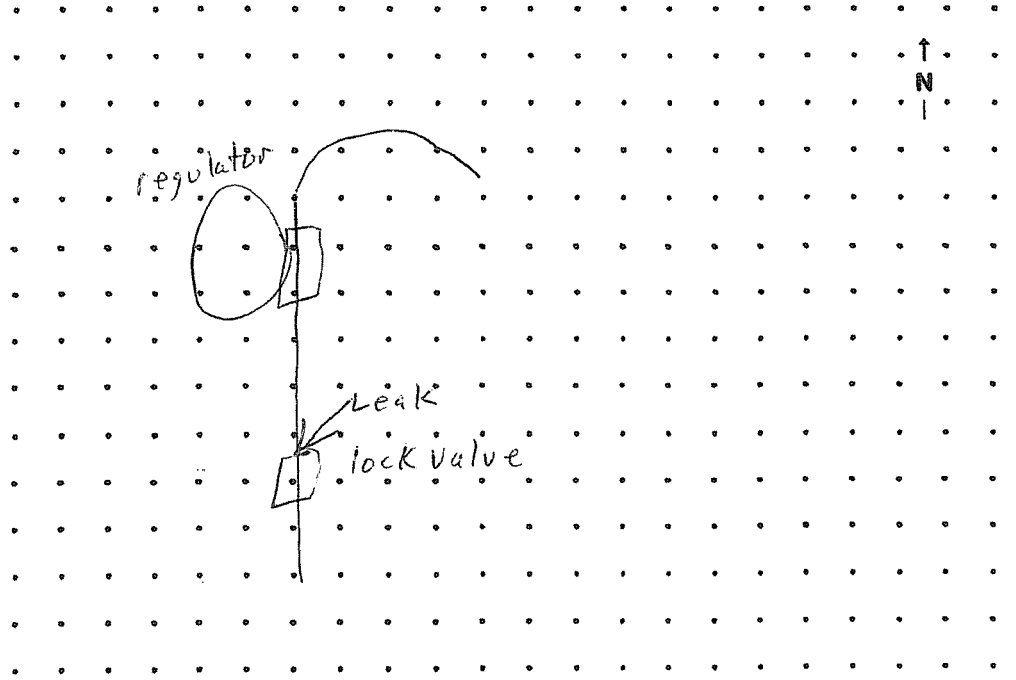
Remarks We had a leak on the lock valve at the service We broke down the meter redoped the lock valve & replumbed the meter set. We tested for leaks & relit the customer.

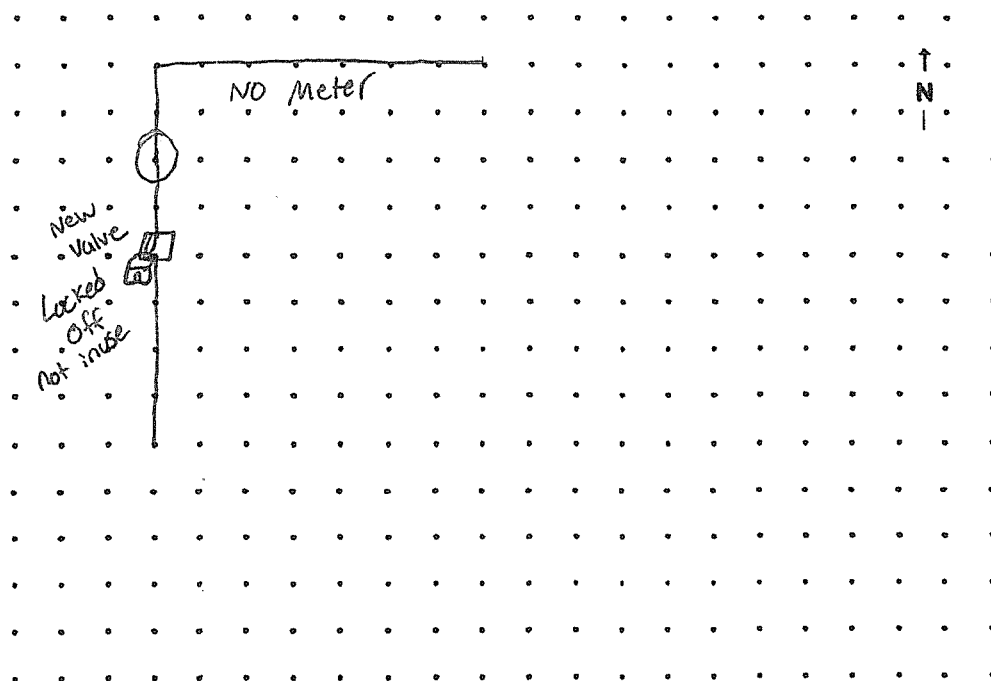
Remarks put in new valve, broke down and redoped
Fittings - Locked off gas not inuse - NO
meter.

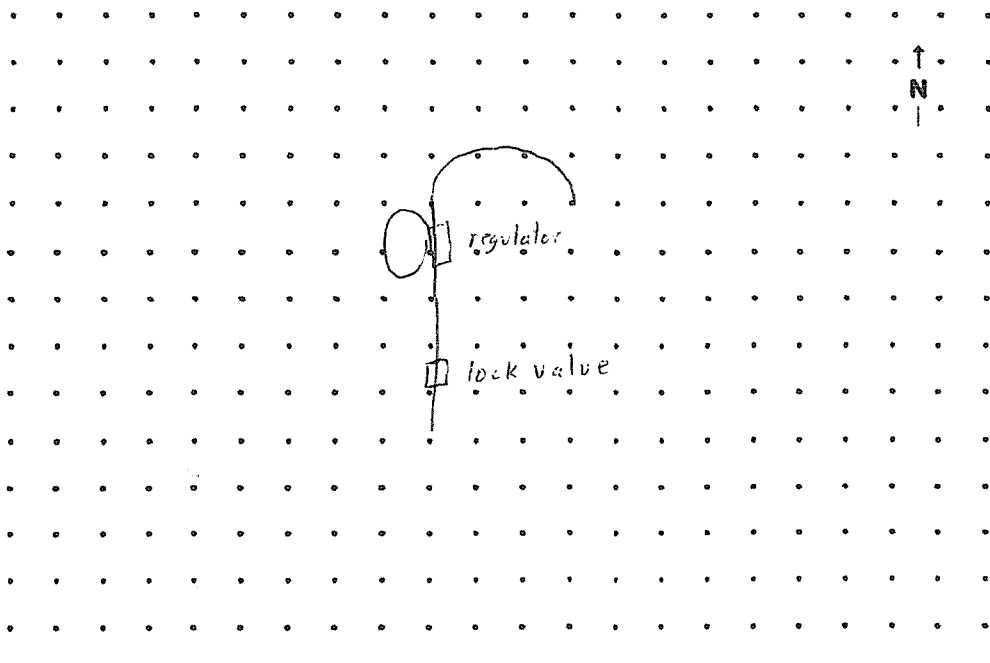
Remarks The regulator on this service was broke. It
looked like it had been hit by a lawn mower or something,
We replaced it & tested for leaks.
