Subject: Case 2012-00362: City of Tompkinsville
From: Joseph Orazen (jorazen@yahoo.com)
To: jason.brangers@ky.gov;
Cc: shmartin1@bellsouth.net; reed@reedmoorelaw.com; jarmscityclerk@yahoo.com; mcphersonc93@yahoo.com;
Date: Tuesday, March 5, 2013 11:15 AM

To:
Jason Brangers
Manager, Pipeline Safety Branch
Kentucky Public Service Commission

**LEAKAGE CONTROL REPORT
FIELD SURVEY**

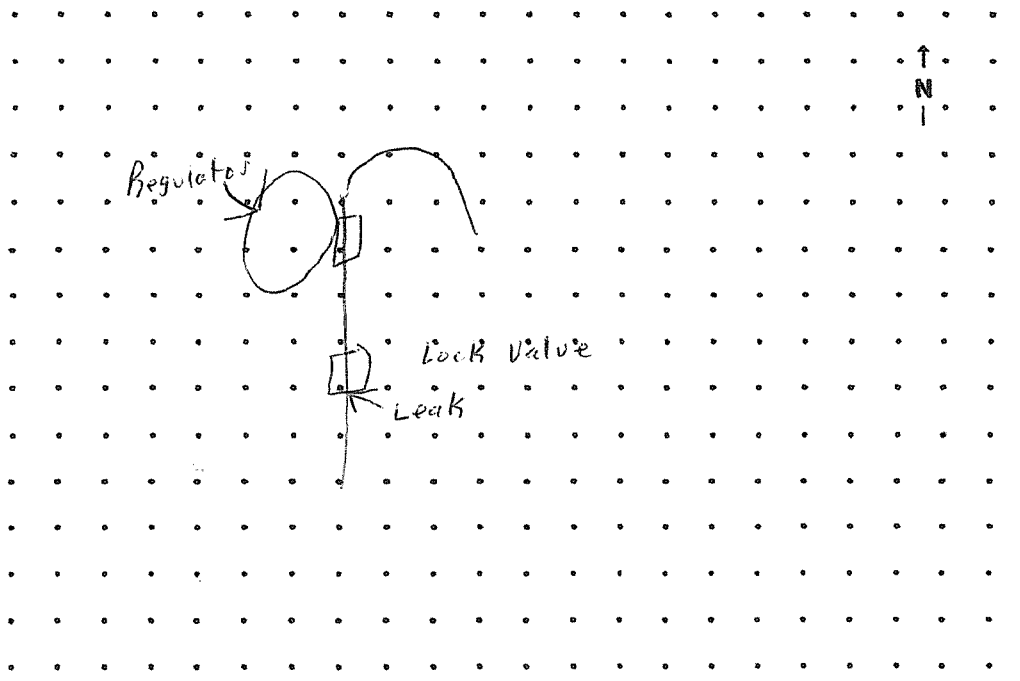
Remarks We had a leak on the lock valve at the meter set. We broke the set down & replaced lock valve and added a new 3" x 3/4 nipple.

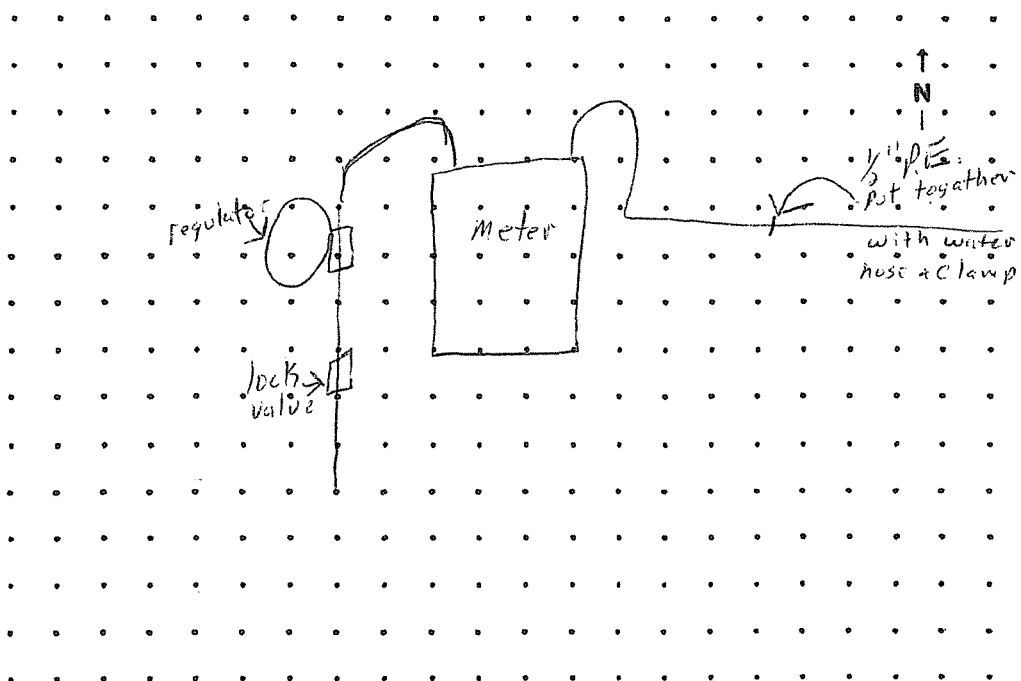
Remarks This service wasn't leaking, but on the downstream side of the meter we found a 1/2" P.E. line above ground tied into the meter going to the store. We turned off the gas & informed the customer that they had to pipe the gas into the building using steel.
