Martin
Contracting INC.

Case No. 2012-00362

1. 2012 Tompkinsville Gas System Regulator Inspection Report

2. Leakage Control Reports:

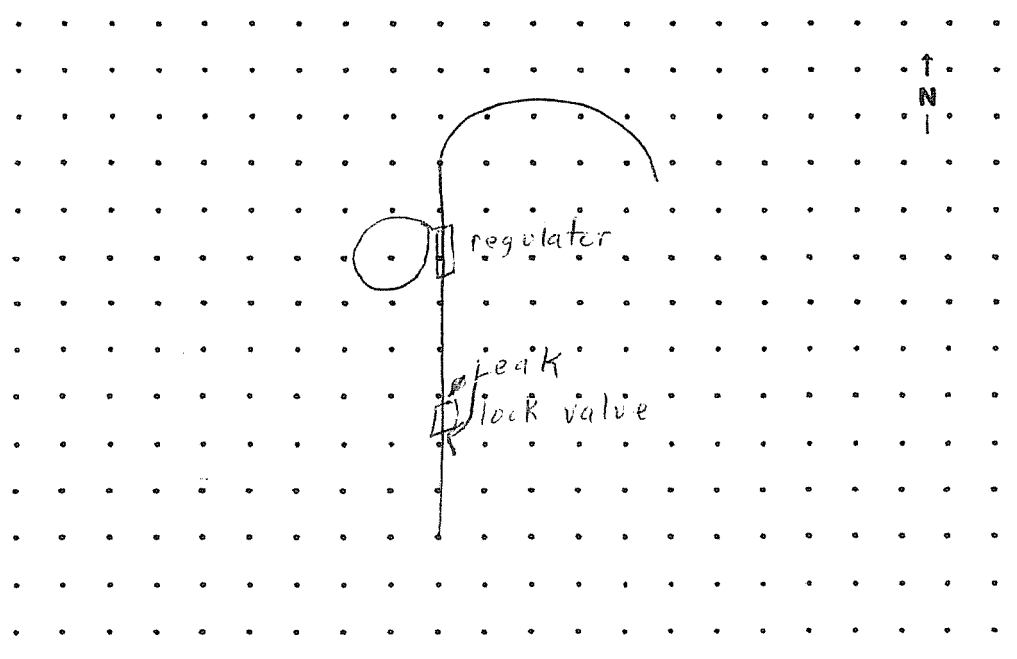
Remarks The leak was on the ~~at~~ inlet side of the lock valve. It didn't look to be in very good shape. We decided it would be best to replace the lock valve & rebuild the meter loop back.

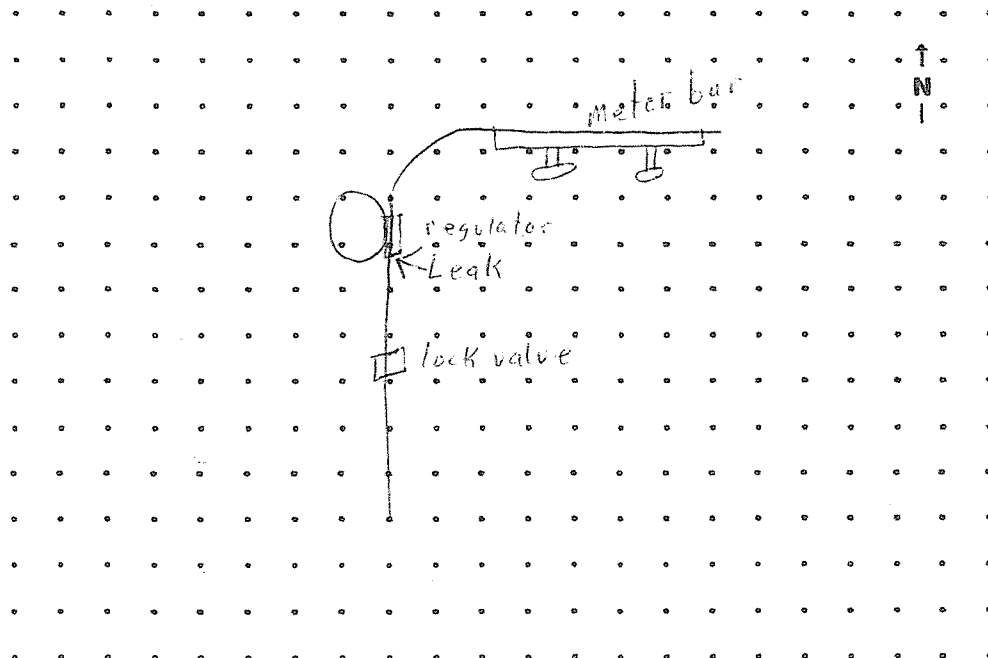
Remarks We had a leak on the inlet side of the regulator. We broke down the service & replaced the regulator. We then rebuilt the meter set, tested for leaks & turned the gas back on.

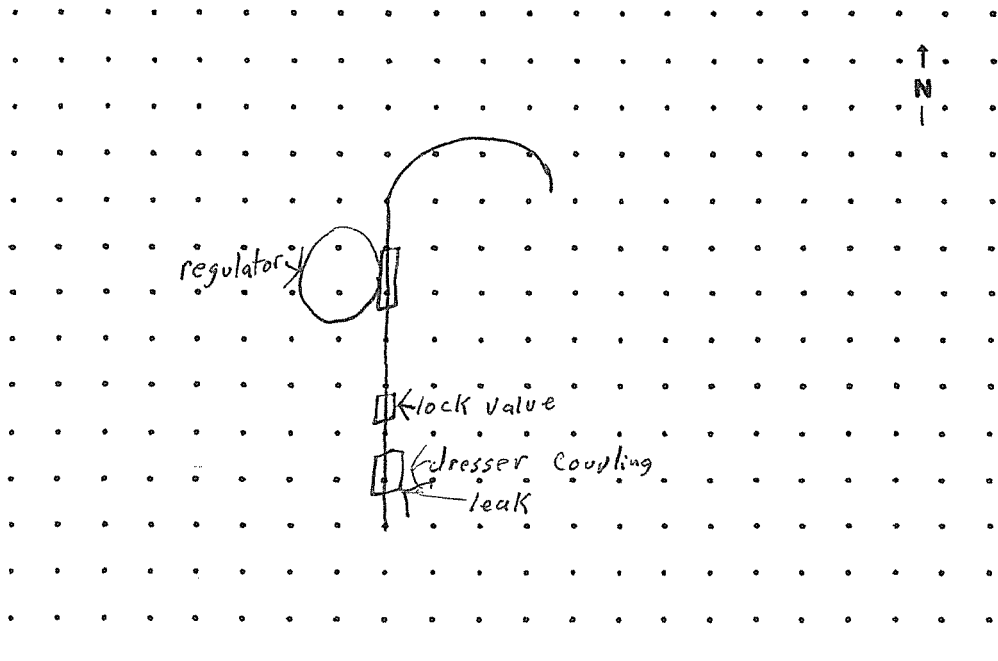
Remarks We had a leak on the dresser fitting at the base of the riser at this service. To get rid of the coupling, we replaced the riser & rebuilt the meter set.
