COMMONWEALTH OF KENTUCKY
BEFORE THE PUBLIC SERVICE COMMISSION

LOUISVILLE GAS AND ELECTRIC COMPANY)	
_____)	
ALLEGED FAILURE TO COMPLY WITH)	CASE NO.
COMMISSION REGULATIONS 807 KAR 5:006,)	2004-00232
SECTION 25(4)(d) AND 807 KAR 5:041,)	
SECTION 3(1))

INCIDENT INVESTIGATION ~ Staff Report

Electric Utility Personal Injury Incident Report

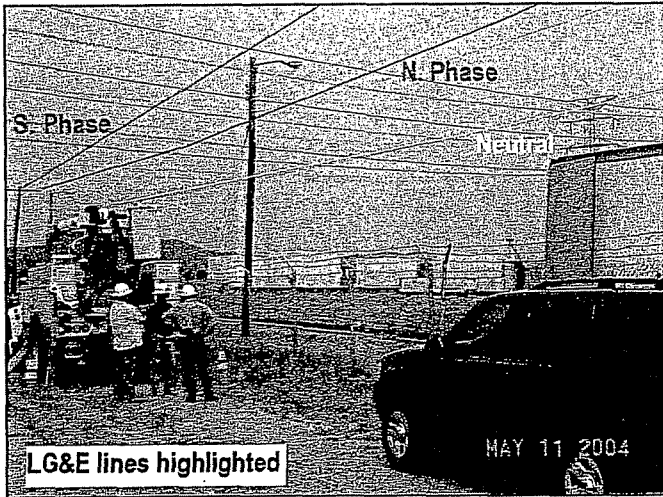
VIEW 1: NEAR CONTACT POINT - FACING NW

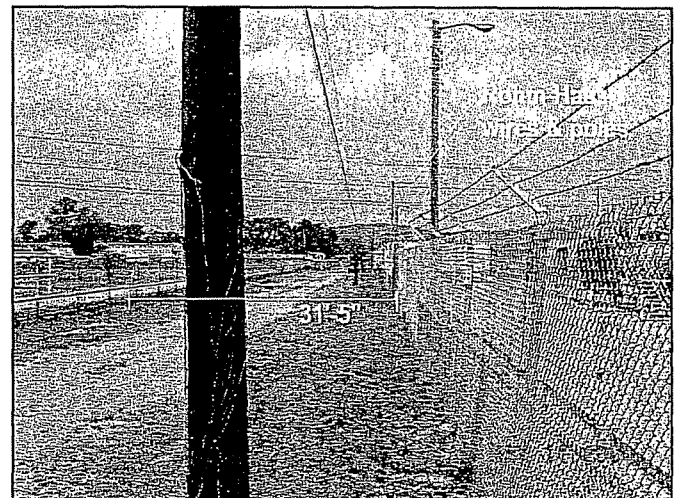
VIEW 6: ACCESS ROAD FROM EAST LG&E POLE - FACING WEST
