KENTUCKY AMERICAN WATER
Filter Building Study – Richmond Road Station
Kickoff Meeting Minutes – 7/31/13

CONDITION ASSESSMENT KENTUCKY AMERICAN WATER COMPANY LEXINGTON, KENTUCKY

Please find enclosed the underwater inspection report for the condition assessment of the Kentucky American Water Company Richmond Road Clear Well located in Lexington, Kentucky. The inspection was performed on August 13, 2013. We appreciate the opportunity to assist with this project.

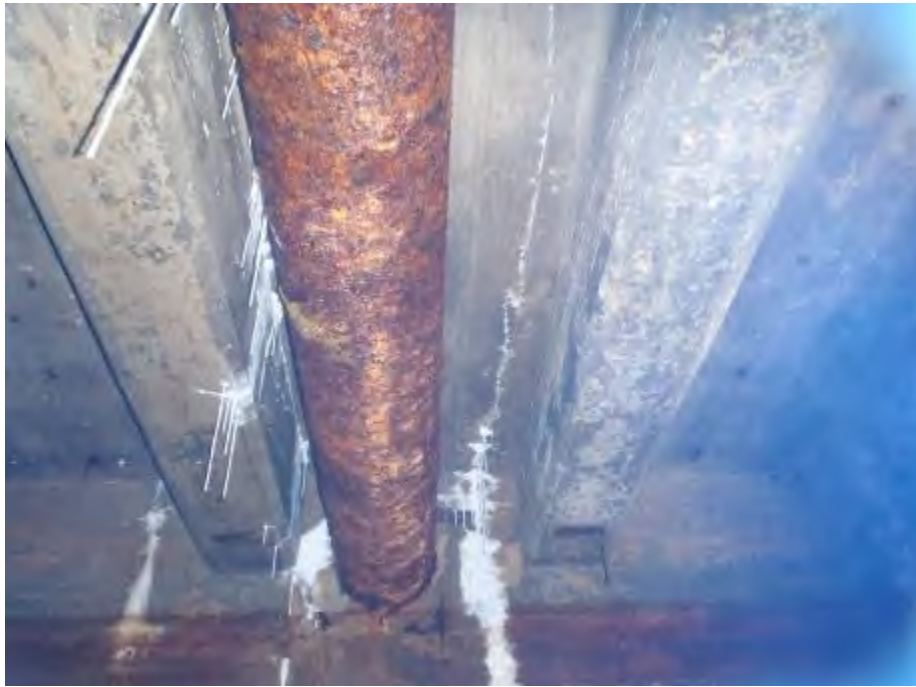
Photo – 1

- A transverse crack with efflorescence was observed on the ceiling, measuring 10 feet long and 1/16 inch to 1/8 inch wide between floor beams 7 and 8. The crack extended from the east wall of the bay to 10 feet to the west.
-

West Bay. Transverse crack on the ceiling between floor beams 7 and 8.

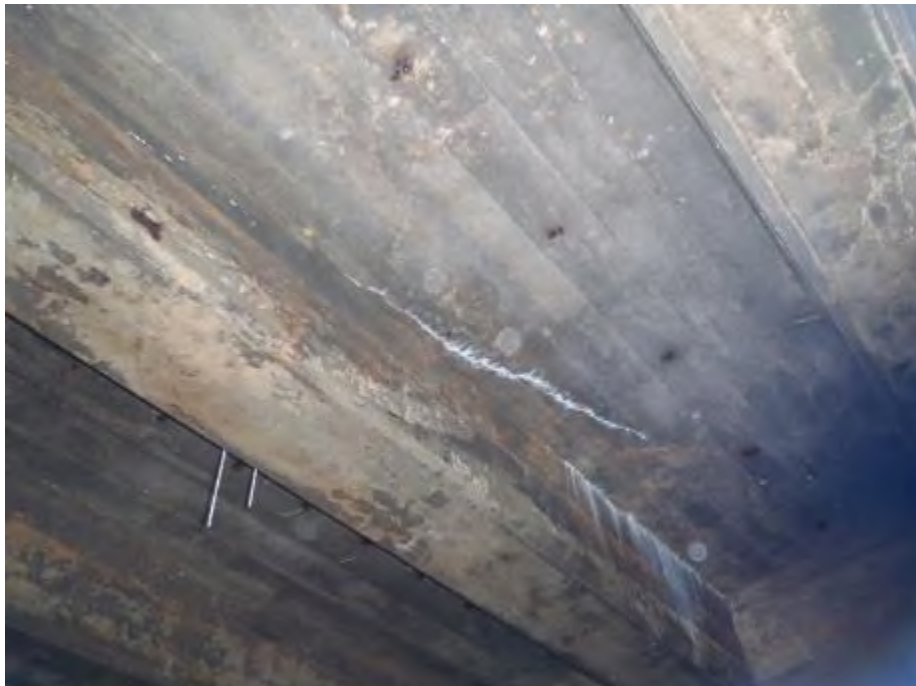
Photo – 2

- A transverse crack with efflorescence was observed on the ceiling, measuring 5 feet long and 1/16 inch wide between floor beams 11 and 12. The crack was centered 4 feet east of the west wall.

West Bay. Transverse crack on the west side of the ceiling between floor beams 11 and 12.

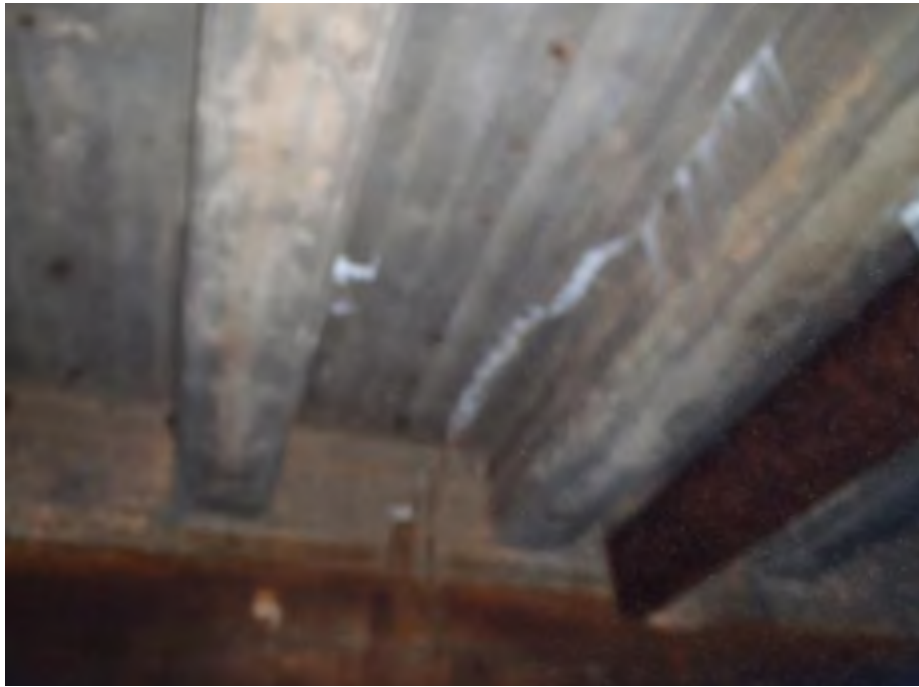
Photo - 3

- A transverse crack with efflorescence was observed on the ceiling, measuring 6 feet long and 1/16 inch wide between floor beams 11 and 12. The crack extended from the east wall of the bay to 6 feet to the west.

West Bay. Transverse crack on the east side of the ceiling between floor beams 11 and 12.

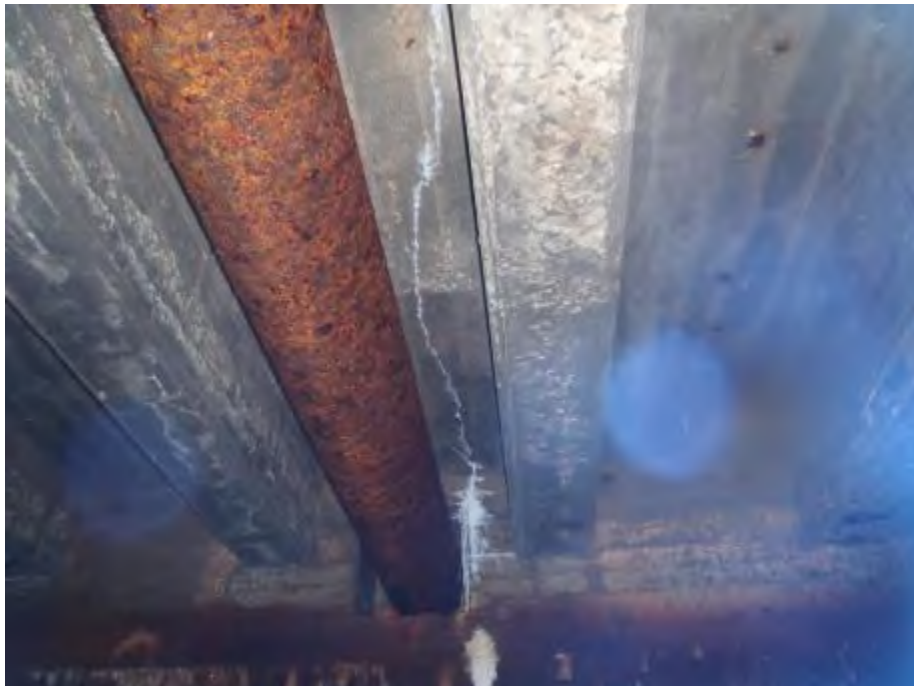
Photo - 4

- A transverse crack with efflorescence was observed on the ceiling, measuring 8 feet long and 1/16 inch wide between floor beams 17 and 18. The crack extended from the east wall of the bay to 8 feet to the west.

West Bay. Transverse crack on the ceiling between floor beams 17 and 18.

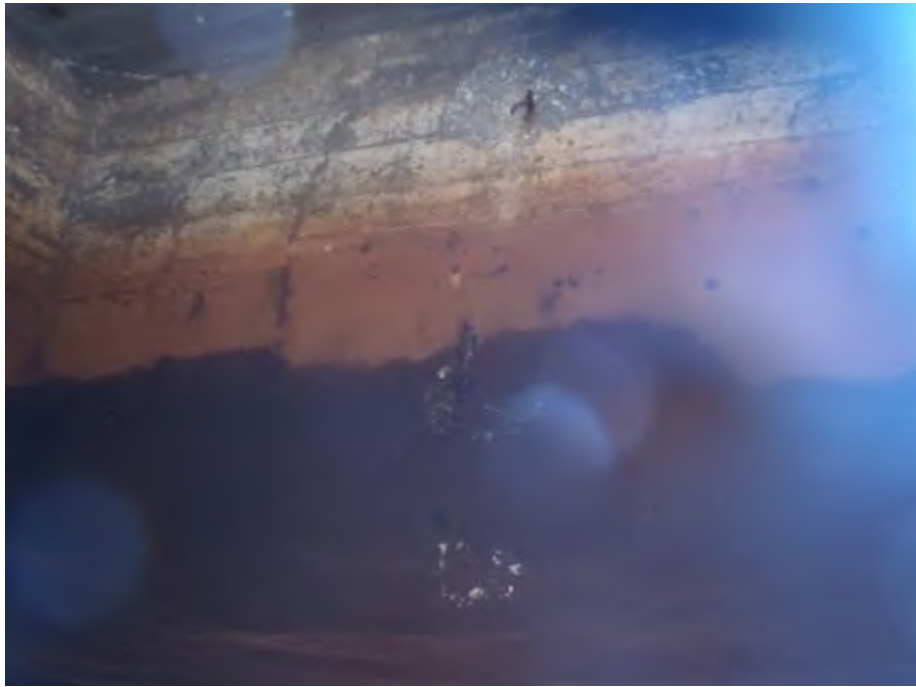
Photo - 5

- A spall was observed on the south wall of the bay, 6 feet from the east wall and 2 feet below the ceiling, measuring 1 foot in diameter and 2 inches of penetration with 1 steel reinforcement bar exposed with up to 75 percent section loss.

- A spall was observed on the south wall of the bay, 6 feet from the east wall and 4 feet below the ceiling, measuring 18 inches high, 4 inches wide, and 3 inches of penetration with 1 reinforcement bar exposed with up to 50 percent section loss.

- A spall was observed on the south wall of the bay, 6 feet from the east wall and 5 feet below the ceiling, measuring 6 inches in diameter and 2 inches of penetration with no reinforcement bars exposed.

West Bay. Three spalls on the south wall, 6 feet west of the east wall.

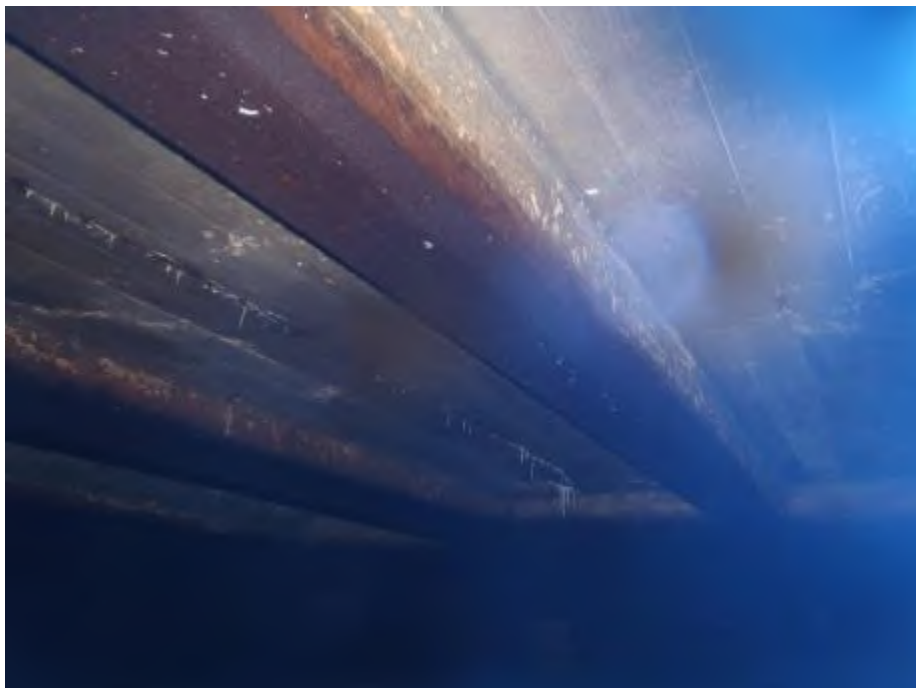
Photo - 6

- The concrete floor beams typically exhibited random hairline cracks. Exposed steel was not observed on the underside of the beams. Cracking, spalls or other forms of deterioration was not observed.

Center Bay. Typical condition of floor beams.

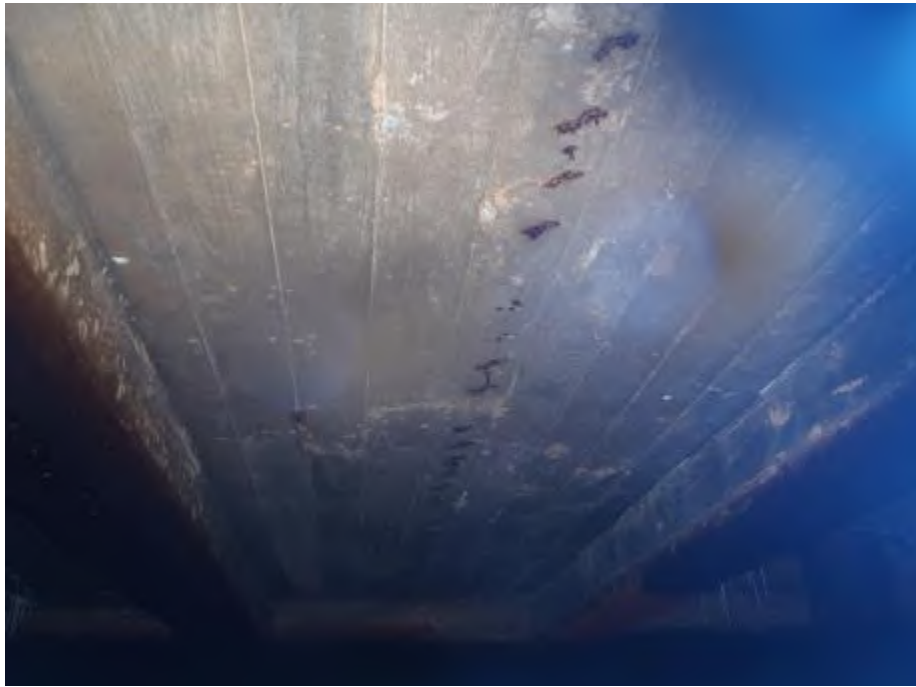
Photo - 7

- The concrete ceiling typically exhibited random hairline cracks and exposed steel form ties or chairs spaced approximately every 6 inches, transversely across the slab at isolated locations.

Center Bay. Typical condition of the ceiling. Note the apparent exposed reinforcement chairs.

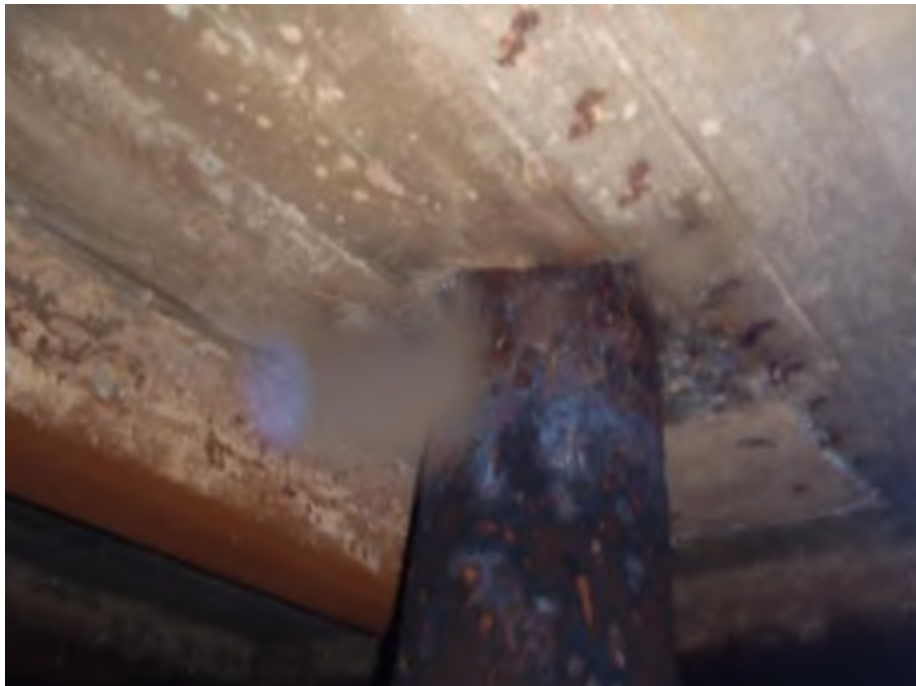
Photo - 8

Center Bay. Typical 10 inch diameter pipe penetration through the ceiling.

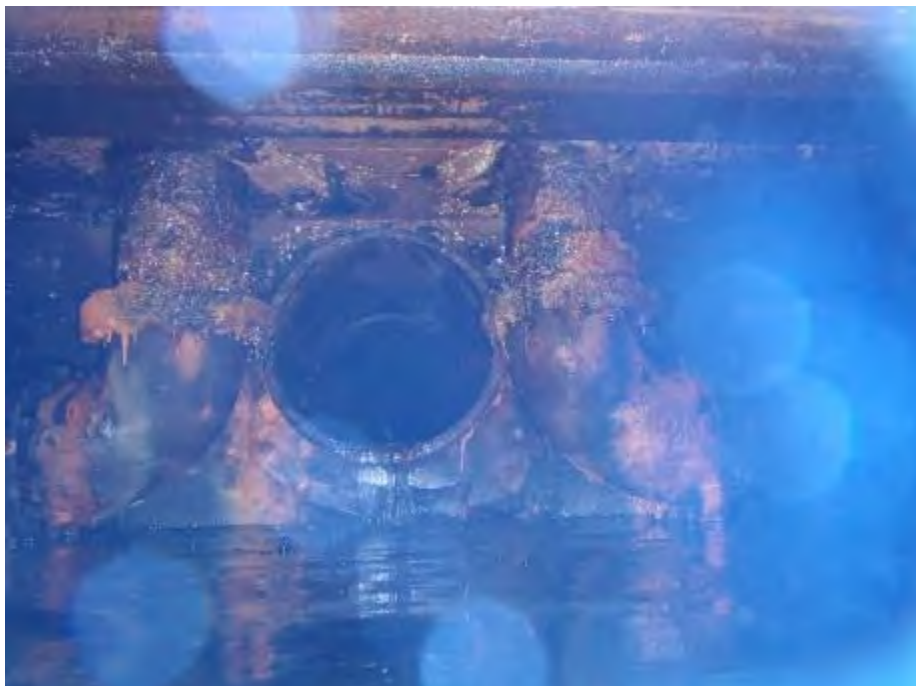
Photo - 10

Center Bay. South wall with 24" pipe and 12 in diameter U-pipe penetration through ceiling.

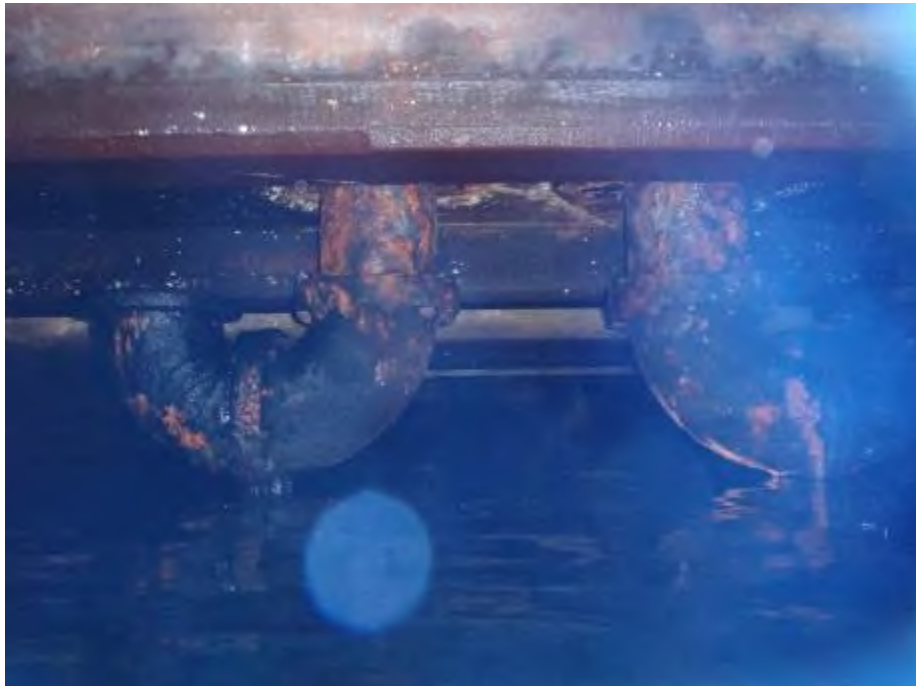
Photo - 11

Center Bay. Typical 12 inch diameter U-pipe penetration through ceiling.

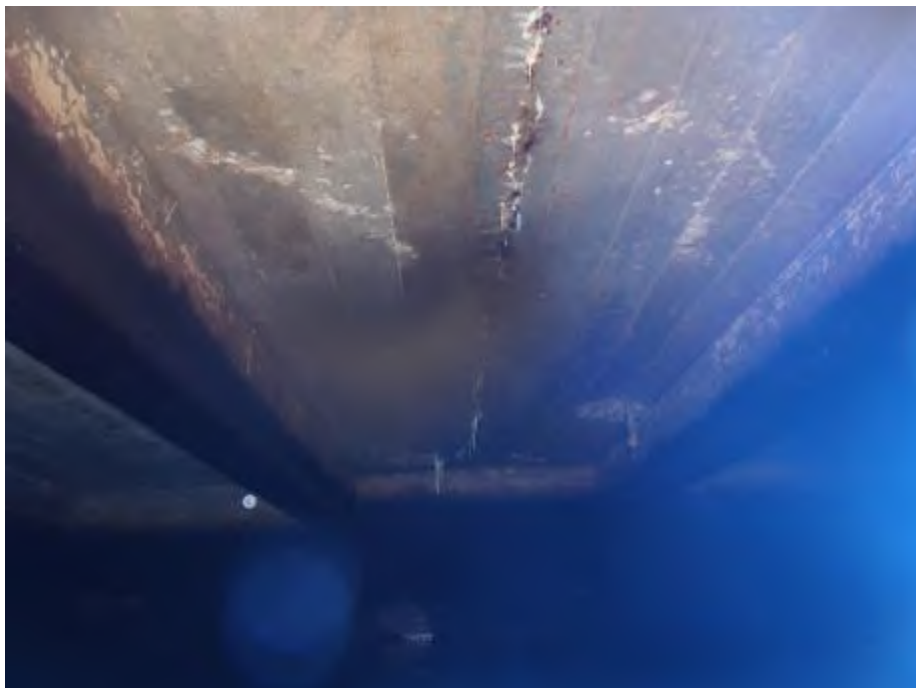
Photo - 12

- A transverse crack with efflorescence was observed on the ceiling measuring 15 feet long and 1/16 inch wide between floor beams 5 and 6. The crack extended from the west wall to the east wall.

Center Bay. Transverse crack on the ceiling between floor beams 5 and 6.

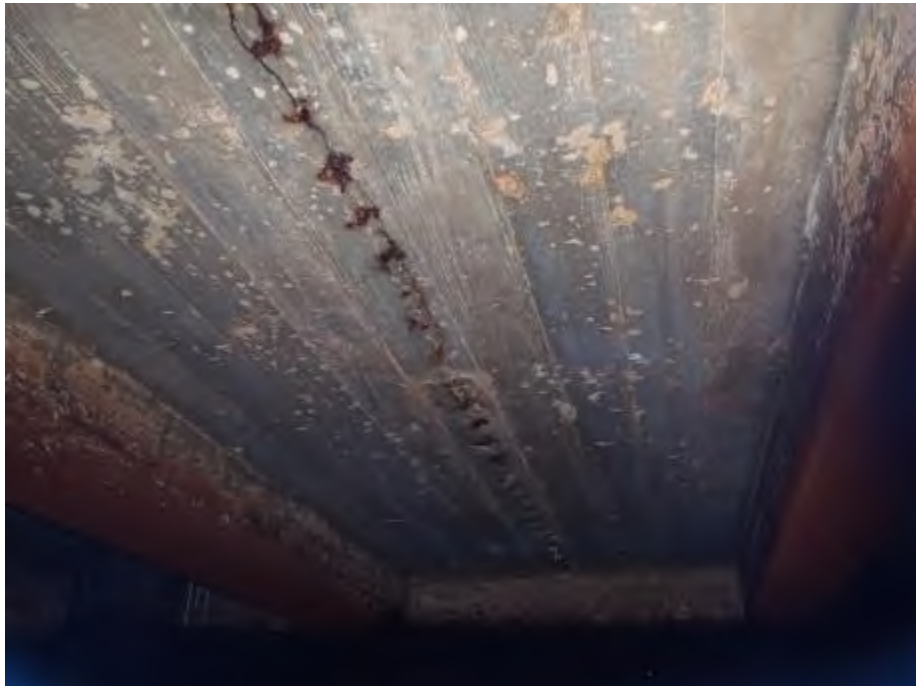
Photo - 13

Center Bay. Transverse crack on the ceiling between floor beams 8 and 9.

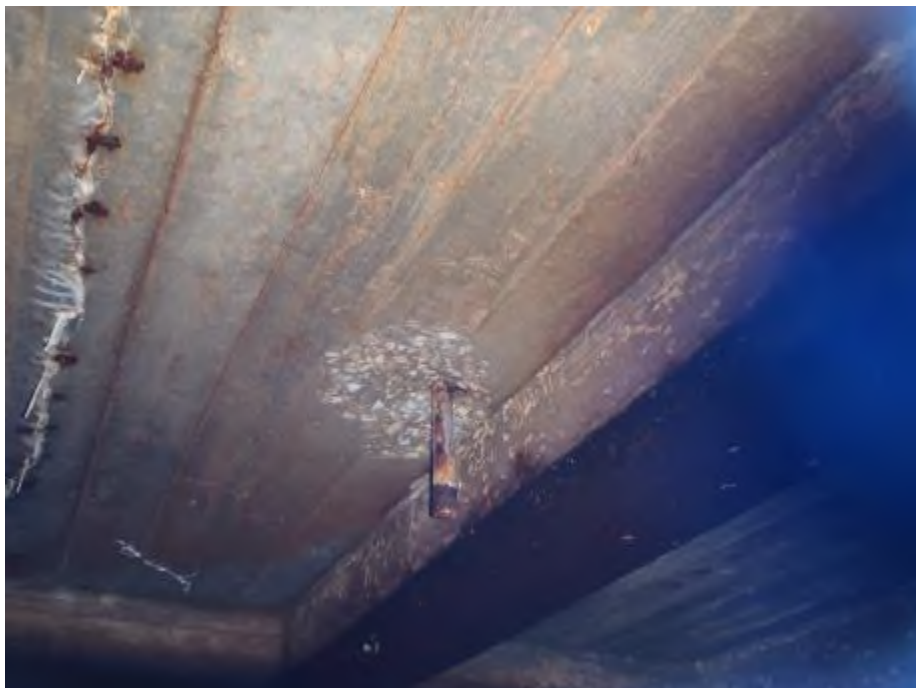
Photo - 14

- A spall was observed on the ceiling between floor beams 5 and 6, 4 feet from the east wall at an existing pipe penetration, measuring 1 foot long, 8 inches wide, and 2 inches of penetration with no reinforcement bars exposed.

Center Bay. Spall on the ceiling floor beams 5 and 6, 4 feet west of the east wall.

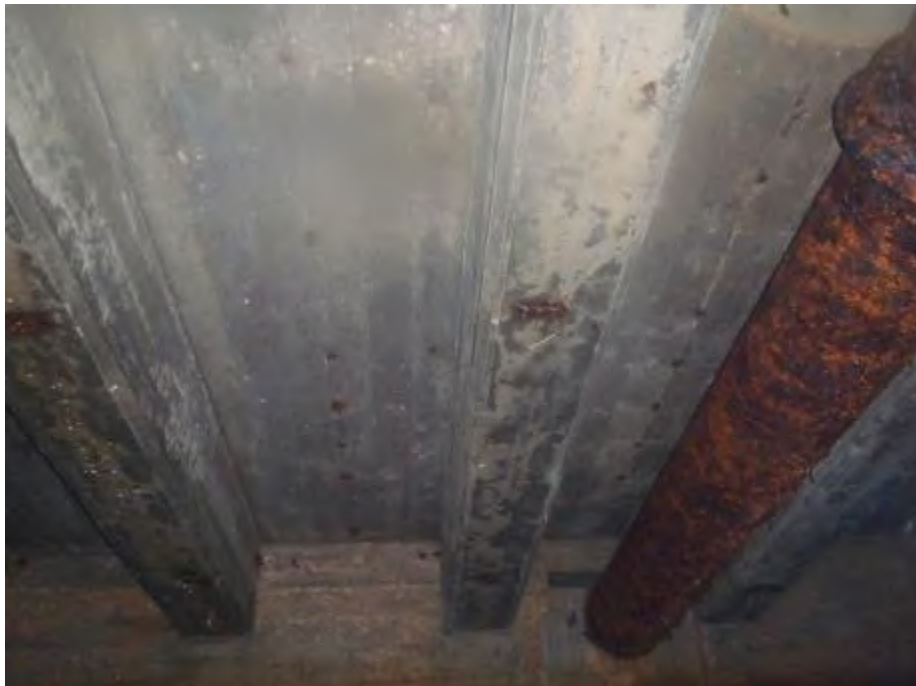
Photo - 16

- The concrete floor beams (filter level floor beams) exhibited random hairline cracks and exposed steel appearing to be reinforcement stirrups or form chairs spaced approximately every 8 feet. The exposed steel appears to be exposed due to insufficient form separation and concrete cover occurring when the beams were cast. The exposed bars have heavy corrosion with up to 50 percent section loss. Cracking, spalls or other forms of deterioration was not observed on the beams.

East Bay. Typical condition of floor beam. Note the exposed stirrup.

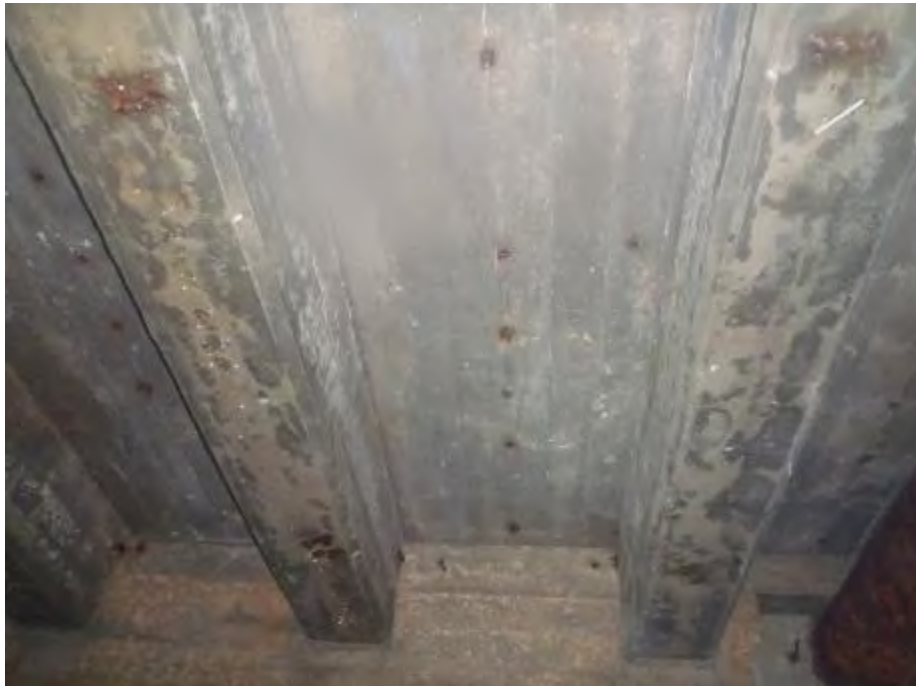
Photo - 17

- The concrete ceiling (underside of the filter level floor) exhibited random hairline cracks. At isolated locations exposed steel from form ties or reinforcement chairs exists, generally spaced approximately every 1 foot transversely across the floor slab.

East Bay. Typical condition of the ceiling. Note the exposed form ties.

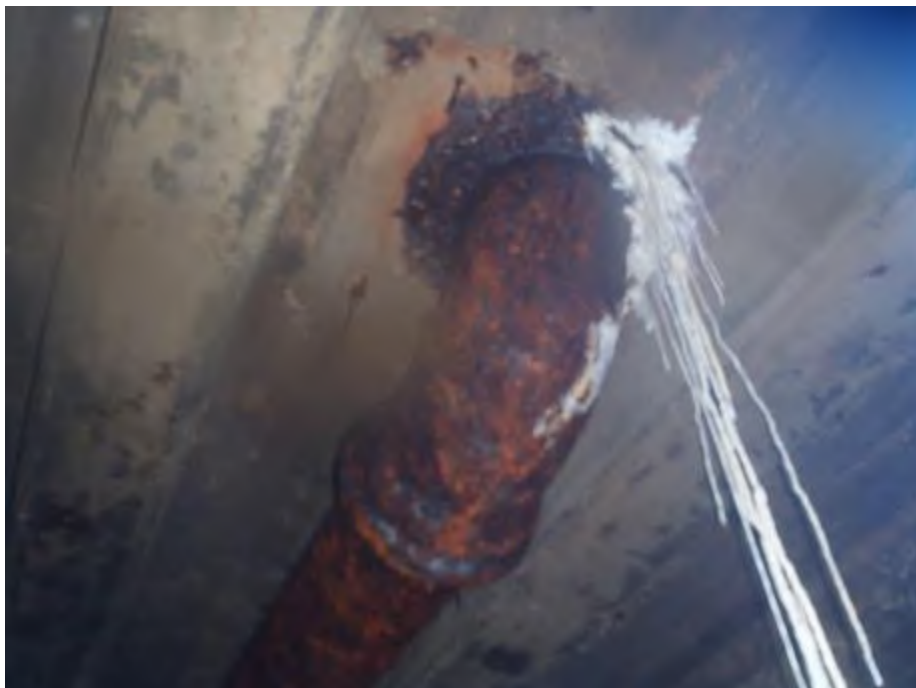
Photo - 18

East Bay. Typical 12 inch diameter pipe penetration through the ceiling.

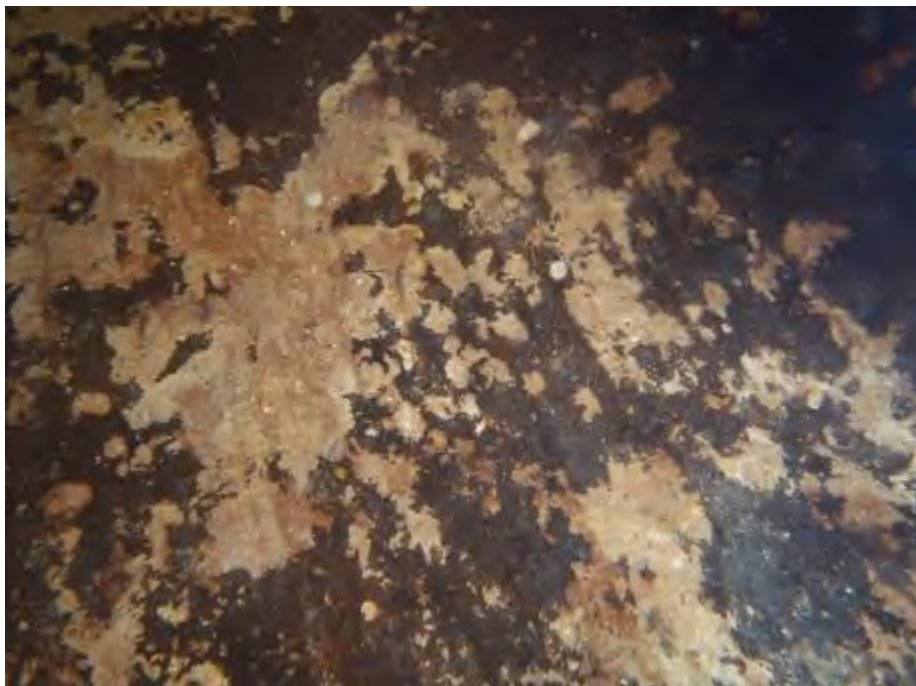
Photo - 20

- The exposed areas of the concrete floor exhibited light scaling up to 1/4 inch deep.
- Pipes penetrating the ceiling typically exhibited heavy corrosion with up to 1/2 inch thick of rust scaling. However, the pipes appeared secure and no holes through the steel casings of the pipes were observed.

East Bay. Underwater photograph showing the typical condition of the floor in an area where the coating has been removed.

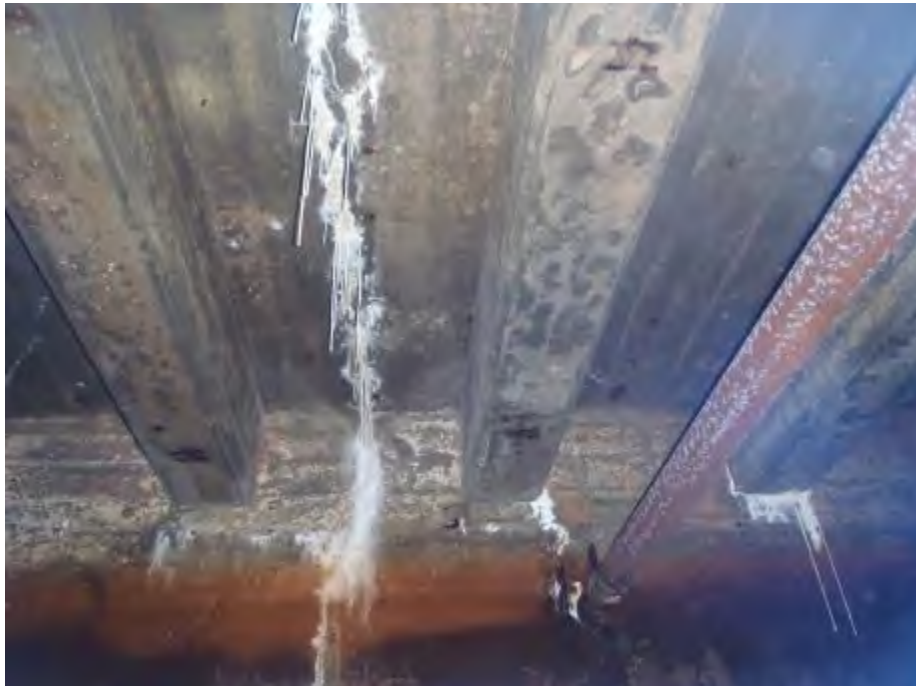
Photo - 21

East Bay. Transverse crack on the ceiling between floor beams 9 and 10.

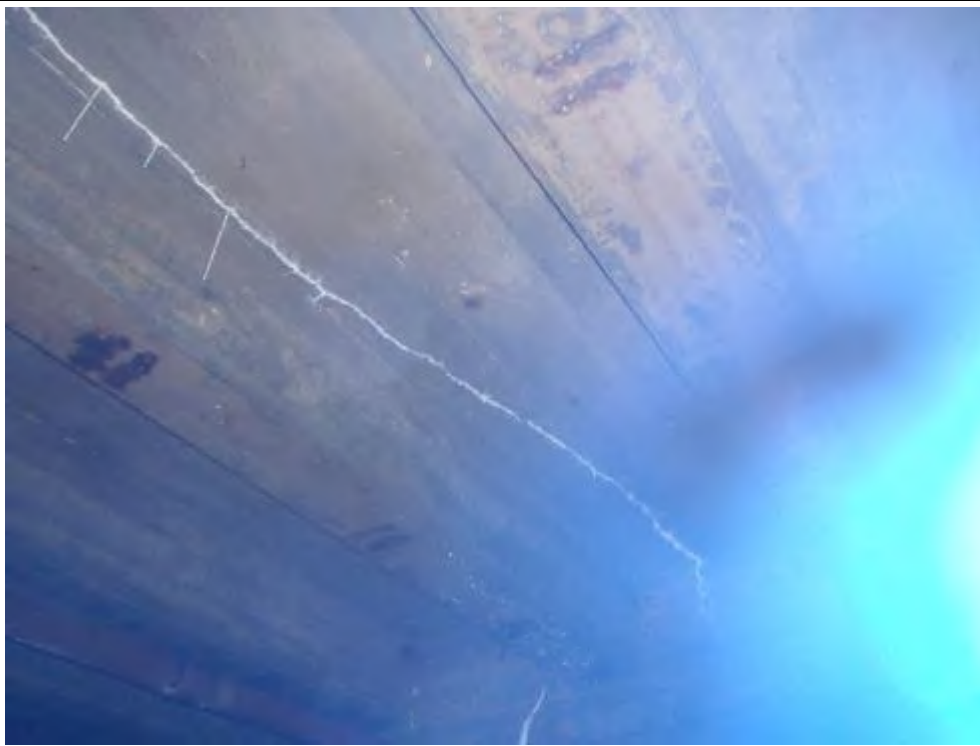
Photo - 22

East Bay. Transverse crack on the ceiling between floor beams 14 and 15.

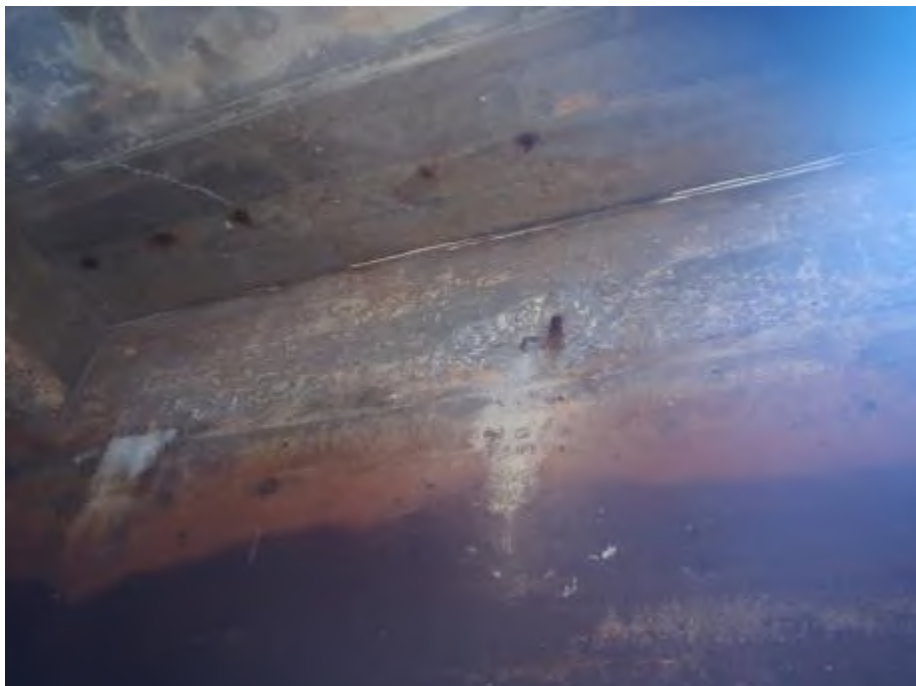
Photo - 24

East Bay. Spall on the south wall 6 feet west of the east wall.

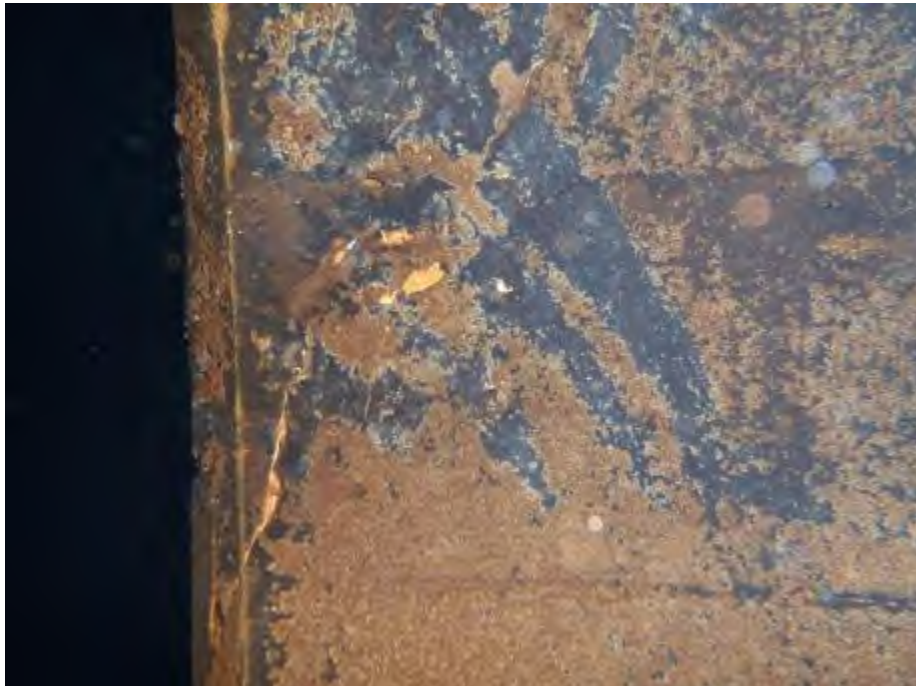
Photo - 25

East Bay. Underwater photo of the diagonal crack on the west wall at floor beam 19.

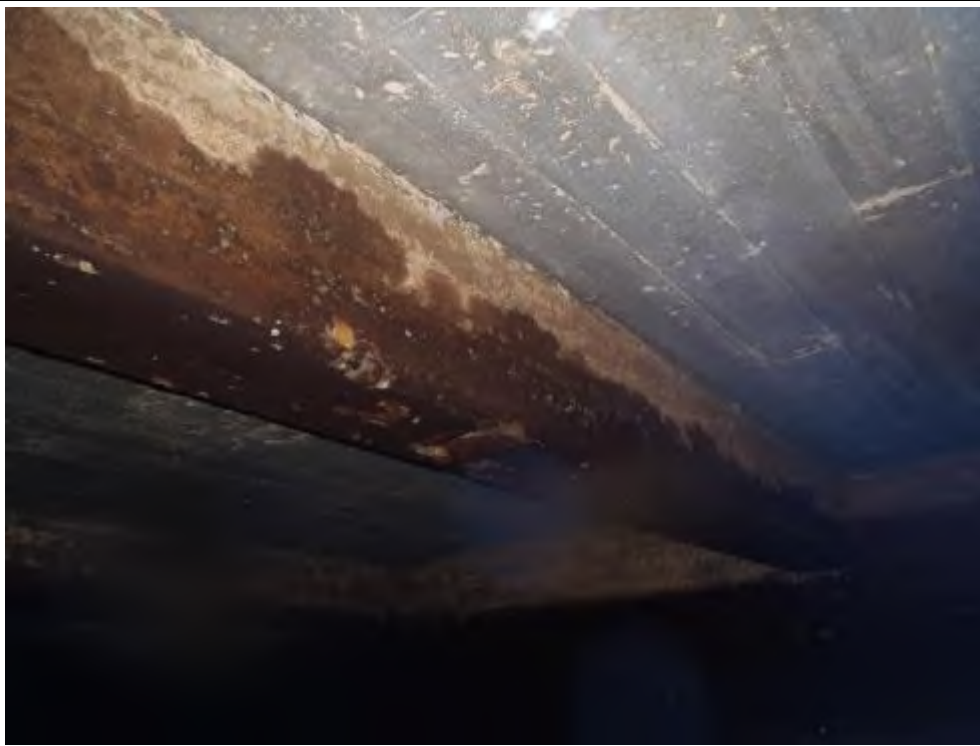
Photo - 26

North Bay. Typical condition of floor beams.
