APPLICATION OF NORTHERN KENTUCKY)	
WATER DISTRICT FOR APPROVAL OF)	CASE NO. 2015-00108
THE FT. THOMAS TREATMENT PLANT)	
BASIN IMPROVEMENTS,)	
ISSUANCE OF A CERTIFICATE OF)	
CONVENIENCE AND NECESSITY AND)	
APPROVAL OF FINANCING)

**NKWD FTTP BASIN
IMPROVEMENTS PROJECT**

**TECHNICAL MEMORANDUM #1
FINAL 3/27/14**

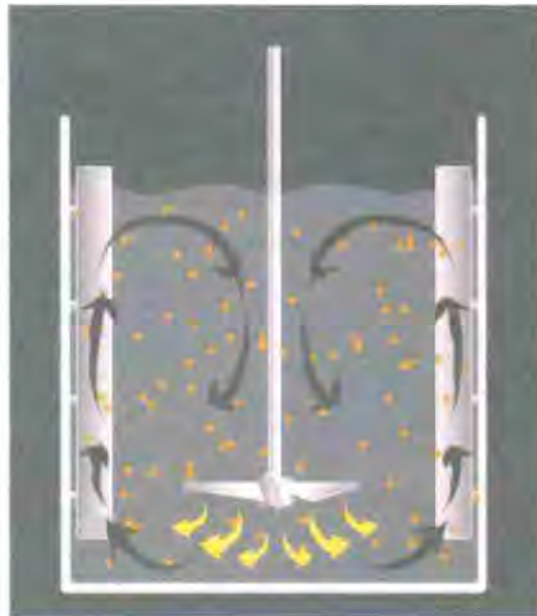
*Image 1: Vertical Impeller Mixer
(Courtesy of Dynamix Agitators, Inc.)*

Vertical paddlewheel flocculators provide more uniform hydraulic mixing velocities than the impeller mixers, and are in widespread use in Kentucky and the surrounding areas and therefore are recommended for this project. However, if the District wants to take a further look into impeller mixers during design, we would be more than happy to assist.

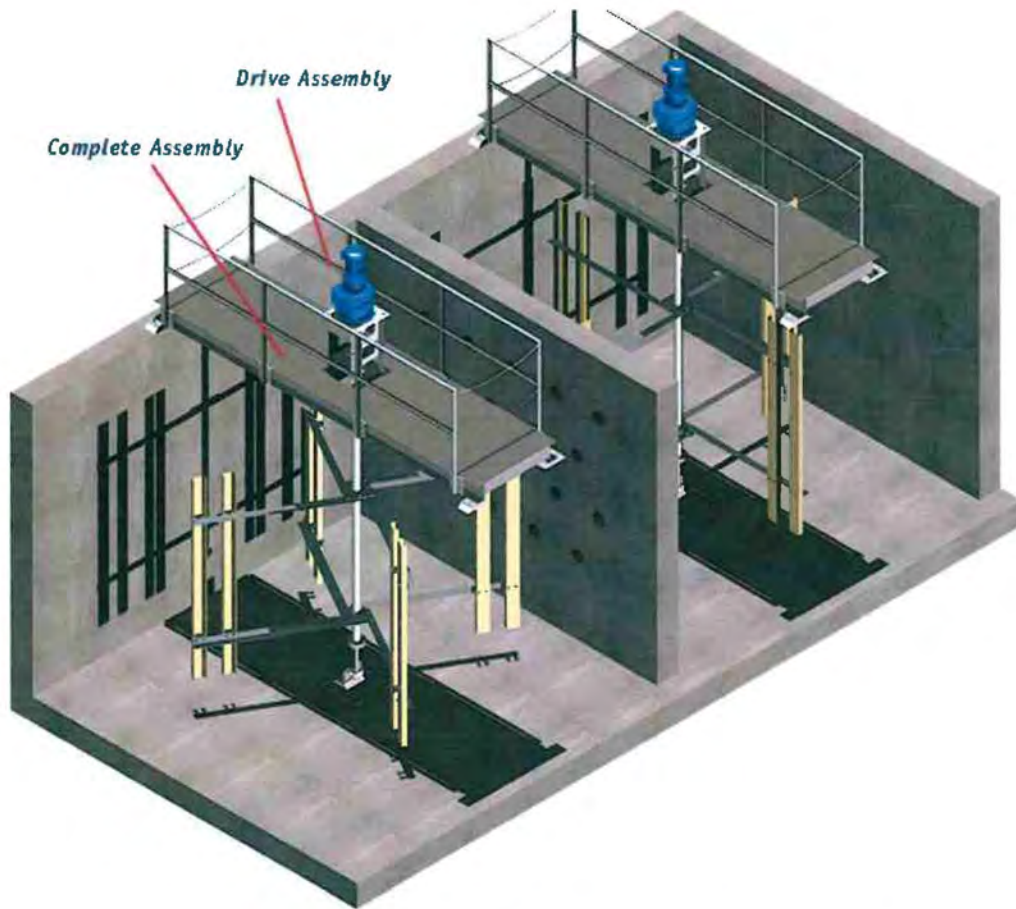
Image 2: Vertical Paddlewheel Flocculators (Courtesy of Jim Myers and Sons, Inc.)

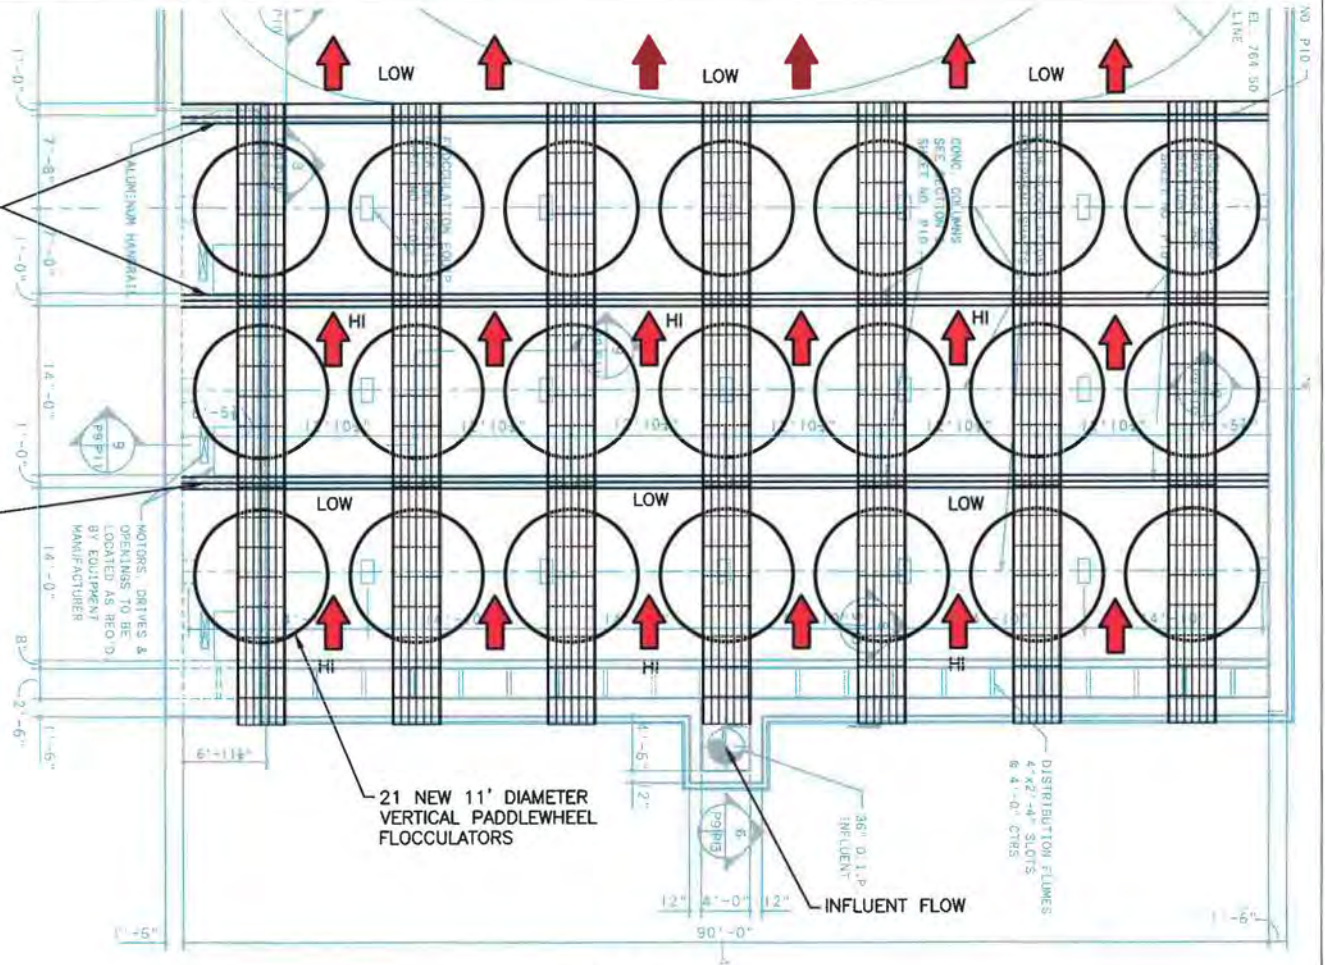
NKWD FFTP BASIN IMPROVEMENTS PROJECT BASINS #1 MODIFICATIONS (ALTERNATE 2)	DATE 3/27/14
	TECHNICAL MEMORANDUM #1	FIGURE 1B

PLAN

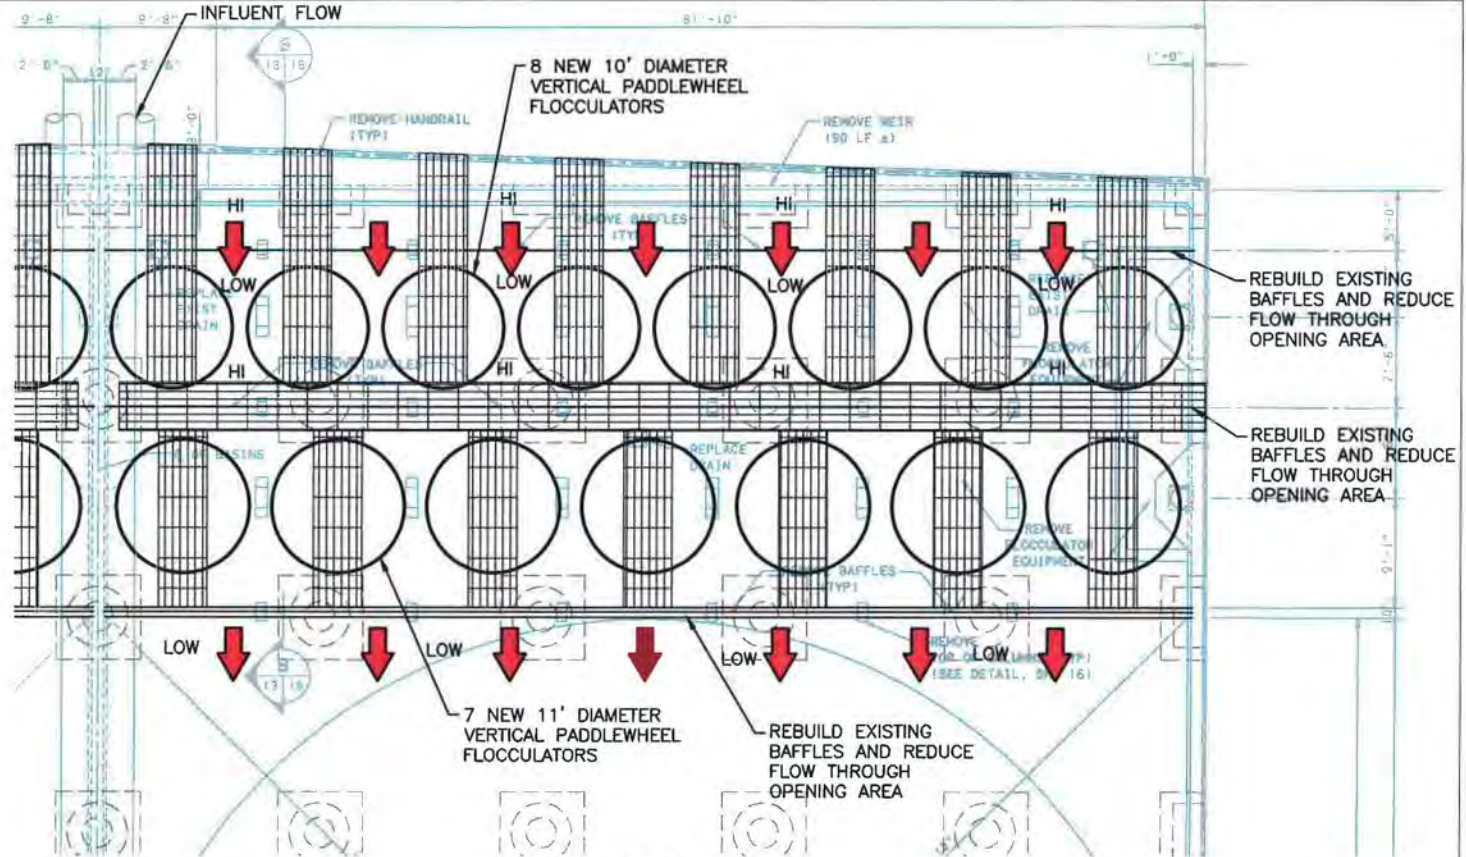
NKWD FTTP BASIN IMPROVEMENTS PROJECT BASINS #2 & #3 MODIFICATIONS (ALTERNATE 2)		<small>DATE</small> 3/27/14
	<small>TECHNICAL MEMORANDUM #1</small>		<small>FIGURE</small> 2B

PLAN

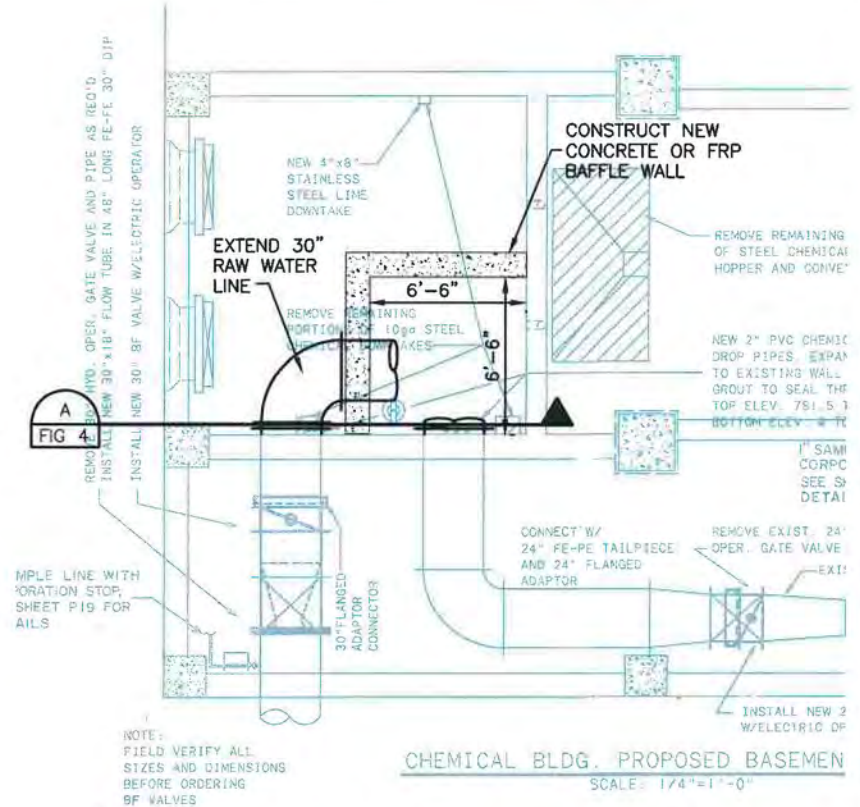
FIGURE
 3

RAPID MIX #1 - UPPER PLAN

RAPID MIX #1 - LOWER PLAN

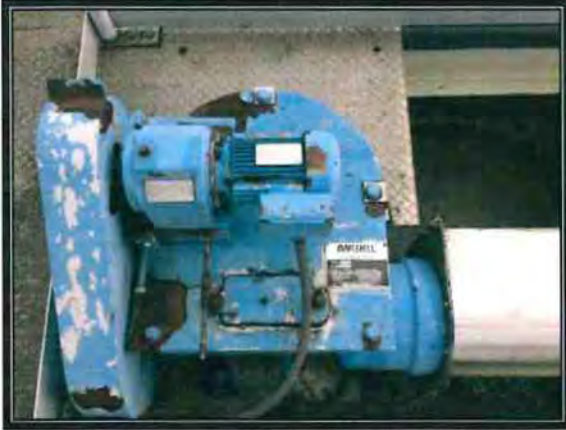
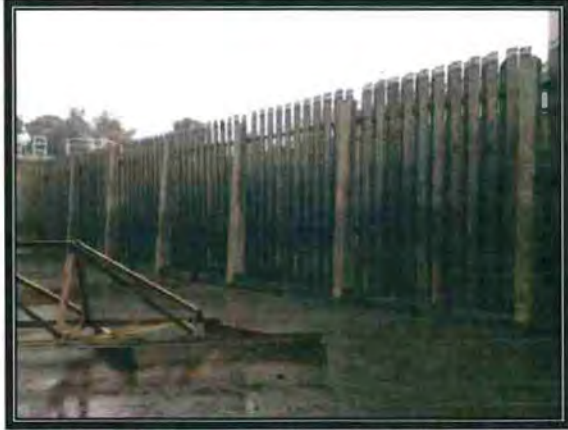
Photo 13 - Basin #2 / #3 Clarifier Sludge Rake Dr. (Typ.) Photo 14 - Basin #2 / #3 Final Baffle Wall (Typ.)

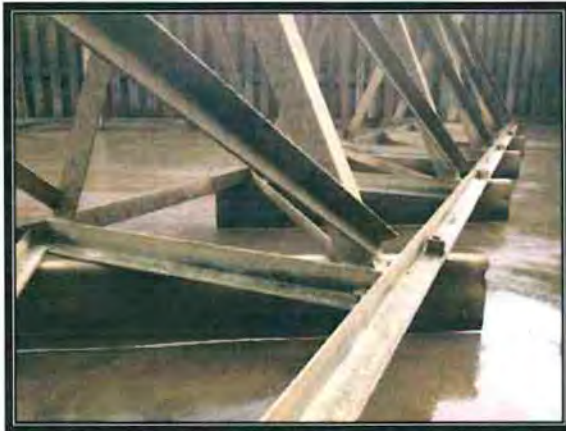
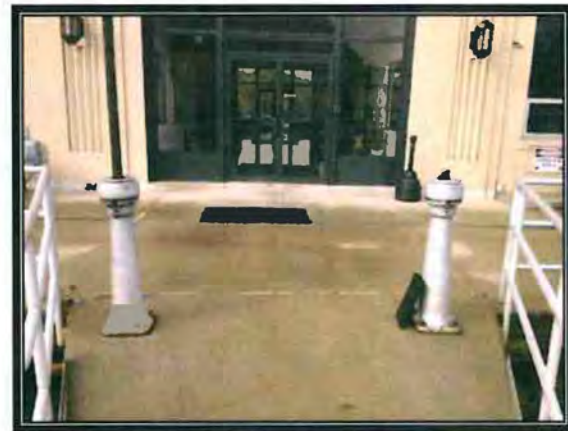
Photo 15 - Basin #2 / #3 Clarifier Sludge Rake (Typ.) Photo 16 - Basin #2 / #3 Effluent Sluice Gate Operators (Typ.)

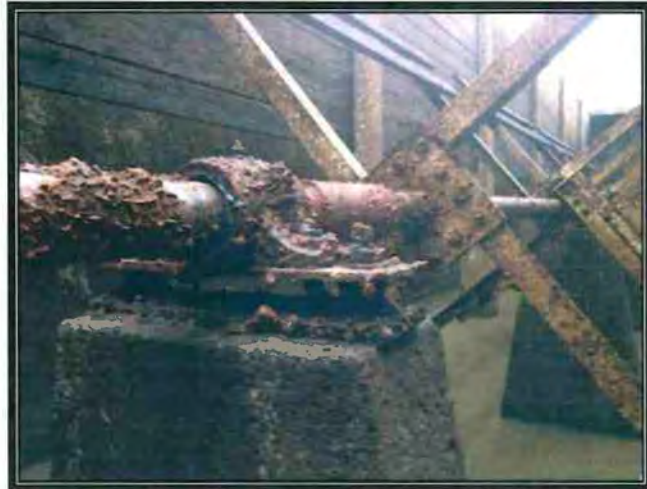
Photo 18 - Basin #2 / #3 Horiz. Flocculator Condition (Typ.)

- iii. Flocculators - The staff indicated that the flocculators were replaced in 1991. Based on HDR's Condition Assessment Best Practice Appendix 3, the expected useful life for the equipment is 20-25 years. The estimated adjusted useful life of the equipment is 22 years and the remaining life is expected to be no more than 3 years. Breakdowns have occurred due to flocculator shaft failures.

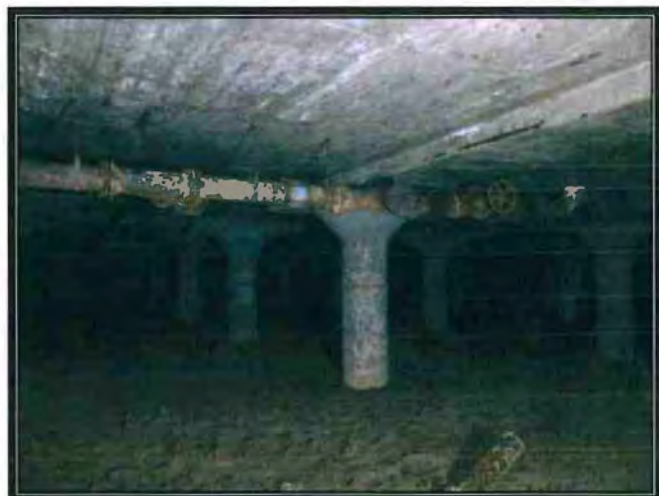
Photo 20 - Basin #2 / #3 Sludge Drain Lines (Typ.)

- i. Sludge Drain Lines and Telescoping Valves – Based on conversations with NKWD staff the sludge drain lines from both basin #2 and #3 occasionally back up and require mechanical means to free blockages in the lines. The HDR basin assessment team was provided access to the basement area beneath the basins and observed the exterior condition of the existing 6" PVC and ductile iron sludge drain lines for basins #2 and #3 (Photo 20, Appendix 'A'). The lines appear to be in good condition from the exterior, but it is unknown without video inspection as to the condition of the interior of the pipe. It is anticipated that the sludge drain lines do not perform adequately due to the small diameter of the pipe and possible slope issues. Per ten states standards, DOW recommends a minimum diameter of 8" and a slope of 2-3% on all gravity sludge lines. The actual pipe slope could not be verified without an elevation survey.

It is recommended that the 6" sludge drain lines be replaced with 8" drain lines regardless of if the pipe has a blockage or not as it is probable that the blockages are being caused by the issues noted above.

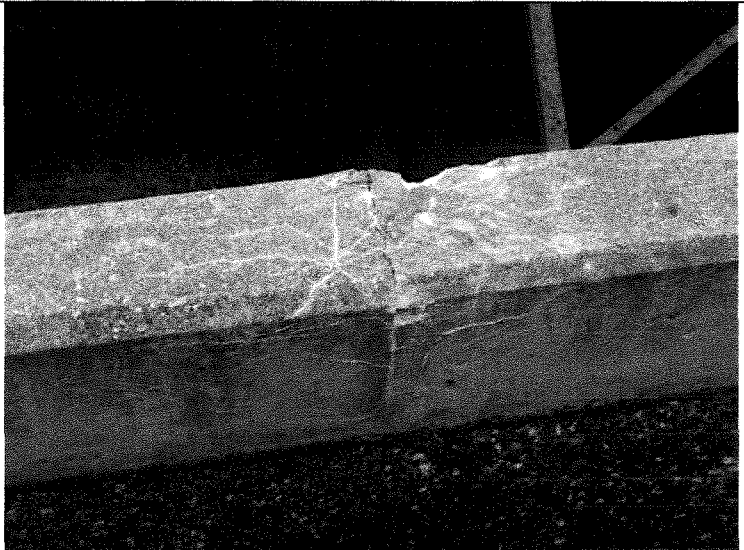
1.	Basin wall top deterioration.

- i. *It is common for concrete that is above the normal water level to deteriorate at a faster rate than concrete that is continuously submerged. This is true for Basin #1, as most of the visible deterioration was within the top 2' feet of the walls. This deterioration primarily consists of cracks and spalling concrete. This deterioration is in limited areas, and is "repairable" in nature. See Photos 1 and 2 in Appendix 'B'.*

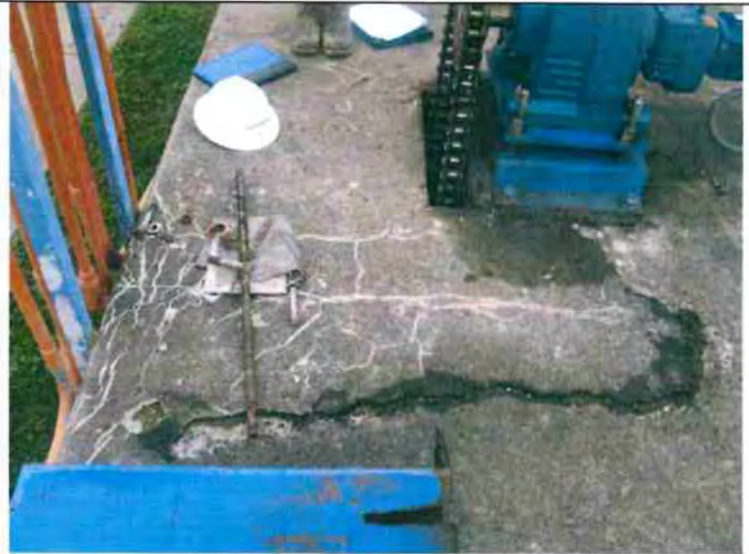
2. Vault top deterioration.

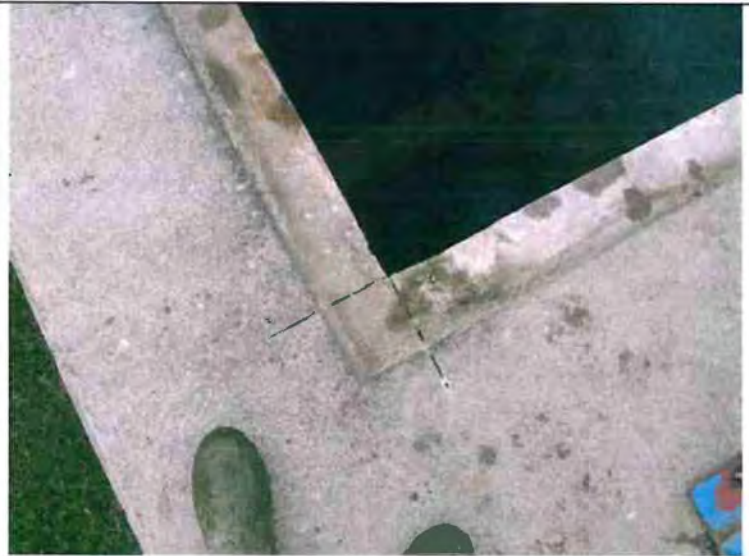
- ii. *An area of noted deterioration was the concrete supports for the existing flocculators and the baffle walls. These members showed significant concrete surface deterioration. This specific deterioration was limited to these elements, thus, suggesting that they may subject to chemical attack. While there was no evidence suggesting that the members were not structurally sound, consideration should be given to coating the concrete to reduce the potential for future deterioration, should the members need to remain in service. See Photo 4 in Appendix 'B'.*

4. Baffle wall support columns with surface deterioration below water level.

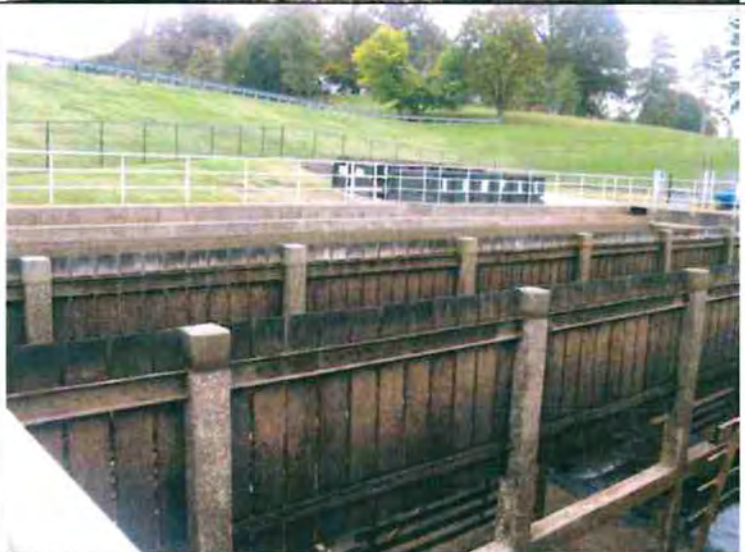
5. Baffle wall support columns with surface deterioration below water level.

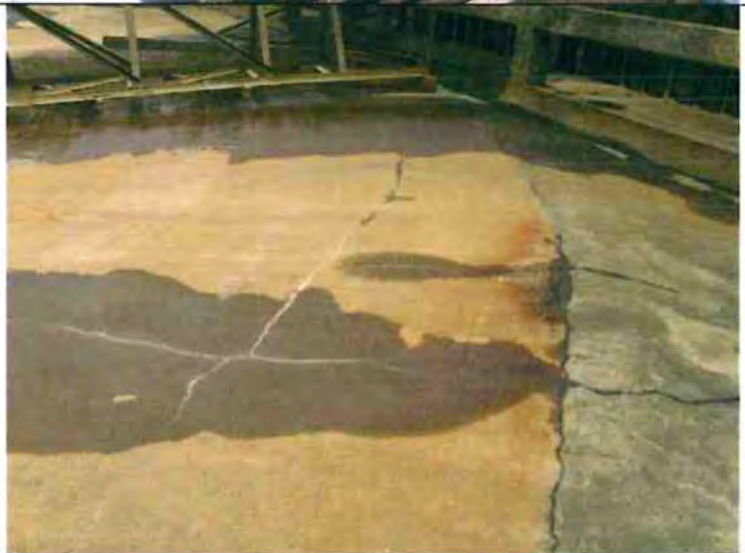
6. Clarifier base slab cracks actively leaking.

- iii. *The clarifier area concrete was noted as being in good condition, with only a few visible cracks. Some of these cracks were leaking, as groundwater was observed actively seeping thru them. These cracks should be injected to help prevent further deterioration of the concrete and any reinforcement that crosses the crack. See Photos 6, 7, and 8 in Appendix 'B'.*

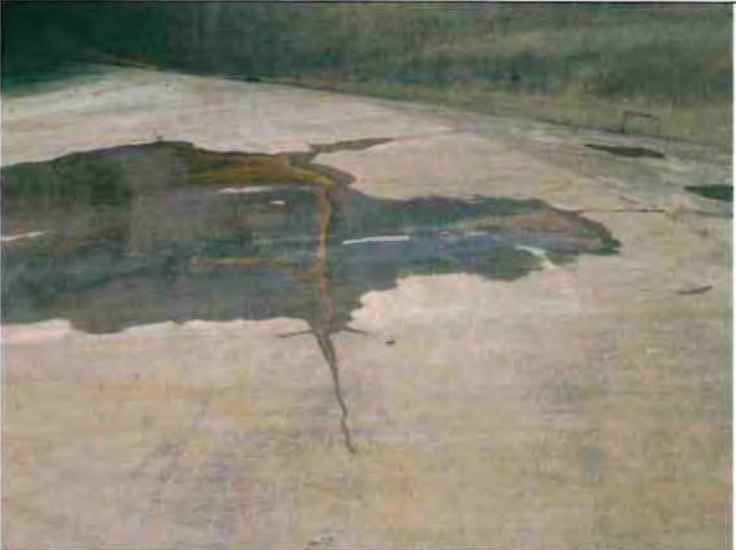
7.	Clarifier base slab cracks actively leaking.

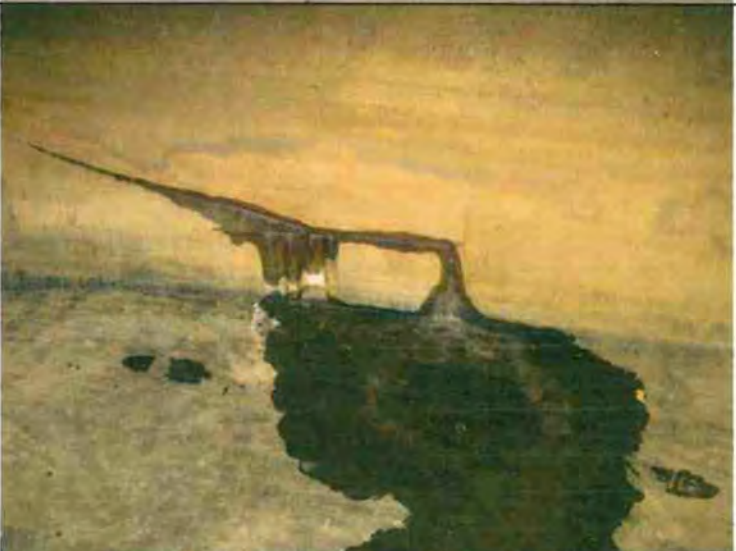
8.	Clarifier wall crack actively leaking.

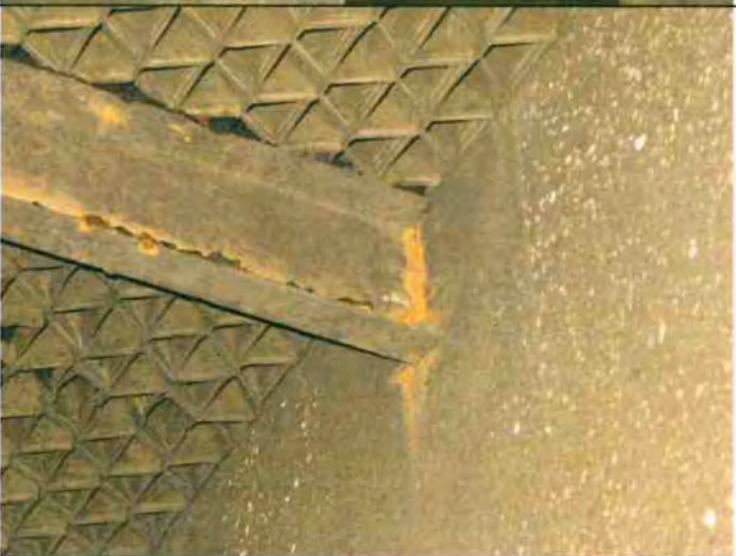
9.	Rusting/pitting of tube settler steel beams.

- iv. *A visual observation of the Clarifier mechanism and other structural steel components suggested that they are in generally sound condition although some localized pitting and corrosion was noticed. It is recommended that these areas should be repaired as part of the normal paint maintenance program, if the equipment is to remain in service.*

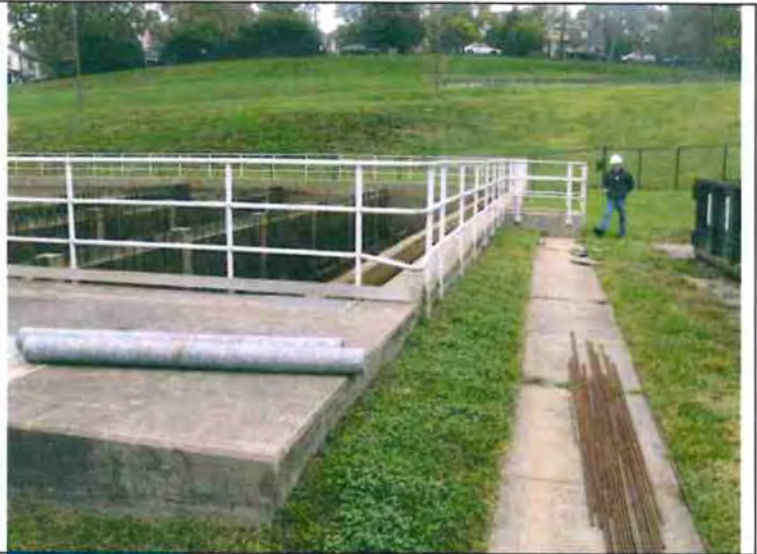
10. Damaged railing.

- v. *The aluminum handrail generally appeared to be in good condition although the horizontal rails were loose in one area (southeast corner of the basin). This railing should be repaired per the manufacturer's recommendation.*

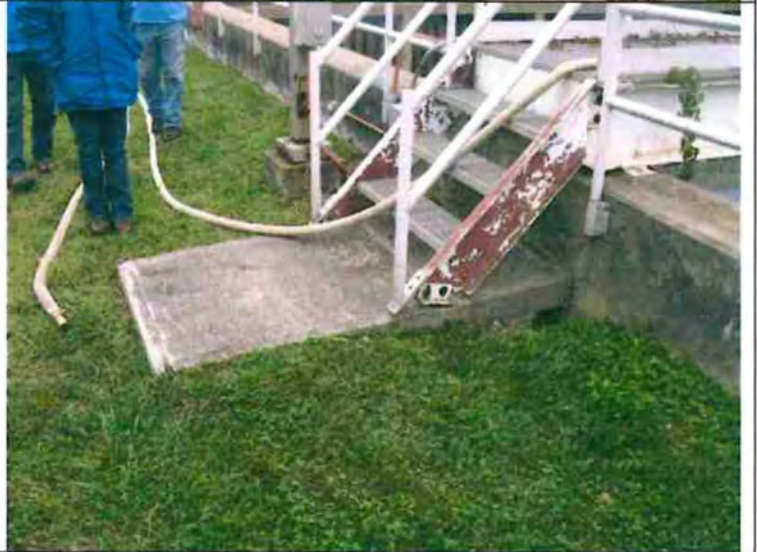
11. Rodent hole beneath stair base.

- vi. *A rodent hole was also noted beneath a stair support pad. This should be corrected to prevent future pad damage. See Photo 11 in Appendix 'B'.*

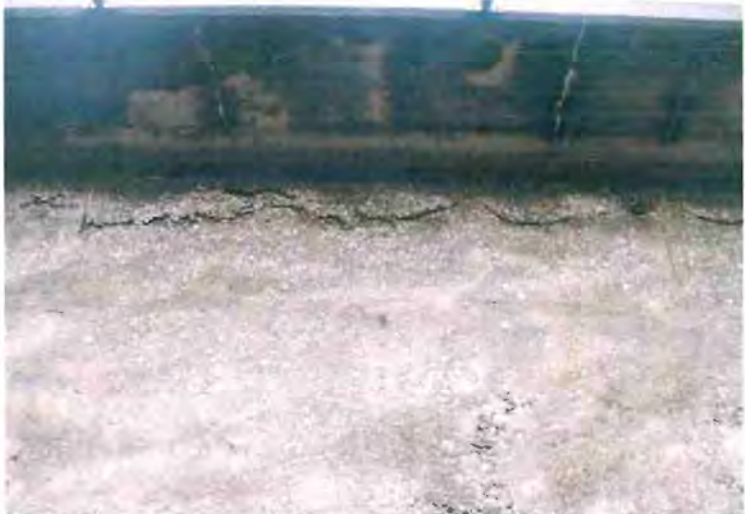
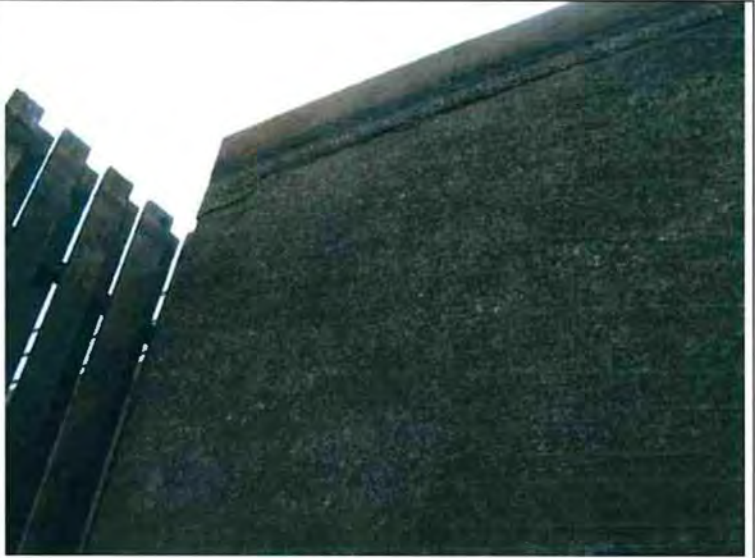
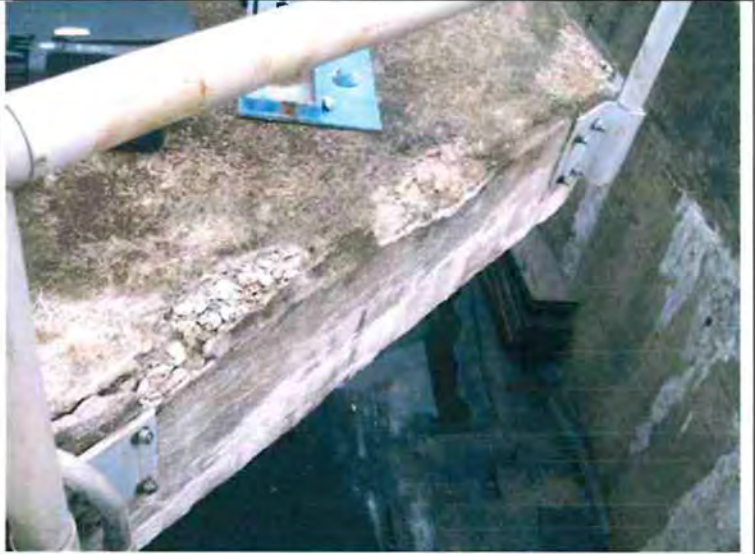
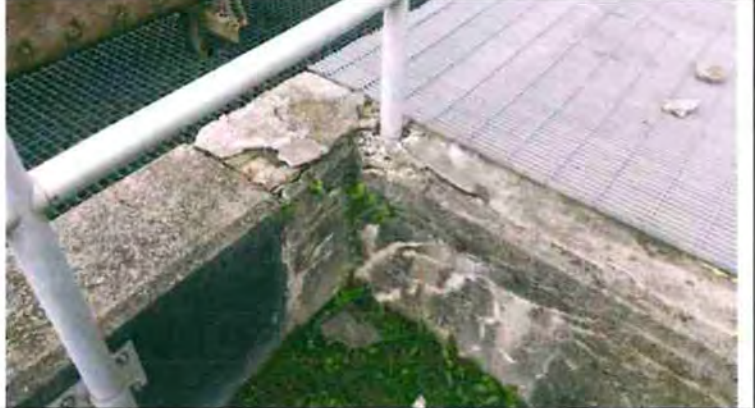
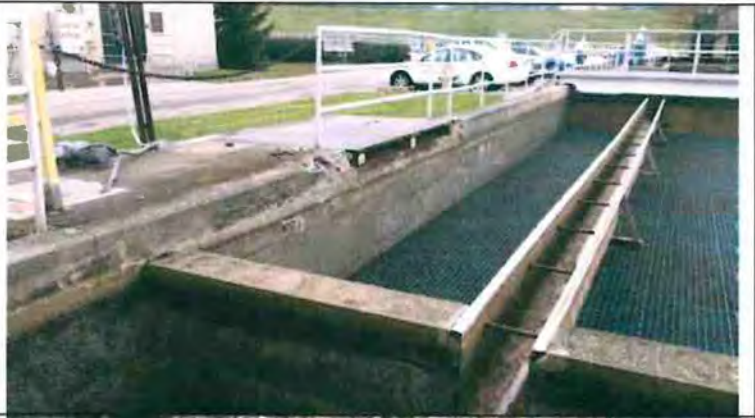
1.	Basin wall top deterioration.

2. Basin wall top deterioration.

3. Basin wall top deterioration.

4. Basin wall top deterioration.

5. Basin wall top deterioration.

- i. Significant deterioration is present in the above grade walls. A close inspection of the walls suggests that their tops have been previously replaced. A review of the existing documents indicates that the walkway between Basins #2 and #3 was replaced in 1991. It's possible that the other work was done at that time, or perhaps as part of another project. This deterioration primarily consists of cracks and spalling concrete. Unlike Basin #1, this deterioration is wide spread, and the recommended repair is to remove sections of wall and replace, as has been done previously. See photos 1-6 (B2) and photos 1-7 (B3).*

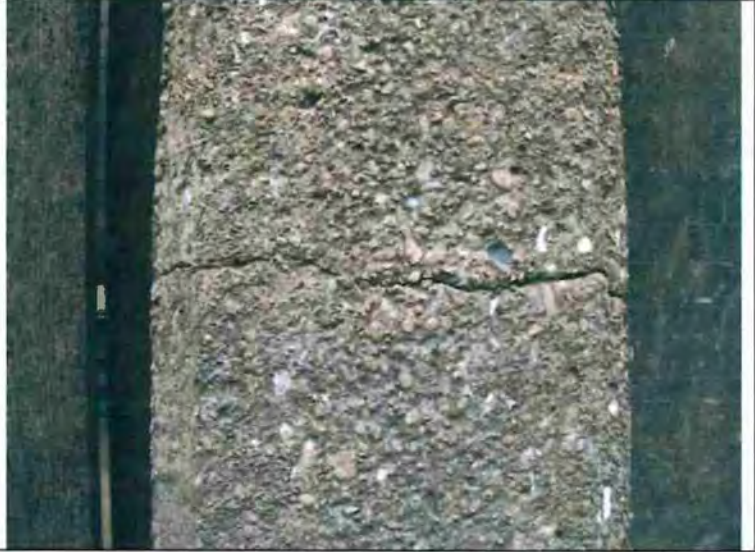
6. Mixer baffle support surface deterioration.

- ii. As in Basin #1, the existing flocculators and baffle wall supports show concrete surface deterioration more so than the other basin areas. While there was no evidence suggesting that the members were not structurally sound, consideration should be given to coating the concrete to reduce the potential for future deterioration, should the members need to remain in service. See photos 7-8 (B3).*

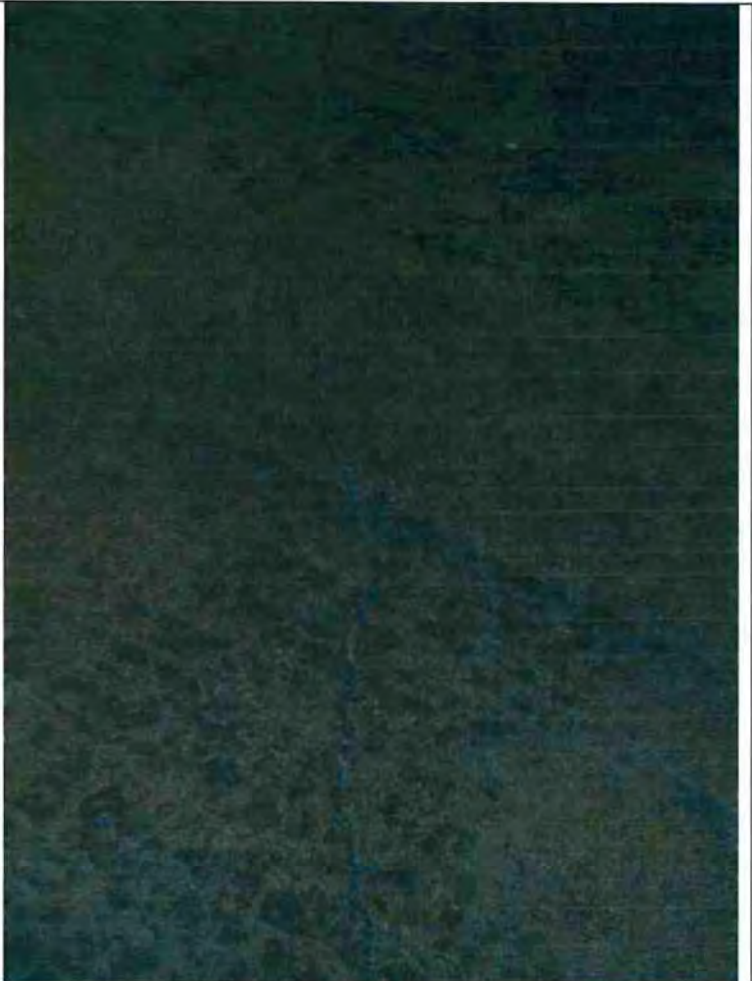
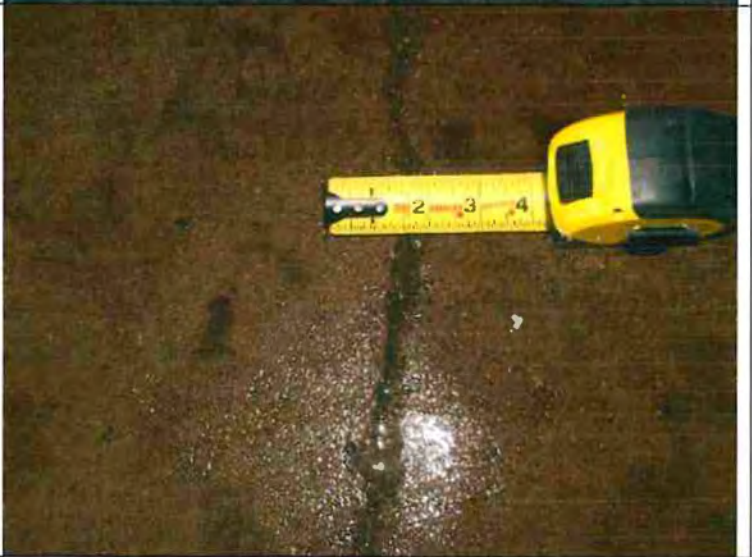
7. "Pattern" cracks in clarifier base slab.

8. "Pattern" cracks in clarifier base slab.

- iii. The clarifier bottom surface is a structural slab supported by concrete piers thus creating a crawlspace beneath the basins. This slab does contain noticeable cracks that relate to the support elements of the basin. These cracks should be repaired to help prevent further deterioration of the concrete and any reinforcement that crosses the crack. See photos 7-8 (B2) and photos 9-10 (B3).*

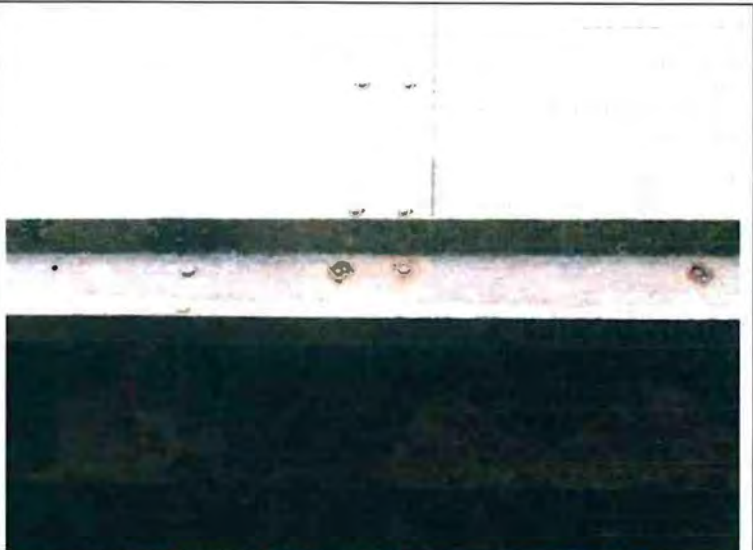
9. Clarifier equipment corrosion.

- v. *A visual observation of the Clarifier mechanism and other structural steel components suggested that they are in generally sound condition although some localized pitting and corrosion being noticed. It is recommended that these areas should be repaired as part of the normal paint maintenance program. See photos 14-17 (B3).*
- vi. *The aluminum handrail generally appeared to be in good condition.*

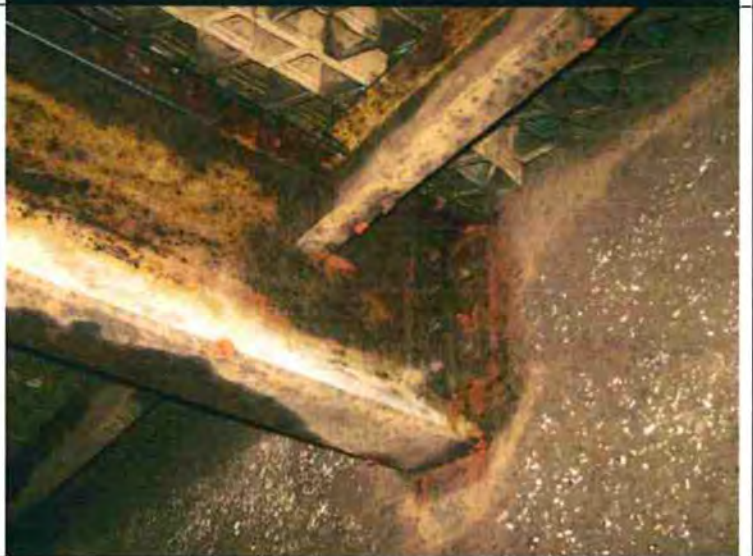
10. Tube settler support beam corrosion.

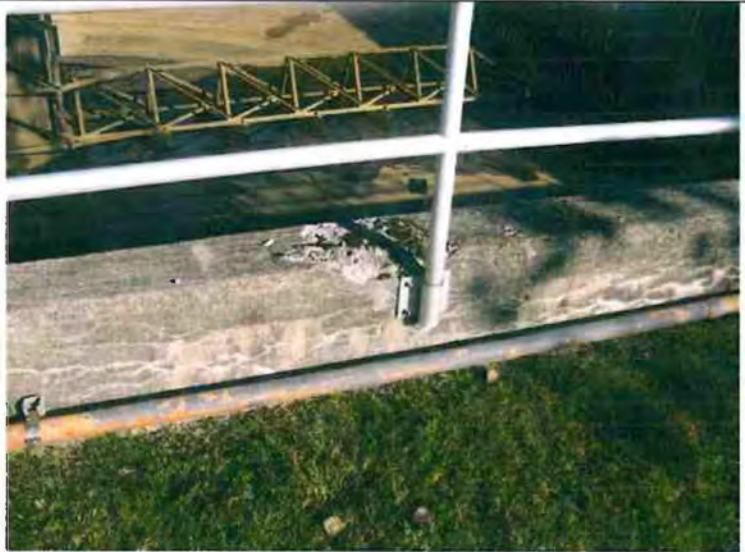
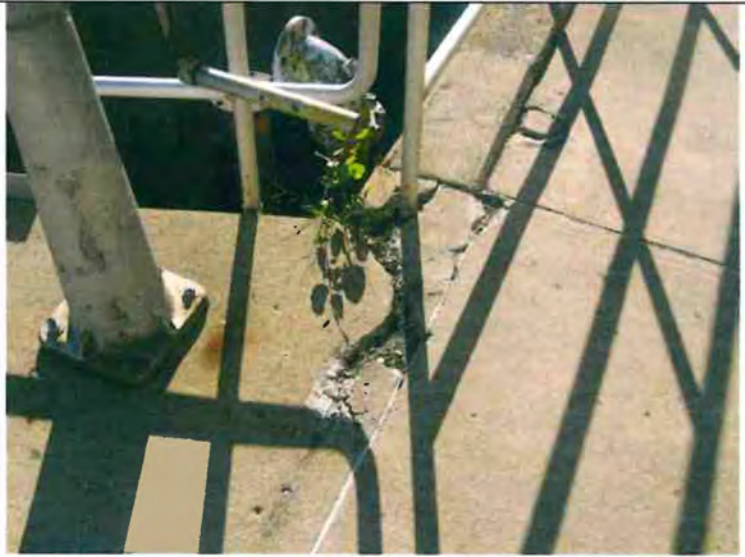
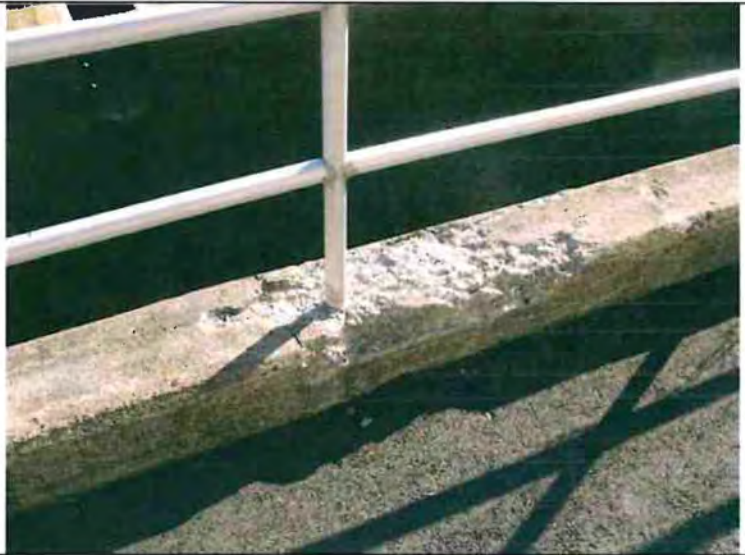
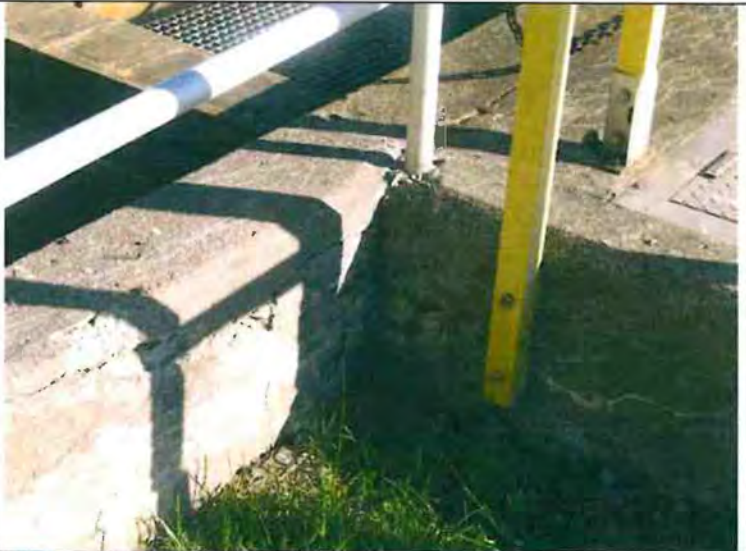
2. Basin wall top deterioration.

3. Basin wall top deterioration.

4. Basin wall top deterioration.

5.	Basin wall top deterioration.

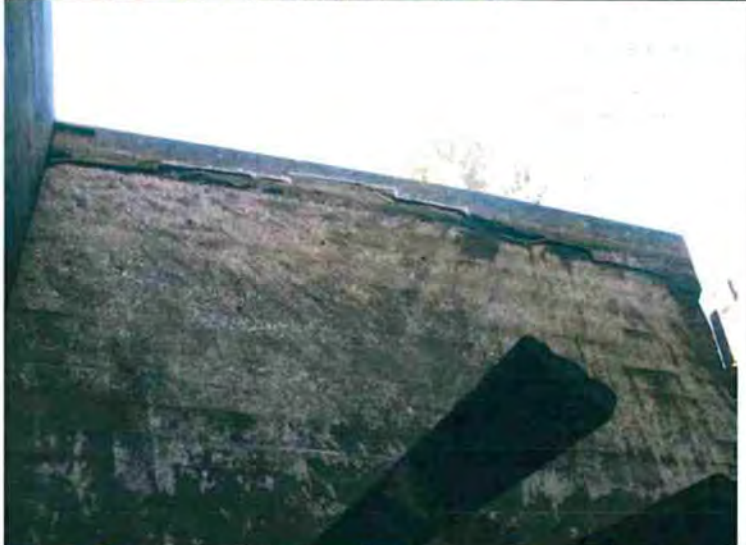
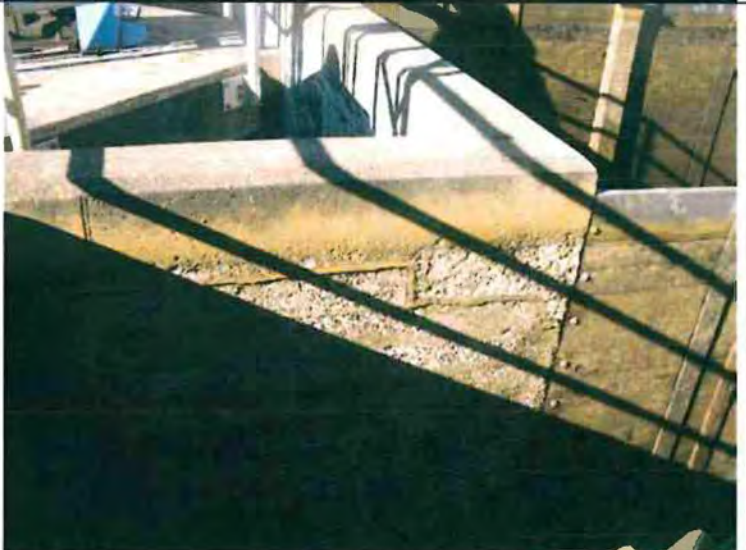
6.	Basin wall top where previously replaced.

7.	Basin wall top where previously replaced.

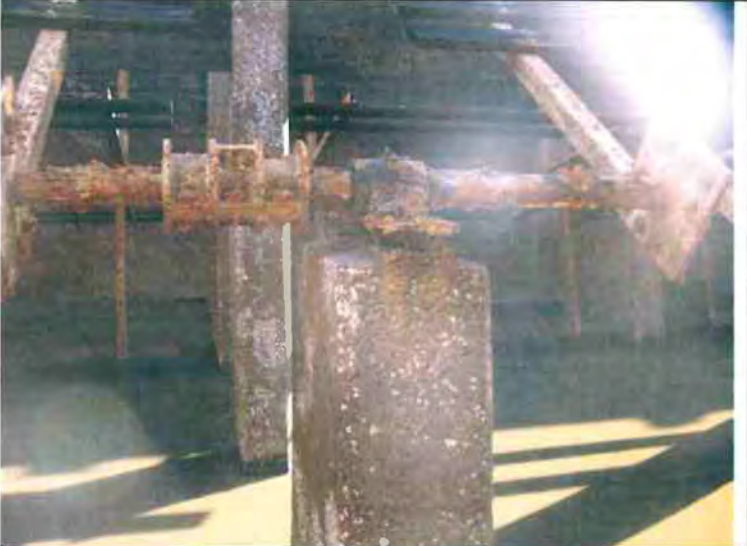
8.	Baffle wall support surface deterioration.

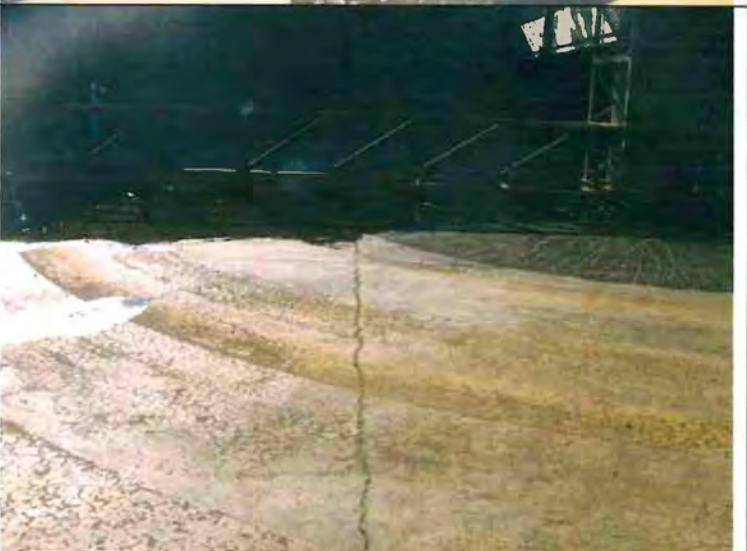
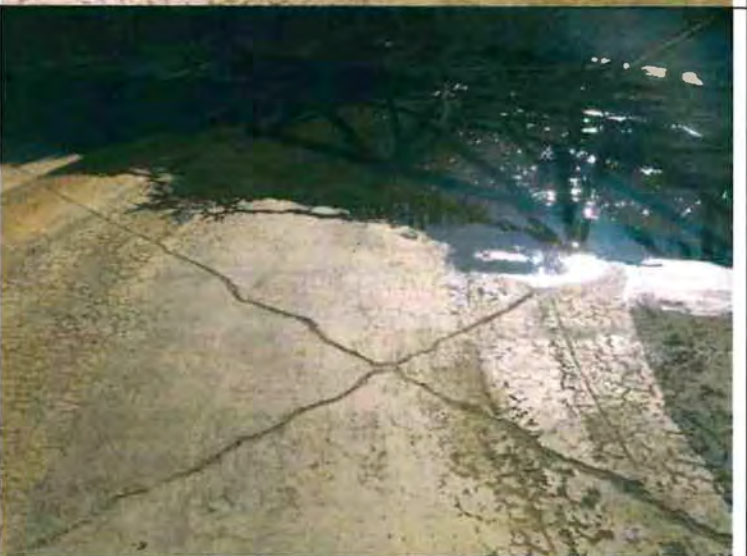
9.	"Pattern" cracks in clarifier base slab.

10.	"Pattern" cracks in clarifier base slab.

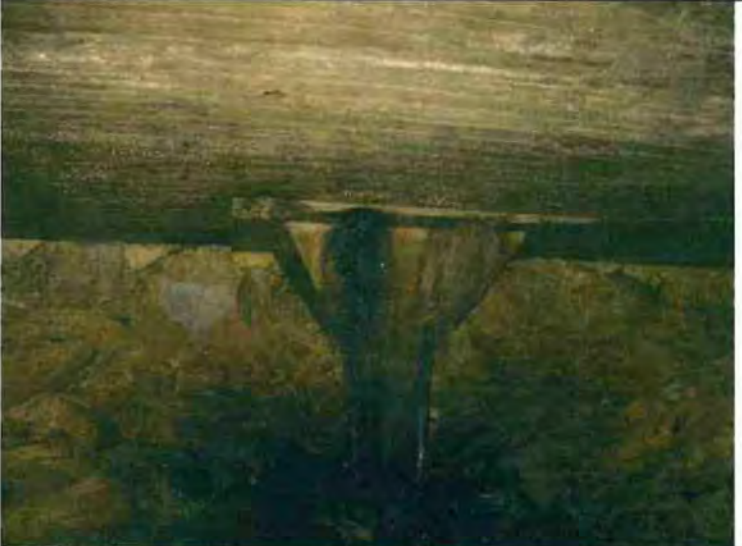
11.	Active leak in crawl space beneath Basin #2 and #3.

- iv. An inspection of the crawl space below Basins #2 and #3 found the concrete pier structure to be in good conditions. Some cracks were apparent on the crawlspace ceiling and an active leak was observed below the North West corner of Basin #2. See photos 11-13 (B3).*

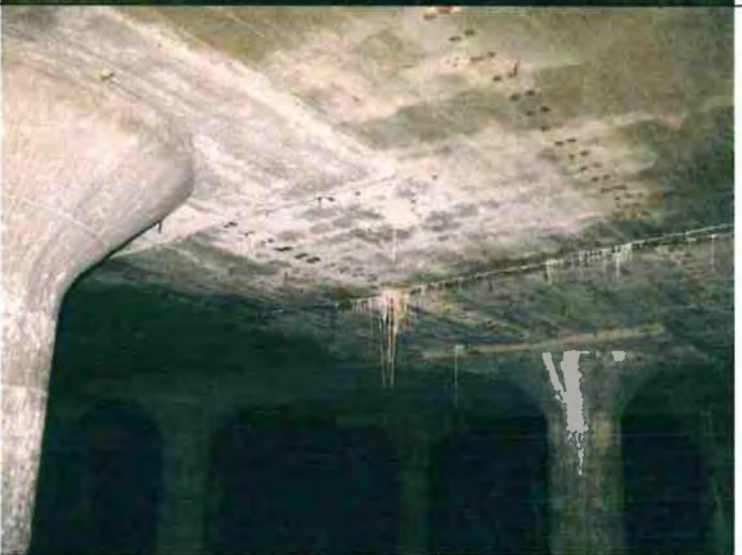
A photograph showing a concrete base slab with several visible cracks. The cracks are dark and run across the surface of the slab. The surrounding area is dark and appears to be a crawl space.
13.	Exposed base slab reinforcement beneath Basin #2 and #3.

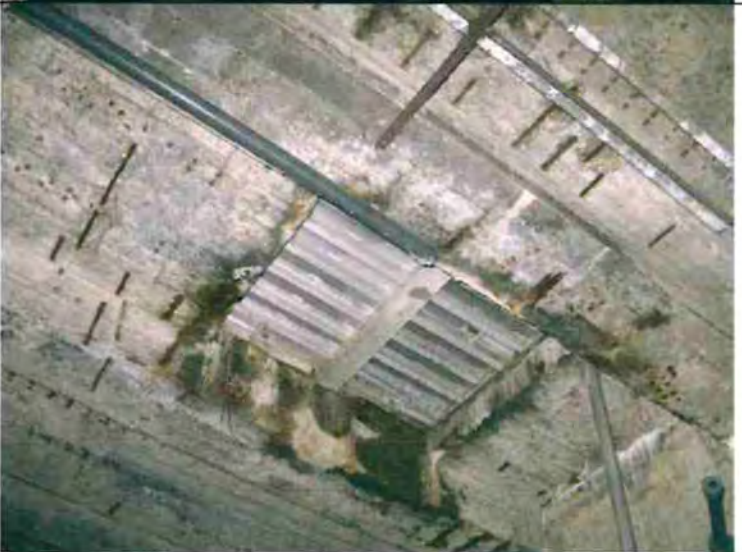
A photograph showing exposed base slab reinforcement. The reinforcement consists of several parallel steel bars (rebar) embedded in a concrete slab. The surrounding area is dark and appears to be a crawl space.

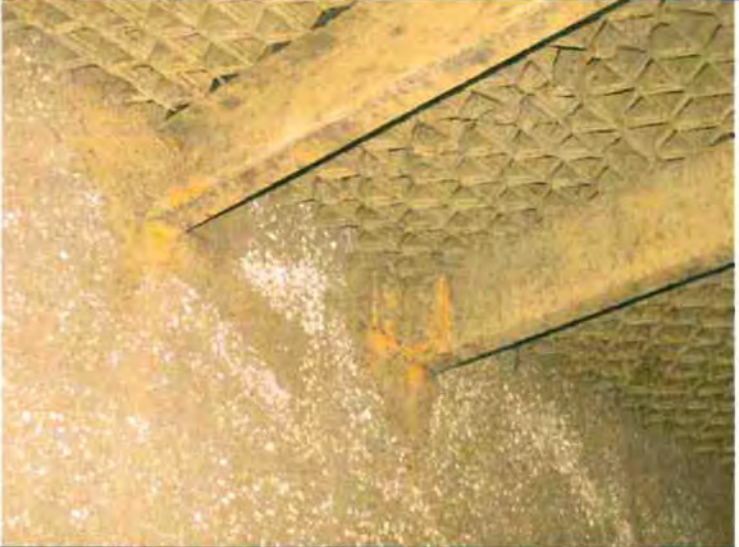
14.	Tube settler support beams with active corrosion.

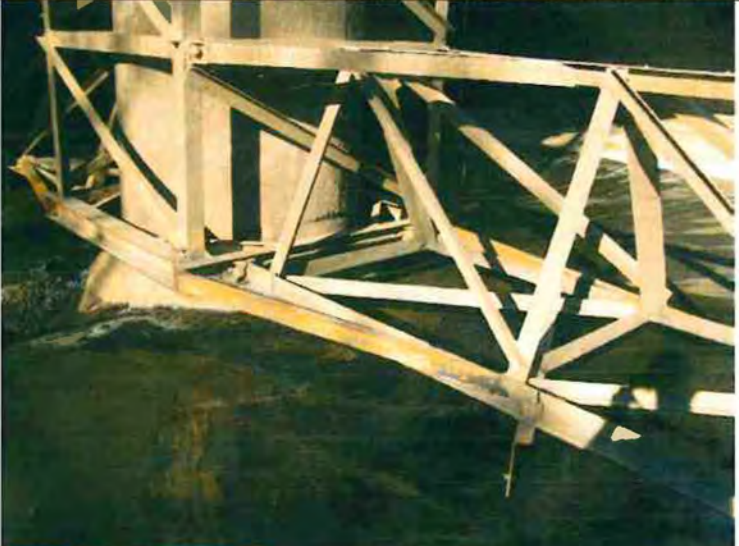
15.	Previous repair to clarifier in Basin #3.

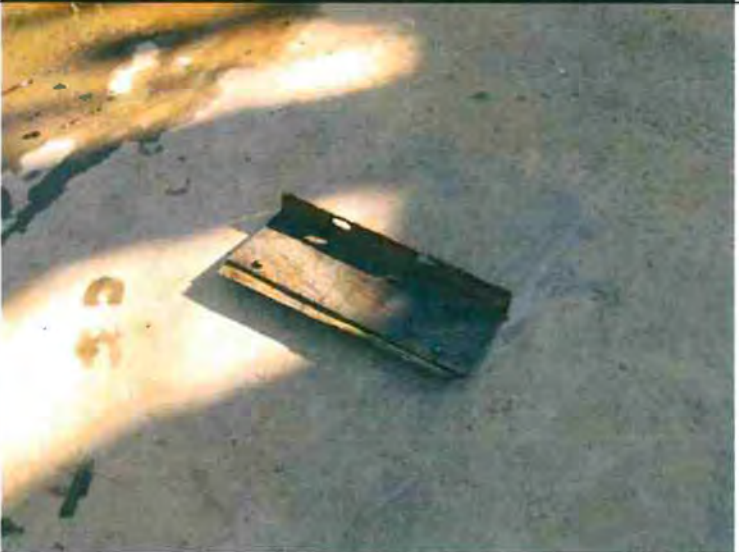
16.	Scraper part from clarifier in Basin #3.
