APPLICATION OF NORTHERN KENTUCKY)	
WATER DISTRICT FOR APPROVAL OF)	CASE NO. 2015-00108
THE FT. THOMAS TREATMENT PLANT)	
BASIN IMPROVEMENTS,)	
ISSUANCE OF A CERTIFICATE OF)	
CONVENIENCE AND NECESSITY AND)	
APPROVAL OF FINANCING)

**NKWD FTTP BASIN
IMPROVEMENTS PROJECT**

**TECHNICAL MEMORANDUM #1
FINAL 3/27/14**

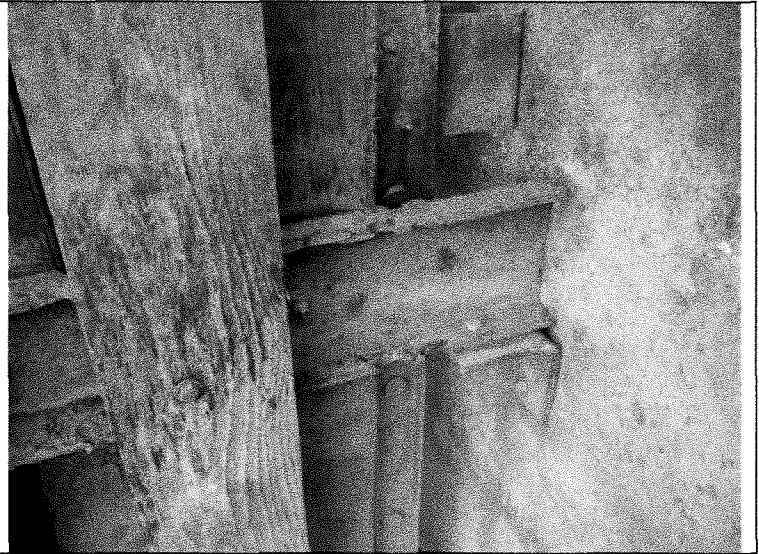
Baffle wall support beam
corrosion.
