APPLICATION OF NORTHERN KENTUCKY)	
WATER DISTRICT FOR ISSUANCE OF)	CASE NO. 2016-00303
OHIO RIVER PUMP STATION)	
NUMBER 2 REHABILITATION)	
CERTIFICATE OF CONVENIENCE)	
AND NECESSITY)

APPLICATION FOR APPROVAL OF CONSTRUCTION

ORPS2 Condition Assessment / MPTP Raw Water Feasibility Study

**OHIO RIVER
PUMPING STATION #2**

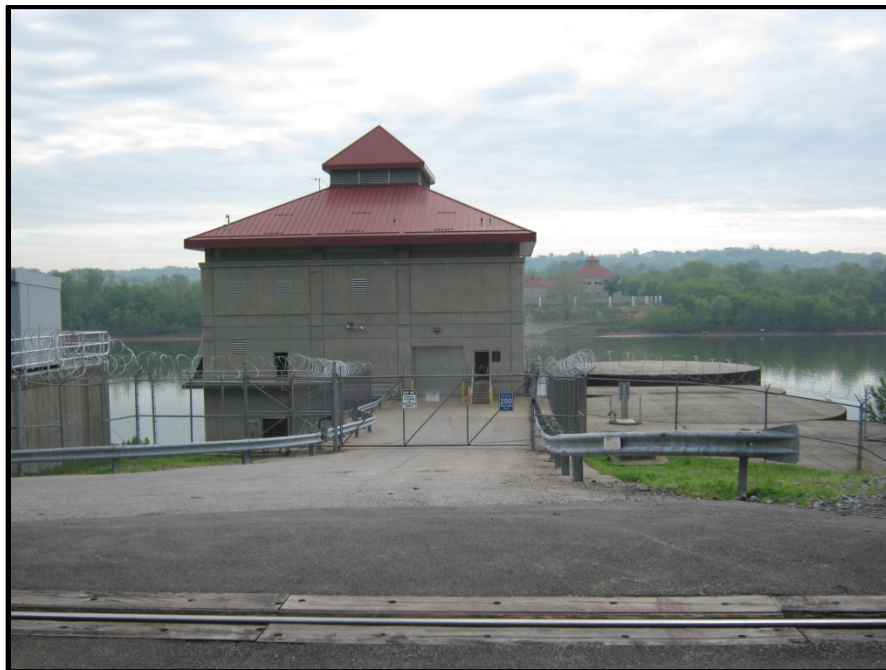
Photo 1.1: ORPS1 Facility

The Ohio River Pump Station #1 (ORPS1) was constructed in 1997 and is in good condition. The station sits on a 2.3 acre plot between Mary Ingles Highway (Route 8), CSX railroad, and the Ohio River. ORPS1 is the dedicated raw water intake for the FTTP and has total capacity of 75 MGD and a firm capacity of 61 MGD.

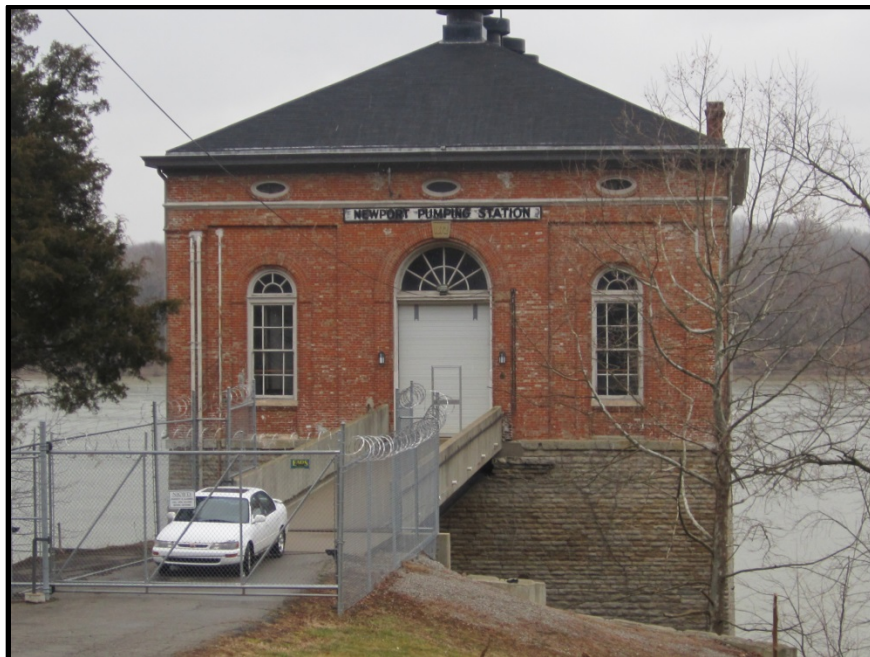
Photo 1.2: ORPS2 Facility

ORPS2 was originally known as the City of Newport Pumping Station, located in Ft Thomas, KY, along the West bank of the Ohio River (photo 1.2). Built in 1872, this intake structure is the sole water supply to the MPTP (former Newport Water Works).

ORPS2 is sited within the banks of the Ohio River adjacent to 18 acres owned by NKWD along Route 8 (Mary Ingles Highway). CSX has a rail line roughly parallel to Route 8 and adjacent to the NKWD property. ORPS2 is located roughly 4,000 feet north of the District's Ohio River Pumping Station No. 1 (ORPS1) that supplies the District's Fort Thomas Treatment Plant. The station is a concrete and brick structure that exhibits signs of corrosion and deterioration. The roof of the building is constructed of wood framing members with wooden plank roofing and composite shingles.

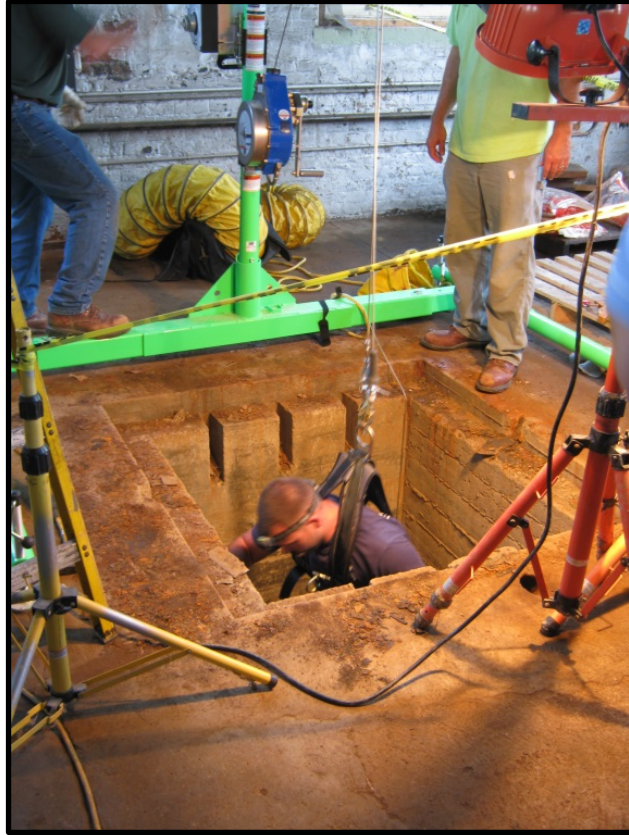
Photo 4.2: Inspector Entering Dry Wet Well

Marine Solutions performed a comprehensive inspection of the lower level interior and exterior surfaces of ORPS2. The exterior inspection was performed through an underwater dive while the interior inspection was performed through a combination of exploratory and hoisted descent into the lower level chambers. These inspections produced a significant amount of information, but were able to only provide partial answers to structural condition questions of the original operations approach of the facility.

This is due, in large part, to the tremendous amounts of sediment that have accumulated in the lower levels of ORPS2. In some areas, it is estimated that nearly 30 feet of mucky river solids have built up over the years of service. As a result, only a fraction of the total volume of the intake lower levels could be visually examined.

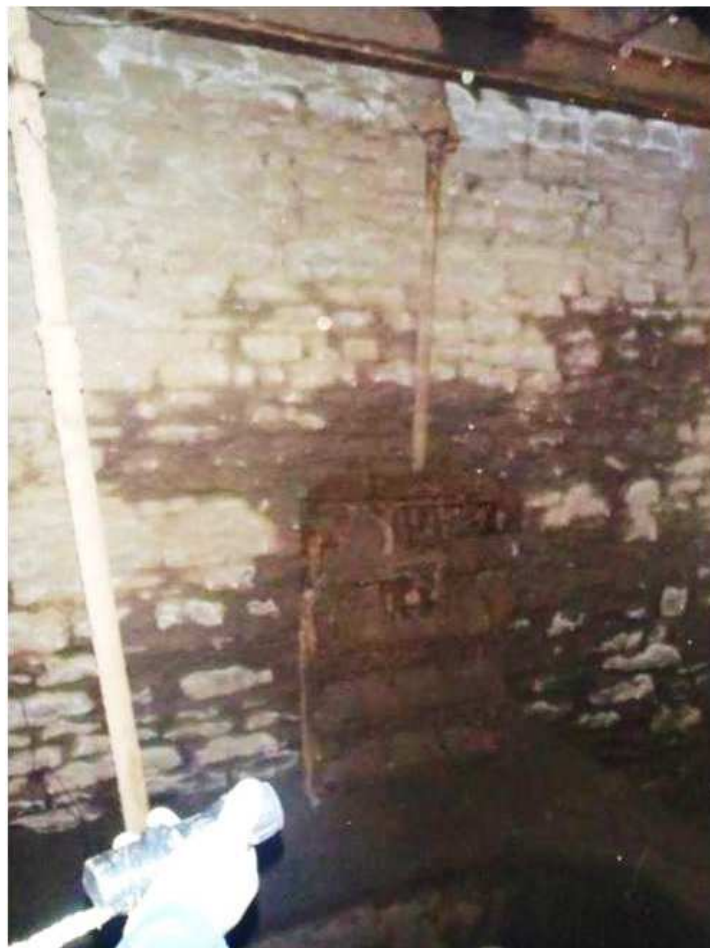
The existing sluice gate is inoperable and the slide is no longer connected to the frame. Photos in the dive inspection report show the gate slide sitting on the wall at elevation 471.0 feet, and the gate stem is bent. Record drawings from 1962 show the installation of the sluice gate on a new wall mounted thimble. The condition of the thimble is unknown, and whether the existing sluice gate frame is still mounted to the thimble is unknown. Exhibit 3 indicates the location of the proposed sluice gate in relation to the trash rack and inlet suction valve replacement.

Figure 1 - Photo of existing sluice gate from dive inspection (photo by Marine Solutions Inc. (MSI))

The condition of the existing electric motor actuator is unknown, but given the unit was installed in 1962, the unit is beyond its expected service life. The existing pedestal was installed at the same time as the gate and actuator, and should also be replaced. There is a disconnect switch in the existing motor control center located at elevation 513.83. However, the switch is outside the line of sight requirement for current 480 volt equipment installations.

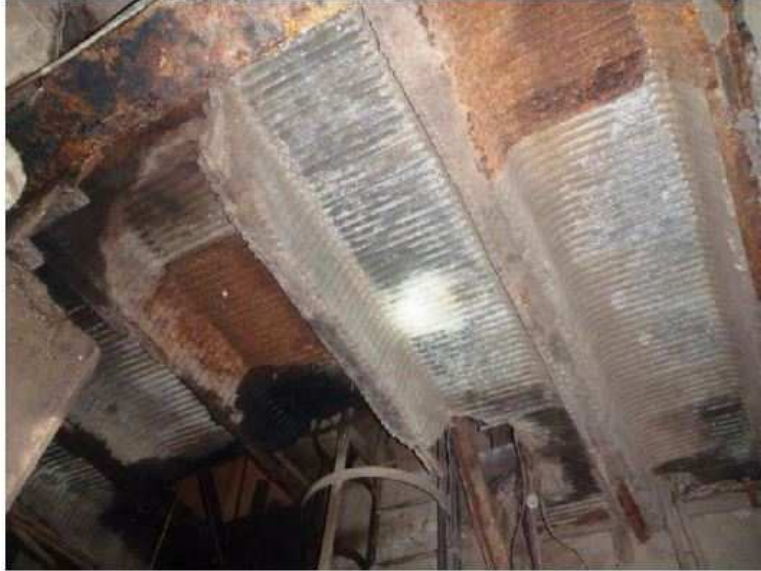
Accessing the wet well is by confined space entry permit. The platforms and ladders should be configured for ease of entry into the wet well with traditional diving gear that utilizes a compressed air hose and helmet. New platforms and ladders should accommodate the anticipated weight associated with this activity.

Figure 2 - Underside of platform at Elevation 483.4 (Photo by MSI)

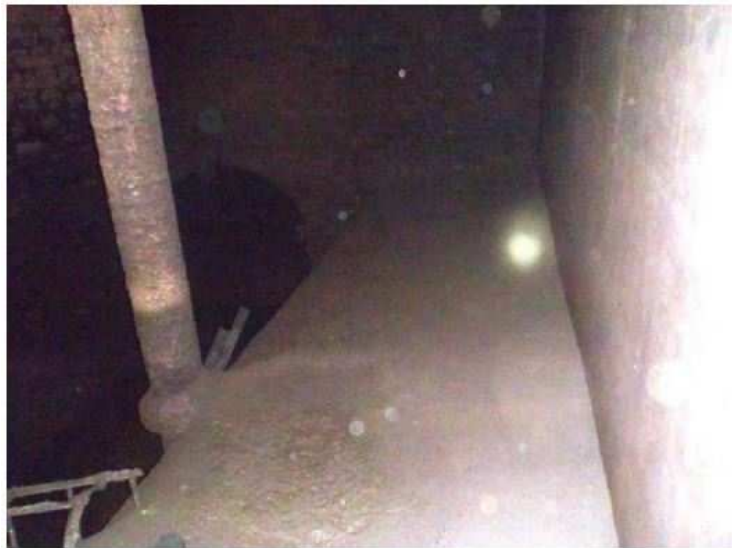
Figure 3 - Platform at Elevation 471.0 (Photo by MSI)

Because the platforms are solid, mud accumulates on the surface when the river is at flood stage. The mud is currently several inches thick and presents a structural concern due to this additional weight. Constructing the new platforms out of grating would minimize the potential for mud accumulation, and cleaning the grating would be easier than a solid platform floor.

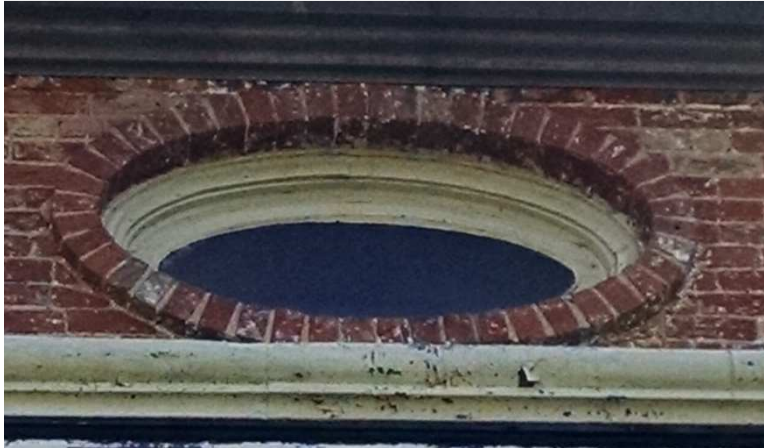
Figure 5 - Typical oval window (Type 3)

Replacing the windows has two major challenges. The primary access to most of the window units is from the interior. Exterior access is limited due to the height of the windows relative to the ground or river, and the lack of a level surface to place a mechanical lifting unit, ladders, or scaffolding. The existing frames were also tested for lead based paint and found to contain levels above the minimum threshold. Demolition of the frames will necessitate managing the lead based paint materials. NKWD is concerned about lead based paint relative to the need for staff to access the facility.

Both manufacturers indicated the replacement of the oval windows will be difficult, particularly the units which can only be accessed from the exterior (east and west elevations). Even though the west elevation is on the bank, replacement of the two oval windows to the left and right of the entrance will require scaffolding approximately 70 feet in height to provide access. The same would be true on the east elevation, but it may be possible to anchor scaffolding to a barge for this work.

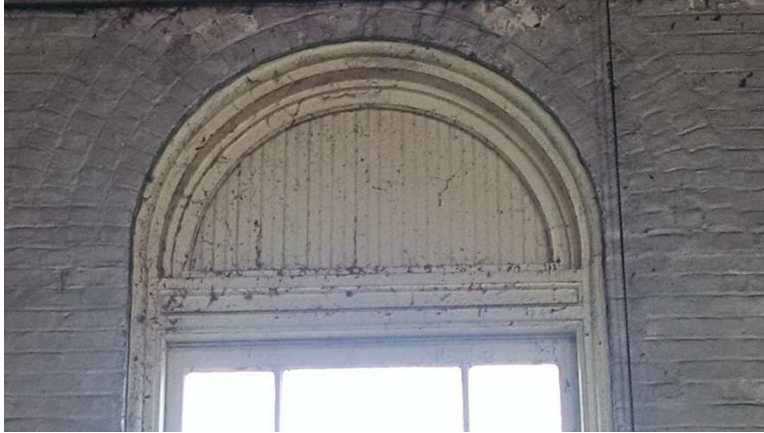
The Type 2 windows would be replaced in a similar fashion. The frame would remain, but the glass pane would be removed and replaced. The hardware needed to open and close the windows would not be replaced at this time, and the existing chains/ropes used to operate the windows would be removed. In some instances, these units have been “blanked” with wood or other material (see Figure 6). Removing the wood should be considered to allow additional light into the rooms. The wood mullions or dividers for the Type 2 windows are inconsistent. Selection of a single mullion pattern would be preferred from a manufacturing and maintenance perspective.

Figure 6 - Type 2 window with blank
