Re: Caldwell Phase II Karst Survey and Assessment
Caldwell Solar, LLC
Princeton, Caldwell County, Kentucky
Terracon Project No. 57205061

As requested, Terracon Consultants, Inc. (Terracon) is submitting this report summarizing the karst survey and assessment at the proposed Caldwell Solar site in northern Caldwell County, Kentucky.

Caldwell Solar Phase II Karst Assessment ■ Caldwell County, Kentucky
July 19, 2021 ■ Terracon Project No. 57205061

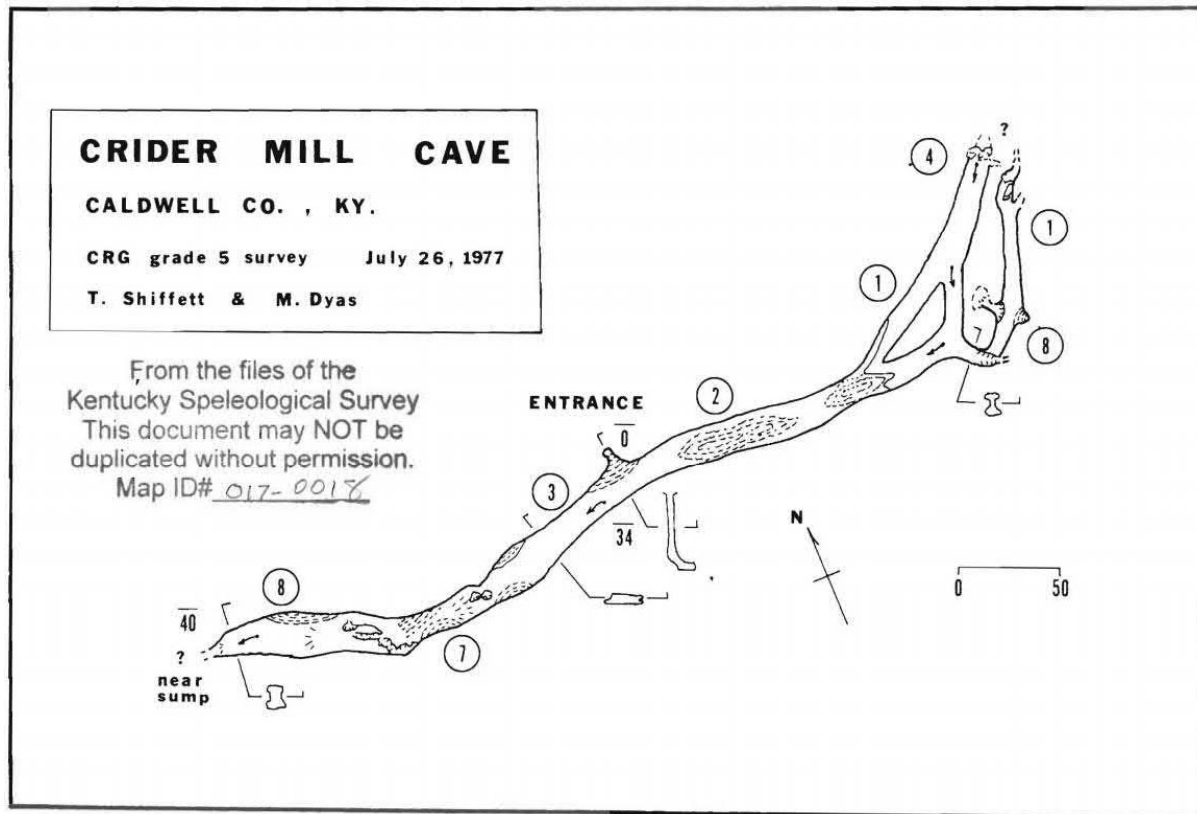
Figure 1. Detailed map of Crider Mill Cave.

Crider Mill Cave has an approximate 34-foot-deep (vertical) pit entrance. The horizontal main passage consists of a few hundred feet of stream passage with ceiling heights ranging from 1-8 feet. The stream flows from northeast to southwest, mirroring the sinking stream alignment at the surface. The cave stream sumps² at either end of the passages. This small cave indicates that there may be other similar stream cave passages beneath the sinking stream segments identified within the AOI. These passages more than likely flood during precipitation events and the water flows along the surface stream channel for a short time, until it sinks back into the subsurface passages.

Based on a 1-mile buffer data review of the site from the Kentucky Speleological Society (KSS) two small documented caves were identified. Crider Mill Cave is located along the sinking creek just north the project site and Crider Road (Appendix A, Exhibit 3), and Francis Cave is located to the east of parcel 25-8 along the base of Bright Hill. A detailed cave map from 1977 was available for Crider Mill Cave (Figure 1) and very little data was present for Francis Cave.

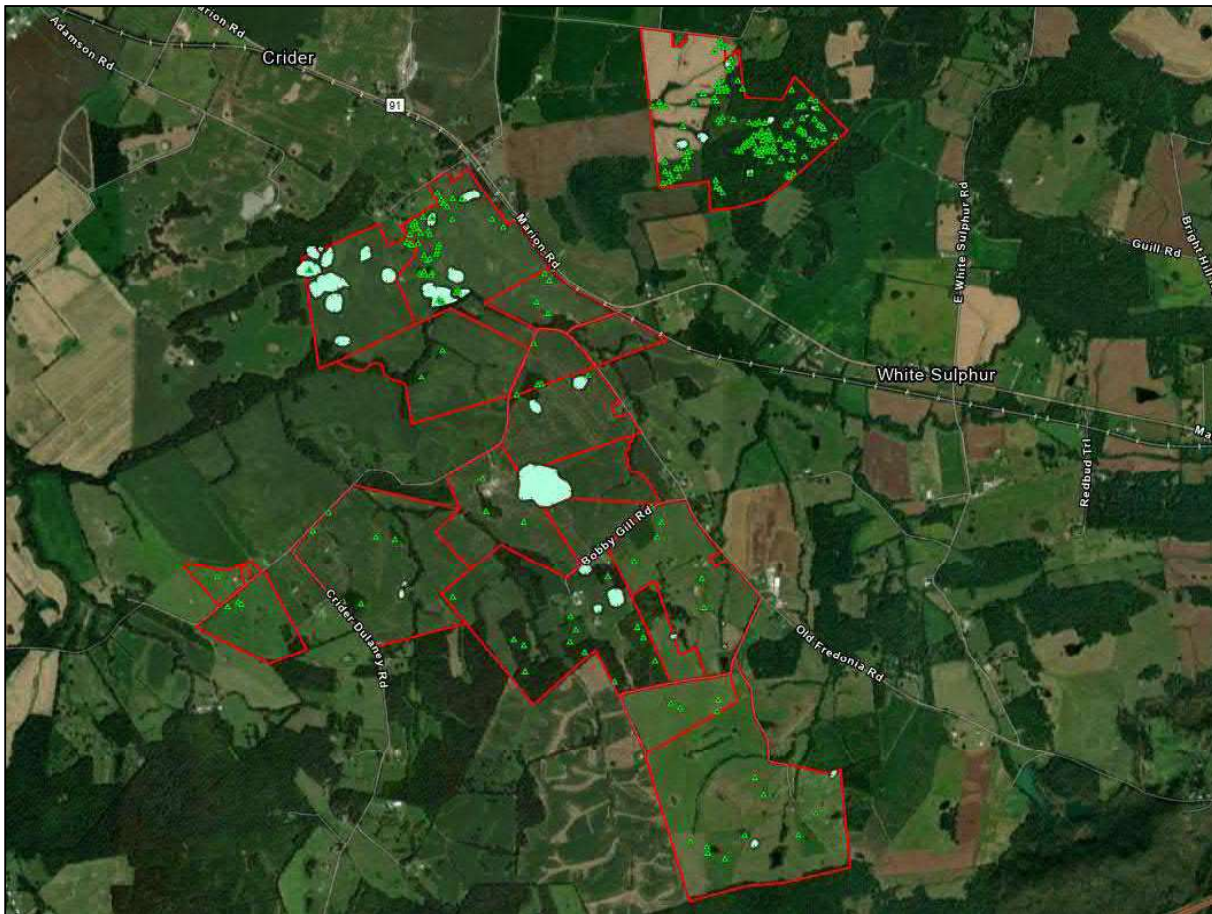
Based on the methods and procedures for the data review as detailed previously in Section 2.1, suspect karst features were identified throughout the site. In total, two hundred and thirty-two (232) point karst features and thirty-three (33) area karst features were identified within the AOI for a total number of two hundred and sixty-five (265) suspected karst features (Figure 2;

Appendix D, Table 1). The largest area features ranged in size from 100 to 1,000 feet in length and width, but only a few feet in depth; therefore, it would be very difficult to identify these subtle features in the field. It is important to note that greater than 50% of the suspect karst features were located within two parcels (25-8 and 16-34A-17-5). The number of the suspect karst features per parcel are shown in the table below.

Figure 2. Map of the site showing the SKF zones identified during the data review prior to field exploration. Proposed workspace (outlined in red), SKF (green points and blue areas).

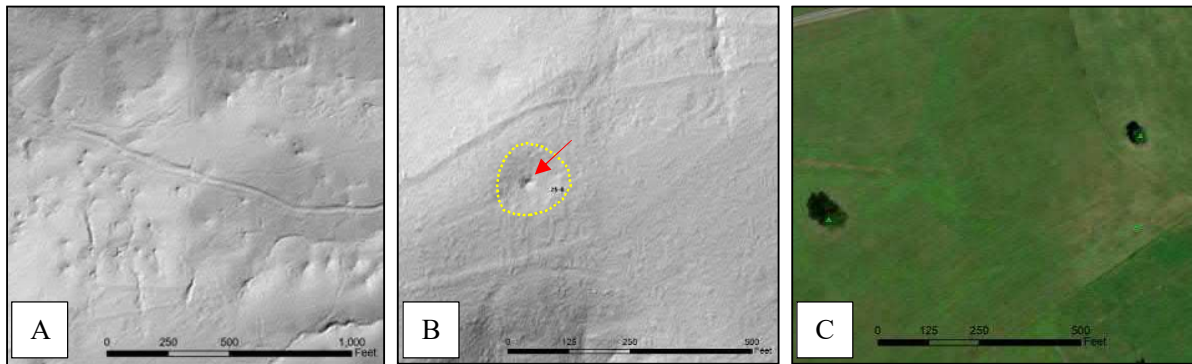
The shaded relief map derived from LiDAR data show concentrations of suspect karst features as shown in Figure 3A, where the topography and location of focused water flow increases sinkhole occurrence and severity. In some cases, broad and shallow closed depressions may have a smaller subsequent collapse along the base or walls of the structure, indicating a reactivation of the sinkhole (Figure 3B). The imagery of the site provides evidence to suggest the presence of sinkholes, even when the LiDAR and 2-foot contour data does not suggest a closed depression. For example, the presence of small groups or single trees in an otherwise developed agriculture field, implies that the landowner has avoided the area for a reason (Figure 3C). In karst prone areas such as this site, these avoidance areas are more often than not either karst features or shallow bedrock, which are both important to investigate during the field survey.

Figure 3. (A) Very dense region of steep walled suspect karst features within parcel 25-8. (B) A suspect karst feature where the broad sinkhole (yellow dashed line) has a smaller subsequent collapse in the center (red arrow). (C) Example of lone trees in an agriculture field which are avoided by the property owner. In areas mapped as underlain by karst, this pattern indicates that there may be karst features near these trees.

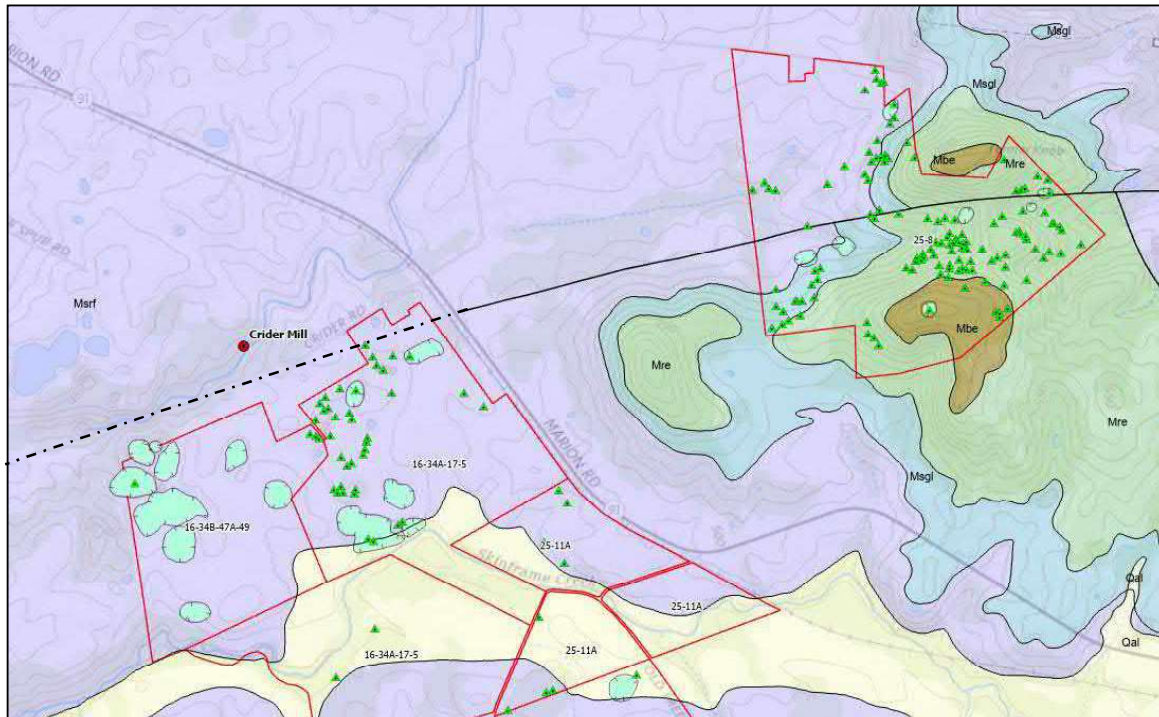
Although the entire expansion region is underlain by carbonate bedrock the distribution of suspect karst features is concentrated within specific areas. This is most likely controlled by lithologic variability within different formations and the deformation and fracturing of bedrock related to faults as shown in Appendix A, Exhibit 2. Many factors control the occurrence of karst features, but the number of clastic units between the carbonate beds, hydrologic conditions, purity of the carbonate layers, topographic relief, and thickness of soil overlying the bedrock may vary between faulted regions within the proposed expansion area and influence the distribution of karst features. For example, the densest concentration of karst features is in parcel 25-8 where both fracturing

related to the strike slip faulting and significant vertical relief likely increase the frequency and severity of the karst features. Although the strike slip fault that passes through Farmer Knob is shown to terminate against Marion Road, it is highly likely that it extends in the southwestern direction past the roadway (shown as black dashed line in Figure 4) and that deformation related to this fault may account for karst feature presence being abundant in parcels 16-34A-17-5 and 16-34B-47A-49, and Crider Mill cave also being located along this alignment. As seen in Figure 4, there is a concentration of suspect karst features near the strike slip fault and the number of features decreases away from the fault zone south of Skinframe Creek.

Figure 4. Geologic map of the northernmost parcels in the study where the highest concentration of suspect karst features was identified. There is a correlation between suspect karst feature occurrence and proximity to the strike slip fault (shown by solid black line) and the extrapolation of the fault (shown by dashed black line). Suspect karst feature points are shown by green triangle symbols, area features are shown as blue polygons, and the parcels are shown by the red polygons.

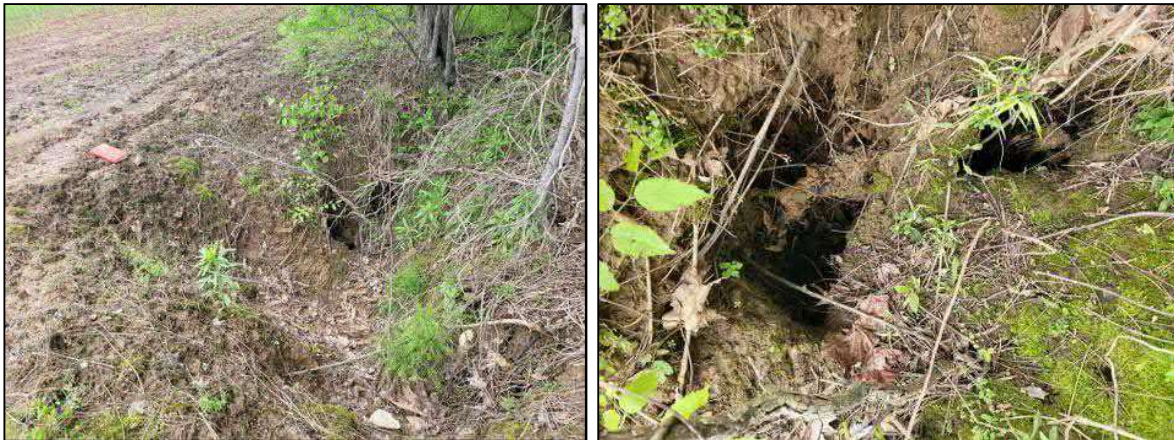
Type 1 – This type of karst feature is characterized by the presence of an open throat at the base and active erosion along the walls and parapet of the feature. These features are considered the highest risk since they are actively growing and may continue to collapse and widen during construction activities and post development. An example of such a feature is shown below in Figure 5.

Figure 5. A sinkhole (25-8-044) undergoing erosion and expansion of the parapet limits as demonstrated by the rough, raveling, and incised surfaces. In addition, the open throats present in the base of the sinkholes readily receive surface runoff with little to no filtration.

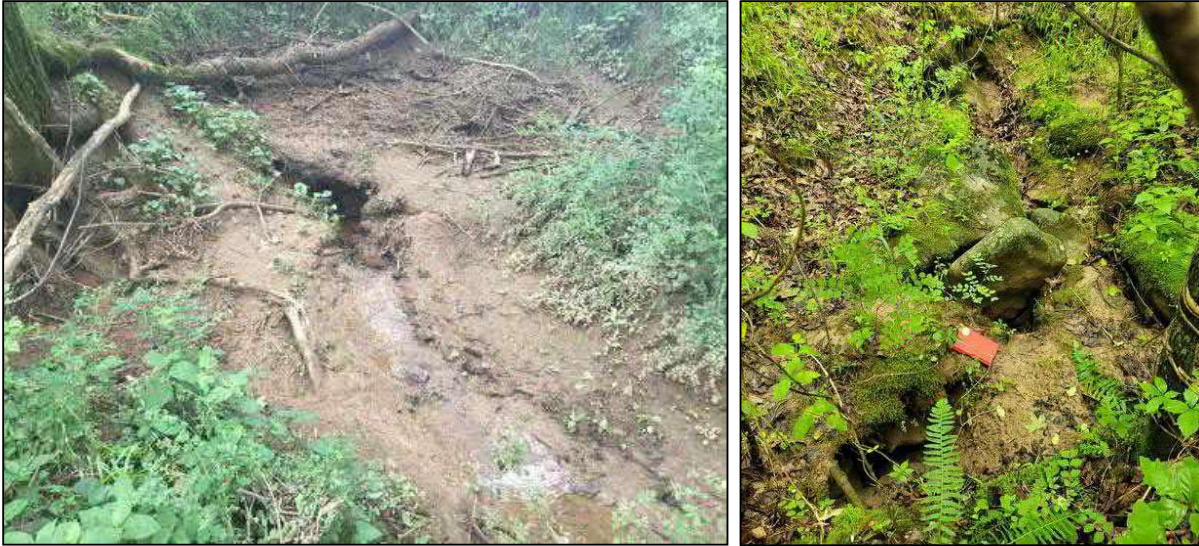
Type 2 – This type of karst feature is characterized by the presence of an incised drainage channel leading to the karst feature indicating that focused drainage enters the structure, which commonly results in active erosion and growth of the sinkhole (Figure 6). In addition, they nearly always contain an open throat. Additionally, these features can be problematic as potential construction activities within the drainage may result in the uncontrolled flow of water transporting sediment and contaminants into the subsurface via the open throat. Awareness of the drainage catchment extent and implementation of proper erosion and sediment controls (ESC) are crucial for these types of karst features.

Figure 6. Two examples of drainage channels leading towards sinkholes with open throats. The photo on the left shows soil raveling at the point of water entry into the subsurface (25-8-022) and the photo on the right shows a drainage channel leading to bedrock bound open throats (25-8-075).

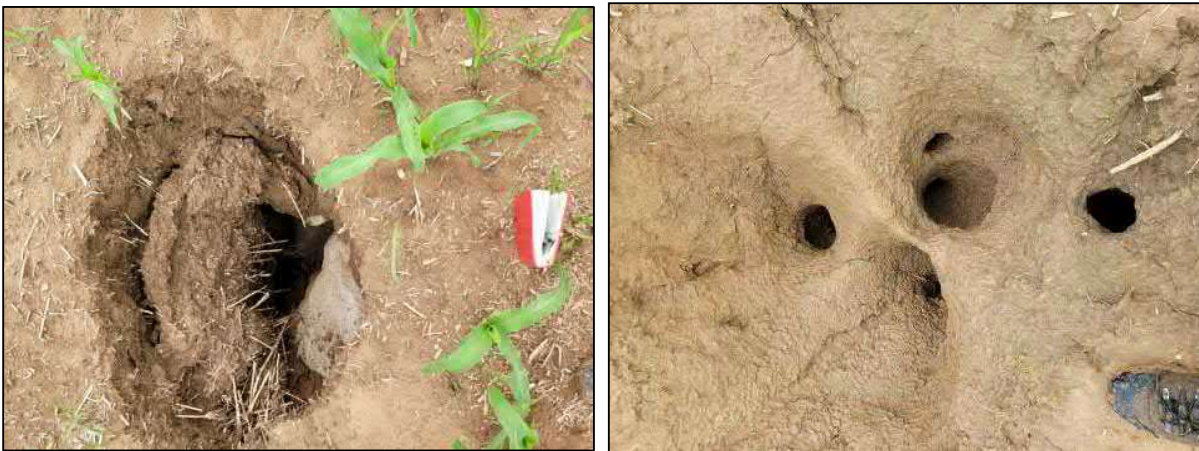
Type 3 – This type of karst feature has an open throat and rough, irregular parapet edges, indicating active erosion, collapse, and growth. The features are typically small (<5 feet) yet indicate that the area around the soil piping is undergoing sinkhole development which may widen, deepen, and affect the surrounding area (Figure 7). It is commonplace to observe multiple soil piping features which may all be feeding into a single open throat in the subsurface. These features pose a significant risk because the karst features are actively developing; therefore, remediation or avoidance is necessary.

Figure 7. Examples of soil piping structures and open throats which are newly developed and indicate that growth and widening of these features is likely. Left = 25-8-012 and Right = 25-8-093.

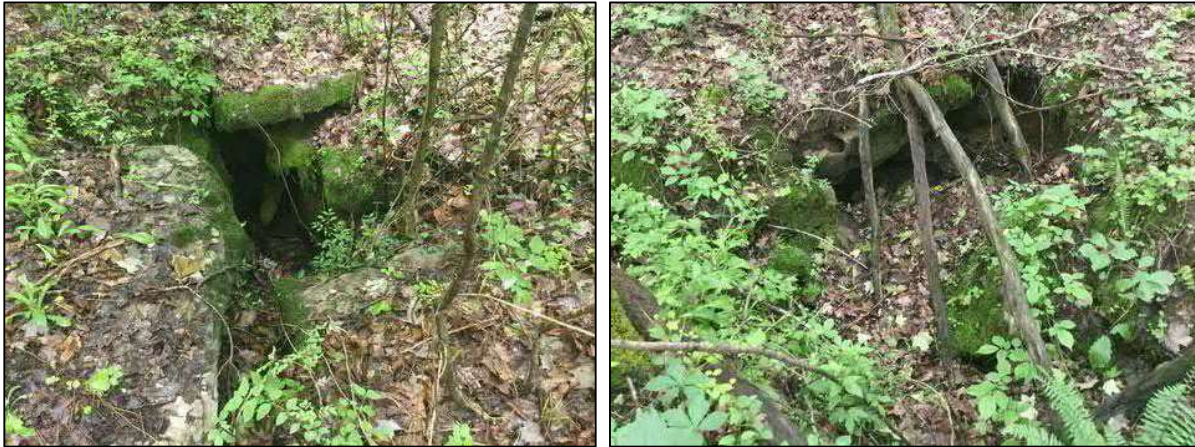
Type 4 – This type of karst feature is a sinkhole with a cave entrance located at the base or within the sidewall of the structure (Figure 8). Caves pose a significant risk since they are relatively large openings that can receive surface runoff, may contain significantly sized chambers and passages

below the surface, and may host cave fauna and sensitive biological habitats. Aside from having certified spelunkers enter the caves and map out the passages, geophysical techniques are often utilized to determine the presence, extent, depth, and size of cave passages in relationship to planned construction. During this survey a total of 6 new possible cave entrances were found in features 25-8-105, 25-8-110, 25-8-126, 25-8-128, 25-8-143, 16-34A-17-5-206.

Figure 8. Two cave entrances observed during the field survey, where the right entrance is located within a low wall of bedrock (25-8-105) the left image shows a cave entrance at the base of a sinkhole (25-8-128).

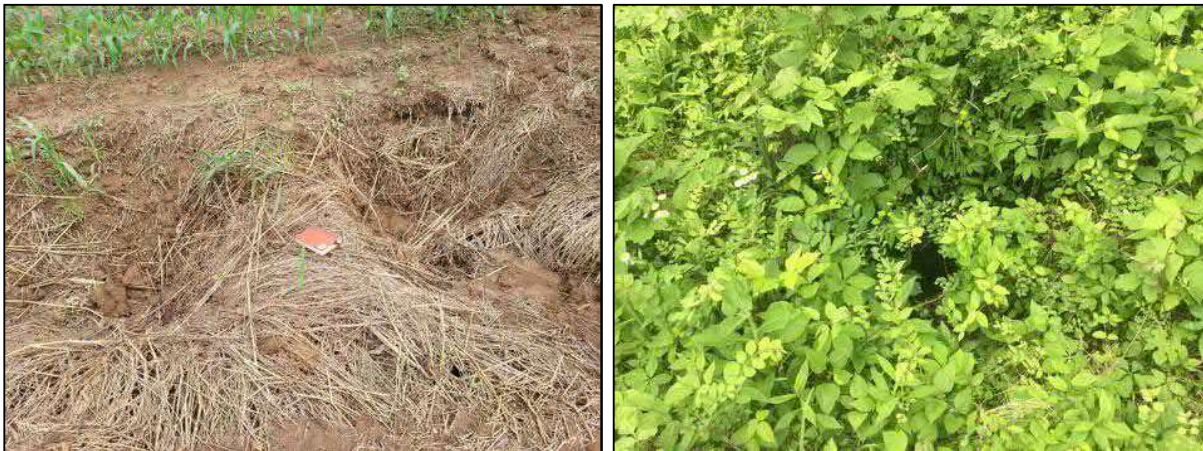
Type 5 – This type of karst feature has an open throat within the structure, yet the remainder of the sinkhole is overgrown with vegetation and the parapet appears to be stable³ (Figure 9). Although there is an opening present leading into the subsurface, the protection and stabilization of the feature by maintaining a vegetated buffer dramatically reduces the risk of impacting the subsurface habitat during construction activities.

Figure 9. Examples of overgrown open throats located at the base of sinkholes. The presence of the plant life indicates that little to no recent erosion has occurred. Left = 25-8-045 and Right = 25-8-031.

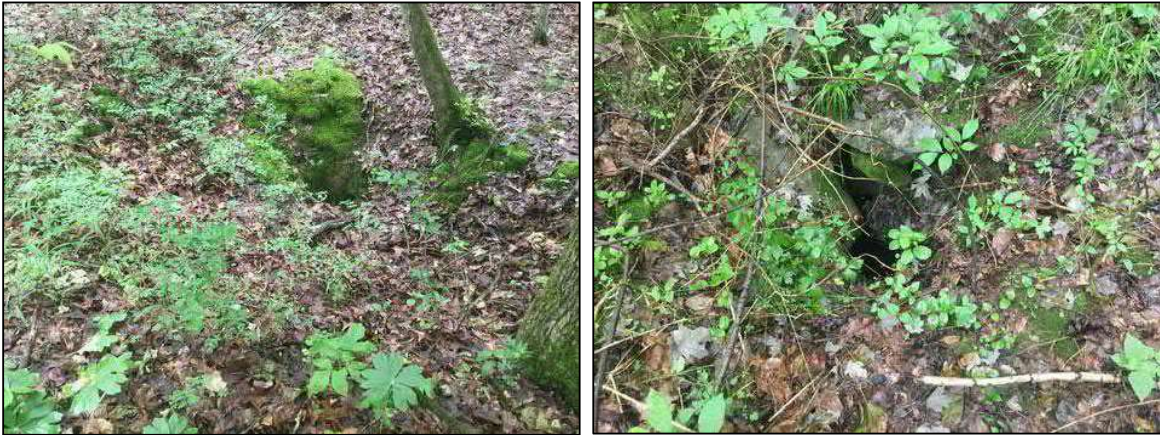
Type 6 – This type of karst feature is characterized by bedrock bound open throats and rock outcrops either located at the base of sinkholes or within generally flat laying bedrock benches (Figure 10). Although the open throats clearly connect to the subsurface, the bedrock does not present much risk of collapse or change in architecture unless the bedrock layer is very thin above an open chamber. The bright green moss growing near the open throat of feature 25-8-063 (Figure 10), indicates the presence of water vapor which implies that the opening is connected to a possible larger cave system below.

Figure 10. Bedrock bound open throats located within a bedrock outcrop flush with ground shown on the left (25-8-063) or at the base of a depression shown on the right (25-8-107).

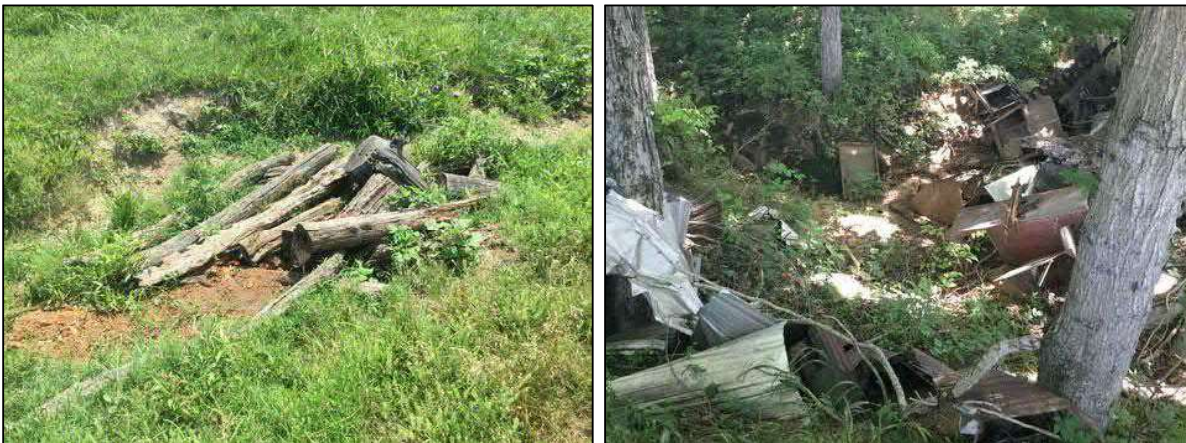
Type 7 – This type of sinkhole has been used by farmers and landowners as a convenient place to deposit field rock, trees, trash, and an assortment of various other items and materials. These karst features were present within the AOI and most typically observed to be infilled with trash and occasional trees (Figure 11). Since these may have been partially or completely filled, it is impossible to fully characterize these features for the presence or absence of an open throat. Therefore, we assume that there is an open throat at the base in order to be conservative for protection measures during construction activities.

Figure 11. Examples of trash and tree filled sinkholes observed during the field survey. The feature on the left (26-30B-30C-31-203) is filled with cut tree trunks and limbs and the feature on the right (16-34A-17-5-220) is filled with old vehicles.

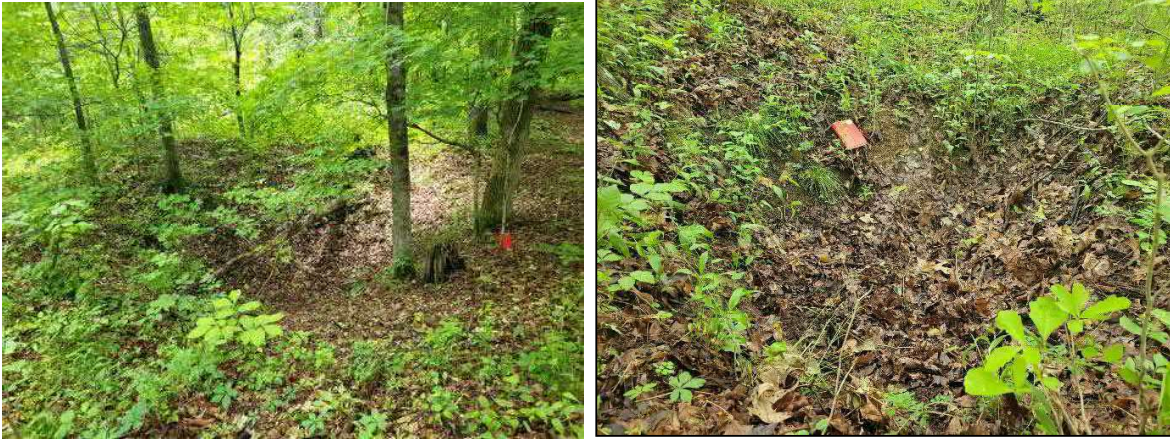
Type 8 – This type of feature is present as small depressions ranging in size from a few feet in length, width and depth, and are typically flush with the ground and exhibit minor soil raveling (Figure 12). There are no open throats within the structures and typically little to no considerable growth of the feature occurs over time unless the topography and hydrology change.

Figure 12. Examples of small depressions where a leaf litter covered feature is shown on the left (25-8-069) and a feature with minor soil raveling along the wall is shown on the right (25-8-109).

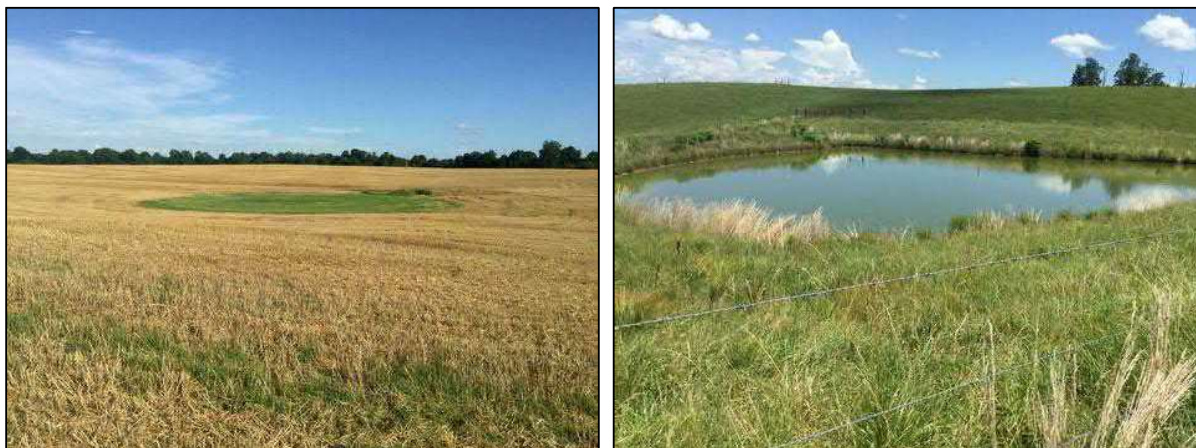
Type 9 – This type of sinkhole is present as a broad and shallow depression, ranging in size from tens to hundreds of feet in diameter and commonly referred to as a “mature” or paleokarst sinkhole (Figure 13). Mature sinkholes often have a roughly circular parapet outline, are bowl shaped, lacking any opening to the subsurface (i.e. “throat”) or showing evidence of active soil raveling or tension cracks around the parapet. Thus, whatever conduit or opening into the underlying karst aquifer that may have functioned to create the structure is probably now clogged with soil, which would act as a filter for water infiltrating from the surface.

Figure 13. Examples of mature sinkholes. The feature on the left (16-34B-47A-49-236) is a large closed depression with evidence of ponding at the center due to the presence of facultative wetland plants⁴. The image on the right (26-30B-30C-31-202) shows a closed depression which has presumably been repurposed into a pond.
