Phase I Environmental Site Assessment

Caldwell Solar Site Additional Area
Fredonia, Kentucky

Phase I Environmental Assessment (ESA) Report

Project #: E320201000 04 AR

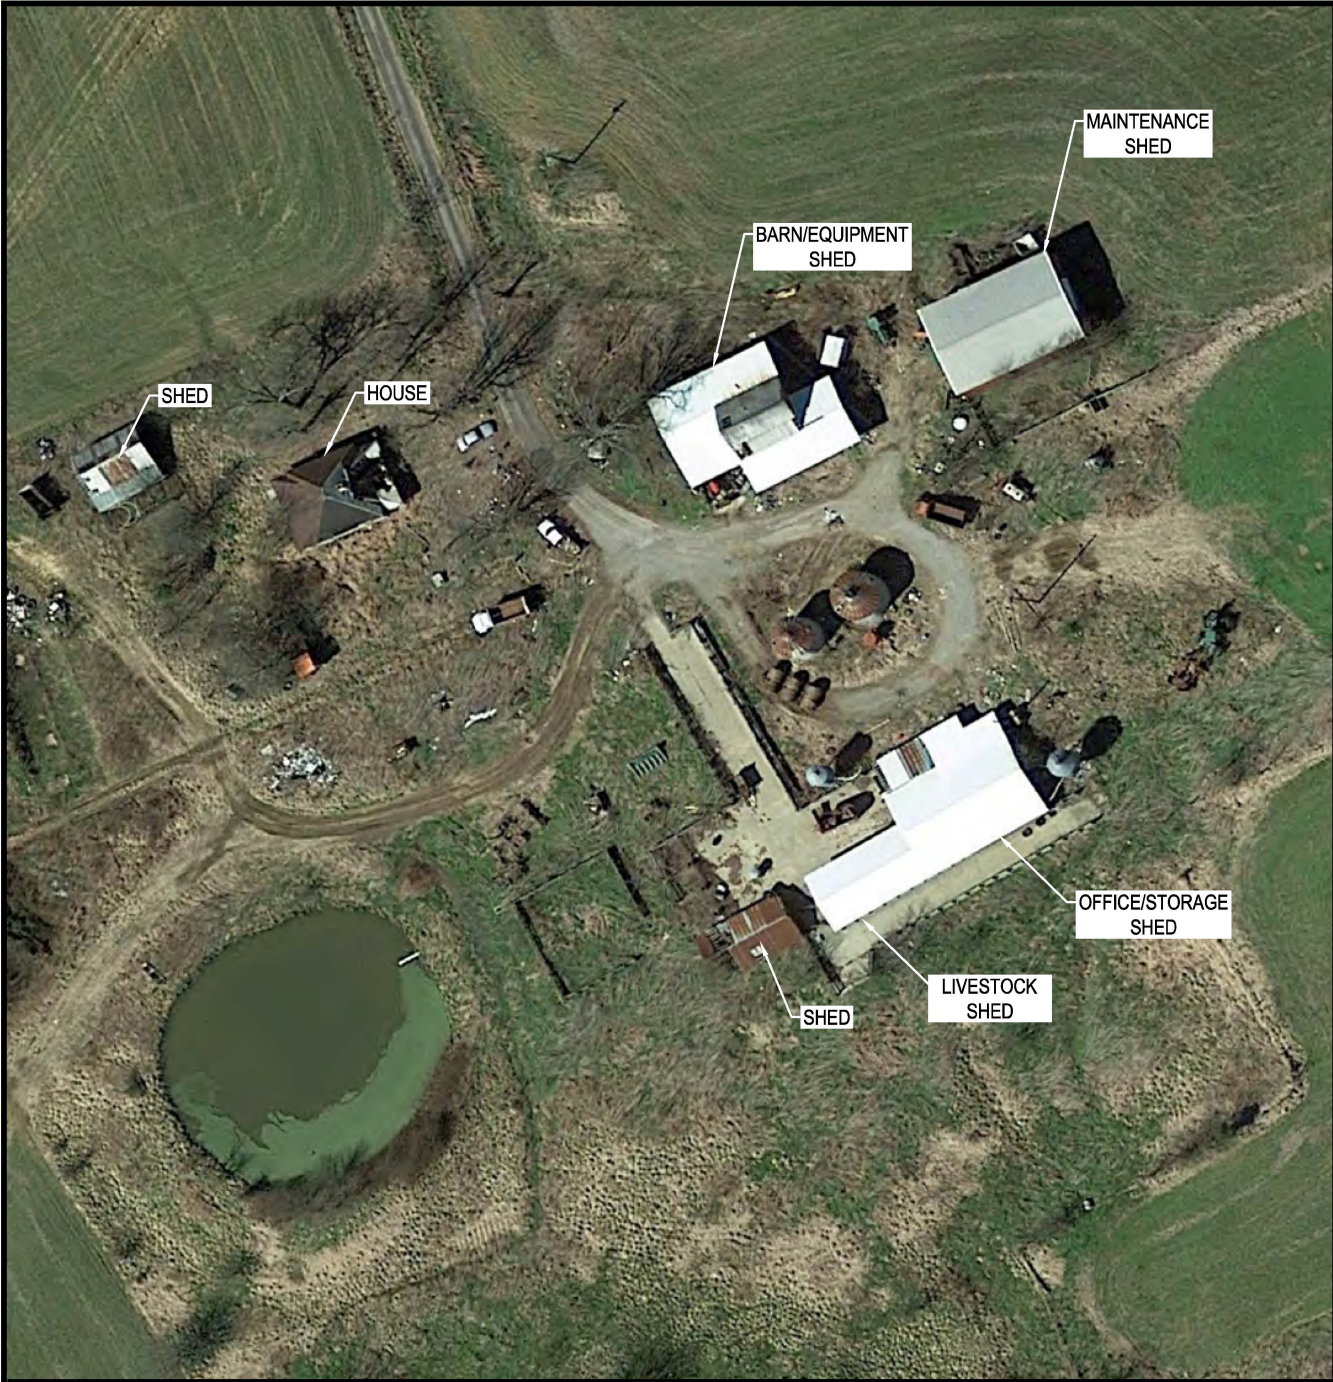
- > Extensive debris including old farm implements and tools, a truck, a combine, a small generator, household trash, old houseware, automotive tires, wire, empty five-gallon plastic buckets for hydraulic fluid and oil, empty gallon and quart size plastic containers for oil, antifreeze, and hydraulic fluid, empty approximately 2.5-gallon gasoline containers, a truck battery, brush piles and scrap plastic, wood, and metal were observed across the Gill Farm Complex (*Photos 21-28* and *Figure 3*).

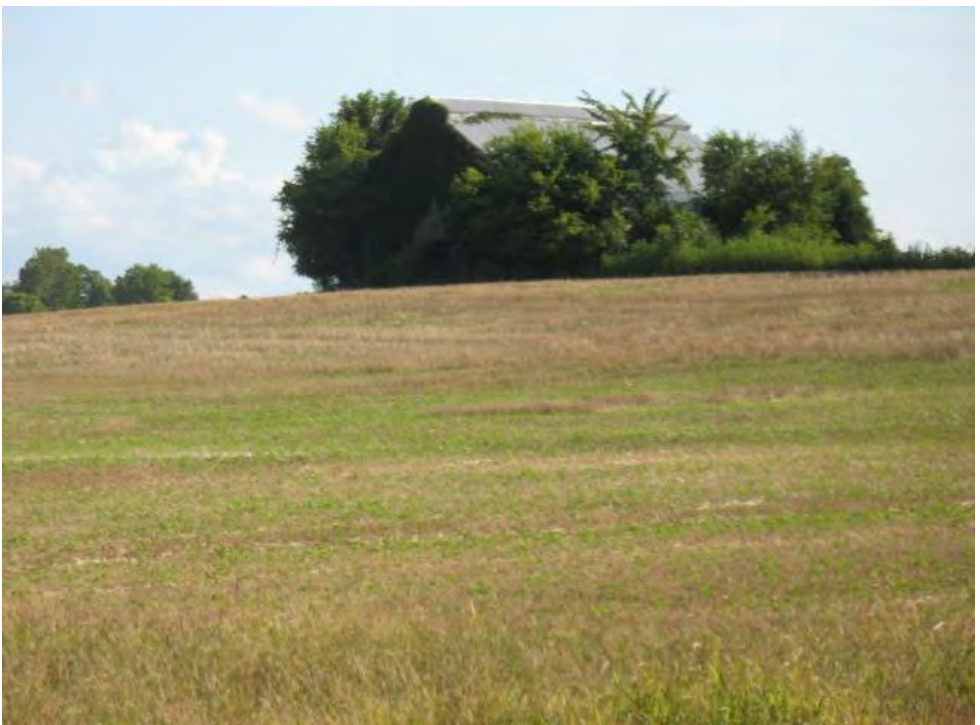
Date: July 13, 2021 Description: Dilapidated and overgrown barn located on the north side of the Site, south of Crider Road (facing southwest).		Photo 2

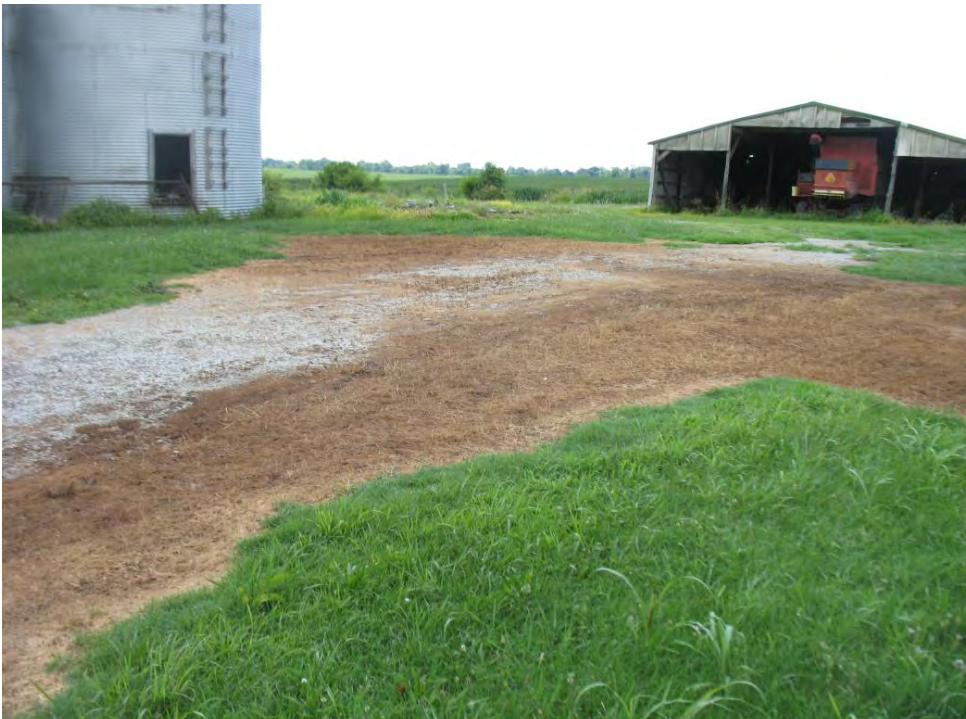
Date: July 13, 2021 Description: Stressed grass at off-site minor fertilizer spill next to silos and equipment shed on north side of Old Fredonia Road (facing northwest).		Photo 16

- > No visual evidence of a release (e.g. staining or stressed vegetation) was observed at the location of SPILLS Incident ID #2424992 (H.T. Hackney) at the intersection of Skinframe Creek and Marion Roads, adjoining the northeast side of the Site (*Photo 4*).
- > Stressed grass was observed next to two silos on the north side of Old Fredonia Road, east of the Jones Farm Complex – West (*Photo 16*). According to Mr. Bill Jones, owner of adjacent property at 6858 Old Fredonia Road, a liquid fertilizer spill caused the burned grass observed near the off-site silos (see *Section 7*). Mr. Jones said that no cleanup was required and no action was taken. Based on the composition of the spill, its off-site location and its minimal extent, the fertilizer spill is not considered a REC in connection with the Site.

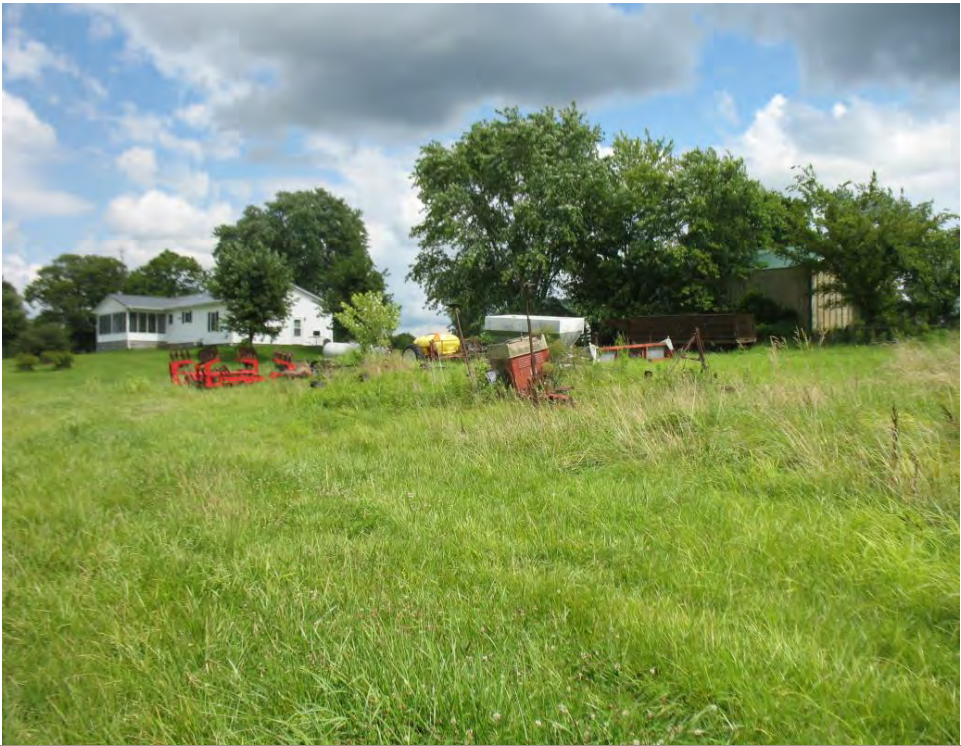
Client: Caldwell Solar, LLC Site Name: Caldwell Solar Site Additional Area	Site Location: Fredonia, Kentucky Project Number: E320201000
Date: July 13, 2021 Description: House and sheds at Jones Farm Complex – West (6858 Old Fredonia Road). Farm implements, empty trailer mounted polyethylene AST and liquid propane gas AST are located north of Old Fredonia Road (facing southeast).	<p style="text-align: center;">Photo 17</p>

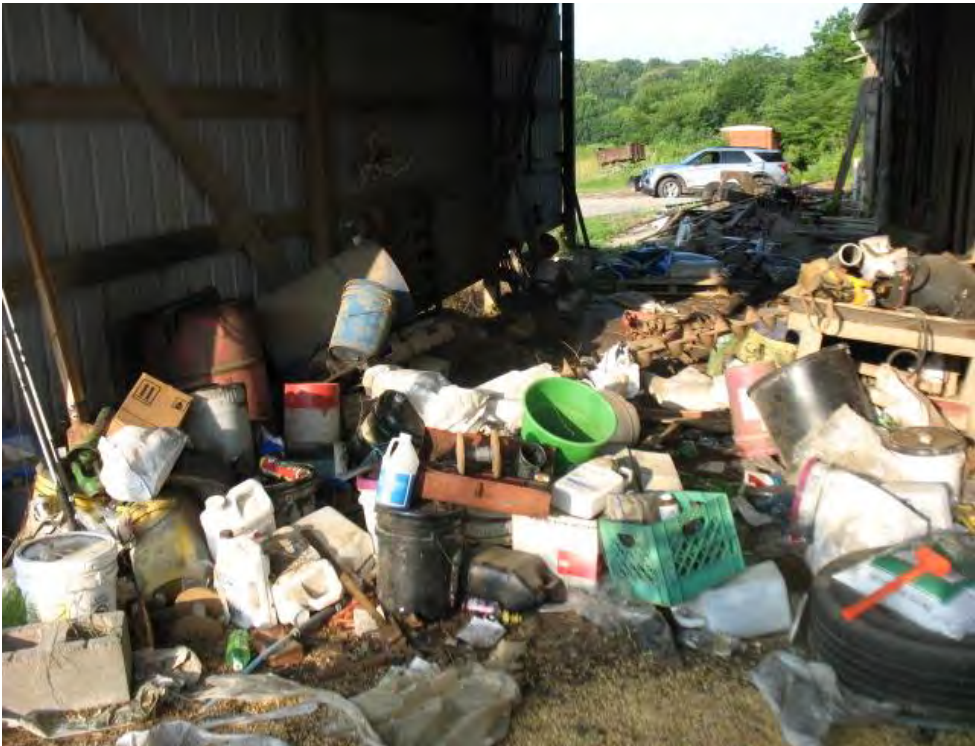
A photograph showing a large, cluttered interior space, likely a barn or shed. The floor is covered with a massive pile of debris and waste. Visible items include several 55-gallon drums, some upright and some tipped over, along with numerous plastic jugs, buckets, and other miscellaneous trash. The background shows the dark interior of the building and a glimpse of the outdoors where a white car is parked.
<p>Date: July 14, 2021</p> <p>Description: Oily, debris covered floor in mechanical shed on northeast side of Gill Farm Complex located at west end of Bobby Gill Road (facing east)</p>	<p style="text-align: center;">Photo 26</p>

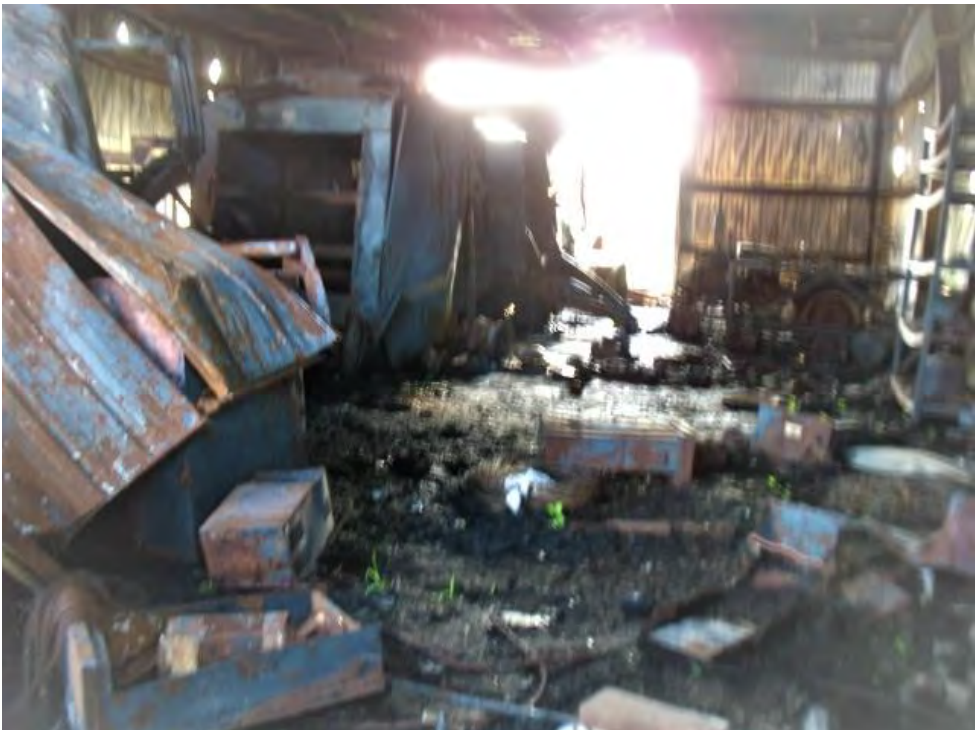
A photograph of the interior of a mechanical shed. The floor is dark, oily, and covered in debris. In the background, a bright light source, possibly an open door or a window, creates a strong glare. The walls of the shed are made of corrugated metal, and various mechanical parts and tools are visible in the shadows.

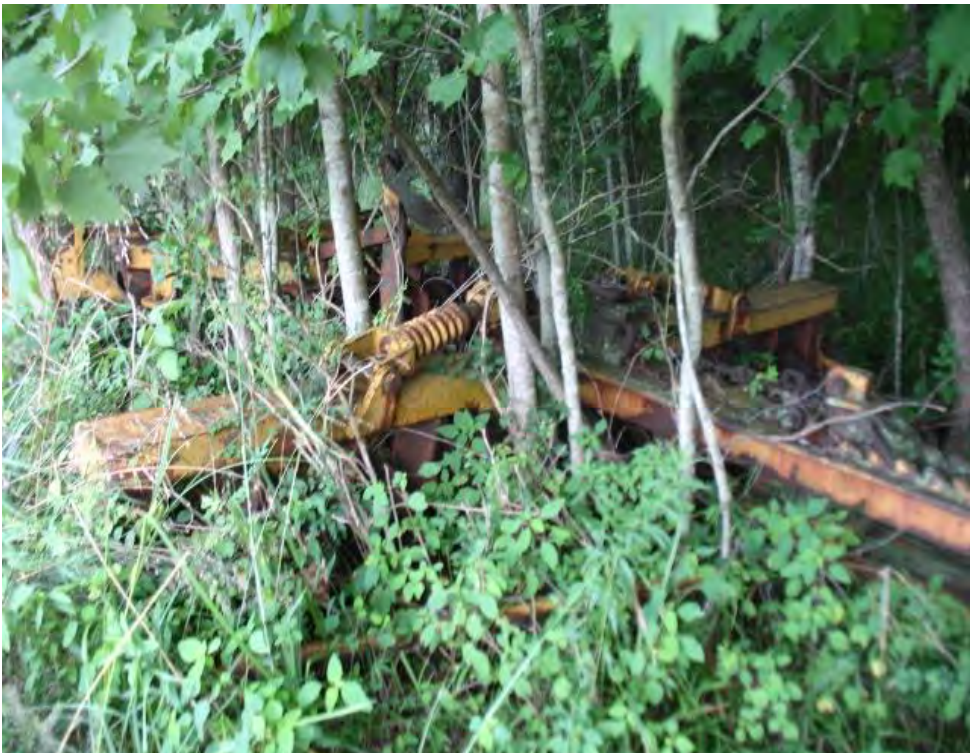
Date: July 14, 2021 Description: Discarded, overgrown disc in woods on north side of Craig Cemetery Road.		Photo 32

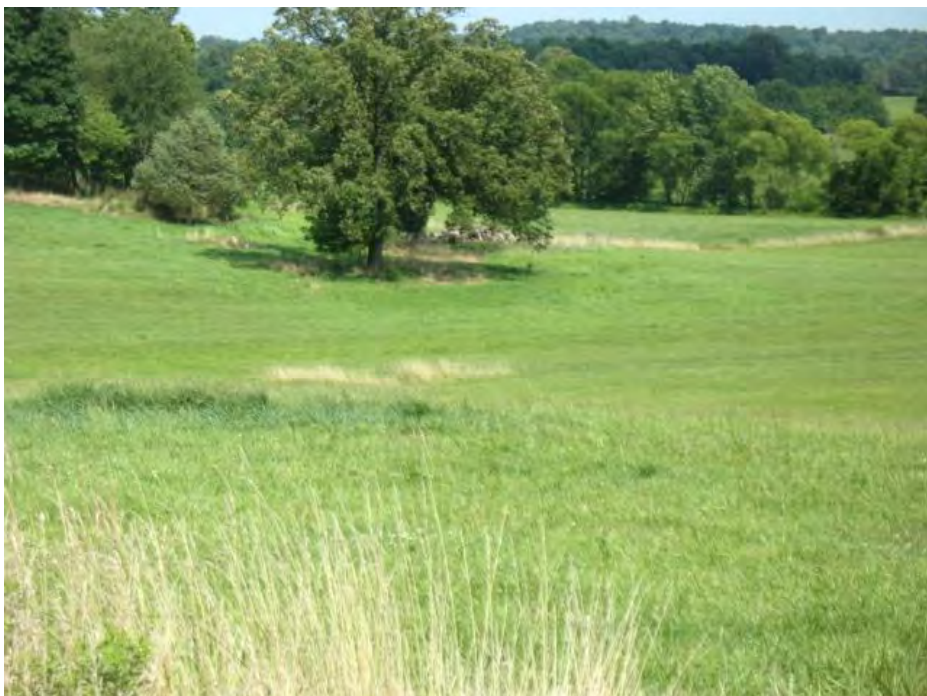
- > No staining, stressed vegetation, or other visible signs of a spill or other release were observed at or around the approximate location of the abandoned William Jones No. 1 well (*Photo 36, Figure 2*). According to Kentucky Department of Mines and Minerals, Division of Oil and Gas records, the William Jones No. 1 (Permit No. 90183) spudded on May 3, 1999, and was drilled to a total depth of 2,943 feet (*Appendix E*). During drilling of this gas exploration well, fresh water was encountered from approximately 470 to 500 feet below ground surface (bgs). No natural gas was encountered. On June 21, 1999, the well was abandoned as a dry hole by plugging from surface to a depth of 601 feet bgs.

Date: July 14, 2021 Description: Approximate location of abandoned oil/gas well, William Jones No. 1 (facing east).	Photo 36
