# Phase I Environmental Site Assessment

Caldwell Solar Site • Fredonia,  
Kentucky

## **Phase I Environmental Assessment (ESA) Report**

Caldwell Solar Site  
Fredonia, Kentucky

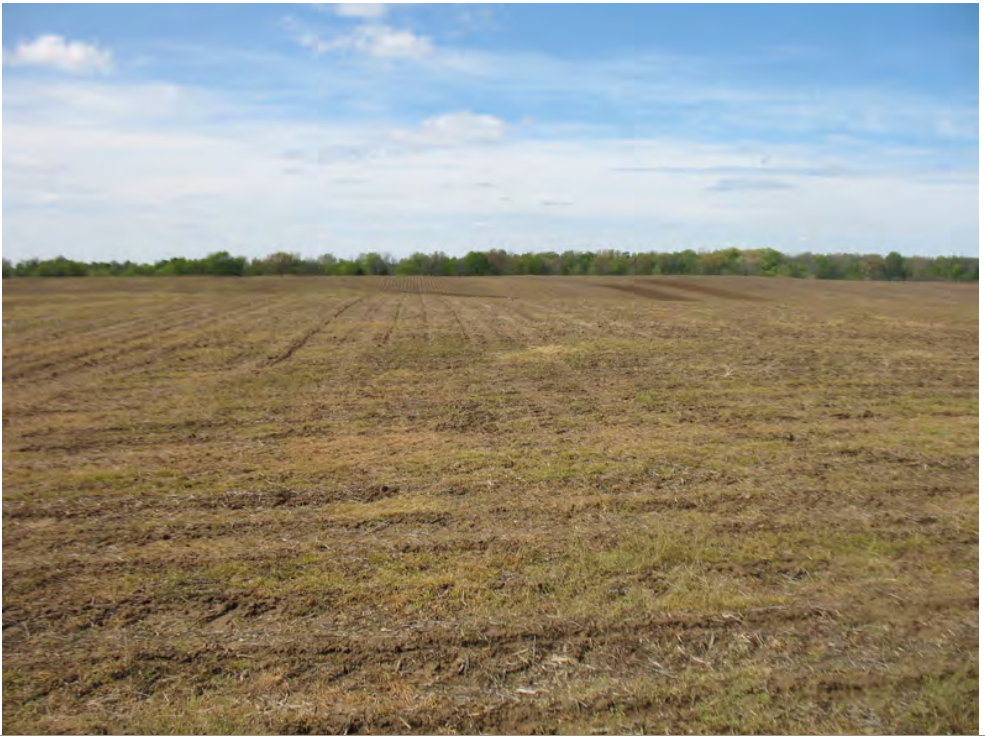
<b>Client:</b> Geronimo® Energy		<b>Site Location:</b> Fredonia, Kentucky	
<b>Site Name:</b> Caldwell Solar Site		<b>Project Number:</b> E320201000	
<b>Date:</b> April 13, 2020  <b>Description:</b> Disced field northwest of Skinframe Creek Road at south corner of Caldwell Solar Site (facing northwest away from the intersection of Skinframe Creek and Crider Dulaney Roads).		<b>Photo 1</b>

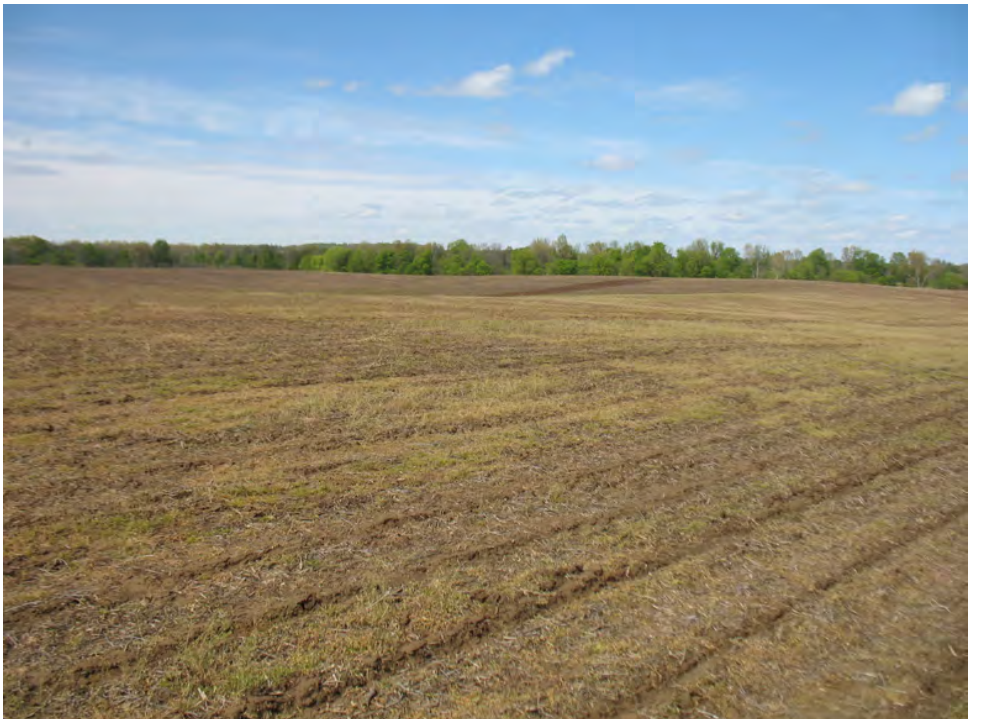
<b>Date:</b> April 13, 2020  <b>Description:</b> Disced field northwest of Skinframe Creek Road at south corner of Caldwell Solar Site (facing north away from Skinframe Creek Road). Two closed dips near the center of this field appear to be possible surface expressions of sinkholes.		<b>Photo 2</b>

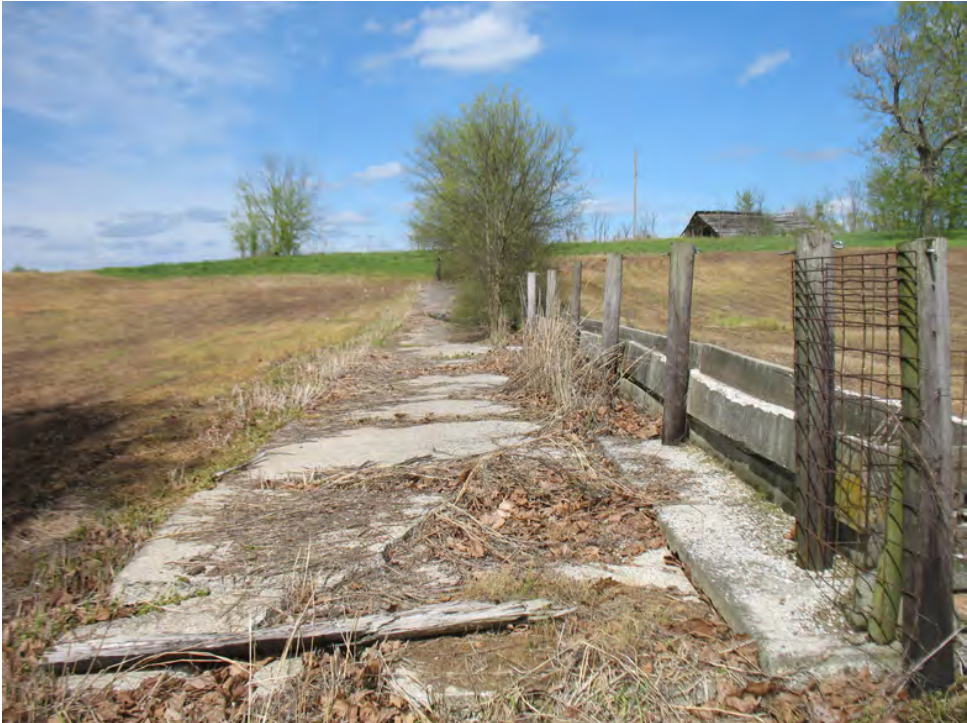
<b>Client:</b> Geronimo® Energy	<b>Site Location:</b> Fredonia, Kentucky
<b>Site Name:</b> Caldwell Solar Site	<b>Project Number:</b> E320201000
<p><b>Date:</b> April 13, 2020</p> <p><b>Description:</b> Disced field on either side of concrete feed trough and concrete slab driveway located northwest of Skinframe Creek Road on south side of Solar Site (facing northeast). Remnant of a small barn is to the right in the background.</p>	<b>Photo 3</b>

- > No staining, stressed vegetation or other visible signs of a spill were observed at the concrete feed trough and driveway, abandoned barn, and abandoned water supply well pump house located on the southeast side of the Site, northwest of Skinframe Creek Road (*Photos 3 and 4*).

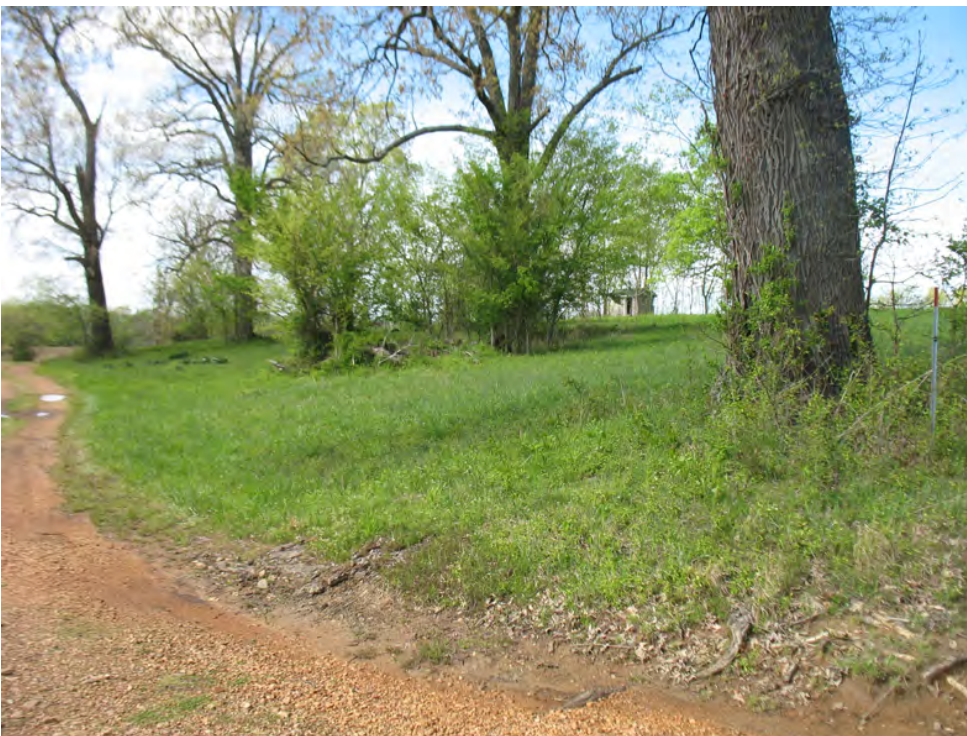
A photograph showing a concrete driveway and a concrete feed trough in a disced field. The field is brown and dry, with some green grass visible in the background. A small barn is visible to the right in the background.
<p><b>Date:</b> April 13, 2020</p> <p><b>Description:</b> Apparent former home site located northwest of Skinframe Creek Road on south side of Solar Site (facing north). A cinderblock water supply well pump house is in the center background.</p>	<b>Photo 4</b>

A photograph showing a dirt road and a cinderblock water supply well pump house. The road is dirt and gravel, and the pump house is a small, rectangular structure made of cinderblocks. There are trees and grass in the background.

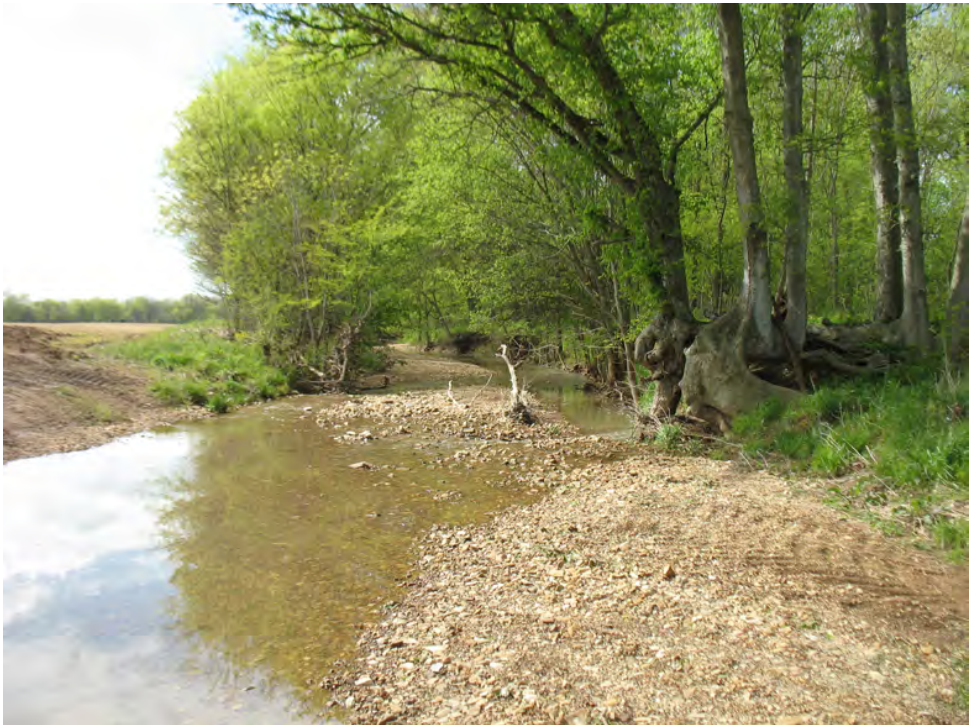
<b>Client:</b> Geronimo® Energy		<b>Site Location:</b> Fredonia, Kentucky	
<b>Site Name:</b> Caldwell Solar Site		<b>Project Number:</b> E320201000	
<b>Date:</b> April 13, 2020  <b>Description:</b> Hewlett Creek, a tributary of Skinframe Creek (facing north-northwest). Hewlett Creek appears to flow into a swallow before reaching Skinframe Creek.		<b>Photo 5</b>

- > Hewlett and Skinframe Creeks were observed on the southeast side of the Caldwell Solar Site following rainfall on April 13, 2020 (*Photos 5 and 6*). Although Hewlett Creek flows northwestward to its confluence with Skinframe Creek, which flows to the southwest, the lower end of Hewlett Creek and Skinframe Creek at the confluence of Hewlett Creek appeared to be dry. A swallow was located along the northwest (downstream) reach of Hewlett Creek. Another swallow is suspected along Skinframe Creek, upstream of the Site.

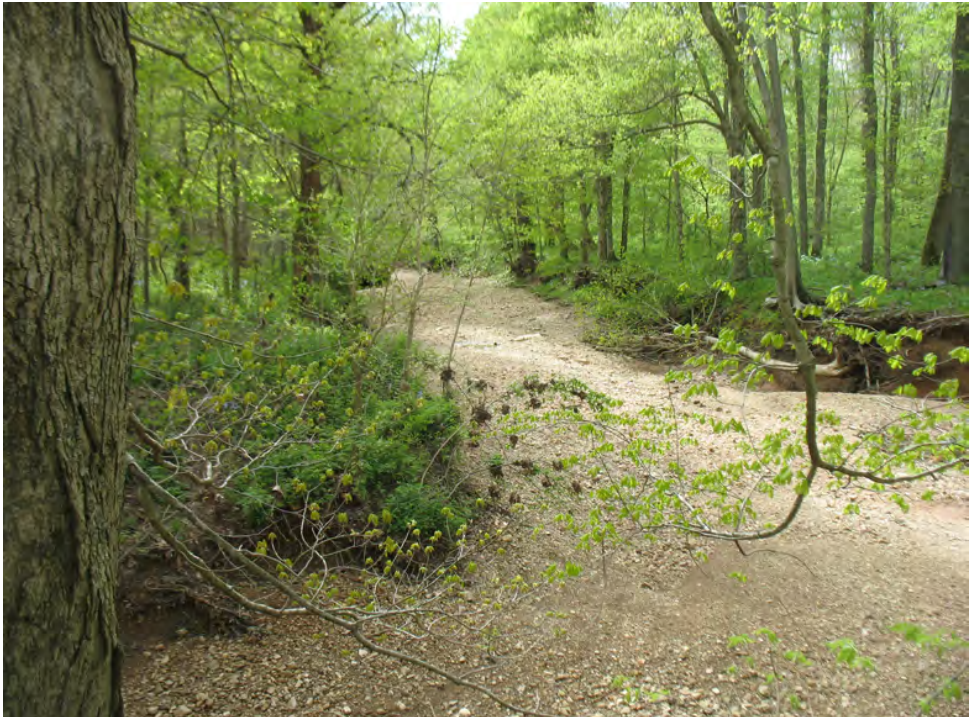
<b>Date:</b> April 13, 2020  <b>Description:</b> Dry bed of Skinframe Creek and mouth of unnamed tributary on south side of Solar Site (facing northwest).		<b>Photo 6</b>

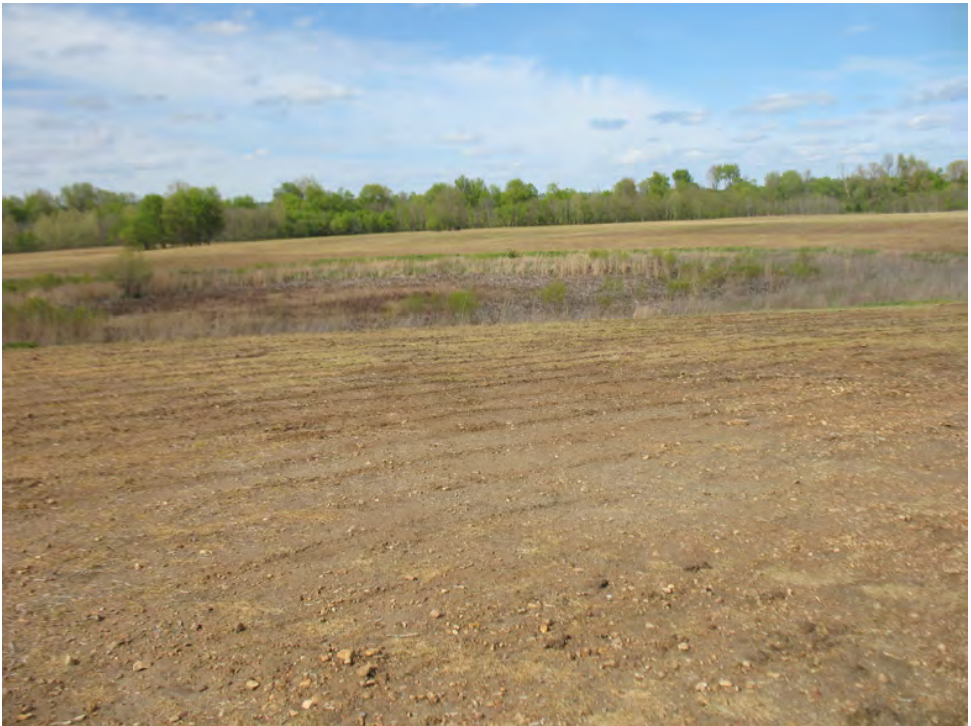
<b>Date:</b> April 13, 2020  <b>Description:</b> Dry pond at sinkhole in disced field northwest of Skinframe Creek Road on south side of Solar Site (facing east). Three other similar features were visible across the south side of this field. Tree clusters in the field also appear to be at sinkholes on the north side of this field. Note the small cluster of trees in the upper left side of photo appears to be a sinkhole.		<b>Photo 8</b>

According to E. Glynn Beck, Generalized Geologic Map for Land-Use Planning: Caldwell County, Kentucky, the Caldwell Solar Site is in an area underlain by limestone prone to karst development. Planning guidance indicates that, depending on topography, this area has slight to moderate limitations for light industrial development. The area is characterized as excellent for foundations, severely limited for septic systems, with locally fast drainage through fractures and danger of groundwater contamination. Locally, the upper few feet may be rippable and sinkholes are possible.

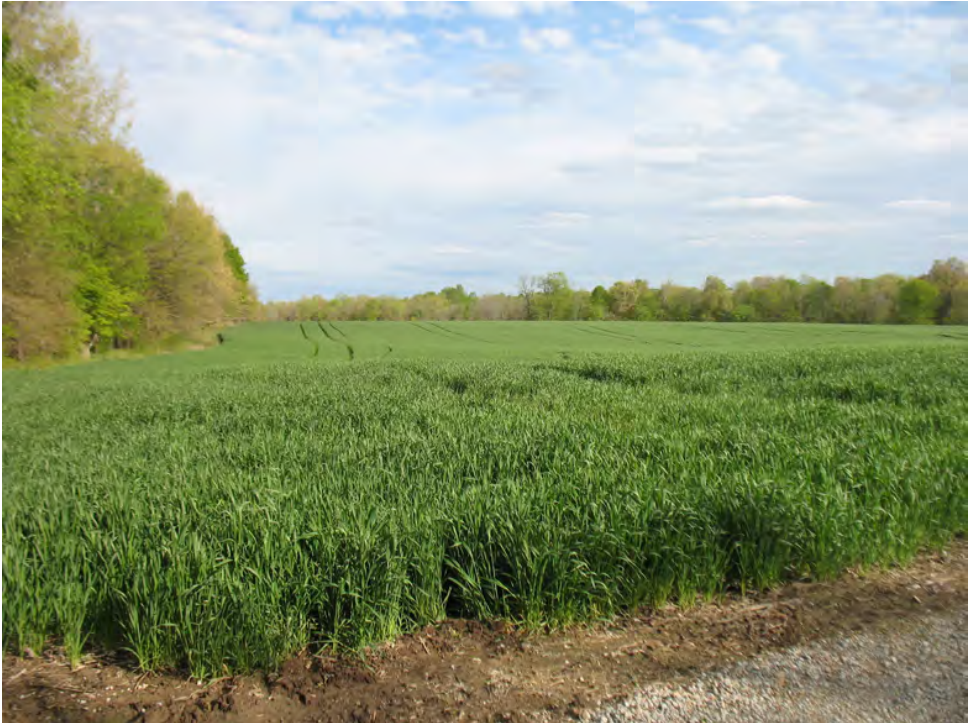
- > No staining, stressed vegetation, or other visible signs of a spill were observed at the abandoned barn/silo, equipment shed, and small house on the east side of the Site, south of Crider Spur Road (*Photo 12*).

- > No visible ashes, staining, stressed vegetation or other visual indication of environmental contamination at the location of open burning, SPILLS Incident ID #2291778, south of Crider Spur Road on the east side of the Site (*Photo 12*).

<b>Date:</b> April 14, 2020  <b>Description:</b> Dilapidated barn, silo, equipment shed, and small house along gravel driveway located south of Crider Spur Road (facing west). Site of February 19, 2009 open burning event investigated under the Kentucky Department of Environmental Protection (KDEP) Air Program.		<b>Photo 12</b>

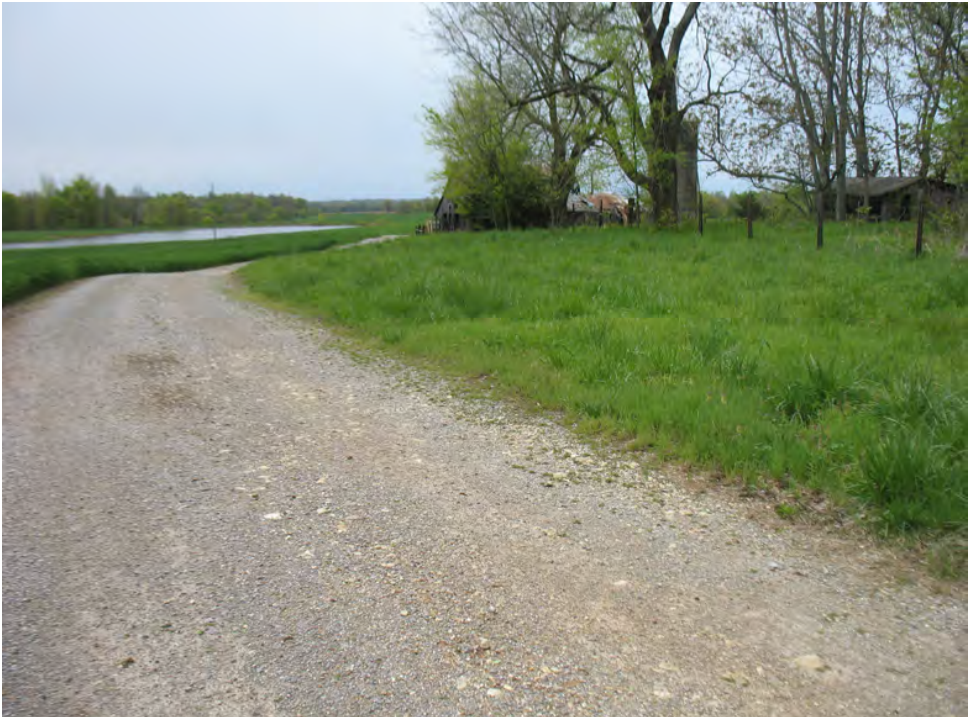
- > No hazardous materials, staining, stressed vegetation, or other visible signs of a spill were observed at the metal equipment shed and equipment lay down area located on the east side of the Site, south of Crider Spur Road (*Photos 13 and 14*).

<b>Client:</b> Geronimo® Energy		<b>Site Location:</b> Fredonia, Kentucky	
<b>Site Name:</b> Caldwell Solar Site		<b>Project Number:</b> E320201000	
<b>Date:</b> April 13, 2020  <b>Description:</b> Equipment shed located south of Crider Spur Road.		<b>Photo 13</b>

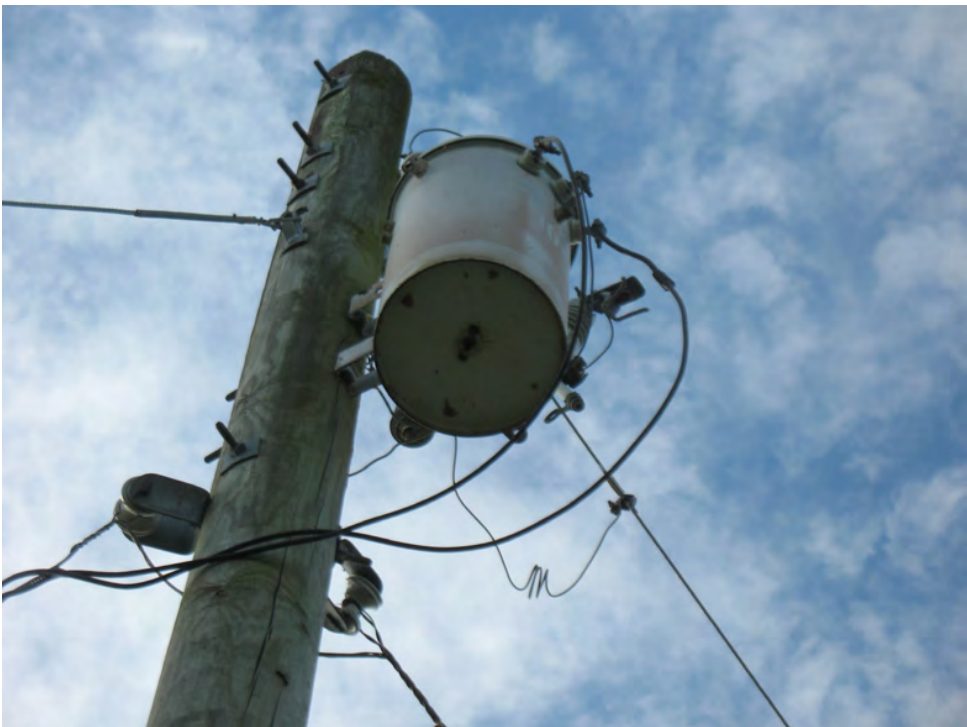
<b>Client:</b> Geronimo® Energy		<b>Site Location:</b> Fredonia, Kentucky	
<b>Site Name:</b> Caldwell Solar Site		<b>Project Number:</b> E320201000	
<b>Date:</b> April 13, 2020  <b>Description:</b> Pole-mounted, Kentucky Utility Company (KU) electrical transformer adjacent to pond and equipment shed located south of Crider Spur Road.		<b>Photo 15</b>

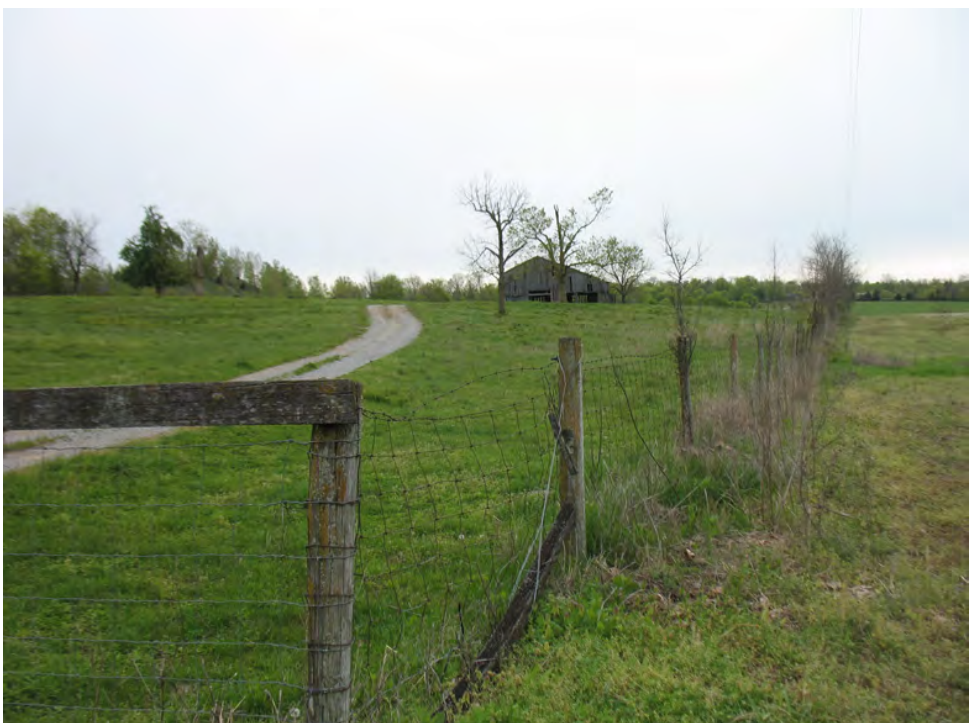
- > No staining, stressed vegetation, or other visible signs of a petroleum or hazardous material spill were observed at an abandoned barn at Bugg Farms on the west side of the Site, north of Fredonia Quarry Road (*Photos 22 and 23*).

<b>Date:</b> April 14, 2020  <b>Description:</b> Grass field used for cattle grazing on Bugg Farms at northwest corner of Solar Site (facing north). Dilapidated barn in background. Stone and brick old house ruins are in tree area to left (see Photo 25).		<b>Photo 22</b>

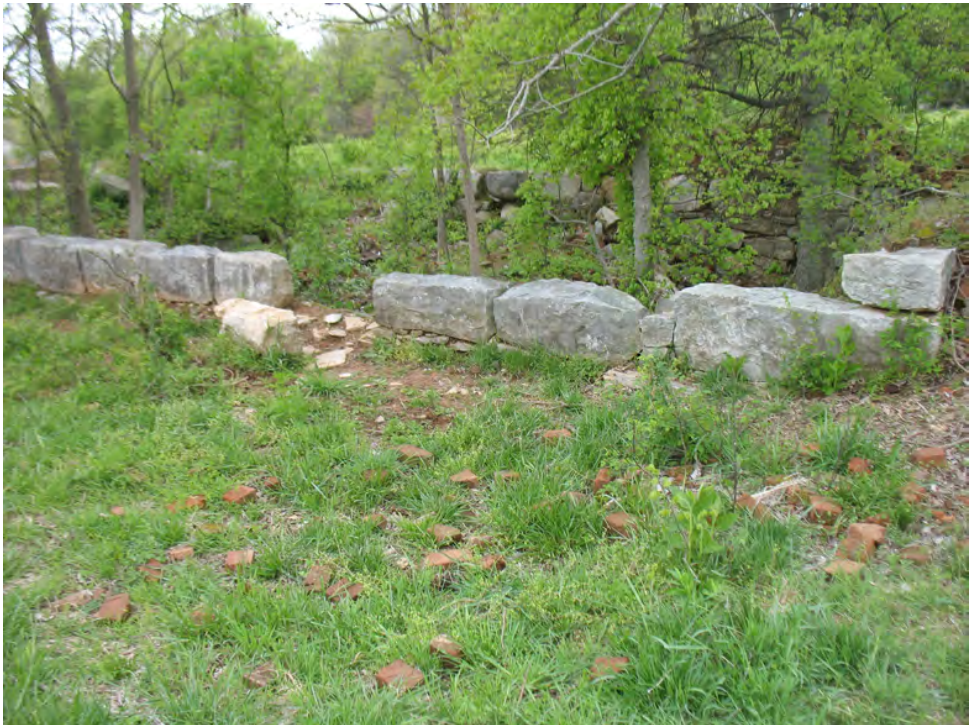
- > Overgrown stone, concrete, and brick remains of a former house were observed at Bugg Farms, north of the gravel extension of Fredonia Quarry Road. No staining or stressed vegetation was observed. (*Photo 25*).

<b>Client:</b> Geronimo® Energy		<b>Site Location:</b> Fredonia, Kentucky	
<b>Site Name:</b> Caldwell Solar Site		<b>Project Number:</b> E320201000	
<b>Date:</b> April 14, 2020  <b>Description:</b> Stone, brick, and concrete ruins of old house at northwest corner of Solar Site.		<b>Photo 25</b>

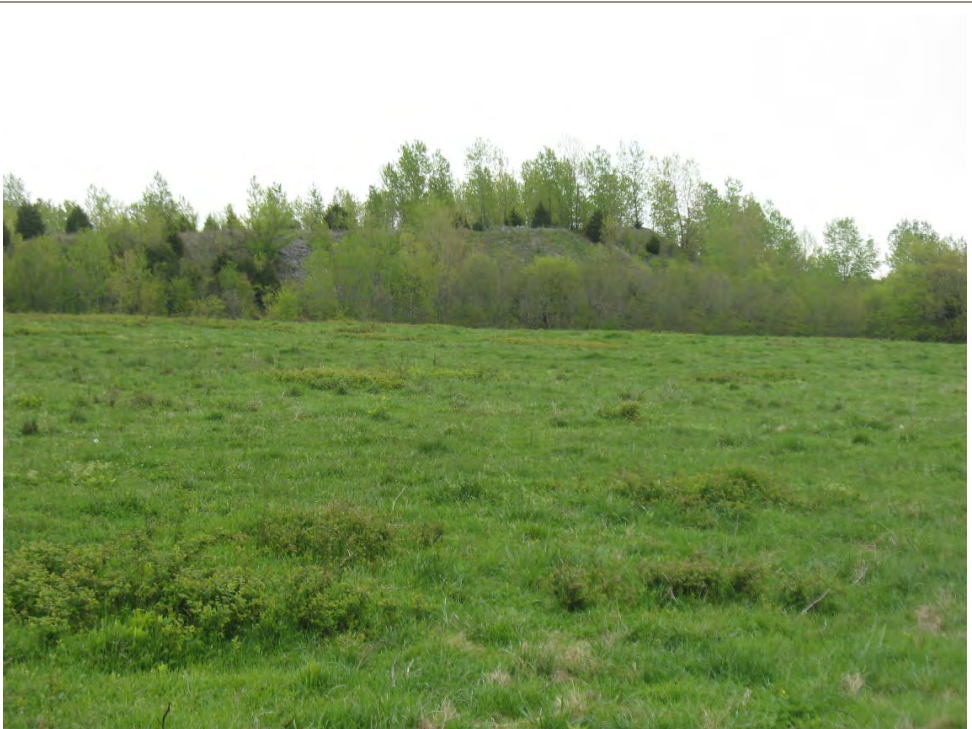
- > Overgrown limestone stockpiles were observed at the adjacent Fredonia Quarry along the northwest Site boundary (*Photo 26*). No staining or stressed vegetation was observed.

<b>Date:</b> April 14, 2020  <b>Description:</b> Partly overgrown stone stockpile at the Fredonia Quarry is adjacent to pasture, woods, and crop fields on the northwest side of the Solar Site (facing northeast)		<b>Photo 26</b>

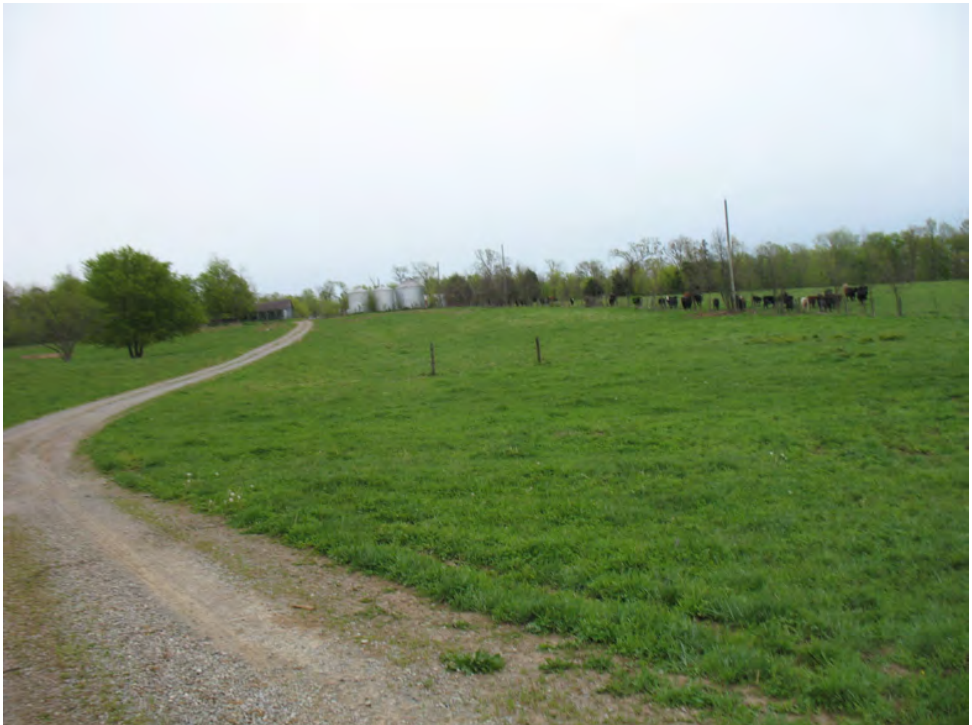
<b>Date:</b> April 14, 2020  <b>Description:</b> Silos and water supply well pump shed at Bugg Farms (facing southwest). Empty, rusted 55-gallon drum, empty five-gallon engine oil bucket, fire hydrant, and junk surround the small pump shed.		<b>Photo 28</b>

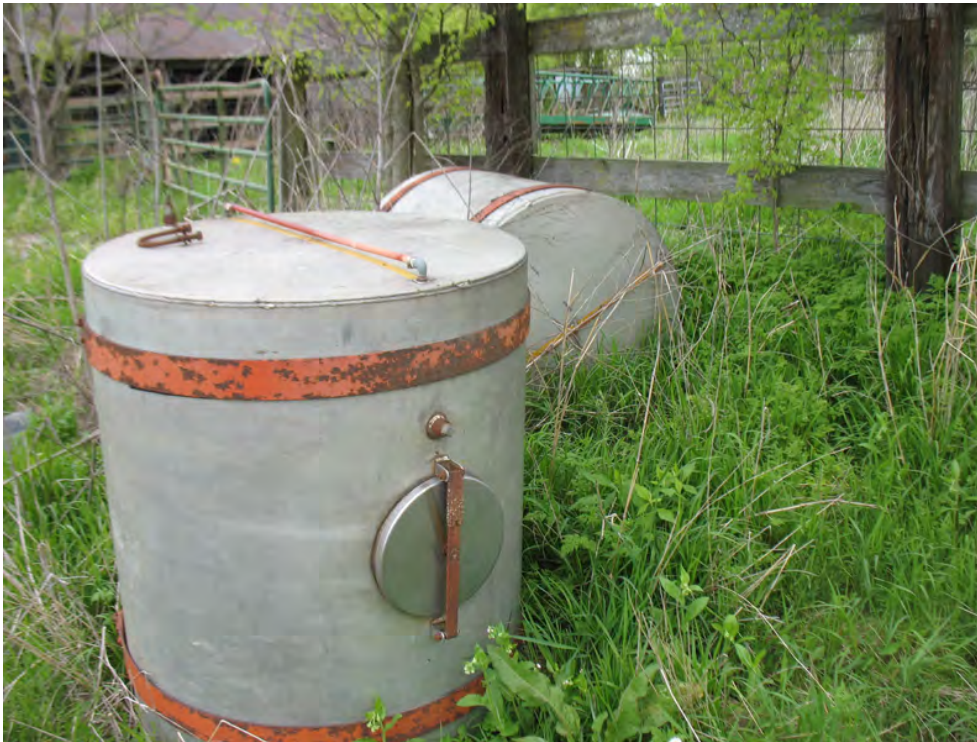
<b>Client:</b> Geronimo® Energy		<b>Site Location:</b> Fredonia, Kentucky	
<b>Site Name:</b> Caldwell Solar Site		<b>Project Number:</b> E320201000	
<b>Date:</b> April 14, 2020  <b>Description:</b> Two empty, portable, steel ASTs for agricultural chemicals near cattle barn at Bugg Farms.		<b>Photo 29</b>

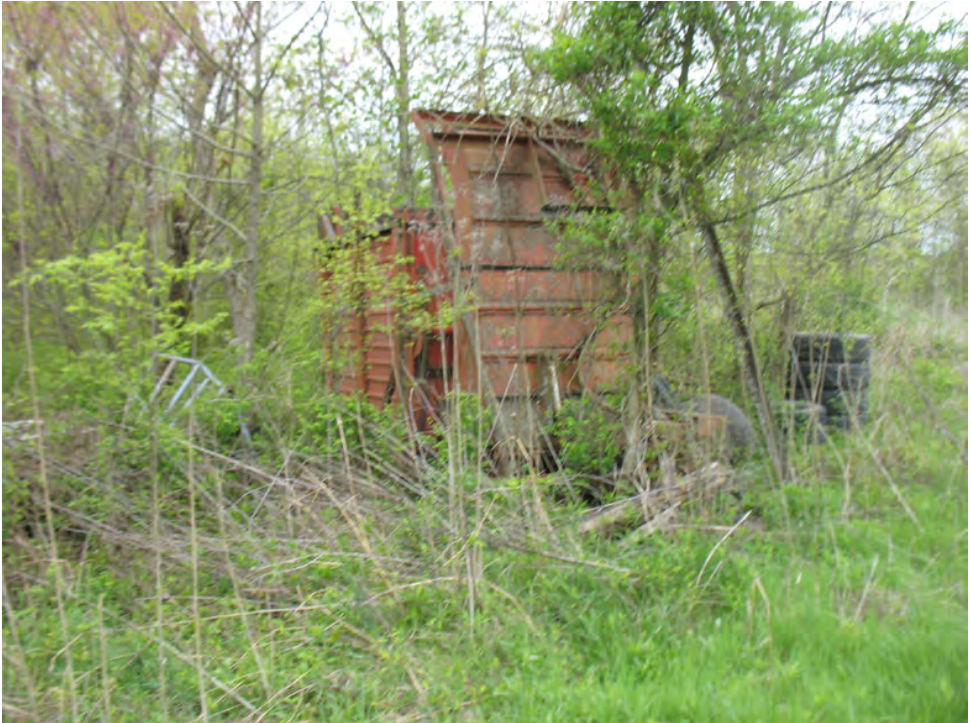
A photograph showing a large, rusted metal structure, possibly a piece of heavy machinery or a shed, partially obscured by dense green foliage and trees. The structure is situated in a wooded area with tall grass in the foreground.	
<b>Date:</b> April 14, 2020  <b>Description:</b> Antique farm implements in woods located east of equipment garage at Bugg Farms.		<b>Photo 32</b>

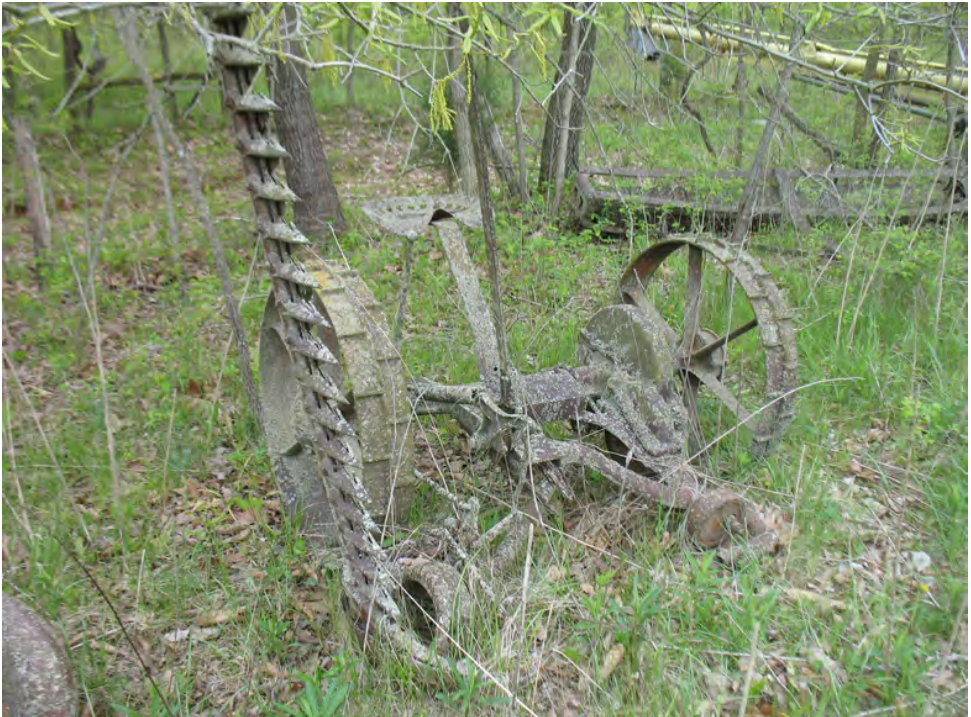
A photograph showing various antique farm implements, including a large, rusted metal wheel and a chain-link structure, lying on the ground in a wooded area. The implements are surrounded by green grass and trees.

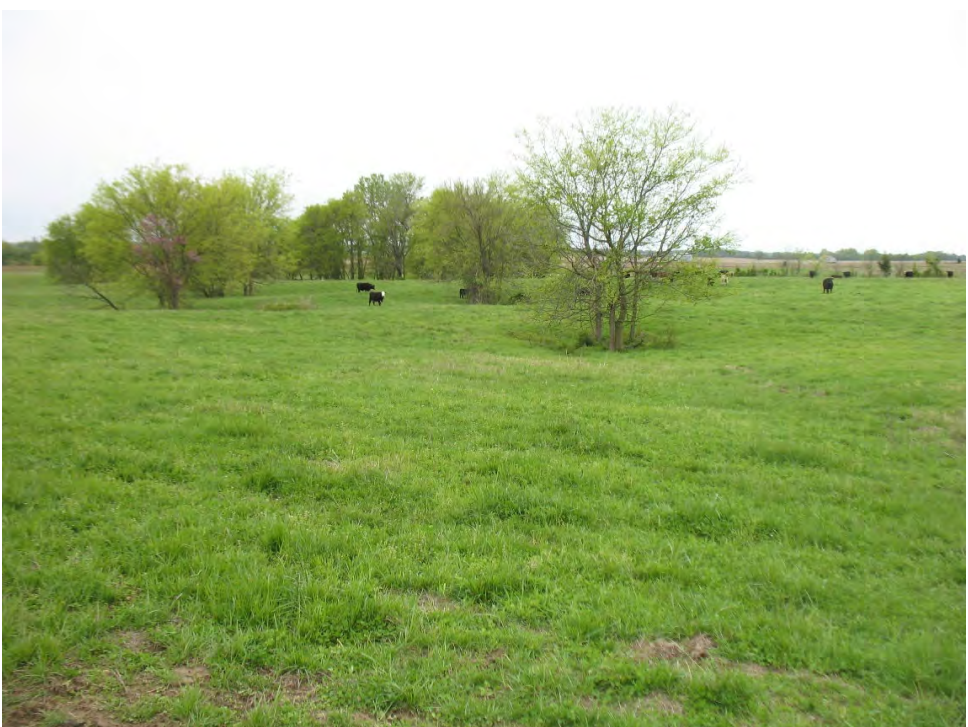
<b>Date:</b> April 14, 2020  <b>Description:</b> Pasture located south of wooded area at Bugg Farms. Tree clusters appear to be in sinkhole depressions.		<b>Photo 34</b>

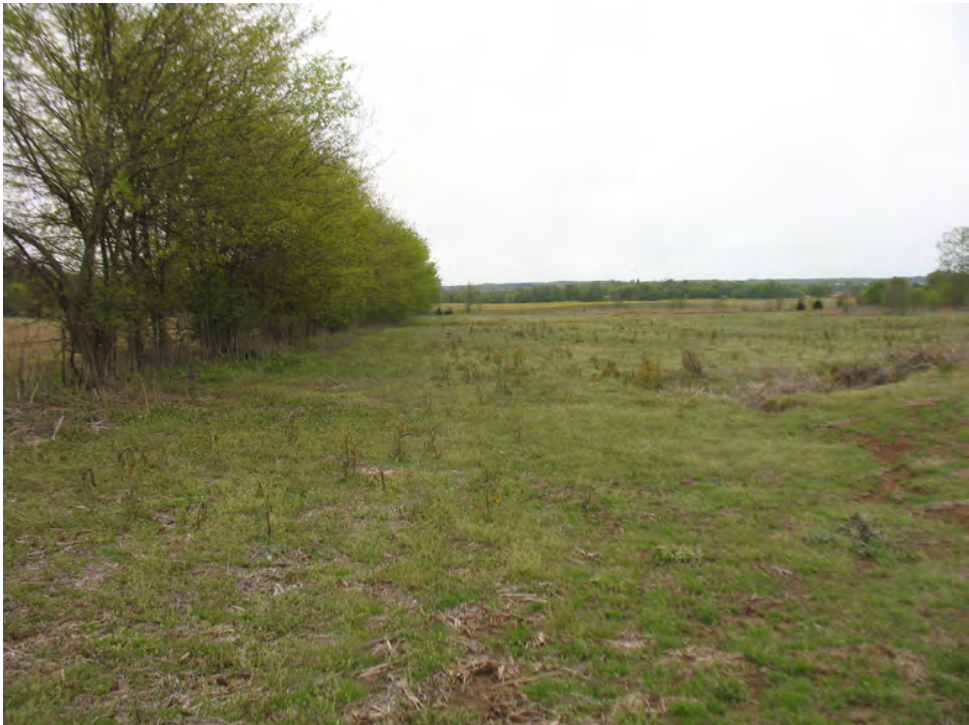
<b>Client:</b> Geronimo® Energy		<b>Site Location:</b> Fredonia, Kentucky	
<b>Site Name:</b> Caldwell Solar Site		<b>Project Number:</b> E320201000	
<b>Date:</b> April 14, 2020  <b>Description:</b> Idle field located southeast of woods at Bugg Farms (facing southeast). Small sinkhole appears to be located on the right side of the photo.		<b>Photo 35</b>
