**ASHWOOD SOLAR SITE
2,045.5-Acre Property,
Lyon and Caldwell Counties, Kentucky
Phase I Environmental Site Assessment**

Project No.: 172658236

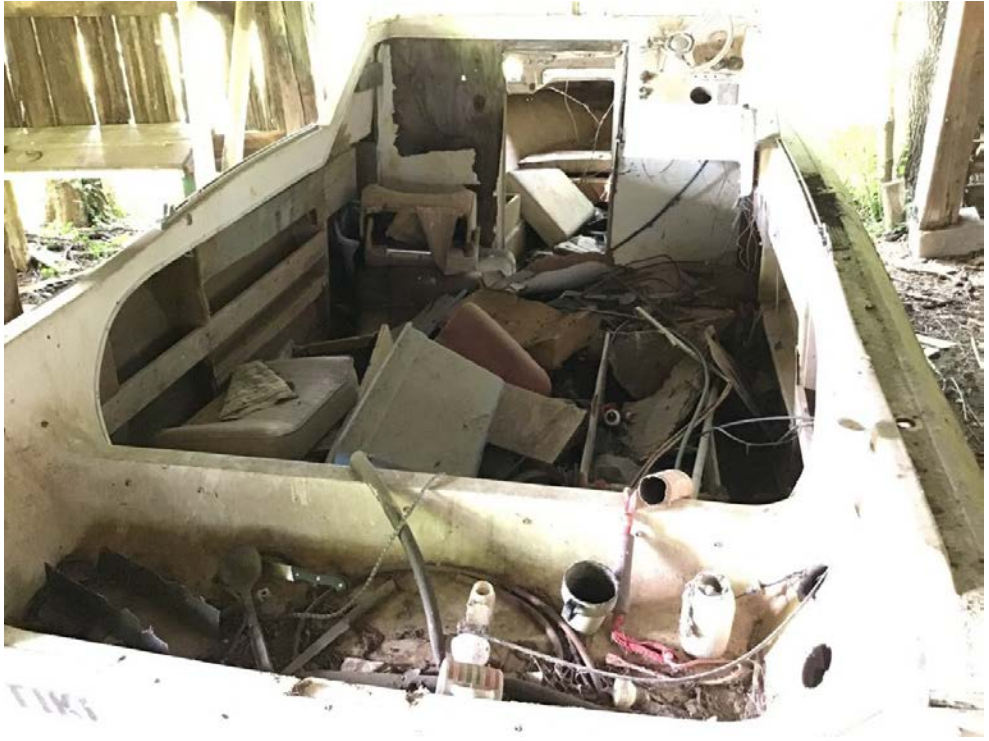
| Photograph ID: 32 | | | |

| Photo Location: Southern portion of Parcel 38-20 | | | |

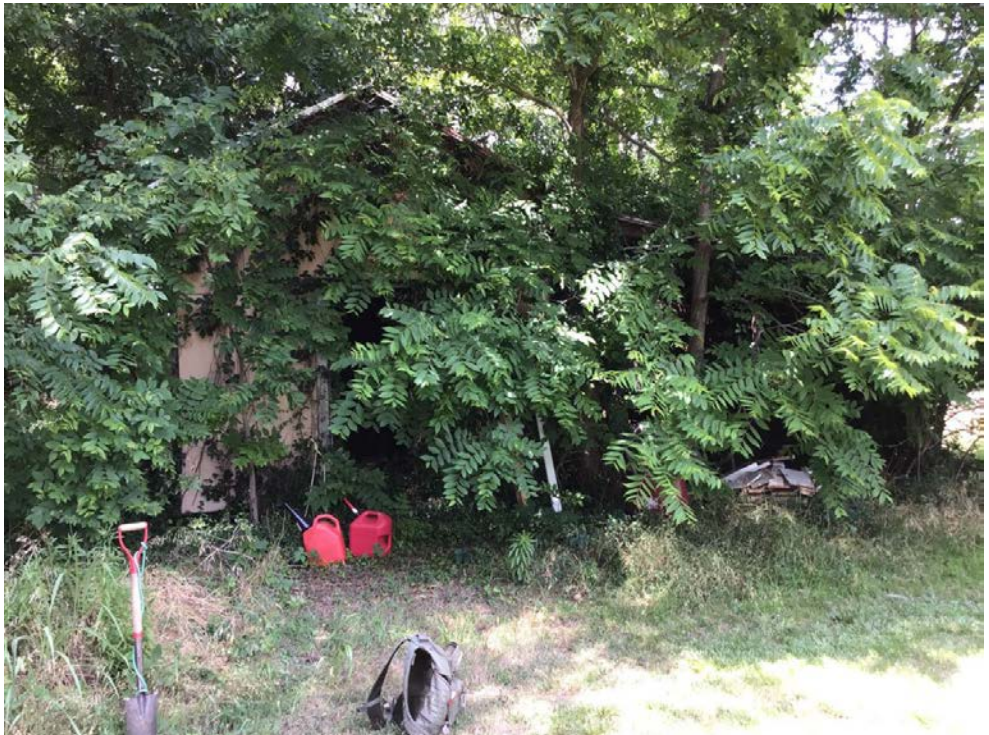
| Photograph ID: 58 | |

| Photo Location: Central portion of Parcel 38-20 | |

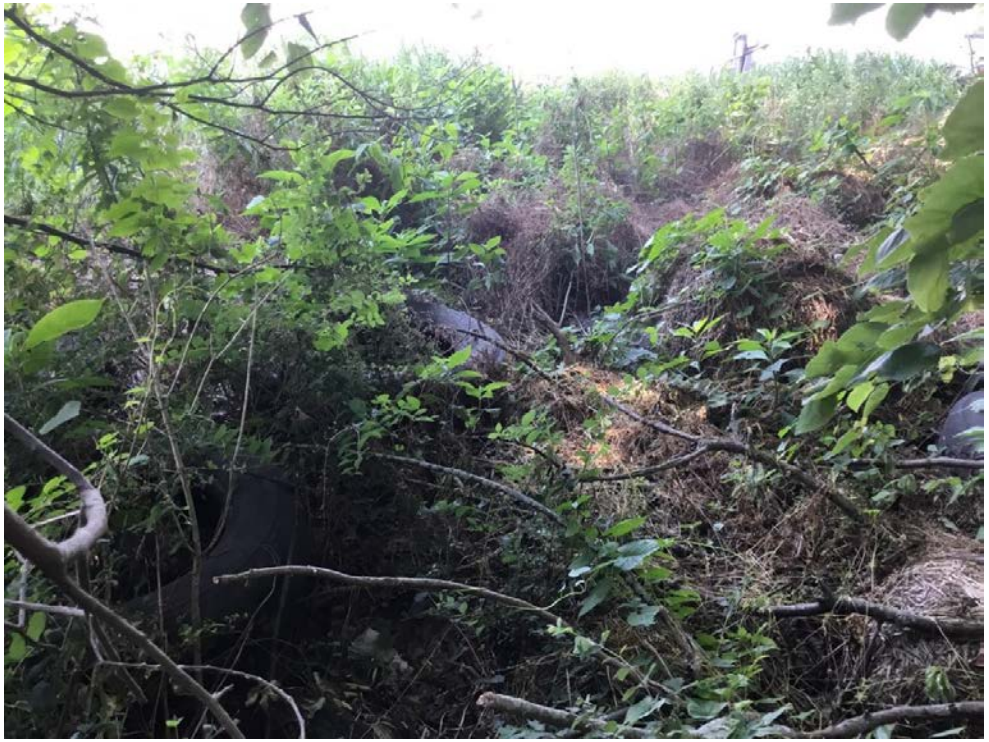
| <p>Photograph ID: 98</p> | |

| <p>Photo Location: Northwestern portion of Parcel 49-8</p> | |

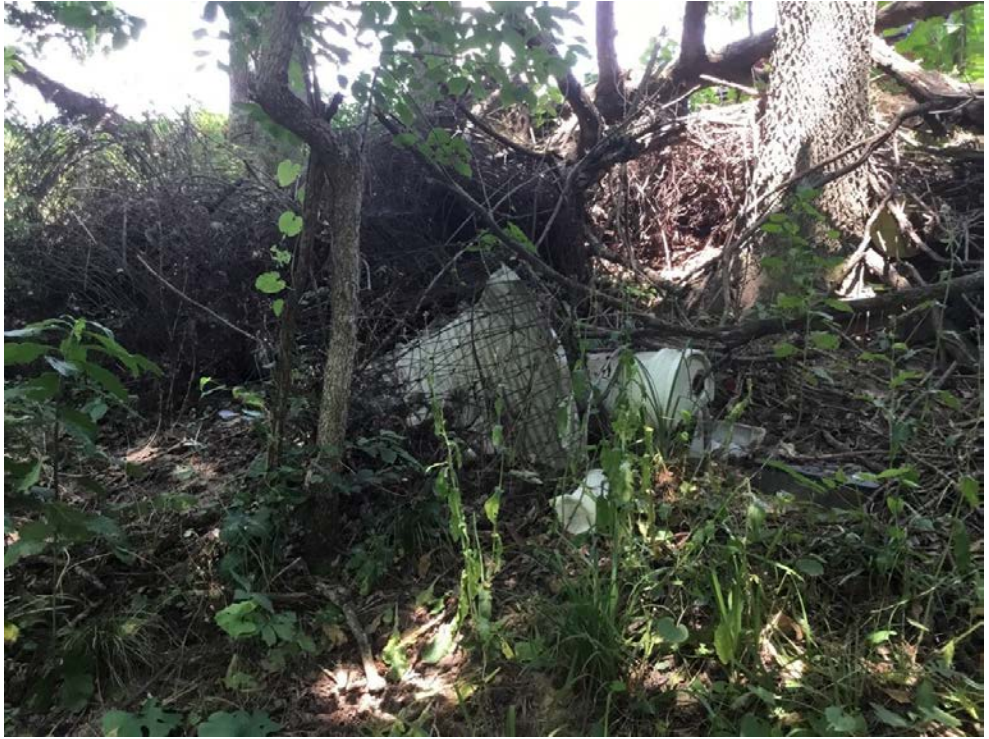
| Photograph ID: 100 | | | |

| Photo Location: Northwestern portion of Parcel 49-8 | | | |

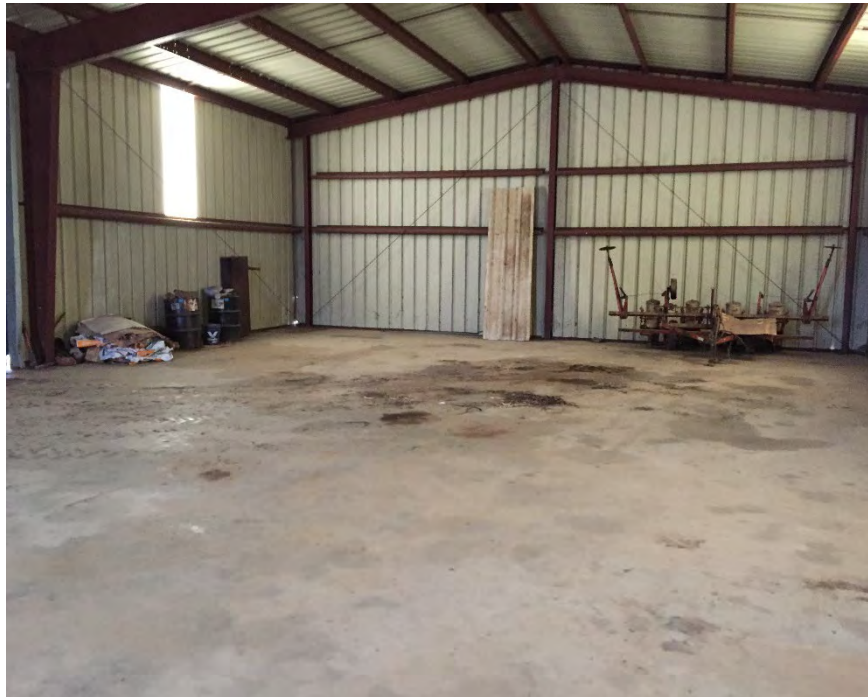
4. Inside the red metal framed barn on Parcel 49-6. The concrete floor was observed to be in good condition with *de minimis* staining observed.

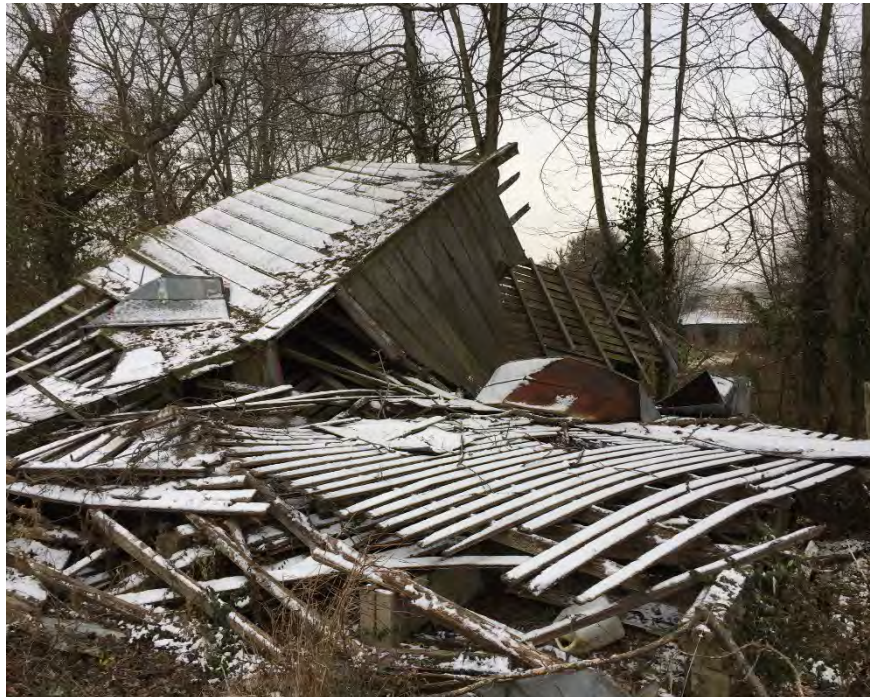
14. A collapsed outbuilding on Parcel 38-20 typical of other collapsed buildings in forested areas throughout the subject site.

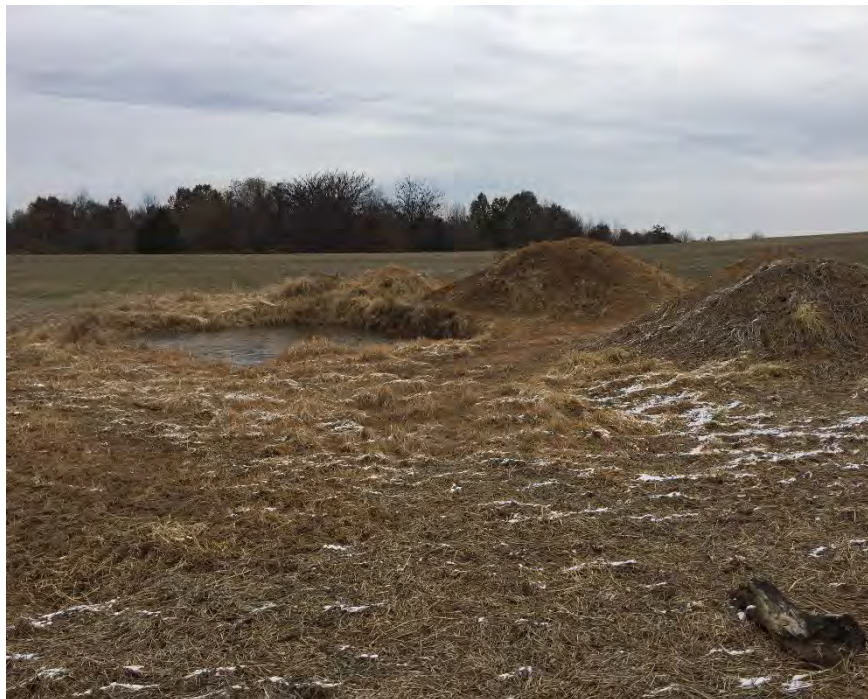
17. Solid waste in a sinkhole on Parcel 39-2. Scrap metal, lumber, shingles and carpet were observed.

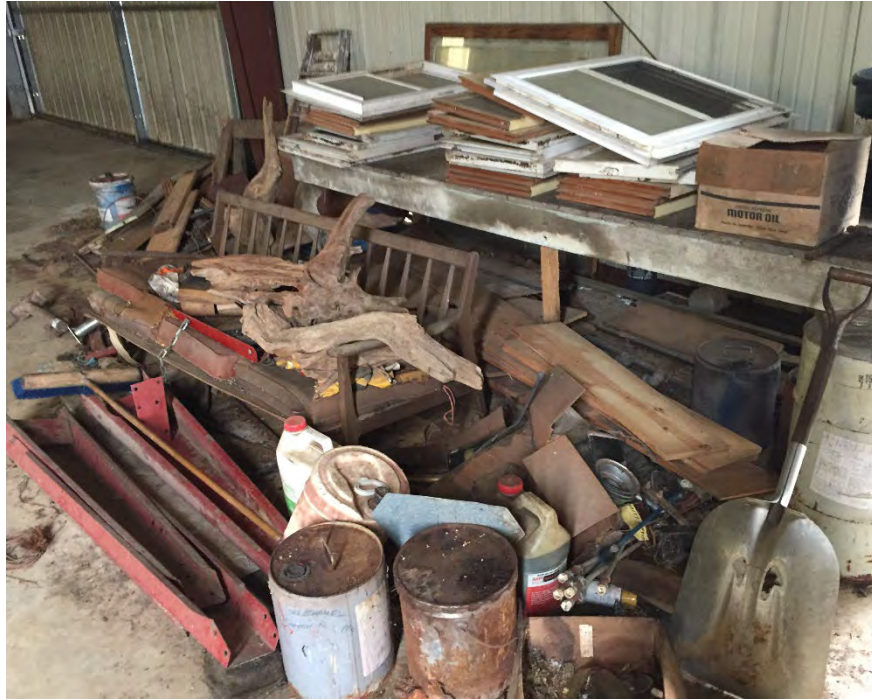
26. Inside the metal frame barn on Parcel 38-14 with an empty oil drum, farm implements, a portable generator, asphalt patch bags and a truck bed fuel tank observed.

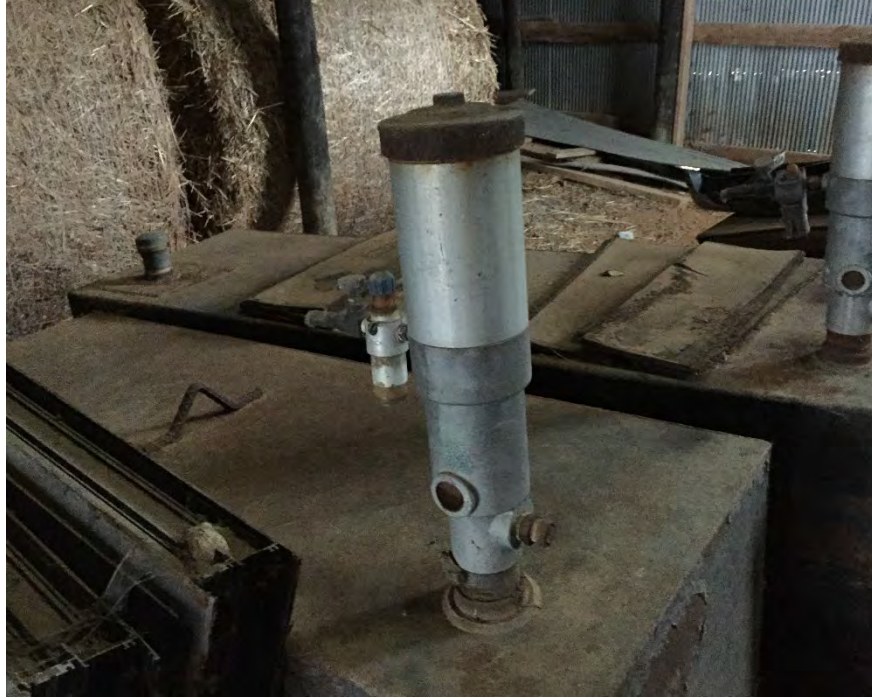
32. Inside the wood framed barn on Parcel 38-15. SMG observed hay bales, lumber, windows, farm implements and parts, a welder, pails of cut nails and two empty fuel tanks
