# **Jurisdictional Waters of the U.S.**

## **Assessment**

Fleming Solar Project  
Fleming County, Kentucky

Jurisdictional Waters of the U.S. Assessment  
Fleming Solar Project

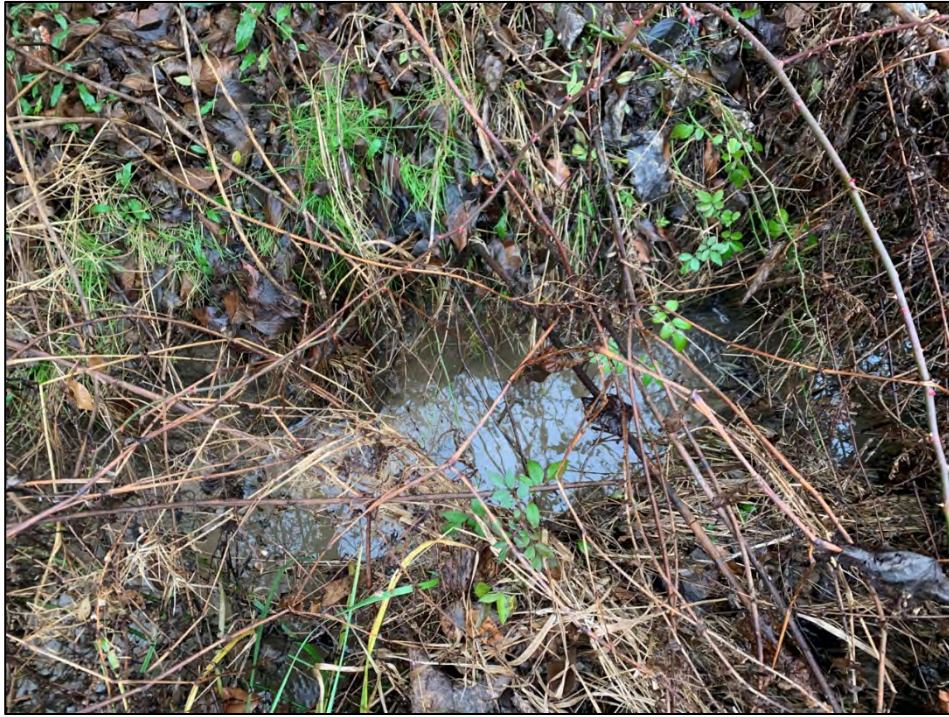
**Photo 1:** Typical view of channel bed with ephemeral and non-contiguous ordinary high-water mark and bed and bank. View of Channel 1E from the southeast portion of the Site.

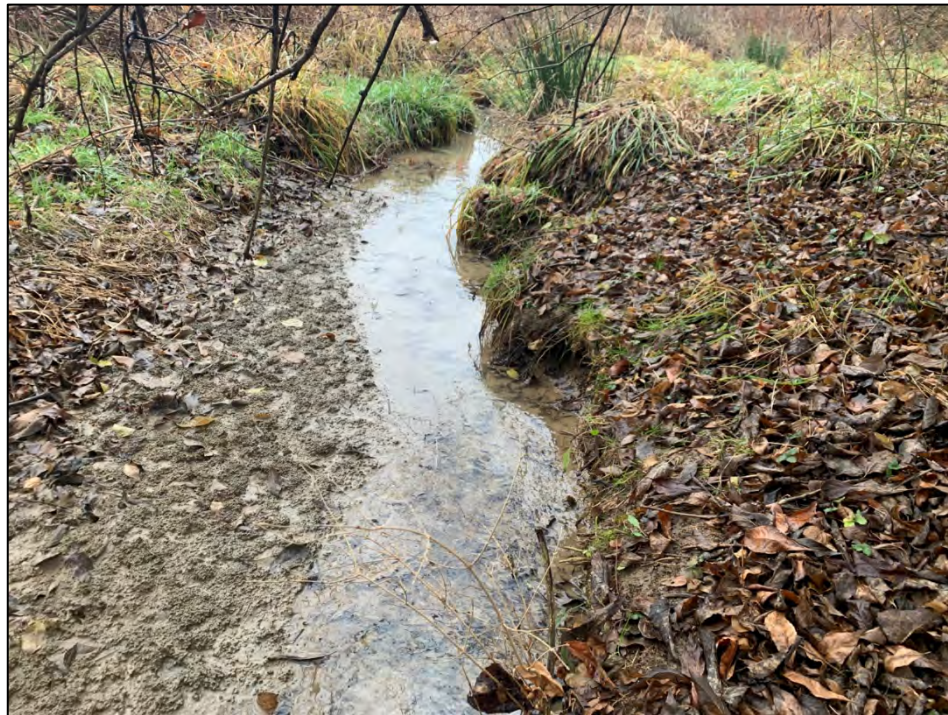
**Photo 2:** Typical view of a channel with intermittent flow and continuous ordinary high-water mark and bed and bank. View from Channel 1, facing south.

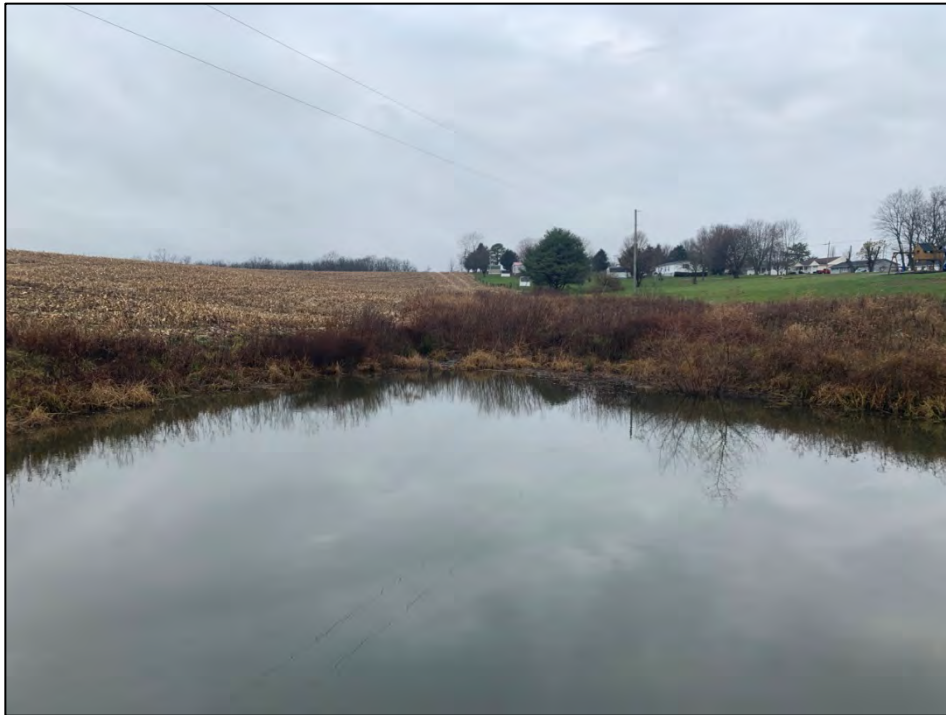
**Photo 3:** Typical view of a constructed pond within the Site. View from Pond 1, facing north.

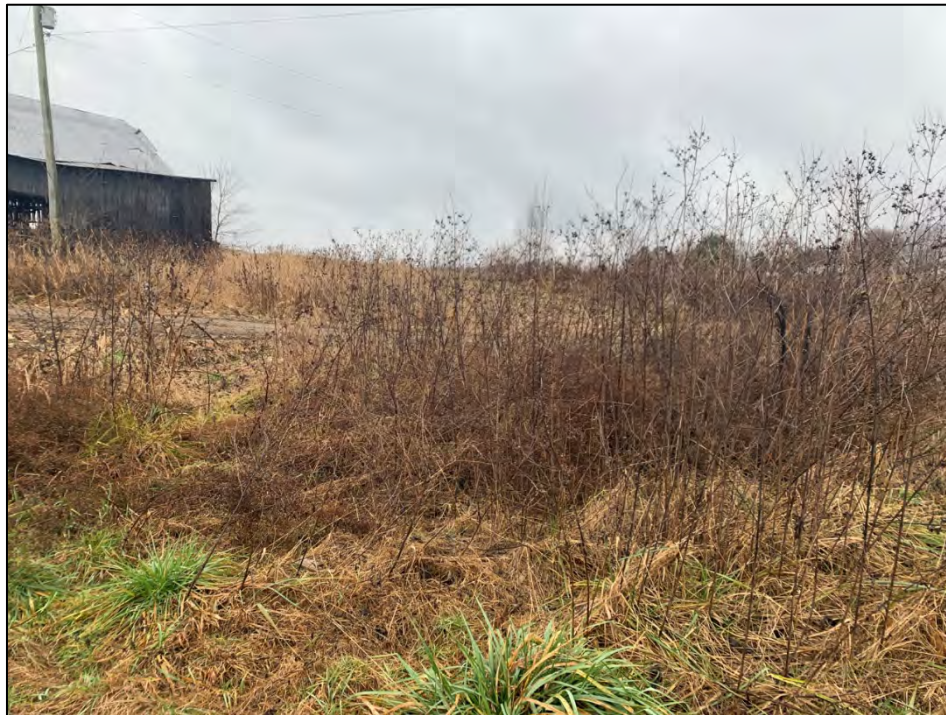
**Photo 4:** View of the upland area below Pond 1 with no overflow outlet. View from DP1-U, facing north.

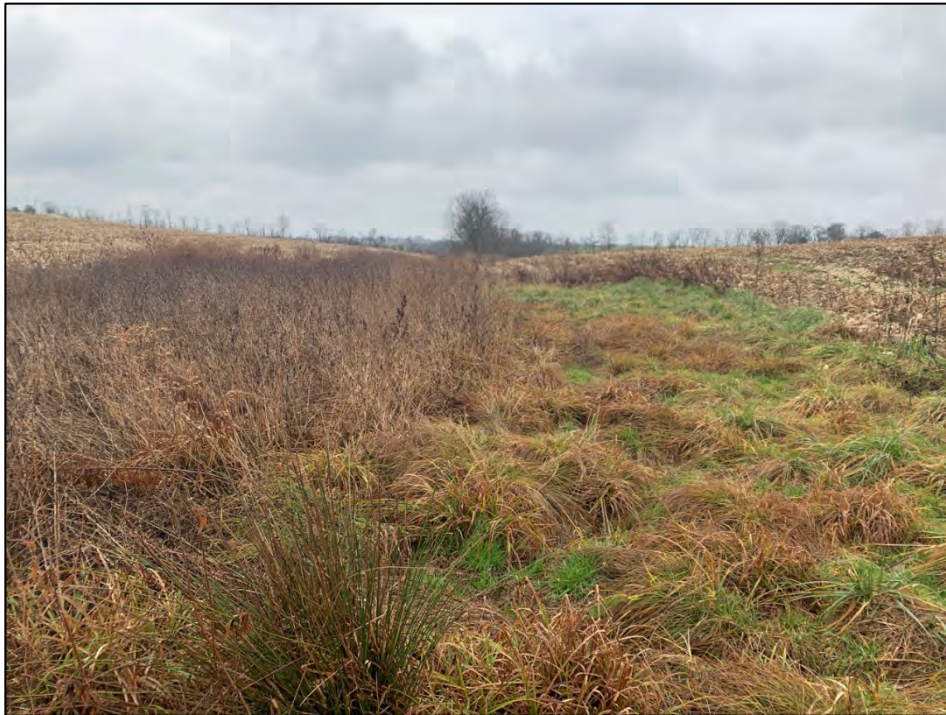
**Photo 5:** View of unconfined linear wetland feature with typical herbaceous vegetation. View of Feature 1 at DP1-W, facing south.

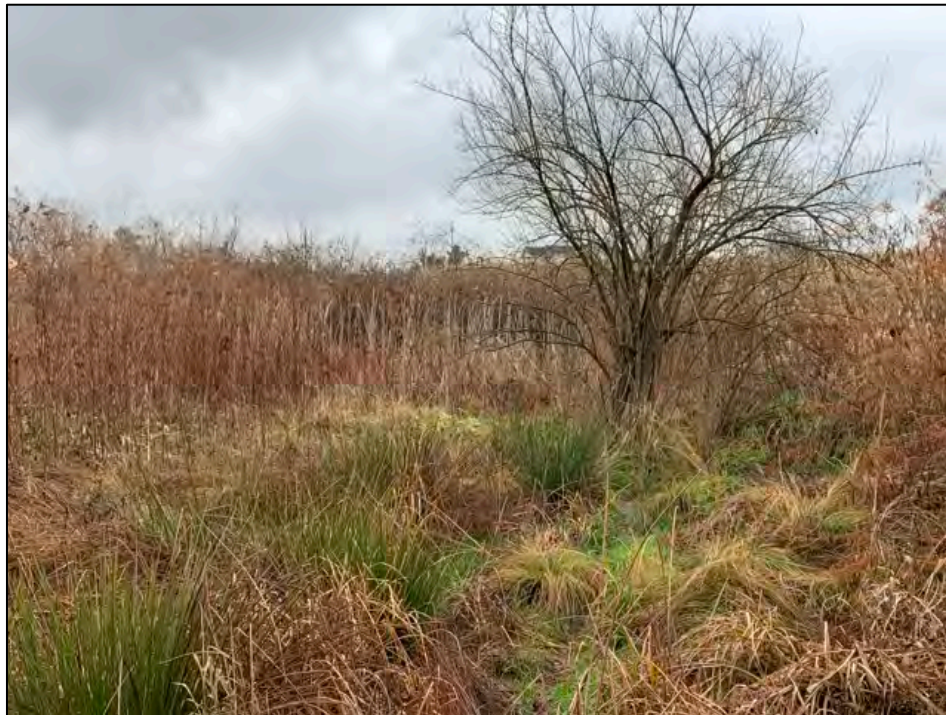
**Photo 6:** View of wetland feature with typical herbaceous and woody vegetation. View of Feature 2 at DP2-W, facing northeast.

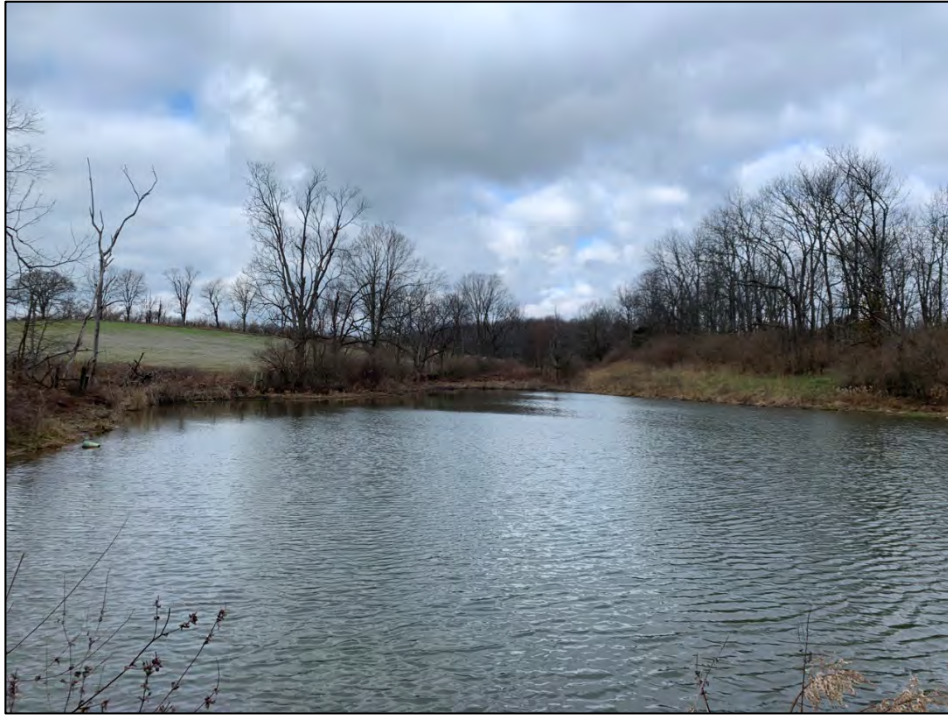
**Photo 7:** View of Pond 2 with forested railroad berm along its east bank. View from the southern portion of Pond 2, facing north.

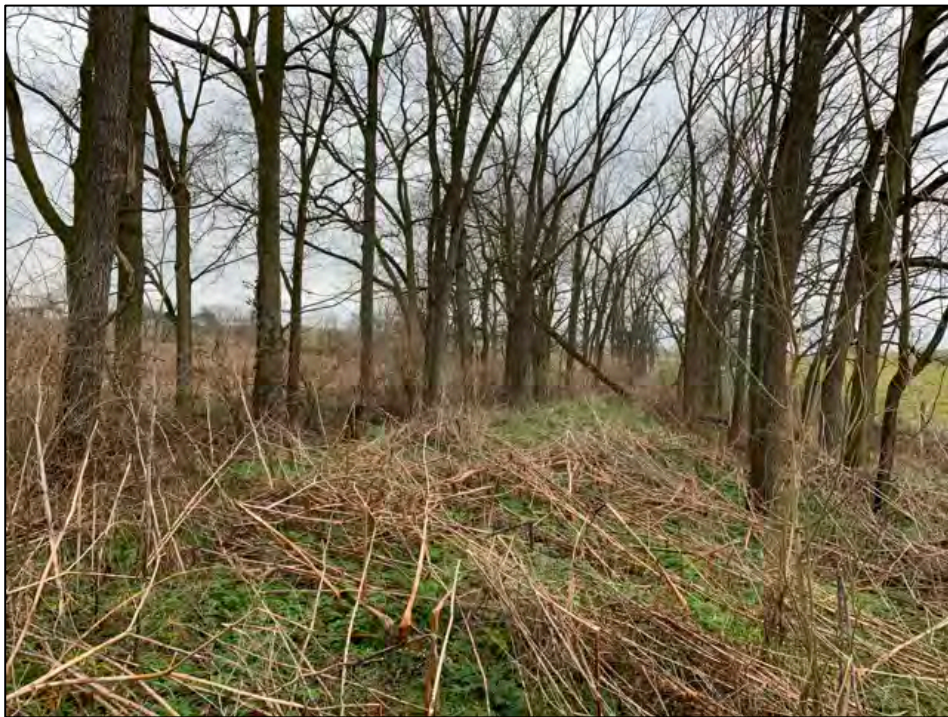
**Photo 8:** View of a now-overgrown railroad berm within the project area, crossing the Site from southeast to northwest. View from east of DP4-U, facing southeast.

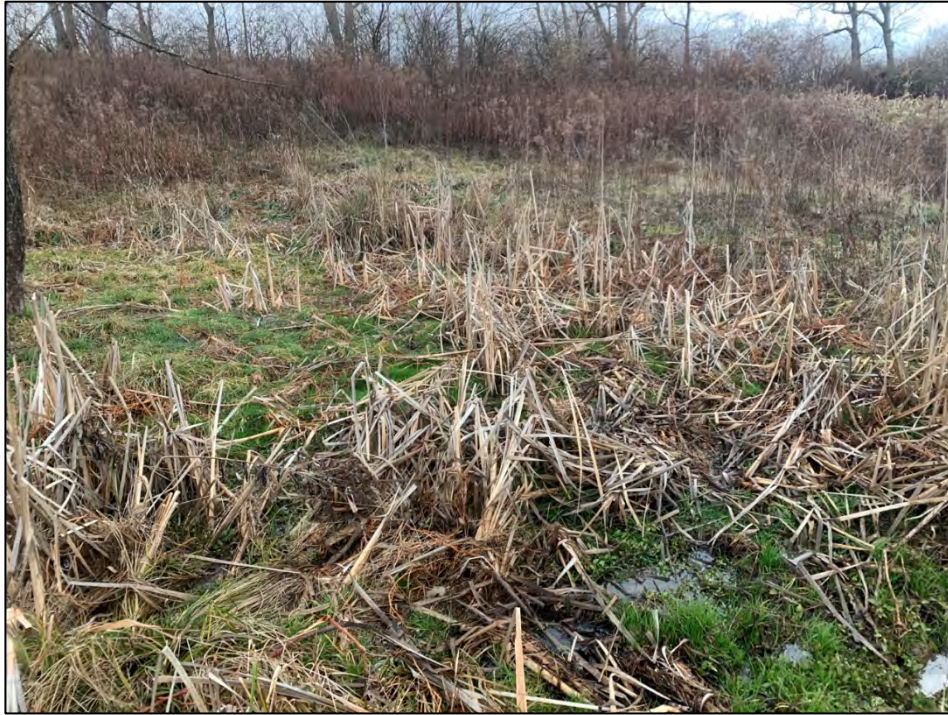
**Photo 9:** View of a constructed wet basin typical of Features 3 and 4. View from DP4-W, facing northeast.

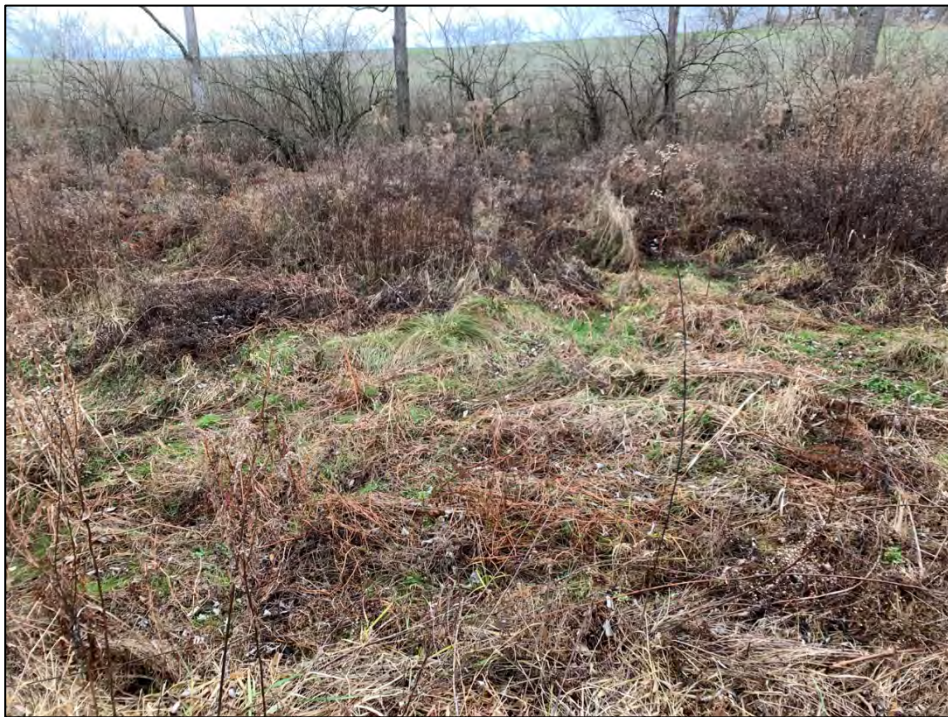
**Photo 10:** View of typical wetland fringe along the banks of a pond. View from the east bank of Feature 6, facing west.

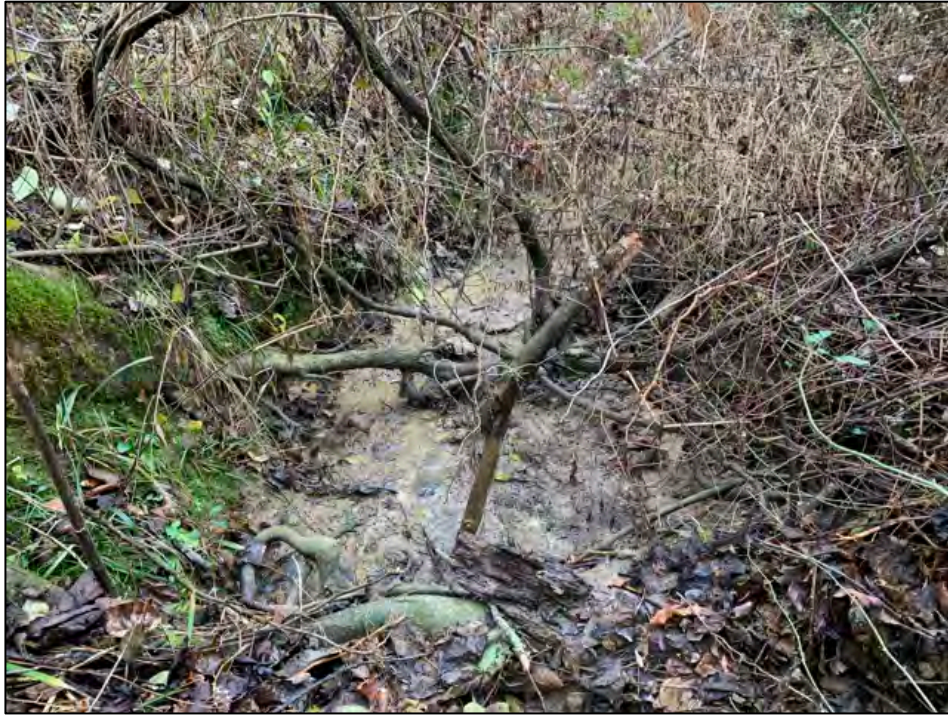
**Photo 11:** View of typical headwater stream with intermittent flow. View from the beginning of Channel 7, facing southwest.

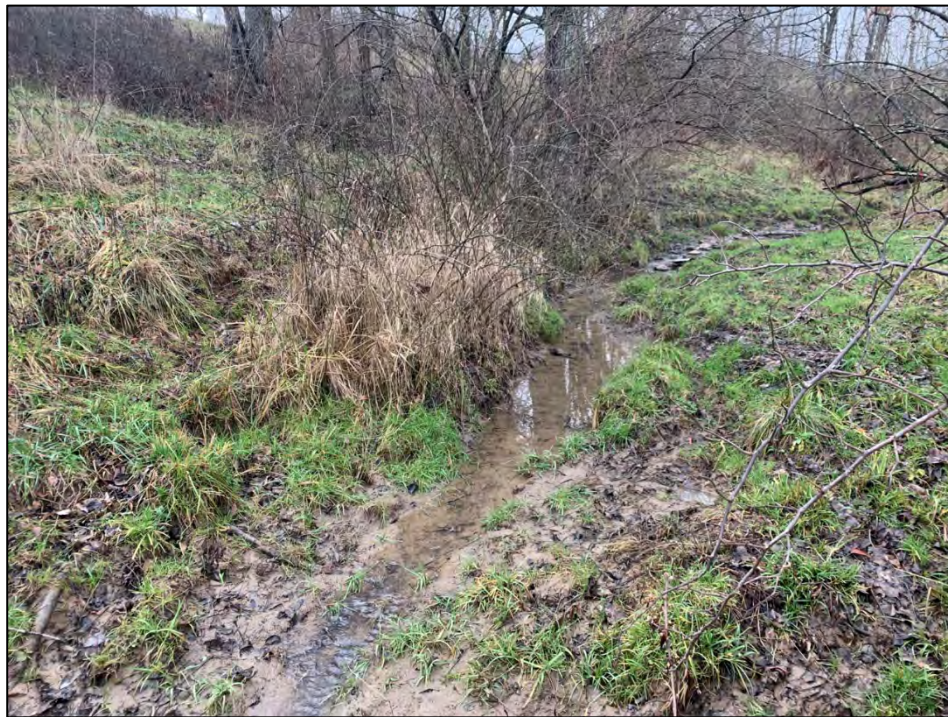
**Photo 12:** View of typical stream with intermittent flow. View of Channel 2 entering the project boundary, facing southwest.

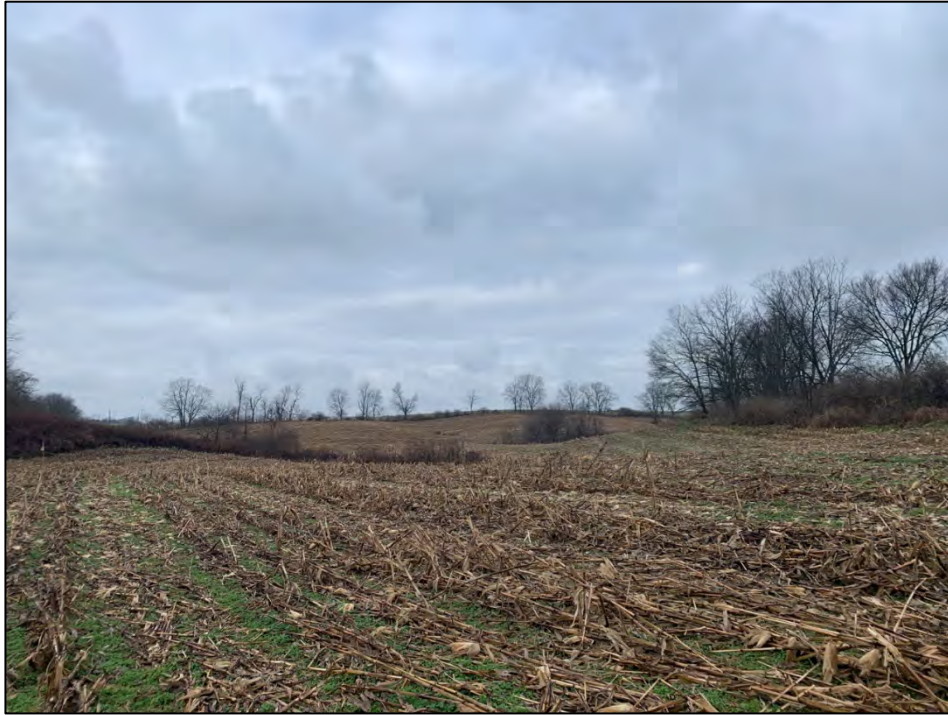
**Photo 13:** Landscape view of riparian buffers ending where Channel 2E and Channel 6 go underground. View from the southeast project boundary, facing northwest.

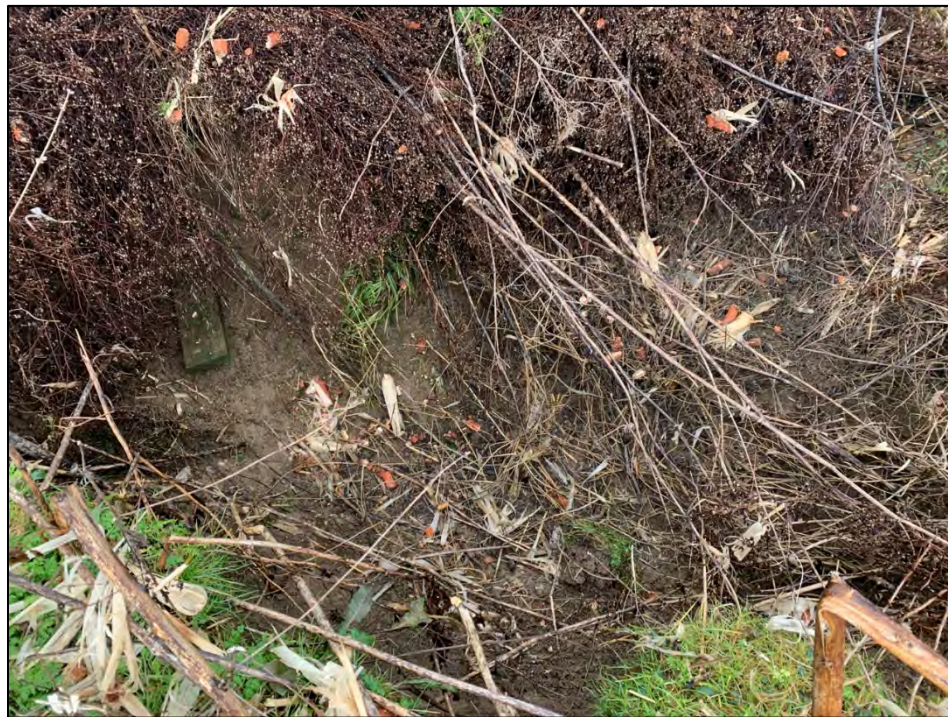
**Photo 14:** View of Channel 2E widening and hole where system goes underground. View from the end of Channel 2E in the southeastern portion of the Site.

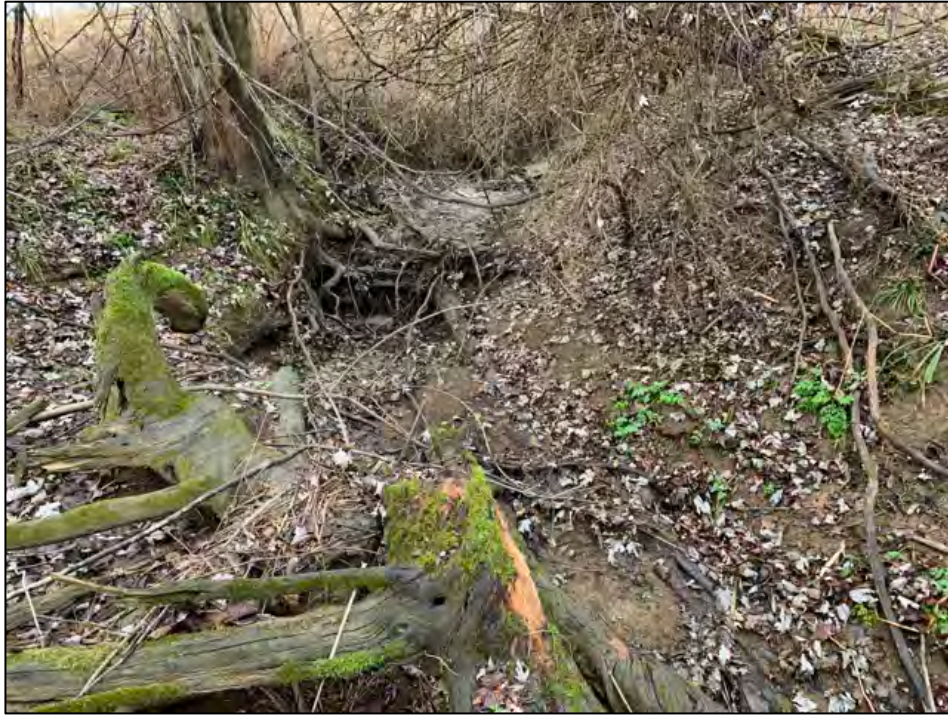
**Photo 15:** View of Channel 6 entering hole in ground. View from the end of Channel 6, facing north.

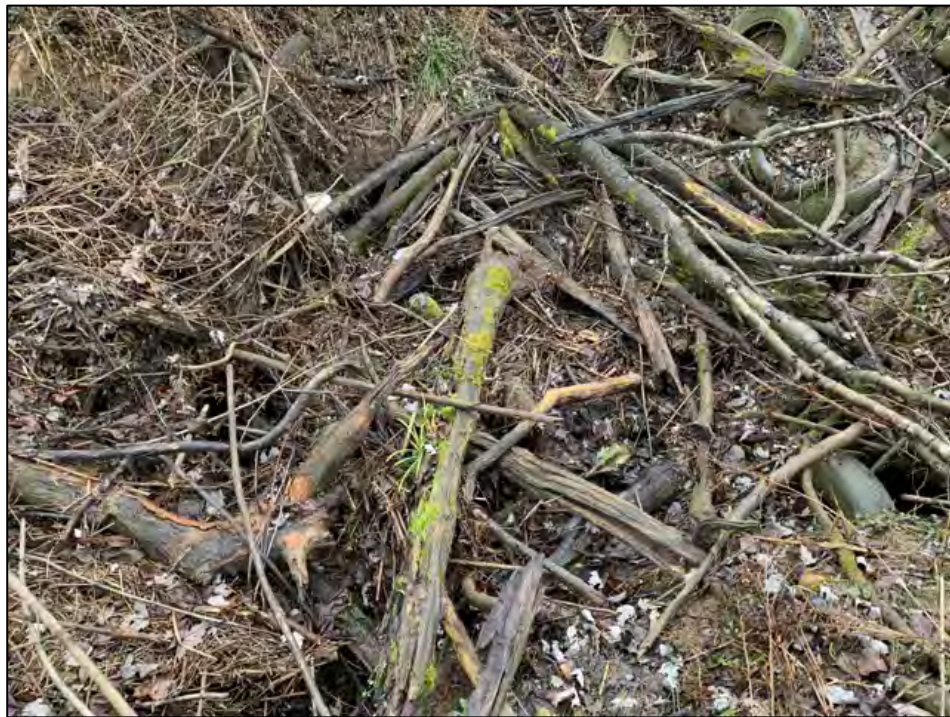
**Photo 16:** View of wooden debris pile covering the hole that Channel 6 flows in too. View from the end of Channel 6, facing south.

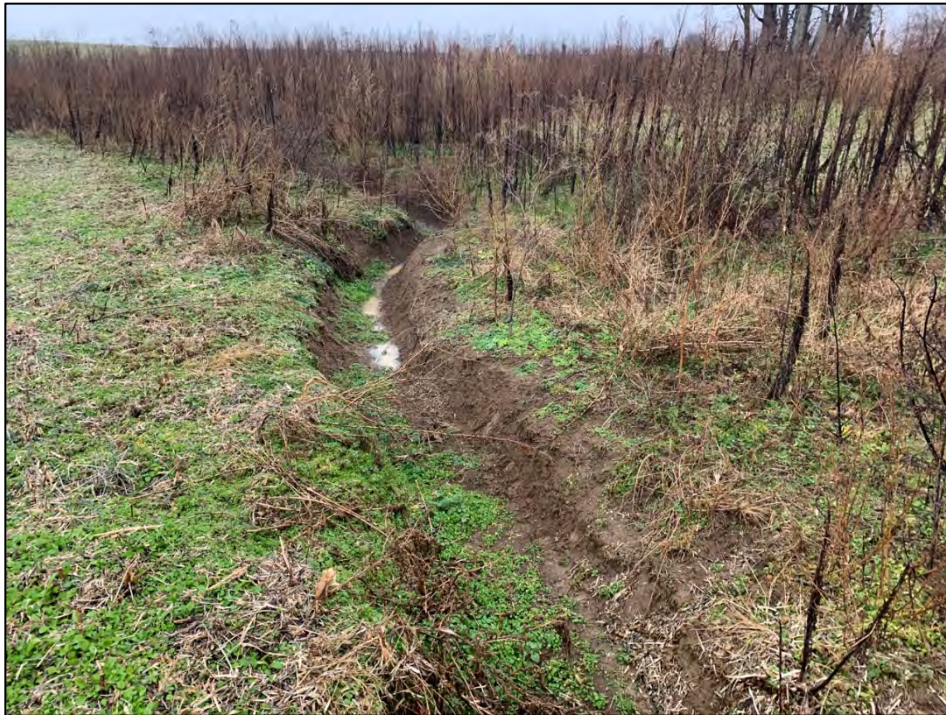
**Photo 17:** View of a typical excavated hillside ditch. View from Channel 4, facing west-northwest.

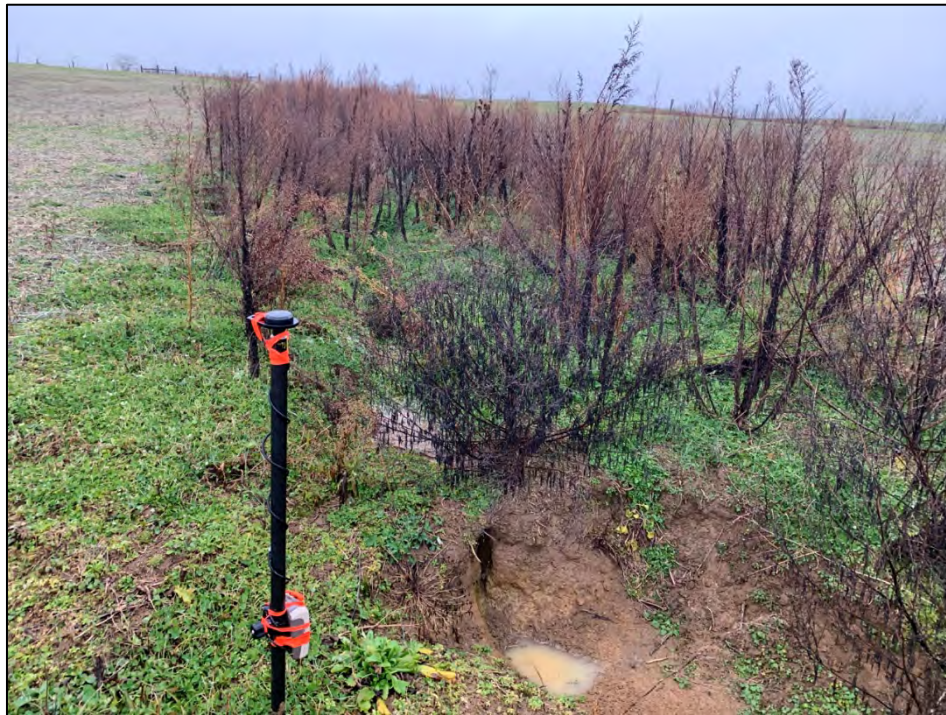
**Photo 18:** View of a typical eroded hillside ditch in a cattle field. View of Channel 5, facing northwest.

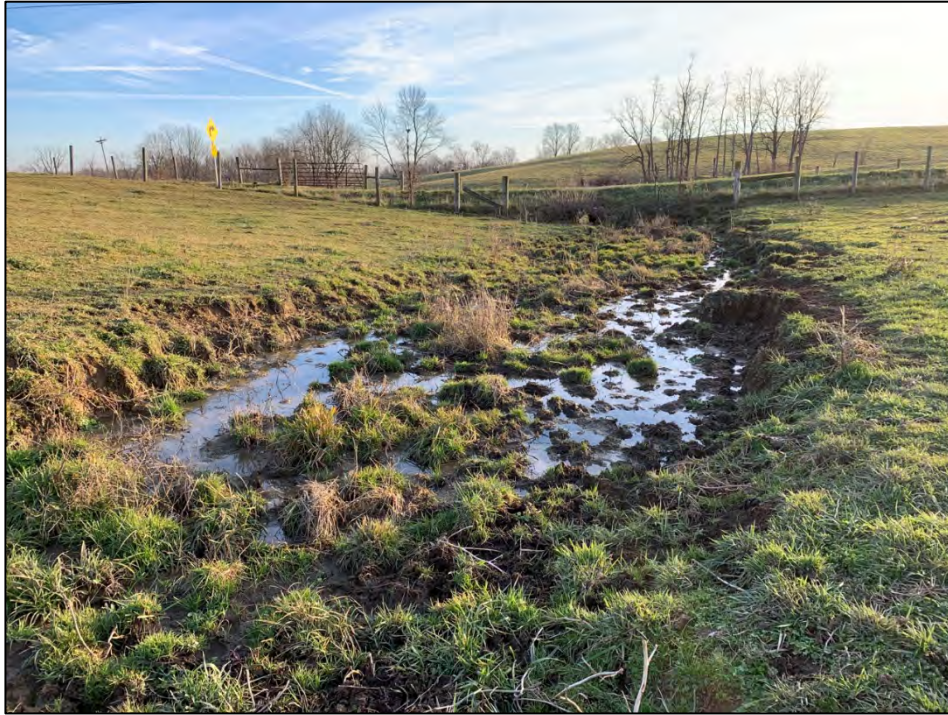
**Photo 19:** View of cattle disturbed feature with wetland characteristics. View from DP12-W, facing south.

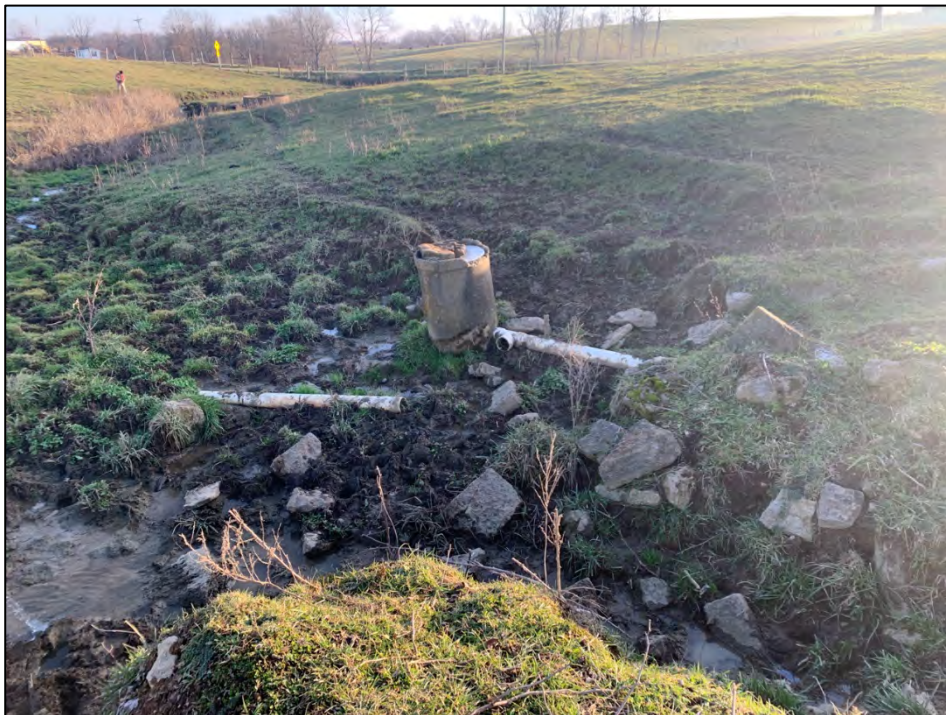
**Photo 20:** View of the well and cistern at the headwater of Feature 12. View from the northern portion of Feature 12, facing south.

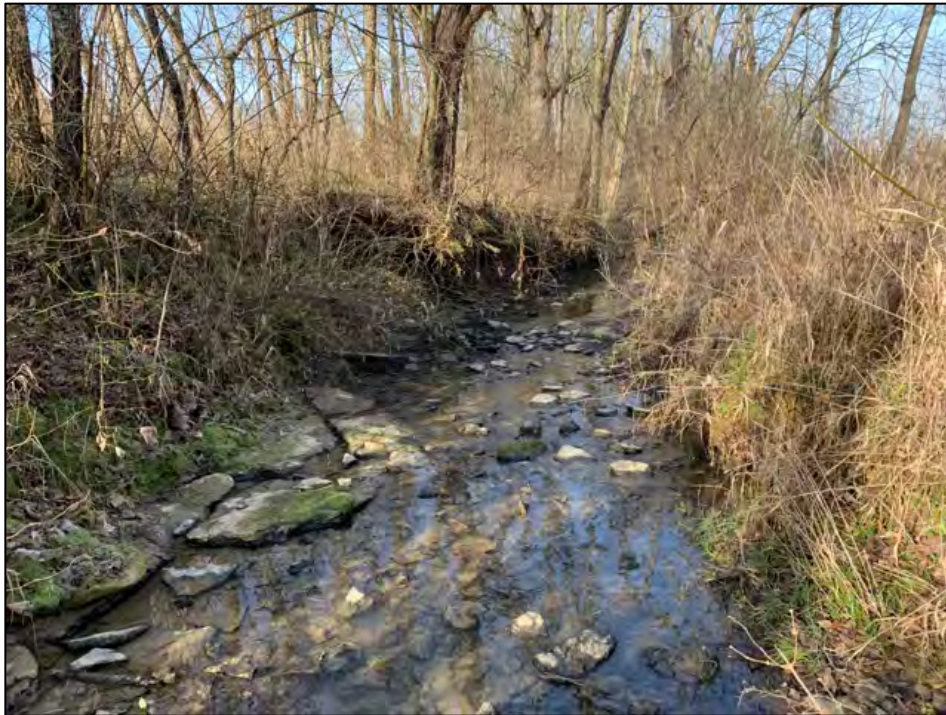
**Photo 21:** Typical view of a second order or greater stream with perennial flow. View of Channel 10 east of its confluence with Channel 12, facing southwest.

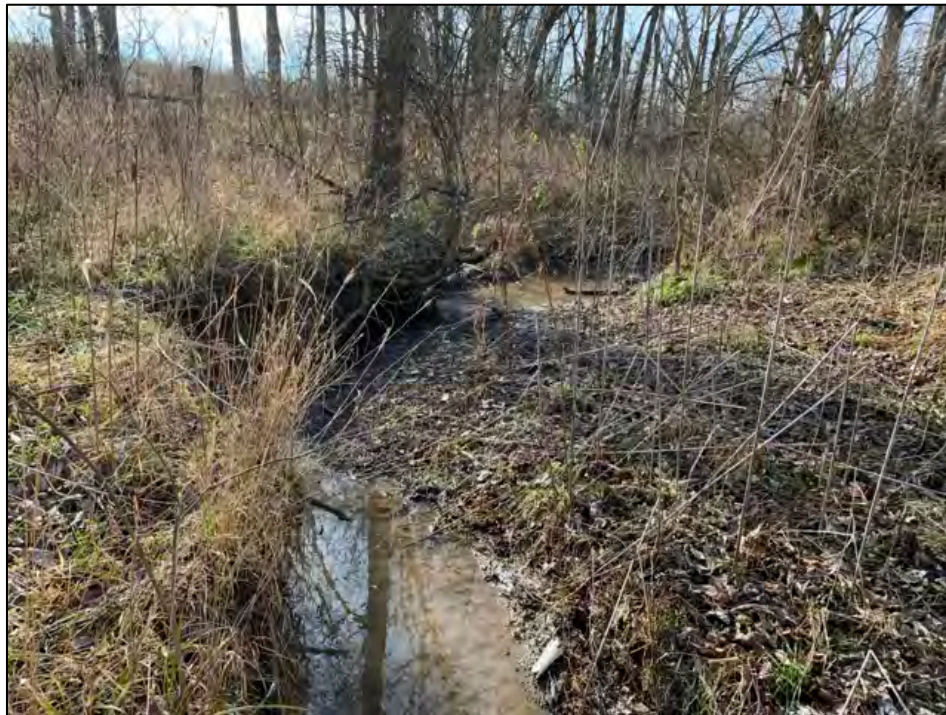
**Photo 22:** Typical view of first order stream with perennial flow. View from the norther portion of Channel 11, facing southwest.

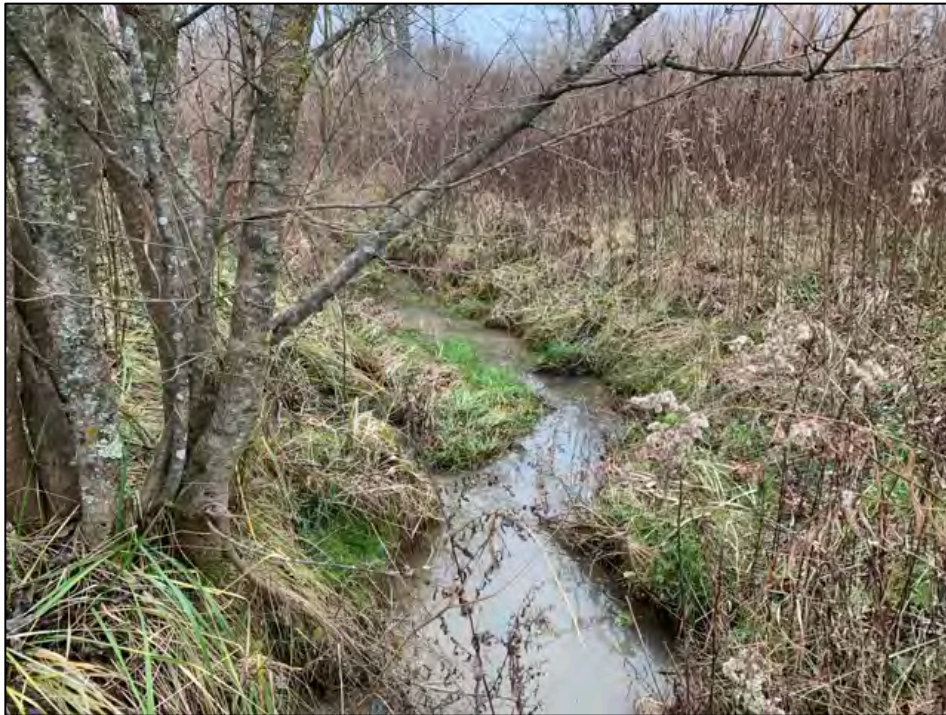
**Photo 23:** Typical view of intermittent stream with forested and herbaceous riparian buffer. View of Channel 12 downstream of its confluence with Channel 14, facing northwest.

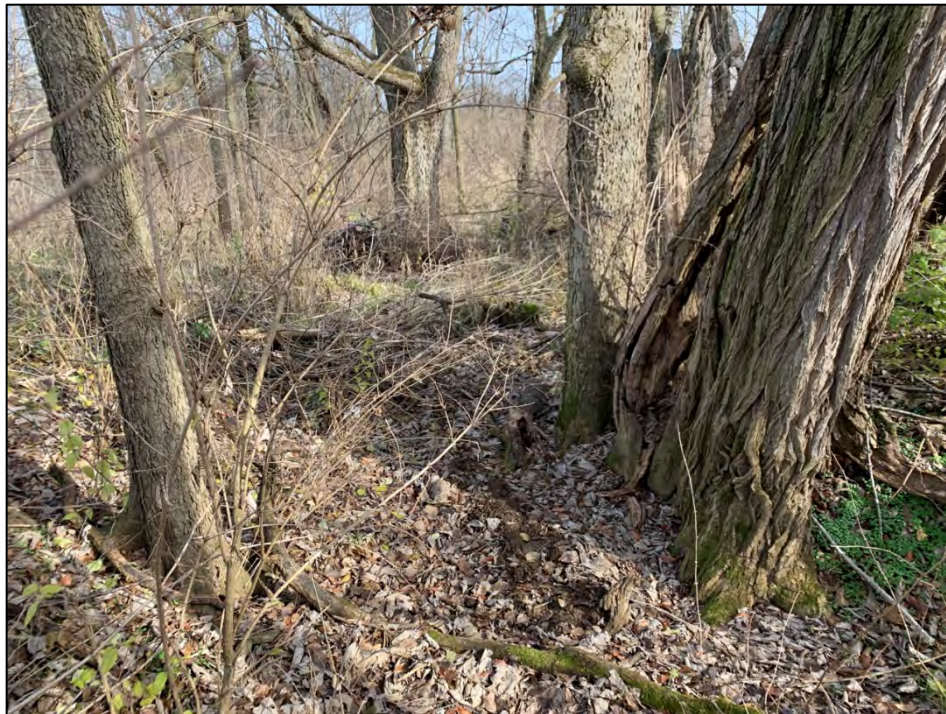
**Photo 24:** View of typical channelized swale along fenced tree line with ephemeral flow. View from the top of Channel 13, facing northwest.

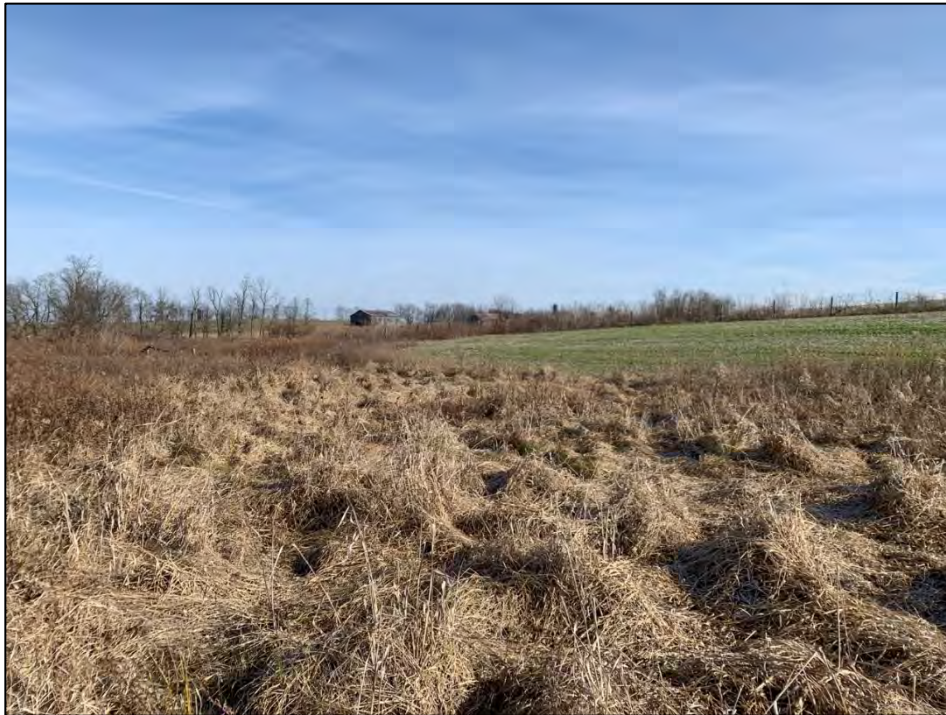
**Photo 25:** Typical view of an herbaceous wetland with adjacent farm field uplands. View from Data Point 10-W, facing northeast.

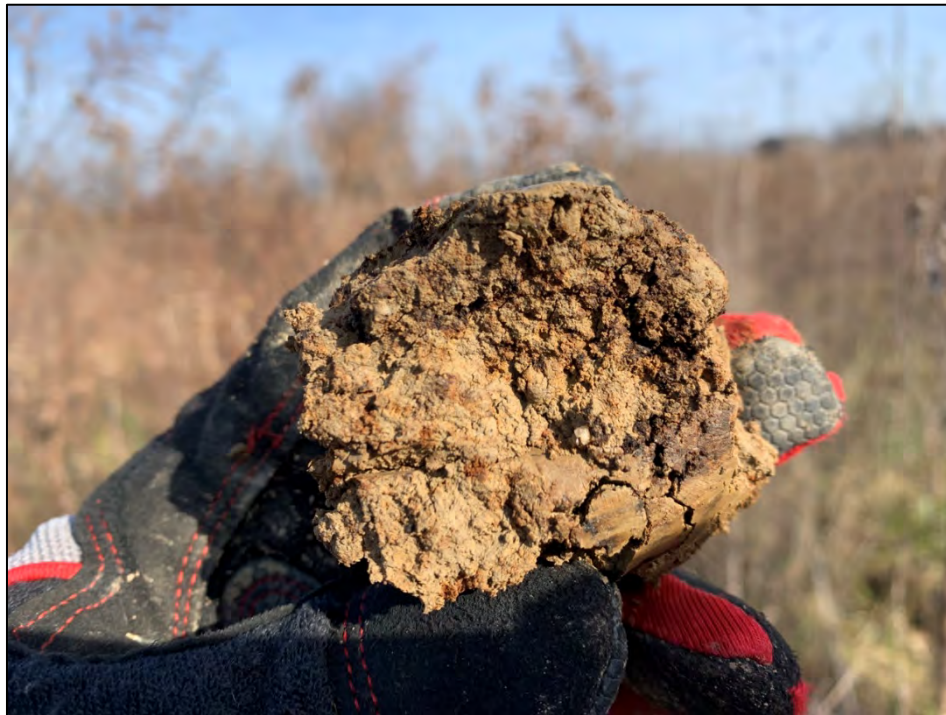
**Photo 26:** Representative wetland soil found throughout the project area displaying a depleted matrix with prominent redox concentrations and oxidized rhizospheres on living roots. View of soil at DP10-W.

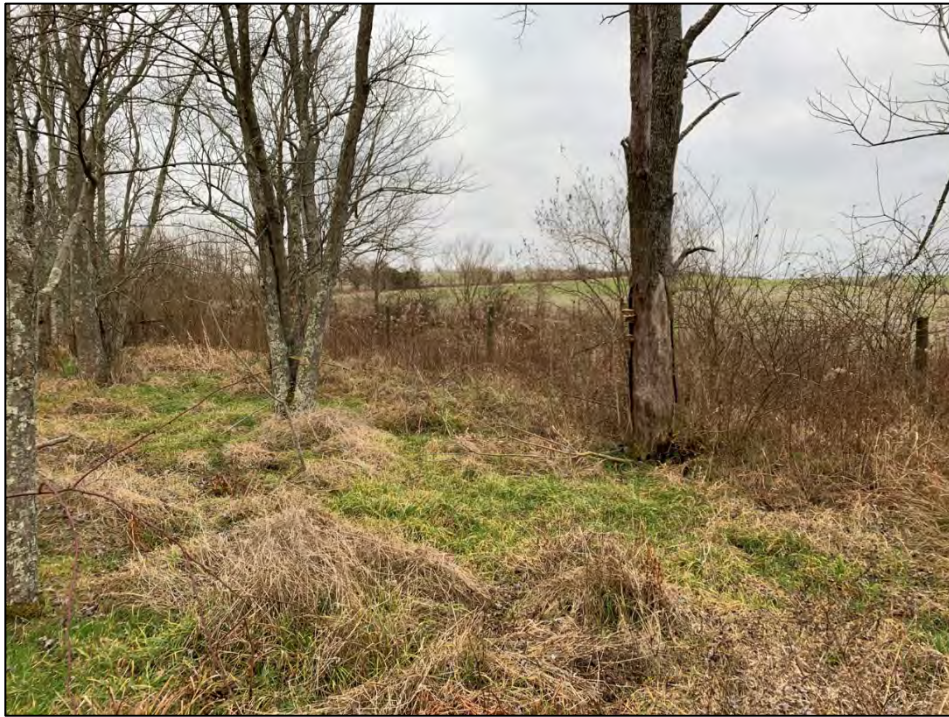
**Photo 27:** View of typical wetland complex. View from DP8-W, facing southeast.

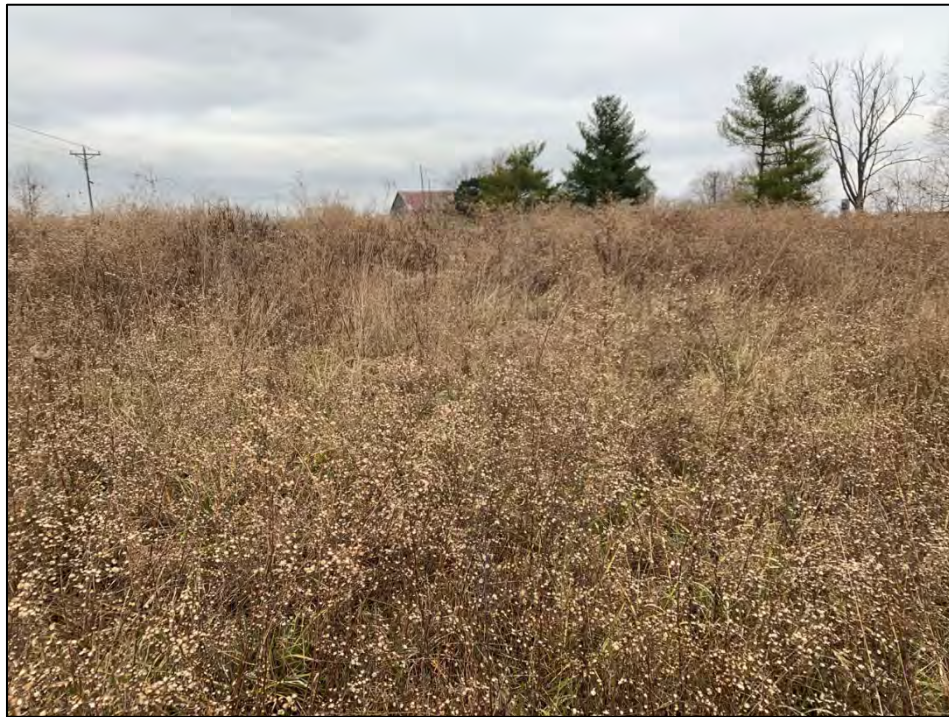
**Photo 28:** View of typical upland boundary on hillslope. View from DP8-U, facing northwest.

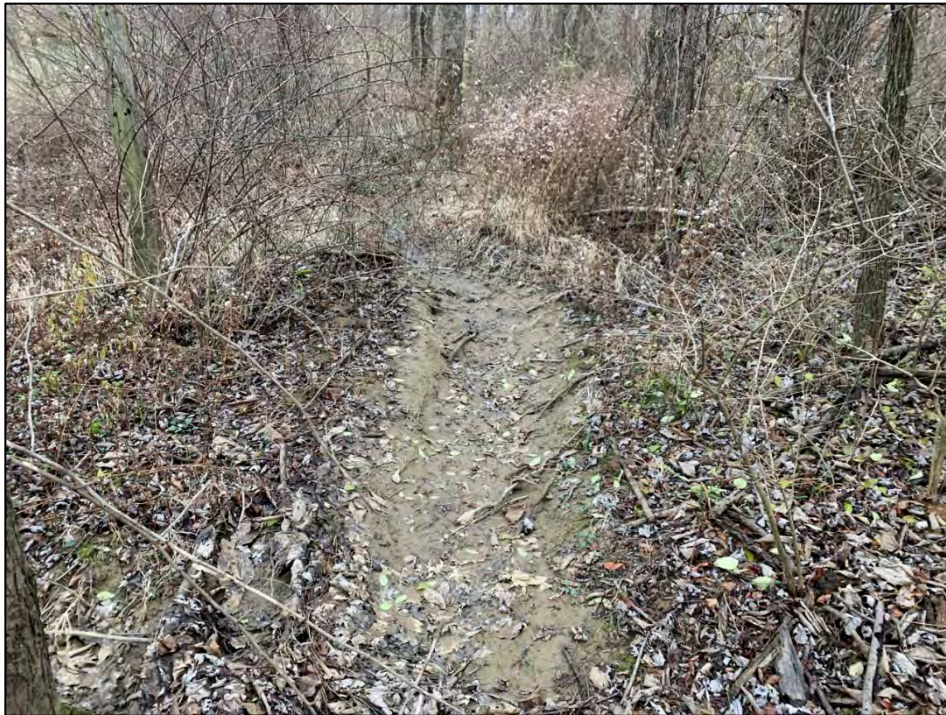
**Photo 29:** Typical view of a channel with ephemeral flow in a forested area. View of Channel 9, facing northeast.

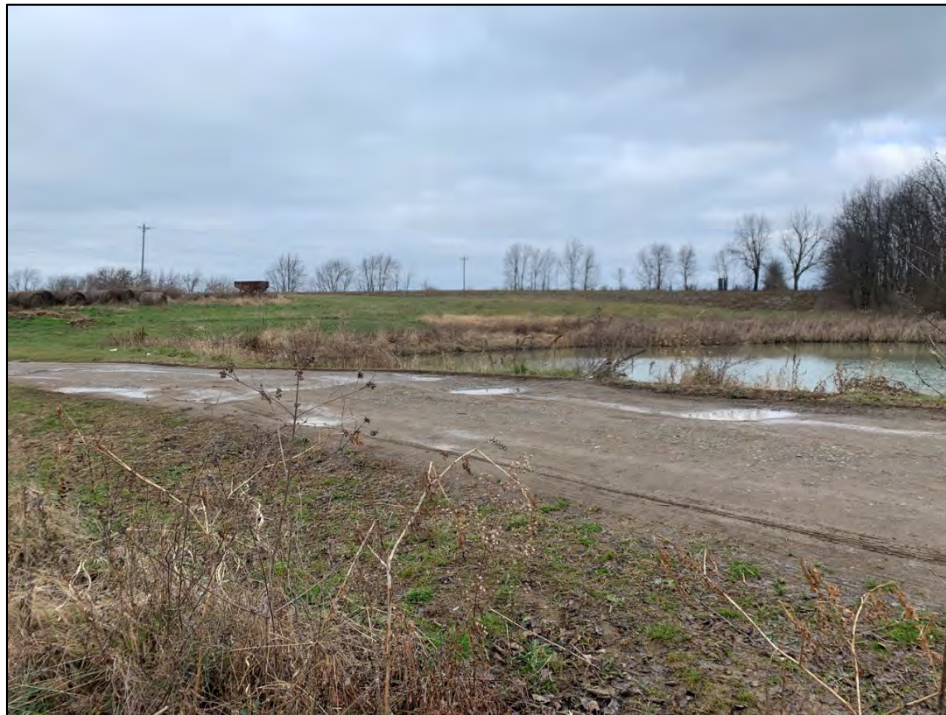
**Photo 30:** View of earthen road and Pond 9 berm with no outlet. View from Feature 9, facing northwest.

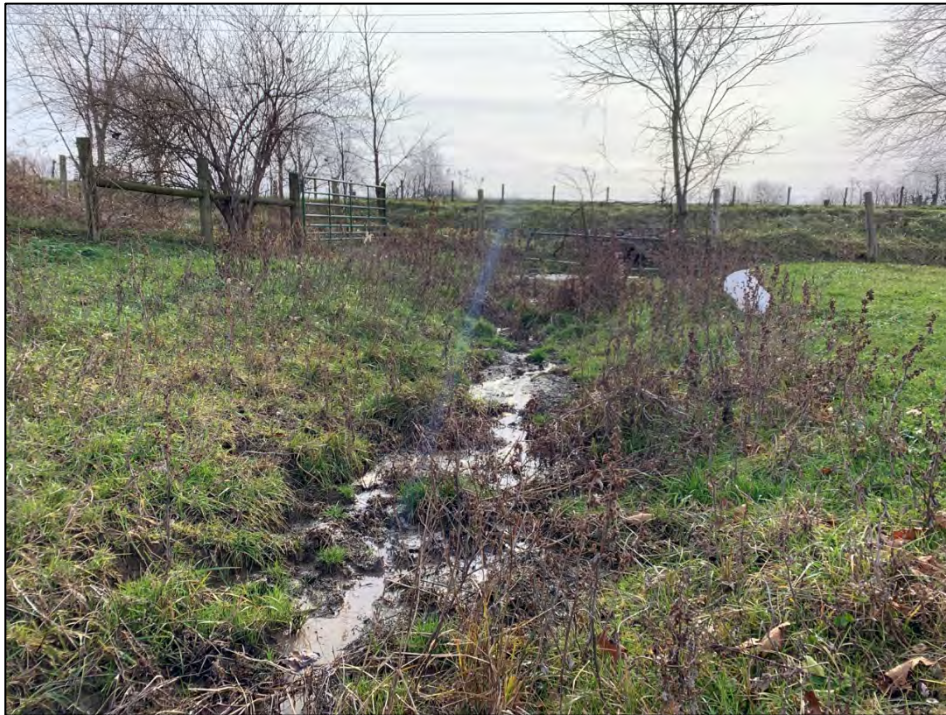
**Photo 31:** View of linear channel within inconspicuous ordinary high-water mark and standing stagnate water from recent precipitation. View of Channel 19 from Pond 5, facing south.

Channel 19 enters the project area from a culvert on Convict Pike and flows north for approximately 65 linear feet to Pond 5 (Figure 4B). Channel 19 is a ditched feature that connects a constructed offsite pond with Pond 5, a constructed pond within the project area. ERP observed standing water within Channel 19 at the time of the delineation likely due to precipitation within the previous 24 hours (Appendix B, Photo 31). Channel 19 exhibits ephemeral flow with non-contiguous OHWM. Channel 19 is excluded from jurisdiction under the NWPR as it exhibits ephemeral flow.
