# **Jurisdictional Waters of the U.S.**

## **Assessment**

Fleming Solar Project  
Fleming County, Kentucky

Jurisdictional Waters of the U.S. Assessment  
Fleming Solar Project

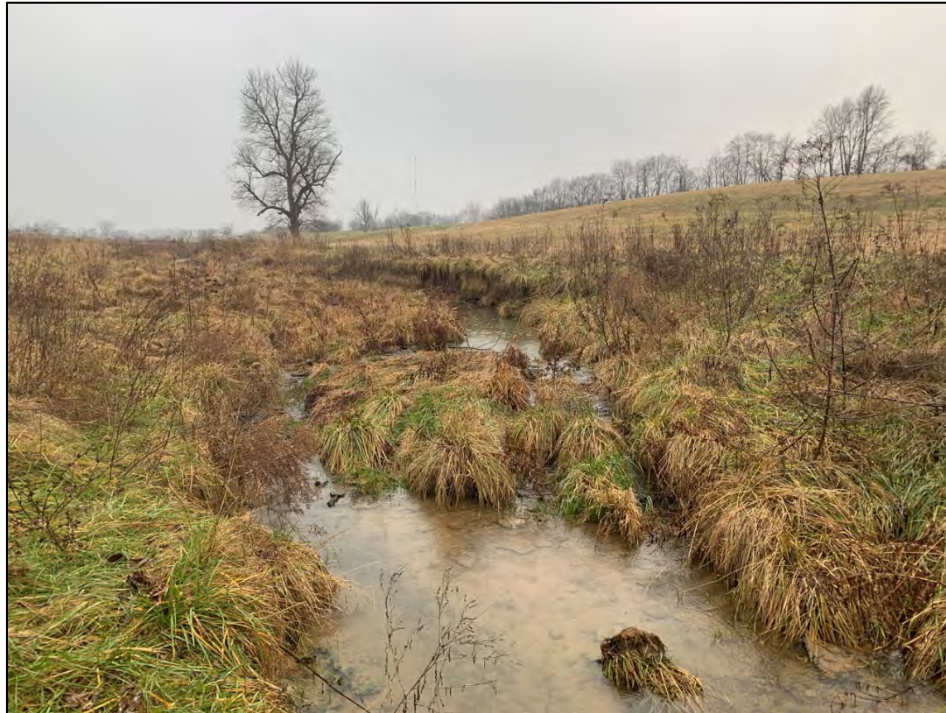
**Photo 32:** View of cattle degraded stream with perennial flow. View from the mid-point of Channel 20, facing south.

Channel 20 originates offsite southwest of the project area and enters the project area from a culvert on Convict Pike in the southwestern portion of the Site (Figure 4A). Channel 20 flows north bisecting the western portion of the Site for approximately 3,079 linear feet where it continues to flow off-site toward Johnson Creek (Figure 4A). Channel 20 is depicted on the USGS, NWI, and NHD and exhibits intermittent to perennial flow. The bed and banks of the southern upstream portion of Channel 20 have been degraded by cattle activity, however ERP observed continuous OHWM and bed and banks throughout the northern portions of the Site (Appendix A, Photo 32). Feature 18 is a wetland located along the stream inner berm that abuts the northern portion of Channel 20 (Figure 4A). Feature 18 is comprised of herbaceous vegetation typical of wetlands, depleted soils, and is hydrologically connected to Channel 20. Channel 20 is considered jurisdictional under the NWPR as it exhibits perennial flow and abuts other jurisdictional waters.

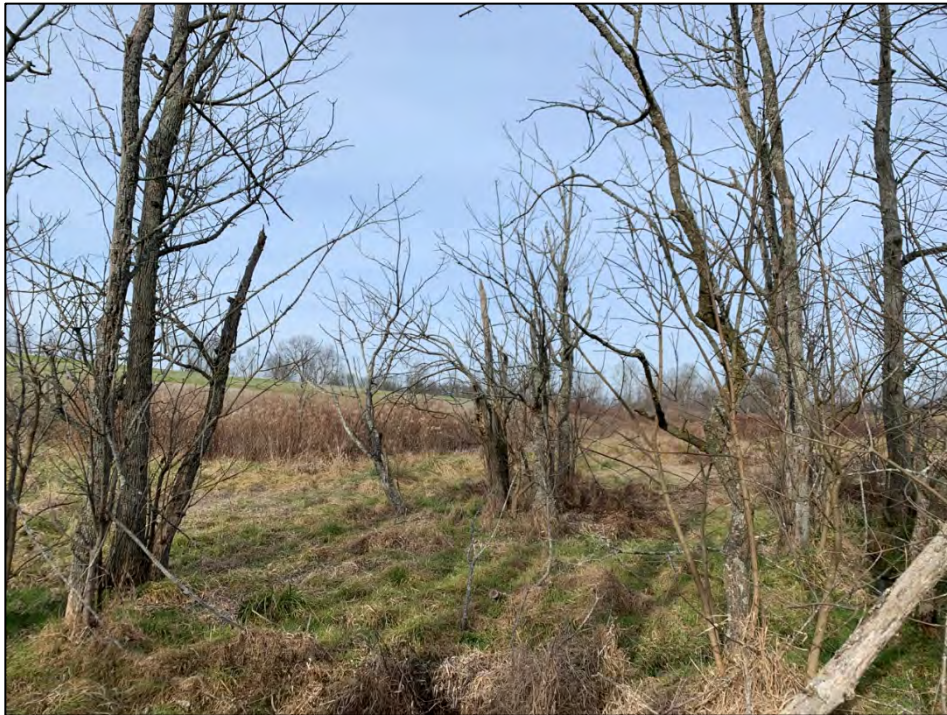
**Photo 33:** View typical wetland complex. View of Feature 13 from Data Point 13-W, facing west.

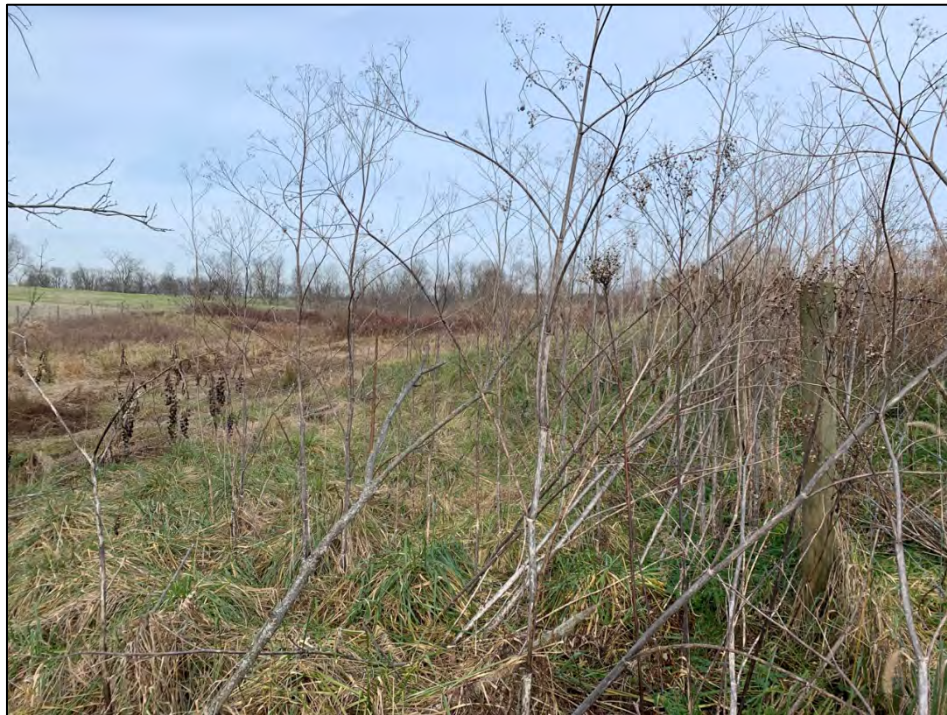
**Photo 34:** View of typical upland vegetation on hillslopes. View from Data Point 13-U, facing north.

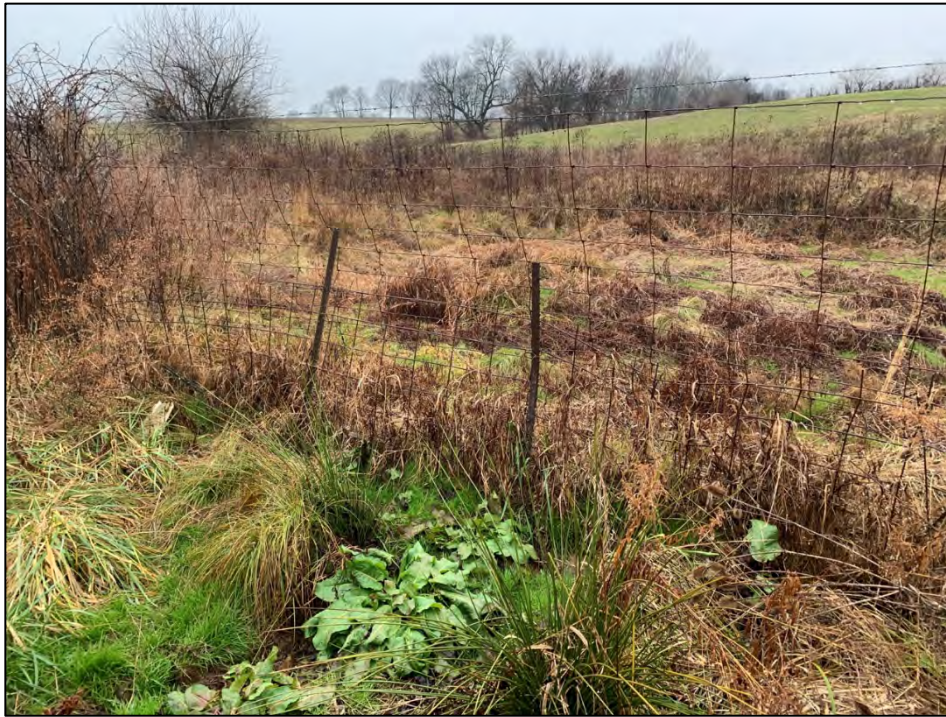
**Photo 35:** View of herbaceous wetland with Channel 20 depicted in the background. View from the north portion of Feature 16, facing west.

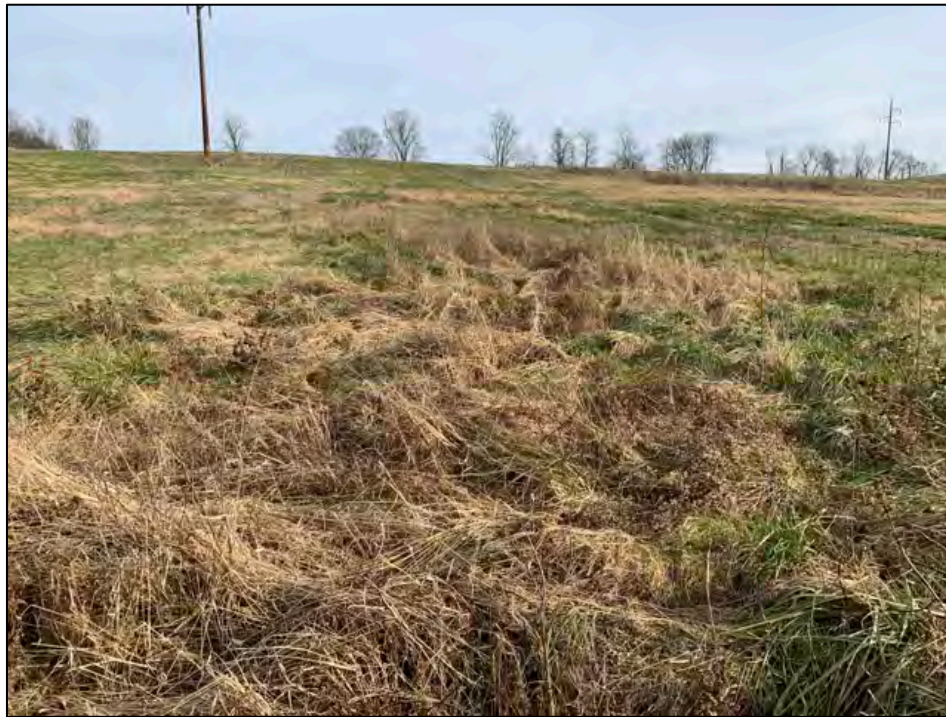
**Photo 36:** View of a wetland depression within a hillslope. View from DP17-W, facing east.

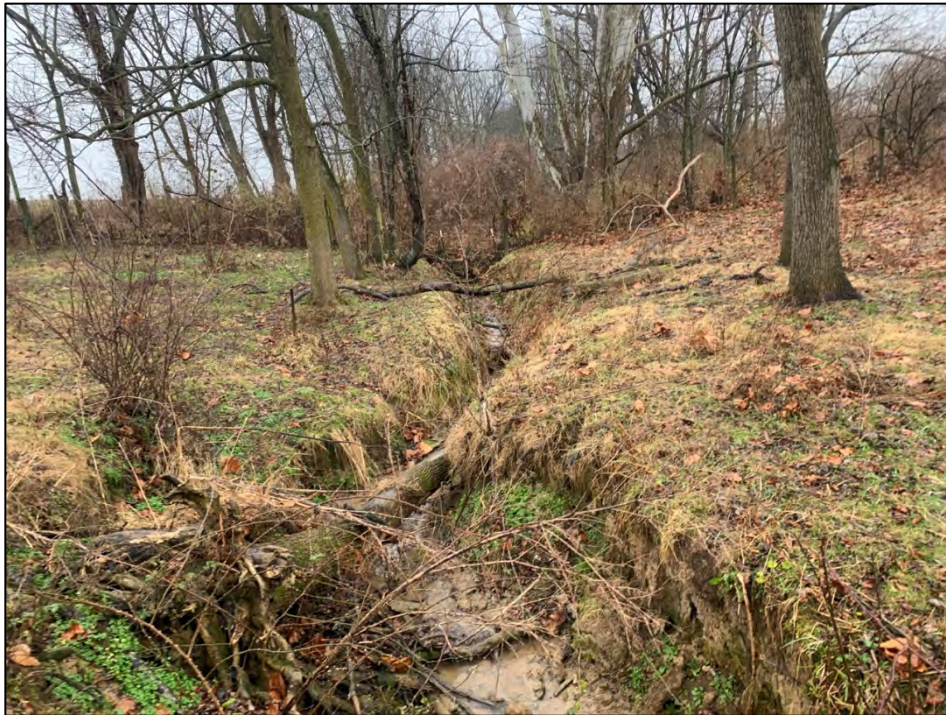
**Photo 37:** View of intermittent stream entering the project boundary from a forested area to a cattle field. View from the western end of Channel 22, facing west.

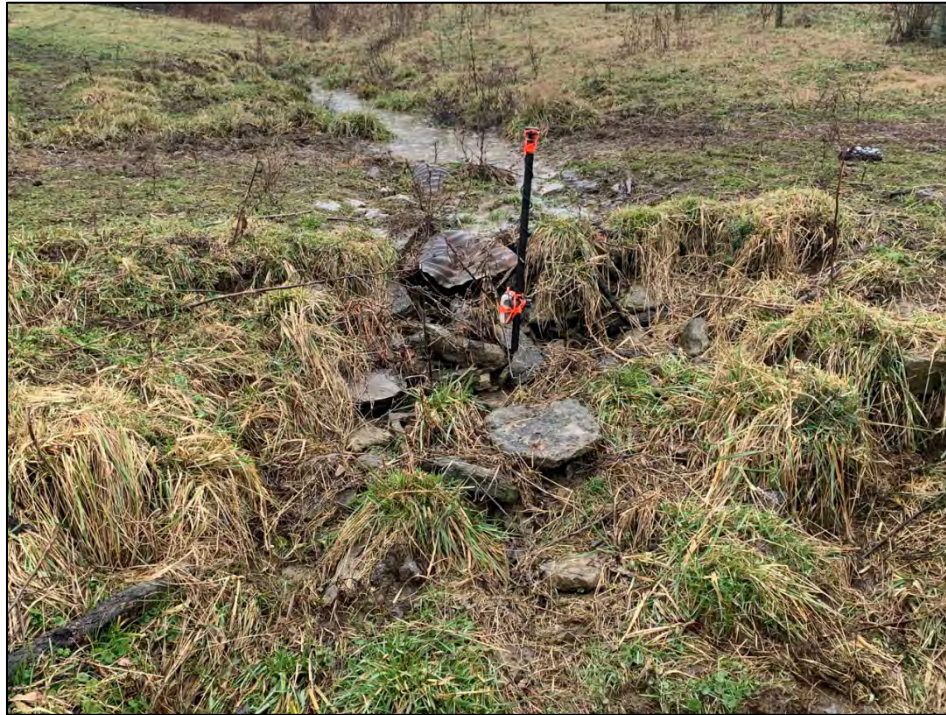
**Photo 38:** View of Channel 22 ending at a pipe. View from the terrace of Channel 20, facing west.

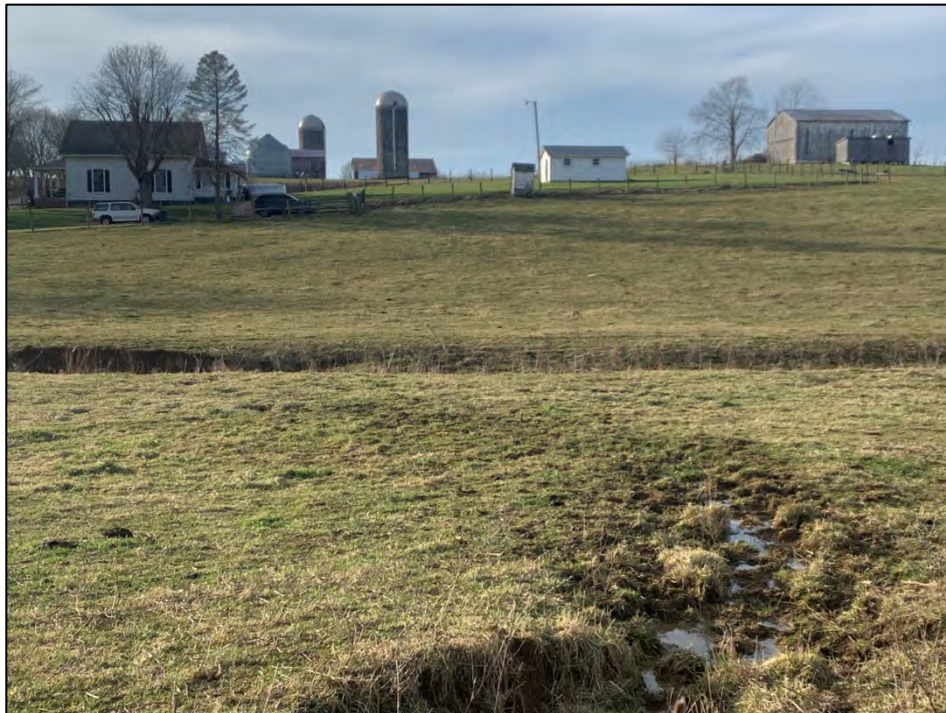
**Photo 39:** View of general onsite cattle pasture with wetland dissipating to sheet flow. View from the end of Feature 15, facing west.

DP15-U). Channel 25 and Features 14 and 15 are located in the southwestern portion of the Site, east of Channel 20, and are entirely within the project area. Due to its ephemeral flow regime and lack of OHWM, Channel 25 is excluded from jurisdiction under the NWPR. Feature 14 flows west to Feature 15 which continues to flow west and dissipates into sheet flow approximately 100 feet east of Channel 20 (Appendix A, Photo 39). Under the NWPR, Features 14 and 15 are excluded from jurisdiction as they are not considered adjacent to downstream waters.

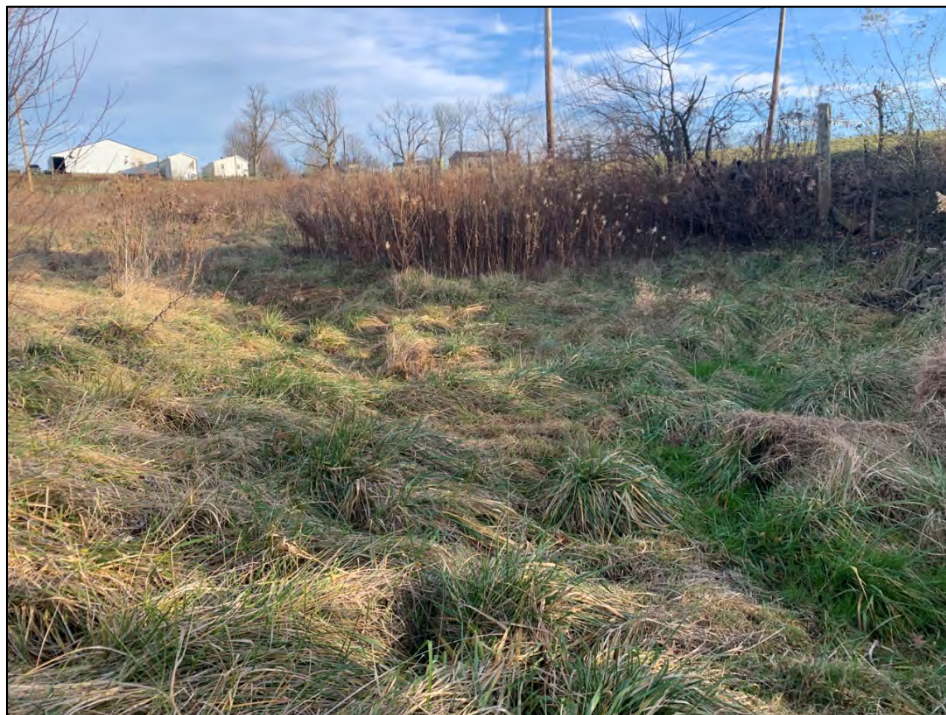
**Photo 40:** View of confined valley with ephemeral flow becoming unconfined and exhibiting wetland characteristics. View from DP15-W, facing east.

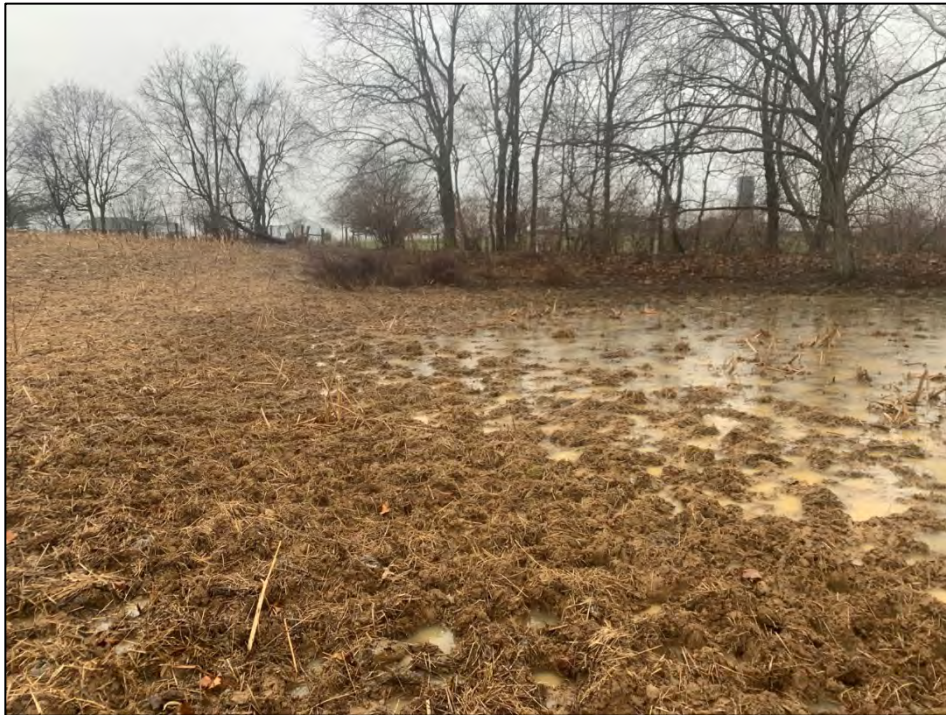
**Photo 41:** View of upland and wetland boundary of a closed depression within a cattle field. View from DP19-W, facing west.

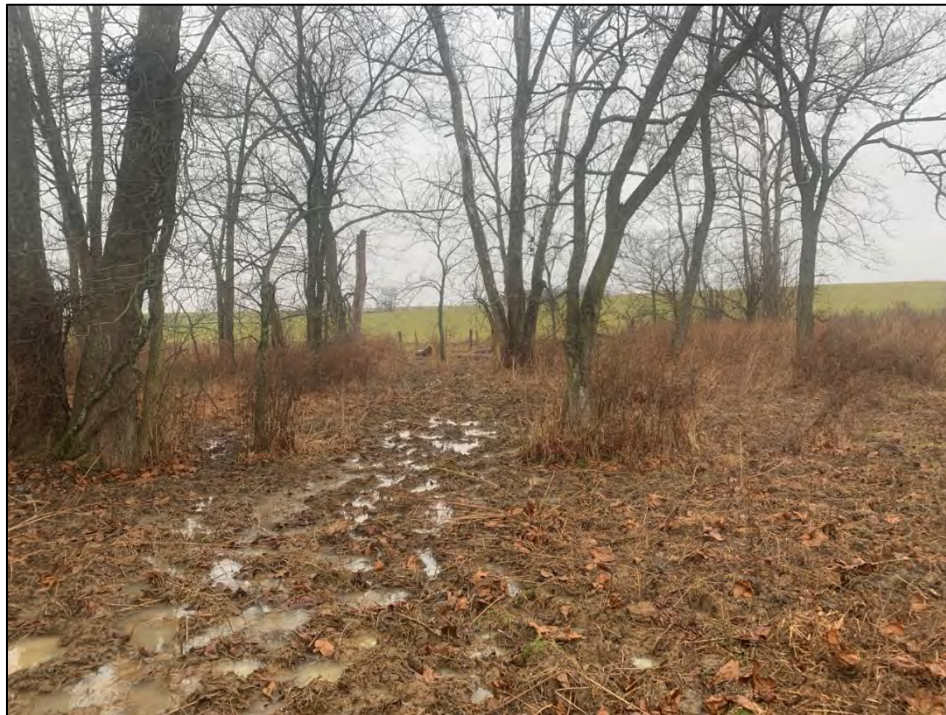
**Photo 42:** View of forested wetland altered by cattle. View from DP20-W, facing west.

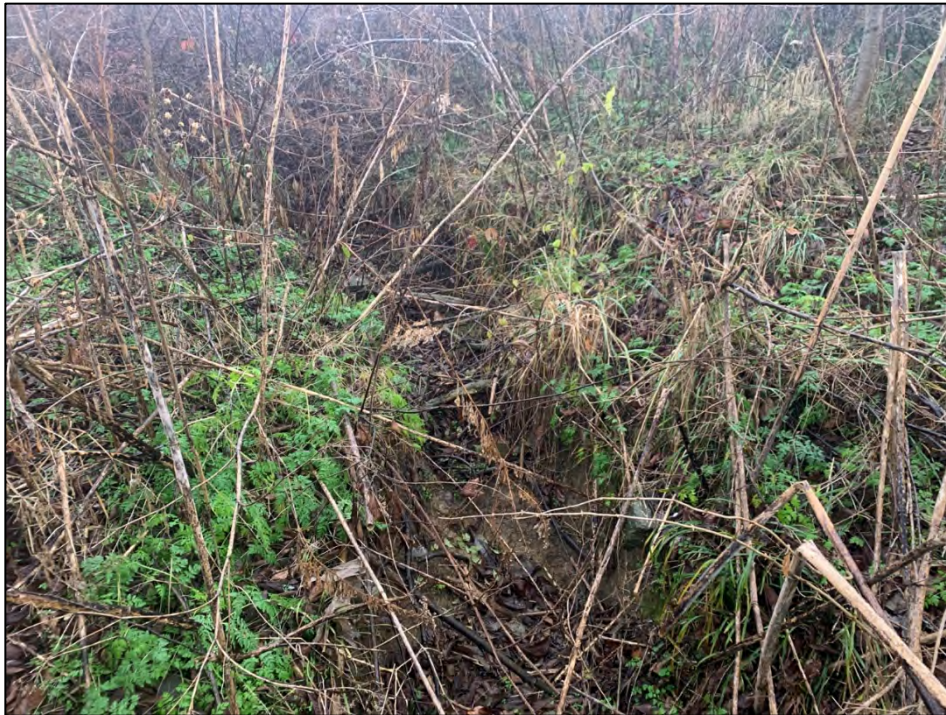
**Photo 43:** View of Channel 34E with a lack of ordinary high-water mark. Located in the northeast portion of the project area, facing southwest.

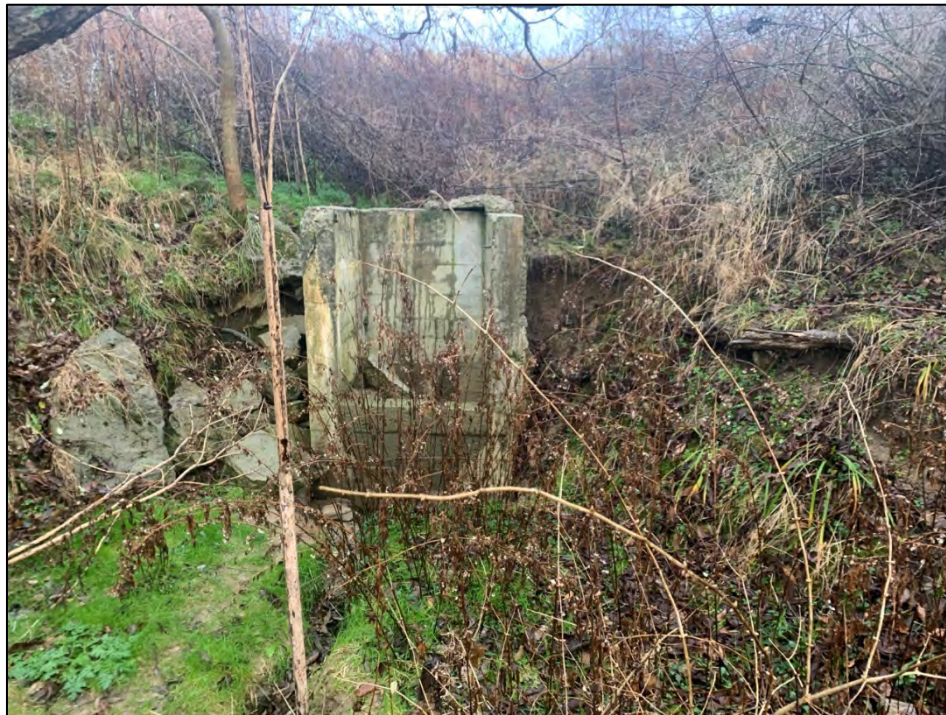
**Photo 44:** View of a typical spring with concrete box found within the project area. View from Channel 34 in northeast portion of the Site, facing southwest.

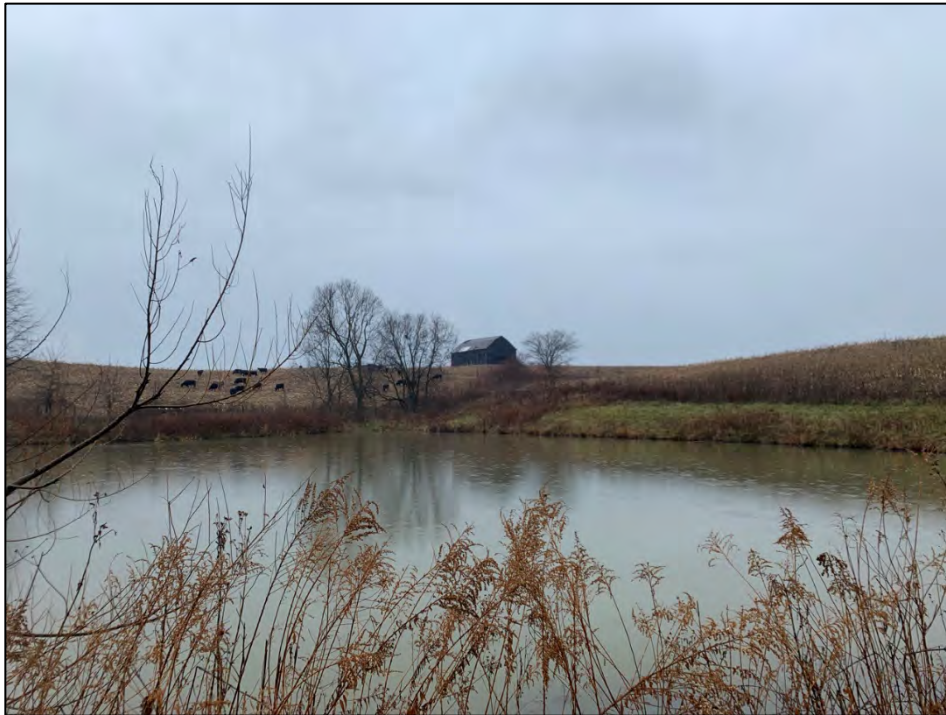
**Photo 45:** View of a typical pond within the project area. View from Pond 10, facing northwest.

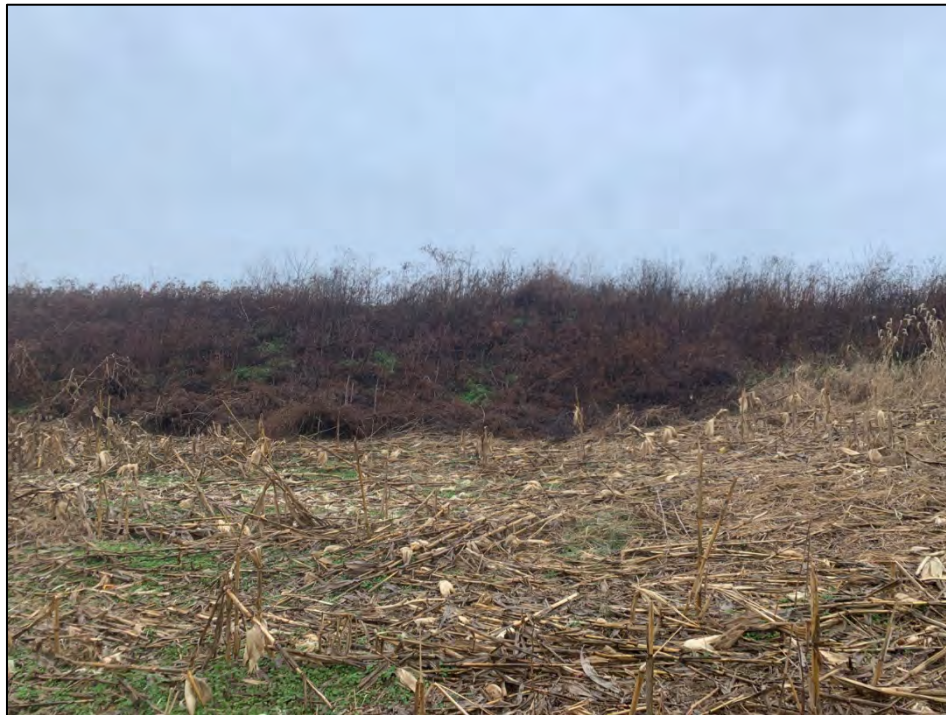
**Photo 46:** View of Pond 10 berm from the lowest downgradient position with no evidence of a channelized structure. View from Pond 10, facing northwest.

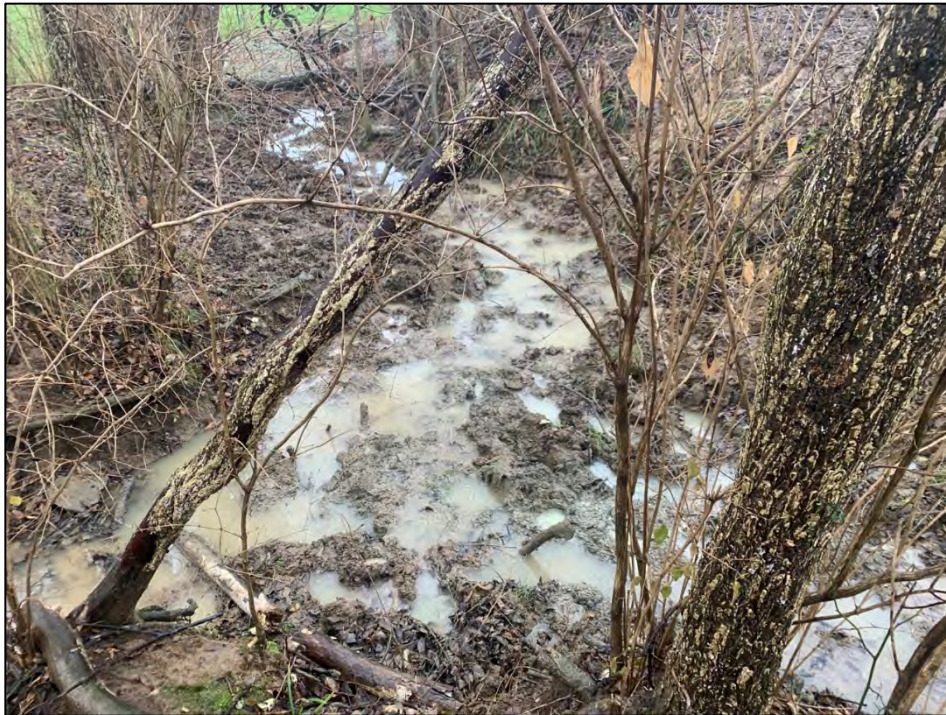
**Photo 47:** View of stream with intermittent flow altered by cattle. View from Channel 26, facing west.

Channel 26 originates onsite in the southwestern portion of the northern project area at concrete box and spring (Figure 4C). Channel 26 flows west intermittently for 67 linear feet where it flows offsite and into an offsite pond. Cattle have altered this feature, and OHWM and bed and bank were not visible at the time of the delineation. However, flowing surface water was observed within Channel 26 (Appendix B, Photo 47). Channel 27E and Channel 27 originate onsite as a tributary to Channel 26 (Figure 4C). Channel 27E exhibited ephemeral flow northwest for approximately 34 linear feet to a headcut. Below the headcut, Channel 27 forms and displayed intermittent flow for approximately eight (8) linear feet to its confluence with Channel 26. Though cattle have altered their natural conditions, Channel 26 and Channel 27 are considered jurisdictional under the NWPR due to the channelized intermittent flow observed and connection to downstream WOUS. Channel 27E displays ephemeral flow and is not considered jurisdictional under the NWPR.

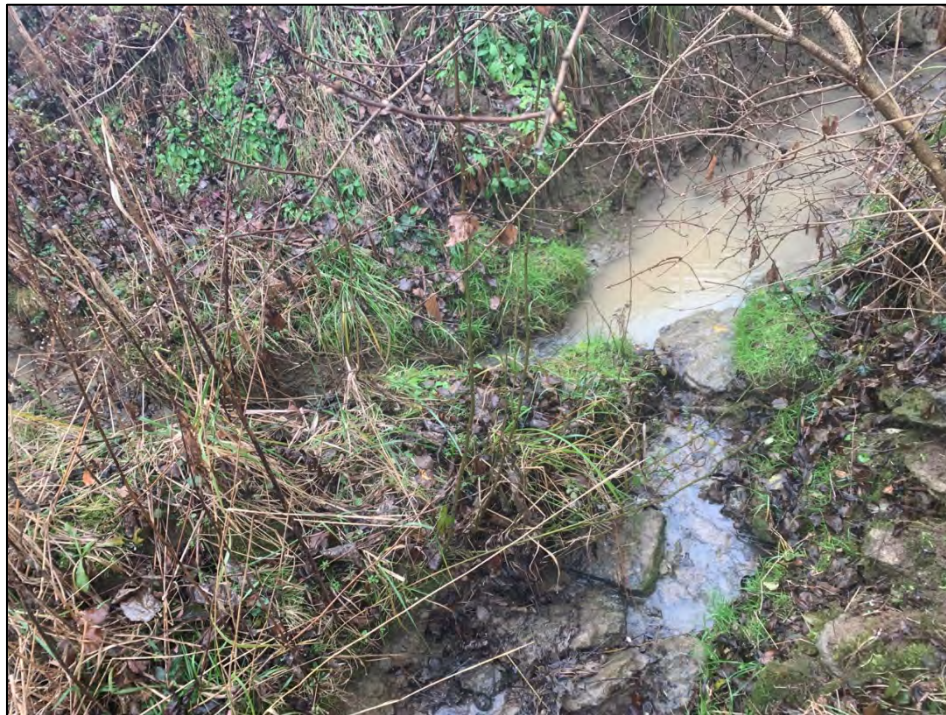
**Photo 48:** View of typical intermittent streams. View from the confluence of Channels 28 and 29, facing south.

Channel 29 and Channel 29E originate within a single drainage onsite east of Channel 28 and flow southwest to a confluence with Channel 28 within the northern project area (Figure 4C). Channel 29E is an erosional feature that lacks OHWM and exhibits ephemeral flow for approximately 68 linear feet to Channel 29. Channel 29 originates at a headcut that intercepts ground water. Channel 29 flows intermittently exhibiting a continuous OHWM and bed and bank for approximately 59 linear feet to its confluence with Channel 28 (Figure 4C). Channel 28 exhibited a continuous OHWM and bed and banks flowing intermittently south for 305 linear feet and offsite (Appendix A, Photo 48). Based on the observed channel characteristics, flow regime, and connection to downstream waters, Channel 28 and Channel 29 are considered jurisdictional under the NWPR. Channel 29E is considered excluded from jurisdiction under the NWPR due to its ephemeral flow regime.

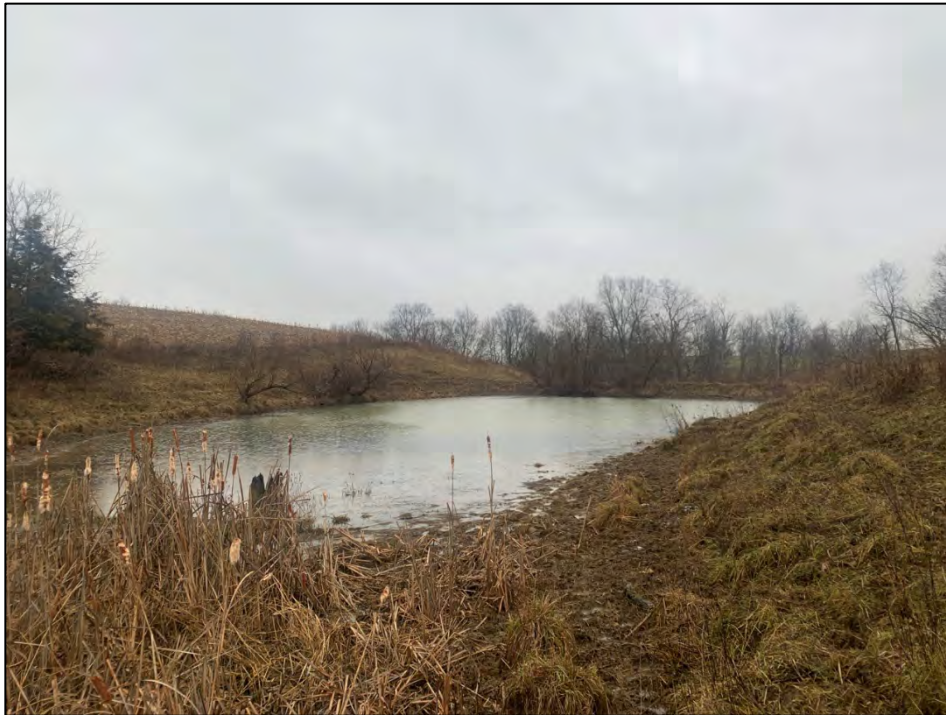
**Photo 49:** View of Pond 11 from the northern project area, facing north.

Pond 11 is an approximately 0.57-acre constructed pond depicted on NHD located in the northern project area (Figure 4C; Appendix A, Photo 49). Channel 33 flows northeast for approximately 72 linear feet into Pond 11 (Figure 4C). Channel 33 exhibits ephemeral flow and lacks OHWM. Channel 32 is an earthen overflow outlet structure of Pond 11 that flows west for approximately 242 linear feet to an onsite confluence with Channel 30 (Figure 4C). Channel 32 is an erosional feature that exhibits ephemeral flow and lacks OHWM and bed and banks (Appendix A, Photo 50). Channel 31 and Channel 30E are erosional features located in the northern project area that exhibit non-continuous OHWM and bed and banks with ephemeral flow to their confluence with Channel 30 (Figure 4C). Channel 31 flows north for approximately 192 linear feet to its confluence with Channel 30. Channel 30E flows north for approximately 222 linear feet to its confluence with Channel 30. Channel 30 originates onsite in the northern portion of the project area at a headcut where Channel 30E and Channel 31 confluence (Figure 4C). Channel 30 exhibits intermittent flow northeast for approximately 117 linear feet to the project boundary with continuous OHWM and bed and banks where it continues to flow offsite (Figure 4C). Channel 30 is jurisdictional under the NWPR as it displays intermittent flow and is connected to downstream surface waters. Channels 30E, 31, 32, and 33 display ephemeral flow and are excluded from jurisdiction under the NWPR. Pond 11 is a constructed farm pond in an upland and is excluded from jurisdiction under the NWPR.

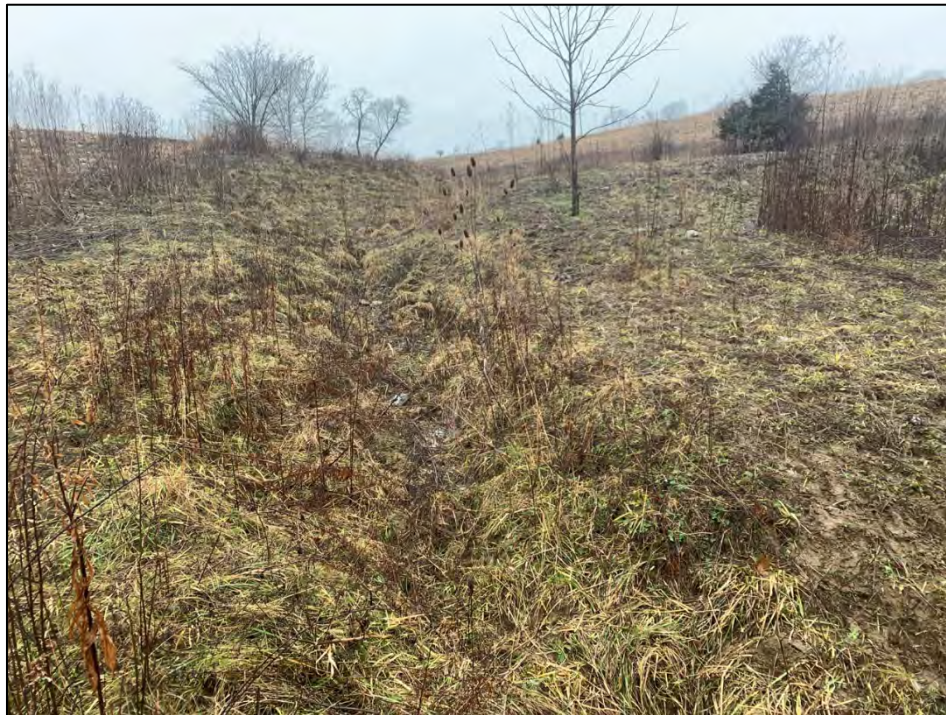
**Photo 50:** View of outlet structure from Pond 11 that lacks ordinary high-waters and bed banks. View from Channel 32, facing west.

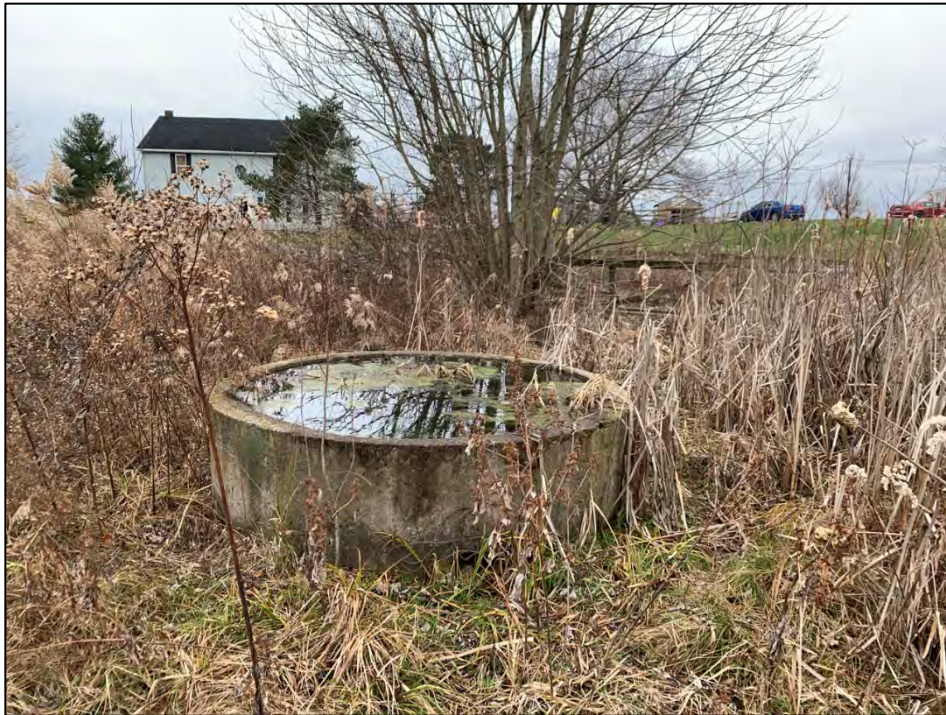
**Photo 51:** View of cistern or well within Feature 9. View from the eastern portion of Feature 9, facing west.

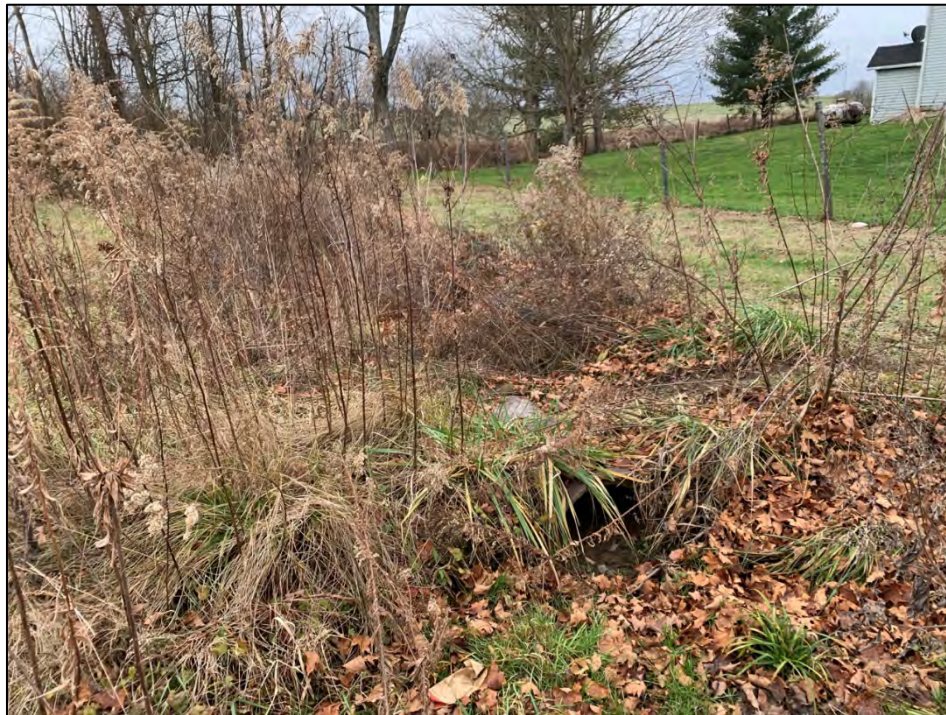
**Photo 52:** View of culvert connecting Feature 9 to Channel 8. View from the southern portion of Feature 9, facing southeast.

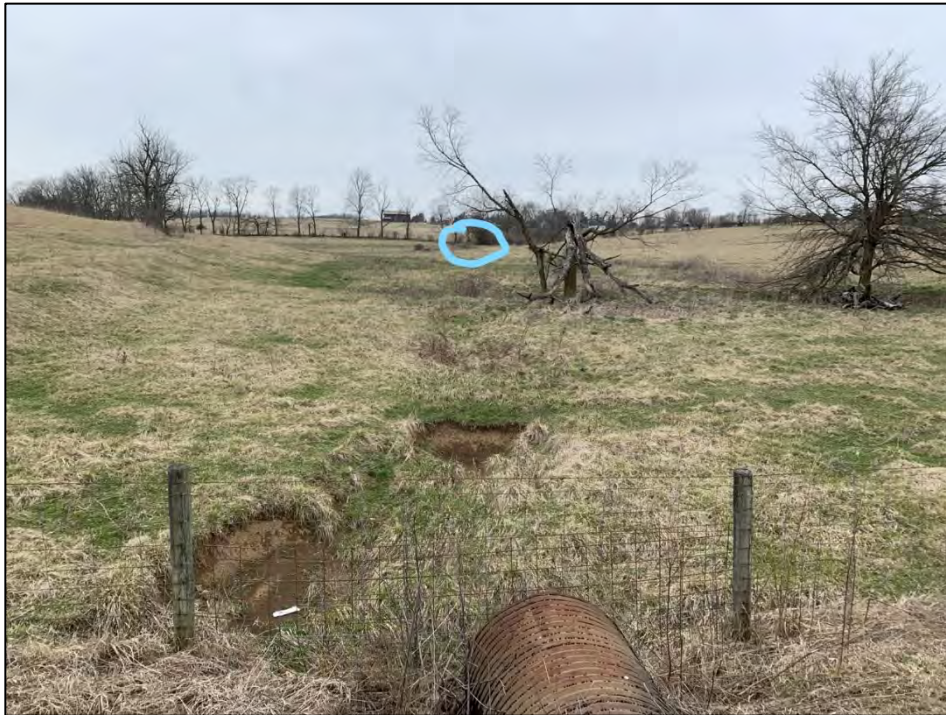
**Photo 53:** View of offsite upland drainage downgradient from Channels 1, 2E, and 6. View from Convict Pike facing west towards Channel 1 circled in blue. Photo taken on March 17, 2021.

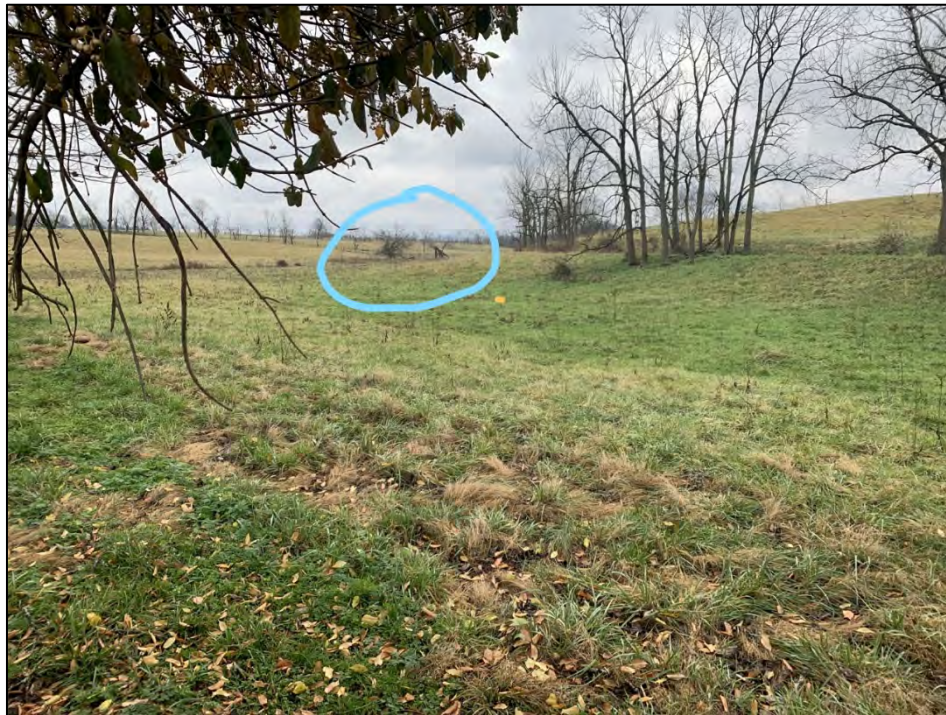
**Photo 54:** Continued view of offsite upland area and the offsite termination point of Channel 1, circled in blue. View from Site boundary, facing southeast towards Convict Pike.

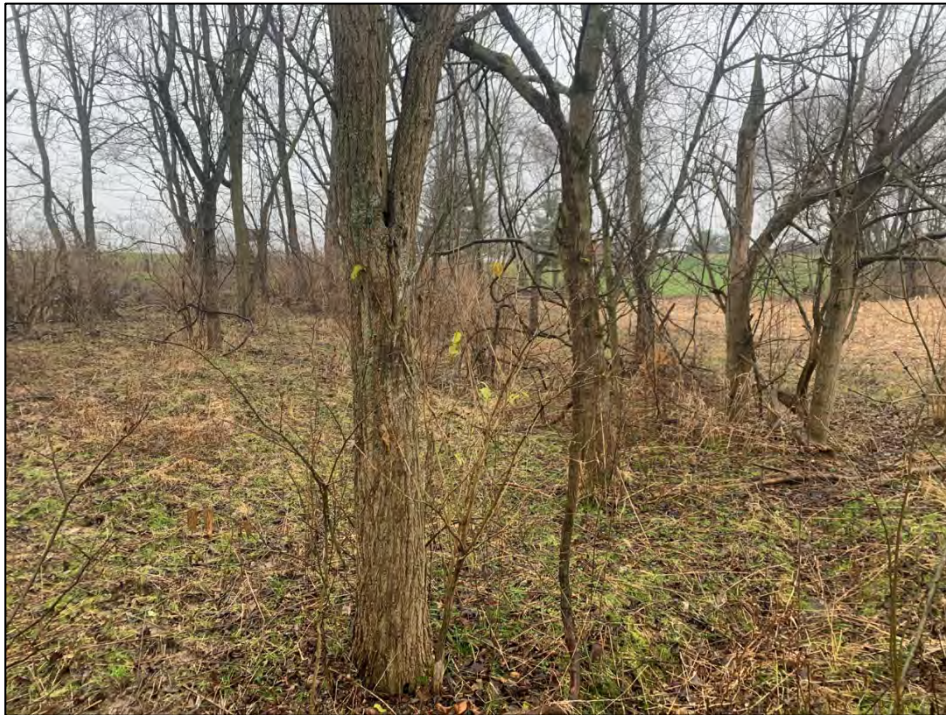
**Photo 55:** Typical view of wooded upland area north of Helena Road. View from DPA-U, facing west.

A small, wooded area north of Helena Road was reviewed for potential surface waters in the central-northern portion of the project area. A representative data point was collected in this wooded area (Appendix B, DPA-U). This wooded area is comprised mostly of hackberry, black walnut (*Junglans nigra*), and honeysuckle bush (*Lonicera maacki*) and is absent of wetland soils and wetland hydrology indicators (Appendix A, Photos 55, 56). DPA-U is representative for all of the small pockets of wooded areas scattered throughout the Site.

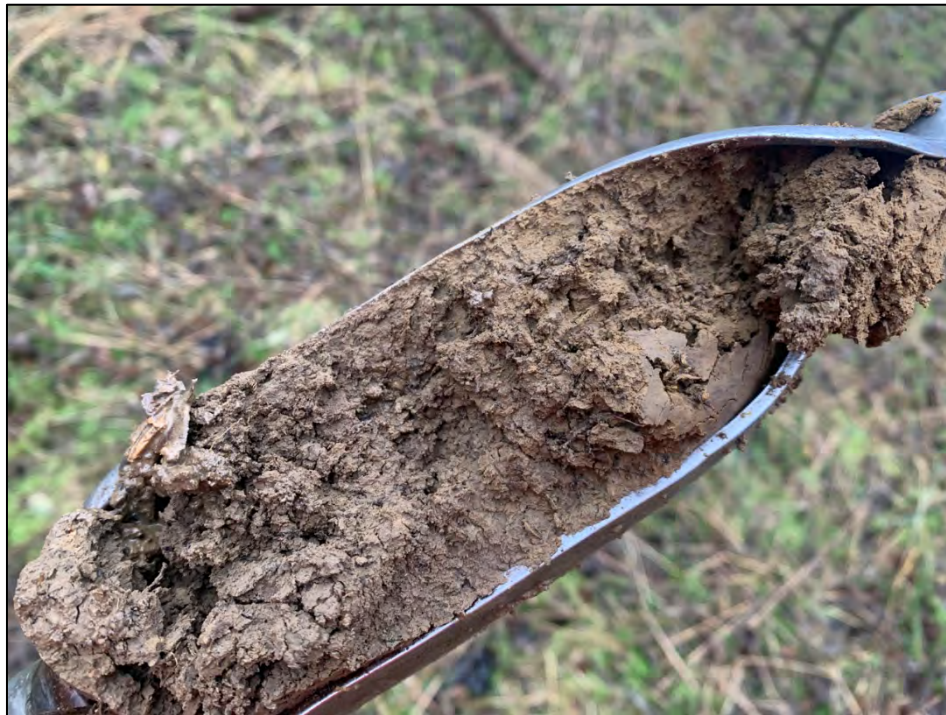
**Photo 56:** Typical view of upland soils within forested, non-agricultural areas of the Site. View from DPA-U.

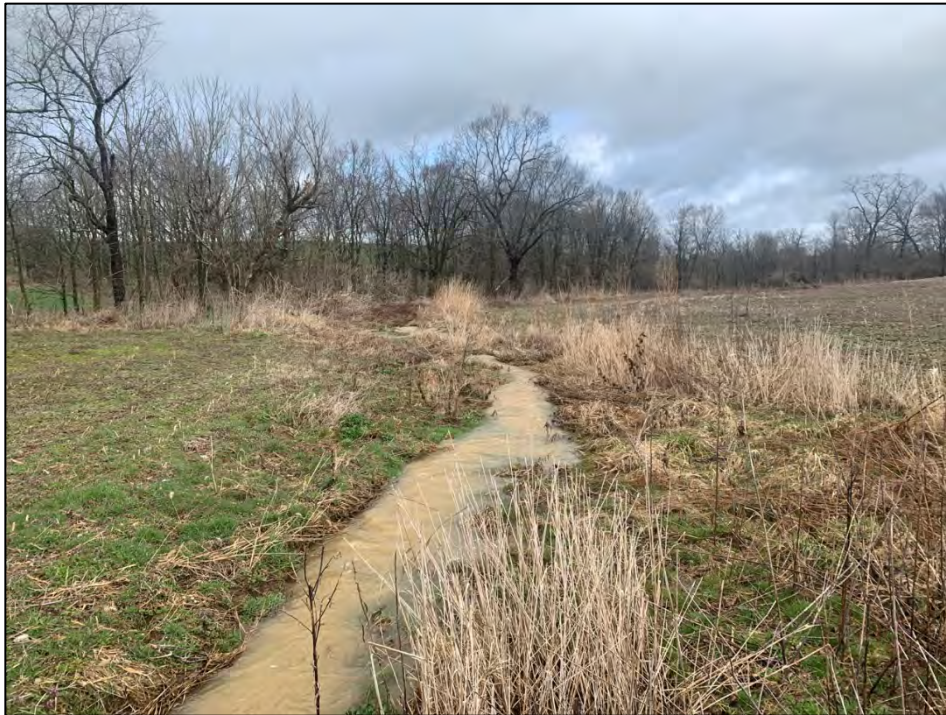
**Photo 57:** Typical view of Channel 37 and valley. View from southern portion of the channel, facing downstream and northwest. Photo taken on March 17, 2021.

Channel 37 originates onsite as an erosional feature and flows northwest to the Project boundary where it has been artificially straightened along a manmade berm. Channel 37 flows north along the inner Project boundary before dissipating into Feature 23 (Figure 4D; Appendix A, Photos 57, 58, and 59). Feature 23 is located in the northwestern corner of the Project area. Feature 23 is comprised of wetland vegetation and soils within oxidized rhizospheres which indicate hydric soils and wetland hydrology are present (Appendix B, DP23-W). During the March delineation, ERP observed that Channel 37 and Feature 23 are confined by a berm on the western Project area boundary (Appendix A, Photo 60; Appendix B, DP23-U). This observation of confinement took place in the wet season and during conditions of severe wetness (Appendix C). Channel 37 and Feature 23 are excluded from jurisdiction under the NWPR as they do not contribute surface water to a WOUS and are not inundated by surface water from a WOUS in a typical year.

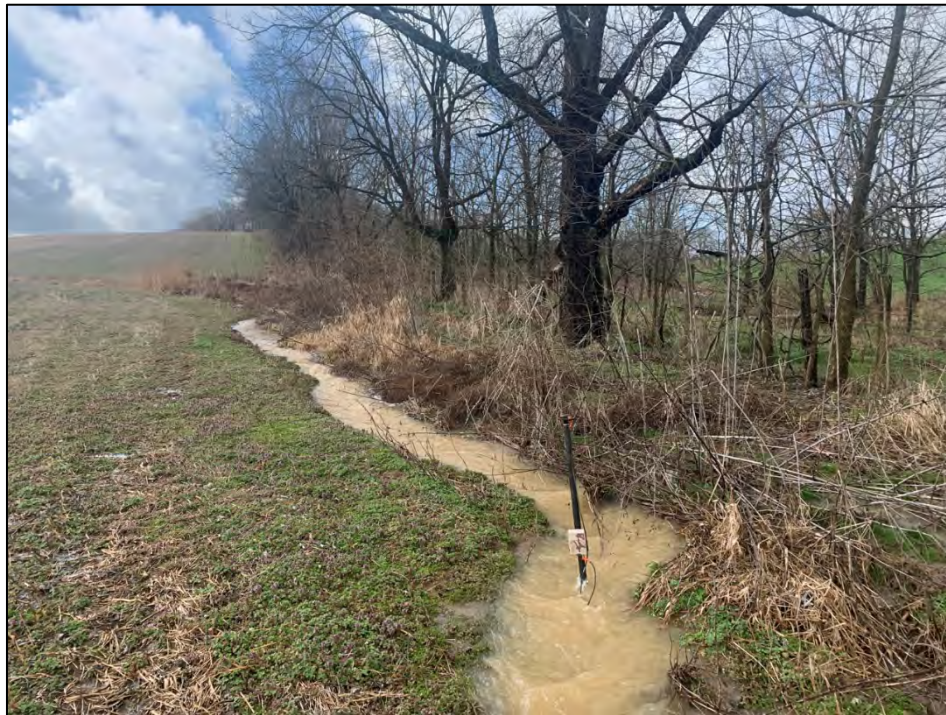
**Photo 58:** Typical view of channelized portion of Channel 37. View from end of Channel 37, facing upstream, south. Photo taken on March 17, 2021.

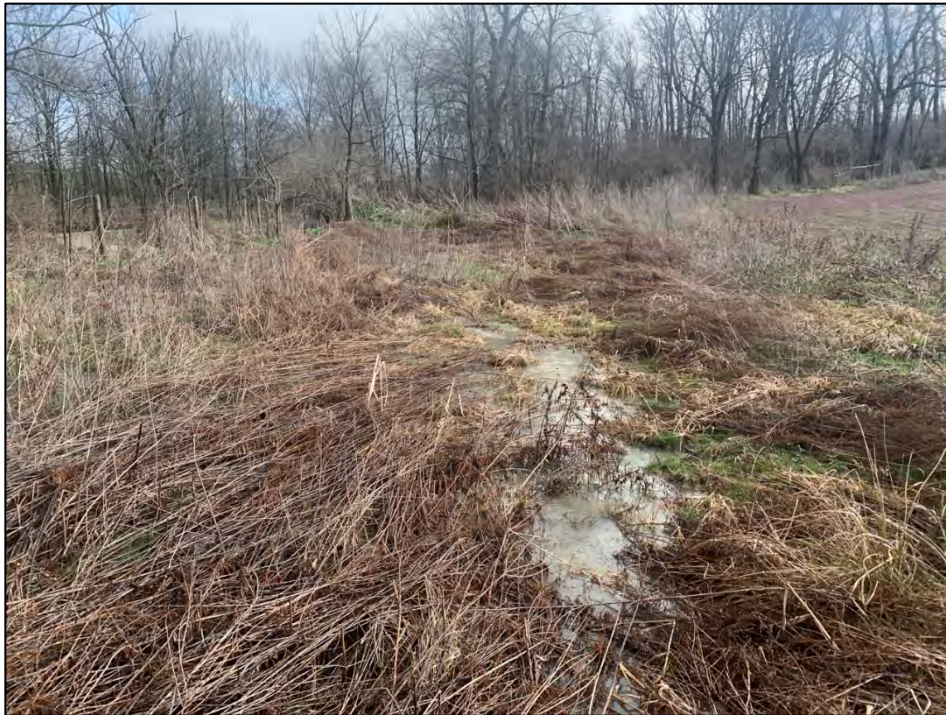
**Photo 59:** Typical view of Feature 23 from its southern end, facing north. Photo taken on March 17, 2021.

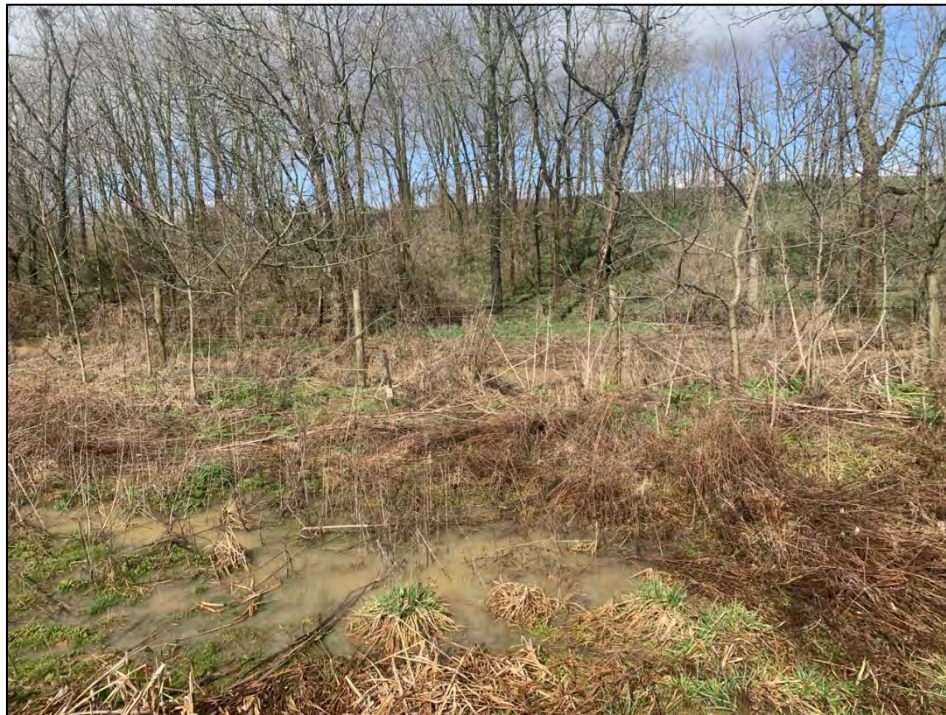
**Photo 60:** Typical view of berm separating Feature 23 and Channel 37 from offsite WoUS. View from DP23-W facing DP23-U. Photo taken on March 17, 2021.
