# **Jurisdictional Waters of the U.S.**

## **Assessment**

Fleming Solar Project  
Fleming County, Kentucky

Jurisdictional Waters of the U.S. Assessment  
Fleming Solar Project

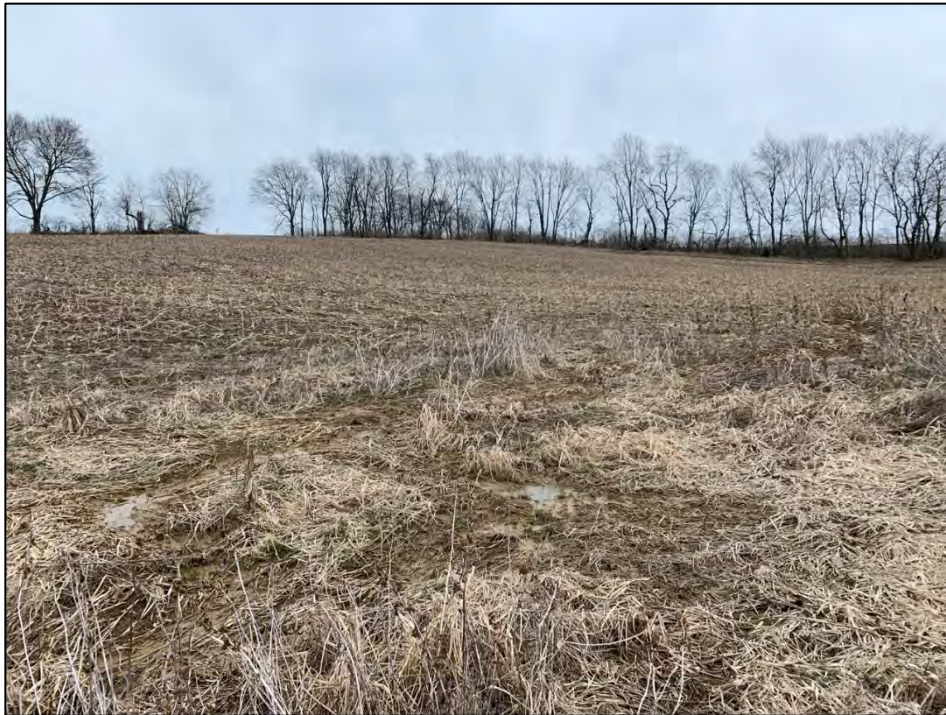
**Photo 61:** Typical view of Feature 24 boundary with adjacent cropland. View from Feature 24 facing northeast towards DP24-U. Photo taken on March 17, 2021.

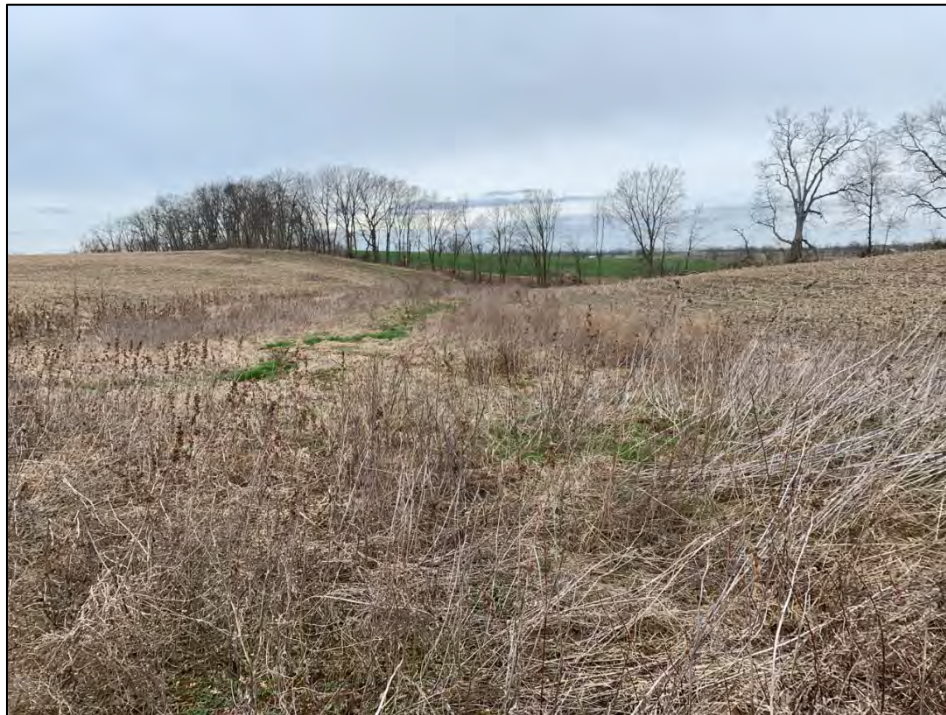
**Photo 62:** Typical view of Feature 24 within the valley. View from DP24-W facing northwest. Photo taken on March 17, 2021.

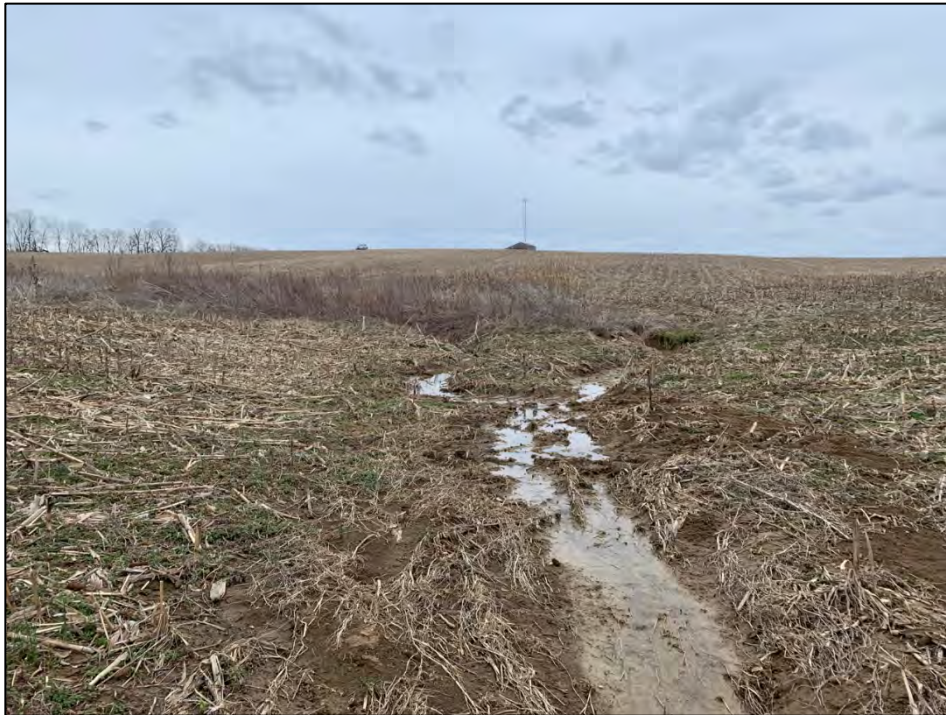
**Photo 63:** Typical view of Channel 38 and Channel 39. View from Channel 38 facing southeast towards Feature 24. Photo taken on March 17, 2021.

Channels 38, 39, and 40 are erosional features that originate onsite in the northwest portion of the project area (Figure 4D). Channel 40 is an earthen swale that exhibits ephemeral flow, lacks an OHWM and bed and bank, and flows west for approximately 185 linear feet to Feature 24 (Appendix A, Photo 64). Feature 24 exhibits partial wetland conditions. Feature 24 is comprised of soils with iron-manganese masses and oxidized rhizospheres, which indicate hydric soils and wetland hydrology are present. The vegetation community of Feature 24 is comprised of mostly non-wetland plants (Appendix A, Photos 61 and 62). Feature 24 flows northwest as flow concentrates into Channels 38 and 39, which flow north, intersect with each other, and continue off site (Figure 4D; Appendix A, Photo 63). Channels 38 and 39 exhibit ephemeral flow with observable bed and bank but inconsistent OHWM. Channels 38 and 39 form where sheet flow concentrates within Feature 24. Soils within the bed of Channels 38 and 39 exhibit both high

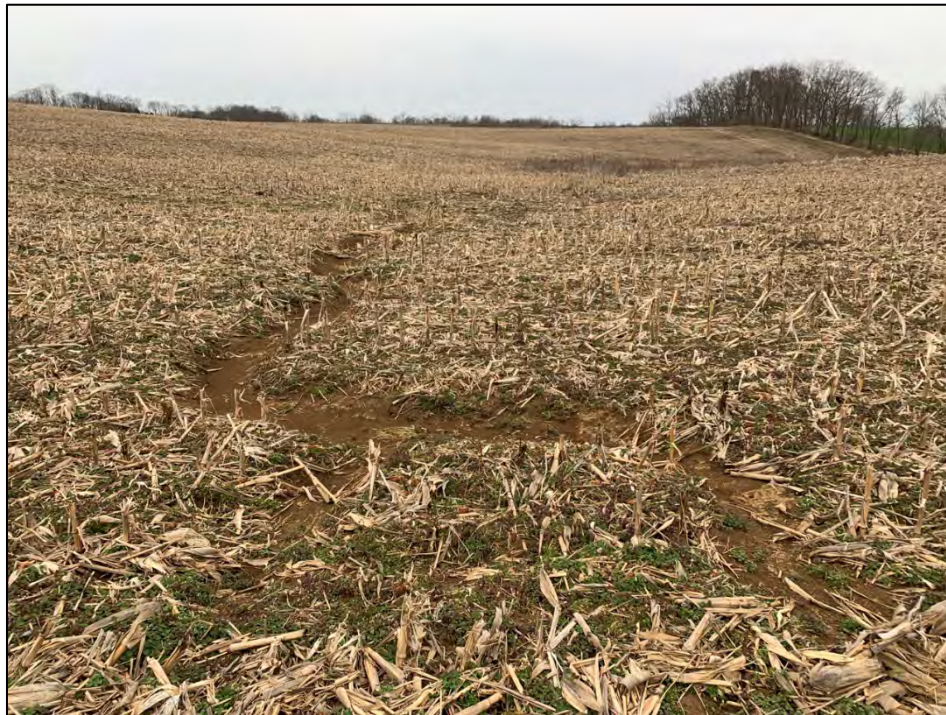
**Photo 64:** Typical view of Channel 40, from its headwater facing west. Photo taken on March 17, 2021.

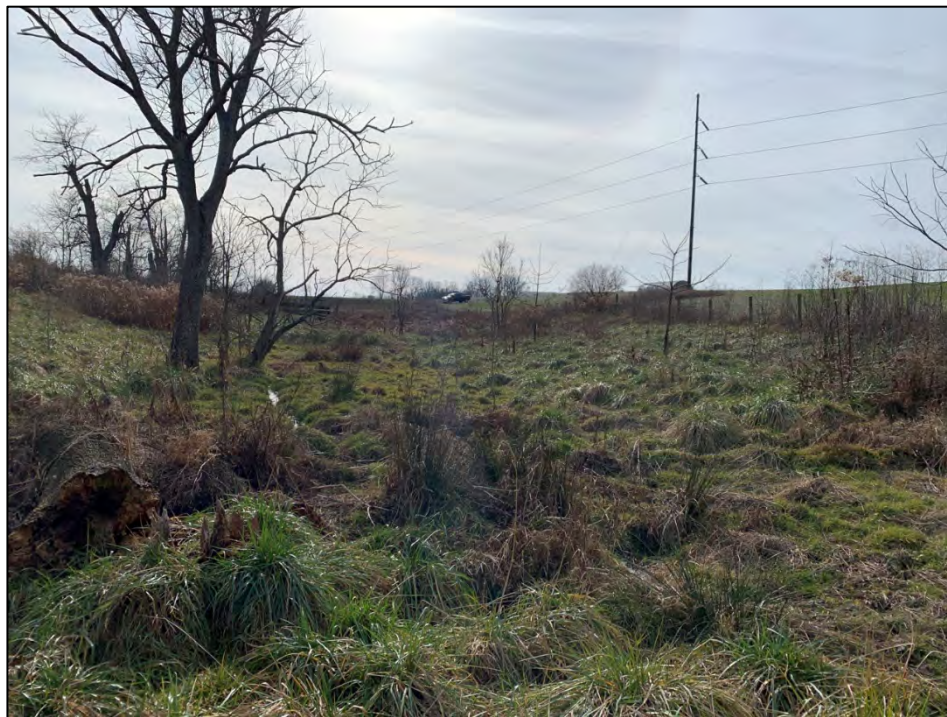
**Photo 4:** View of a NWI wetland located within a large swale in the southern portion of the project area, looking south.

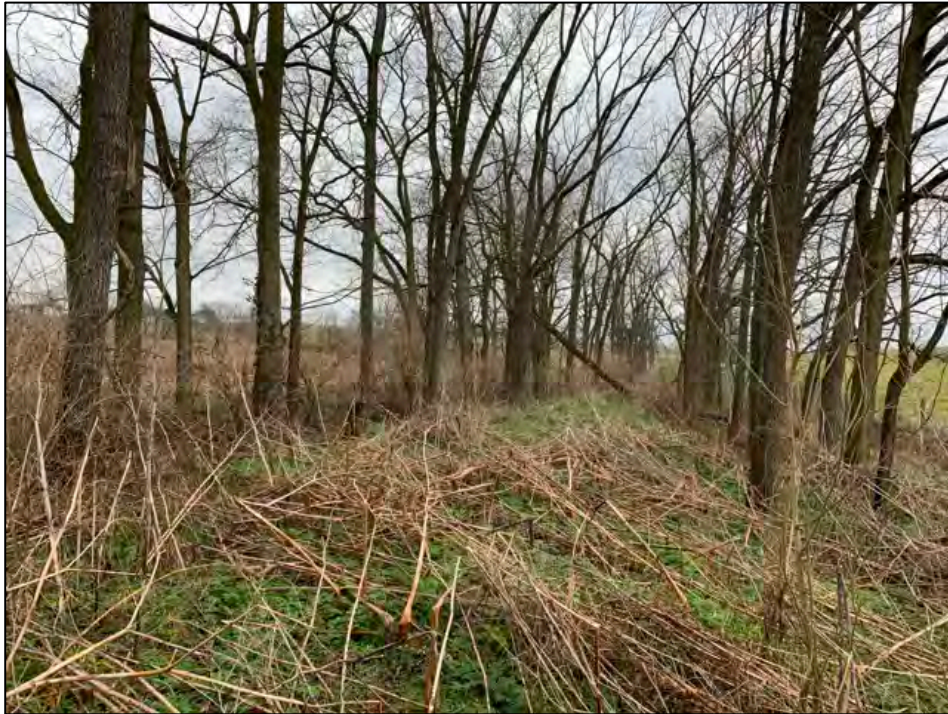
**Photo 6:** View of a now-overgrown railroad berm within the project area, crossing the Site from southeast to northwest; photo taken in the southeastern portion.
