- Attn: Mr. Matt Towery, P.E. P: (561) 691-2249 E: matt.towery@nexteraenergy.com
- Re: Karst Feature Survey and Assessment Report Green River Solar Meade and Breckenridge Counties, Kentucky Terracon Project No. JD215085

# **1.0 PROJECT INFORMATION**

Green River Solar 
Meade and Breckenridge Counties, Kentucky November 11, 2021 
Terracon Project No. JD215085

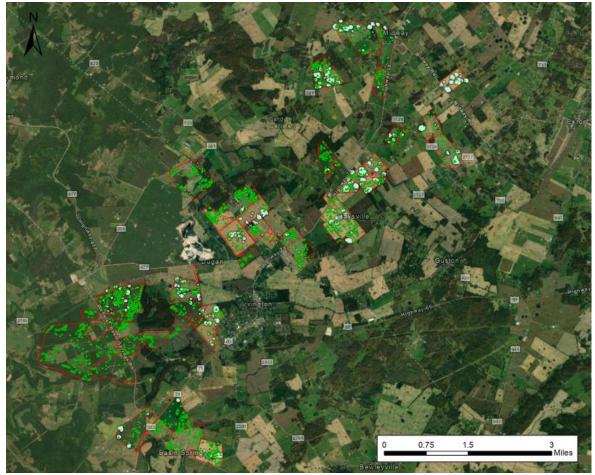
Based on the methods and procedures for the data review as detailed previously in Section 2.1, suspect karst features were identified throughout the site. In total, one thousand and forty-six (1,046) point karst features and one hundred and thirty-six (136) area karst features were identified within the AOI for a total number of one thousand and one hundred and eighty-two (1,182) suspected karst features (Figure 1; Appendix D, Table 1). The largest area features

Figure 1. Map of the AOI showing the distribution of suspect point and area karst features.

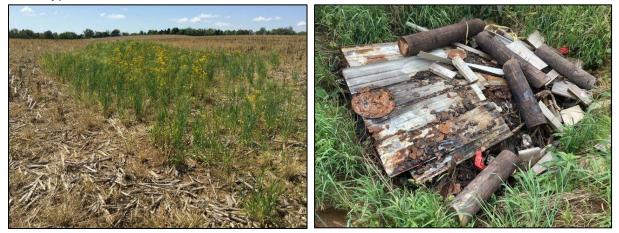
**Character 2 –** The presence of an open throat (e.g. an opening into the subsurface, usually at the base of a sinkhole, an opening within a rock outcrop, or a cave entrance) in a karst feature is important since it may allow the unimpeded flow of surface runoff into the subsurface and eventually the groundwater table. This is a serious environmental concern to the groundwater and proper erosion and sediment control and buffering must be utilized during construction around these types of karst features.

Absent = 0

Small/Unknown = 1 (unknown)

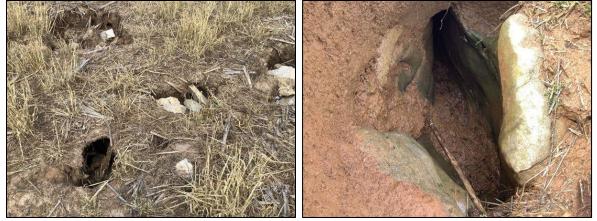
Small/Unknown = 1 (small)

Large/Open = 2

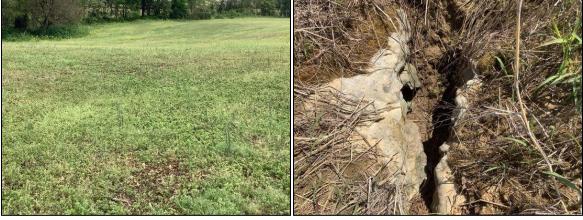
No Raveling = 0

Minor Soil Raveling = 1

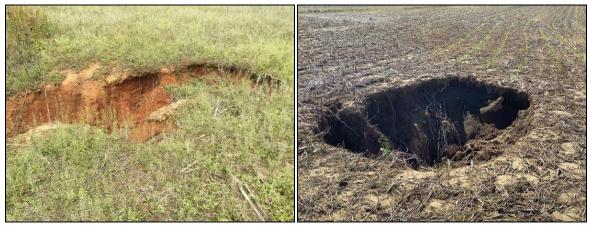
Major Soil Raveling = 3

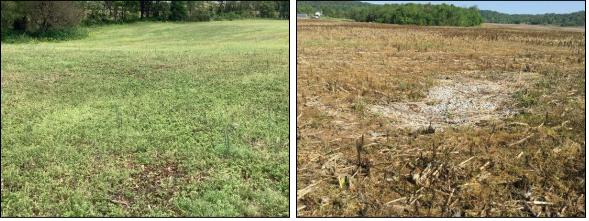
**Character 4** - An important factor that we note when assessing karst features is evidence for surface drainage focused into the karst feature. This is typically manifested as matted down grass/vegetation in the direction of the sinkhole in the case of surface runoff (sheet flow) or distinct erosion and channel development where water commonly drains into the karst features. If the channel leading to the karst feature exhibits signs of erosion and downcutting, then this further supports the notion that the karst feature base level is decreasing and typically growing. It should be noted that it is very difficult to differentiate between "no drainage" and "sheet flow", as only a slight downward gradient of even gentle slopes will result in sheet flow to a feature. This type of flow is often attenuated by vegetation, plow lines, or soil irregularity. Thus, if it is uncertain that a feature receives sheet flow versus no flow, it is always coded conservatively (i.e. using sheet flow). Finally, it should be noted that some features exhibit flow channels that drain towards the feature (an insurgence or "swallet"), and in some cases away from the feature (i.e. an ephemeral or "wet weather" spring). In rare cases they may receive flow during low water table conditions and reverse their flow during a high water table (referred to as an "estavelle"). However, we code any well-developed flow channel the same (see below).

No evidence of drainage = 0

Sheet flow = 1 (washed-in plant debris)

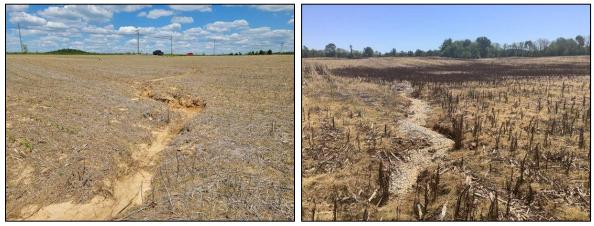
Drainage channel = 2 (flow towards feature) Drainage channel = 2 (flow away from feature)

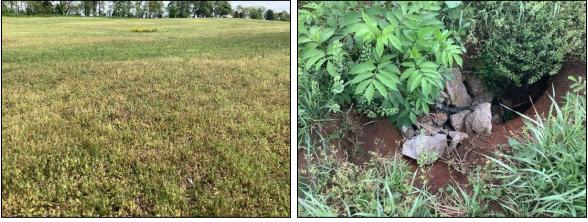
**Character 5** - The presence, type, and state of vegetative cover surrounding and within the karst feature is an indicator for sinkhole development and the existence of a natural buffer. If little to no vegetative cover is present within the sinkhole then this indicates that it is changing fast enough to inhibit plant growth and is vulnerable to surface runoff. If the sinkhole is overgrown, then this signifies that the sinkhole is more stable and that a natural vegetated buffer is present, which functions to filter out suspended soil/contamination in surface runoff.

Fully vegetated = 0

Partially vegetated = 1

Soil/rock = 2 (failed backfill)

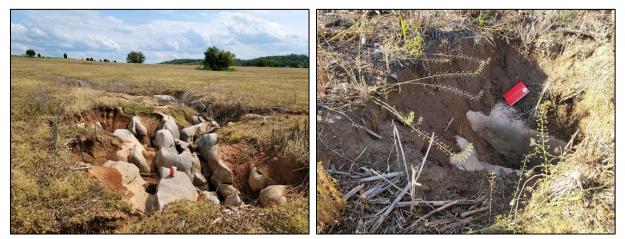
**Type 1** – This type of karst feature is characterized by the presence of an open throat at the base and active erosion along the walls and parapet of the feature. These features are considered the highest risk since they are actively growing and may continue to collapse and widen during construction activities and post development. Two examples of such features are shown below in Image 1.

**Image 1**. Both sinkholes are undergoing erosion and expansion of the parapet limits as demonstrated by the rough, raveling, and incised surfaces. In addition, the open throats present in the base of the sinkholes readily receive surface runoff with little to no filtration.

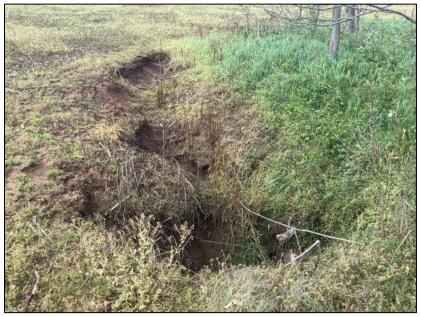
**Type 2** – This type of karst feature is characterized by the presence of an incised drainage channel leading to the karst feature indicating that focused drainage enters the structure. This commonly results in active erosion and growth of the sinkhole (Image 2). In addition, they nearly always contain an open throat. Additionally, these features can be problematic as potential construction activities within the drainage may result in the uncontrolled flow of water transporting sediment and contaminants into the subsurface via the open throat. Awareness of the drainage catchment extent and implementation of proper erosion and sediment controls (ESC) are crucial for these types of karst features.

Image 2. Example of feature with drainage channel leading to open throat.

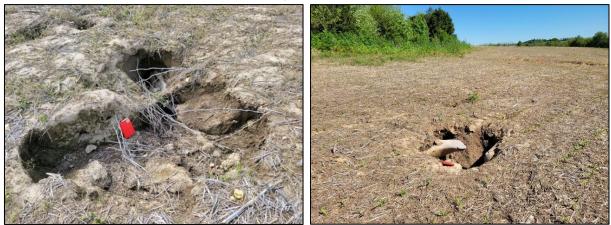
**Type 3** – This type of karst feature has an open throat and rough, irregular parapet edges, indicating active erosion, collapse, and growth. The features are typically small (<5 feet) yet indicate that the area around the soil piping is undergoing sinkhole development which may widen, deepen, and affect the surrounding area (Image 3). It is commonplace to observe multiple soil piping features which may all be feeding into a single open throat in the subsurface. These features pose a significant risk because the karst features are actively developing; therefore, official remediation or avoidance is necessary.

**Image 3.** Examples of soil piping structures and open throats which are newly developed and indicate that growth and widening of these features is likely.

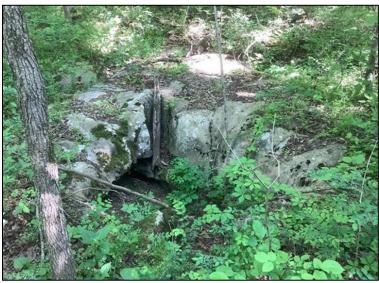
**Type 4** – This type of karst feature is a sinkhole with a cave entrance located at the base or within the sidewall of the structure (Image 4). Caves pose a significant risk since they are relatively large openings that can receive surface runoff, may contain significantly sized chambers and passages below the surface, and may host cave fauna and sensitive biological habitats. Aside from having certified spelunkers enter the caves and map out the passages, geophysical techniques are often utilized to determine the presence, extent, depth, and size of cave passages in relationship to planned construction.

Image 4. Sinkhole with cave entrance in left sidewall.

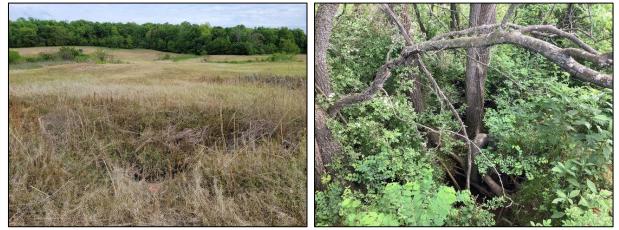
**Type 5** – This type of karst feature has an open throat within the structure, yet the remainder of the sinkhole is overgrown with vegetation and the parapet appears to be stable<sup>3</sup> (Image 5). Although there is an opening present leading into the subsurface, the protection and stabilization of the feature by maintaining a vegetated buffer dramatically reduces the risk of impacting the subsurface habitat during construction activities.

**Image 5.** Examples of overgrown open throats located at the base of sinkholes. The presence of the plant life indicates that little to no recent erosion has occurred.

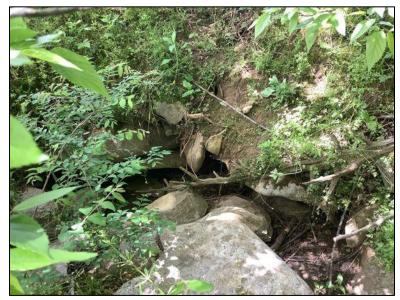
**Type 6** – This type of karst feature is characterized by bedrock bound open throats and rock outcrops either located at the base of sinkholes or within generally flat laying bedrock benches (Image 6). Although the open throats clearly connect to the subsurface, the bedrock does not present much risk of collapse or change in architecture unless the bedrock layer is very thin above an open chamber.

**Image 6.** Bedrock bound open throat located within a bedrock outcrop.

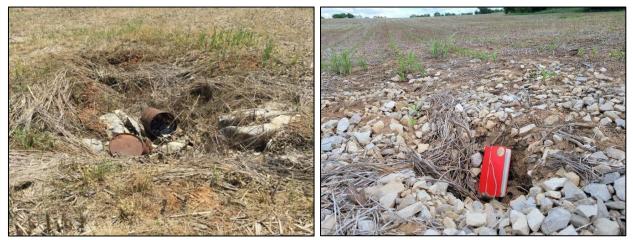
**Type 7** – This type of sinkhole has been used by farmers and landowners as a convenient place to deposit field rock, trees, trash, and a menagerie of various items and materials. This practice of depositing trash is highly discouraged since the contaminants originating from the infill material may quickly reach and may affect the subsurface aquifer. Nevertheless, these karst features were present within the AOI and most typically observed to be infilled with trash and occasional trees (Image 7). Since these may have been partially or completely filled, it is impossible to fully characterize these features for the presence or absence of an open throat. Therefore, we assume that there is an open throat at the base in order to be conservative for protection measures during construction activities.

A second type of sinkhole that falls into this category are ones which have been backfilled by local farmers using gravel or soil. These are very common at the Green River Site, and inevitably occur within areas of row crop cultivation. These sinkholes which were "remediated" by the landowner are extremely common within the area of the current field survey, comprising nearly half of all the identified features. In many cases they appeared to be stable, with no evidence of reactivation (i.e. the development of a new throat). However, it is impossible to determine when, and if, features like these might undergo renewed development and collapse, since the point in time when they were actually backfilled is generally unknown. Therefore, interviews with the landowner can assist in determining the stability of the features based on when they were backfilled and how often new features tended to appear within a specific parcel of land.

**Image 7.** Examples of a trash filled sinkhole observed during the field survey (left), and a backfilled sinkhole in a planted field (right). Note that the backfilled sinkhole has begun to reactivate, and a new throat is beginning to form.

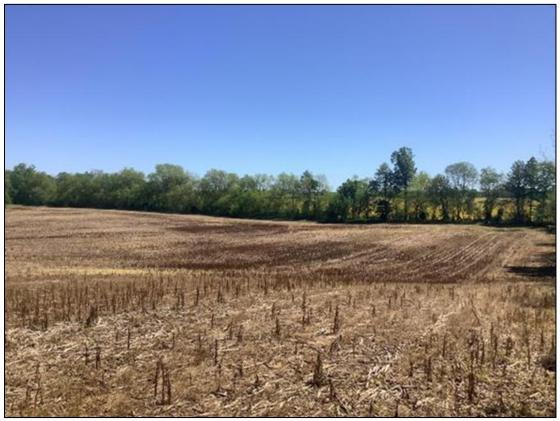
**Type 8** – This type of sinkhole is present as a broad and shallow depression, ranging in size from tens to hundreds of feet in diameter and commonly referred to as a "mature" or paleokarst sinkhole (Image 8). Mature sinkholes often have a roughly circular parapet outline, are bowl shaped, lack any opening to the subsurface (i.e. "throat"), and do not show evidence of active soil raveling or tension cracks around the parapet. Thus, whatever conduit or opening into the underlying karst aquifer that may have functioned to create the structure is probably now clogged with soil, which would act as a filter for water infiltrating from the surface.

Image 8. Large closed depression in a previously harvested cornfield.
