**Kentucky State Board on Electric Generation and Transmission Siting  
McCracken County Solar, LLC – Case No. 2020-00392  
Application – Exhibit 14  
Volume 2, Tab 14**

**Additional Information**

**Case No. 2020-00392  
Application - Exhibit 14  
Includes five Attachments**

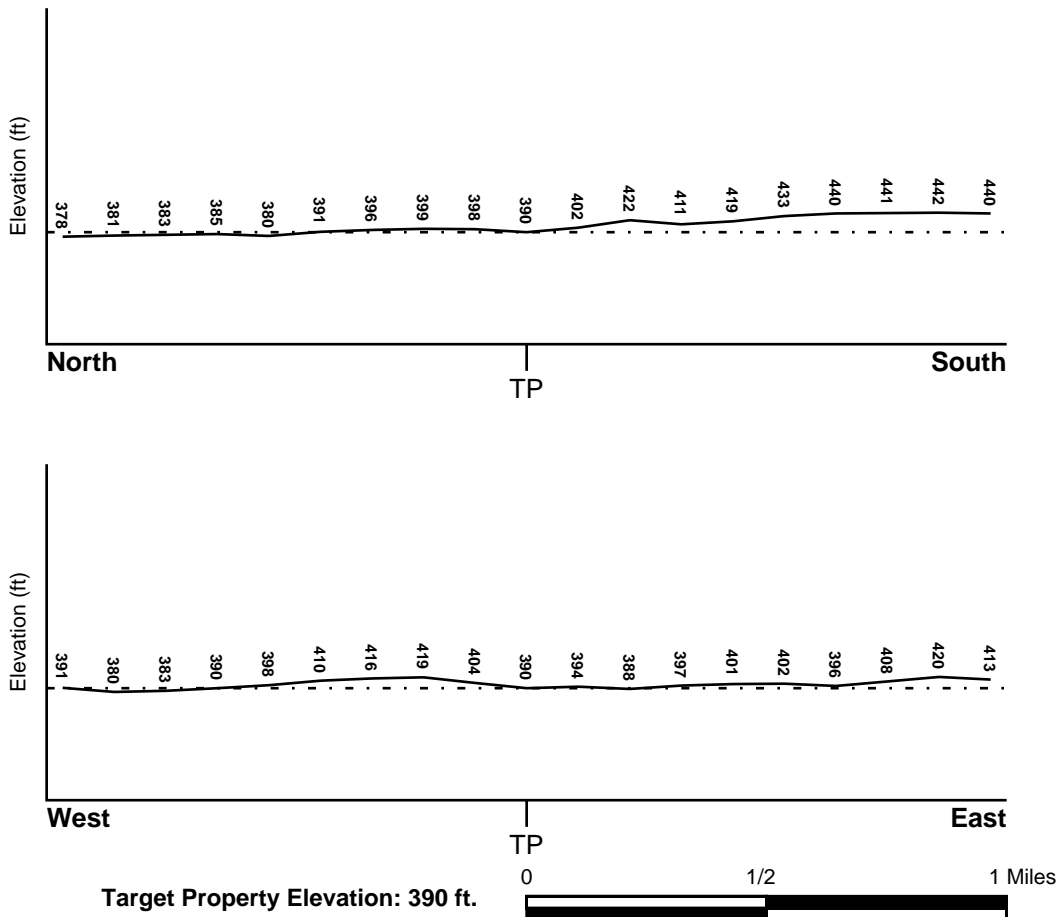
### SURROUNDING TOPOGRAPHY: ELEVATION PROFILES

Source: Topography has been determined from the USGS 7.5' Digital Elevation Model and should be evaluated on a relative (not an absolute) basis. Relative elevation information between sites of close proximity should be field verified.
