Preliminary Karst Assessment

**Proposed Hoffman Solar Project – Summers Parcel
Franklin, Simpson County, Kentucky**

November 30, 2020
Terracon Project No. 57195114

Re: Preliminary Karst Assessment
Proposed Hoffman Solar Project – Summers Parcel
Tyree Chapel Road
Franklin, Simpson County, Kentucky
Terracon Project No. 57195114

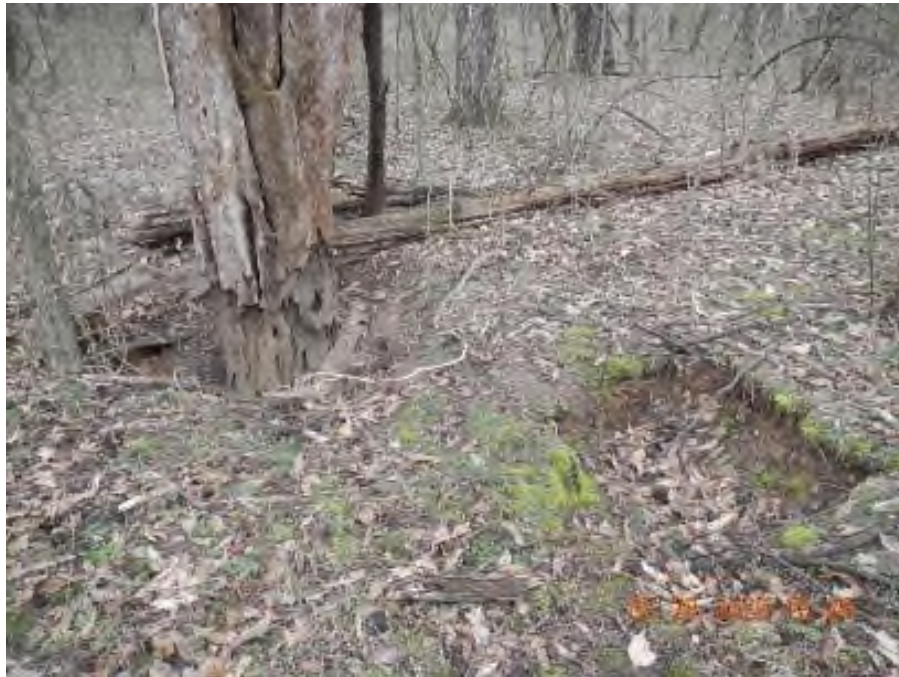
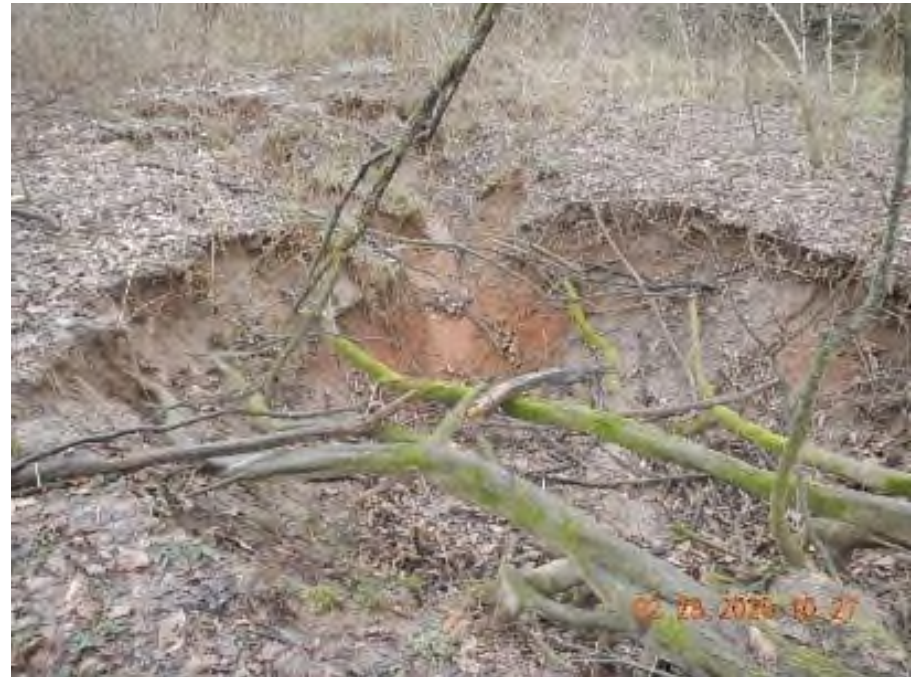
Photo 101

Feature F-48: Multiple sinkholes in wooded area on southern portion of property.
with open throat.

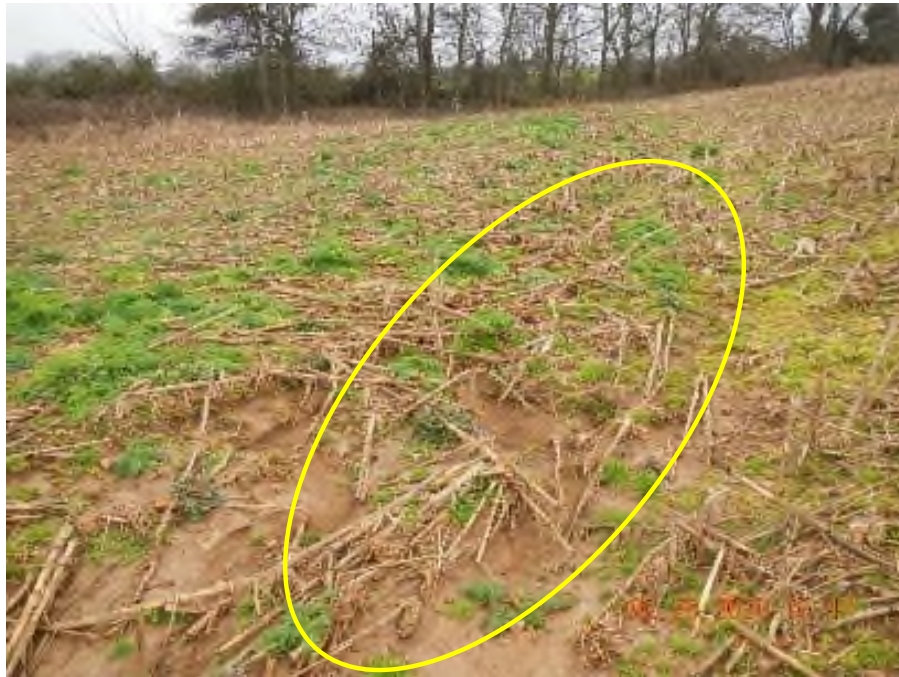
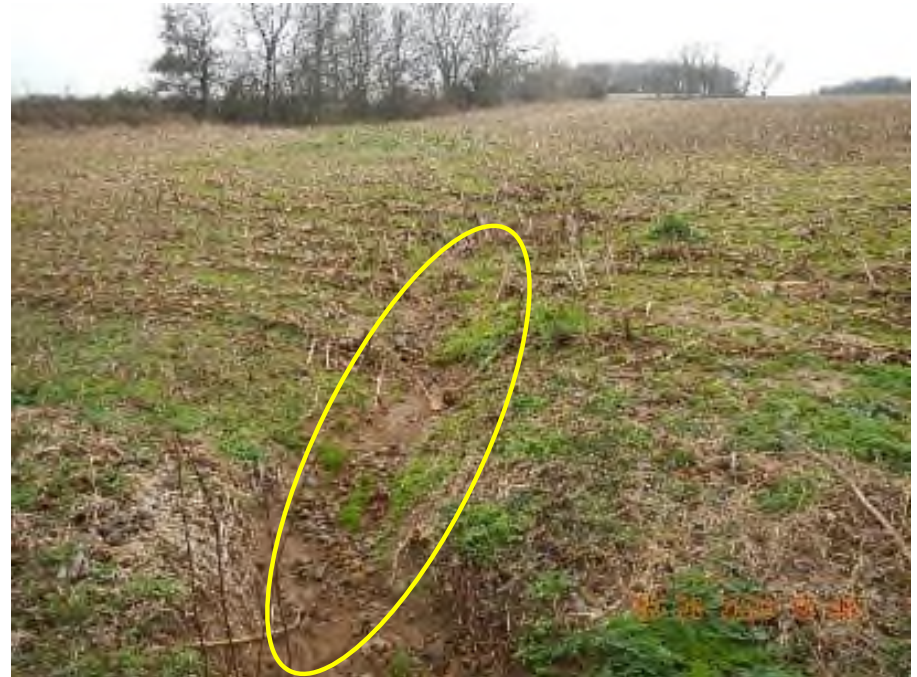
Photo 103

Feature F-49: Surface water drainage and rill erosion draining to wooded area.

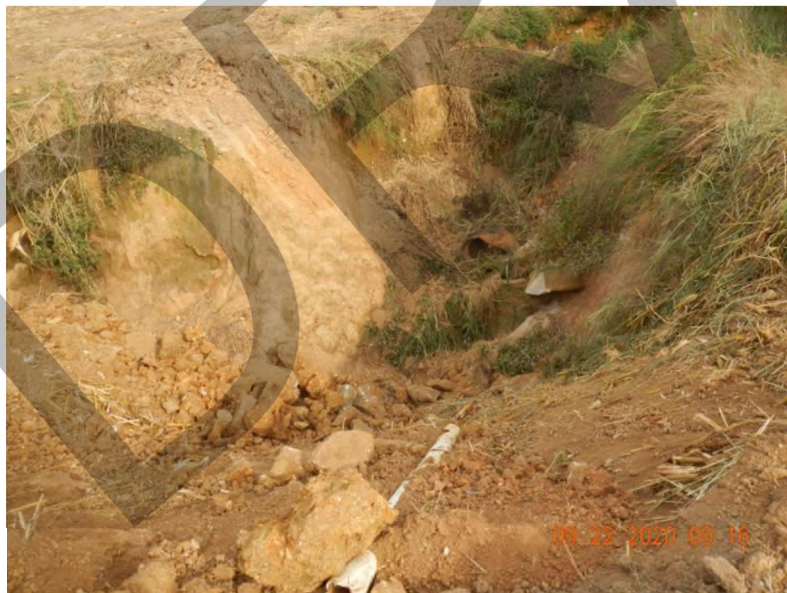
Feature F-56 is noted as in the vicinity of a freshwater pond mapped by the USFWS NWI. At time of reconnaissance the feature's open throat appeared to have been modified with soil apparently dug out and staged next to it. Multiple open throats were observed within the feature along the side walls and floor. In addition to exposed bedrock, debris was observed within the feature. The irregular shaped feature was approximately 20ft by 40 ft and approximately 15 to 20 ft deep. Our geophysical exploration ERI-16 indicated an anomaly located at approximate depth of 20 ft and extending to 40 ft below the ground surface at feature F-56 perimeter.

Figure 1: View of feature F-56, apparent modified sink with multiple open throats.

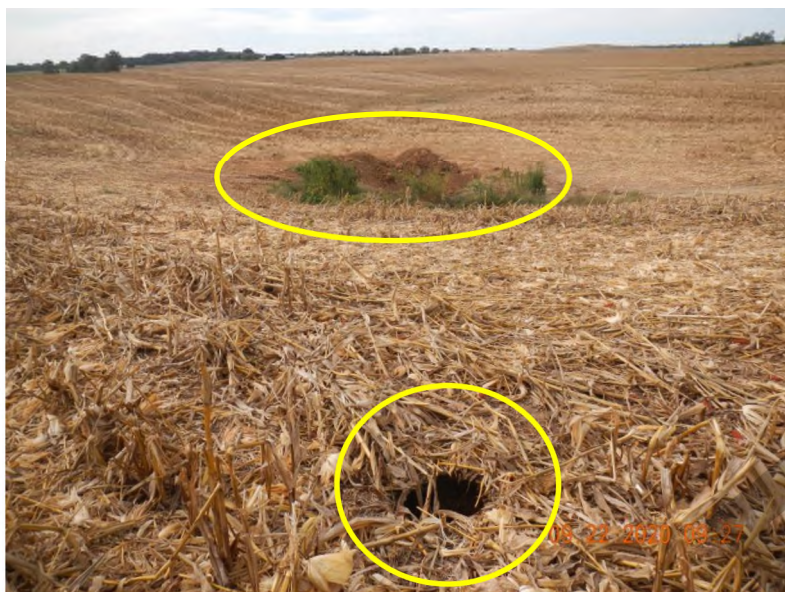
Figure 2: View of small cover collapse features F-80 (foreground) and F-56 (background).

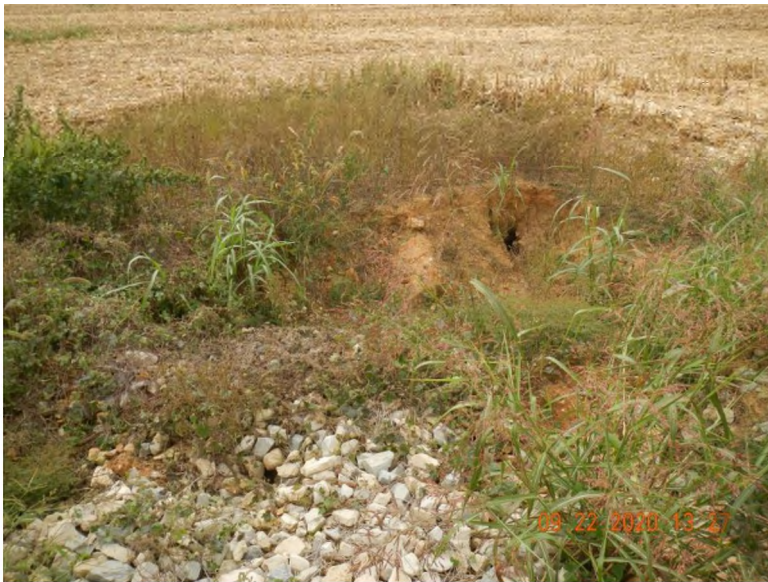
Features F-73, F-74, and F-75 appear to have been previously filled with rock and soil, however, soil piping or throats have since reopened with these features. Features F-73 are in the proximity of NWI map freshwater ponds on the northern portion of the parcel. Our geophysical exploration ERI-14 indicated a 224-foot long anomaly on the east side of the feature F-74 located approximately at depths ranging between of 15 to 30 ft below the ground surface. ATP-34 and ATP-35 located at east side of feature F-74 indicated approximately similar bedrock depths, no voids were encountered by these ATP borings.

Figure 3: View of feature F-73, reopened throat that was one filled with soil and rock.

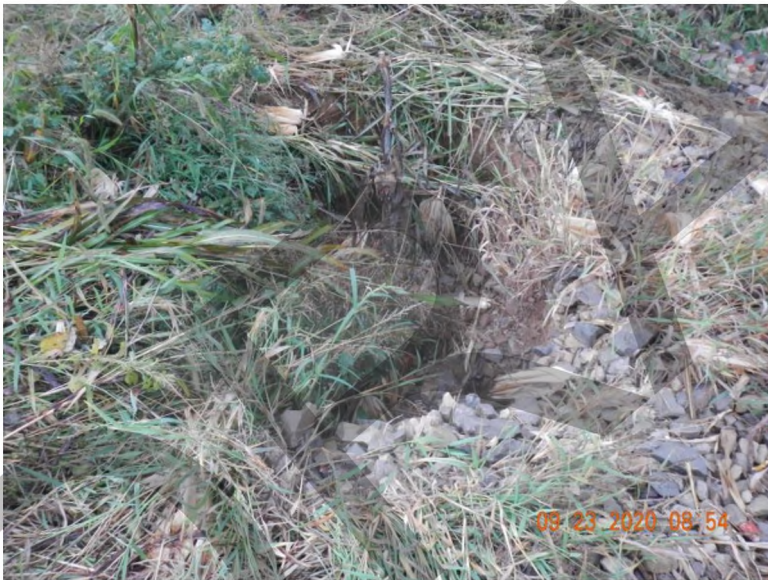
Figure 4: View of feature F-75, reopened throat that was one filled with soil and rock.

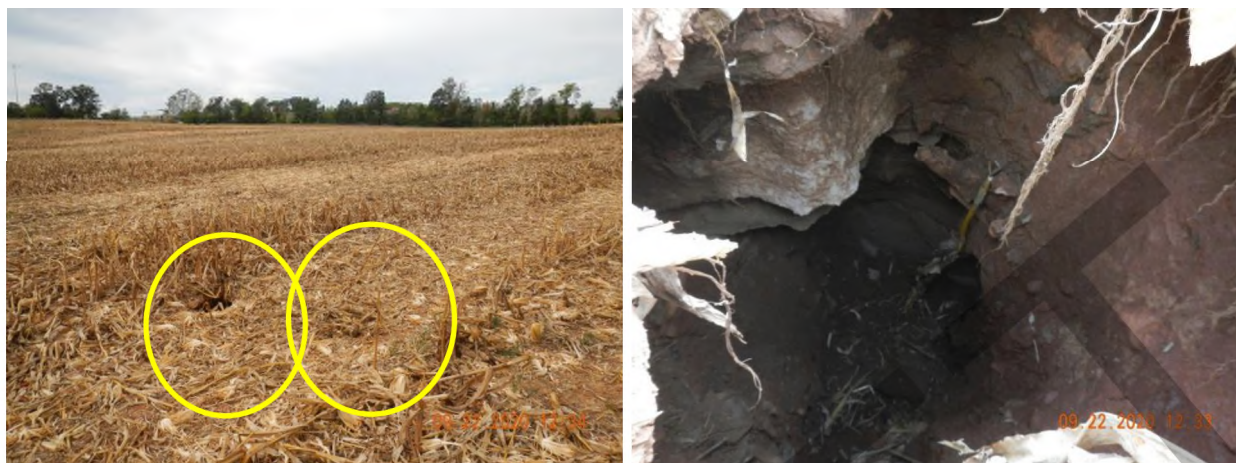
Feature F-72 is a small collapse approximately two feet in diameter with exposed bedrock close to the surface and a visible open throat. The ERI-14 indicated about 1,015-foot long anomaly located on the west side of the feature F-72. ATP-29 through -32 drilled in the vicinity of the feature and anomaly encountered multiple soil-filled voids and weathered rock zones within the bedrock.

Figure 5: View of feature F-72, cover-collapse sinkhole.

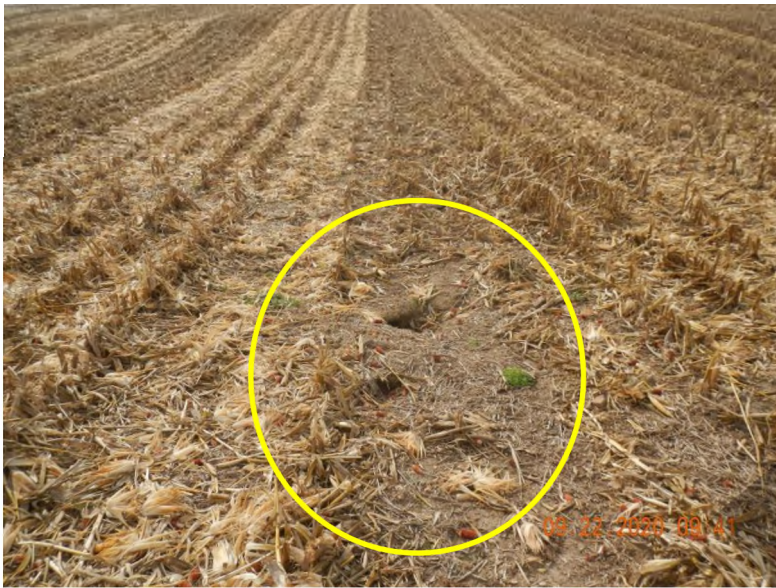
Multiple incidents of cover collapse features with soil piping were observed throughout the site located inside the depression areas (features F-60, F-61, and F-65). Exposed bedrock was not observed with the throats of features. These features are usually connected to a drop in the water table and form with a lowering of the water table. The features appeared to be relatively small in diameter (one to three feet) and ranged in depth from one to four feet deep.

Figure 6: View of feature F-60, soil piping on central portion of parcel.

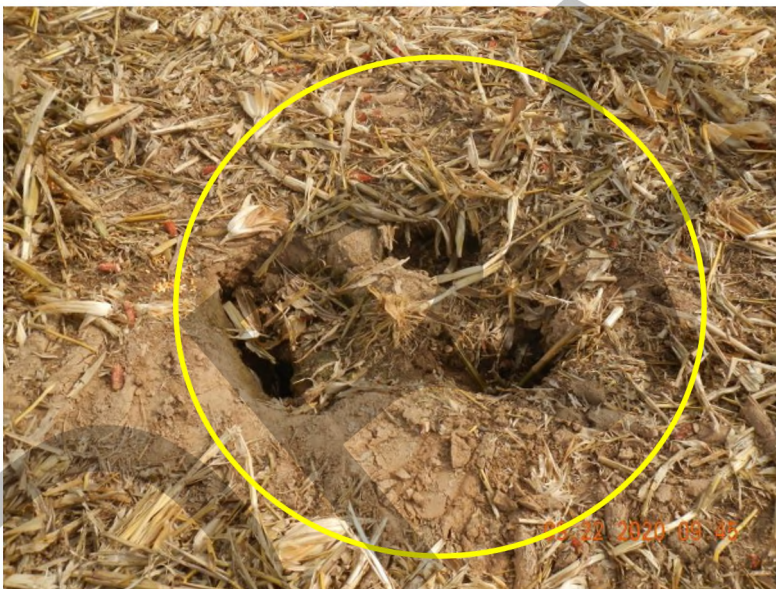
Clusters of open throats in one area was observed at features F-61 and F-65. The cluster of open throats were observed to be inside the depression area. ERI-16 results indicated two anomalies on the west side of feature F-60 and F-61. ATP-9 located at the vicinity of feature F-60 indicated two soil-filled and weathered rock zones at the depth of 16 ft and 21 ft, and two void zones within the underlying bedrock from a depth of about 15 ft to 16 ft, and 24 ft to 29 ft. ATP-10 located at the vicinity of feature F-61 indicated one soil-filled zone at the depth of 27 ft and 28 ft, and two void zones within the underlying bedrock from a depths of about 15 ft to 16 ft, and 19 ft to 20 ft.

Figure 7: View of feature F-61, soil piping on central portion of parcel.

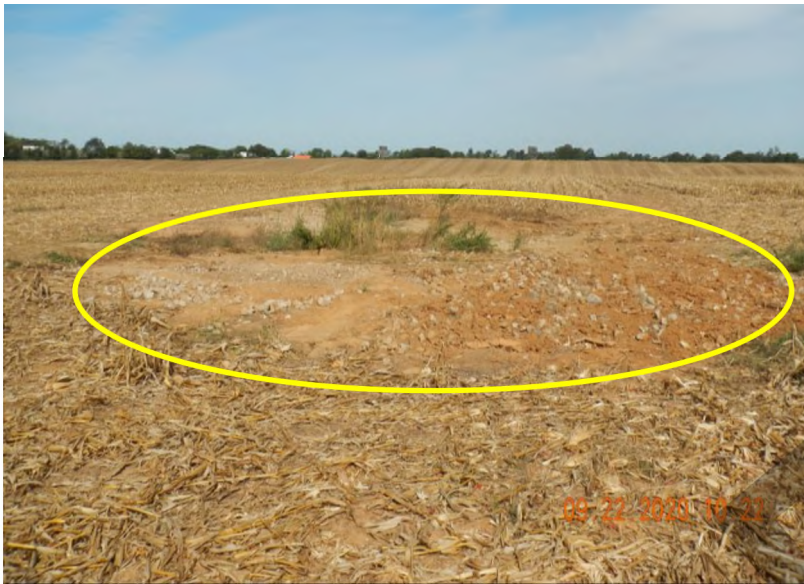
Feature F-67 appeared to be a filled-in cover-collapse sinkhole in the vicinity of a NWI mapped freshwater pond.

Figure 8: View of feature F-67: Filled-in cover-collapse sinkhole in the vicinity of a NWI freshwater pond.

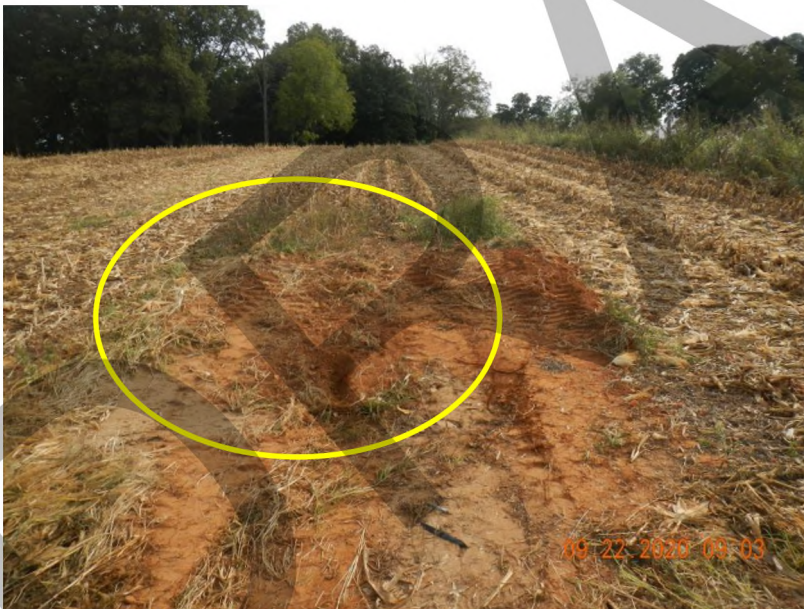
At feature F-55 we observed an apparent filled-in cover-collapse sinkhole.

Figure 9: View of feature F-55, area of apparent fresh disturbed soil.

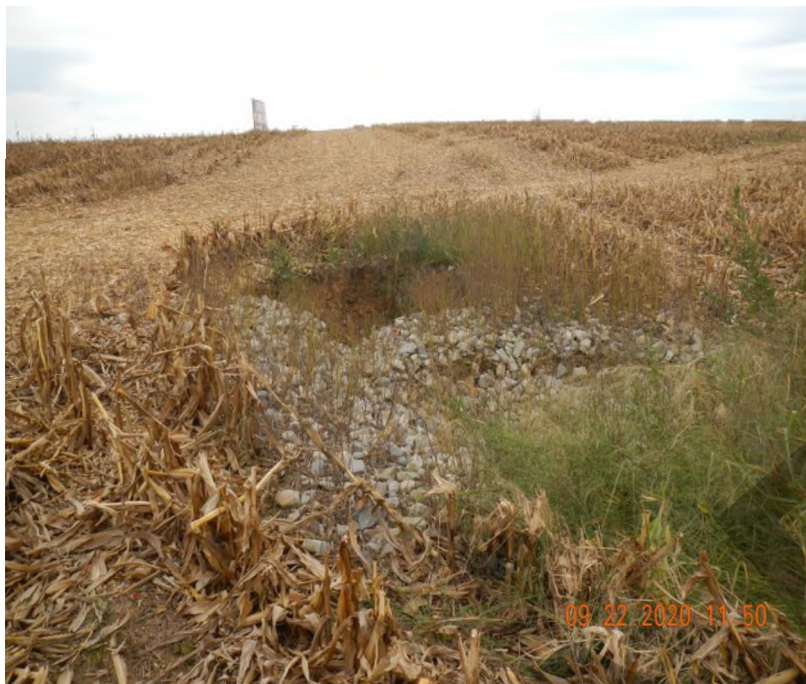
Feature F-70 is located on the west side of ATP-26 and ATP-27 in the proximity of mapped wetland area by Terracon on the northern portion of the parcel. It appears that F-70 is a cover collapse feature filled with soil and rock, but no open throat was observed at the time of our site reconnaissance.

Figure 10: View of feature F-70, reopened throat that was one filled with soil and rock.

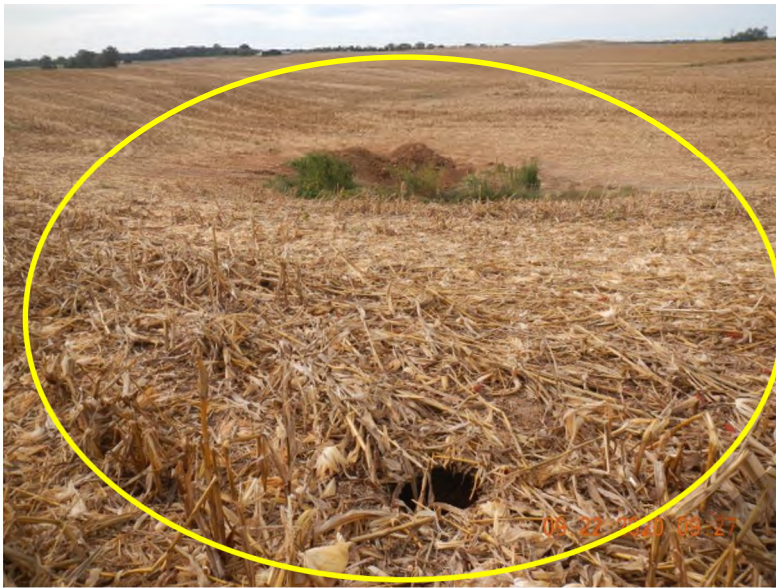
Figure 11: View of feature F-57, cover collapse feature F-80 (foreground) upgradient from F-56 (background).

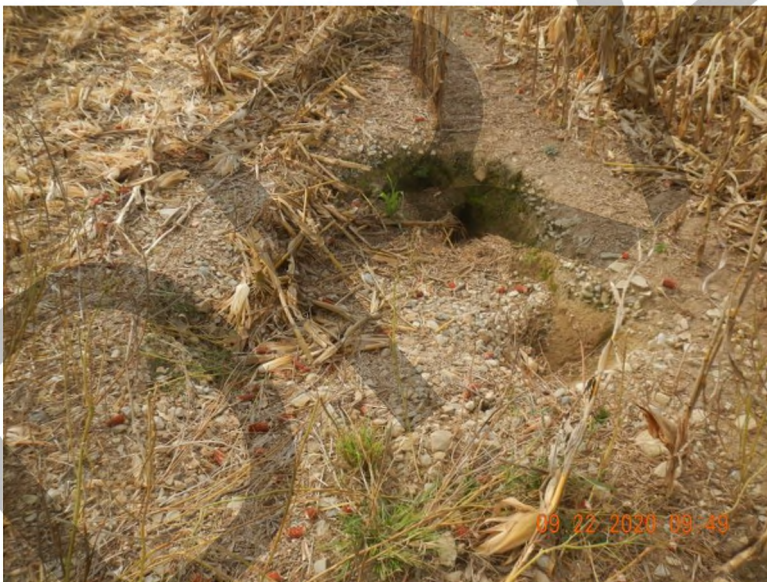
Feature F-63 is approximately 225 by 330 feet and about 15 feet deep. The reopened throat appeared to have been covered in soil and gravel. ATP-23 located at about the center of feature F-63 did not encounter voids in the underlying bedrock.

Figure 12: View of feature F-63, reopened throat that was filled with soil and gravel.

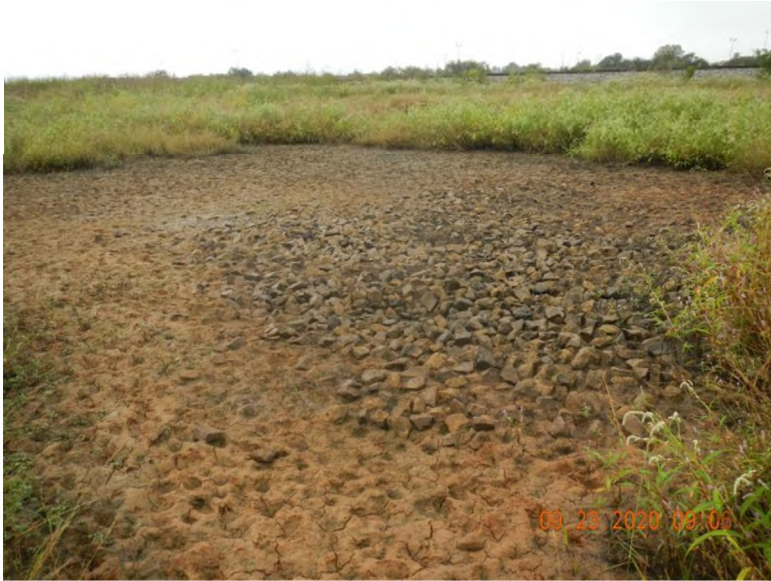
Feature F-76 is in the proximity of NWI map freshwater pond. The feature appears to have been filled with soil and rock where a throat has reopened. Observations of vegetation and ground surface indicate potential estavelle, closed depression that acts as an insurgence for surface water during dry periods, and floods or acts as an ephemeral spring during times of water table elevation.

Figure 13: View of feature F-76, reopened throat that was one filled with soil and rock.

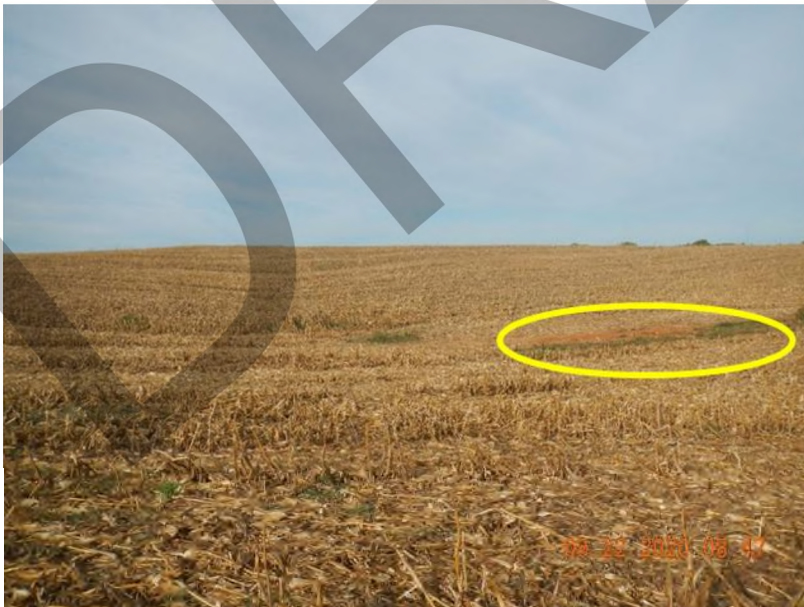
Feature F-54 is approximately 390 by 350 feet and about 30 feet deep. The filled in open throat appeared to be covered with fresh soil and gravel. The ERI-15 results indicated two anomalies on the center-north side of feature F-54 at depth ranging between about 15 to 20 feet below the ground surface. ATP boring ATP-37 located at center of feature F-54 indicated two 5-foot thick voids within the underlying bedrock at depths of about 28 to 33 feet, and two 7, and 17-foot thick void zones at depths of about 16 ft to 33 ft and 34 ft to 41 ft below the ground surface. Features F-58 and F-64 were small, gently sloped cover subsidence with an apparent fresh soil and gravel filled open throat.

Figure 14: View of feature F-54, large cover subsidence with apparent backfilled filled-in open throat. Multiple surface drainage pathways and soil piping on interior walls.

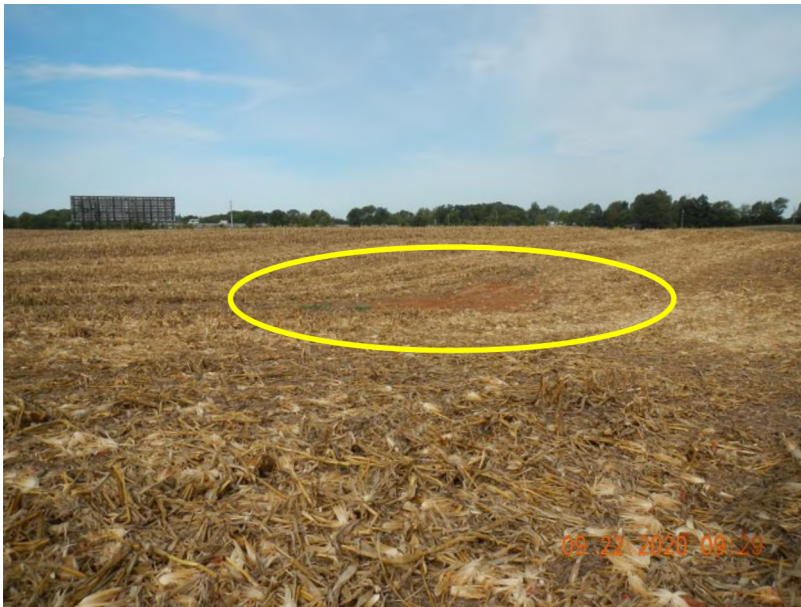
Figure 15: View of feature F-58, small, gently sloped cover subsidence with an apparent fresh soil and gravel filled open throat.

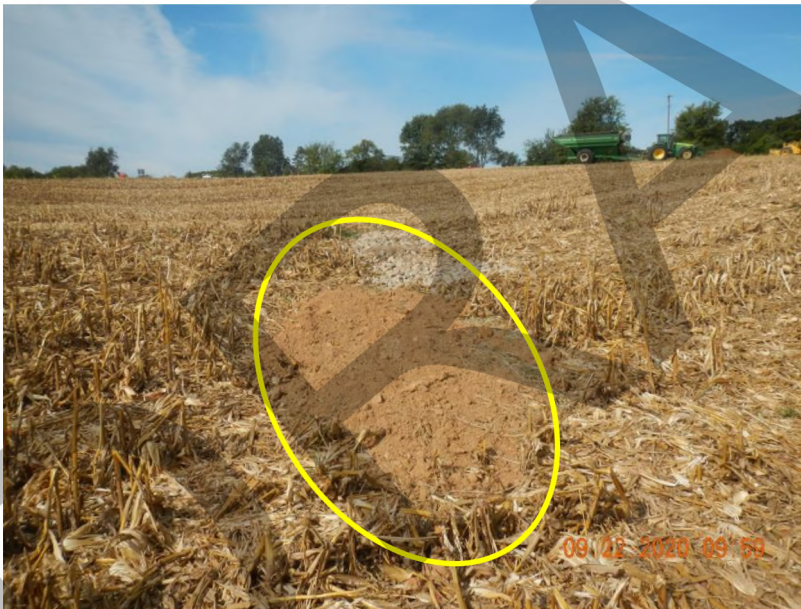
Figure 16: View of feature F-64, small, gently sloped cover subsidence with an apparent fresh soil and gravel filled open throat.

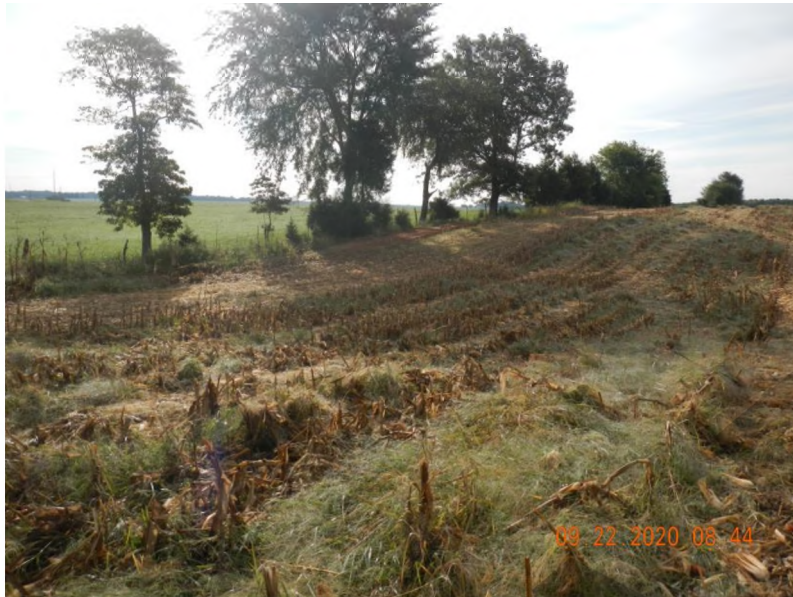
Feature F-53 is located on the southeastern portion of the parcel adjoining to feature F-54.

Figure 17: Feature F-53: Small, gentle sloped cover subsidence with no open throat observed.

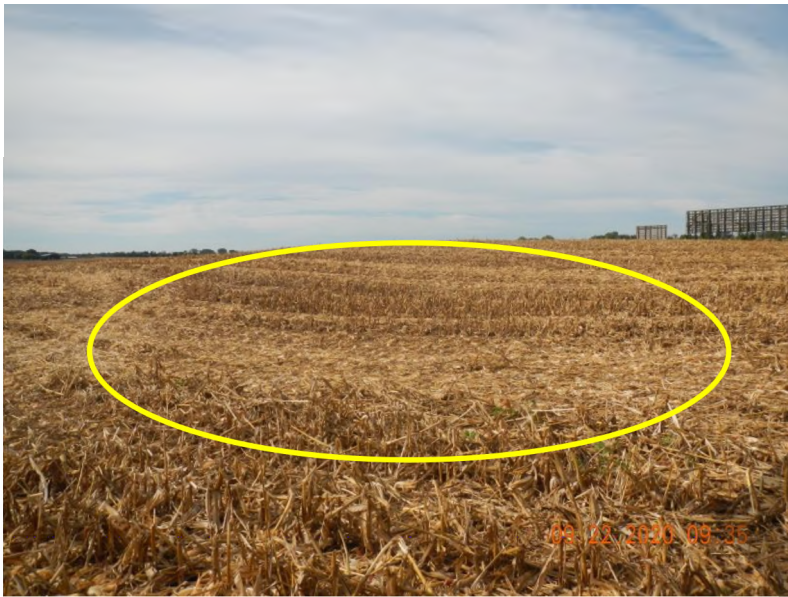
Features F-59 and F-62 was identified to be on the northeastern portion of the parcel Feature F-59 was located due east of the existing billboards. ATP boring ATP-7 located at center of feature F-59 indicated one 23-foot thick voids within the underlying bedrock at depths of about 15 to 38 feet, and two 1 to 2-foot thick weathered rock zones at depths of about 41 ft to 42 ft and 46 ft to 48 ft below the ground surface.

Figure 18: View of feature F-59, small, gentle sloped cover subsidence sinkhole with no open throat observed.

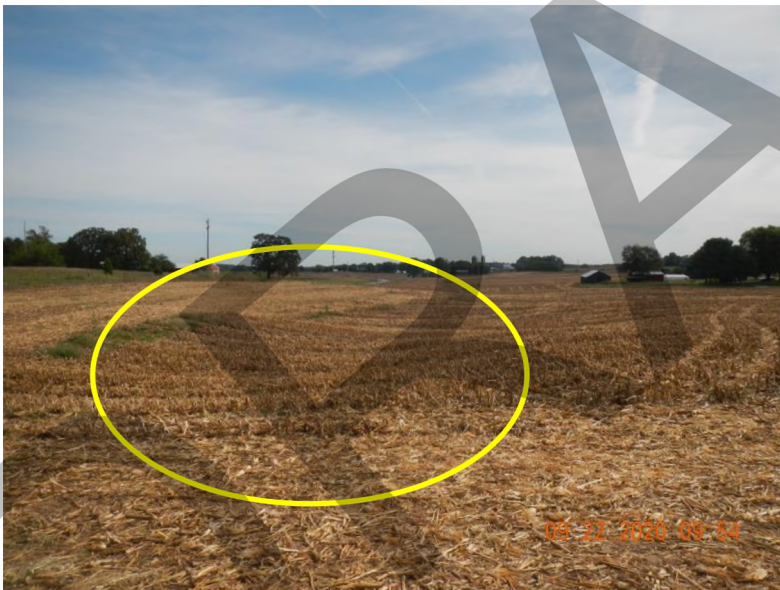
Figure 19: View of feature F-62, small, gentle sloped cover subsidence sinkhole with no open throat observed.

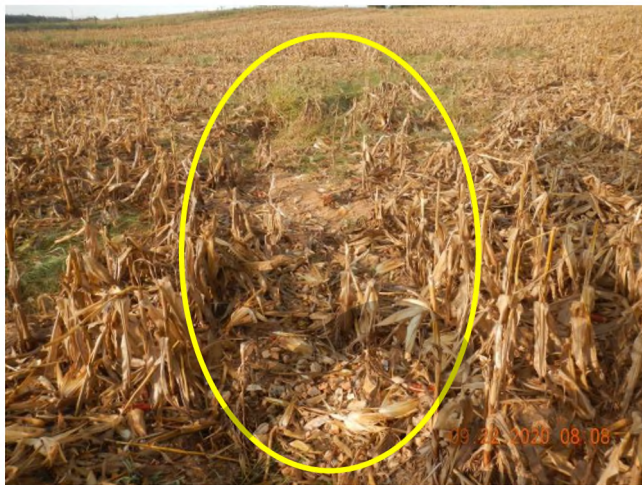
While not a karst features themselves, surface drainage channels of concentrated surface water flow in karst areas may development of soil-piping features and sinking streams which provide direct pathways to the subsurface. This study noted 3 continuous surface drainage channels on the Summers parcel forming erosion rills (features F-52, 66, 68,69, and 71). Some of these areas were highly vegetated. The features all have an east to west trend with one in the middle of the parcel forking to the south. Based on the review of the historical imagery database in Google Earth Pro™ for the years between 1998 to 2017, it appears that feature F-52 is located in the footprint of a possible historic farmer pond or filled-in sinkhole with holding water. At the time of our site reconnaissance, we did not observe any evidence of the pond or surface water at vicinity of feature F-52.

Figure 20: View of feature F-52, erosion rill and surface drainage pathway on southern portion of the parcel.

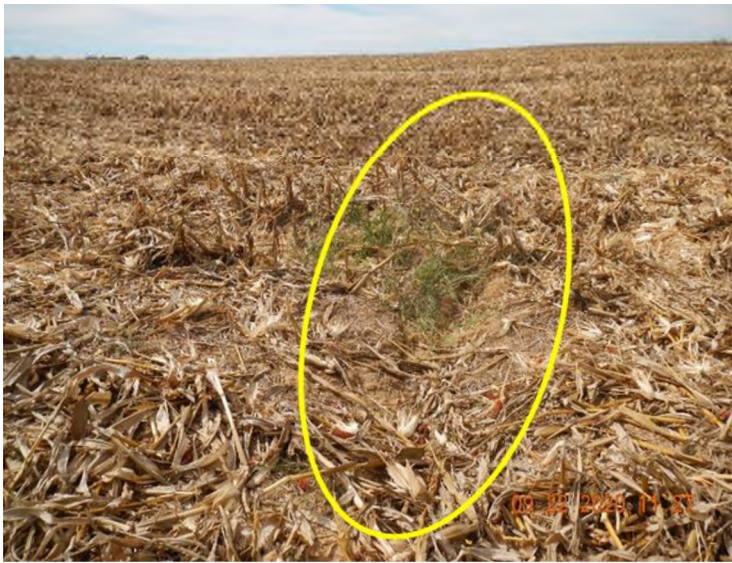
Figure 22: View of feature F-68, erosion Rill and surface drainage pathway on central of the parcel. No open throats or soil piping was observed.

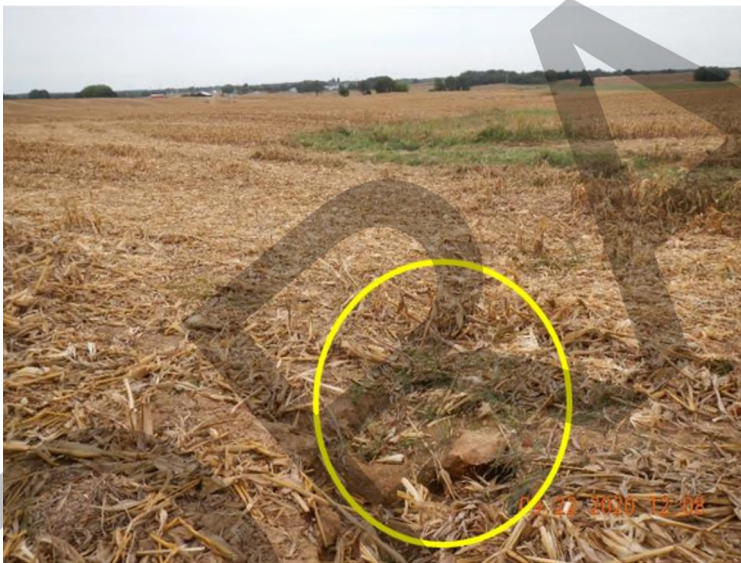
Figure 23: View of feature F-71, erosion Rill and surface drainage pathway on central of the parcel. No open throats or soil piping was observed.

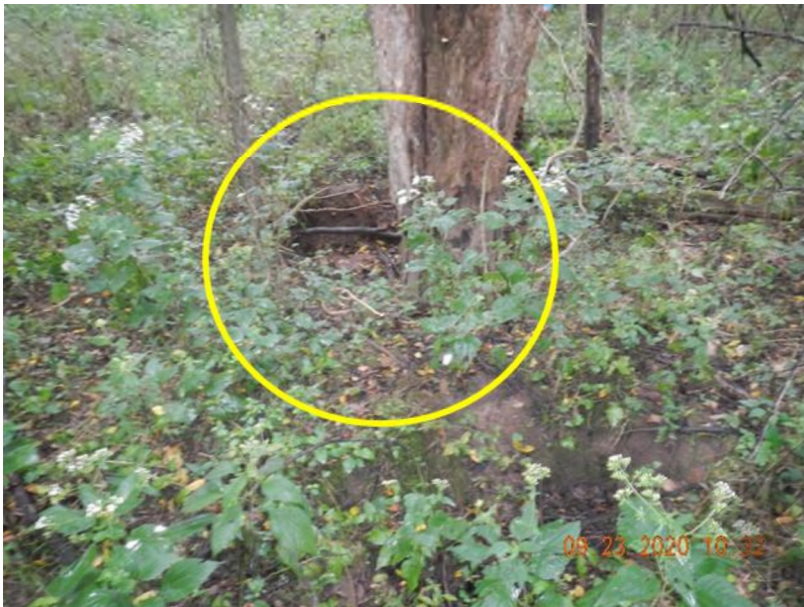
Figure 24: View of feature F-77, cover-collapse filled in with debris refilling the collapse.

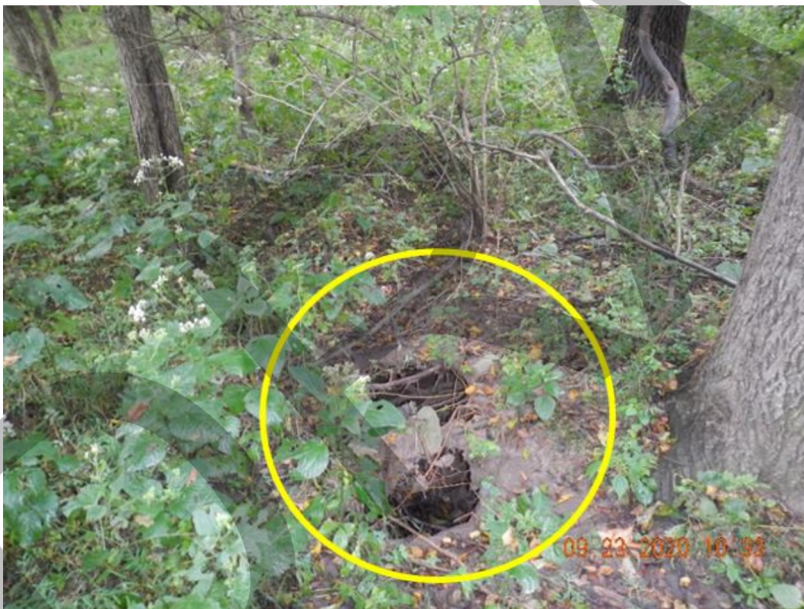
Figure 25: View of feature F-78, multiple soil piping features in one area.

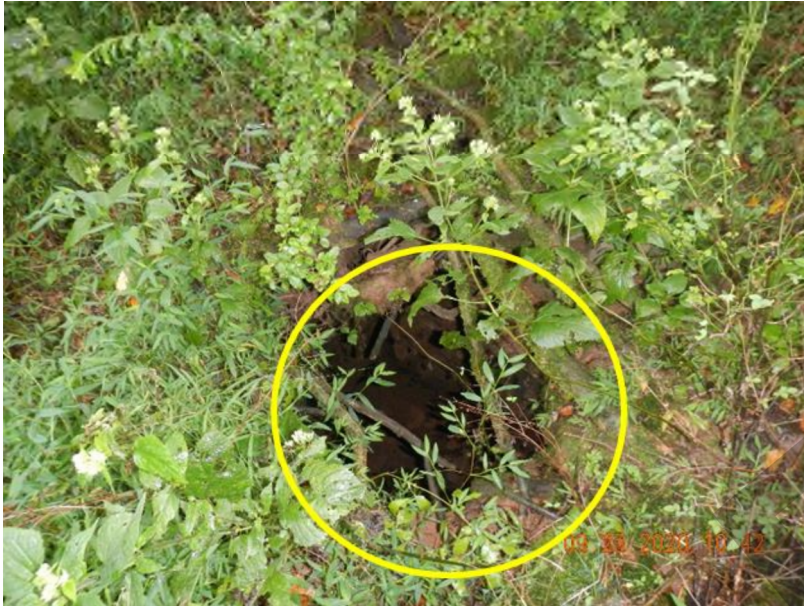
In addition to the Summer parcel, Terracon representatives conducted a field survey in the wooded area on the southern portion of the original parcel. The area is noted as having surface drainage pathways running north – south throughout the parcel. Features F-77, F-78, and F-79 were observed in this area. The three features observed in this area are soil piping and collapse features, which are typical in areas that receive water. Open throat was observed at feature F-79.

Figure 26: View of feature F-79, cover-collapse feature, open throat observed.

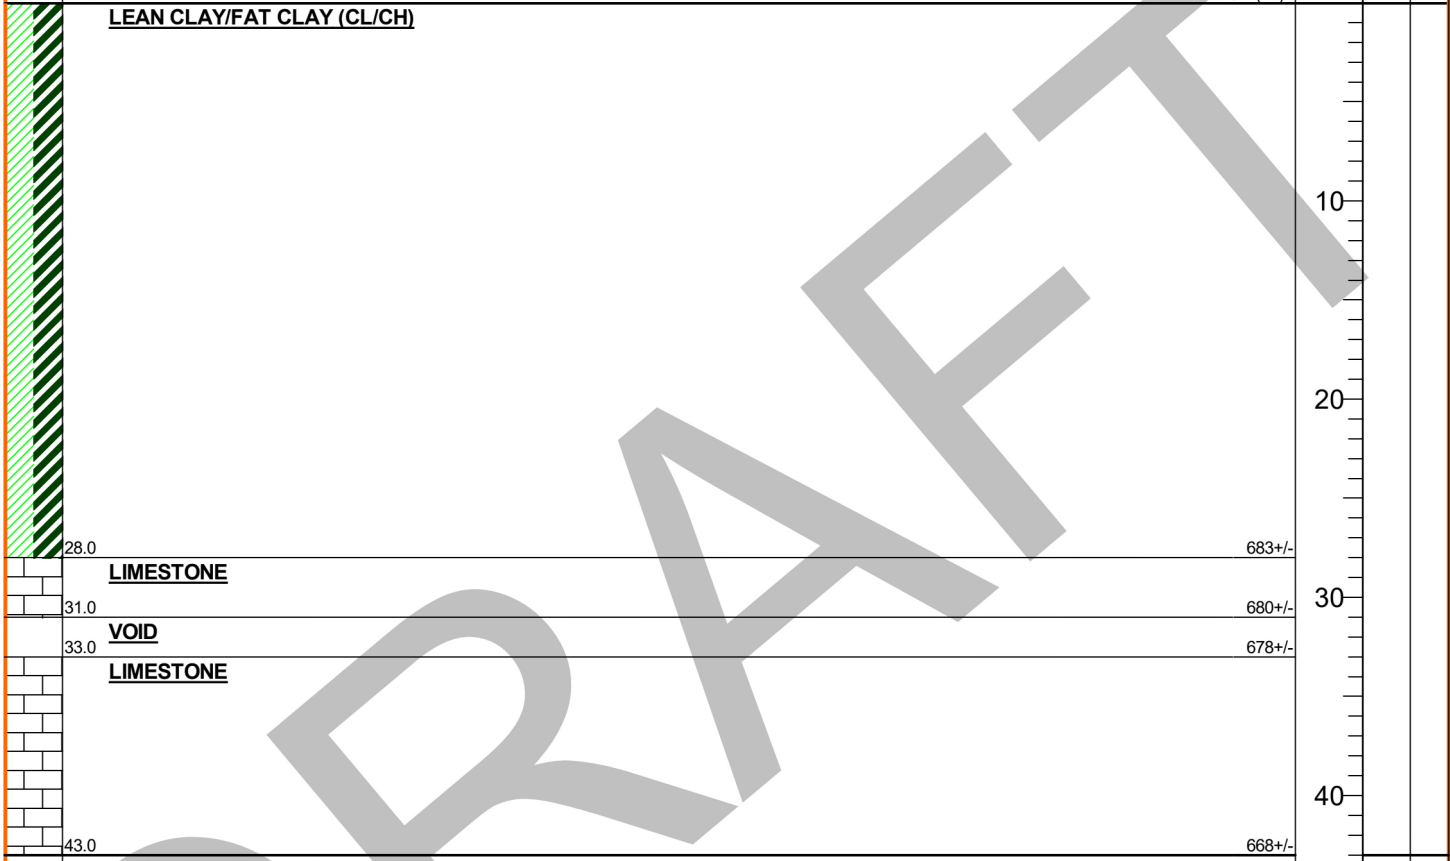
GRAPHIC LOG	LOCATION See Exploration Plan Latitude: 36.6717° Longitude: -86.5427°			
	Approximate Surface Elev.: 711 (Ft.) +/-	DEPTH (Ft.)	WATER LEVEL OBSERVATIONS	SAMPLE TYPE
DEPTH	ELEVATION (Ft.)

Stratification lines are approximate. In-situ, the transition may be gradual.

Advancement Method: Rotary drilling with compressed air.	Elevations measured in the field using Leica Zeno 20 GIS unit.	Notes:	
Abandonment Method:			
WATER LEVEL OBSERVATIONS	Terracon	Boring Started: 11-10-2020	Boring Completed: 11-10-2020
<i>Groundwater levels were not observed due to drillign method.</i>	13050 Eastgate Park Way Ste 101 Louisville, KY	Drill Rig: T-450	Driller: Johnnie Farmer
		Project No.: 57195114

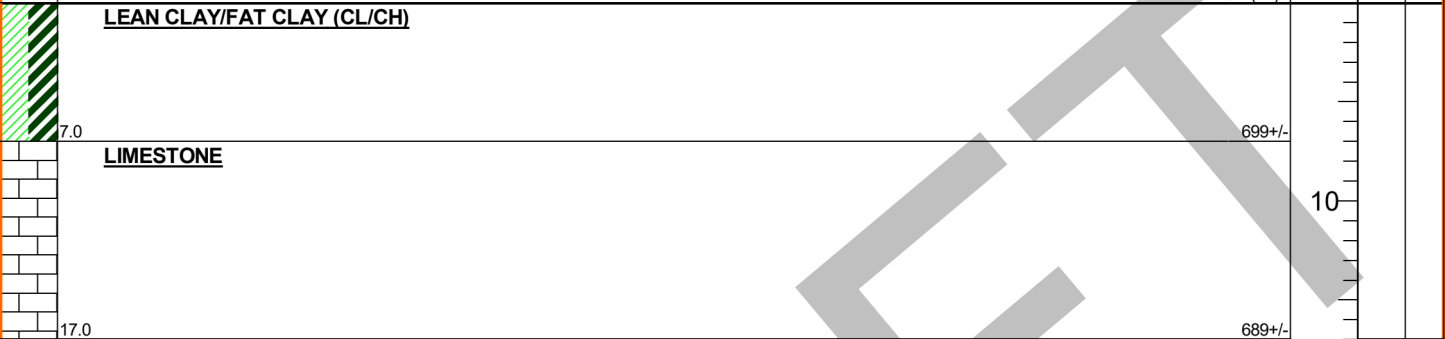
GRAPHIC LOG	LOCATION See Exploration Plan Latitude: 36.6734° Longitude: -86.5435° DEPTH Approximate Surface Elev.: 706 (Ft.) +/- ELEVATION (Ft.)	DEPTH (Ft.)	WATER LEVEL OBSERVATIONS	SAMPLE TYPE
--------------------	---	--------------------	---------------------------------	--------------------

Boring Terminated at 17 Feet

Advancement Method: Rotary drilling with compressed air.	Elevations measured in the field using Leica Zeno 20 GIS unit.	Notes:	
Abandonment Method:			
WATER LEVEL OBSERVATIONS		Boring Started: 11-10-2020	Boring Completed: 11-10-2020
Groundwater levels were not observed due to drillign method.		Drill Rig: T-450	Driller: Johnnie Farmer
		Project No.: 57195114

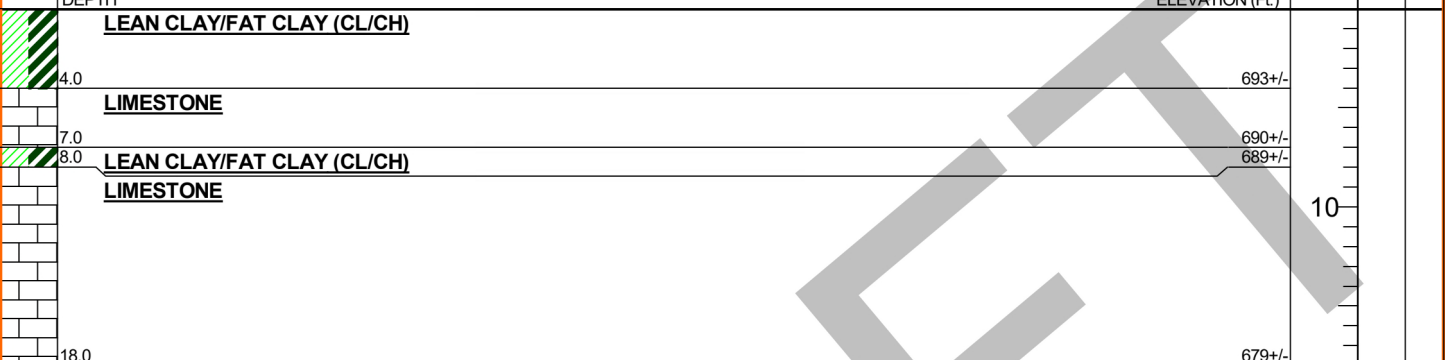
GRAPHIC LOG	LOCATION See Exploration Plan Latitude: 36.6754° Longitude: -86.5459° DEPTH Approximate Surface Elev.: 697 (Ft.) +/- ELEVATION (Ft.)	DEPTH (Ft.)	WATER LEVEL OBSERVATIONS	SAMPLE TYPE
--------------------	---	--------------------	---------------------------------	--------------------

Stratification lines are approximate. In-situ, the transition may be gradual.

Advancement Method: Rotary drilling with compressed air.	Elevations measured in the field using Leica Zeno 20 GIS unit.	Notes:
Abandonment Method:		
WATER LEVEL OBSERVATIONS	Terracon 13050 Eastgate Park Way Ste 101 Louisville, KY	Boring Started: 11-10-2020 Drill Rig: T-450 Project No.: 57195114
Groundwater levels were not observed due to drillign method.		Boring Completed: 11-10-2020 Driller: Johnnie Farmer
