Final Geotechnical Study

Geotechnical Report

ibV Energy - Rhudes Creek Solar Project

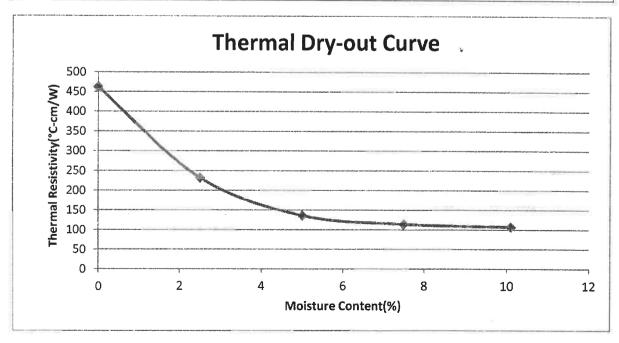
Standard Proctor Value: 115.3 Remolded Dry Density: 98.005 (85%) Optimum Moisture Content: 10.1% In-Situ Moisture Content: 20.83%

Moisture Content (%)	Initial Soil Temperature (°C)	Thermal Resistivity (°C-cm/W)	
0	26.5	462	
2.5	26.2	232	
5	25.9	136	
7.5	25.7	114	
10.1	25.5	107

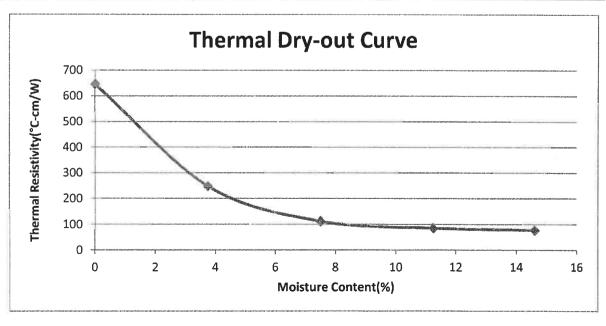
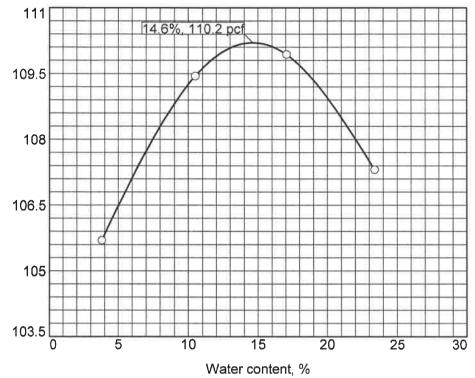
Curve No. S-21

Standard Proctor Value: 110.2 Remolded Dry Density: 93.67 (85%) Optimum Moisture Content: 14.6% In-Situ Moisture Content: 20.83%

Moisture Content (%)	Initial Soil Temperature (°C)	Thermal Resistivity (°C-cm/W)	
0	26.4	647	
3.75	26	248	
7.5	25.7	112	
11.25	25.6	85	
14.6	25.5	77

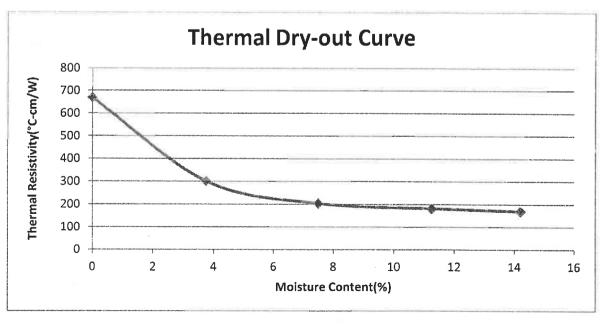
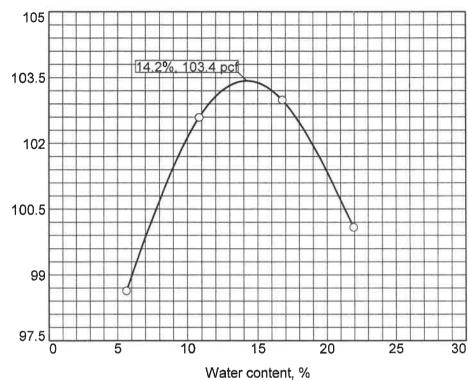
Curve No. S-22

Standard Proctor Value: 103.4 Remolded Dry Density: 87.89 (85%) Optimum Moisture Content: 14.2% In-Situ Moisture Content: 23.5 %

Moisture Content (%)	Initial Soil Temperature (°C)	Thermal Resistivity (°C-cm/W)	
0	26.7	669	
3.75	26.3	301	
7.5	26	204	
11.25	25.8	182	
14.2	25.6	170

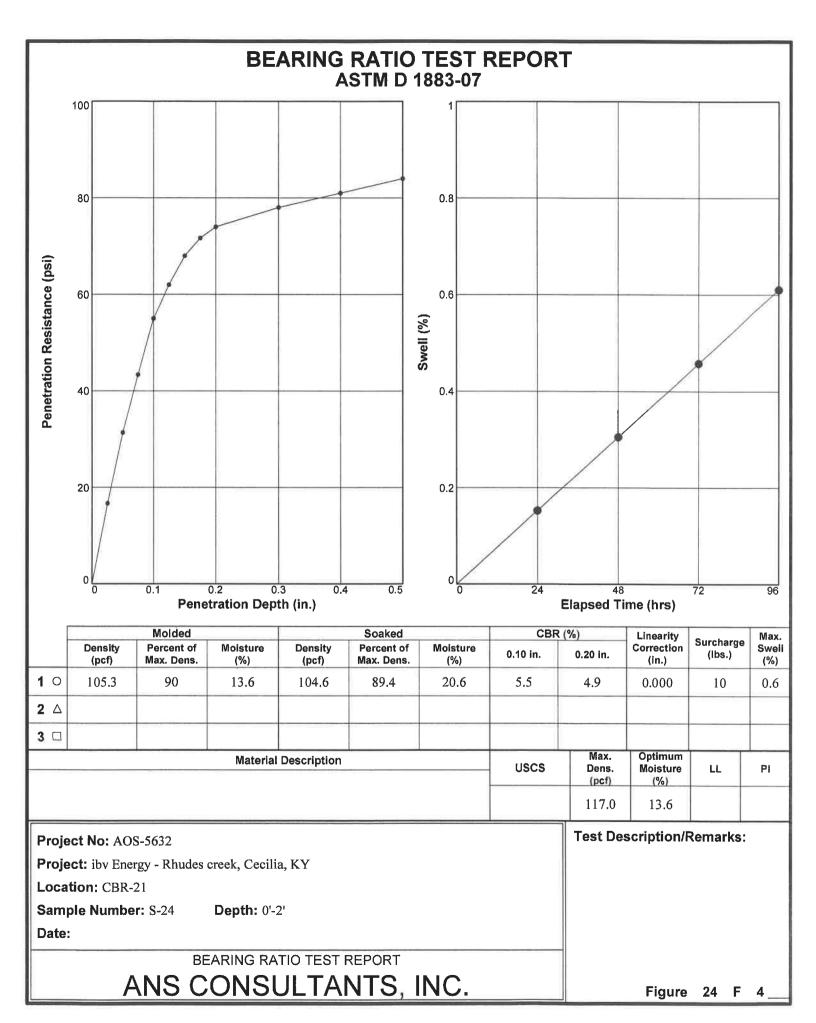
CALIFORNIA BEARING RATIO RESULTS

TEST RESULTS	Material Description
Maximum dry density = 117.0 pcf	
Optimum moisture = 13.6 %	Remarks:
Project No. AOS-5632 Client: ANS GEO, Inc.	
Project: ibv Energy - Rhudes creek, Cecilia, KY	
○ Location: CBR-21 Depth: 0'-2' Sample Number: S	-24 Checked by:
ANS CONSULTANTS, INC.	Title:
South Plainfield, New Jersey	Figure 24 F 2

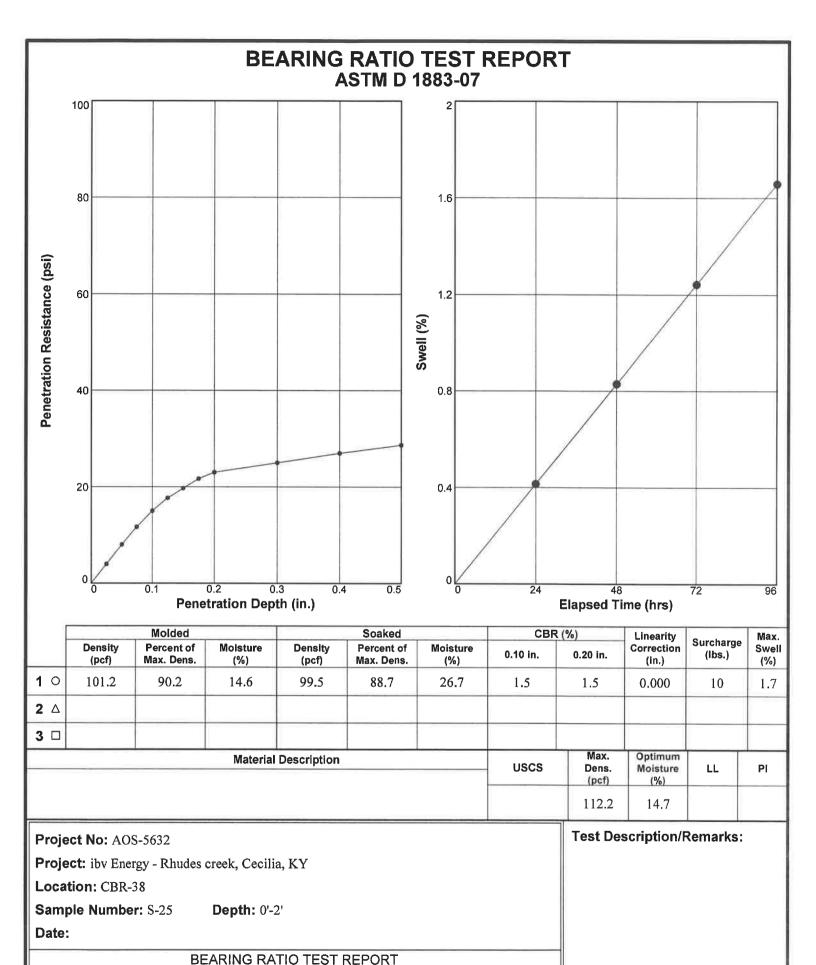
Figure 25 F 4

TEST RESULTS	Material Description
Maximum dry density = 112.2 pcf	
Optimum moisture = 14.7 %	Remarks:
Project No. AOS-5632 Client: ANS GEO, Inc.	
Project: ibv Energy - Rhudes creek, Cecilia, KY	
○ Location: CBR-38 Depth: 0'-2' Sample Number: S-25	Checked by:
ANS CONSULTANTS, INC.	Title:
South Plainfield, New Jersey	Figure 25 F 2

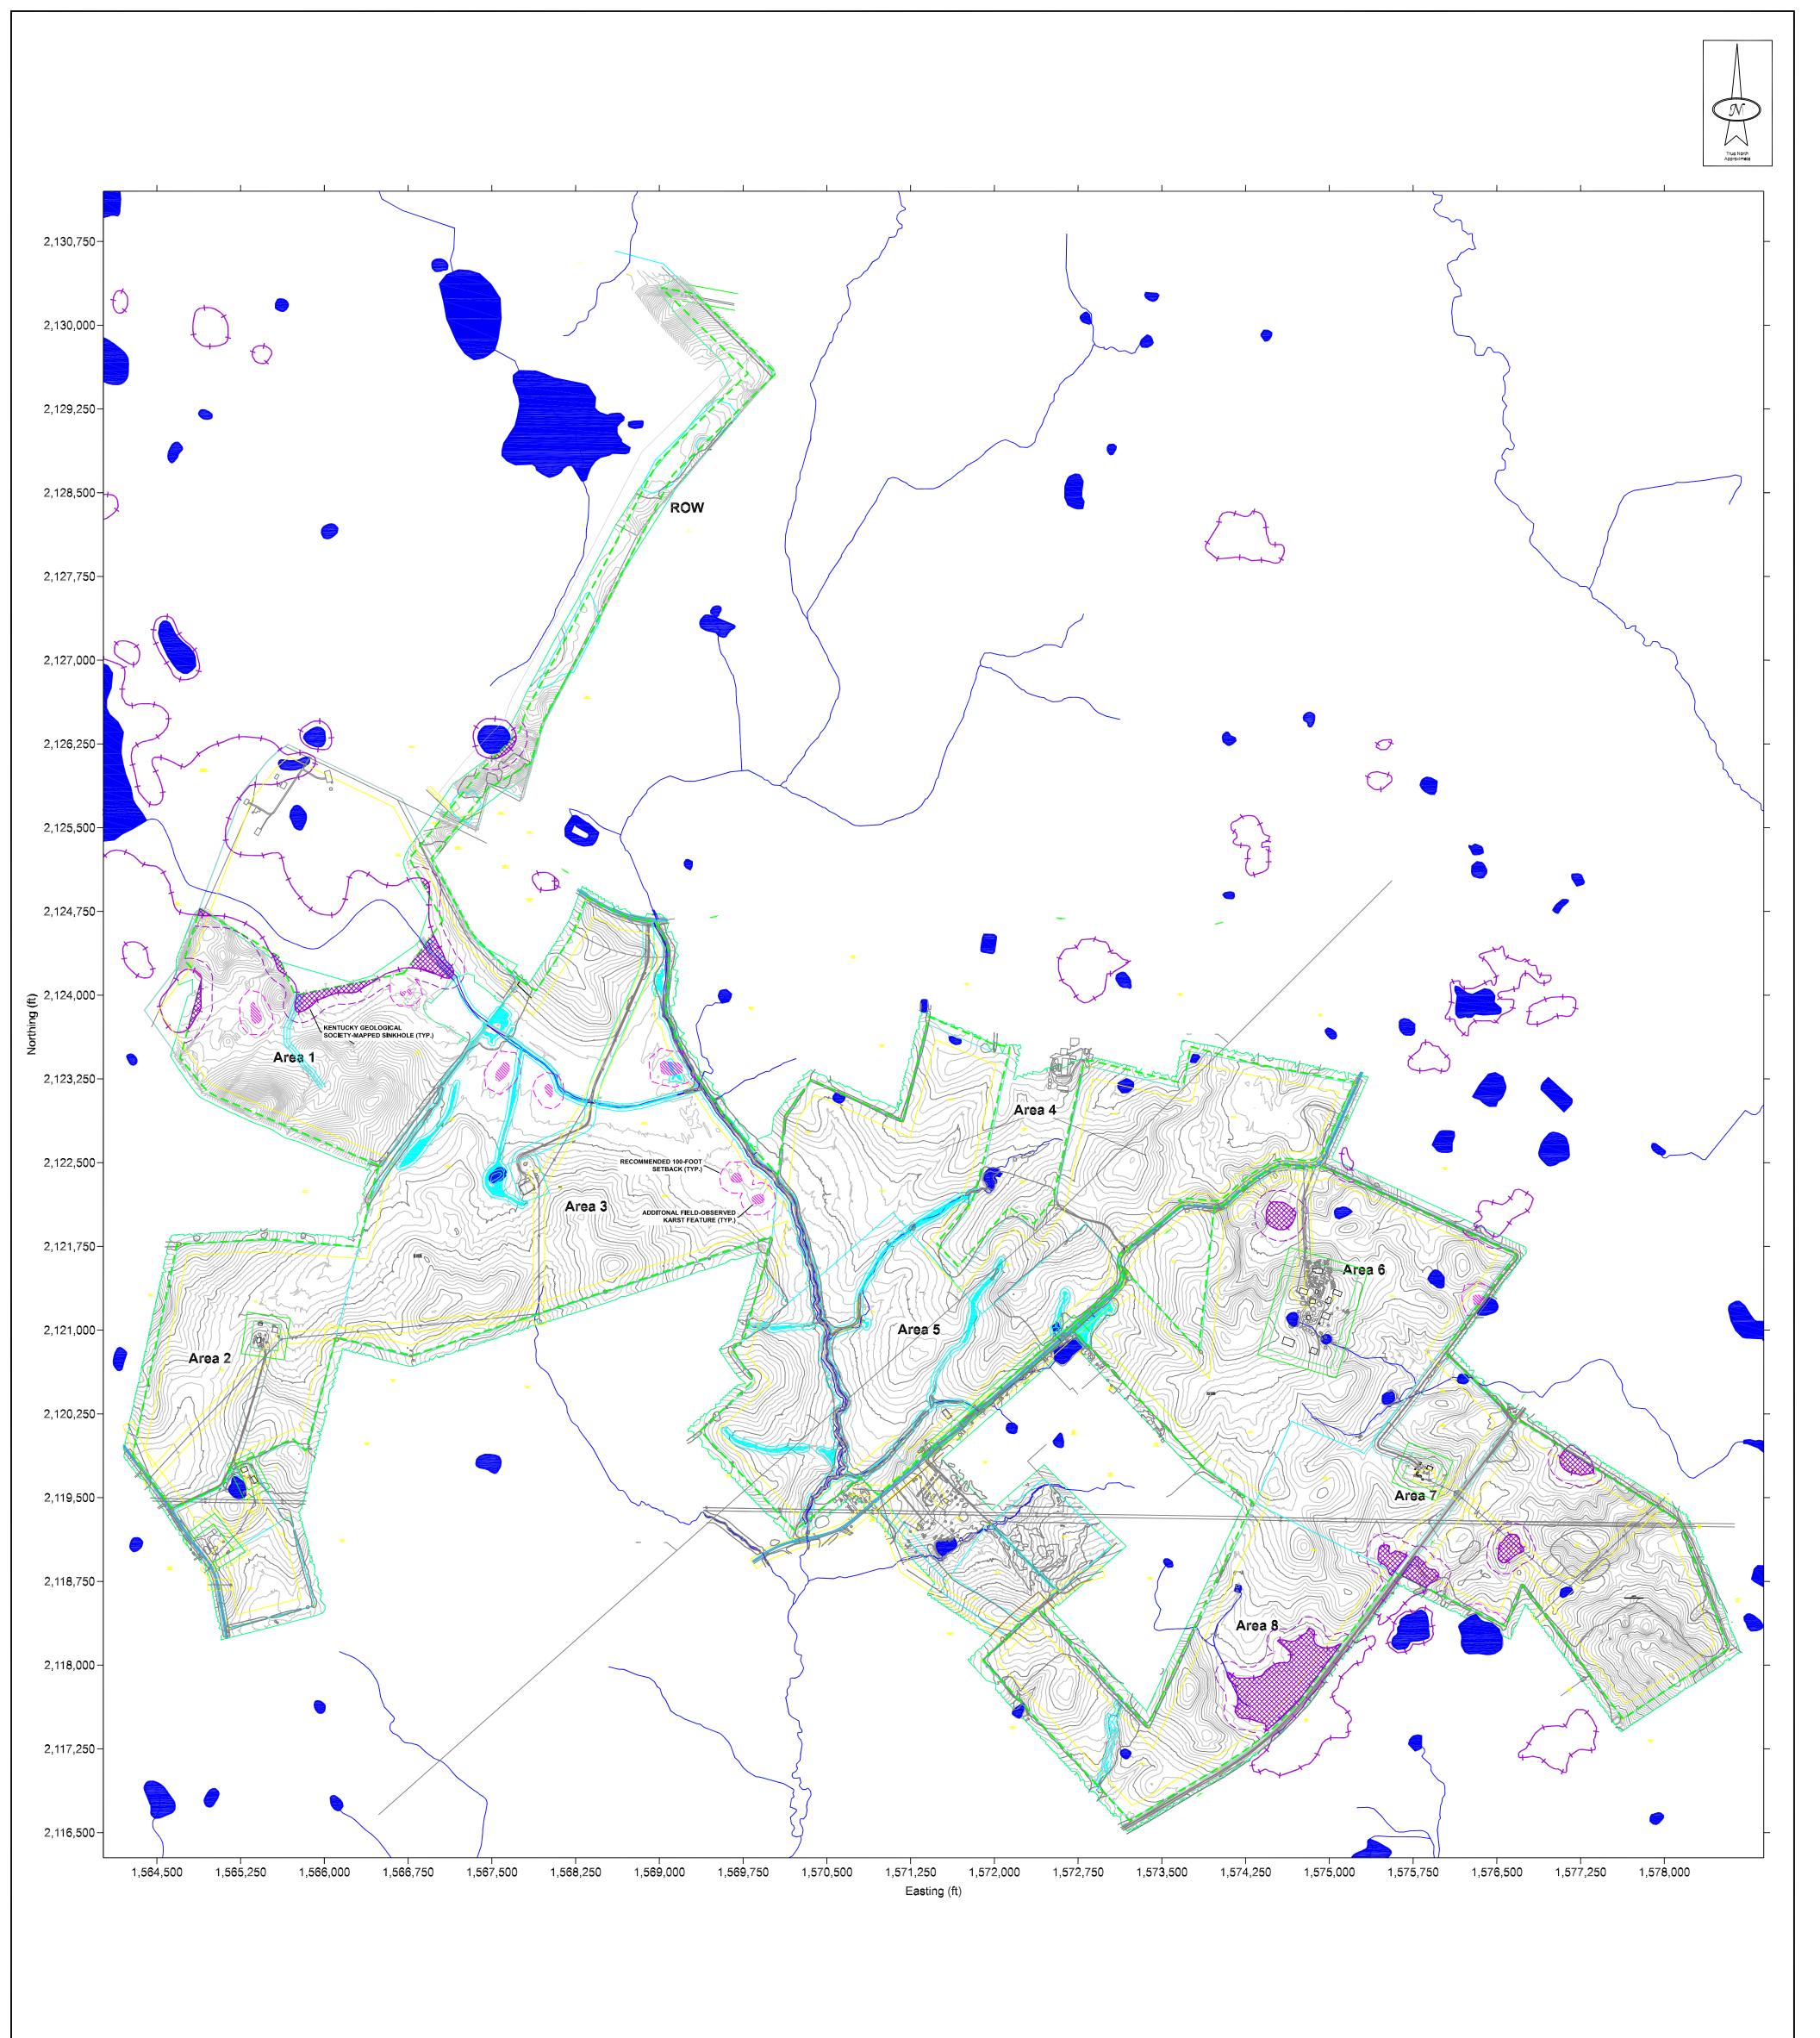
10	7	25	Erosion creek	50	Yes		Leads into sinkhole
10	'	26			Yes	Yes, offset from profile	
10	0	27			Yes		
10	8	28	Erosion creek	80	Yes		
11	ROW	29	Depression	300 - 474			Standing water

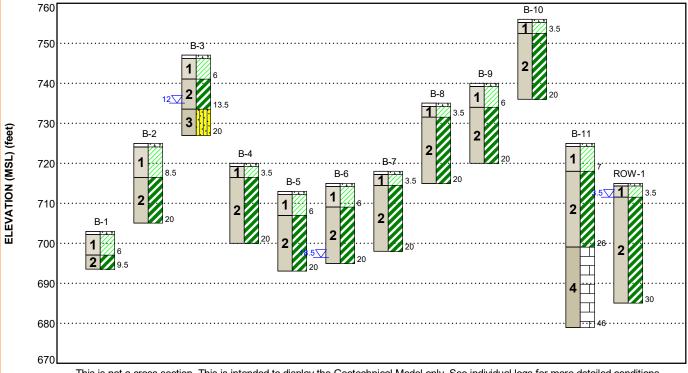
This is not a cross section. This is intended to display the Geotechnical Model only. See individual logs for more detailed conditions.

Model Layer	Layer Name	General Description
1	LEAN CLAY (CL)	with silt, trace fine sand, brown with reddish brown, soft to hard
2	FAT CLAY (CH)	trace fine sand, with limestone fragments, reddish brown to brown and gray, soft to stiff
3	SILTY SAND (SM)	black, medium dense
4	LIMESTONE	light with dark gray, moderate to very close spacing, thin bedding, unweathered to slightly weathered, medium strong to very strong rock

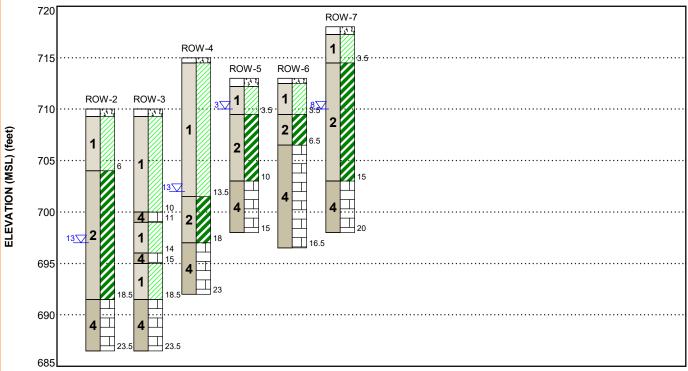
This is not a cross section. This is intended to display the Geotechnical Model only. See individual logs for more detailed conditions.

Model Layer	Layer Name	General Description
1	LEAN CLAY (CL)	with silt, trace fine sand, brown with reddish brown, soft to hard
2	FAT CLAY (CH)	trace fine sand, with limestone fragments, reddish brown to brown and gray, soft to stiff
3	SILTY SAND (SM)	black, medium dense
4	LIMESTONE	light with dark gray, moderate to very close spacing, thin bedding, unweathered to slightly weathered, medium strong to very strong rock

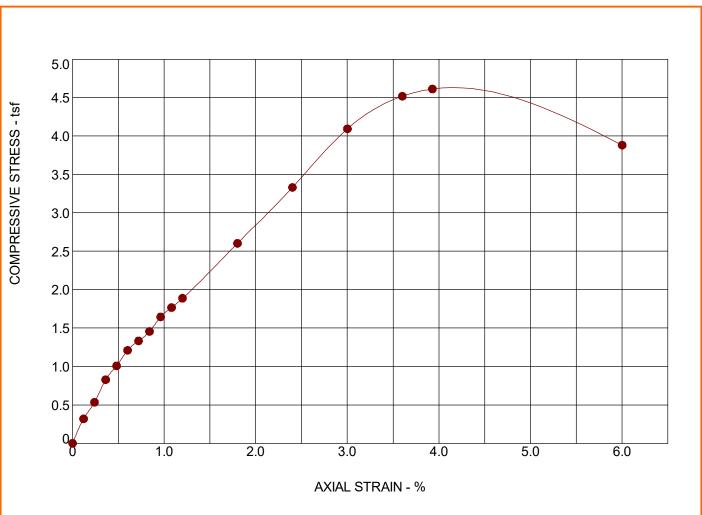
SPECIMEN FAILURE PHOTOGRAPH

ASTM D2166

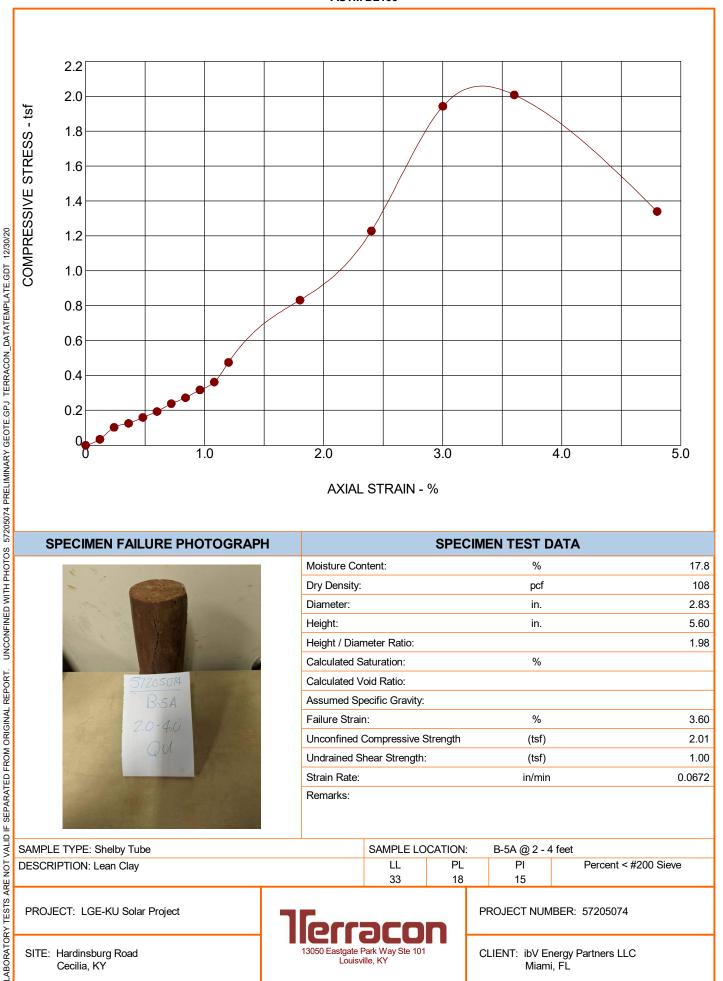
SPECIMEN FAILURE PHOTOGRAPH

ASTM D2166

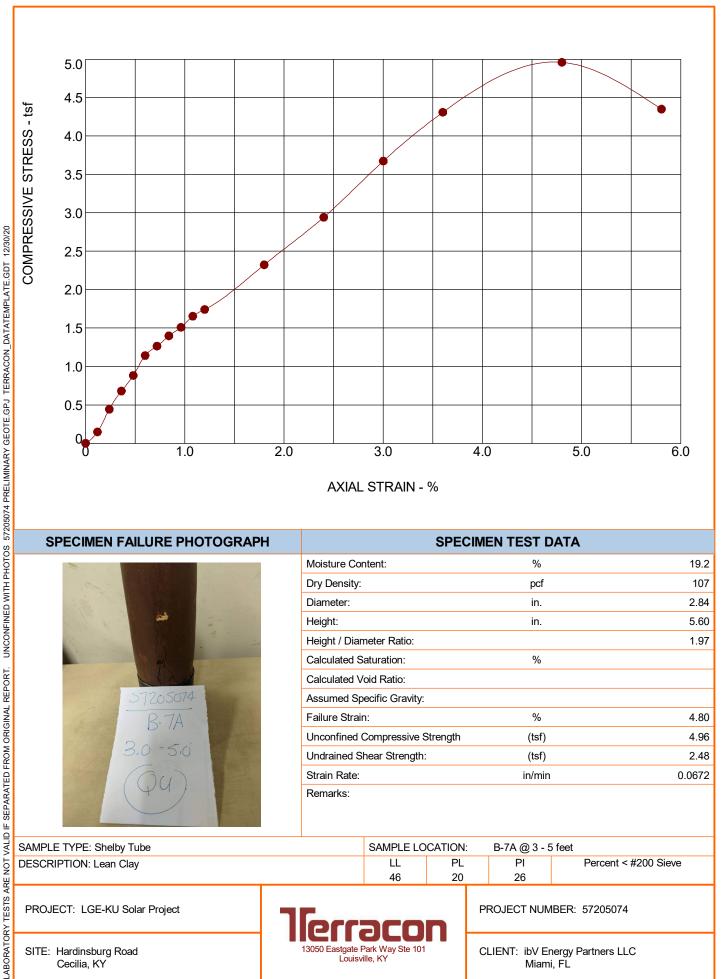
SPECIMEN FAILURE PHOTOGRAPH

ASTM D2166
