Blue Moon Energy LLC  
Response to Public Service Commission's Second Request for Information  
Case No. 2021-00414

Estimated Sound Receptors  
Level of 55 dBA

Delineated Wetlands and Waterbodies

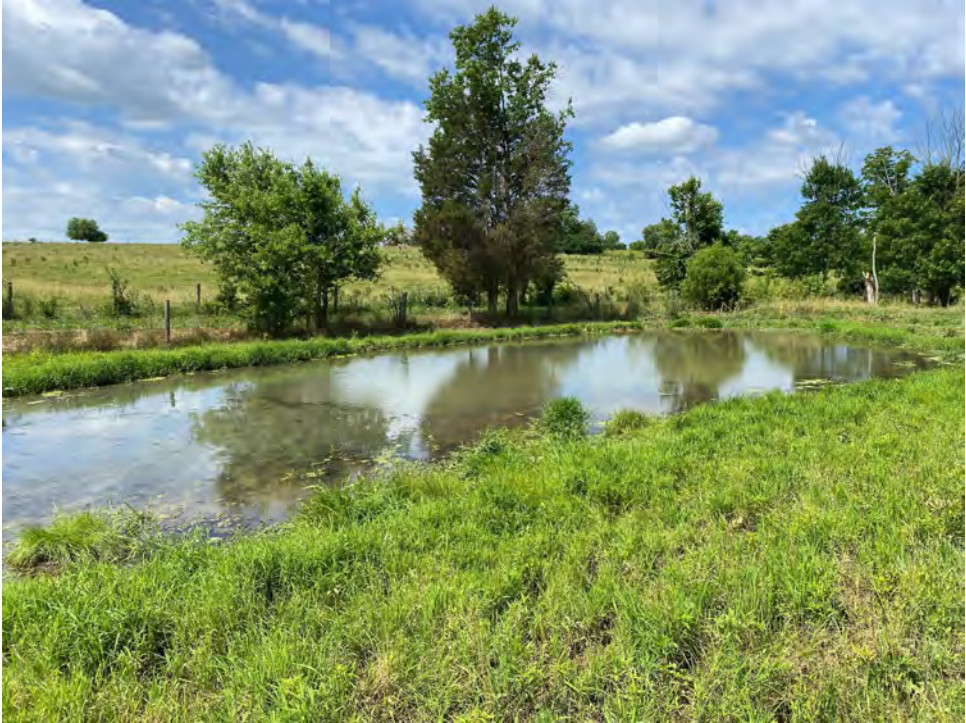
<b>Property Name:</b> Blue Moon Solar Project		<b>County/State:</b> Harrison County, Kentucky	<b>Project No.</b> E320201803
<b>Photo No.</b> <b>1</b>	<b>Date:</b> 5-22-2021

<b>Coordinates:</b> 38.359127, -84.231475			
<b>Photo Direction:</b> Southwest			
<b>Description:</b> Freshwater Pond (Wet 1)

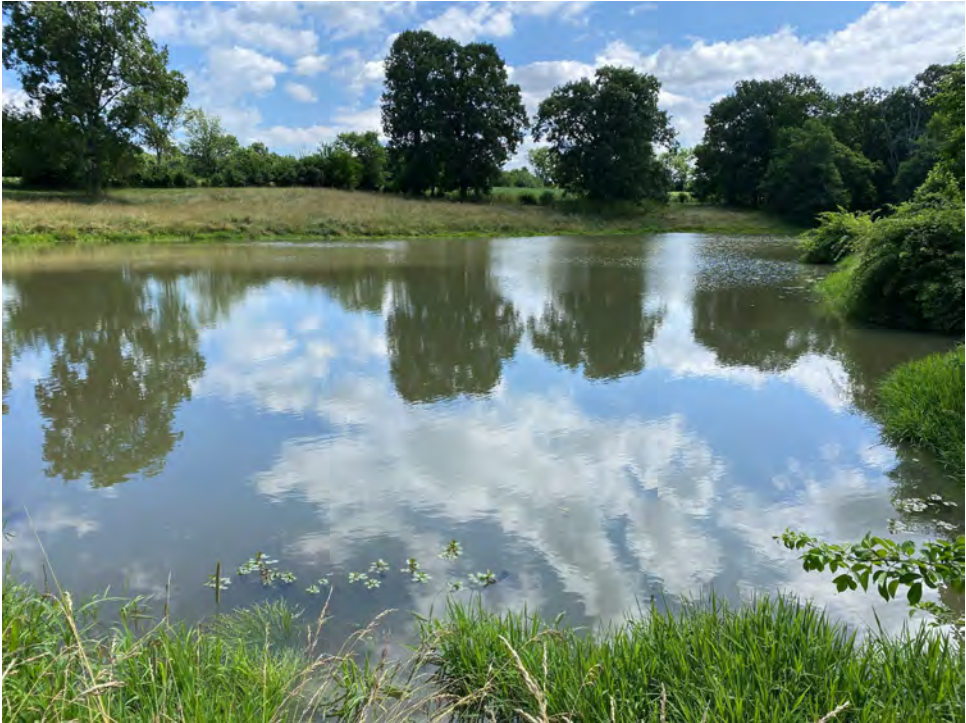
<h1>PHOTOGRAPHIC LOG</h1>	
<b>Property Name:</b> Blue Moon Solar Project		<b>County/State:</b> Harrison County, Kentucky	<b>Project No.</b> E320201803
<b>Photo No.</b> <b>2</b>	<b>Date:</b> 5-22-2021

<b>Coordinates:</b> 38.363793, -84.234322			
<b>Photo Direction:</b> East			
<b>Description:</b> Freshwater Pond (Wet 2)

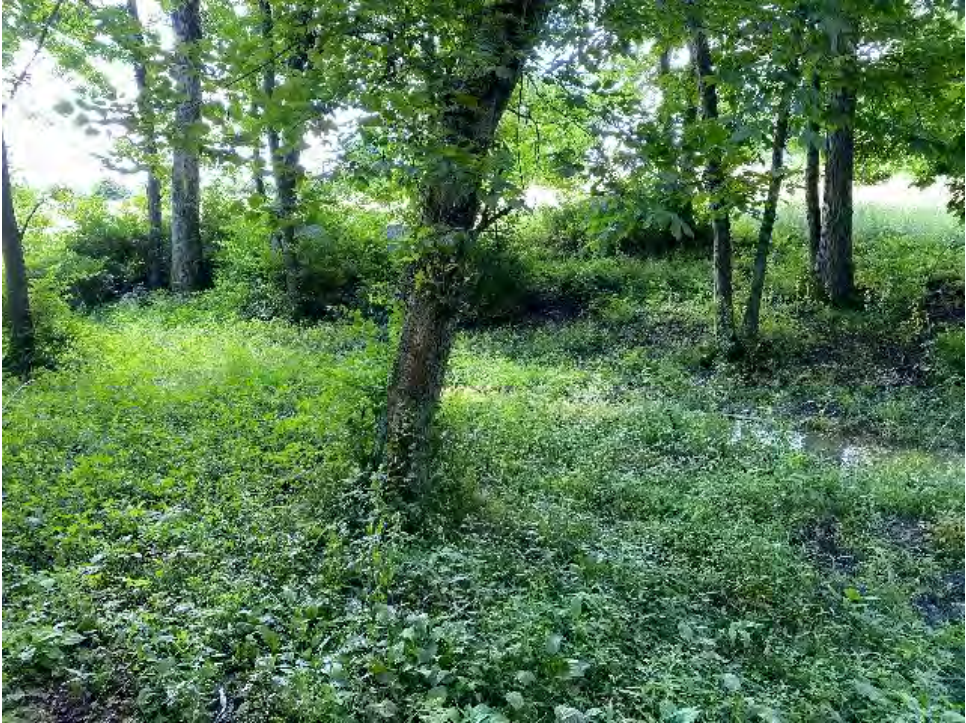
<b>Property Name:</b> Blue Moon Solar Project		<b>County/State:</b> Harrison County, Kentucky	<b>Project No.</b> E320201803
<b>Photo No.</b> <b>3</b>	<b>Date:</b> 5-22-2021

<b>Coordinates:</b> 38.364239, -84.235985			
<b>Photo Direction:</b> South			
<b>Description:</b> Data Point 5 - Forested Wetland (Wet 3)

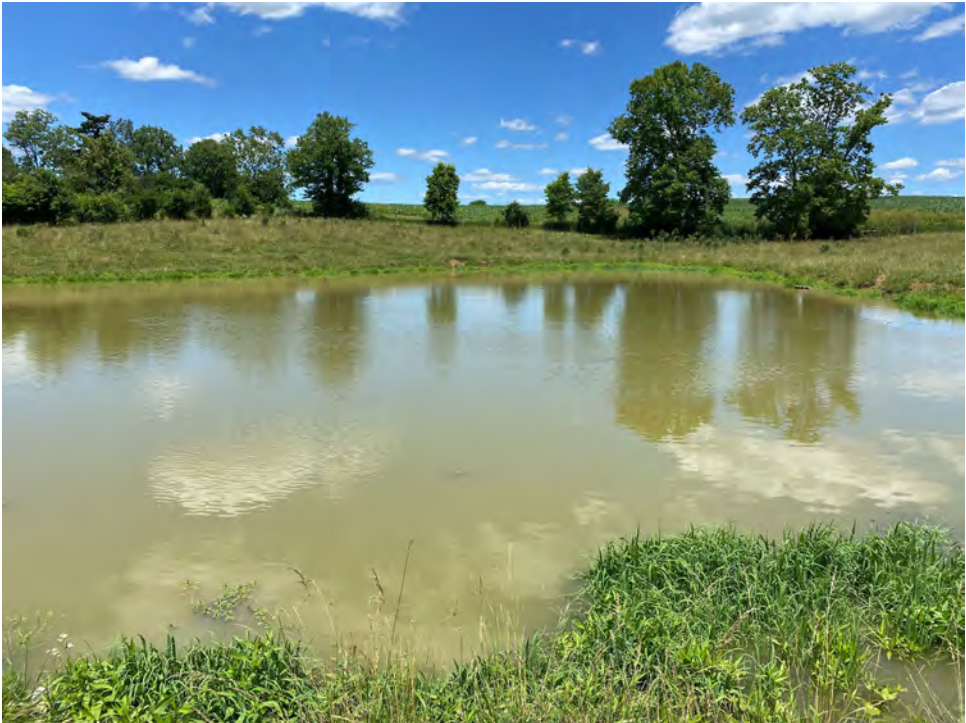
<b>Property Name:</b> Blue Moon Solar Project		<b>County/State:</b> Harrison County, Kentucky	<b>Project No.</b> E320201803
<b>Photo No.</b> <b>4</b>	<b>Date:</b> 5-22-2021

<b>Coordinates:</b> 338.378647, -84.259714			
<b>Photo Direction:</b> North			
<b>Description:</b> Freshwater Pond (Wet 4)

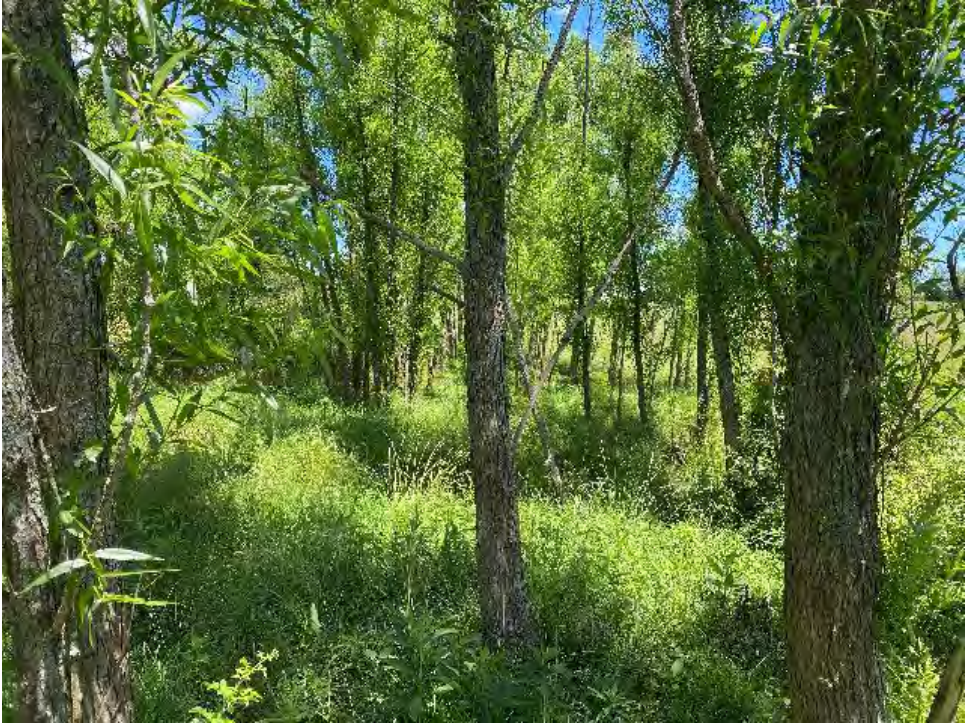
<b>Property Name:</b> Blue Moon Solar Project		<b>County/State:</b> Harrison County, Kentucky	<b>Project No.</b> E320201803
<b>Photo No.</b> <b>5</b>	<b>Date:</b> 5-22-2021

<b>Coordinates:</b> 38.371549, -84.258811			
<b>Photo Direction:</b> Southeast			
<b>Description:</b> Data Point 8 - Forested Wetland (Wet 5)

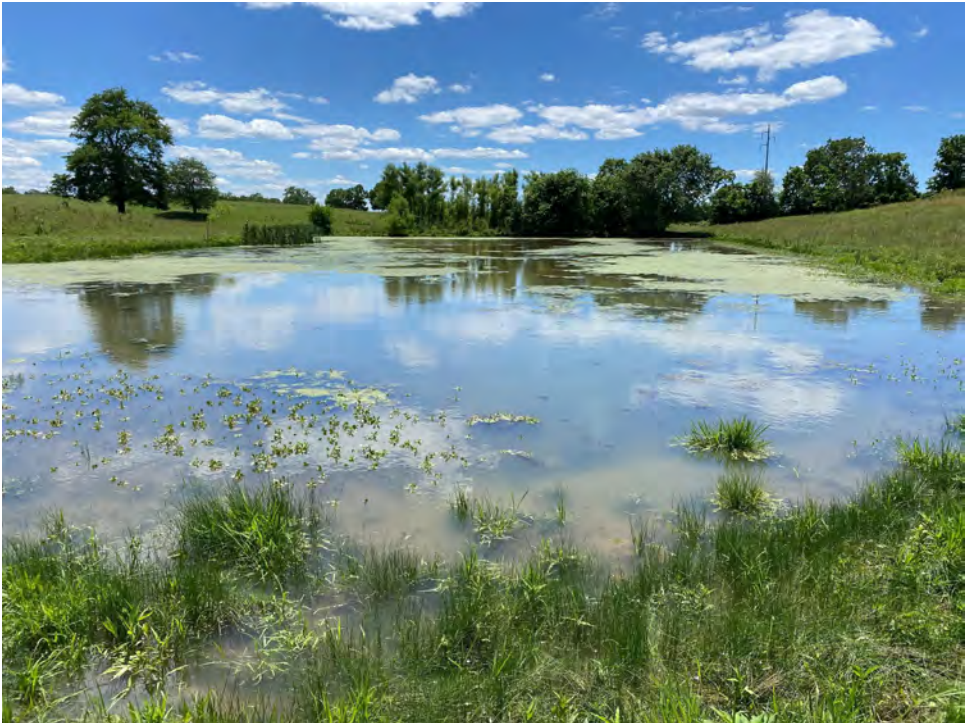
<b>Property Name:</b> Blue Moon Solar Project		<b>County/State:</b> Harrison County, Kentucky	<b>Project No.</b> E320201803
<b>Photo No.</b> <b>6</b>	<b>Date:</b> 5-22-2021

<b>Coordinates:</b> 38.372055, -84.258325			
<b>Photo Direction:</b> South			
<b>Description:</b> Freshwater Pond (Wet 6)

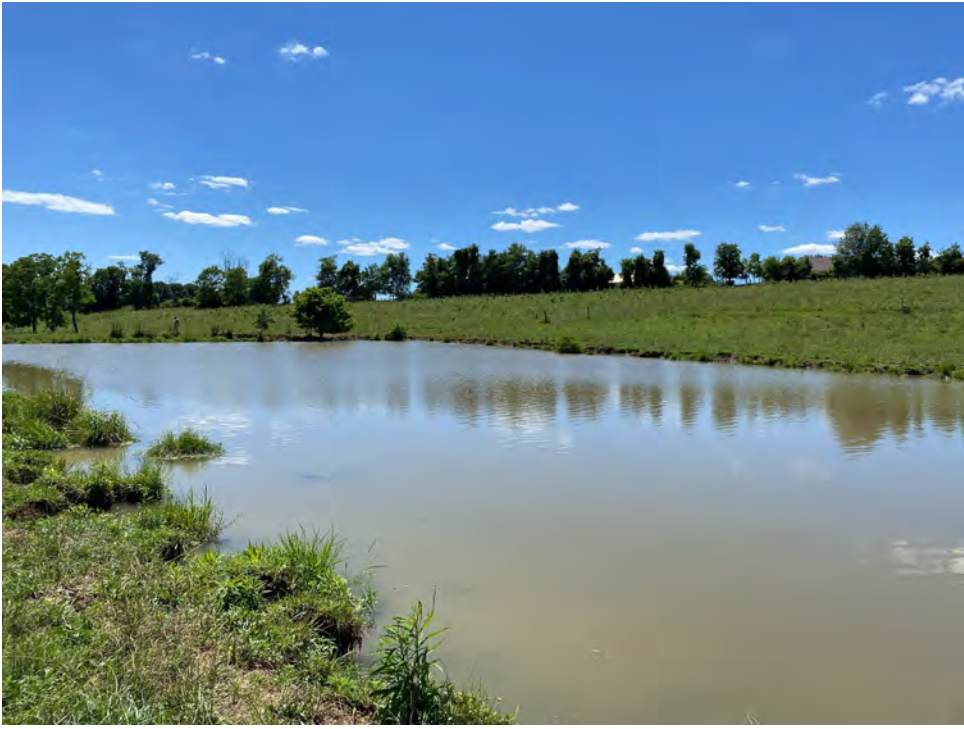
<b>Property Name:</b> Blue Moon Solar Project		<b>County/State:</b> Harrison County, Kentucky	<b>Project No.</b> E320201803
<b>Photo No.</b> <b>7</b>	<b>Date:</b> 5-22-2021

<b>Coordinates:</b> 38.369899, -84.260801			
<b>Photo Direction:</b> Southwest			
<b>Description:</b> Freshwater Pond (Wet 7)

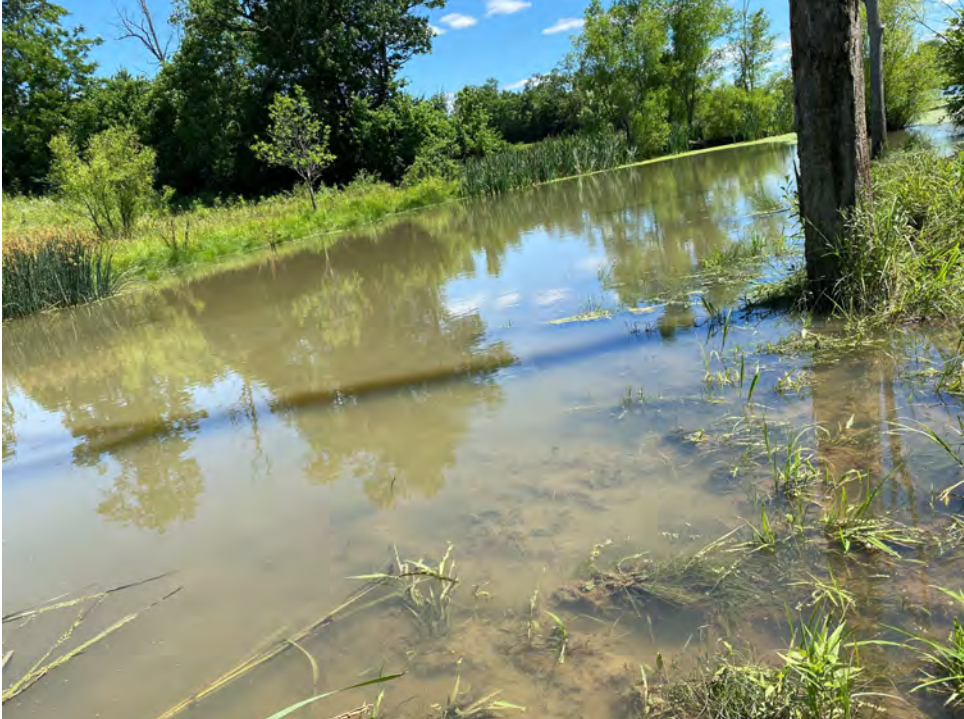
<h1>PHOTOGRAPHIC LOG</h1>	
<b>Property Name:</b> Blue Moon Solar Project		<b>County/State:</b> Harrison County, Kentucky	<b>Project No.</b> E320201803
<b>Photo No.</b> <b>8</b>	<b>Date:</b> 5-22-2021

<b>Coordinates:</b> 38.367383, -84.261856			
<b>Photo Direction:</b> Southeast			
<b>Description:</b> Freshwater Pond (Wet 8)

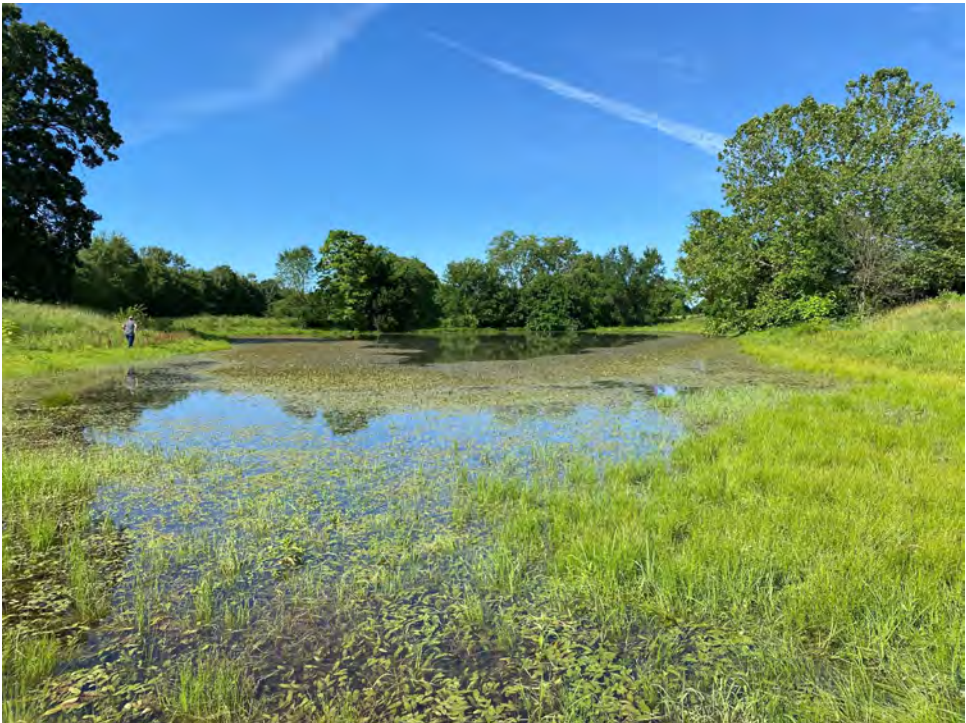
<b>Property Name:</b> Blue Moon Solar Project		<b>County/State:</b> Harrison County, Kentucky	<b>Project No.</b> E320201803
<b>Photo No.</b> <b>10</b>	<b>Date:</b> 5-23-2021

<b>Coordinates:</b> 38.368591, -84.253674			
<b>Photo Direction:</b> Southwest			
<b>Description:</b> Freshwater Pond (Wet 10)

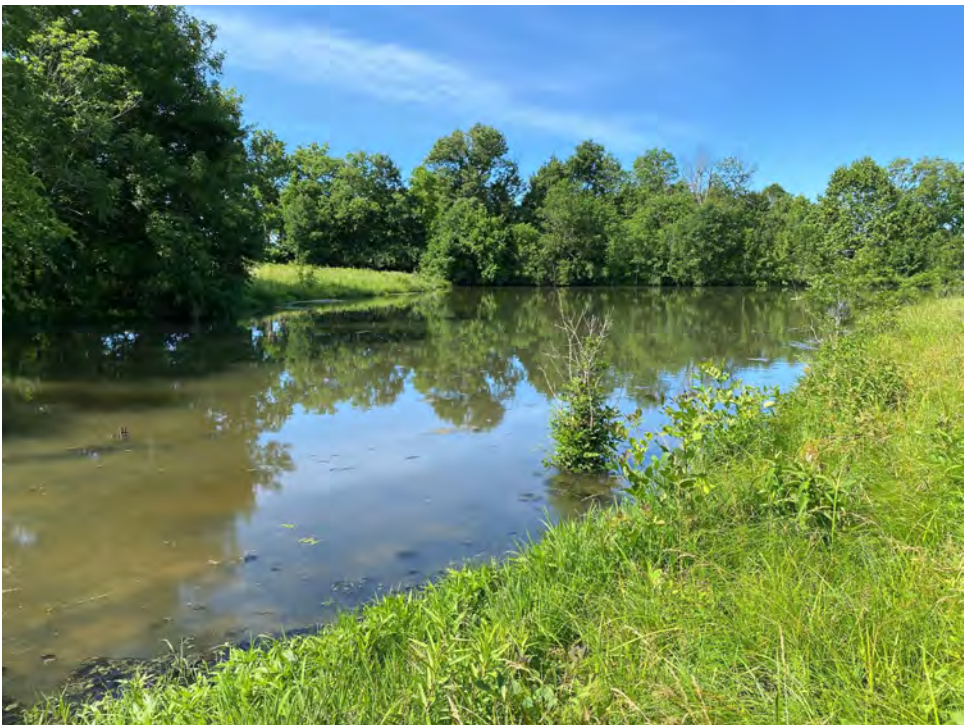
<b>Property Name:</b> Blue Moon Solar Project		<b>County/State:</b> Harrison County, Kentucky	<b>Project No.</b> E320201803
<b>Photo No.</b> <b>13</b>	<b>Date:</b> 5-23-2021

<b>Coordinates:</b> 38.367227, -84.255162			
<b>Photo Direction:</b> Southeast			
<b>Description:</b> Freshwater Pond (Wet 13)

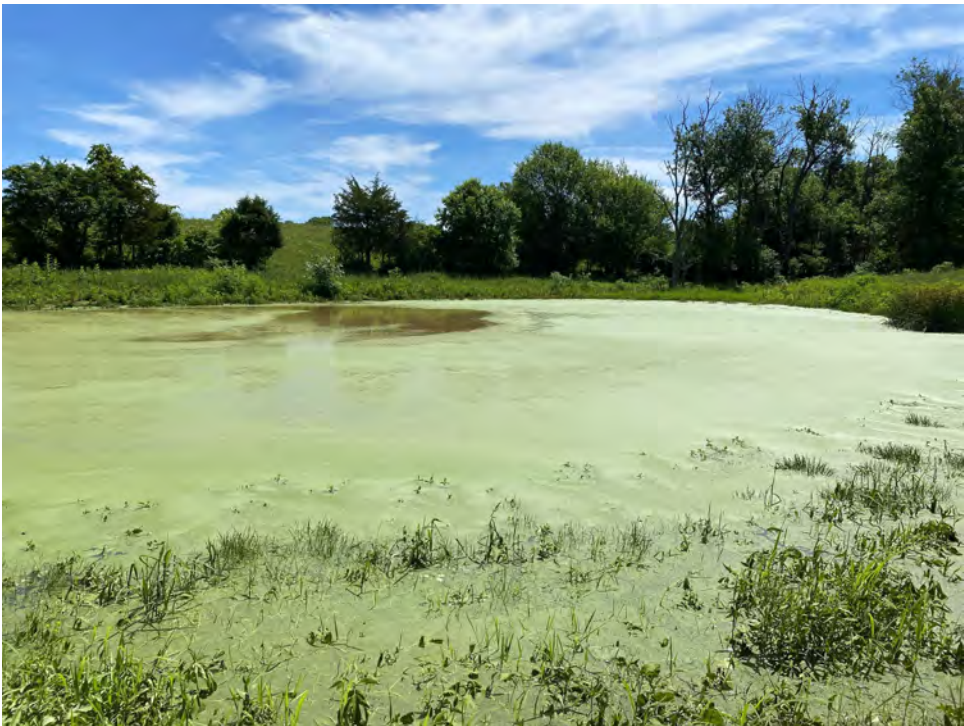
<b>Property Name:</b> Blue Moon Solar Project		<b>County/State:</b> Harrison County, Kentucky	<b>Project No.</b> E320201803
<b>Photo No.</b> <b>14</b>	<b>Date:</b> 5-23-2021

<b>Coordinates:</b> 38.361376, -84.255561			
<b>Photo Direction:</b> Northeast			
<b>Description:</b> Freshwater Pond (Wet 14)

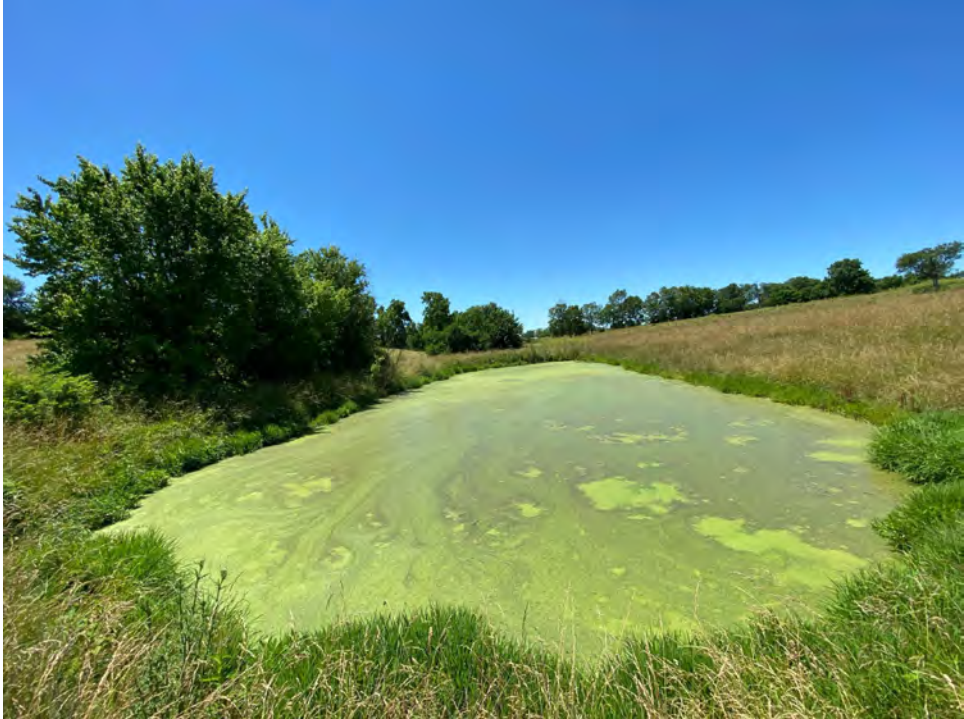
<b>Property Name:</b> Blue Moon Solar Project		<b>County/State:</b> Harrison County, Kentucky	<b>Project No.</b> E320201803
<b>Photo No.</b> <b>16</b>	<b>Date:</b> 5-22-2021

<b>Coordinates:</b> 38.367311, -84.248770			
<b>Photo Direction:</b> East			
<b>Description:</b> Freshwater Pond (Wet 16)

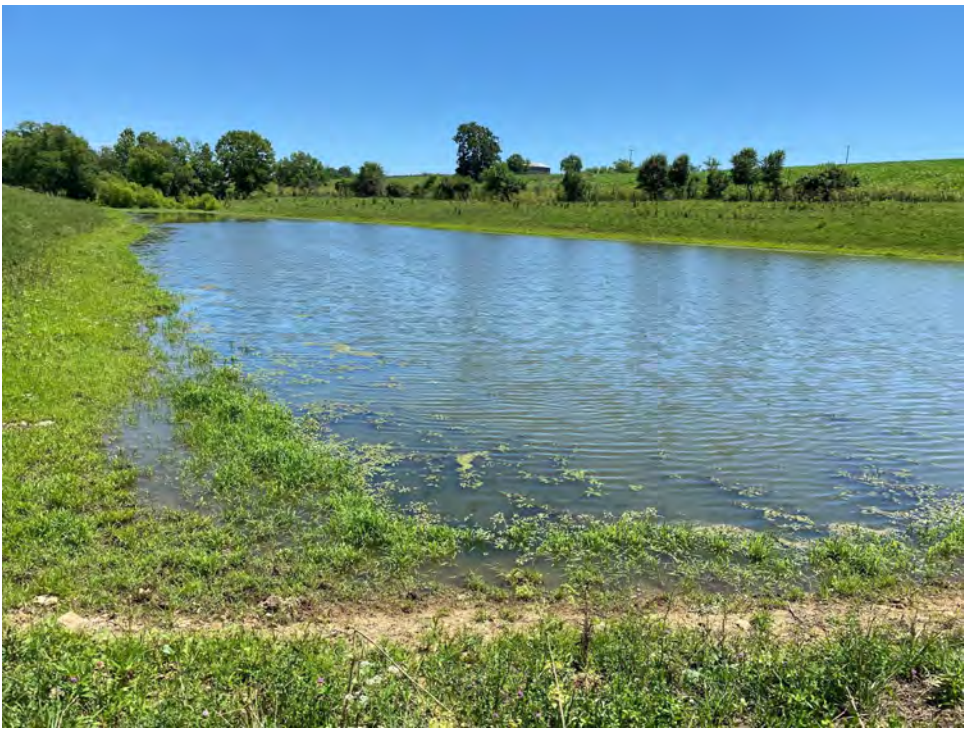
<b>Property Name:</b> Blue Moon Solar Project		<b>County/State:</b> Harrison County, Kentucky	<b>Project No.</b> E320201803
<b>Photo No.</b> <b>17</b>	<b>Date:</b> 5-23-2021

<b>Coordinates:</b> 38.382064, -84.256514			
<b>Photo Direction:</b> Southwest			
<b>Description:</b> Freshwater Pond (Wet 17)

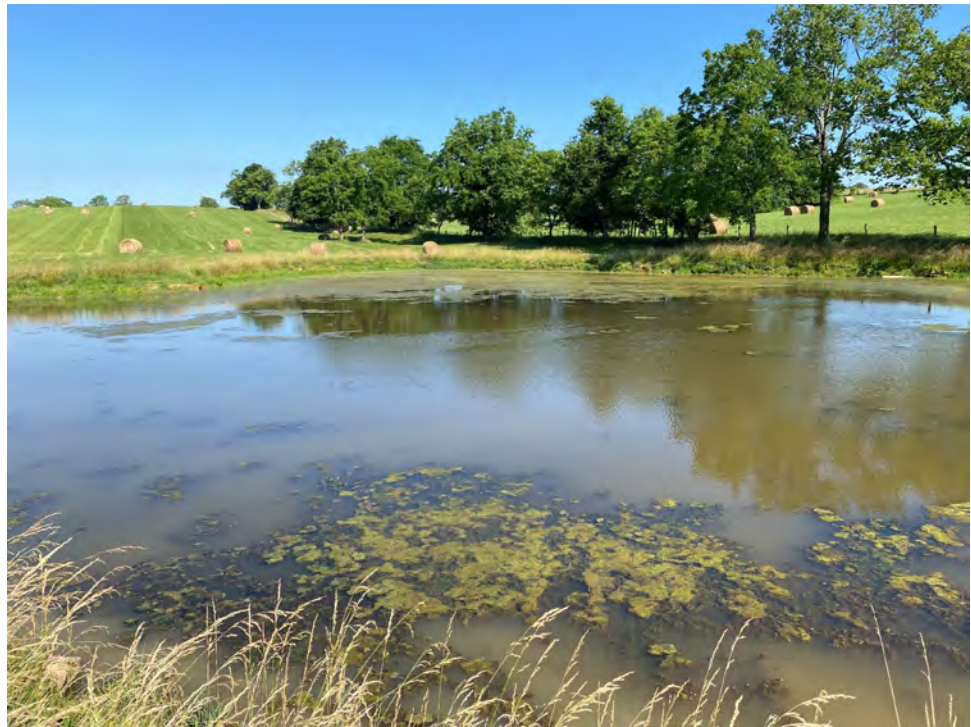
**Property Name:**  
Blue Moon Solar Project**County/State:**  
Harrison County, Kentucky**Project No.**  
E320201803**Photo No.**  
**19****Date:**  
5-24-2021**Coordinates:**  
38.386011, -84.245137**Photo Direction:**  
West**Description:**  
Freshwater Pond (Wet 19)

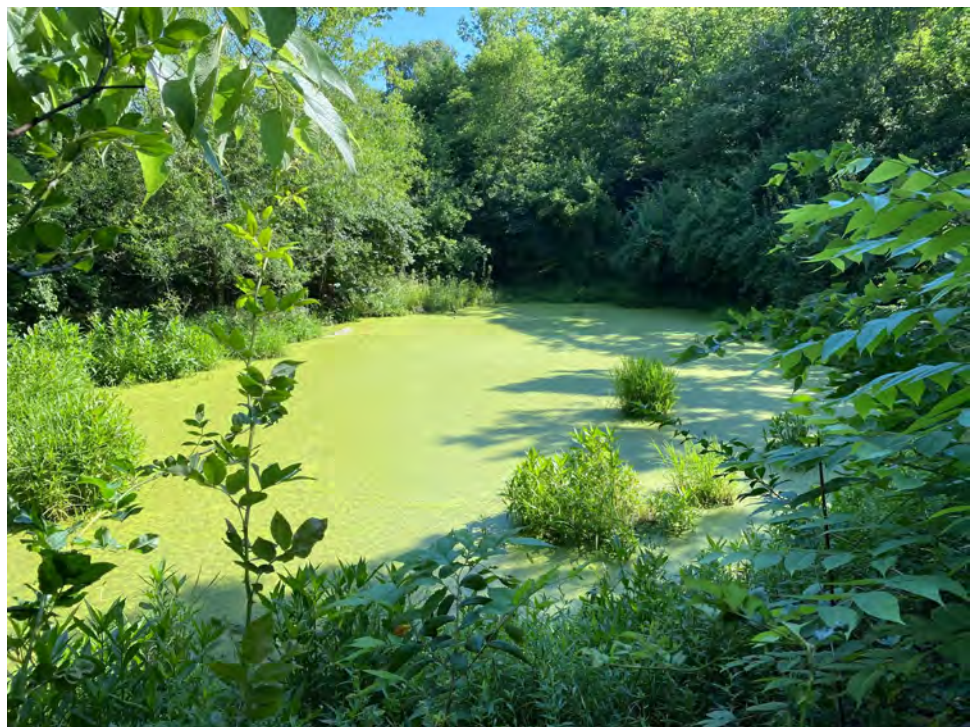
**Property Name:**  
Blue Moon Solar Project**County/State:**  
Harrison County, Kentucky**Project No.**  
E320201803**Photo No.**  
**20****Date:**  
5-24-2021**Coordinates:**  
38.392023, -84.245149**Photo Direction:**  
Southeast**Description:**  
Freshwater Pond (Wet 20)

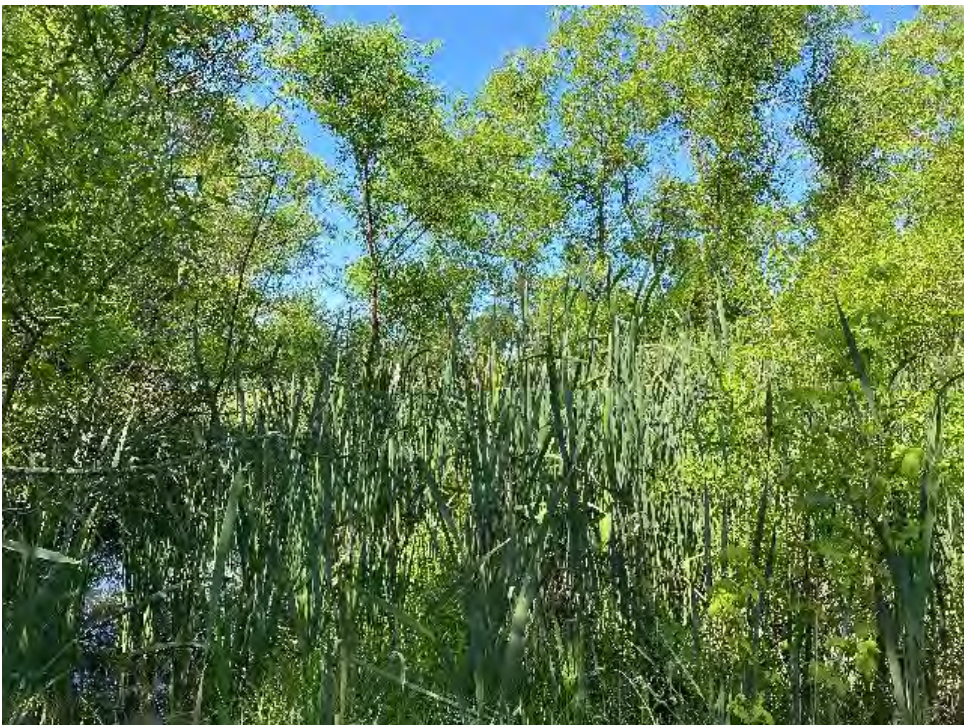
<b>Property Name:</b> Blue Moon Solar Project		<b>County/State:</b> Harrison County, Kentucky	<b>Project No.</b> E320201803
<b>Photo No.</b> <b>21</b>	<b>Date:</b> 5-24-2021

<b>Coordinates:</b> 38.387869, -84.242881			
<b>Photo Direction:</b> Southwest			
<b>Description:</b> Data Point 26 - Forested Wetland (Wet 21)

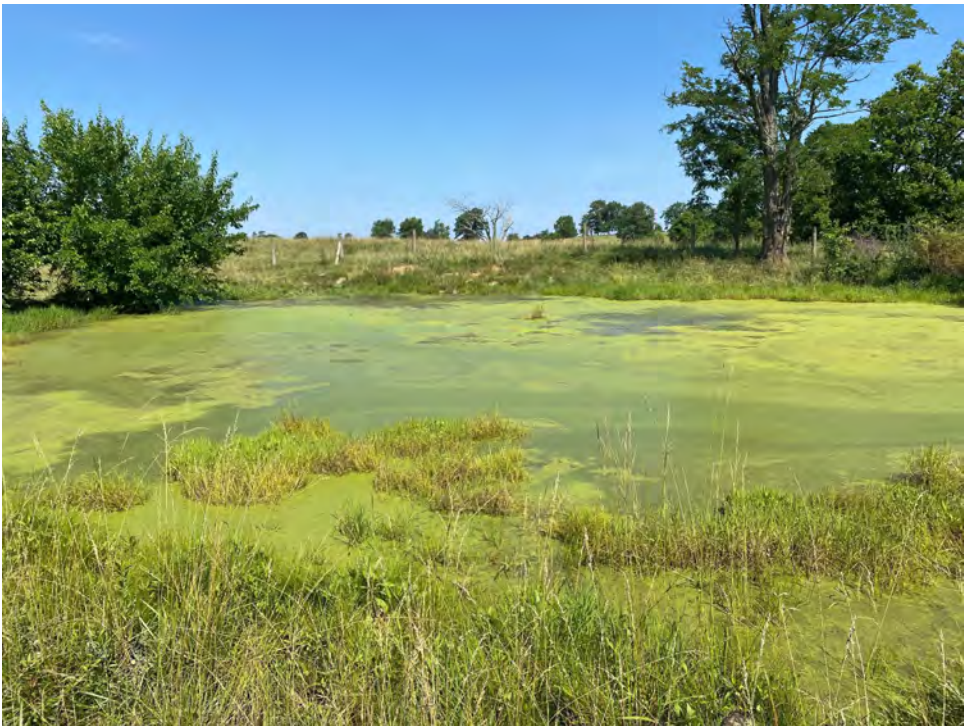
<b>Property Name:</b> Blue Moon Solar Project		<b>County/State:</b> Harrison County, Kentucky	<b>Project No.</b> E320201803
<b>Photo No.</b> <b>22</b>	<b>Date:</b> 5-24-2021

<b>Coordinates:</b> 38.387821, -84.246047			
<b>Photo Direction:</b> West			
<b>Description:</b> Freshwater Pond (Wet 22)

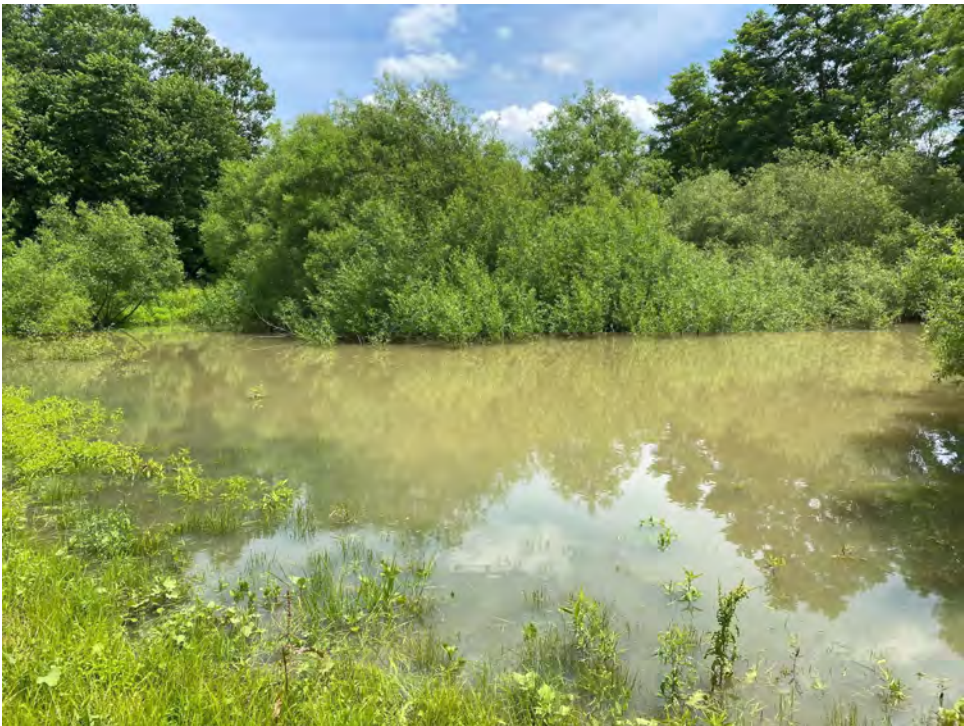
<b>Property Name:</b> Blue Moon Solar Project		<b>County/State:</b> Harrison County, Kentucky	<b>Project No.</b> E320201803
<b>Photo No.</b> <b>24</b>	<b>Date:</b> 5-24-2021

<b>Coordinates:</b> 38.390310, -84.227186			
<b>Photo Direction:</b> East			
<b>Description:</b> Freshwater Pond (Wet 24)

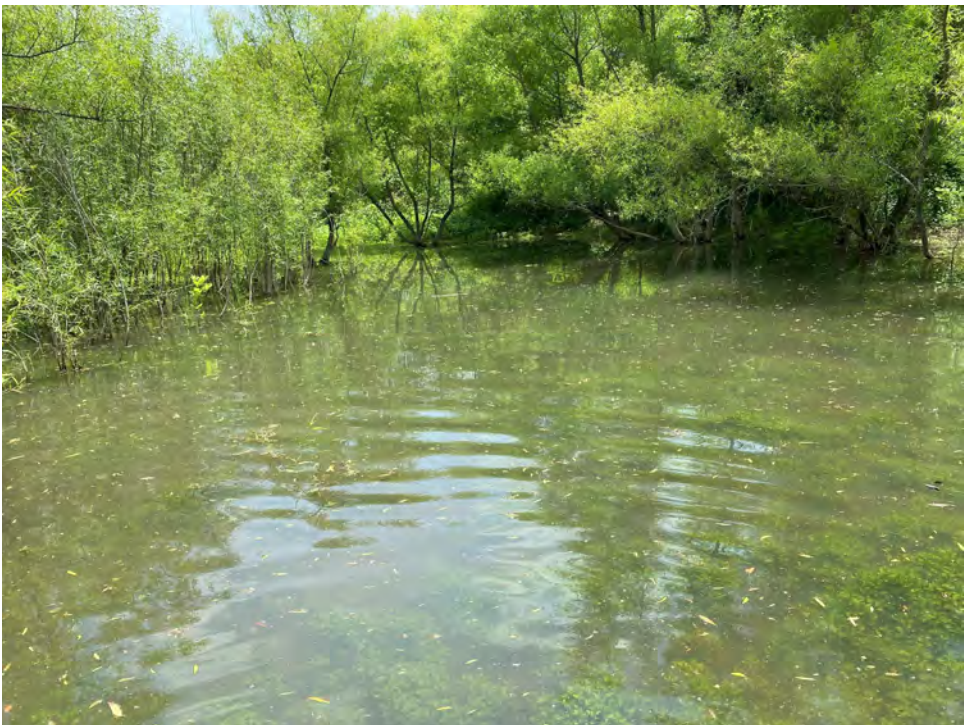
<b>Property Name:</b> Blue Moon Solar Project		<b>County/State:</b> Harrison County, Kentucky	<b>Project No.</b> E320201803
<b>Photo No.</b> <b>25</b>	<b>Date:</b> 5-24-2021

<b>Coordinates:</b> 38.389511, -84.228088			
<b>Photo Direction:</b> Southeast			
<b>Description:</b> Freshwater Pond (Wet 25)

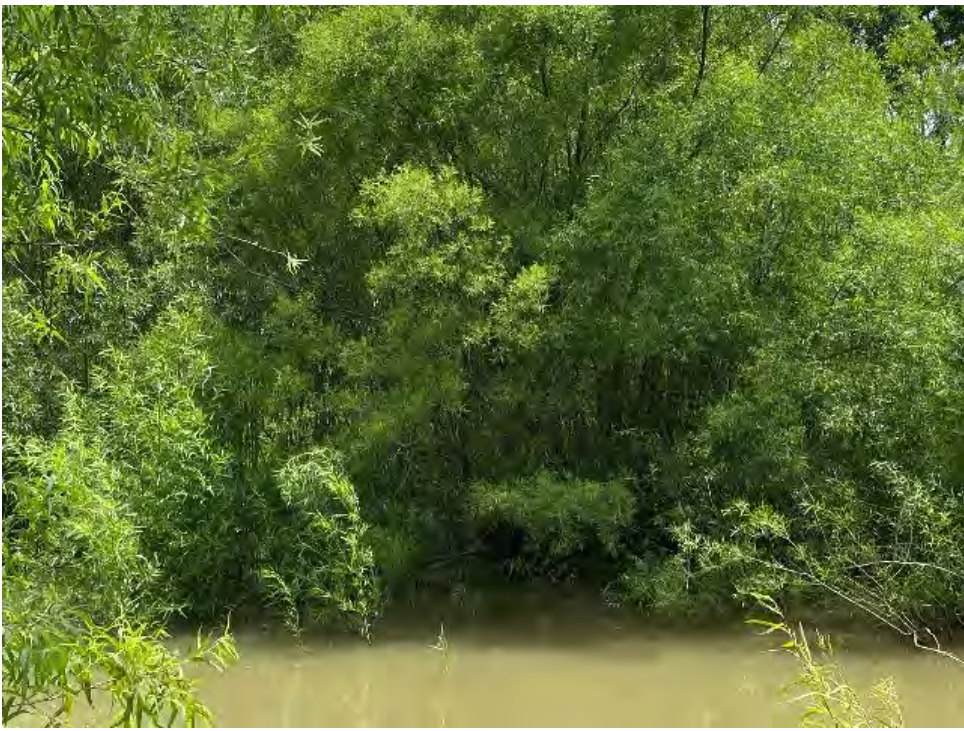
<b>Property Name:</b> Blue Moon Solar Project		<b>County/State:</b> Harrison County, Kentucky	<b>Project No.</b> E320201803
<b>Photo No.</b> <b>27</b>	<b>Date:</b> 5-24-2021

<b>Coordinates:</b> 38.390269, -84.227019			
<b>Photo Direction:</b> East			
<b>Description:</b> Data Point 36 - Forested Wetland (Wet 27)

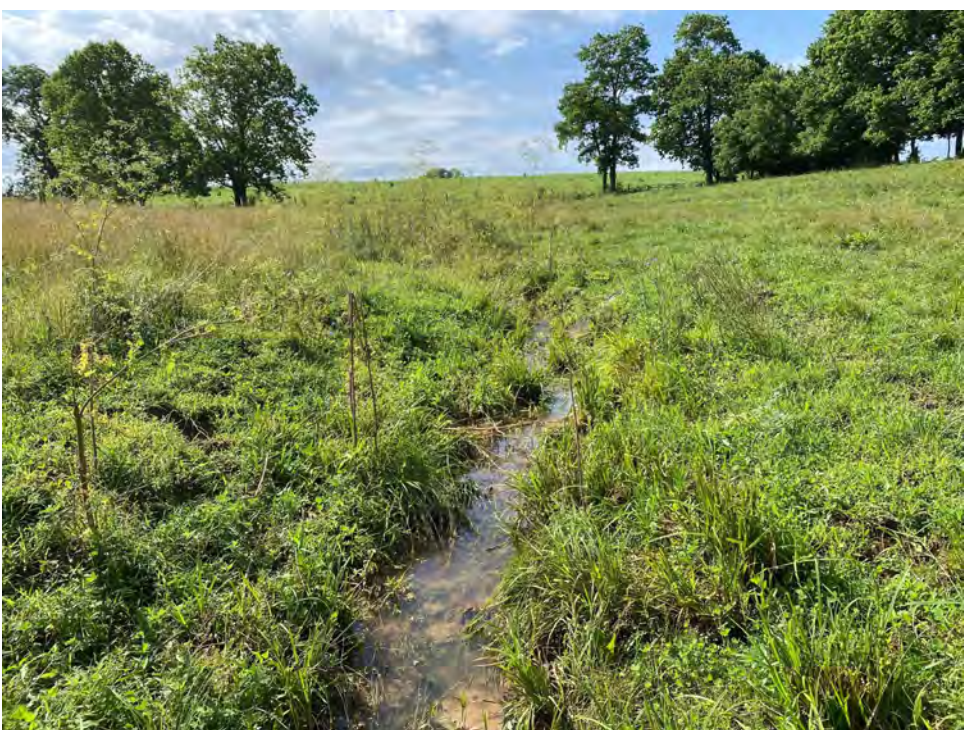
<b>Property Name:</b> Blue Moon Solar Project		<b>County/State:</b> Harrison County, Kentucky	<b>Project No.</b> E320201803
<b>Photo No.</b> <b>28</b>	<b>Date:</b> 5-22-2021

<b>Coordinates:</b> 38.35832, -84.22957			
<b>Photo Direction:</b> Northeast			
<b>Description:</b> Ephemeral Stream (S-1)

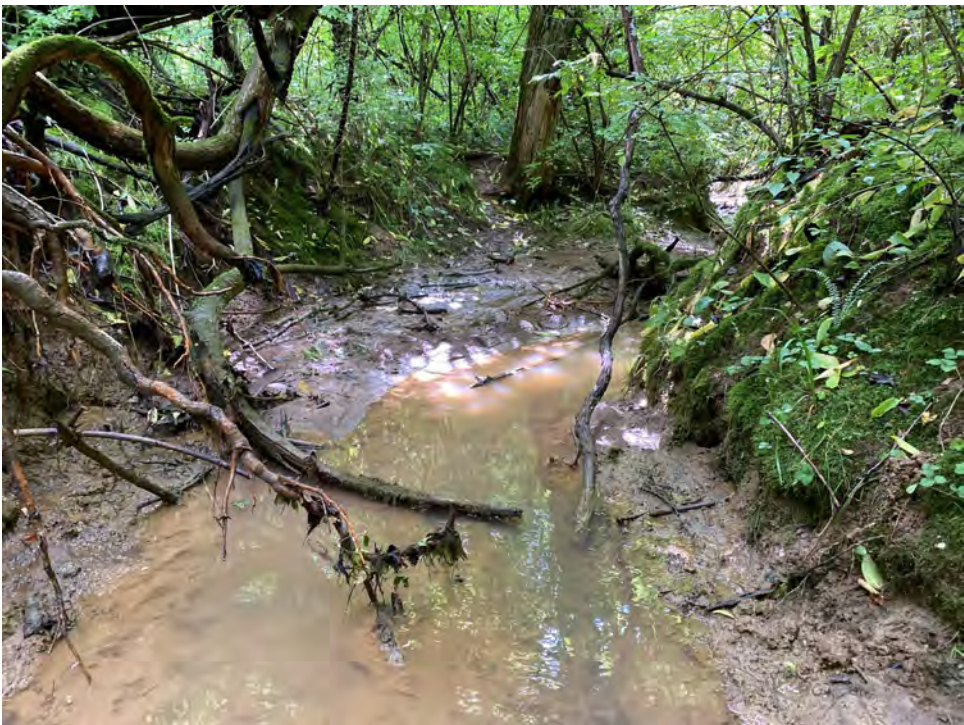
<b>Property Name:</b> Blue Moon Solar Project		<b>County/State:</b> Harrison County, Kentucky	<b>Project No.</b> E320201803
<b>Photo No.</b> <b>29</b>	<b>Date:</b> 5-22-2021

<b>Coordinates:</b> 38.36068, -84.2271			
<b>Photo Direction:</b> Northeast			
<b>Description:</b> Intermittent Stream (S-2)

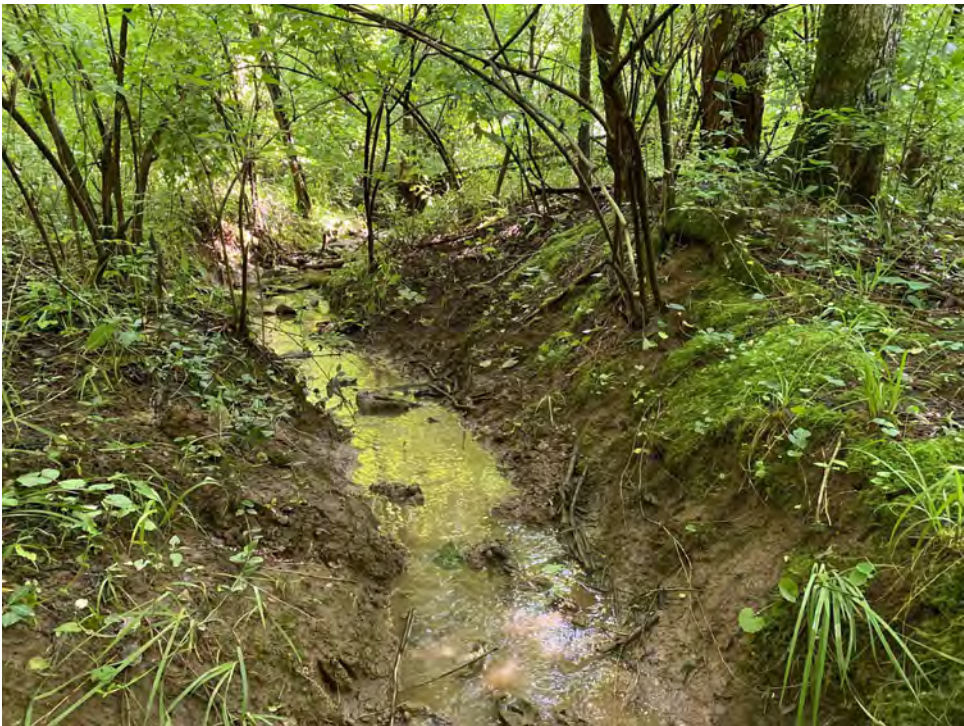
<b>Property Name:</b> Blue Moon Solar Project		<b>County/State:</b> Harrison County, Kentucky	<b>Project No.</b> E320201803
<b>Photo No.</b> <b>30</b>	<b>Date:</b> 5-22-2021

<b>Coordinates:</b> 38.36054, -84.22803			
<b>Photo Direction:</b> North			
<b>Description:</b> Ephemeral Stream (S-3)

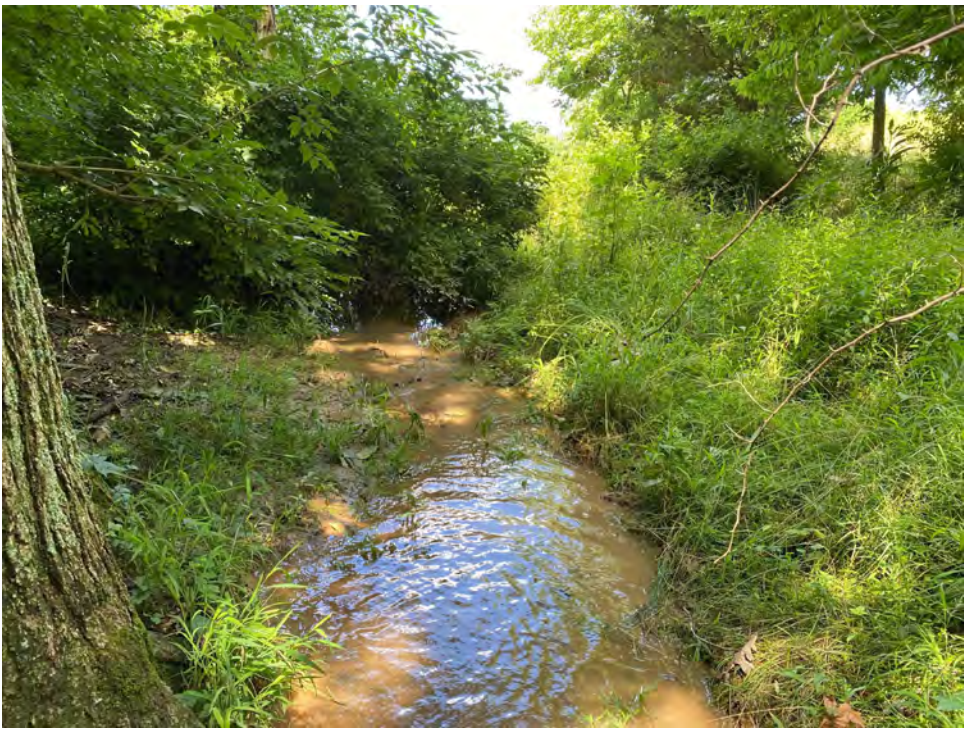
<b>Property Name:</b> Blue Moon Solar Project		<b>County/State:</b> Harrison County, Kentucky	<b>Project No.</b> E320201803
<b>Photo No.</b> <b>31</b>	<b>Date:</b> 5-22-2021

<b>Coordinates:</b> 38.36357, -84.23342			
<b>Photo Direction:</b> West			
<b>Description:</b> Ephemeral Stream (S-4)

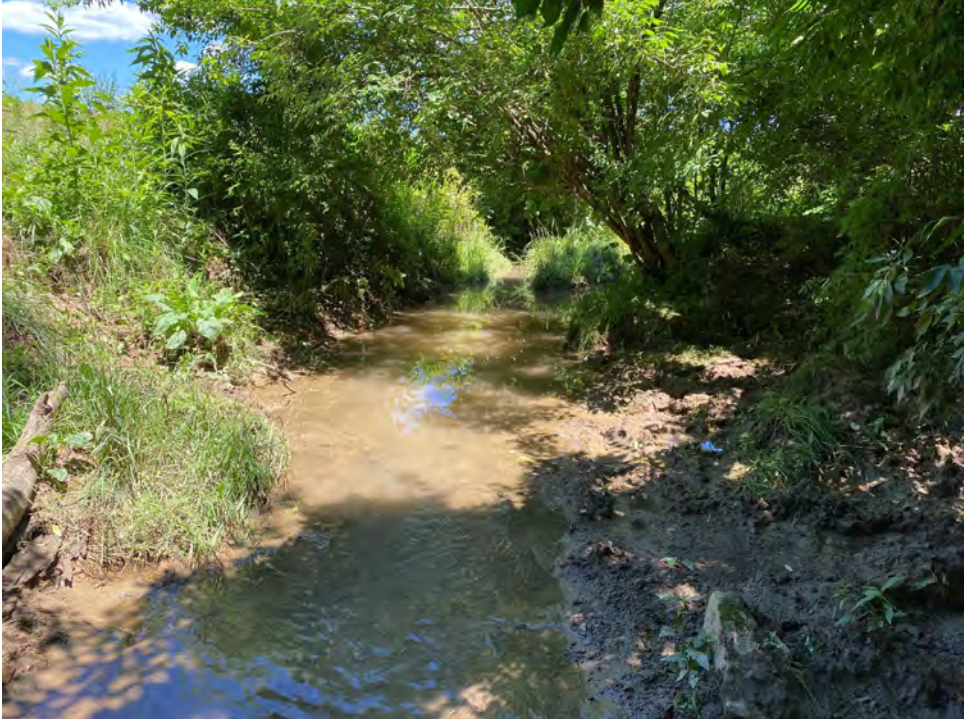
<b>Property Name:</b> Blue Moon Solar Project		<b>County/State:</b> Harrison County, Kentucky	<b>Project No.</b> E320201803
<b>Photo No.</b> <b>33</b>	<b>Date:</b> 5-22-2021

<b>Coordinates:</b> 38.37534, -84.26093			
<b>Photo Direction:</b> Northeast			
<b>Description:</b> Intermittent Stream (S-6B)

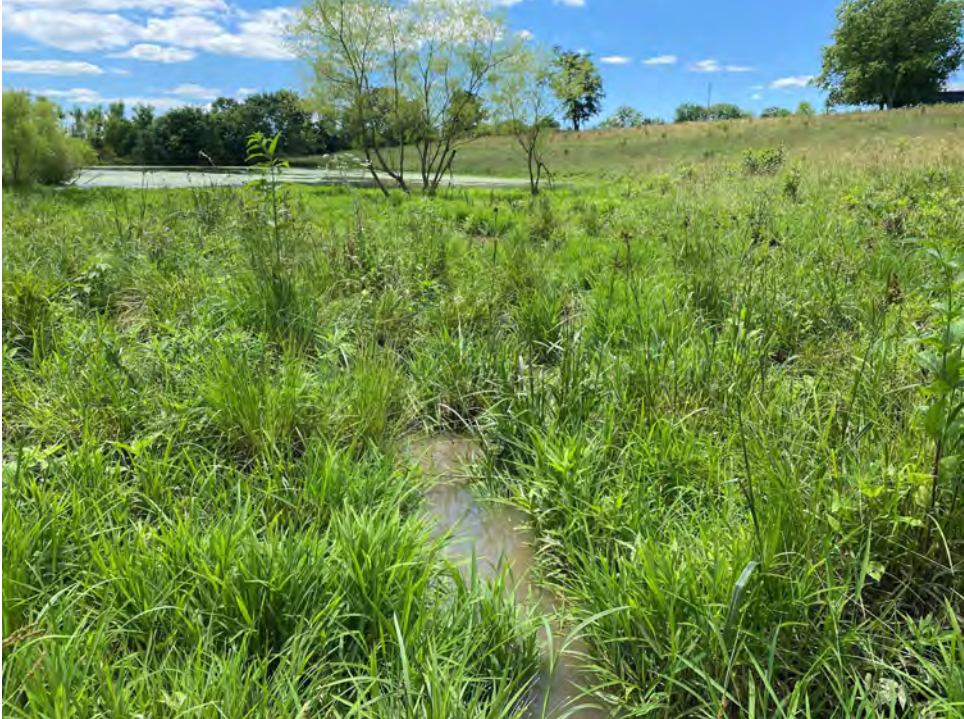
<b>Property Name:</b> Blue Moon Solar Project		<b>County/State:</b> Harrison County, Kentucky	<b>Project No.</b> E320201803
<b>Photo No.</b> <b>34</b>	<b>Date:</b> 5-22-2021

<b>Coordinates:</b> 38.37256, -84.25766			
<b>Photo Direction:</b> Southwest			
<b>Description:</b> Ephemeral Stream (S-7)

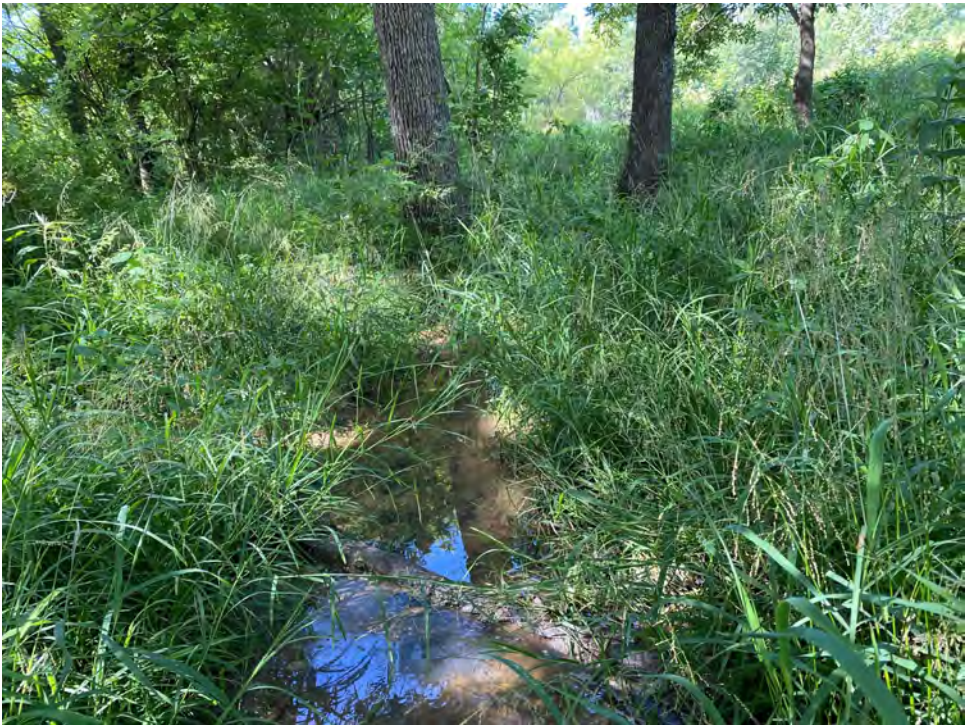
<b>Property Name:</b> Blue Moon Solar Project		<b>County/State:</b> Harrison County, Kentucky	<b>Project No.</b> E320201803
<b>Photo No.</b> <b>35</b>	<b>Date:</b> 5-23-2021

<b>Coordinates:</b> 38.36774, -84.25448			
<b>Photo Direction:</b> Southeast			
<b>Description:</b> Ephemeral Stream (S-8)

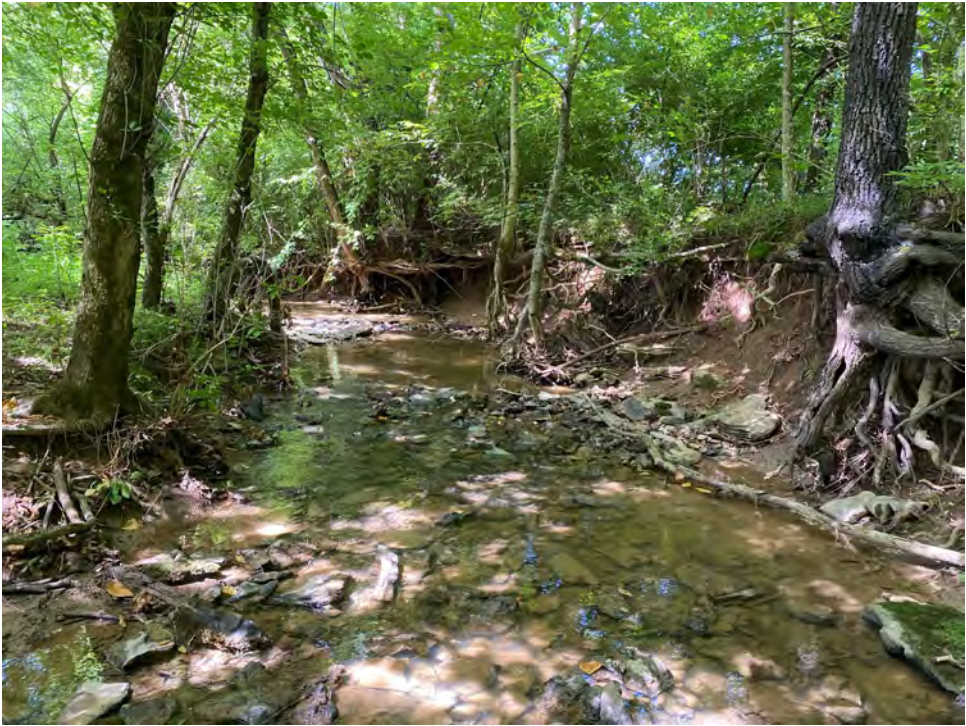
<b>Property Name:</b> Blue Moon Solar Project		<b>County/State:</b> Harrison County, Kentucky	<b>Project No.</b> E320201803
<b>Photo No.</b> <b>36</b>	<b>Date:</b> 5-23-2021

<b>Coordinates:</b> 38.36268, -84.25653			
<b>Photo Direction:</b> South			
<b>Description:</b> Intermittent Stream (S-9)

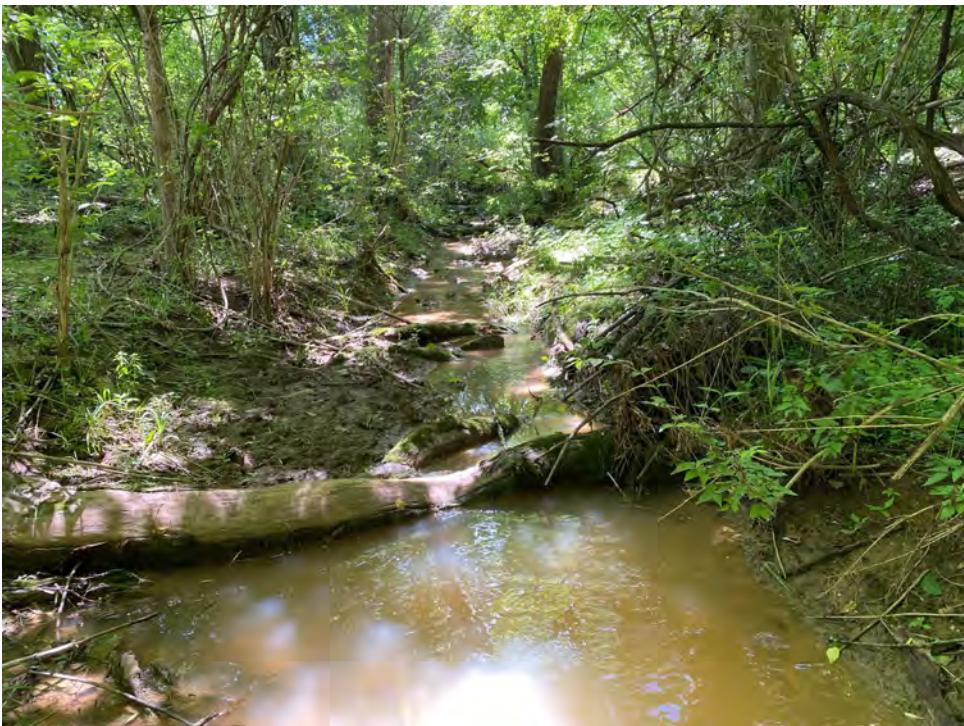
<b>Property Name:</b> Blue Moon Solar Project		<b>County/State:</b> Harrison County, Kentucky	<b>Project No.</b> E320201803
<b>Photo No.</b> <b>37</b>	<b>Date:</b> 5-23-2021

<b>Coordinates:</b> 38.36182, -84.25644			
<b>Photo Direction:</b> Northeast			
<b>Description:</b> Intermittent Stream (S-10B)
