Blue Moon Energy LLC  
Response to Public Service Commission's Second Request for Information  
Case No. 2021-00414

Estimated Sound Receptors  
Level of 55 dBA

Delineated Wetlands and Waterbodies

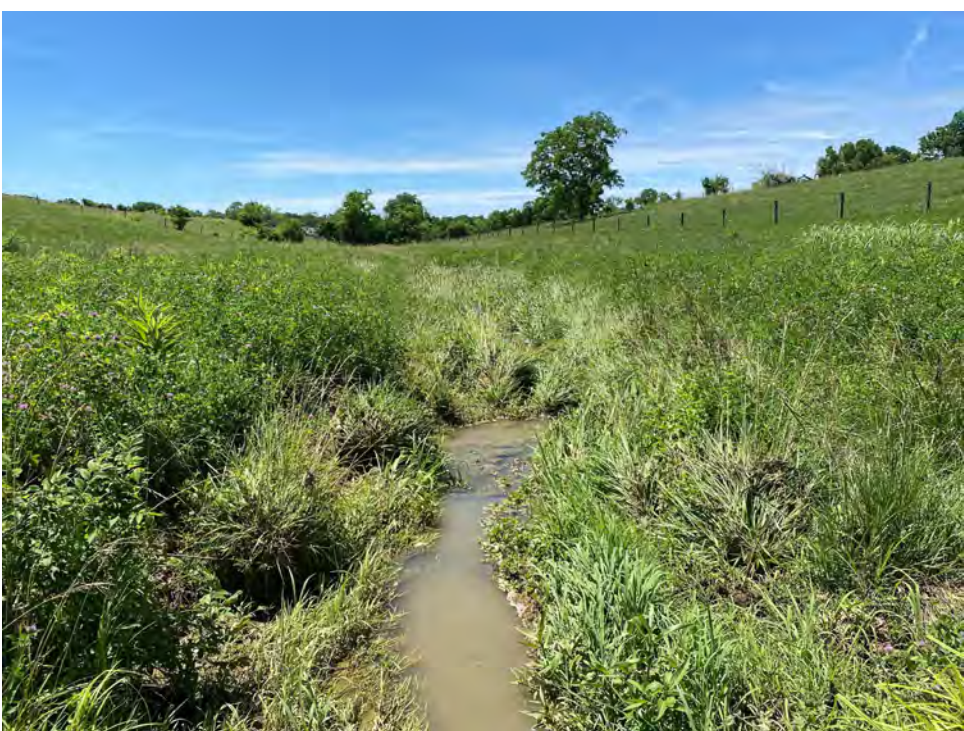
<h1>PHOTOGRAPHIC LOG</h1>	
<b>Property Name:</b> Blue Moon Solar Project		<b>County/State:</b> Harrison County, Kentucky	<b>Project No.</b> E320201803
<b>Photo No.</b> <b>40</b>	<b>Date:</b> 5-23-2021

<b>Coordinates:</b> 38.38302, -84.25876			
<b>Photo Direction:</b> Southwest			
<b>Description:</b> Ephemeral Stream (S-13)

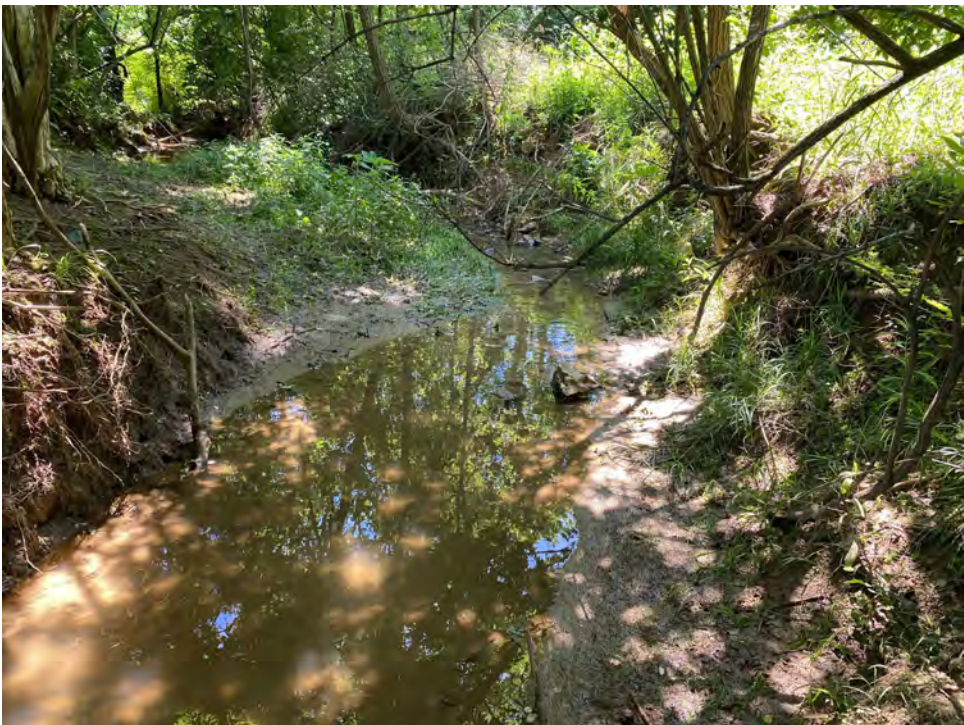
<b>Property Name:</b> Blue Moon Solar Project		<b>County/State:</b> Harrison County, Kentucky	<b>Project No.</b> E320201803
<b>Photo No.</b> <b>41</b>	<b>Date:</b> 5-23-2021

<b>Coordinates:</b> 38.38808, -84.25813			
<b>Photo Direction:</b> West			
<b>Description:</b> Intermittent Stream (S-14B)

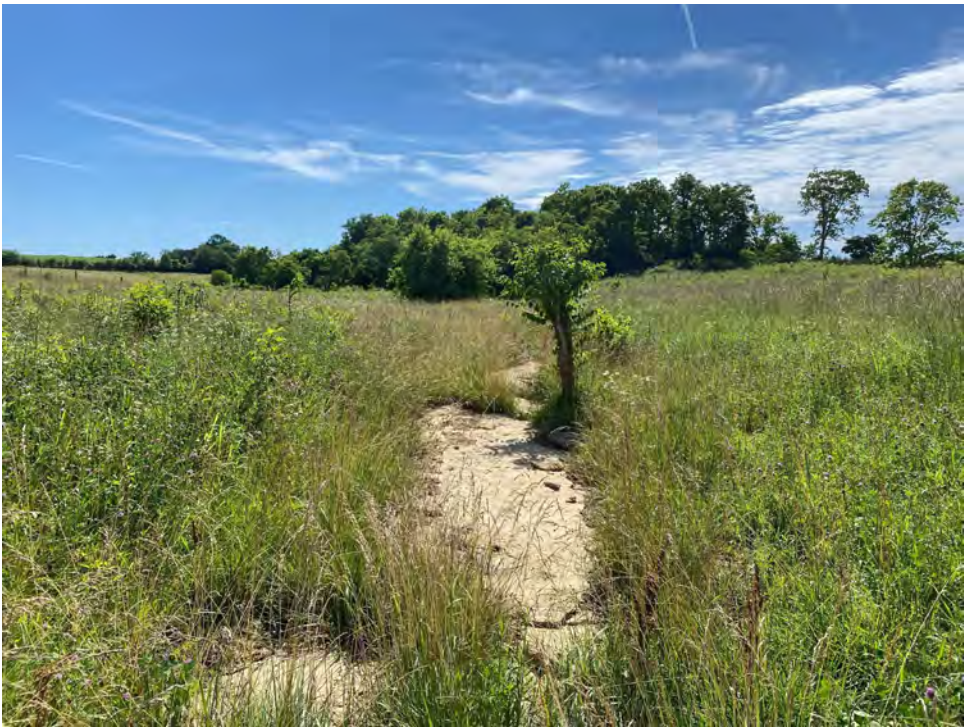
<b>Property Name:</b> Blue Moon Solar Project		<b>County/State:</b> Harrison County, Kentucky	<b>Project No.</b> E320201803
<b>Photo No.</b> <b>42</b>	<b>Date:</b> 5-23-2021

<b>Coordinates:</b> 38.3894, -84.25429			
<b>Photo Direction:</b> Northeast			
<b>Description:</b> Ephemeral Stream (S-15)

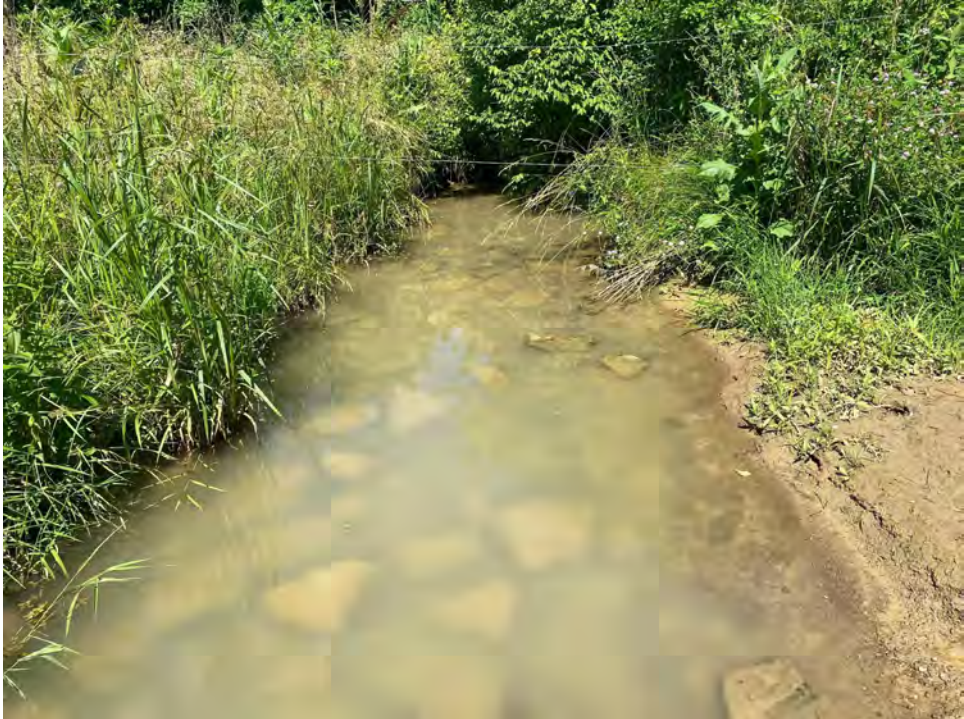
<b>Property Name:</b> Blue Moon Solar Project		<b>County/State:</b> Harrison County, Kentucky	<b>Project No.</b> E320201803
<b>Photo No.</b> <b>43</b>	<b>Date:</b> 5-24-2021

<b>Coordinates:</b> 38.38935, -84.23907			
<b>Photo Direction:</b> South			
<b>Description:</b> Intermittent Stream (S-16)

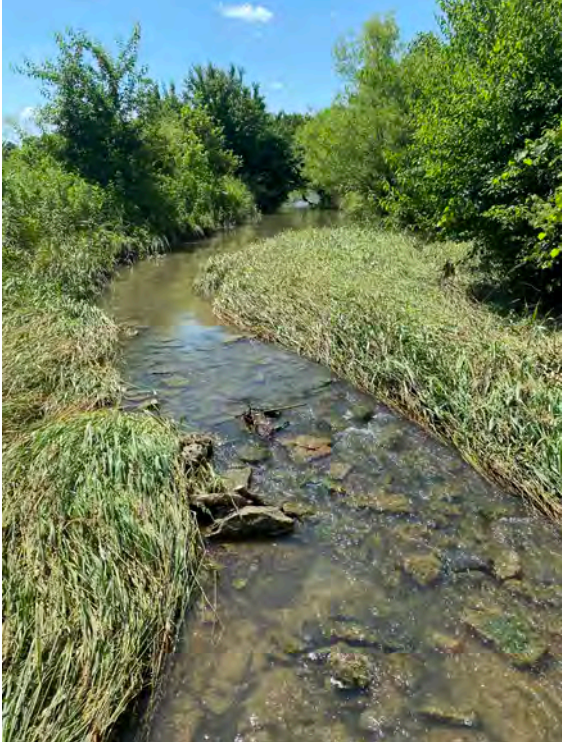
<b>Property Name:</b> Blue Moon Solar Project		<b>County/State:</b> Harrison County, Kentucky	<b>Project No.</b> E320201803
<b>Photo No.</b> <b>44</b>	<b>Date:</b> 5-24-2021

<b>Coordinates:</b> 38.39195, -84.2328			
<b>Photo Direction:</b> South			
<b>Description:</b> Perennial Stream (S-17)

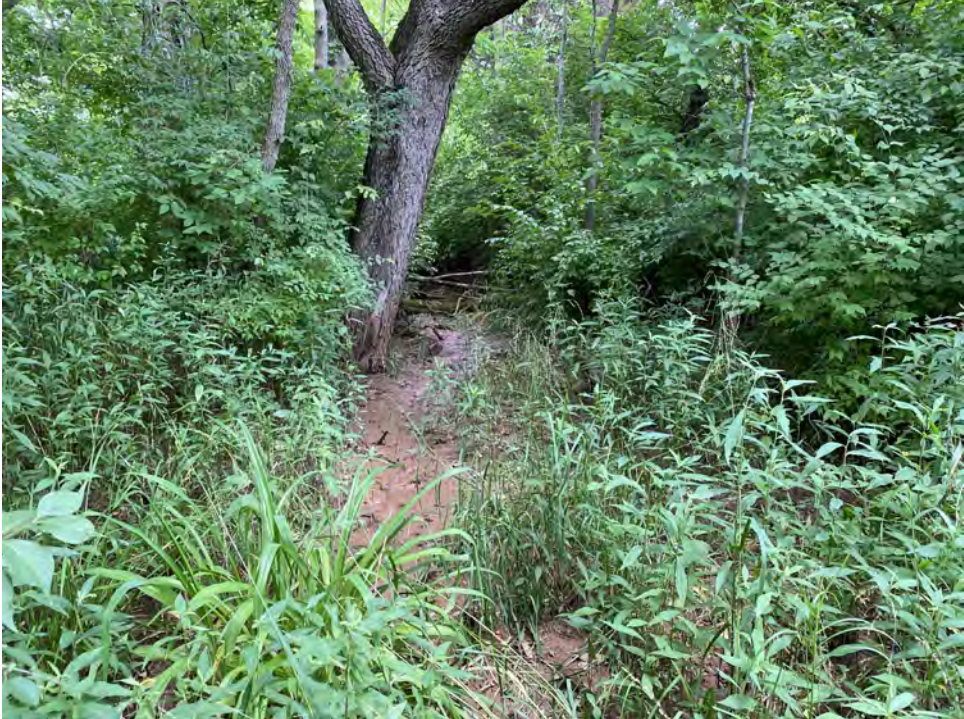
<h1>PHOTOGRAPHIC LOG</h1>	
<b>Property Name:</b> Blue Moon Solar Project		<b>County/State:</b> Harrison County, Kentucky	<b>Project No.</b> E320201803
<b>Photo No.</b> <b>46</b>	<b>Date:</b> 5-24-2021

<b>Coordinates:</b> 38.39055, -84.22672			
<b>Photo Direction:</b> South			
<b>Description:</b> Ephemeral Stream (S-18)

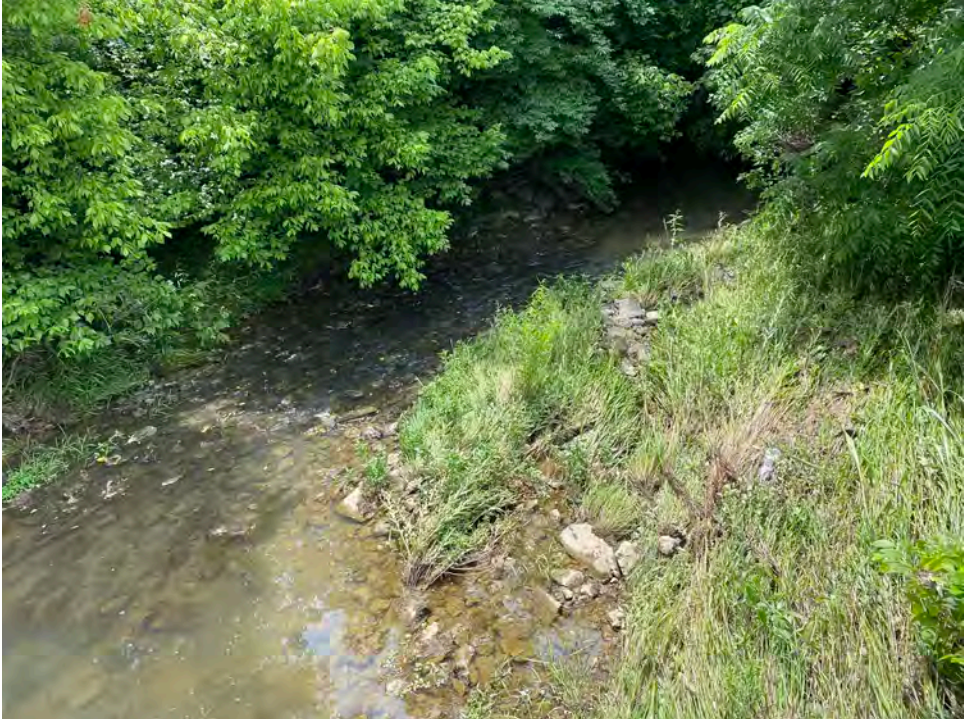
<b>Property Name:</b> Blue Moon Solar Project		<b>County/State:</b> Harrison County, Kentucky		<b>Project No.</b> E320201803
<b>Photo No.</b> <b>47</b>	<b>Date:</b> 5-24-2021

<b>Coordinates:</b> 38.39316, -84.21968			
<b>Photo Direction:</b> North			
<b>Description:</b> Perennial Stream (S-19) – Indian Creek

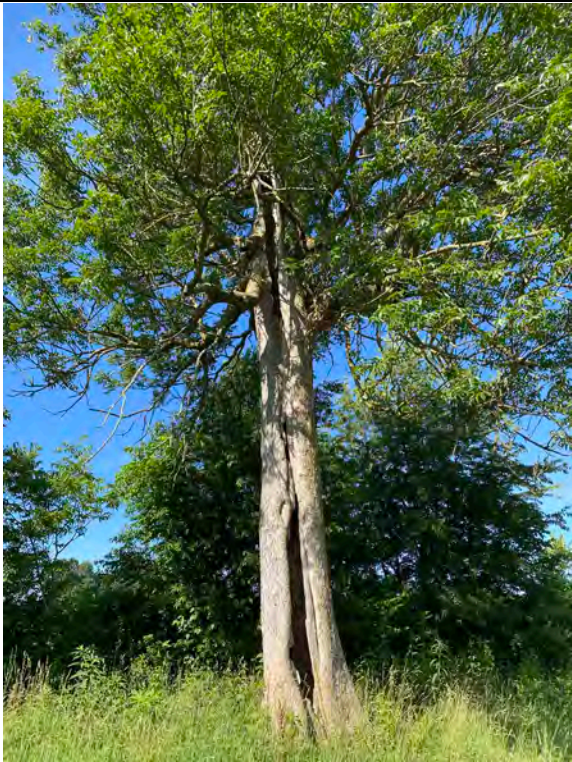
<b>Property Name:</b> Blue Moon Solar Project		<b>County/State:</b> Harrison County, Kentucky		<b>Project No.</b> E320201803
<b>Photo No.</b> <b>46</b>	<b>Date:</b> 5-24-2021

<b>Coordinates:</b> 38.368406, -84.25289				
<b>Photo Direction:</b> West				
<b>Description:</b> Potential Bat Tree – Large Hollow Cavity

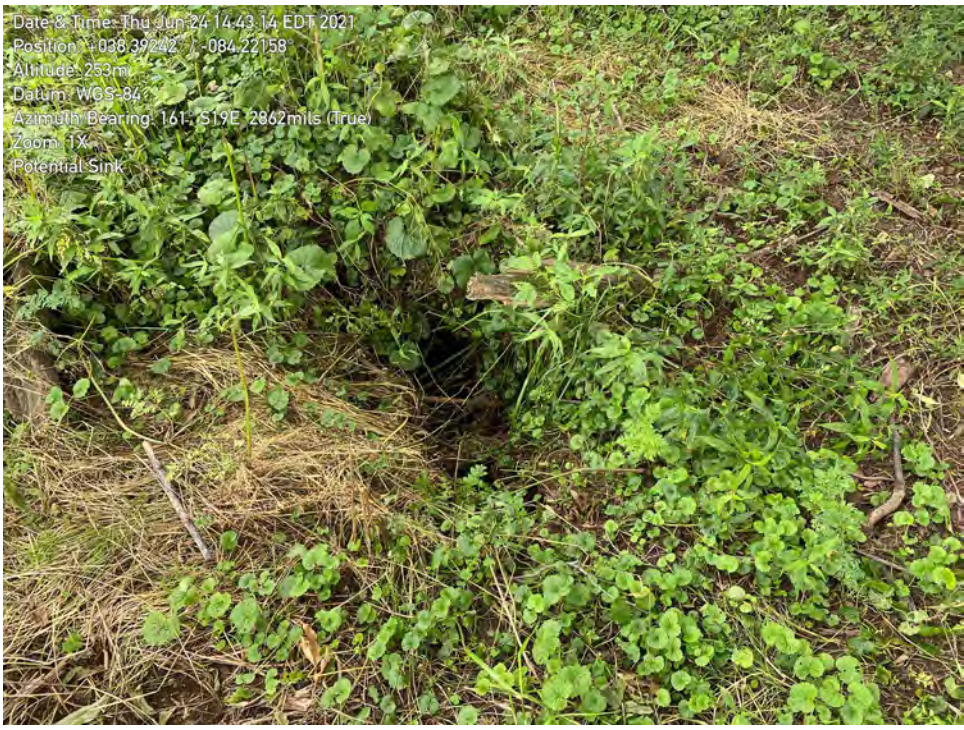
<b>Coordinates:</b> 38.39242, -84.22158				
<b>Photo Direction:</b> East				
<b>Description:</b> Potential Sinkhole near DP-37

Date & Time: Thu Jun 24 14:43:14 EDT 2021  
 Position: +038.39242, -084.22158  
 Altitude: 253m  
 Datum: WGS-84  
 Azimuth Bearing: 161.519E 2062mils (True)  
 Zoom: 1X  
 Potential Sink

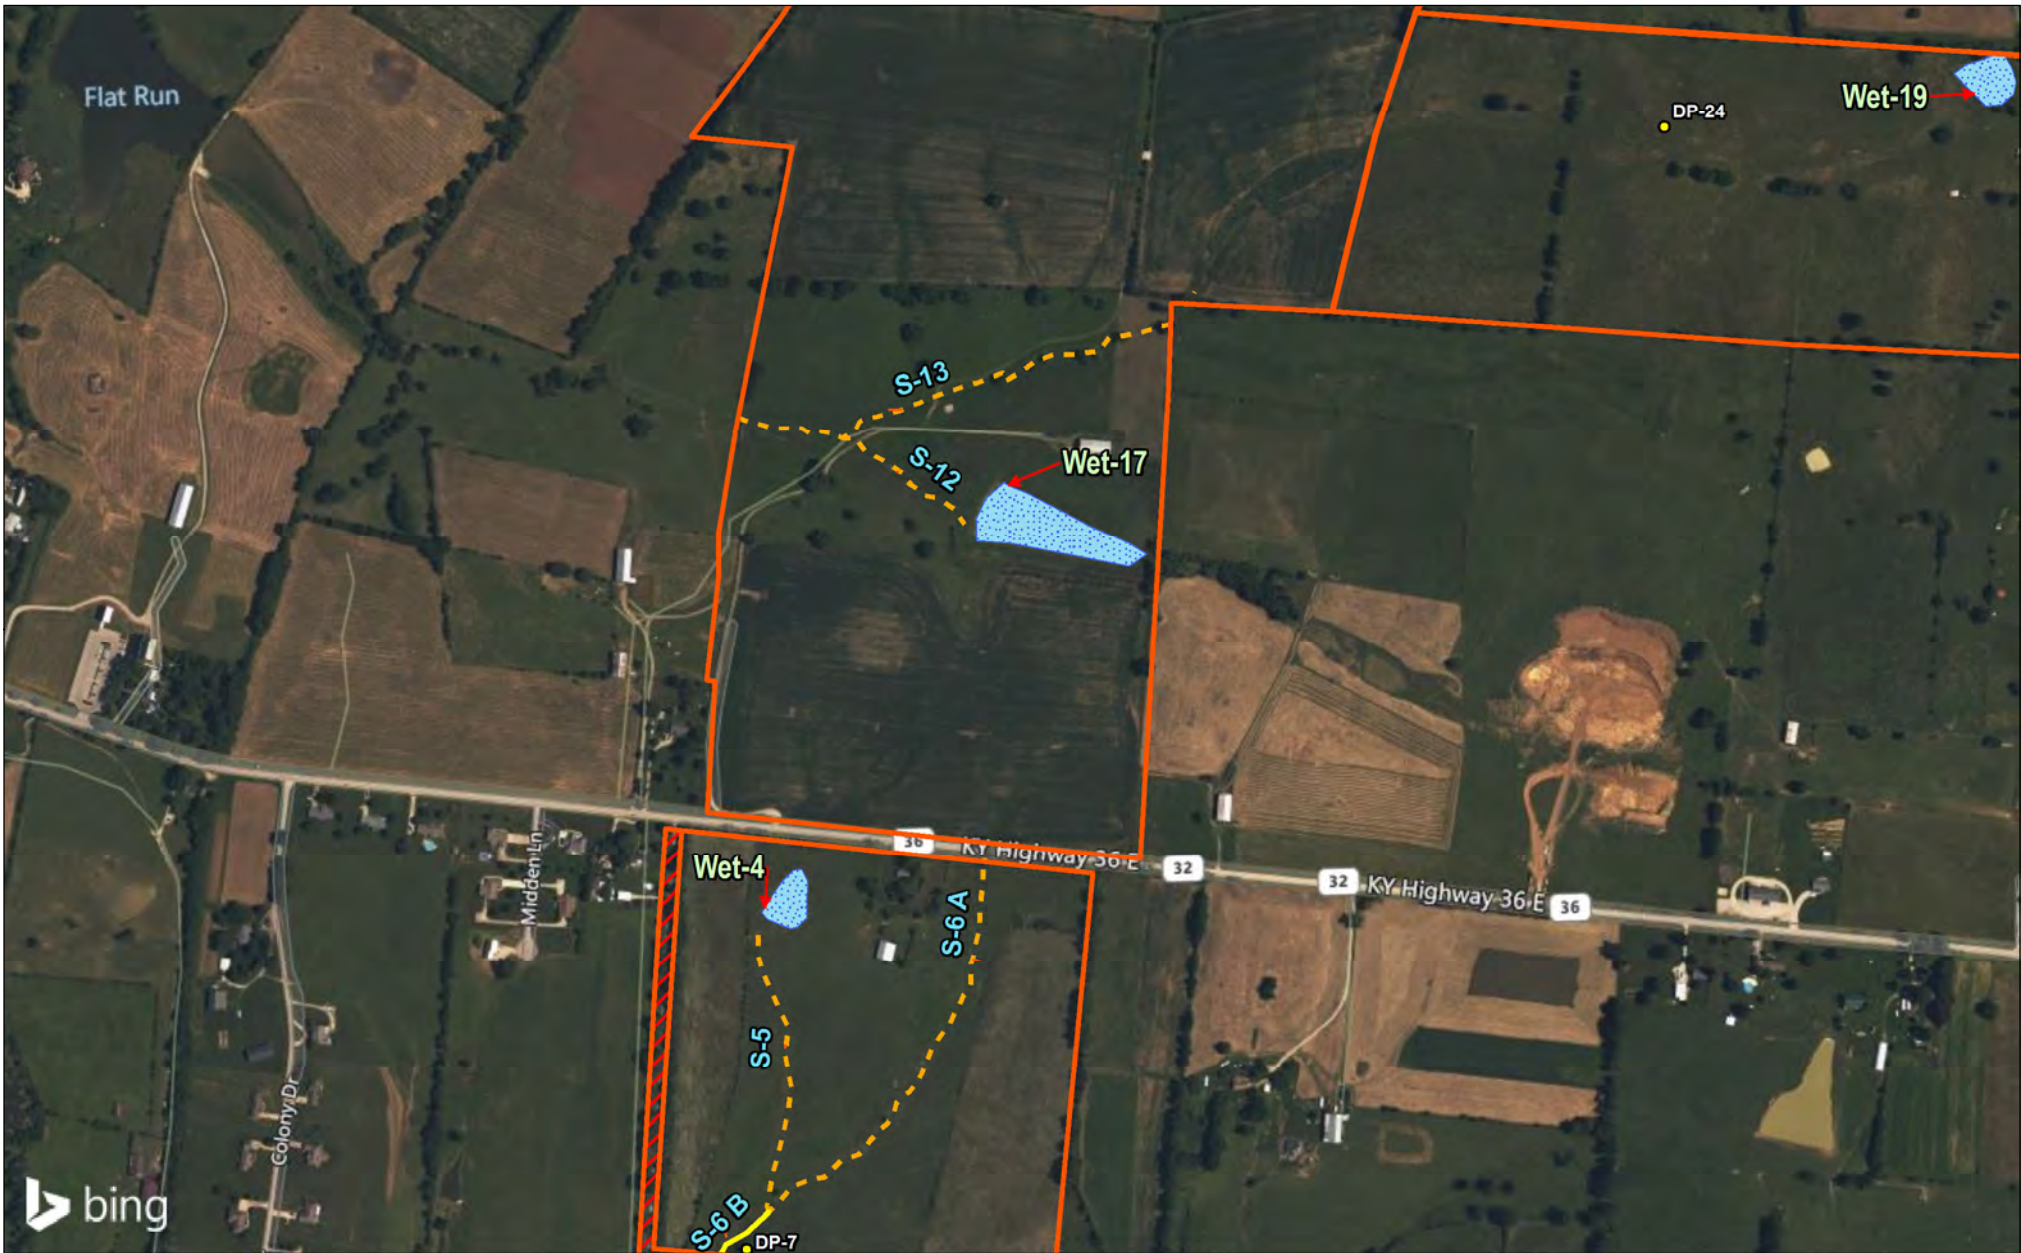
Date: June 2021	Project No: E320201803	Figure No: C-3
--------------------	---------------------------	-------------------

Delineated Wetlands and Waterbodies

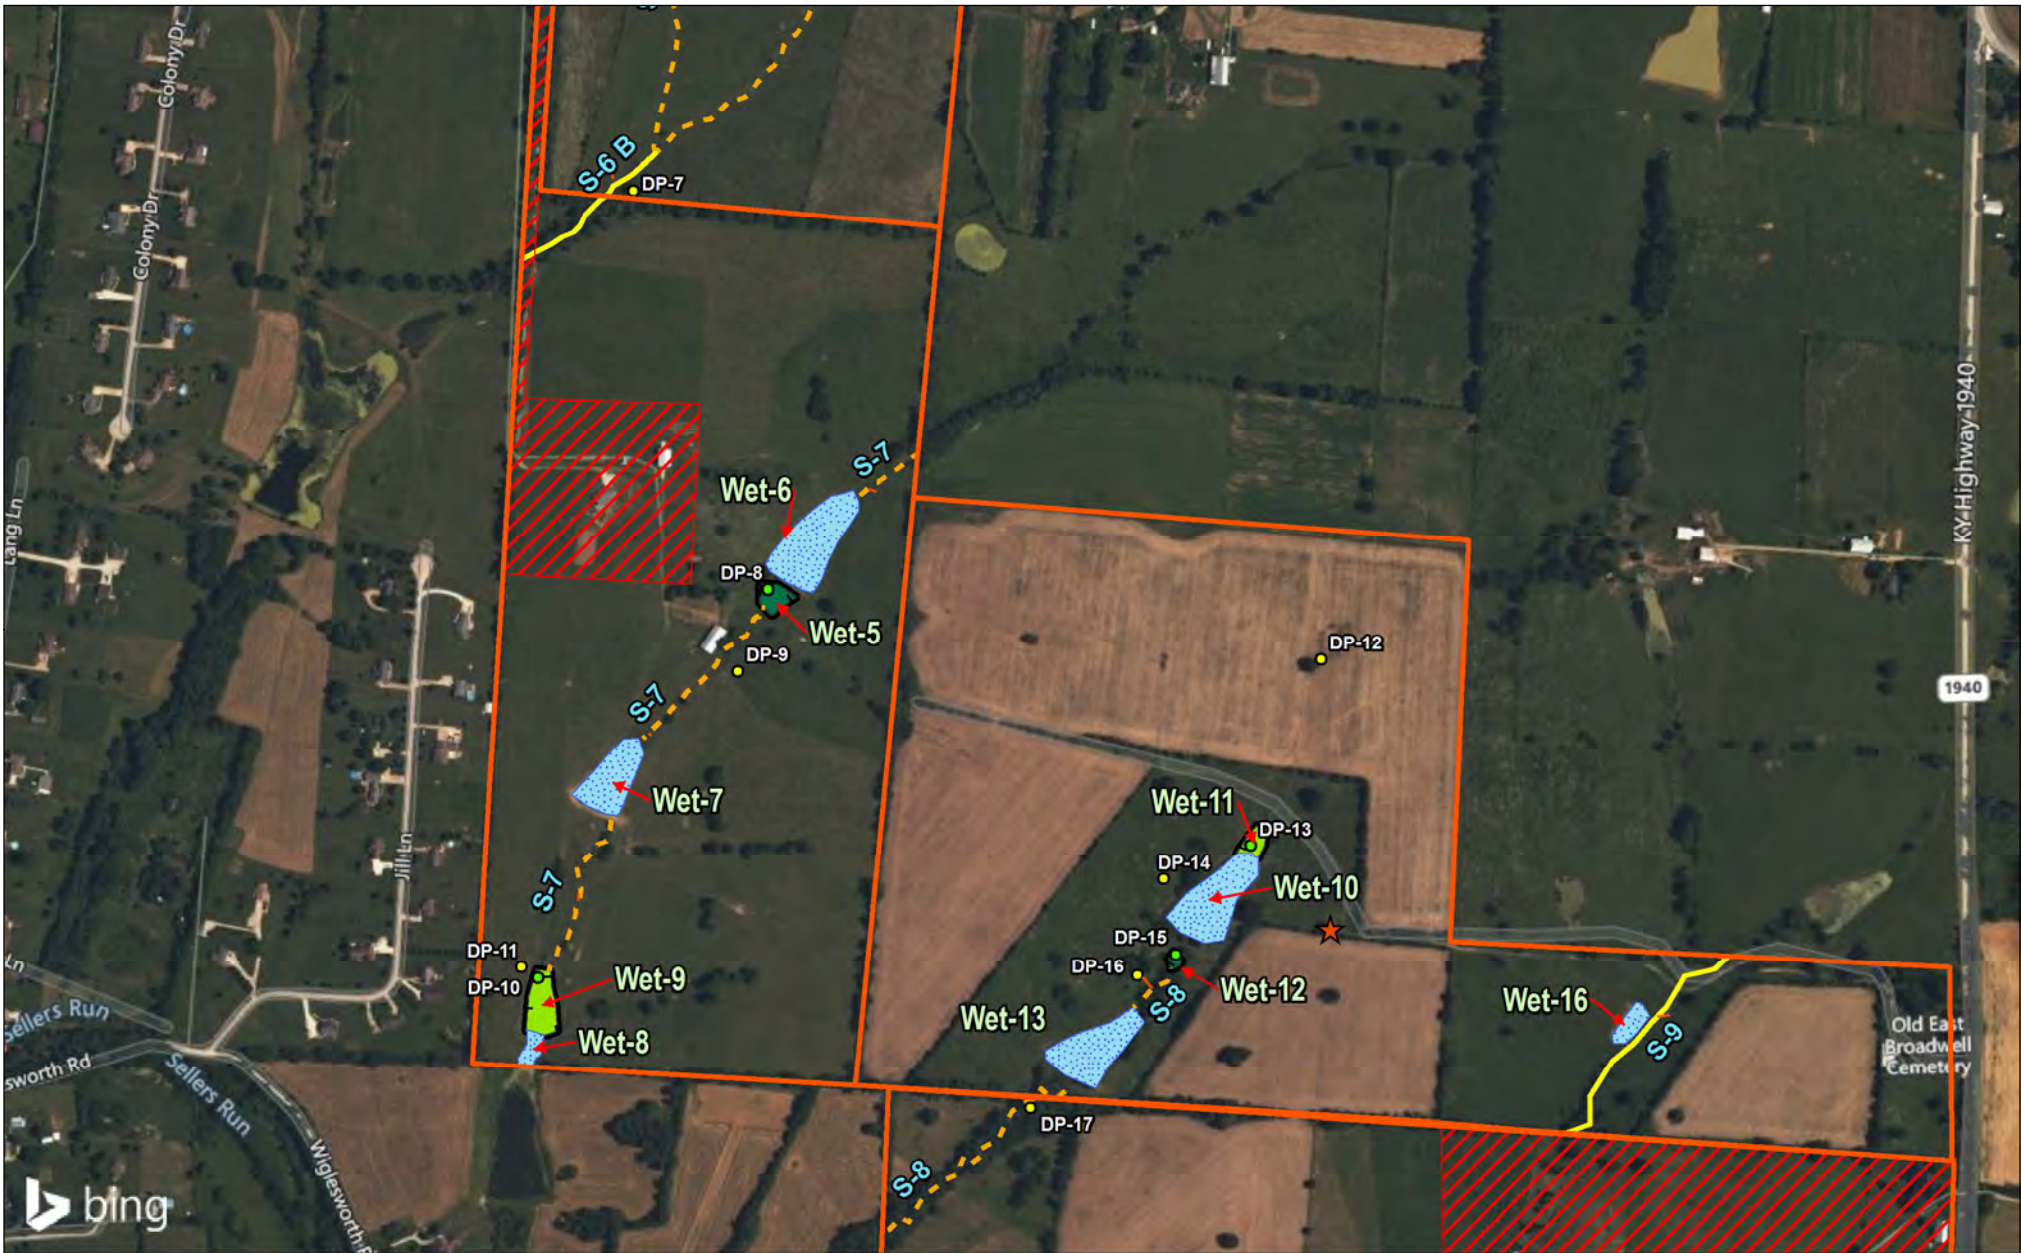
Date:	Project No:	Figure No:
June 2021	E320201803	C-4

**Delineated Wetlands and Waterbodies**

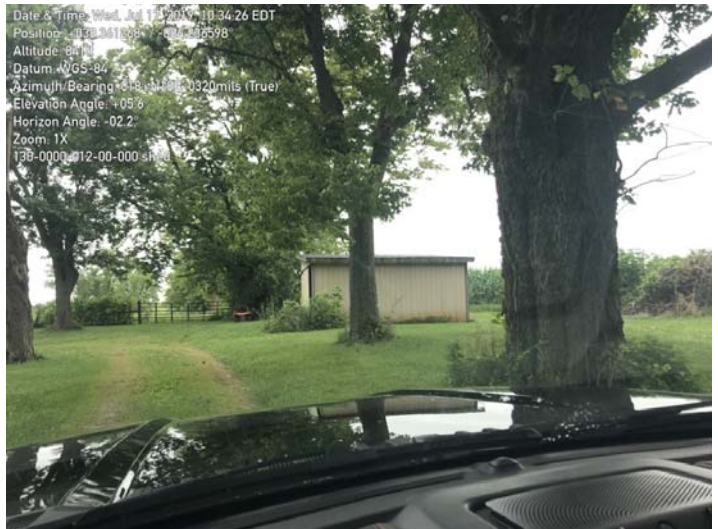
Date & Time: Wed, Jul 17, 2019, 16:34:26 EDT  
 Position: +48.146188° / -086.26598°  
 Altitude: 841ft  
 Datum: WGS-84  
 Azimuth/Bearing: 133° S133E 0320mils (True)  
 Elevation Angle: +05.6°  
 Horizon Angle: -02.2°  
 Zoom: 1X  
 130-0000-012-00-000 shed

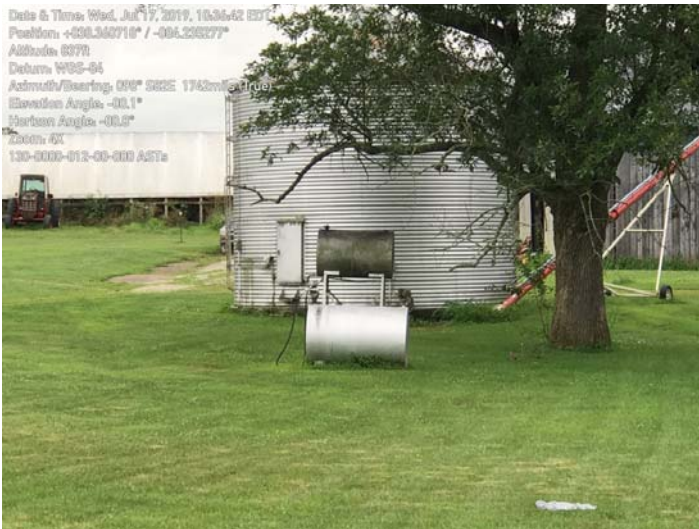
Date & Time: Wed, Jul 17, 2019, 16:36:42 EDT  
 Position: +48.146271° / -086.266277°  
 Altitude: 837ft  
 Datum: WGS-84  
 Azimuth/Bearing: 000° S00E 1742mils (True)  
 Elevation Angle: -00.1°  
 Horizon Angle: -00.6°  
 Zoom: 6X  
 130-0000-012-00-000 ASTs

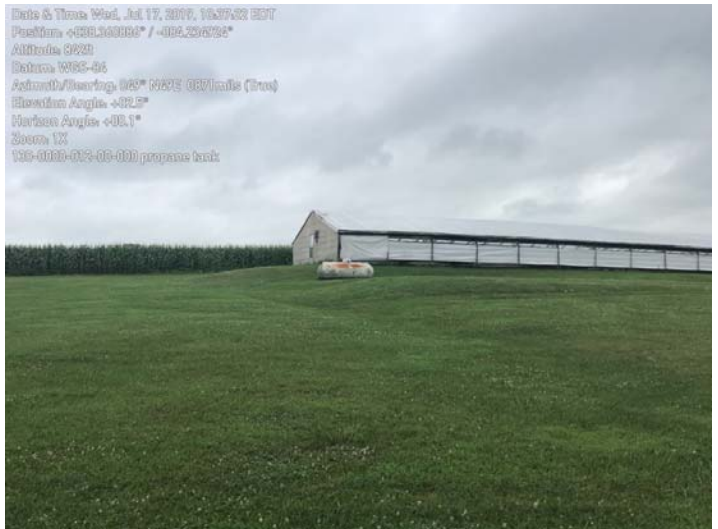
Date & Time: Wed, Jul 17, 2019, 16:37:02 EDT  
 Position: +48.146088° / -086.266784°  
 Altitude: 832ft  
 Datum: WGS-84  
 Azimuth/Bearing: 085° S085E 0301mils (True)  
 Elevation Angle: +02.7°  
 Horizon Angle: +00.1°  
 Zoom: 1X  
 130-0000-012-00-000 propane tank

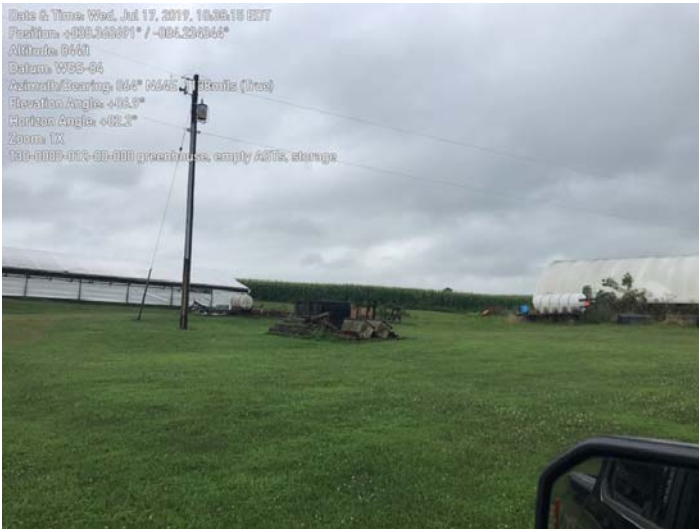
Date & Time: Wed, Jul 17, 2019, 16:36:18 EDT  
 Position: +48.146491° / -086.266464°  
 Altitude: 844ft  
 Datum: WGS-84  
 Azimuth/Bearing: 064° N064E 0100mils (True)  
 Elevation Angle: +04.9°  
 Horizon Angle: +01.2°  
 Zoom: 1X  
 130-0000-012-00-000 propane tank, empty ASTs, storage

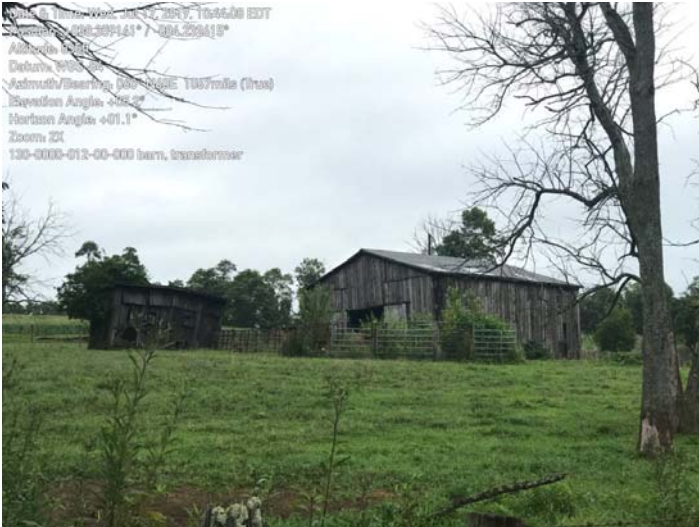
Date & Time: Wed, Jul 17, 2019, 10:46:00 EDT  
Position: +499.349161° / -106.233618°  
Altitude: 650ft  
Datum: WGS-84  
Azimuth/Bearing: 135° SSW 3297mils (True)  
Elevation Angle: +02.2°  
Horizon Angle: +01.1°  
Zoom: 1X  
130-0000-012-00-000 barn, transformer

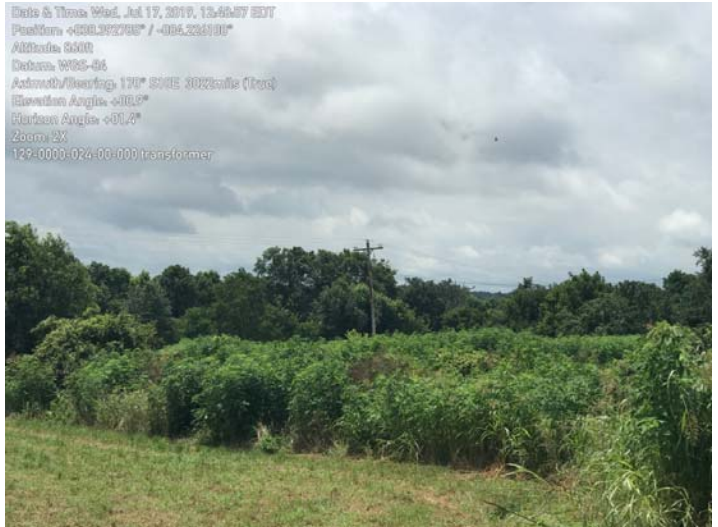
Date & Time: Wed, Jul 17, 2019, 12:46:07 EDT  
Position: +499.349206° / -106.233610°  
Altitude: 650ft  
Datum: WGS-84  
Azimuth/Bearing: 135° SSW 3297mils (True)  
Elevation Angle: +02.2°  
Horizon Angle: +01.7°  
Zoom: 2X  
129-0000-024-00-000 transformer

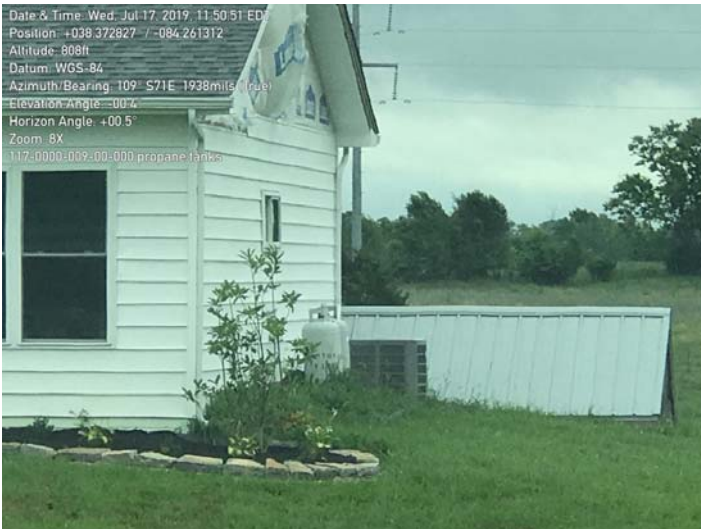
Date & Time: Wed, Jul 17, 2019, 11:50:51 EDT  
Position: +038.372827° / -094.261312°  
Altitude: 808ft  
Datum: WGS-84  
Azimuth/Bearing: 109° S71E 1938mils (True)  
Elevation Angle: -00.7°  
Horizon Angle: +00.5°  
Zoom: 8X  
117-0000-009-00-000 propane tanks

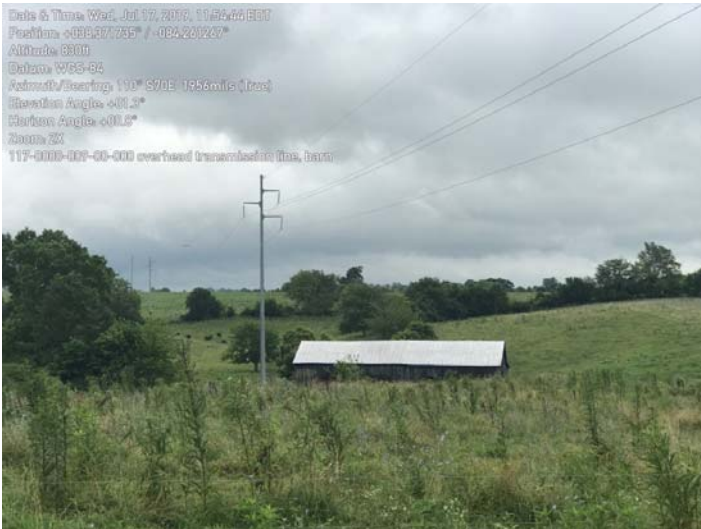
Date & Time: Wed, Jul 17, 2019, 11:52:46 EDT  
Position: +038.377755° / -094.231227°  
Altitude: 830ft  
Datum: WGS-84  
Azimuth/Bearing: 130° S70E 1956mils (True)  
Elevation Angle: +01.2°  
Horizon Angle: +01.6°  
Zoom: 2X  
117-0000-009-00-000 overhead transmission line, barn

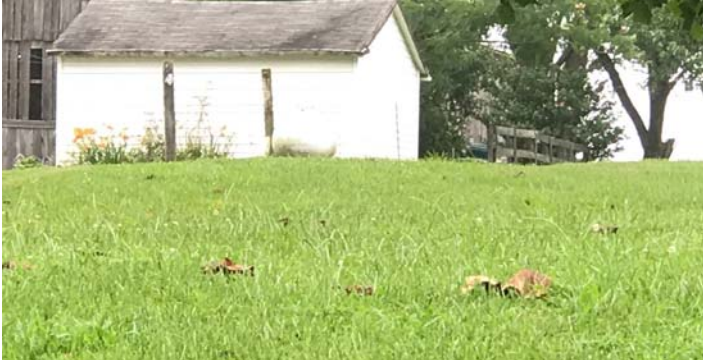
Date & Time: Wed, Jul 17, 2019, 11:24:05 EDT  
Position: +436.340000° / -084.249104°  
Altitude: 856ft  
Datum: WGS-84  
Azimuth/Bearing: 092° S88E 1630mils (True)  
Elevation Angle: +02.4°  
Horizon Angle: -00.8°  
Zoom: 8X  
117-0000-022-00-000 propane tank

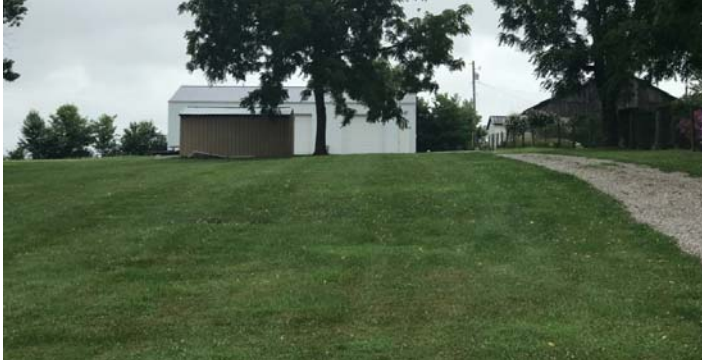
Date & Time: Wed, Jul 17, 2019, 11:25:44 EDT  
Position: +436.340000° / -084.249104°  
Altitude: 856ft  
Datum: WGS-84  
Azimuth/Bearing: 102° S88E 1610mils (True)  
Elevation Angle: +04.4°  
Horizon Angle: +00.2°  
Zoom: 8X  
117-0000-022-00-000 propane tank

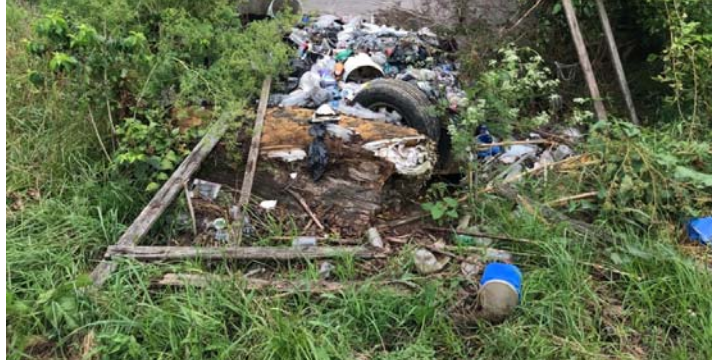
Date & Time: Wed, Jul 17, 2019, 12:00:43 EDT  
Position: +038.378540° / -084.258439°  
Altitude: 840ft  
Datum: WGS-84  
Azimuth/Bearing: 354° N06W 4.213mils (True)  
Elevation Angle: -12.4°  
Horizon Angle: +01.6°  
Zoom: 1X  
116-0000-012-01-000 trash pile

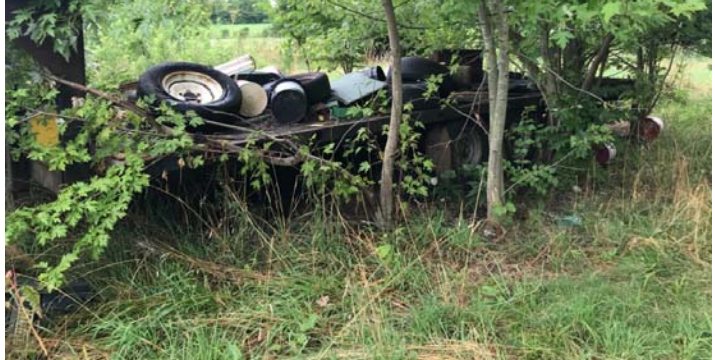
Date & Time: Wed, Jul 17, 2019, 12:04:27 EDT  
Position: +038.378594° / -084.258439°  
Altitude: 840ft  
Datum: WGS-84  
Azimuth/Bearing: 278° N08W 4.692mils (True)  
Elevation Angle: -08.4°  
Horizon Angle: +01.9°  
Zoom: 1X  
116-0000-012-01-000 trash
