Landscape Plan

Telesto Energy Project

May 2022

E319302605

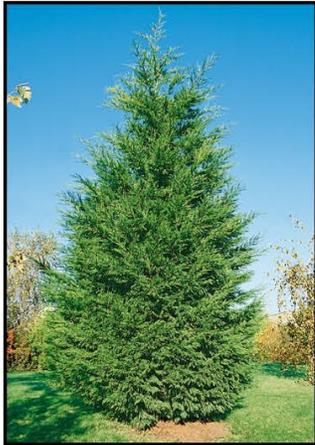
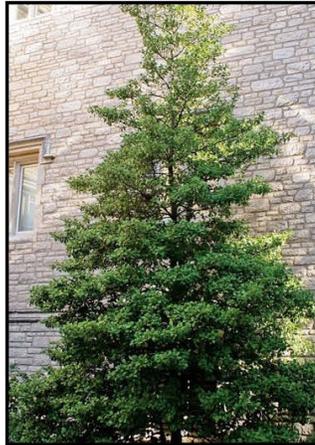
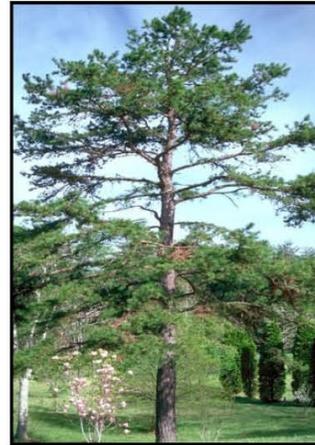
Figure 5-1 Proposed Plant Material Selection for the Telesto Energy Project

Eastern Cedar

American Holly

Virginia Pine

While the table above provides a comprehensive list of tree species found within the limits of the site, it is important to select species that are best suited for the Project area and the purpose of the modules (see Section 6). It is also important to add some other native species to increase diversity and provide additional benefits such as ornamental and screening value (Figure 5-1).

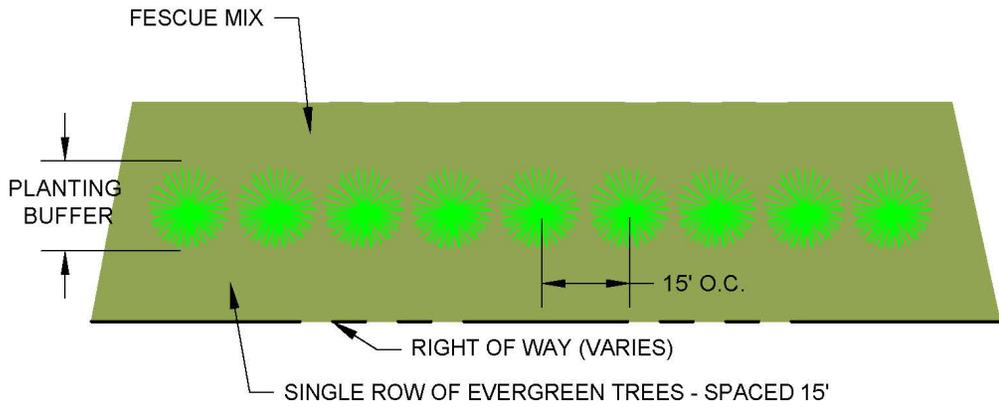
Figure 6-1 **Module 1 Screening**

SCREENING PLANTING MODULE 1 - PLAN VIEW
NOT TO SCALE

Scientific Name	Common Name
Trees	
<i>Juniperus virginiana</i>	Eastern Cedar
<i>Ilex opaca</i>	American Holly
<i>Pinus virginiana</i>	Virginia Pine

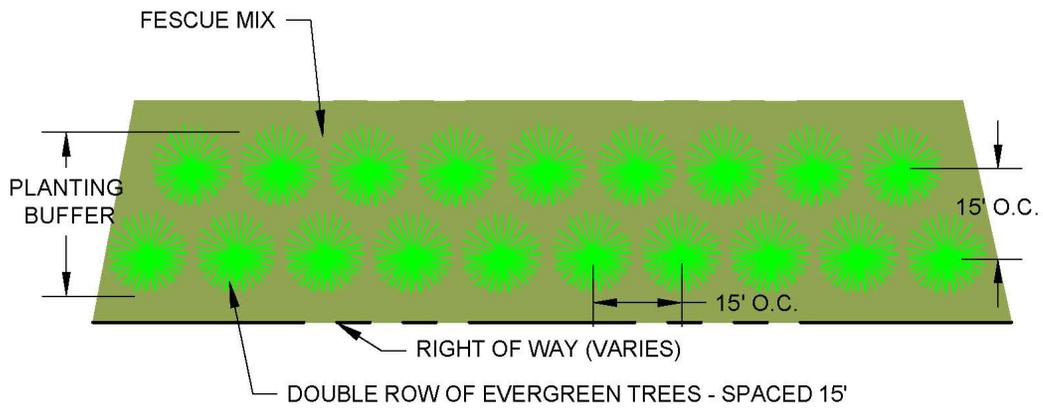
Figure 6-2 **Module 2 Screening**

SCREENING PLANTING MODULE 2 - PLAN VIEW
NOT TO SCALE

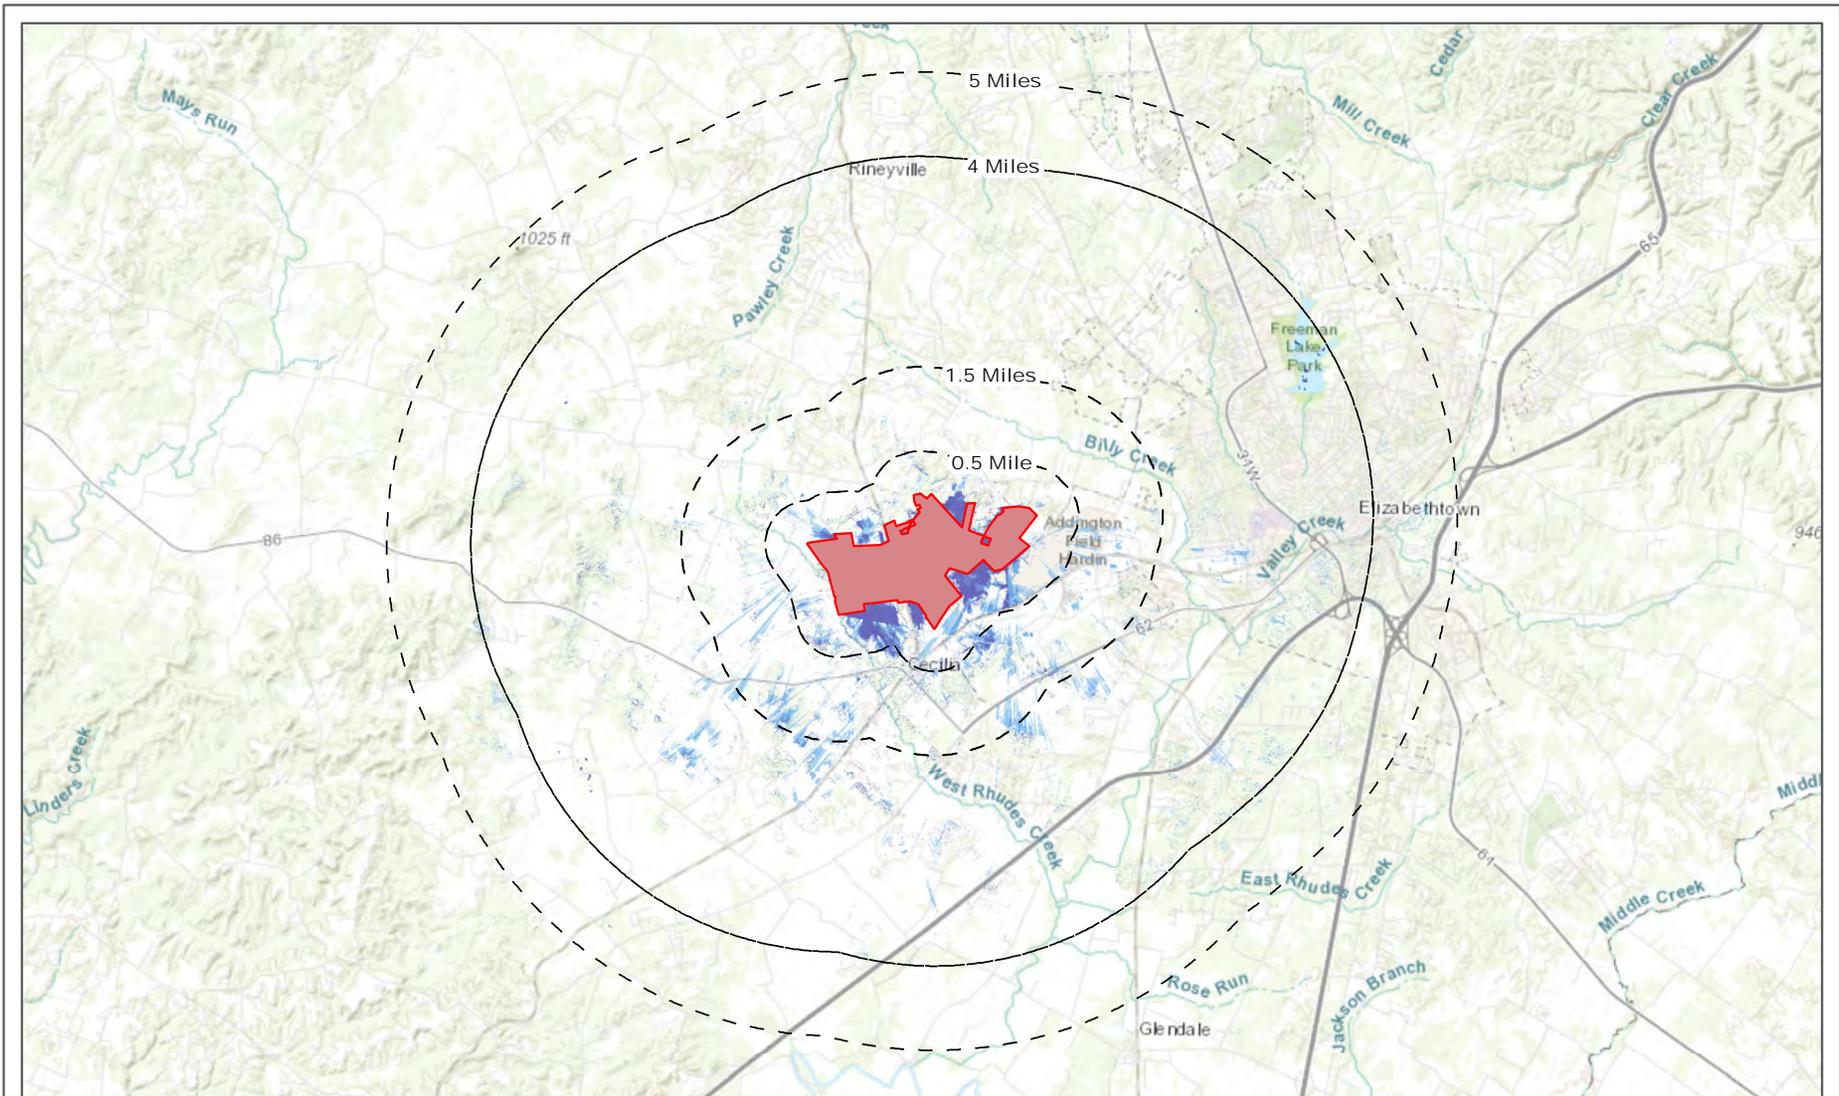
3-1 Viewshed Analysis - PV Panel (5-mile radius)

Figure 3-1 of the DSM viewshed analysis for a 5-mile radius depicts a viewshed that incorporates a vegetative model. This figure illustrates that visibility beyond a 0.5-mile radius will be primarily limited to discrete corridors of agricultural fields at higher elevations to the southwest and southeast. Further analysis is provided on the vegetative model below.

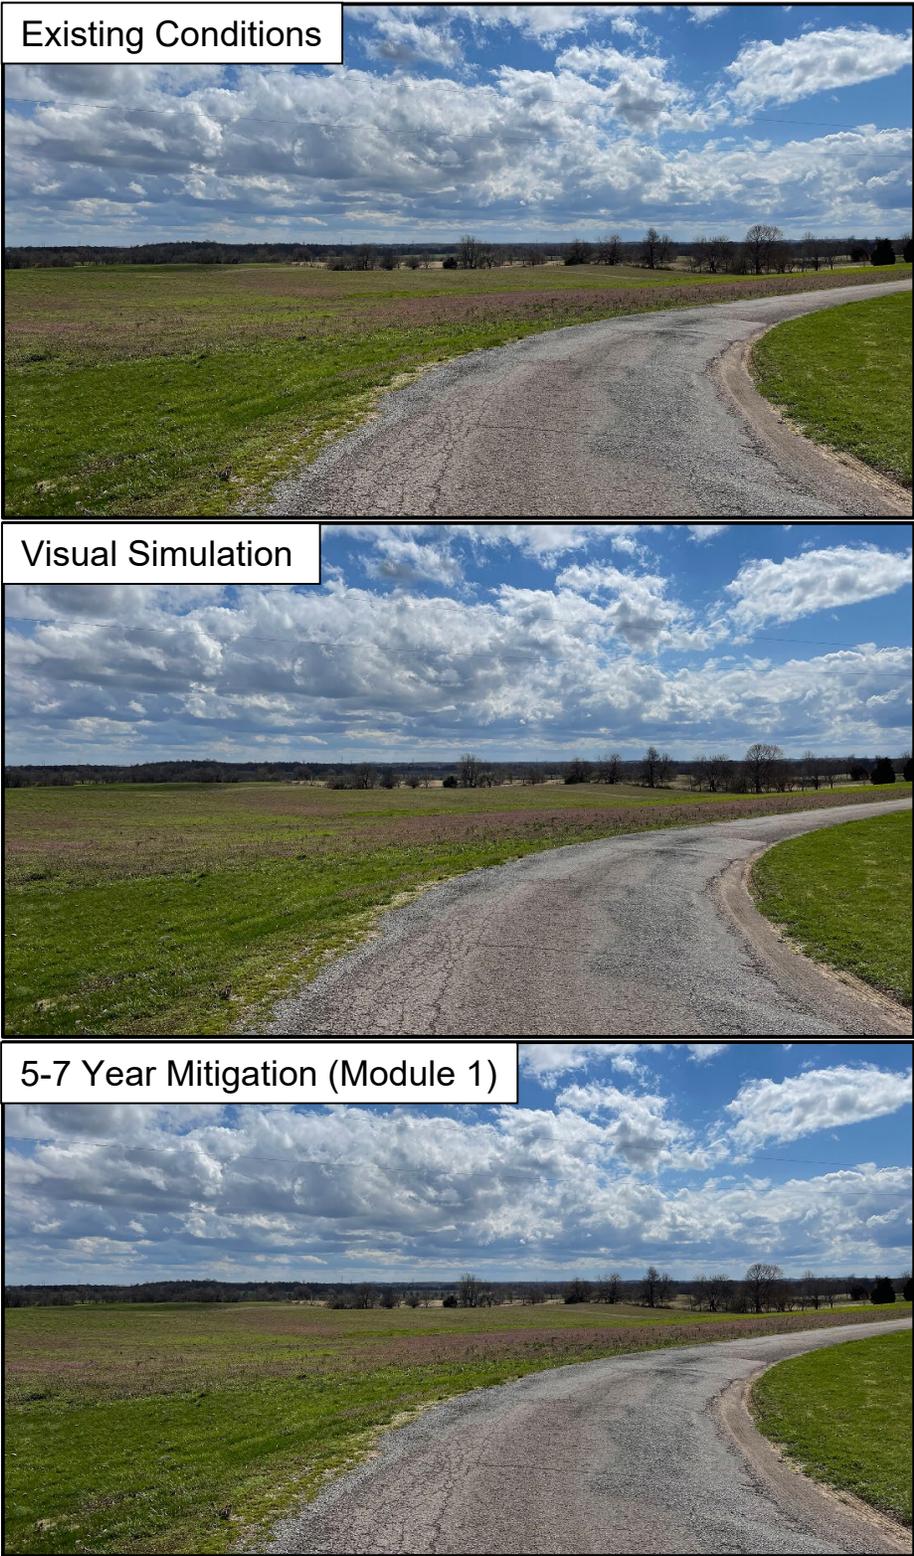
Figure 3-4 Viewpoint 1 - Existing Conditions, Visual Simulation, and 5-7 Year Mitigation

Viewpoint 1 is situated along a curve of Goodman Lane, facing south towards an agricultural field. The existing conditions in this view from several residences show the rural field that extends from the foreground to the background of the visual. The hedgerows viewed in the middle of the image are located approximately 1,200 feet from the viewpoint (Figure 3-4, Existing Conditions).

With proposed mitigation plantings placed and established 5 to 7 years following installation, the area comprising the proposed panel arrays is surrounded by a single row of large evergreen trees. Although stationary views of the Project remain available through gaps in the vegetation, adjacent plantings interrupt the horizontal lines of the Project components, allowing them to blend into the vegetated background (Figure 3-4, 5 to 7 Year Mitigation).

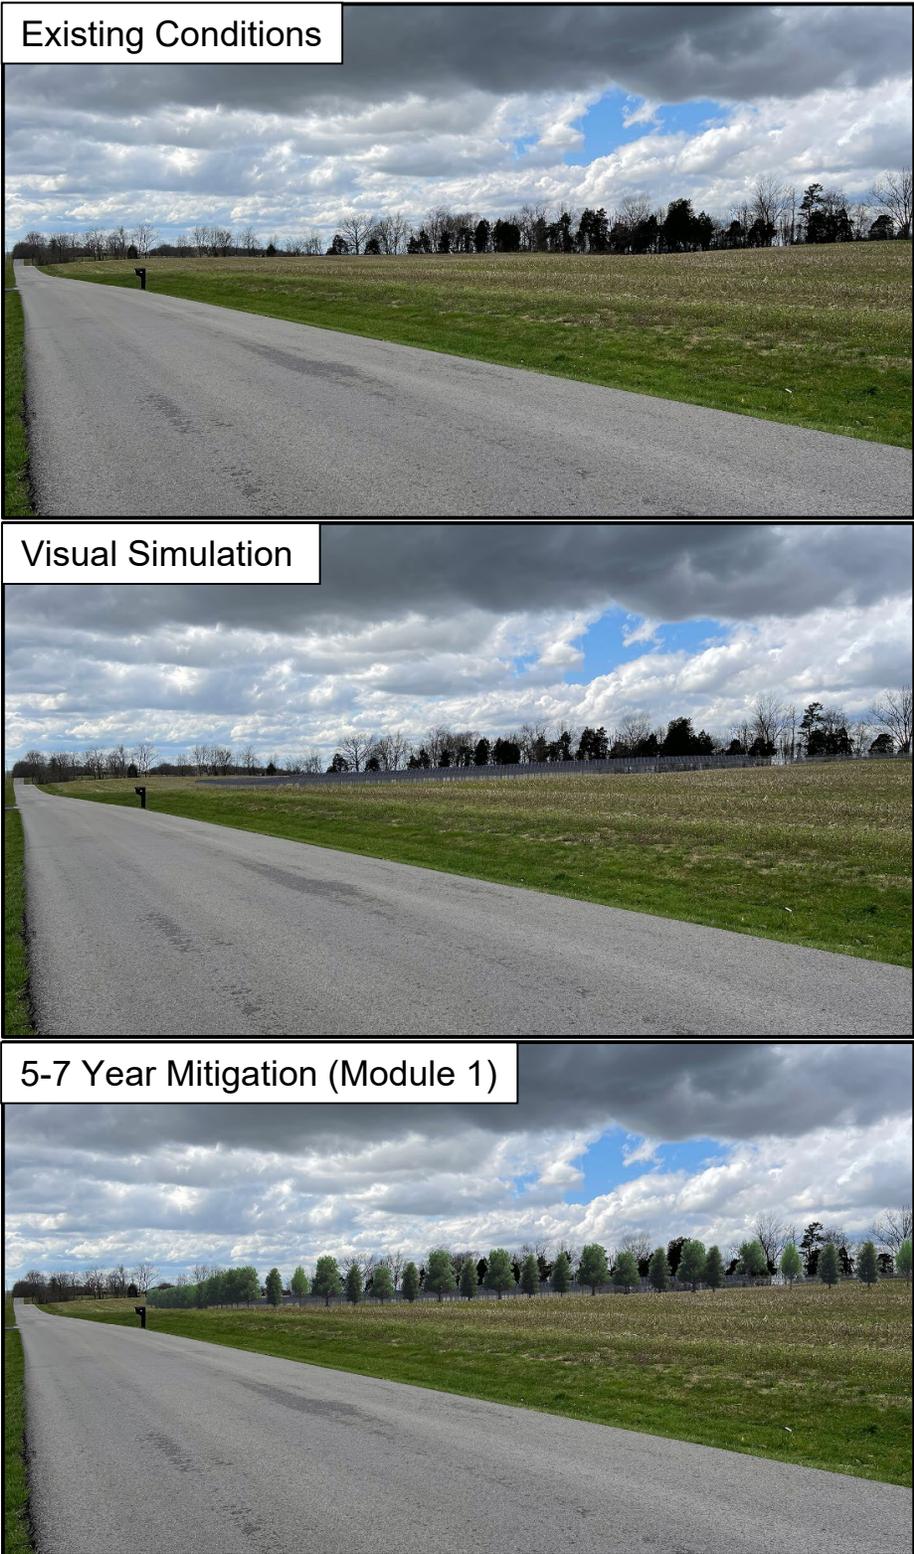
Figure 3-5 Viewpoint 5 - Existing Conditions, Visual Simulation, and 5-7 Year Mitigation

Viewpoint 5 is situated along Hayden School Road facing west towards an open agricultural field. The existing conditions in this view show the rural field in the foreground, with a forested riparian area in background of the visual. (Figure 3-5, Existing Conditions).

With proposed mitigation plantings placed and established 5 to 7 years following installation, the area comprising the proposed panel arrays is surrounded by a single row of large evergreen trees. Although views of the panel arrays remain available from Hayden School Road, the duration of these views will be limited for drivers passing by the Project (Figure 3-5, 5 to 7 Year Mitigation).

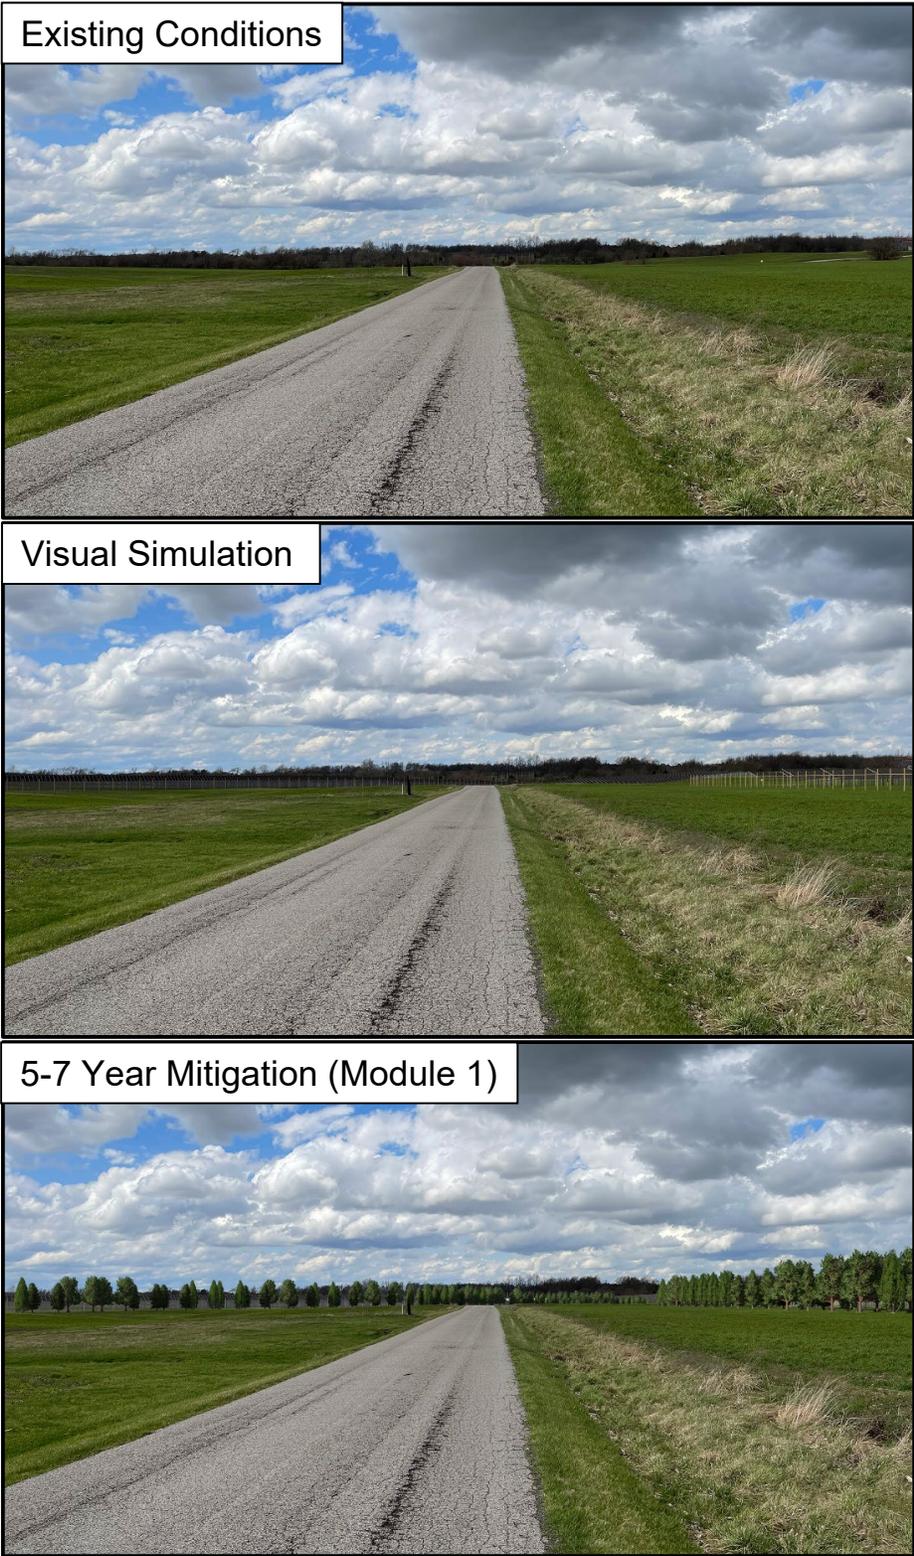
Figure 3-6 Viewpoint 6 - Existing Conditions, Visual Simulation, and 5-7 Year Mitigation

Viewpoint 6 is situated along Cecilia Road, facing northwest along the road with open agricultural fields on both sides. The existing conditions in this view show the rural fields in the foreground of the visual, with several vegetated fence rows and riparian areas visible on slightly elevated topography in the background (Figure 3-6, Existing Conditions).

With proposed mitigation plantings placed and established 5 to 7 years following installation, the areas comprising the proposed panel arrays are surrounded by double rows of large evergreen trees. Although views of the panel arrays remain available from Cecilia Road through gaps in the vegetation, the duration of these views will be limited for drivers passing the Project (Figure 3-6, 5 to 7 Year Mitigation).

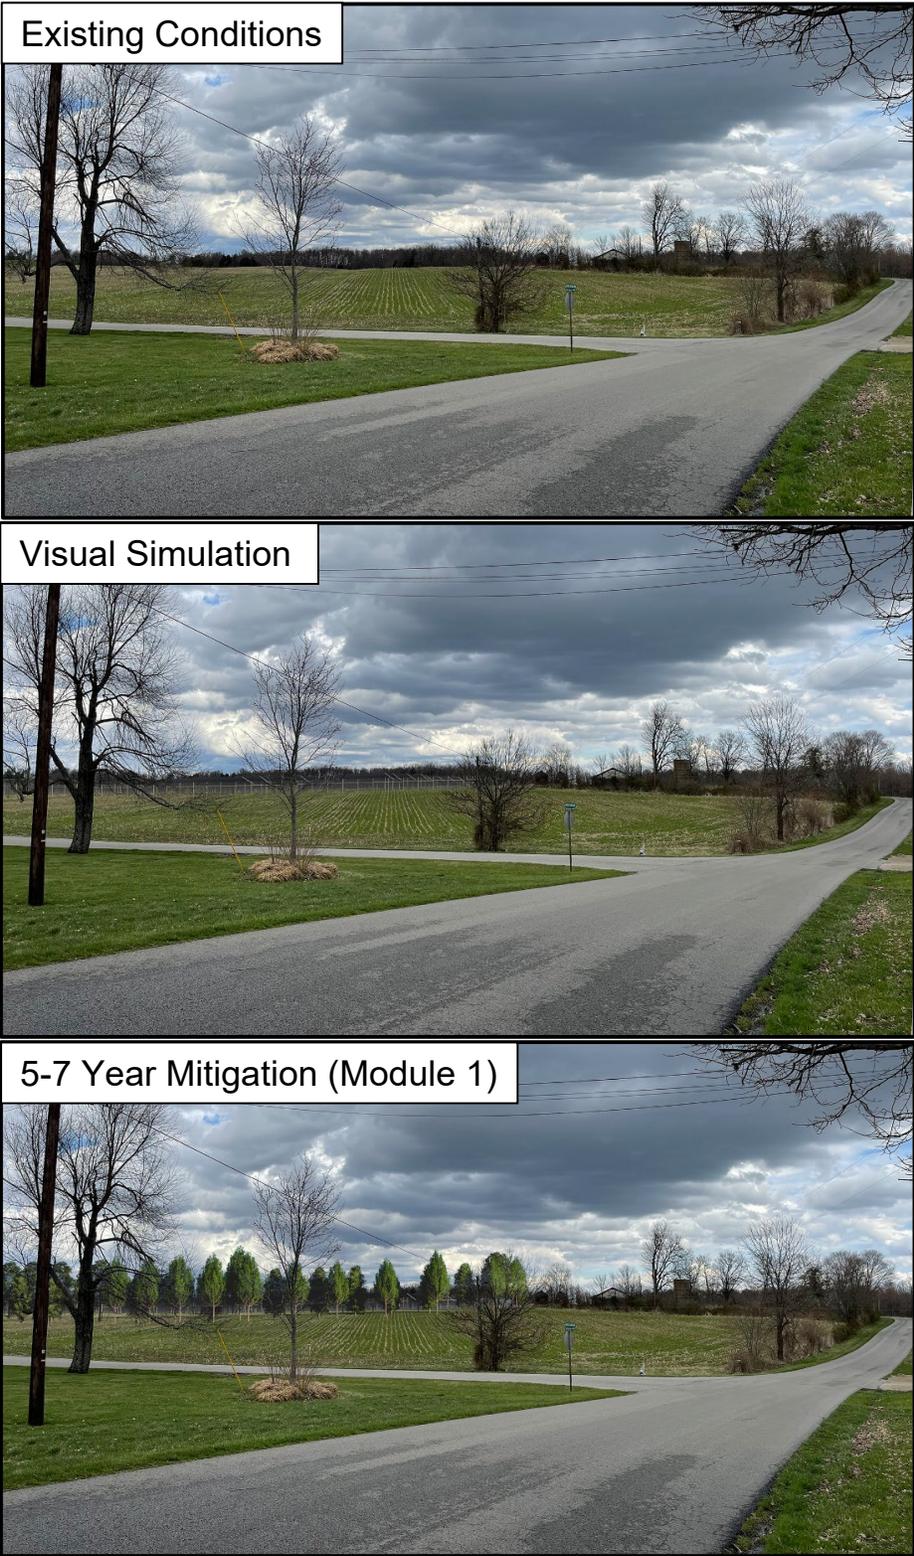
Figure 3-7 Viewpoint 7 - Existing Conditions, Visual Simulation, and 5-7 Year Mitigation

Viewpoint 7 is situated Hayden School Road, facing northeast towards an open agricultural field. The existing conditions in this view show residential yards on both sides of the road in the foreground of the visual, with a vegetated fence row beginning 180-feet from the viewpoint. In the middle ground, a house and silo structure can be viewed approximately 555-feet from the viewpoint. In the background of the visual, the agricultural field is bounded by vegetated fence rows and forested riparian areas (Figure 3-7, Existing Conditions).

With proposed mitigation plantings placed and established 5 to 7 years following installation, the area comprising the proposed panel arrays is surrounded by a double row of large evergreen trees. Although views of the panel arrays remain available from Hayden School Road through gaps in the vegetation, the duration of these views will be limited for drivers passing the Project (Figure 3-7, 5 to 7 Year Mitigation).

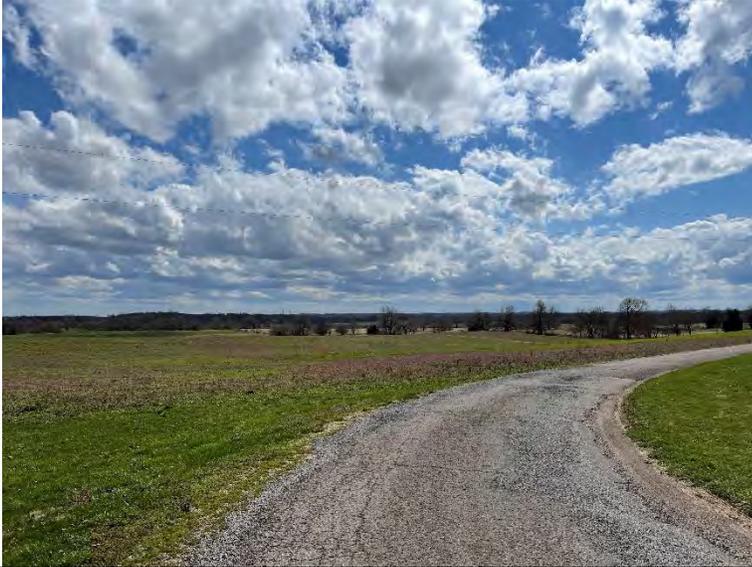
Viewpoint 1

View from Goodman Ln in Hardin County. 911 feet from the nearest proposed PV panel, in the Near-Foreground distance zone.

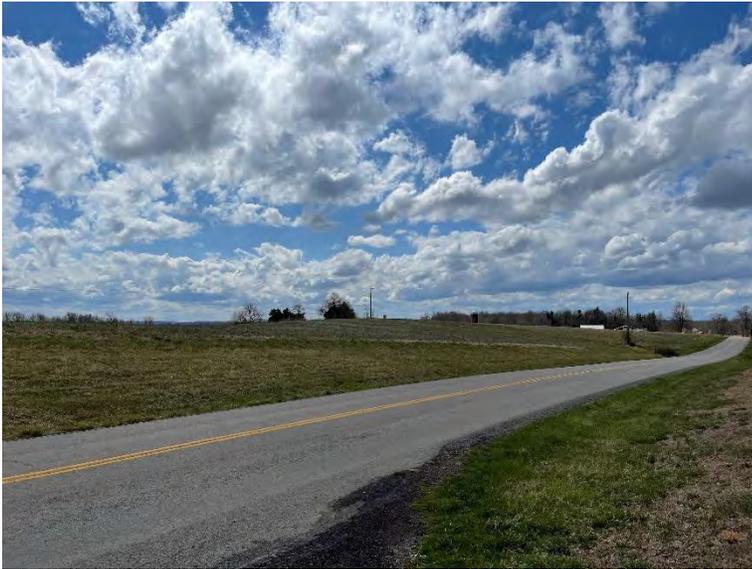
Viewpoint 2

View from KY-1357 (St. John Rd) in Hardin County. 1,771 feet from the nearest proposed PV panel, in the Near-Foreground distance zone.

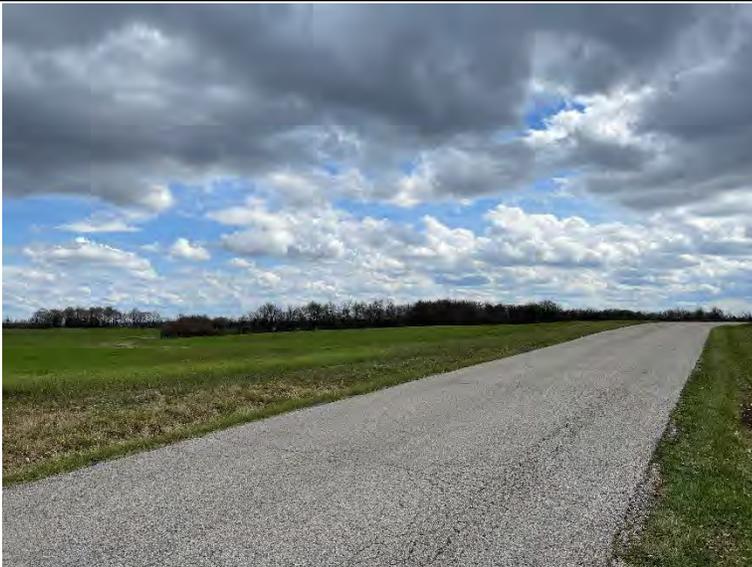
Viewpoint 3

View from the Ccilia Rd in Hardin County. 627 feet from the nearest proposed PV panel, in the Near-Foreground distance zone.

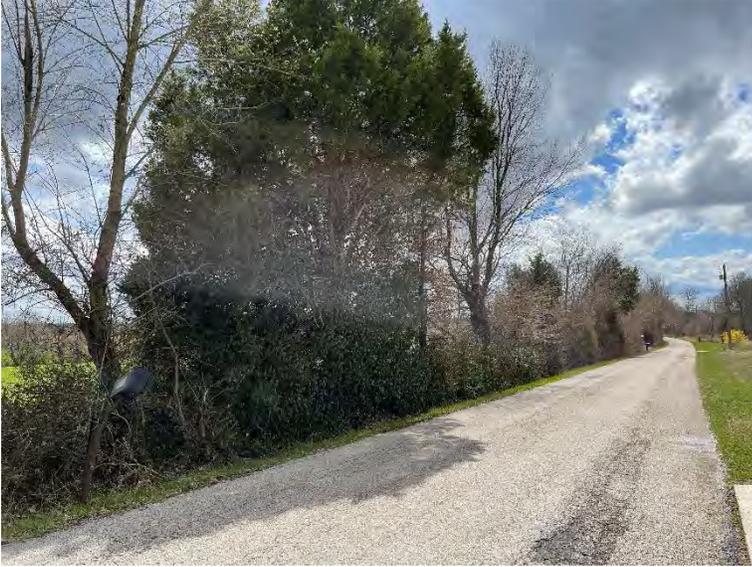
Viewpoint 4

View from Cecilia Rd in Hardin County. 888 feet from the nearest proposed PV panel, in the Near-Foreground distance zone.

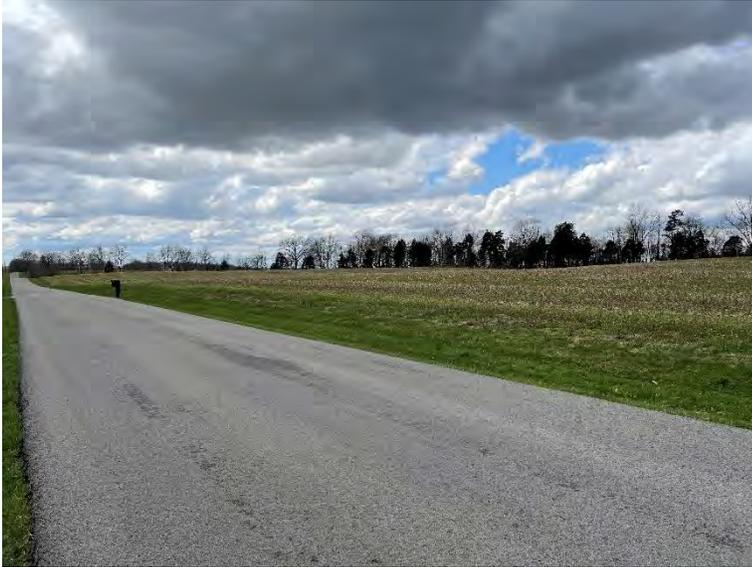
Viewpoint 5

View Hayden School Rd in Hardin County. 372 feet from the nearest proposed PV panel, in the Near-Foreground distance zone.

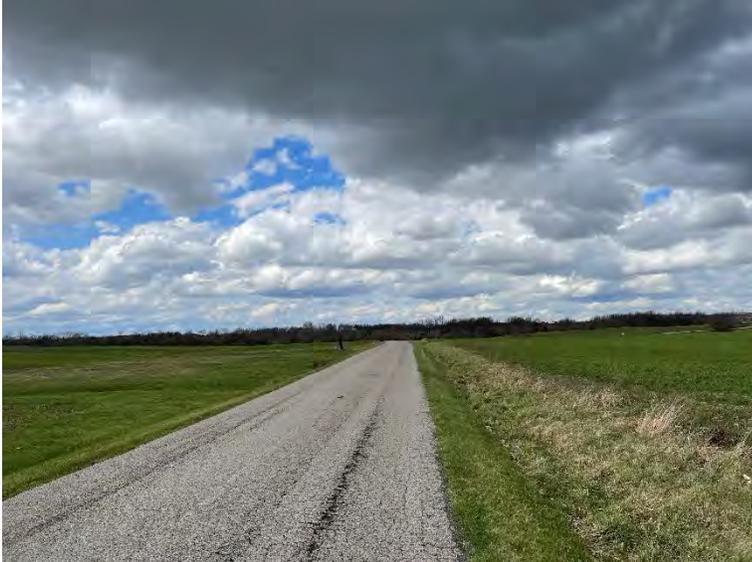
Viewpoint 6

View from Cecilia Rd in Hardin County. 205 feet from the nearest proposed PV panel, in the Near-Foreground distance zone.

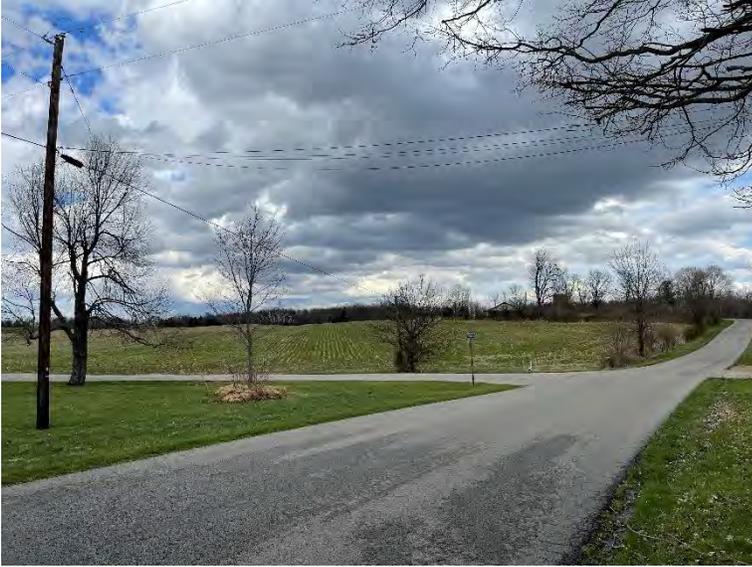
Viewpoint 7

View Hayden School Rd in Hardin County. 490 feet from the nearest proposed PV panel, in the Near-Foreground distance zone.

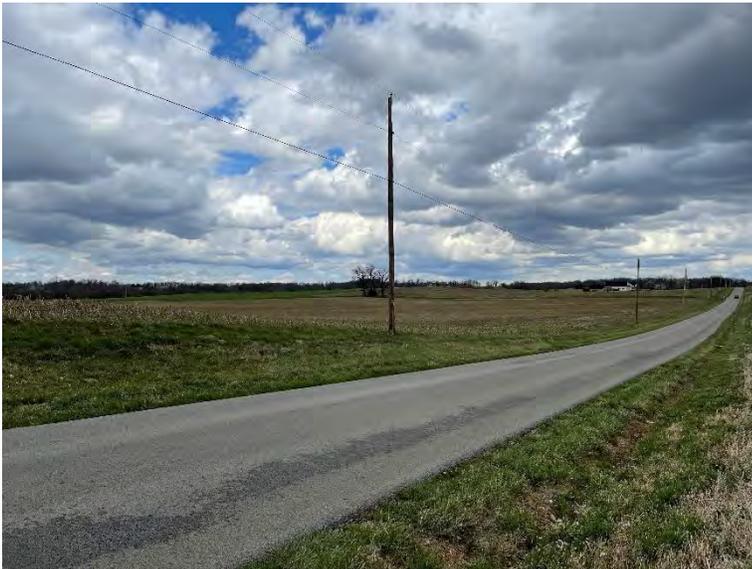
Viewpoint 8

View Hayden School Rd in Hardin County. 1,441 feet from the nearest proposed PV panel, in the Near-Foreground distance zone.

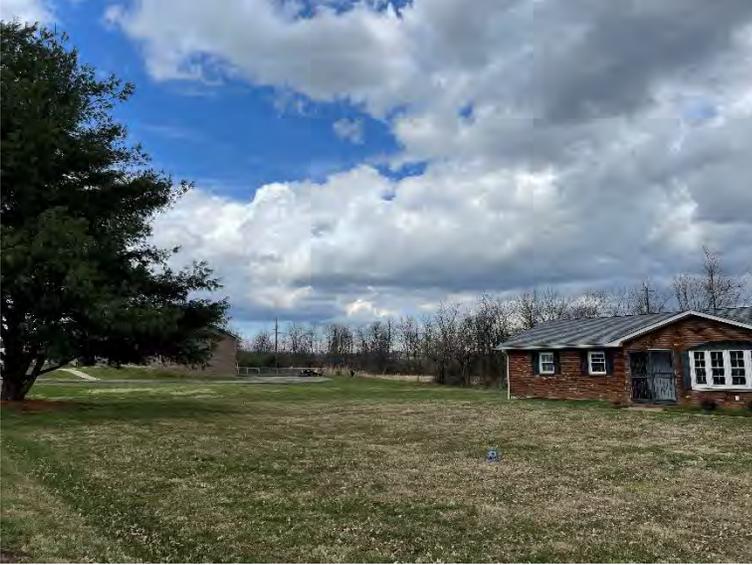
Viewpoint 10

View from N Sunset Dr in Hardin County. 2,605 feet from the nearest proposed PV panel, in the Near-Foreground distance zone.

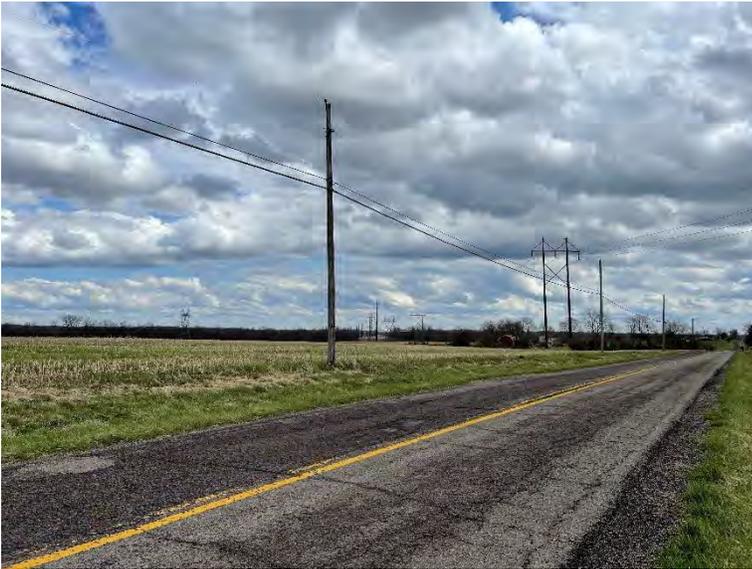
Viewpoint 11

View from KY-253 (Bethlehem Academy Rd) in Hardin County. 2,621 feet from the nearest proposed PV panel, in the Near-Foreground distance zone.
