DATA REQUEST

- Refer to Kentucky Power's response to Commission Staff's Second Request for Information (Staff's Second Request), Item 1. The topographical maps in Exhibit 4 do not provide the same level of detail as the maps in Exhibit 10.
 - a. Provide the siting study map of the proposed transmission route, included on pages 81 through 92 of Exhibit 10 to the Application, with the parcel numbers from Exhibit 12 to the Application used to identify any relevant parcels shown in the siting study map and showing the location of the 400-foot Filing Area.
 - b. Explain why there are more parcels shown on the siting study map than on the map provided as Exhibit 4 to the Application.

KPSC 3_2 Refer to Kentucky Power's response to Staff's Second Request for Information, Item 1. Explain why the right of way (ROW) for Parcel 43 will need to be 360 feet.

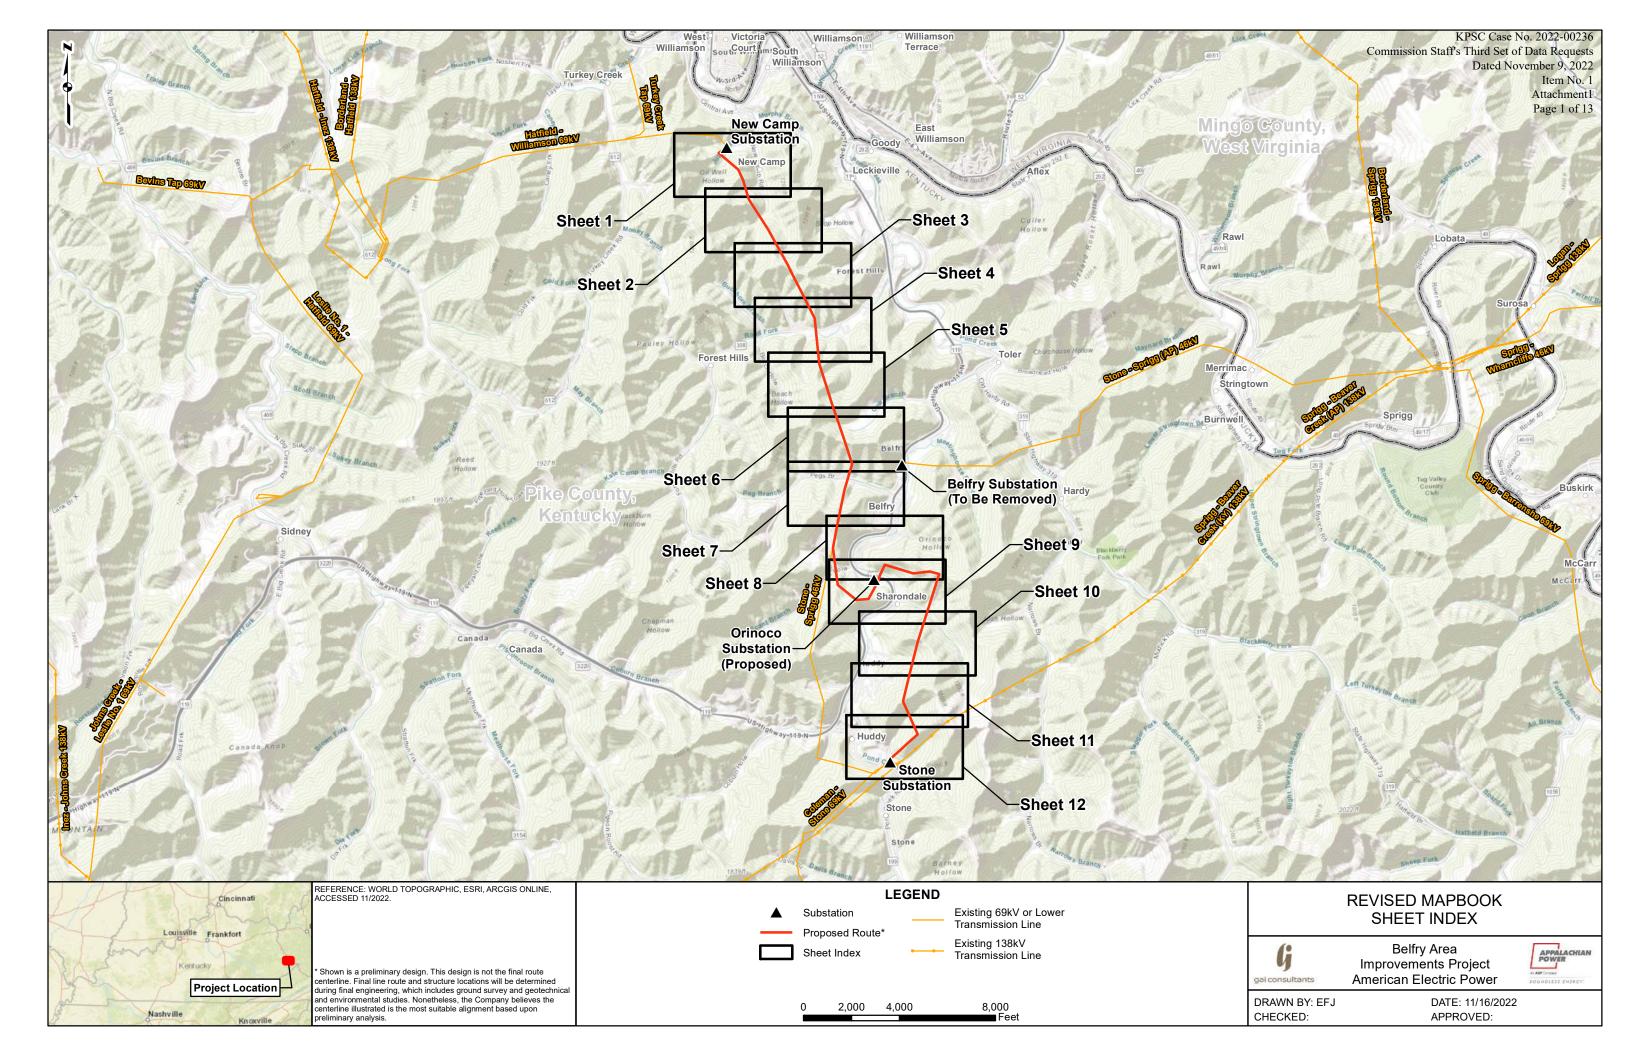
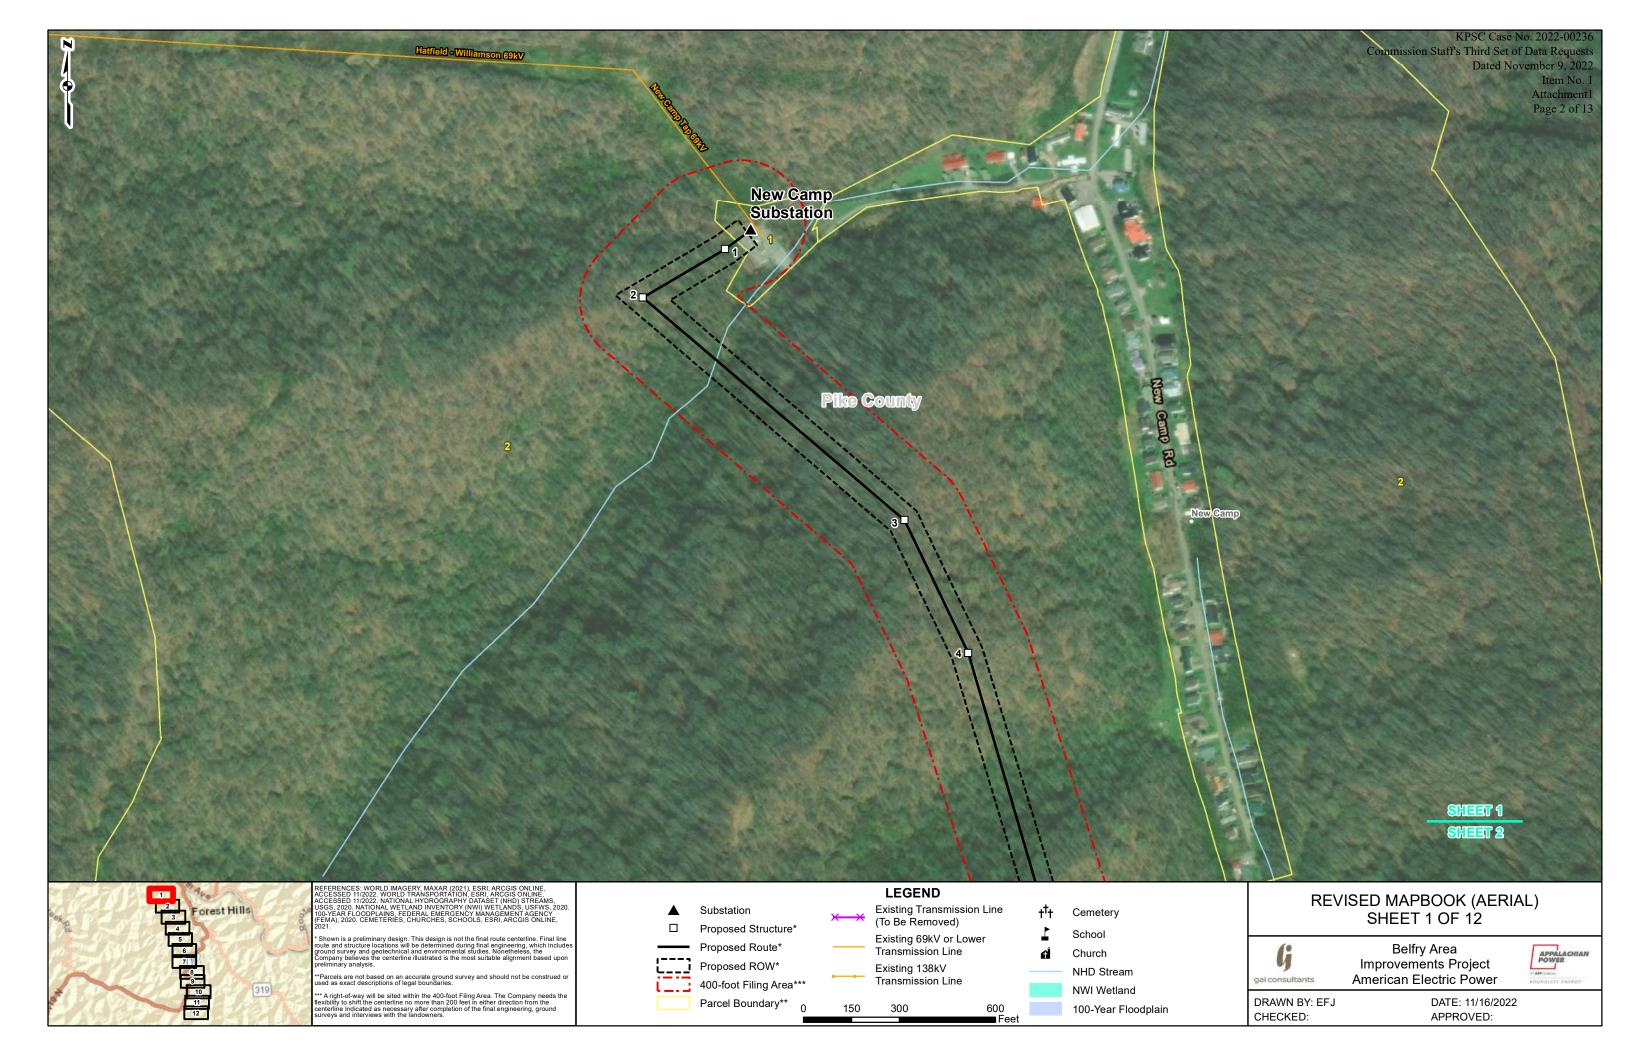
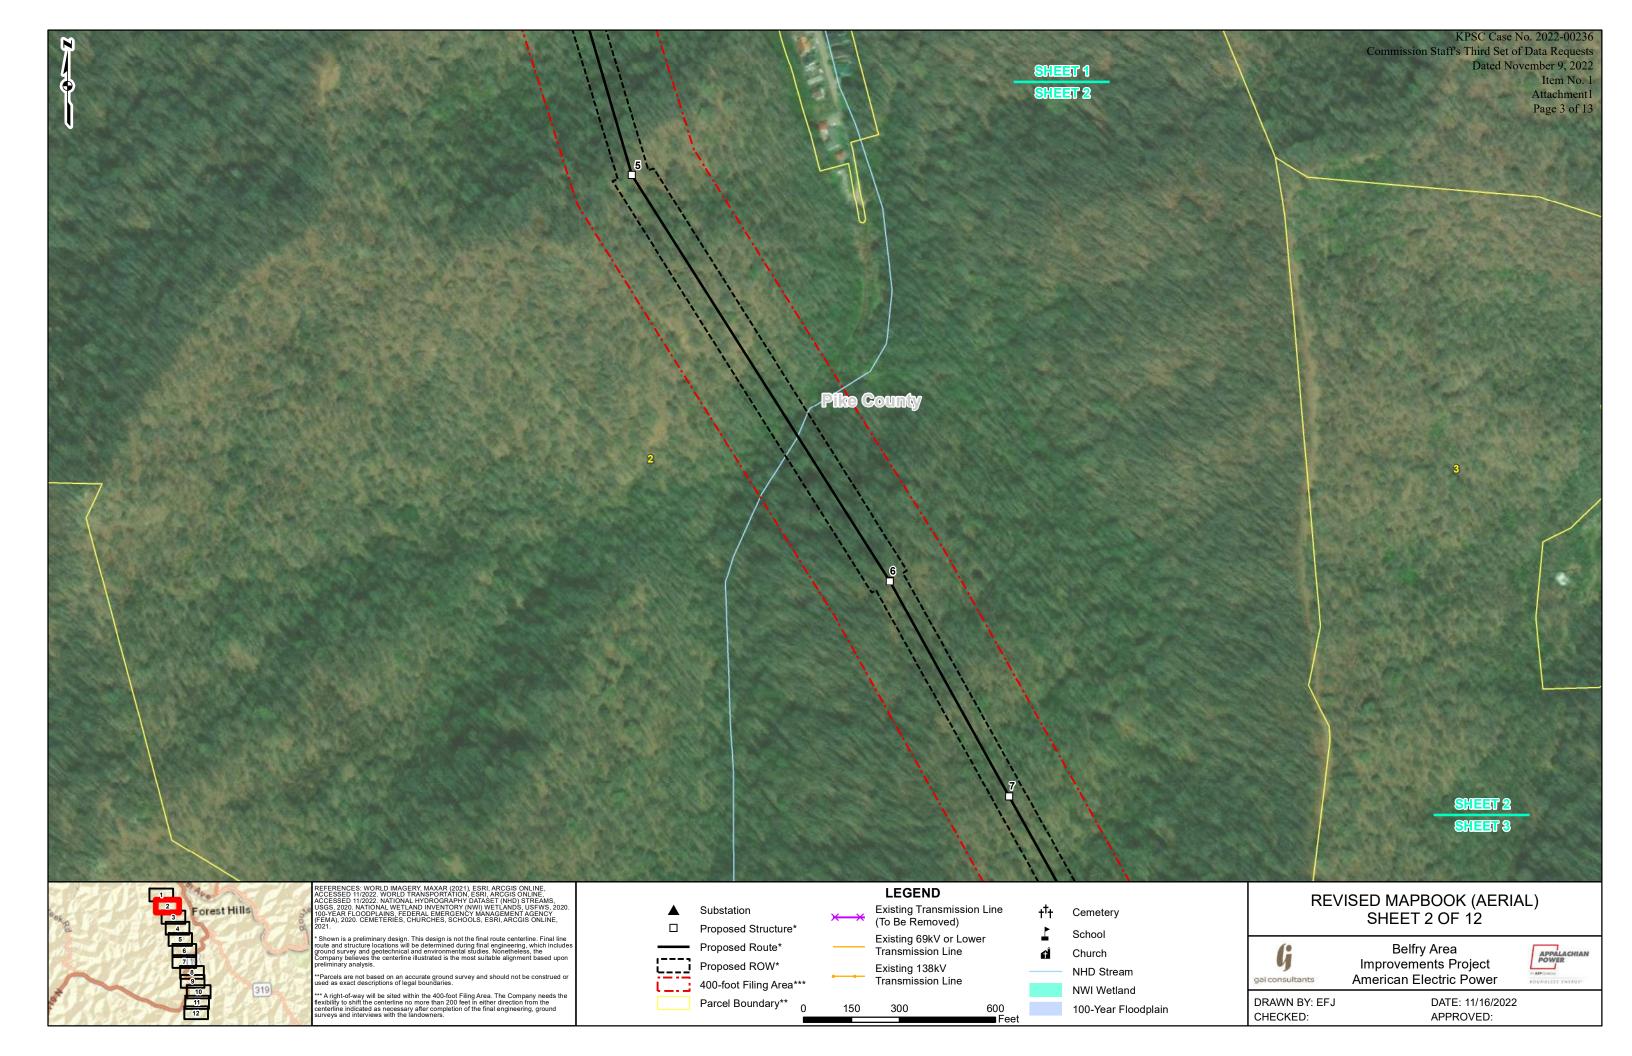
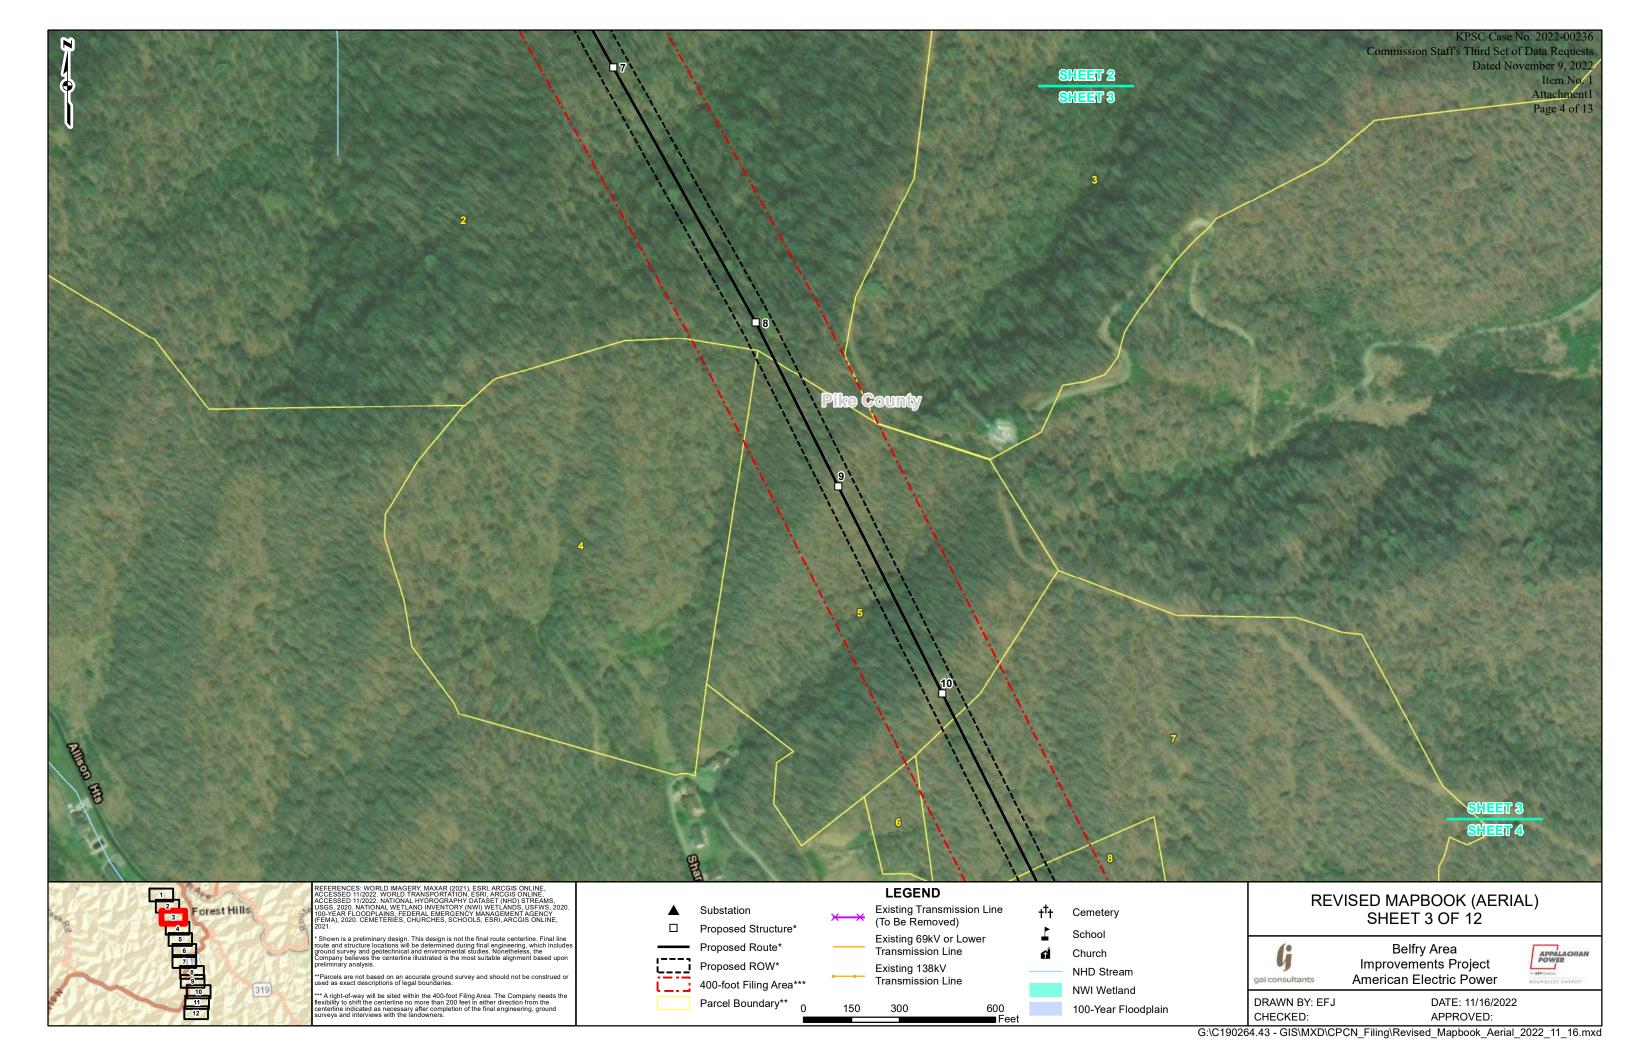
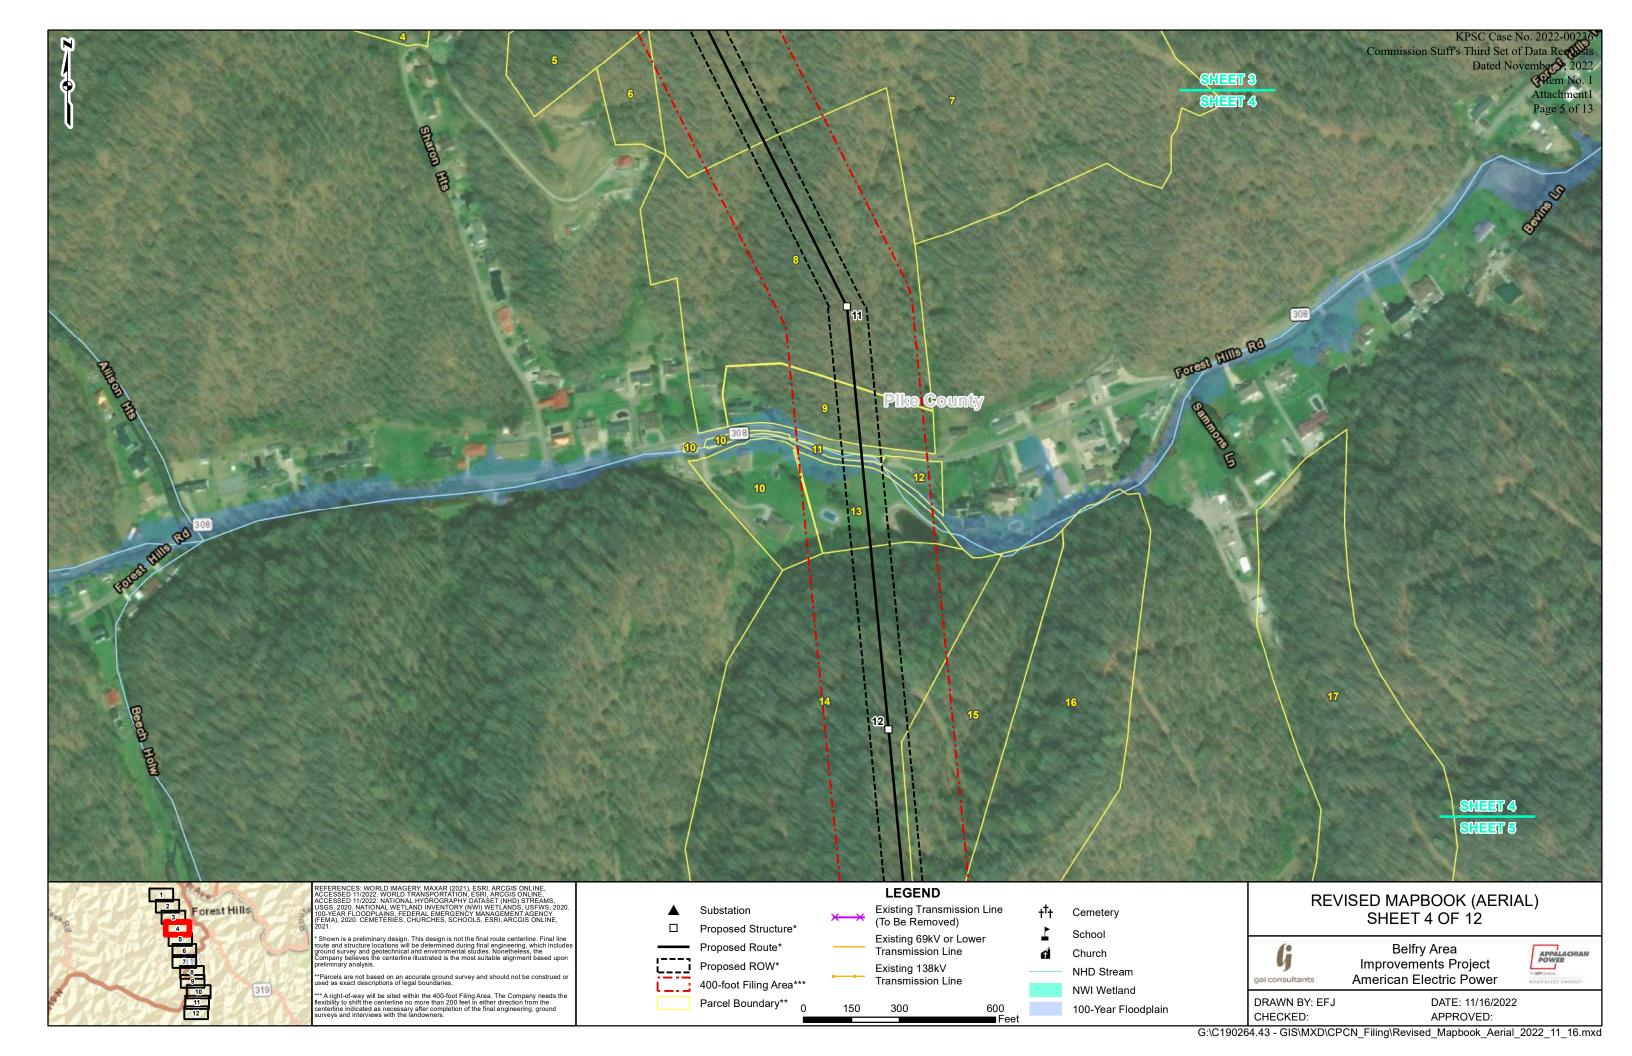
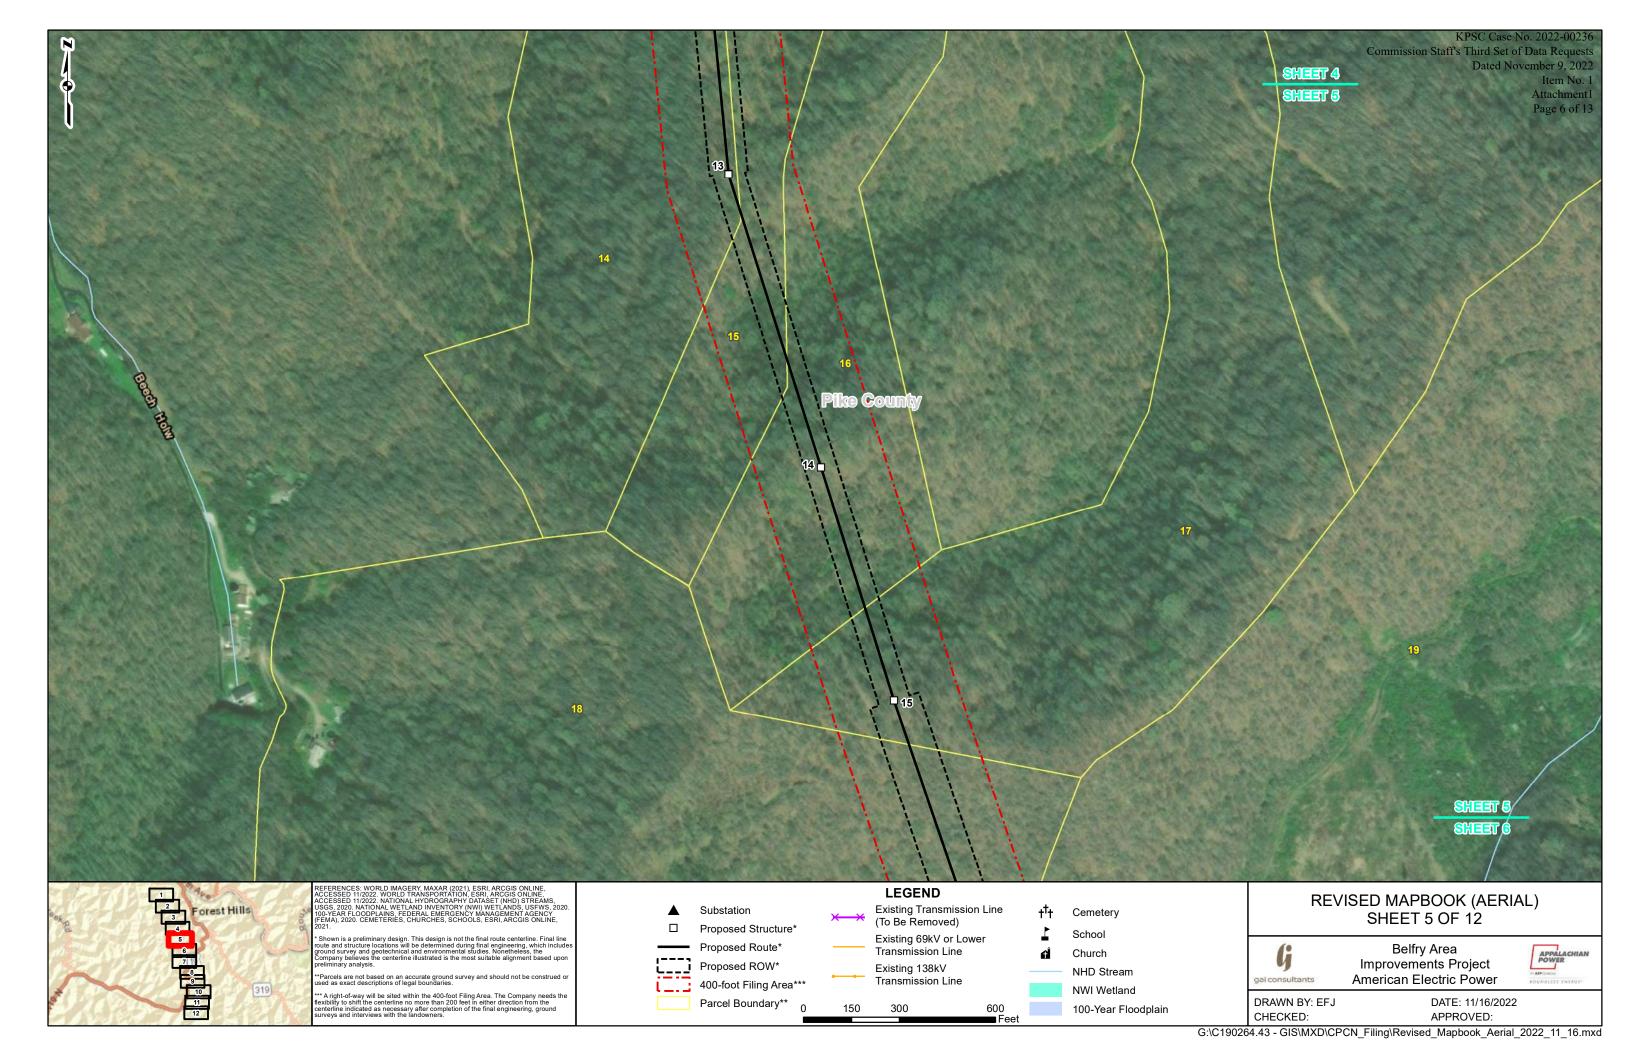
- a. The requested mapping is provided as KPCO_R_KPSC_3_1_Attachment1 (aerial) and KPCO_R_KPSC_3_1_Attachment2 (topographic).
- b. The Exhibit 10 Siting Study map shows more parcels than the Exhibit 4 Proposed Route map because it includes parcels from the virtual open house. Landowners within a 1000-foot area (500 feet to either side of centerline) of all Study Segments were invited to the virtual open house. Exhibit 4 shows only those parcels on the Proposed Route that are crossed by the ROW or the 400-foot area. There were many more parcels crossed by the entire Study Segment network shown at the open house than by the final Proposed Route selected; therefore, more parcels are shown on the Siting Study map than used for the Proposed Route filing map.

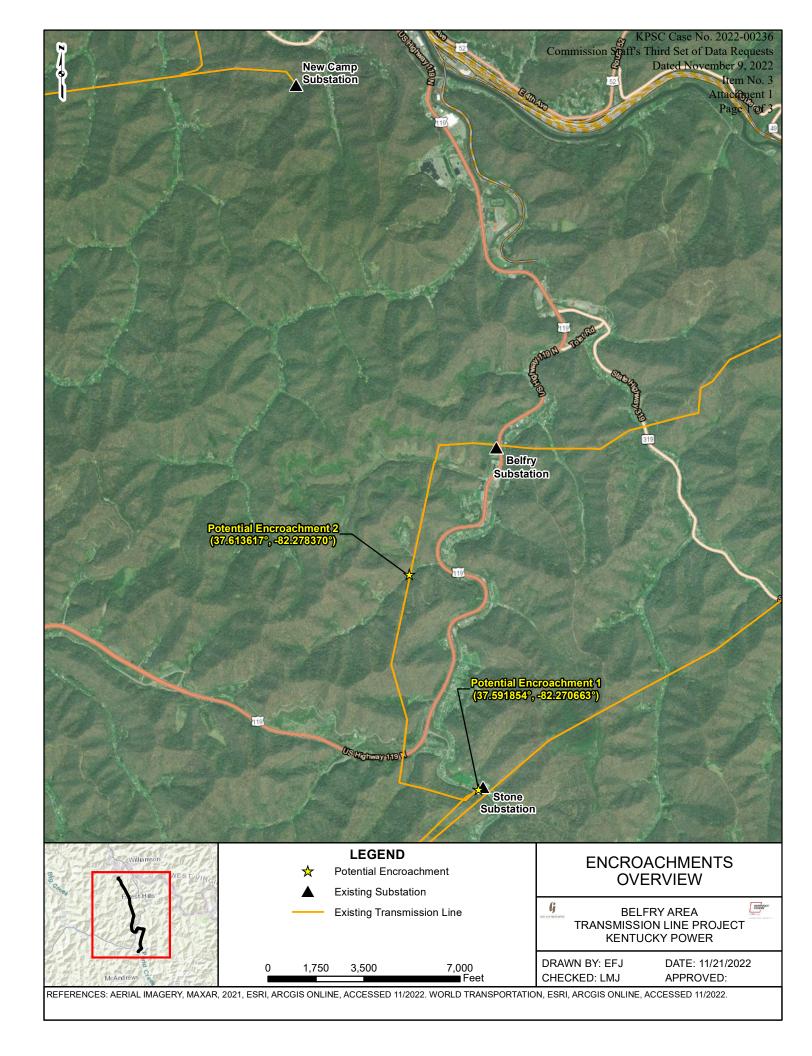
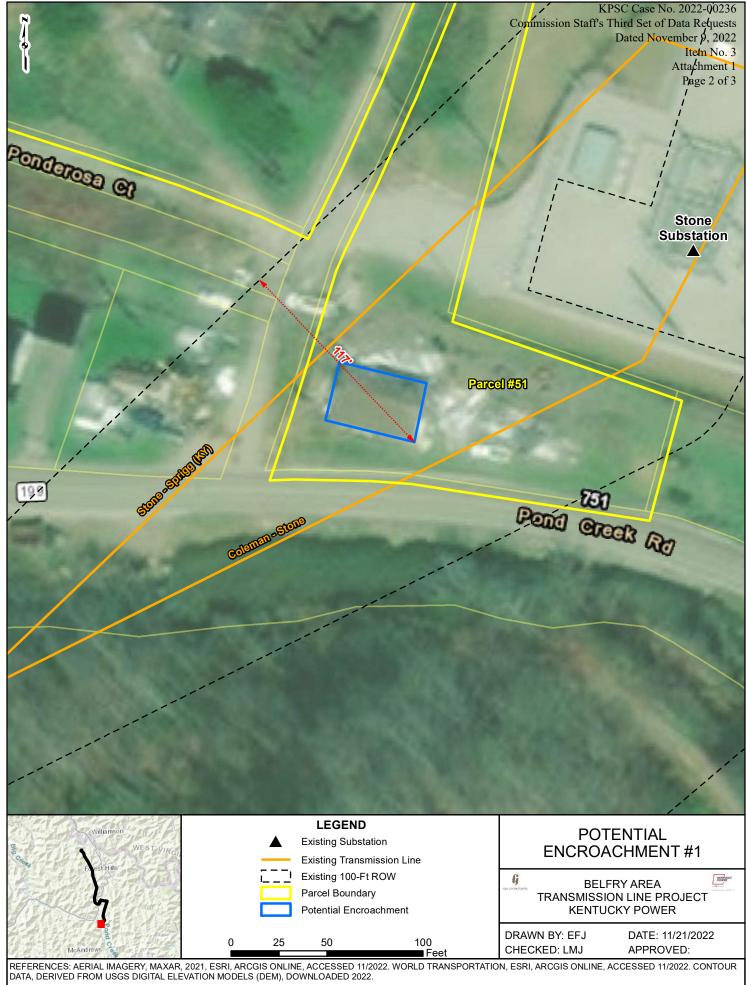
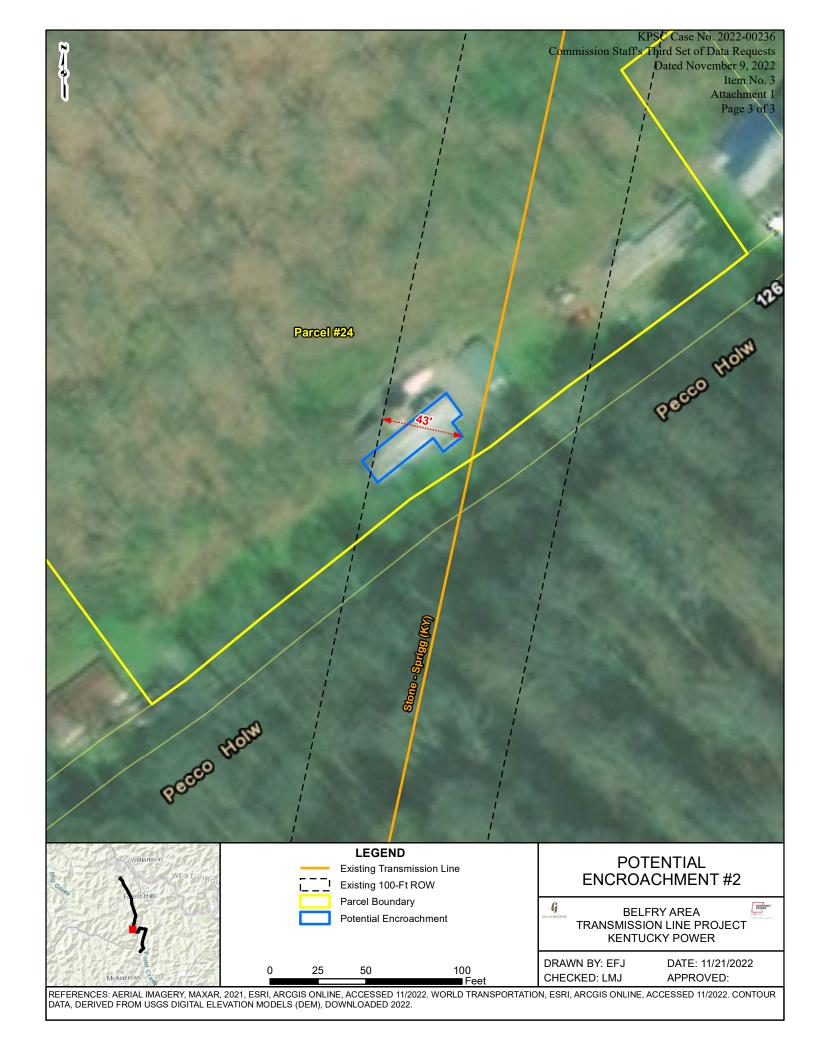
- a. Please see KPCO_R_KPSC_3_3_Attachment1 for maps depicting potential existing encroachments along the existing transmission line. Only those areas of the existing transmission line where rebuilding on-centerline was considered are depicted in the maps.
- b. and c. Kentucky Power does not maintain the requested information in the manner requested. The Company identifies encroachments in the context of inspecting its facilities. There are several ways that an encroachment is typically identified:
 - 1. As part of a routine or special inspection;
 - 2. Identified by an AEP employee or the public as a potential concern;
 - 3. As part of the activity preparing for a maintenance or capital project.

d. In this instance, the encroachments were identified during the engineering of this Project. Once the Company developed Study Segments for the Project that considered rebuilding on centerline, engineers reviewed those areas for potential encroachments. The two areas identified in the maps would have potential encroachments to the line if rebuilt in place. No actions were taken because in both cases, no immediate safety risks were identified, relocating the line off centerline in both cases was necessary for terrain access and outage constraints, and the encroachments could be, and were, mitigated by relocating the line.
