MEMO

Subject: Pine Grove Solar Biological Resources Technical Memo

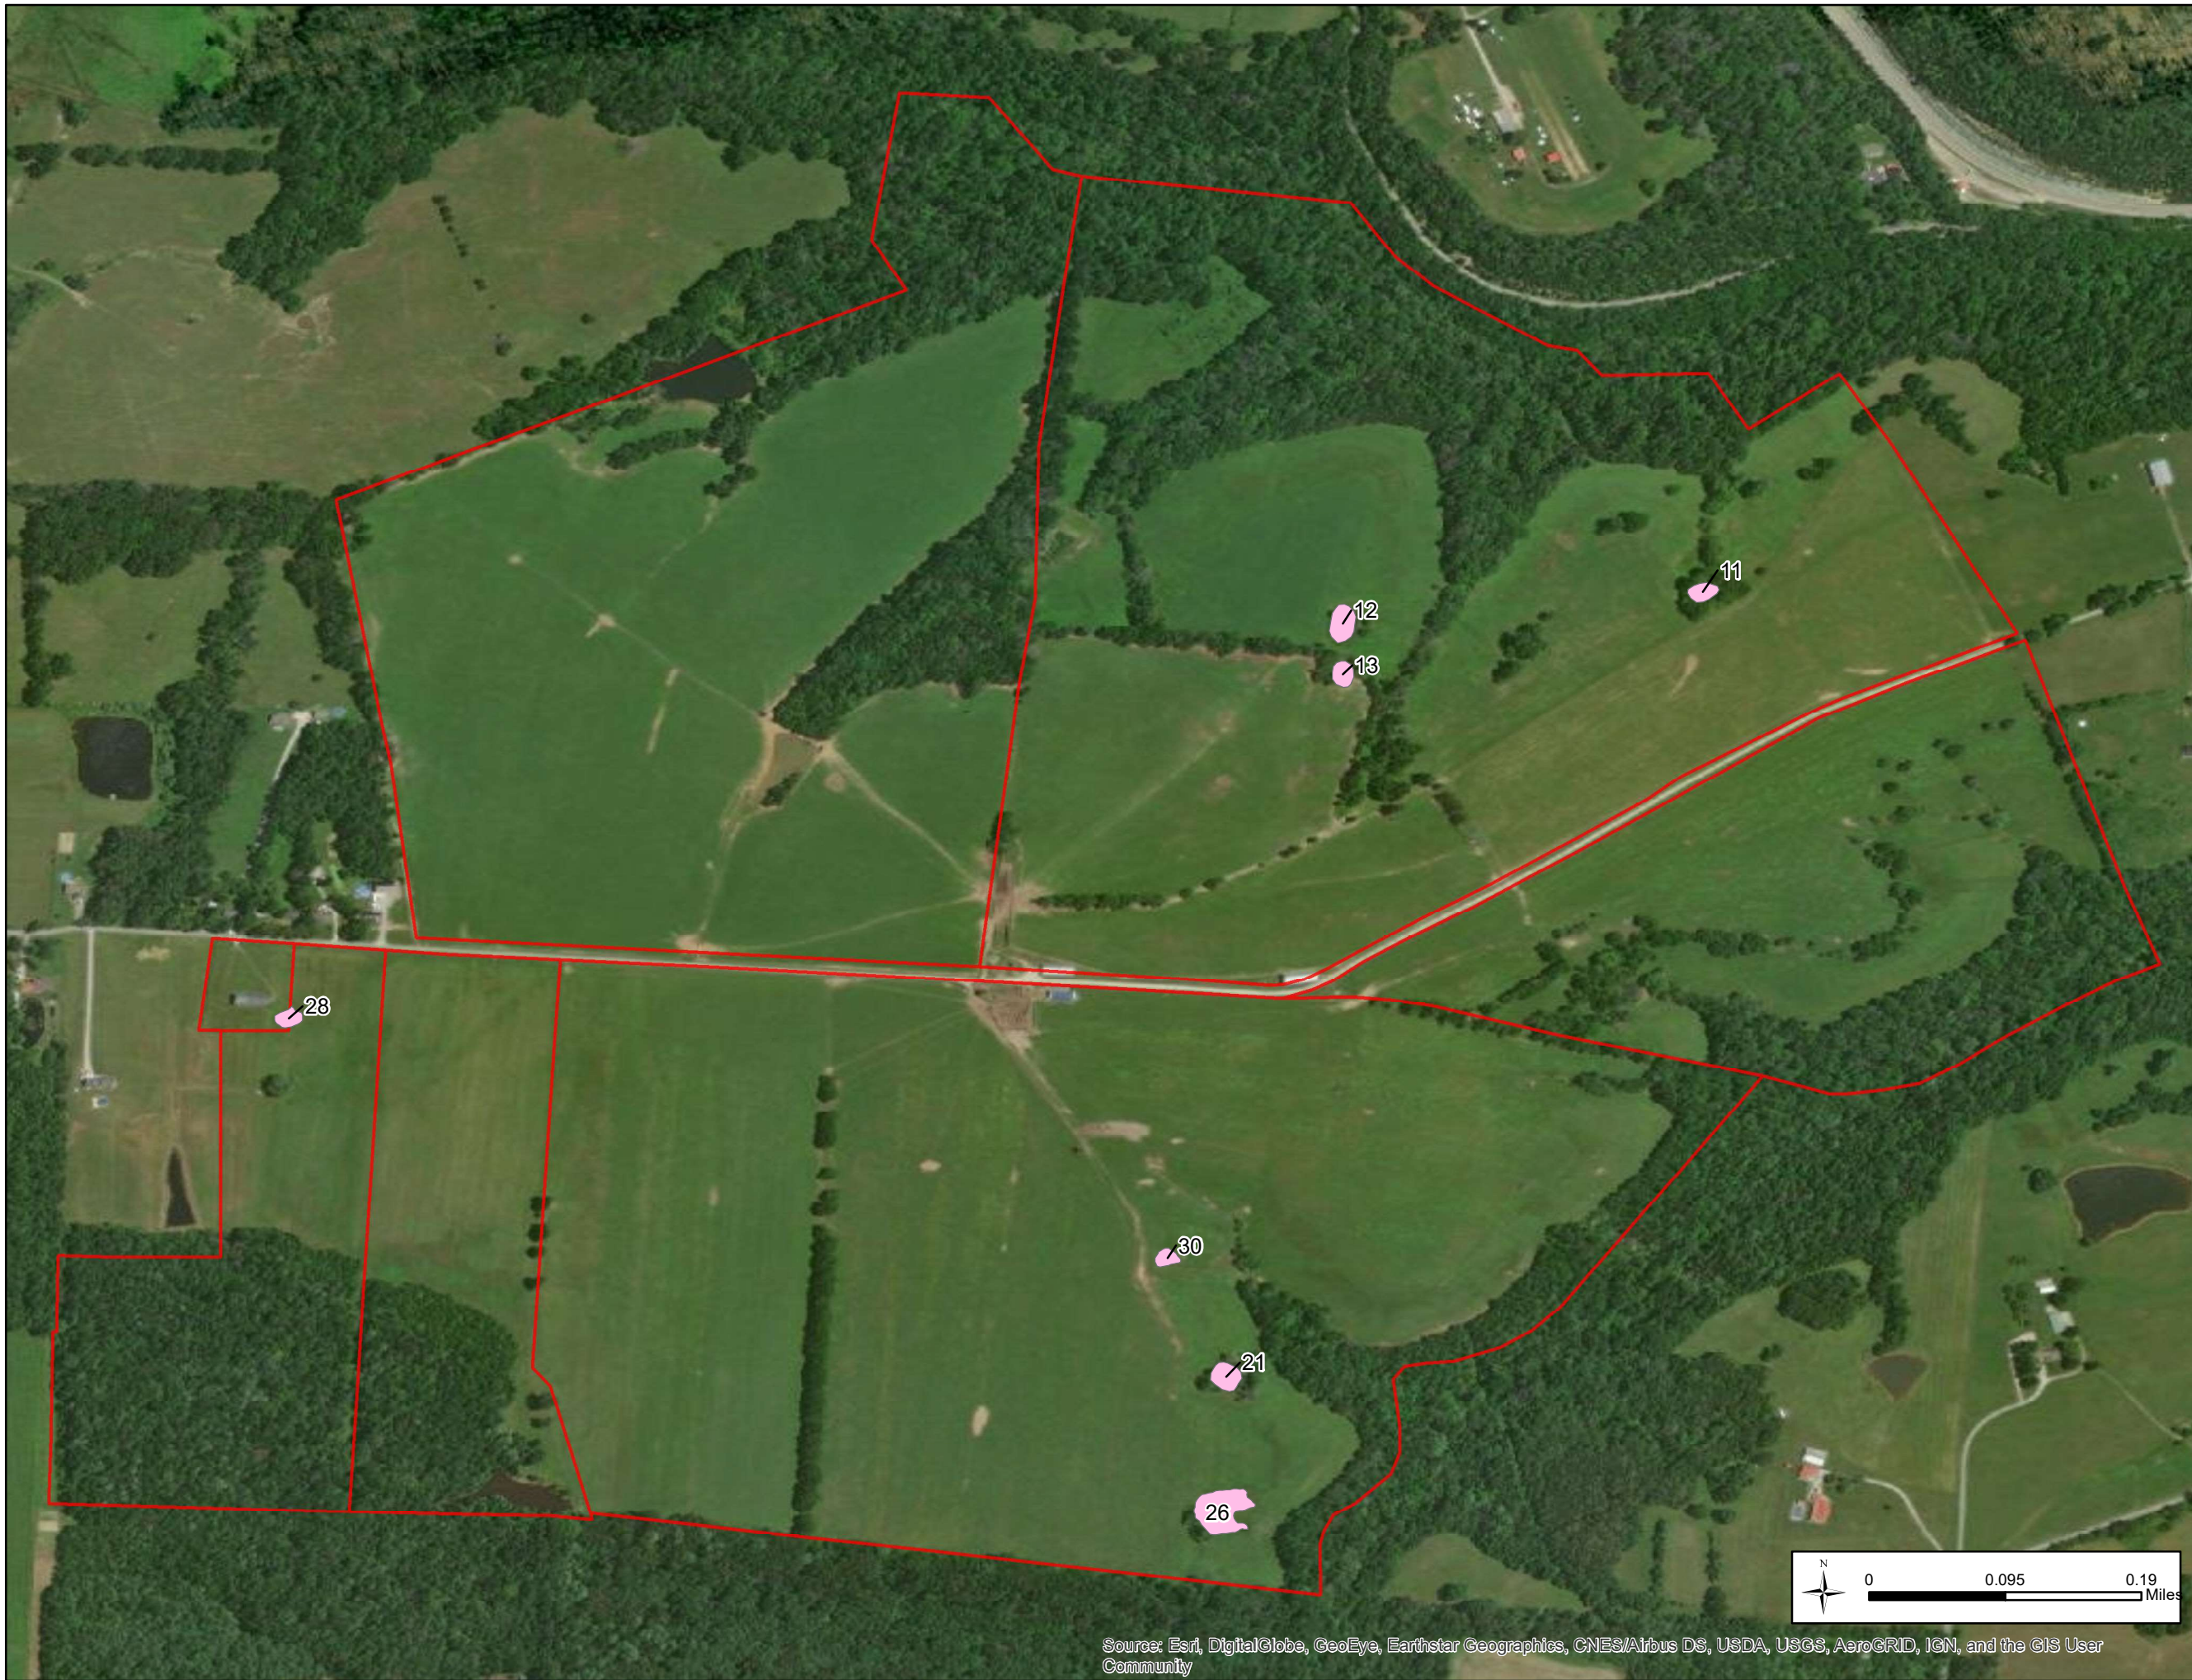
A site-specific investigation for historical and potential sinkholes, including reviewing for sinkhole openings and/or exposed rock areas, was conducted. A total of seven sinkholes were observed within the Project Area. These sinkholes were characterized as sinkhole ponds, with no evidence of exposed rock or openings which would provide suitable habitat for bat species. Photographs of each sinkhole are included in Attachment D. Figure 3 includes the locations of the sinkholes identified within the Project Area.

- Surveyed Parcels
- Sinkhole locations

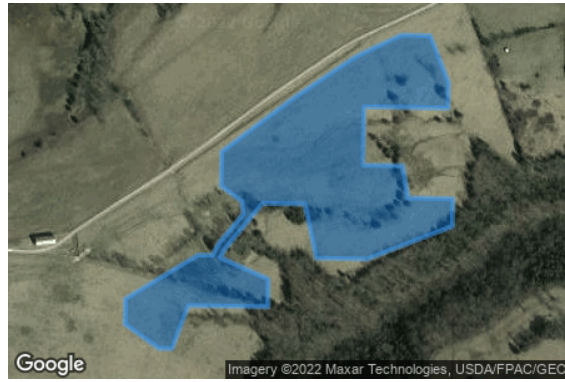
Vertex	Latitude (°)	Longitude (°)	Ground elevation (ft)	Height above ground (ft)	Total elevation (ft)
1	37.711149	-84.108979	880.04	5.00	885.04
2	37.710550	-84.109607	880.04	5.00	885.04
3	37.710417	-84.109706	880.04	5.00	885.04
4	37.710122	-84.108880	880.04	5.00	885.04
5	37.709746	-84.108888	880.04	5.00	885.04
6	37.709765	-84.110253	880.04	5.00	885.04
7	37.709181	-84.110537	880.04	5.00	885.04
8	37.709185	-84.110766	880.04	5.00	885.04
9	37.709512	-84.111345	880.04	5.00	885.04
10	37.709856	-84.111338	880.04	5.00	885.04
11	37.710451	-84.110091	880.04	5.00	885.04
12	37.710448	-84.109845	880.04	5.00	885.04
13	37.710611	-84.109732	880.04	5.00	885.04
14	37.711005	-84.109314	880.04	5.00	885.04
15	37.711177	-84.109343	880.04	5.00	885.04
16	37.711384	-84.109695	880.04	5.00	885.04
17	37.711851	-84.109685	880.04	5.00	885.04
18	37.712564	-84.108473	880.04	5.00	885.04
19	37.713139	-84.107378	880.04	5.00	885.04
20	37.713429	-84.106598	880.04	5.00	885.04

21	37.713422	-84.106100	880.04	5.00	885.04
22	37.712787	-84.105784	880.04	5.00	885.04
23	37.712436	-84.105791	880.04	5.00	885.04
24	37.712456	-84.107237	880.04	5.00	885.04
25	37.711671	-84.107254	880.04	5.00	885.04
26	37.711661	-84.106575	880.04	5.00	885.04
27	37.711224	-84.106477	880.04	5.00	885.04
28	37.711213	-84.105711	880.04	5.00	885.04
29	37.710837	-84.105719	880.04	5.00	885.04
30	37.710394	-84.107185	880.04	5.00	885.04
31	37.710406	-84.108058	880.04	5.00	885.04
32	37.711139	-84.108258	880.04	5.00	885.04
33	37.711149	-84.108979	880.04	5.00	885.04

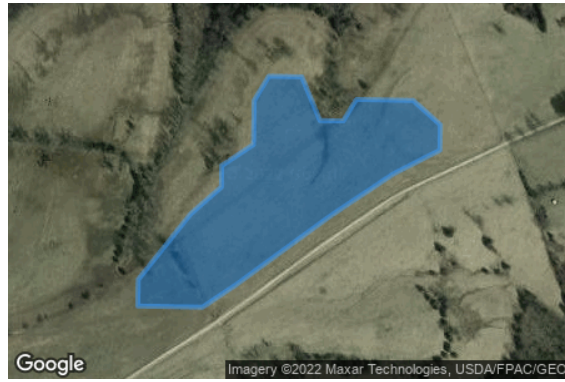
Vertex	Latitude (°)	Longitude (°)	Ground elevation (ft)	Height above ground (ft)	Total elevation (ft)
1	37.714925	-84.109689	880.04	5.00	885.04
2	37.714917	-84.109122	880.04	5.00	885.04
3	37.714325	-84.108812	880.04	5.00	885.04
4	37.714319	-84.108410	880.04	5.00	885.04
5	37.714610	-84.108188	880.04	5.00	885.04
6	37.714597	-84.107210	880.04	5.00	885.04
7	37.714267	-84.106743	880.04	5.00	885.04
8	37.713924	-84.106750	880.04	5.00	885.04
9	37.713605	-84.107544	880.04	5.00	885.04
10	37.713035	-84.108629	880.04	5.00	885.04
11	37.712094	-84.110266	880.04	5.00	885.04
12	37.711797	-84.110830	880.04	5.00	885.04
13	37.711813	-84.111941	880.04	5.00	885.04
14	37.712171	-84.111933	880.04	5.00	885.04
15	37.713059	-84.111034	880.04	5.00	885.04
16	37.713423	-84.110506	880.04	5.00	885.04
17	37.713713	-84.110499	880.04	5.00	885.04
18	37.713999	-84.109954	880.04	5.00	885.04
19	37.714596	-84.109941	880.04	5.00	885.04
20	37.714925	-84.109689	880.04	5.00	885.04

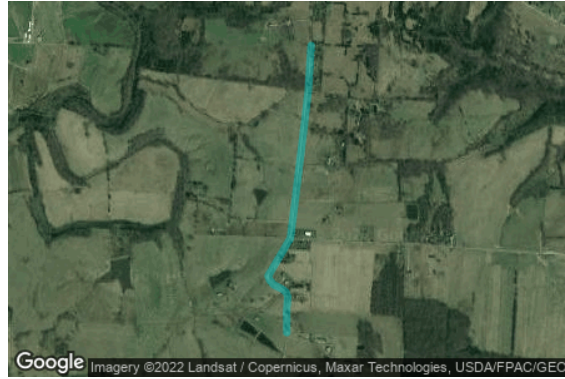
Name: Brassfield Rd
Path type: Two-way
Observer view angle: 50.0°

Vertex	Latitude (°)	Longitude (°)	Ground elevation (ft)	Height above ground (ft)	Total elevation (ft)
1	37.706362	-84.133317	908.77	0.00	908.77
2	37.707525	-84.133328	905.76	0.00	905.76
3	37.708297	-84.133253	908.79	0.00	908.79
4	37.708544	-84.133371	902.61	0.00	902.61
5	37.708713	-84.133628	901.63	0.00	901.63
6	37.708943	-84.134197	909.58	0.00	909.58
7	37.709214	-84.134508	908.05	0.00	908.05
8	37.709435	-84.134605	906.39	0.00	906.39
9	37.711480	-84.133070	919.69	0.00	919.69
10	37.715447	-84.132448	900.63	0.00	900.63
11	37.719436	-84.131847	876.86	0.00	876.86
12	37.721914	-84.131654	888.72	0.00	888.72

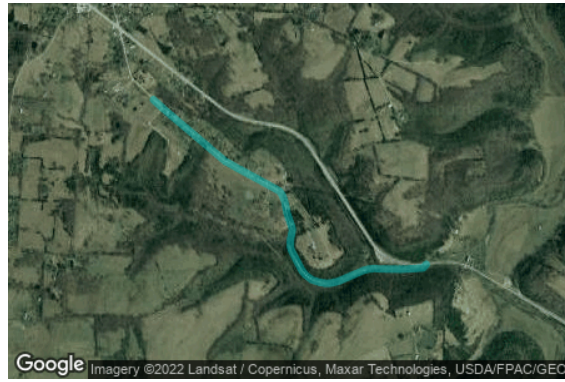
Name: Bybee Loop Rd
Path type: Two-way
Observer view angle: 50.0°

Vertex	Latitude (°)	Longitude (°)	Ground elevation (ft)	Height above ground (ft)	Total elevation (ft)
1	37.718451	-84.102880	626.04	0.00	626.04
2	37.718256	-84.103105	625.46	0.00	625.46
3	37.718188	-84.104489	635.15	0.00	635.15
4	37.718205	-84.106130	633.89	0.00	633.89
5	37.718230	-84.106452	636.69	0.00	636.69
6	37.718179	-84.106903	639.48	0.00	639.48
7	37.718120	-84.107203	648.22	0.00	648.22
8	37.717543	-84.108888	684.16	0.00	684.16
9	37.717441	-84.109424	689.38	0.00	689.38
10	37.717424	-84.109800	695.66	0.00	695.66
11	37.717484	-84.110218	707.93	0.00	707.93
12	37.717611	-84.110733	715.65	0.00	715.65
13	37.717865	-84.111173	726.40	0.00	726.40
14	37.718129	-84.111430	737.86	0.00	737.86
15	37.719181	-84.112133	757.00	0.00	757.00
16	37.719418	-84.112219	769.00	0.00	769.00
17	37.719770	-84.112214	779.58	0.00	779.58
18	37.720297	-84.112085	803.18	0.00	803.18
19	37.720492	-84.112122	803.61	0.00	803.61
20	37.720687	-84.112214	813.16	0.00	813.16

21	37.721231	-84.112444	826.27	0.00	826.27
22	37.721837	-84.112605	834.54	0.00	834.54
23	37.722190	-84.112766	842.62	0.00	842.62
24	37.722420	-84.112965	845.03	0.00	845.03
25	37.723642	-84.115813	855.86	0.00	855.86
26	37.724049	-84.116720	866.66	0.00	866.66
27	37.726883	-84.120958	875.68	0.00	875.68
28	37.727376	-84.121634	878.71	0.00	878.71

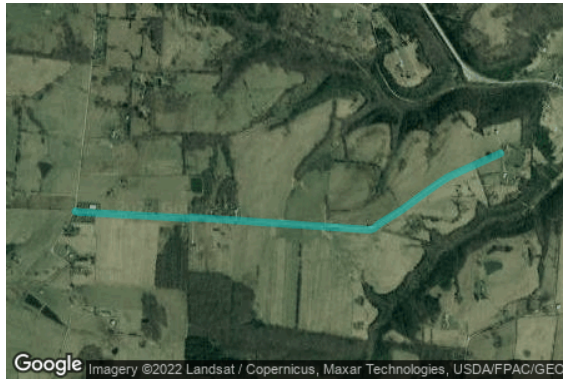
Name: Pine Grove Rd
Path type: Two-way
Observer view angle: 50.0°

Vertex	Latitude (°)	Longitude (°)	Ground elevation (ft)	Height above ground (ft)	Total elevation (ft)
1	37.714621	-84.103819	826.74	0.00	826.74
2	37.713365	-84.107341	846.60	0.00	846.60
3	37.713076	-84.107942	850.98	0.00	850.98
4	37.712075	-84.109723	869.33	0.00	869.33
5	37.711570	-84.110580	877.45	0.00	877.45
6	37.710790	-84.112178	888.33	0.00	888.33
7	37.710560	-84.112500	894.33	0.00	894.33
8	37.710501	-84.112736	893.89	0.00	893.89
9	37.710484	-84.112908	893.64	0.00	893.64
10	37.711155	-84.125031	913.27	0.00	913.27
11	37.711104	-84.125343	914.76	0.00	914.76
12	37.711443	-84.132885	923.49	0.00	923.49
13	37.711481	-84.133030	920.45	0.00	920.45

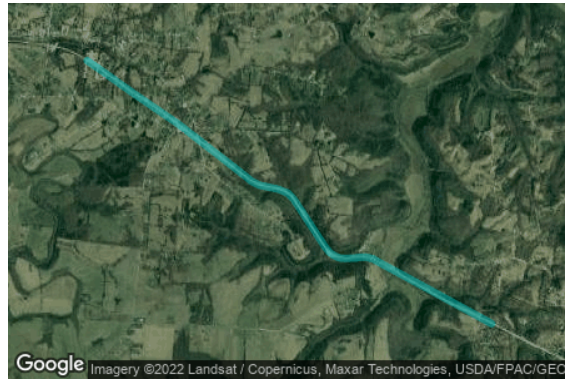
Name: Rt 52
Path type: Two-way
Observer view angle: 50.0°

Vertex	Latitude (°)	Longitude (°)	Ground elevation (ft)	Height above ground (ft)	Total elevation (ft)
1	37.711339	-84.083718	787.84	0.00	787.84
2	37.718075	-84.099404	622.57	0.00	622.57
3	37.718380	-84.100079	620.38	0.00	620.38
4	37.718550	-84.101002	618.67	0.00	618.67
5	37.718533	-84.101914	619.04	0.00	619.04
6	37.718465	-84.102257	619.25	0.00	619.25
7	37.718414	-84.103738	636.30	0.00	636.30
8	37.718456	-84.104553	643.68	0.00	643.68
9	37.718694	-84.105326	654.31	0.00	654.31
10	37.719059	-84.105991	663.73	0.00	663.73
11	37.719585	-84.106560	675.04	0.00	675.04
12	37.724781	-84.110894	765.52	0.00	765.52
13	37.725494	-84.111752	777.19	0.00	777.19
14	37.725901	-84.113018	791.63	0.00	791.63
15	37.726359	-84.115700	819.21	0.00	819.21
16	37.726750	-84.116688	830.48	0.00	830.48
17	37.727395	-84.117696	842.71	0.00	842.71
18	37.733038	-84.126923	910.66	0.00	910.66
19	37.736279	-84.132931	875.63	0.00	875.63
20	37.739843	-84.139325	875.38	0.00	875.38
