BLUEGRASS WATER

Bluegrass Water Rate Case Docket 2022-00432

System Updates

Bluegrass Water's Supplemental Response to PSC 2-3

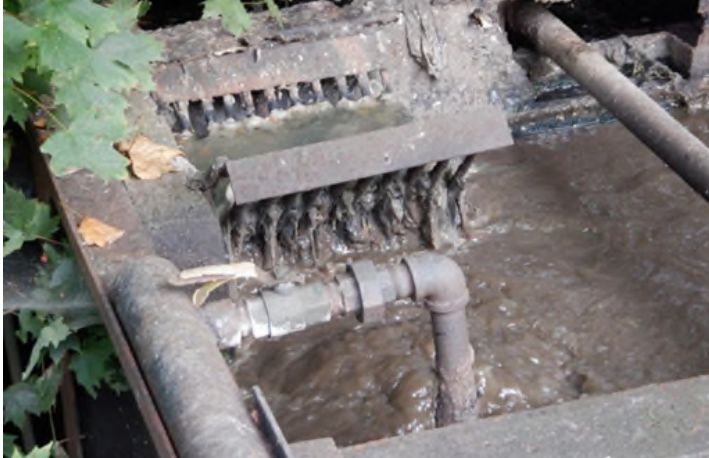
Airview-1

Before: Failed bar screens, clogged structure

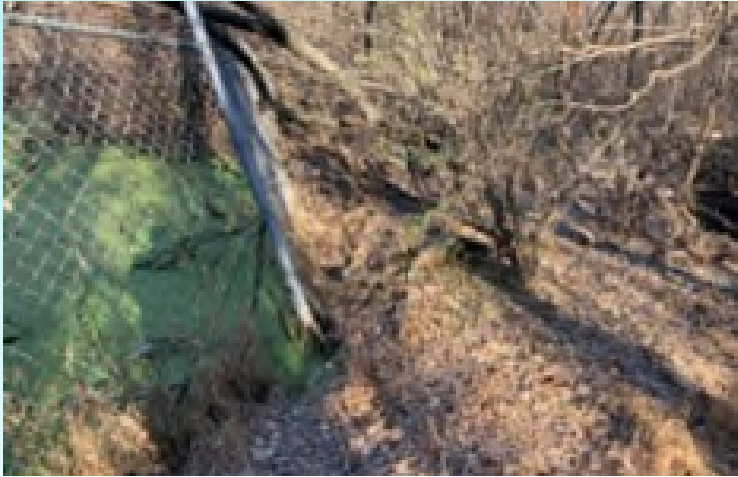
Airview-2

Before: Rusted tank, compromised fencing

After: New fencing, recoated tank

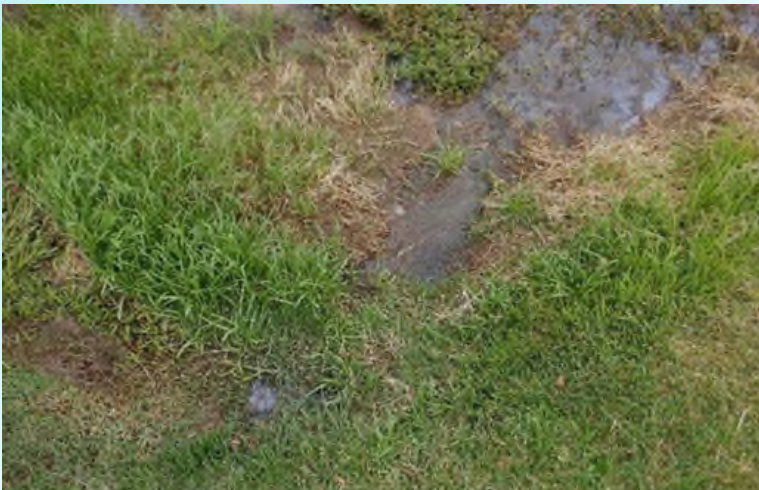
Arcadia & Carriage Park

Before: Leaking, eroding, vegetation growing in berms

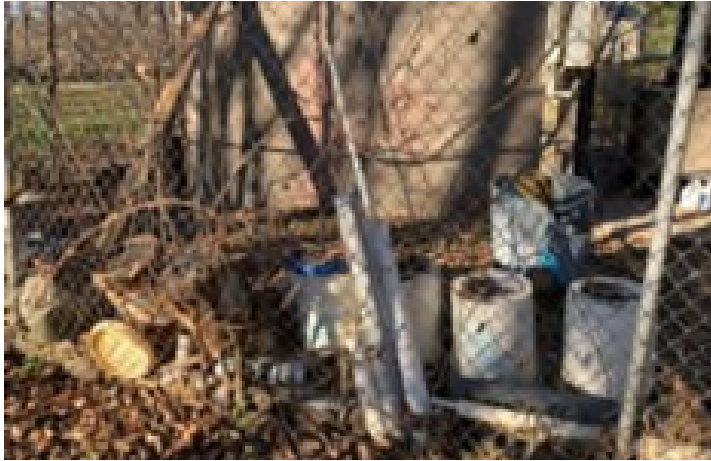
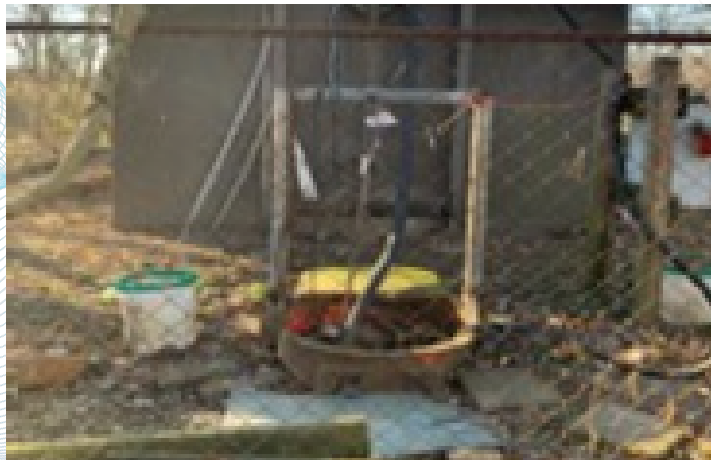
Fox Run-1

Before: Failed fencing, broken barbed wire, trash, deteriorated tank coating, no safety rails

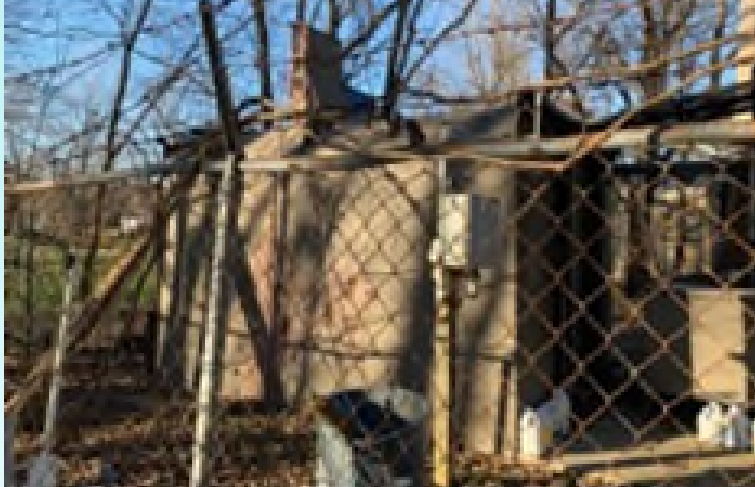
Fox Run-2

Before: Deteriorated service area, no safety rails

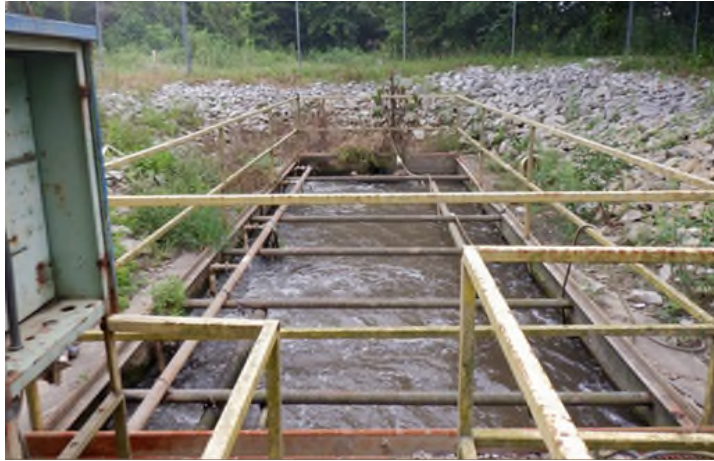
Golden Acres

Before: Corroded equipment due to flooding, loose rails

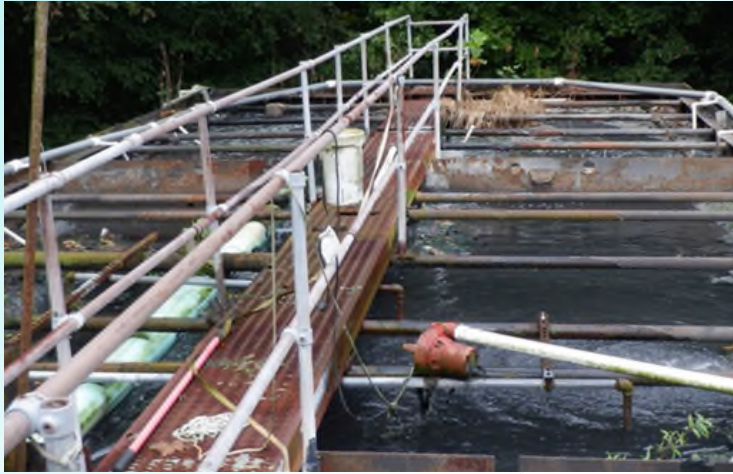
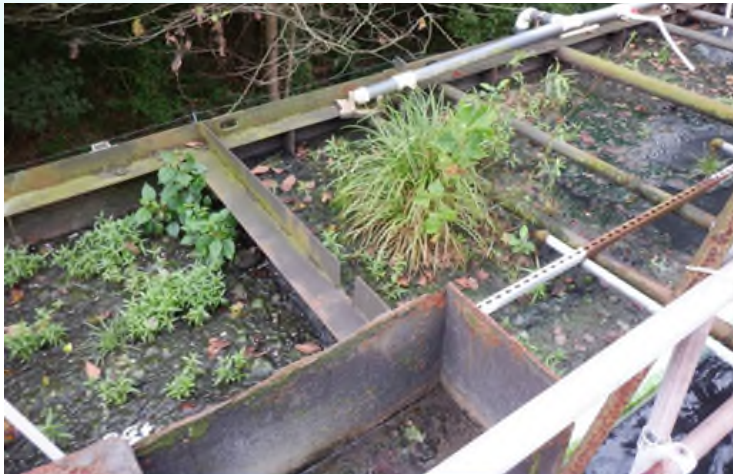
Great Oaks-1

Before: Failing catwalk & handrails, sludge accumulation & overgrowth

After: Safe catwalk & handrails restored; Accumulated sludge & vegetation cleared

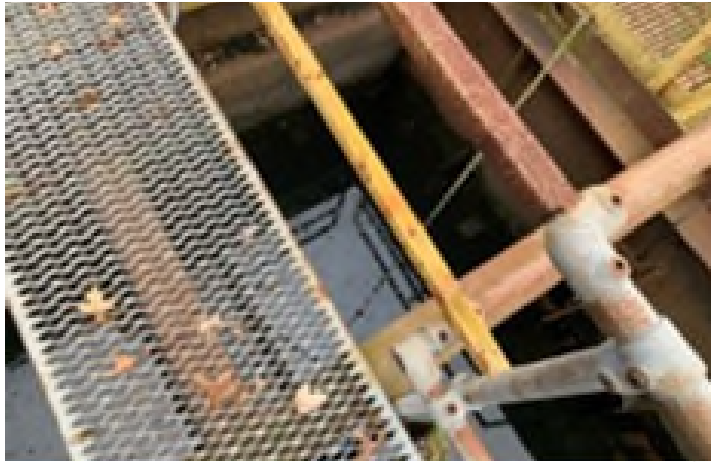
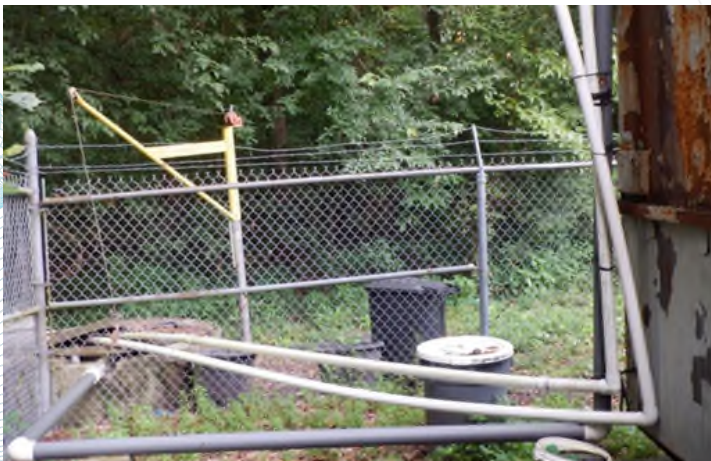
Great Oaks-2

Before: Failed digester out of service due to leaking into contact chamber, improper influent lines, tank corrosion

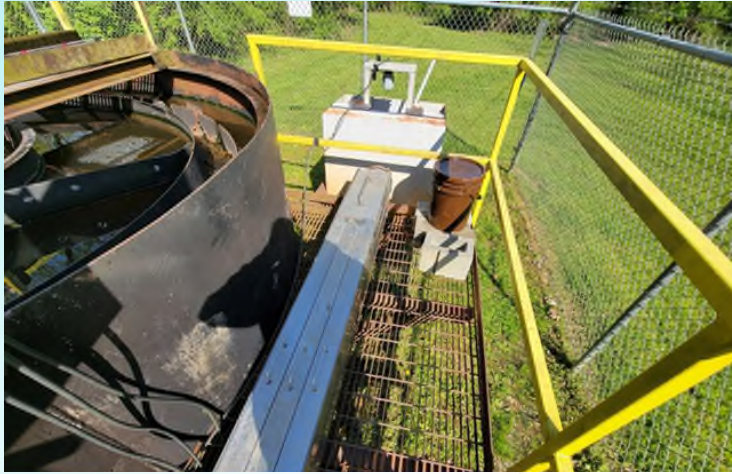
Kingswood

Before: Obsolete, broken UV disinfection system,
damaged handrails & catwalk

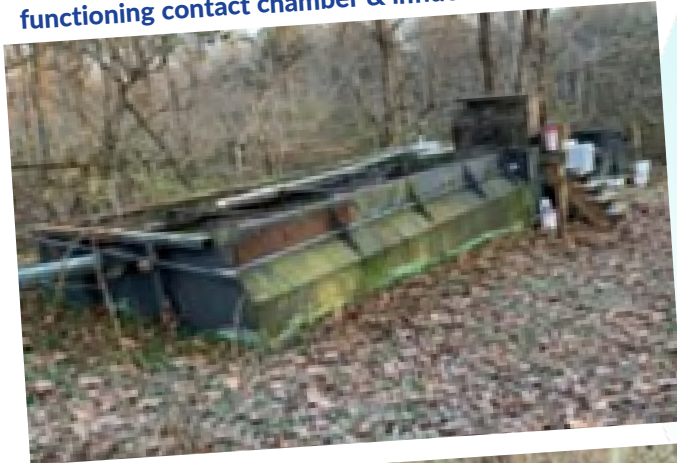
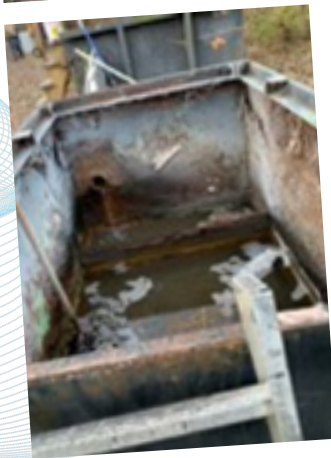
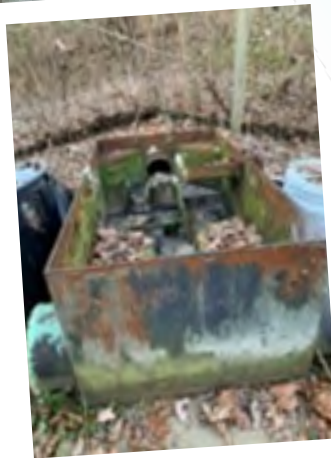
Lake Columbia

Before: Deteriorating aeration plant, deteriorated low functioning contact chamber & influence screen box

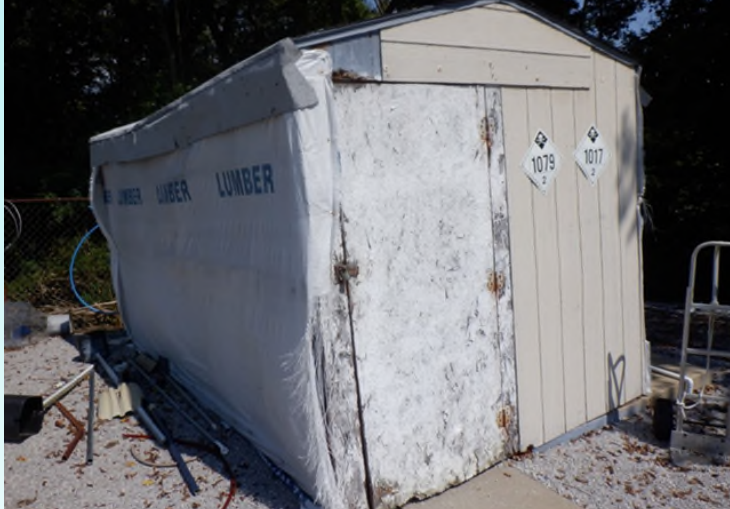
LH

Before: Failing disinfection shed, no safety rails around treatment basin

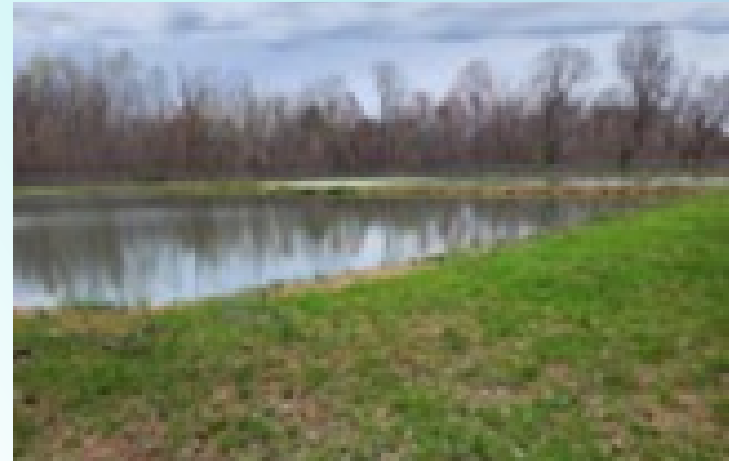
Marshall Ridge

Before: Overgrowth of vegetation and duckweed in lagoon

After: Berms cleared and duckweed reduced

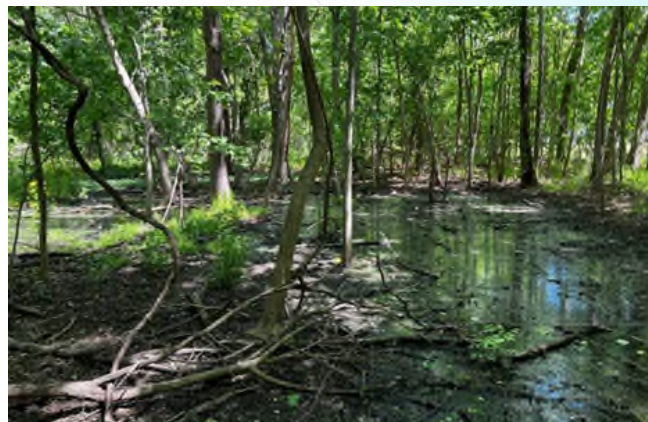
Failed drain field, in the process of being permitted for drain field replacement and additional work

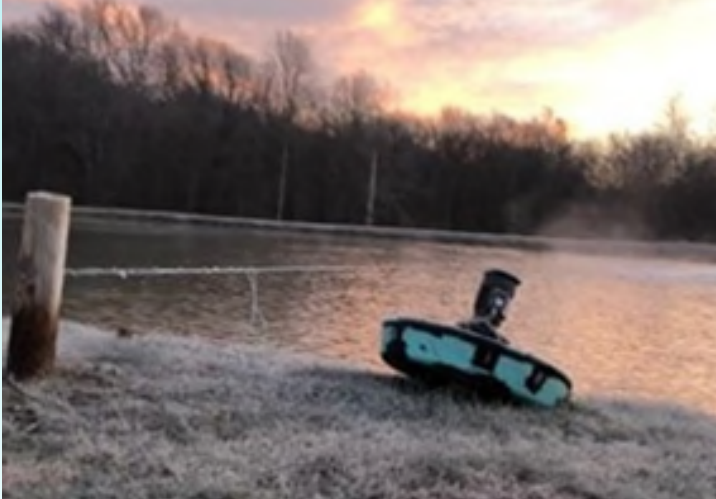
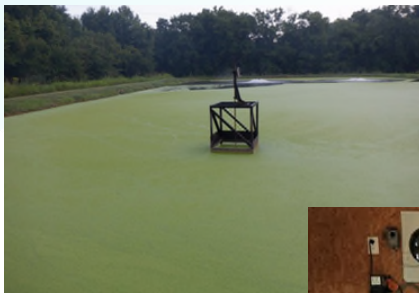
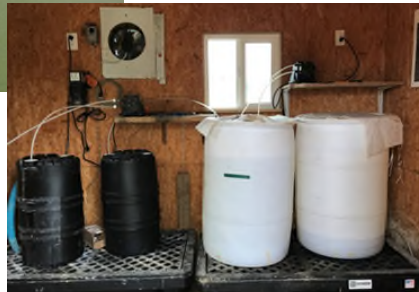
Persimmon Ridge

Before: Damaged aeration, damaged lagoon baffle, poorly dosed chlorine with no monitoring scale

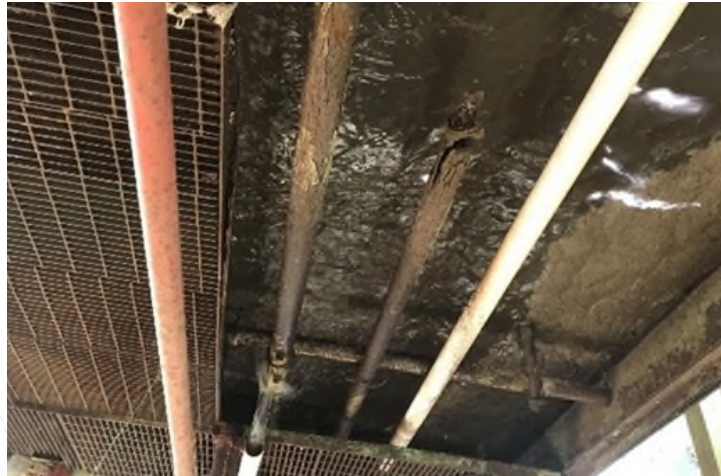
River Bluffs-1

Before: Terrible effluent quality, deteriorated aeration piping

After: Improved effluent quality, new aeration piping

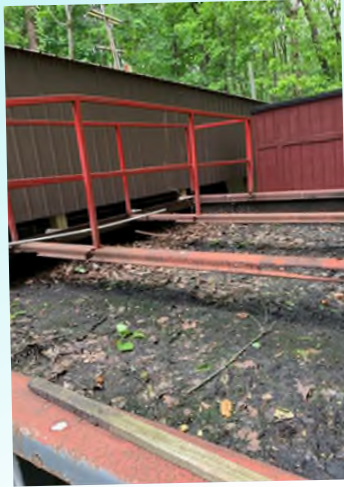
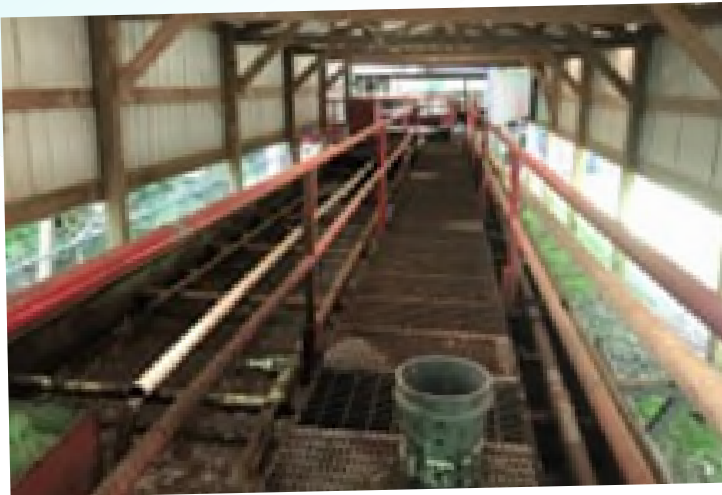
River Bluffs-2

Before: Digester filled with solids, severe corrosion throughout plant

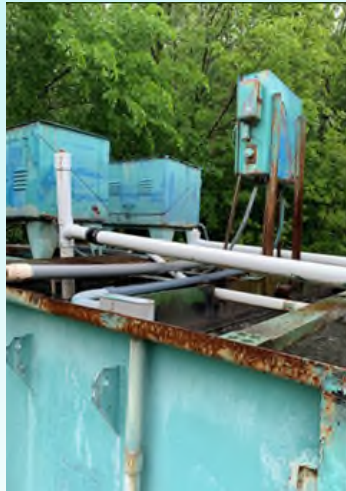
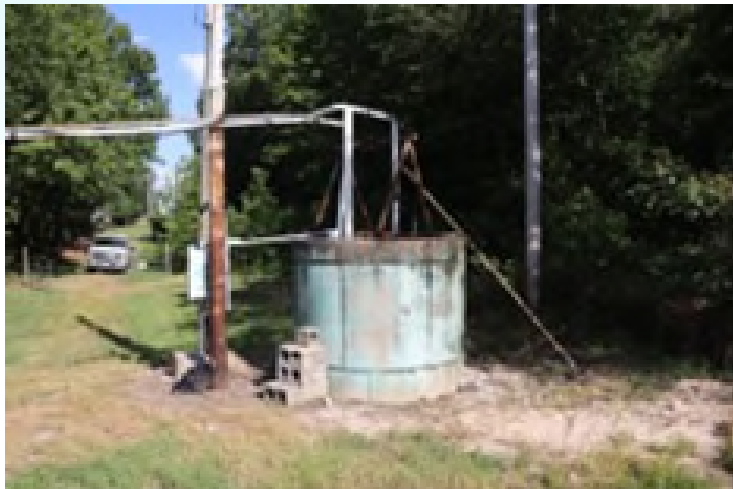
Timberland-1

Before: Failing blowers & control system, poor influent lift station with overhead line causing splashing of waste

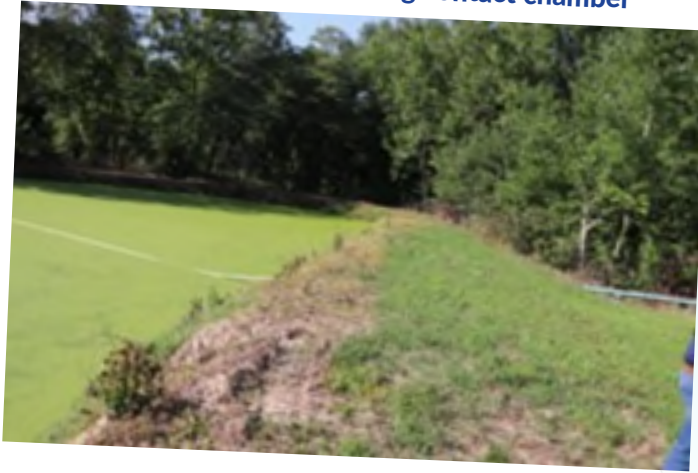
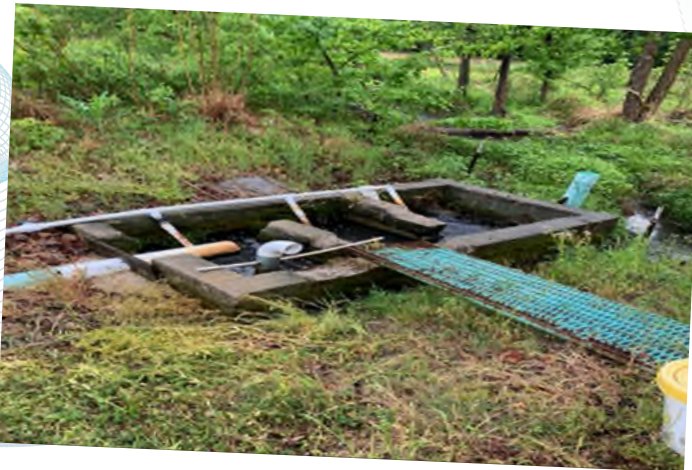
Timberland-2

Before: Overgrown, stagnant lagoon with damaged berms, failing contact chamber

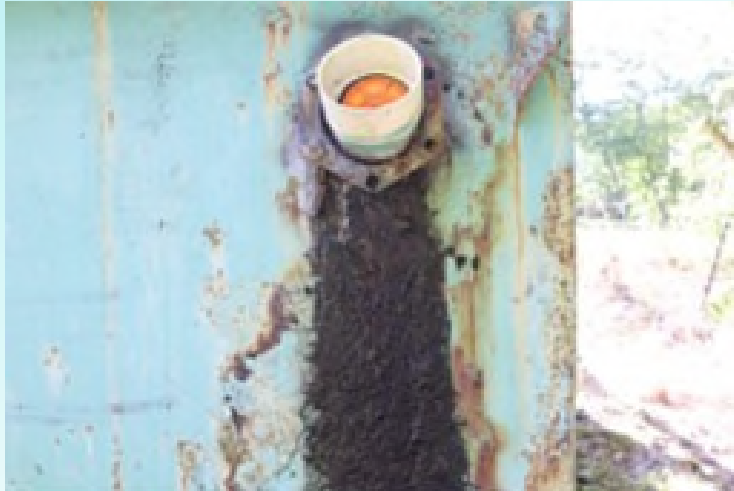
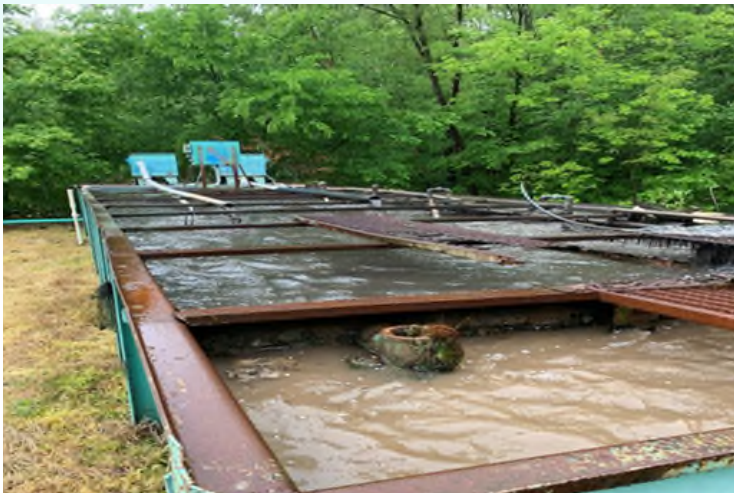
Timberland-3

Before: Corroded, leaking tanks, corrosion on much of the equipment and catwalks
