RE: Cultural Historic Overview Study for the Mercer County Solar Project in
Mercer County, Kentucky
CRA Project Number: K20S007
CRA Publication Series: 20-399

APPENDIX A. PHOTOGRAPHS OF SURVEYED RESOURCES.

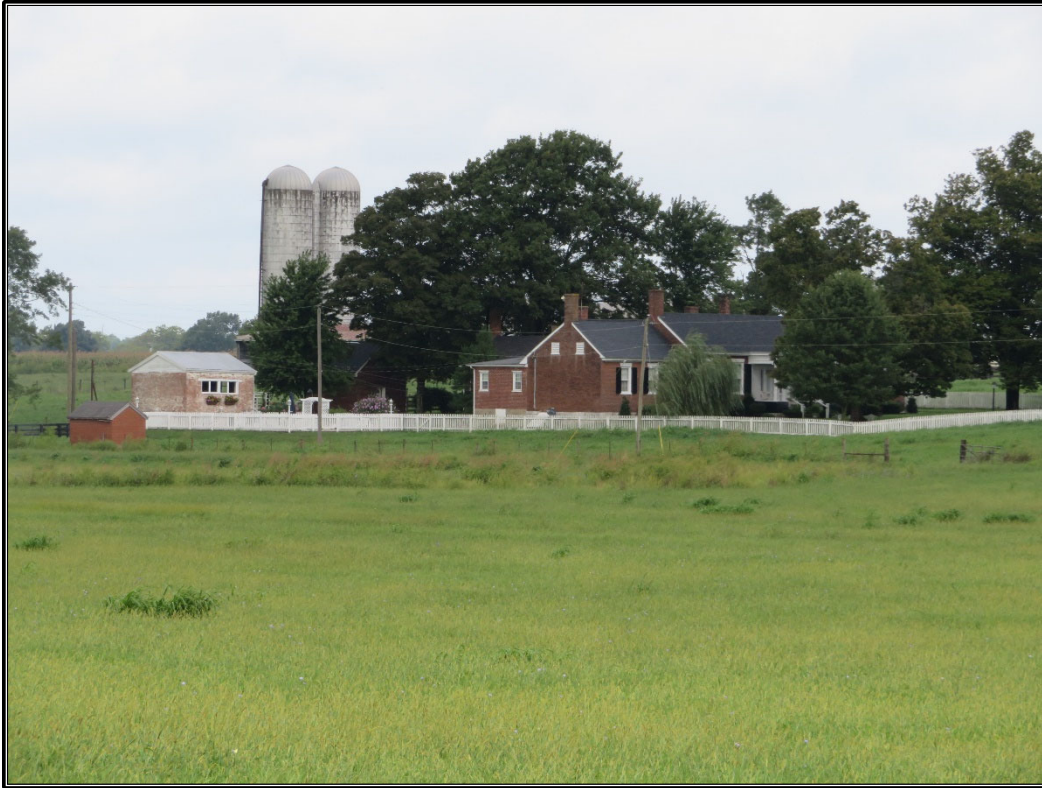
Figure 3. ME 150: NRHP-listed house and outbuilding, looking northwest.

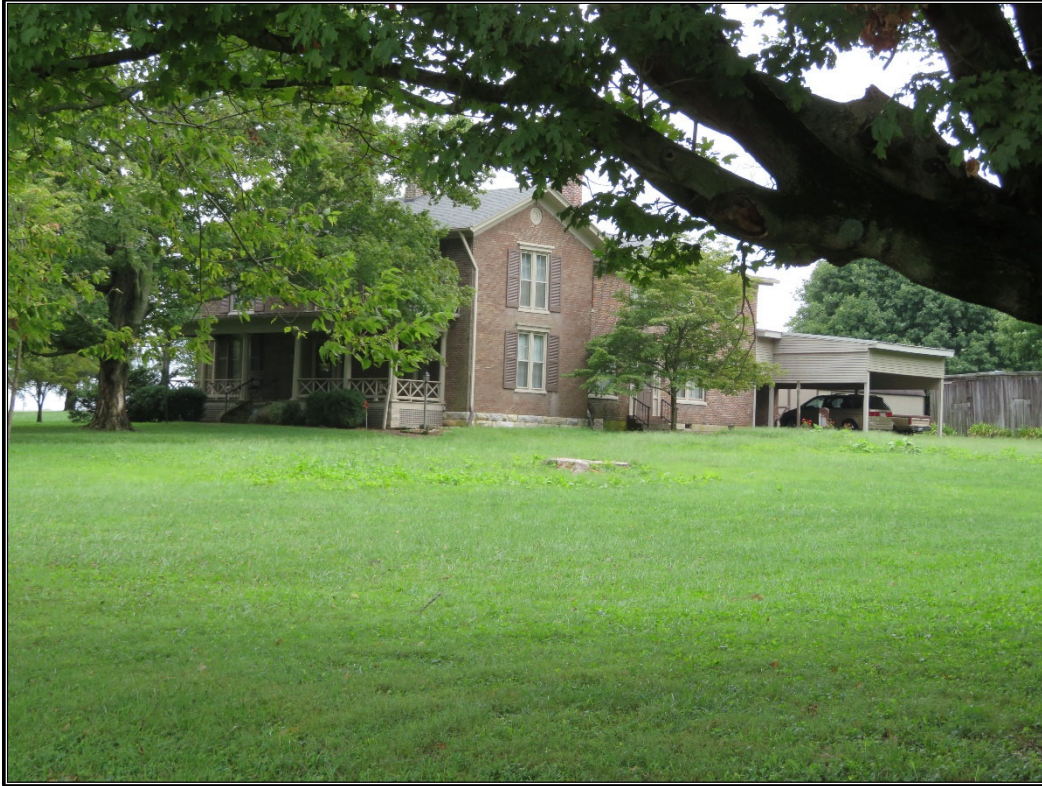
Figure 5. ME 151: NRHP-listed house associated with McAfee Farm Historic District, looking northeast.

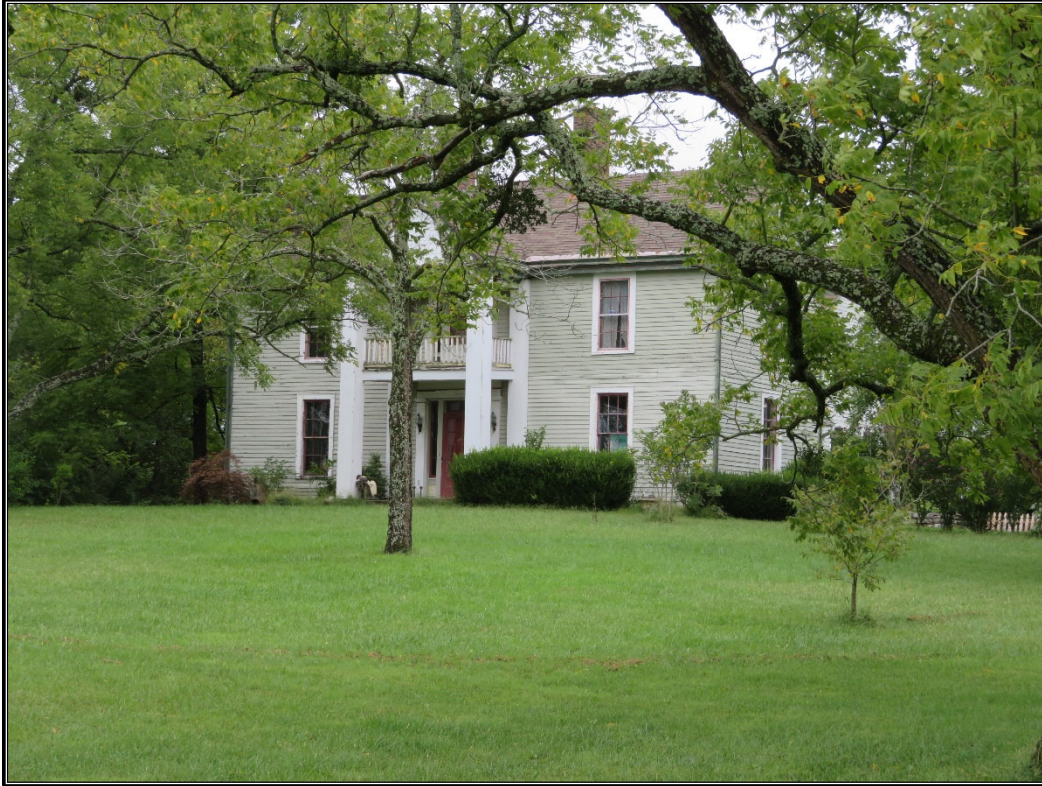
Figure 7. ME 170: NRHP-listed house, looking northwest.

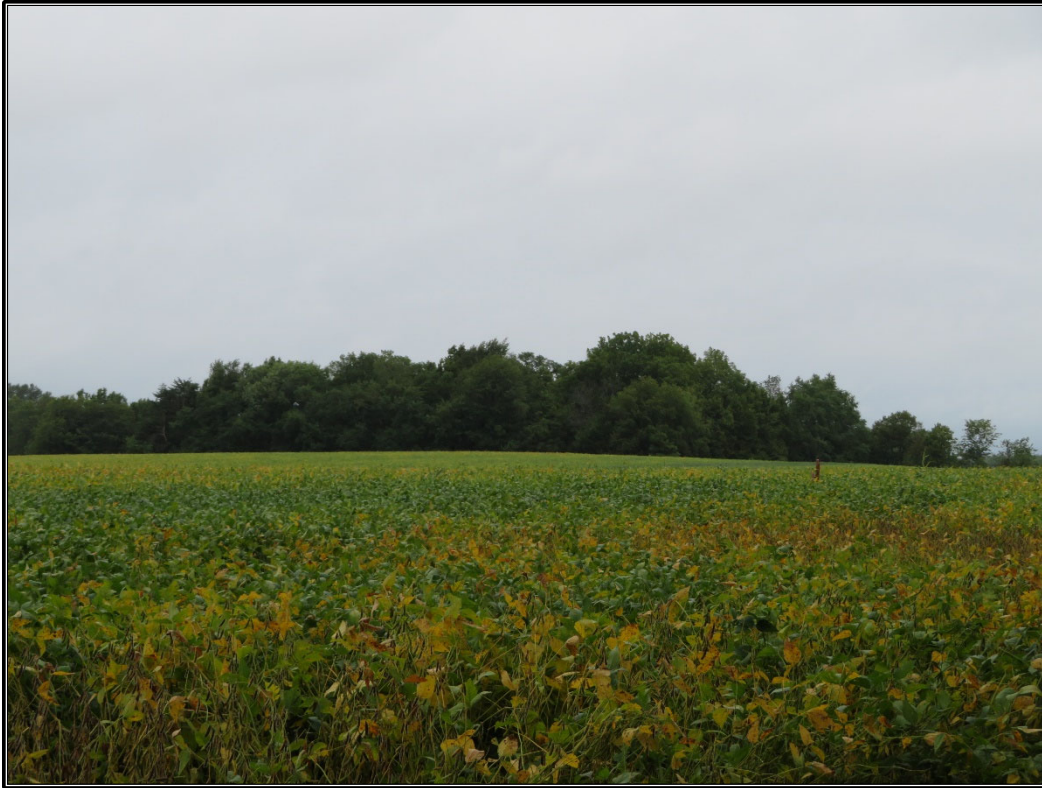
ME 178	John McGee House	685 Jackson Pike	Listed under Mercer County MRA; Significant under Criterion C as a good example of an early stone house built by an early settler. NRHP includes domestic area with one contributing outbuilding.	Not visible from ROW, but NRHP boundary located outside study area	9
ME 476	Farmstead	265 Jackson Pike	Previously surveyed with no NRHP evaluation provided (Brother 2009); undetermined status in KHC database. Potentially eligible based on CRA field observations.	Common house and outbuilding forms; outbuildings losing structural integrity	11 and 12

Figure 9. ME 178: View towards NRHP-listed house, which is not visible from the study area looking northwest.

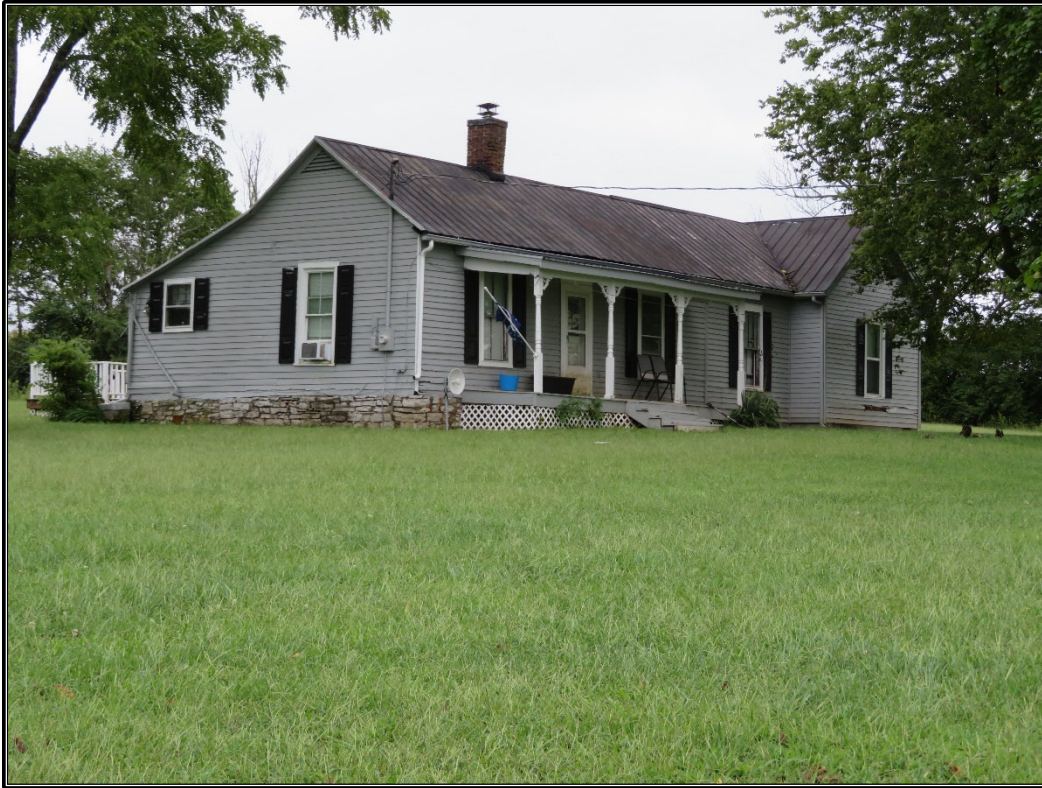
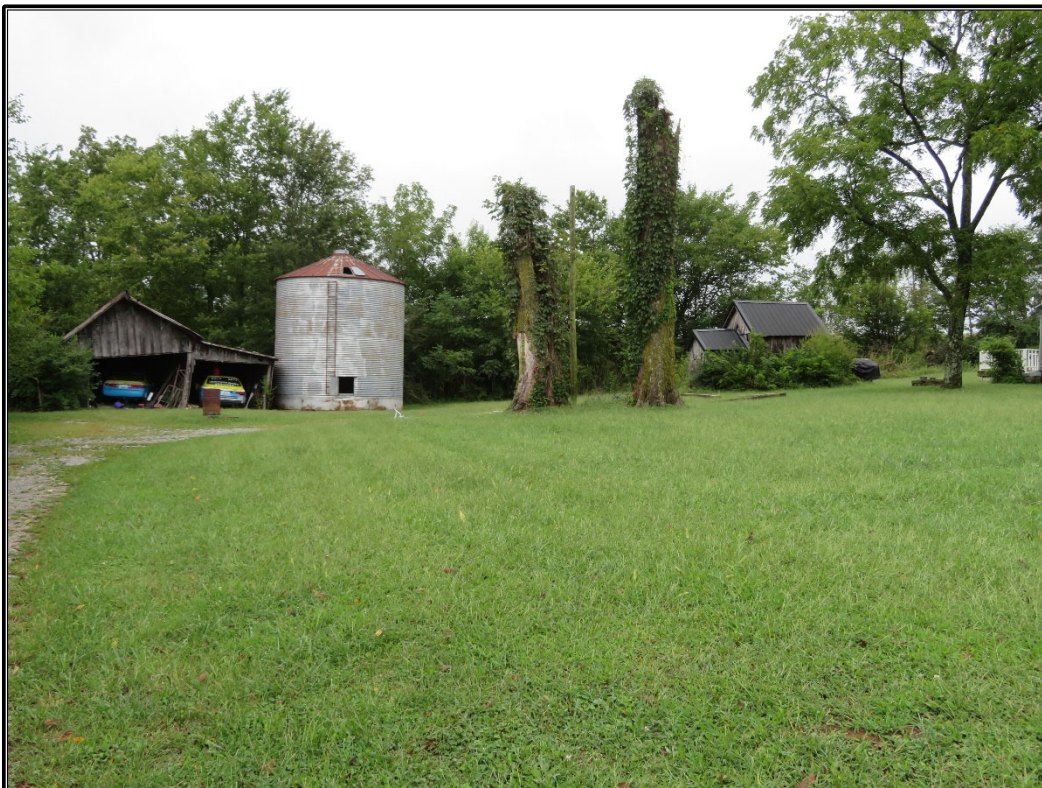
ME 476 is potentially significant, but requires additional investigation. The resources associated with ME 534 and the barn associated with CRA 1 were not visible from the ROW during the overview study and therefore could not be assessed. Thus, these sites require further examination to determine their eligibility under Criterion A, B, or C. Therefore, the NRHP eligibility of ME 534 and CRA 1 is recommended undetermined for this overview study.

Figure 11. ME 476: House, looking east.

Figure 12. ME 476: Outbuildings, looking east-northeast.

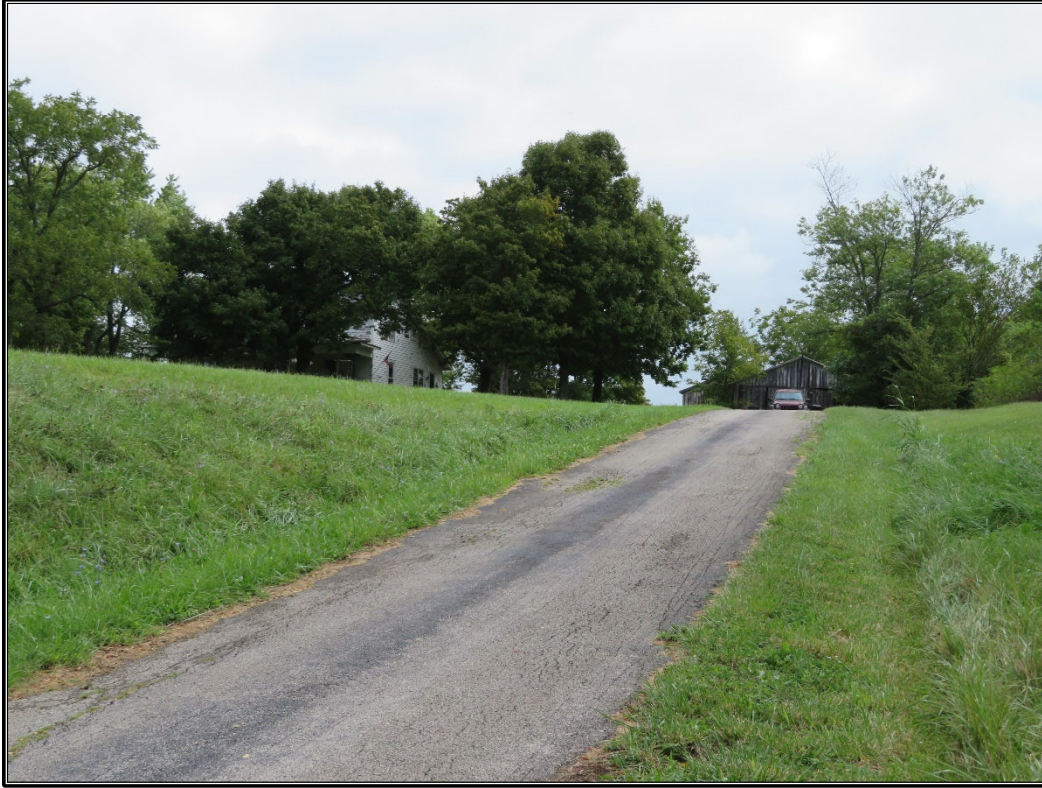
ME 479	James Ellis Farm	1749 Louisville Road	Previously surveyed with no NRHP evaluation provided (Brother 2009); undetermined status in KHC database. Not eligible based on CRA field observations.	Common house and outbuilding forms; alterations	13
ME 504	Two barns, outbuildings, and modern house	1406 Bohon Road	Recommended not eligible (Martinolich and Spurlock 2012); KHC concurred. Not eligible based on CRA field observations.	Common building forms; alterations	14
ME 505	House and modern barns	1108 Bohon Road	Recommended not eligible (Martinolich and Spurlock 2012); KHC concurred. Not eligible based on CRA field observations.	Common building forms; alterations	15
ME 506	House and barn	1220 Bohon	Recommended not eligible (Martinolich and Spurlock 2012); KHC concurred. Not eligible based on CRA field observations.	Common building forms; house in poor condition (vacant), affecting its integrity of materials and workmanship.	16

Figure 13. ME 479: House and barn, looking northeast.

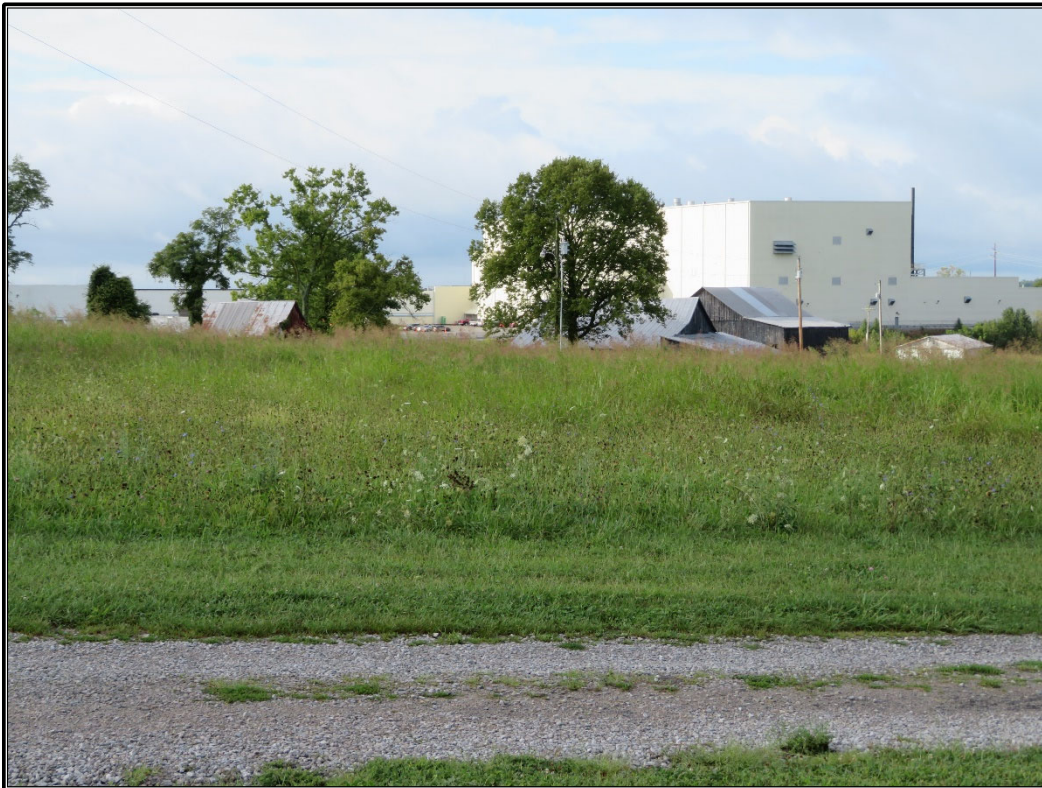
Figure 14. ME 504: Barns and outbuildings, looking south-southwest.

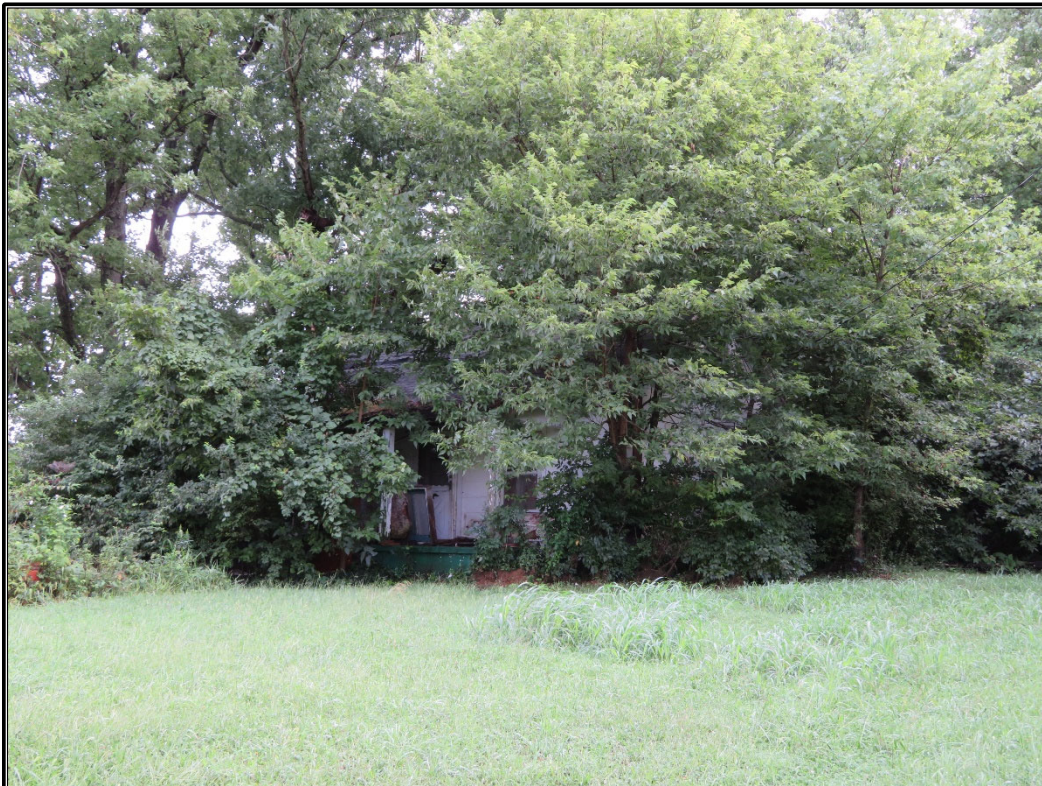
Figure 16. ME 506: Vacant house, looking north-northeast.

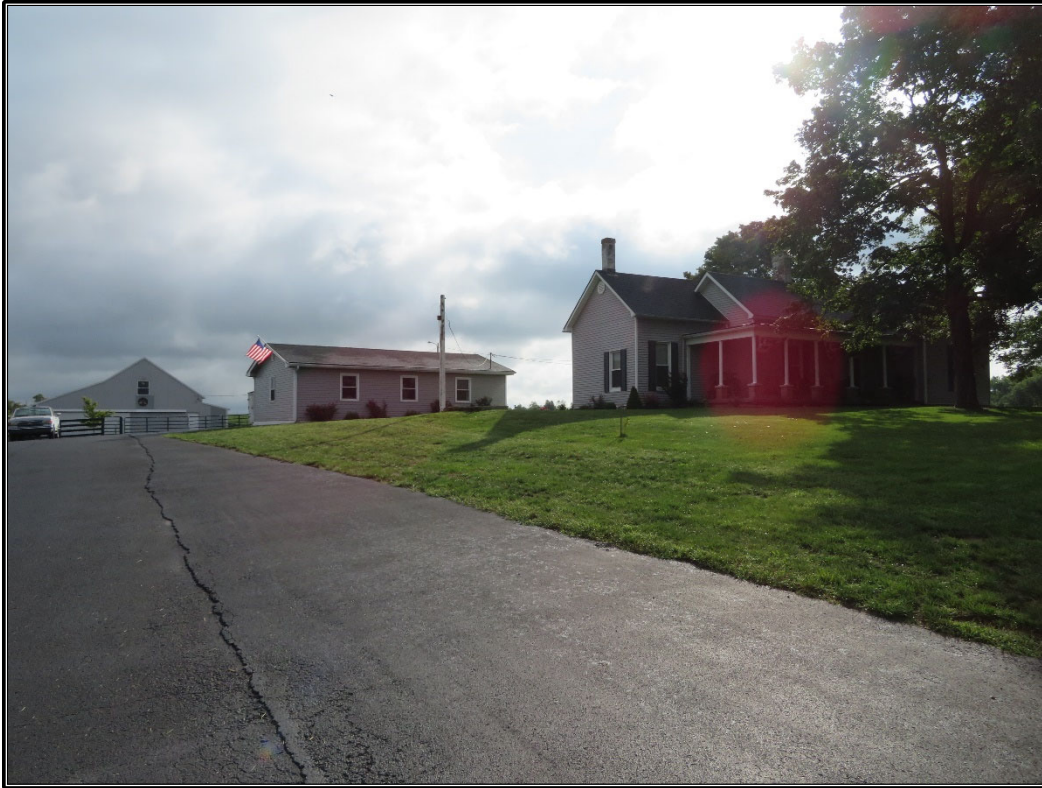
ME 507	House, barn, and garage	1271 Bohon Road	Recommended not eligible (Martinolich and Spurlock 2012); KHC concurred. Not eligible based on CRA field observations.	Common building forms; alterations	17
ME 508	Barn and modern house	1327 Bohon Road	Recommended not eligible (Martinolich and Spurlock 2012); KHC concurred. Not eligible based on CRA field observations.	Common building forms; alterations	18
ME 509	Barn and residence	1330 Bohon Road	Barn recommended not eligible (Martinolich and Spurlock 2012); KHC concurred. House also located on parcel, but not previously surveyed. House and barn not eligible based on CRA field observations.	Common building forms; alterations	19 and 20
ME 510	Concrete culvert	Carrying Norfolk Southern Railroad over defunct Fountain Trace	Recommended not eligible (Martinolich and Spurlock 2012); KHC concurred. Not eligible based on previous recommendation and concurrence. Not visible from ROW.	According to the previous survey, the culvert is an unexceptional example of its type. The structure is not visible from the ROW, but through prior report recommendation and concurrence by KHC the resource has been determined not eligible.	21

Figure 17. ME 507: House and outbuildings, looking northeast.

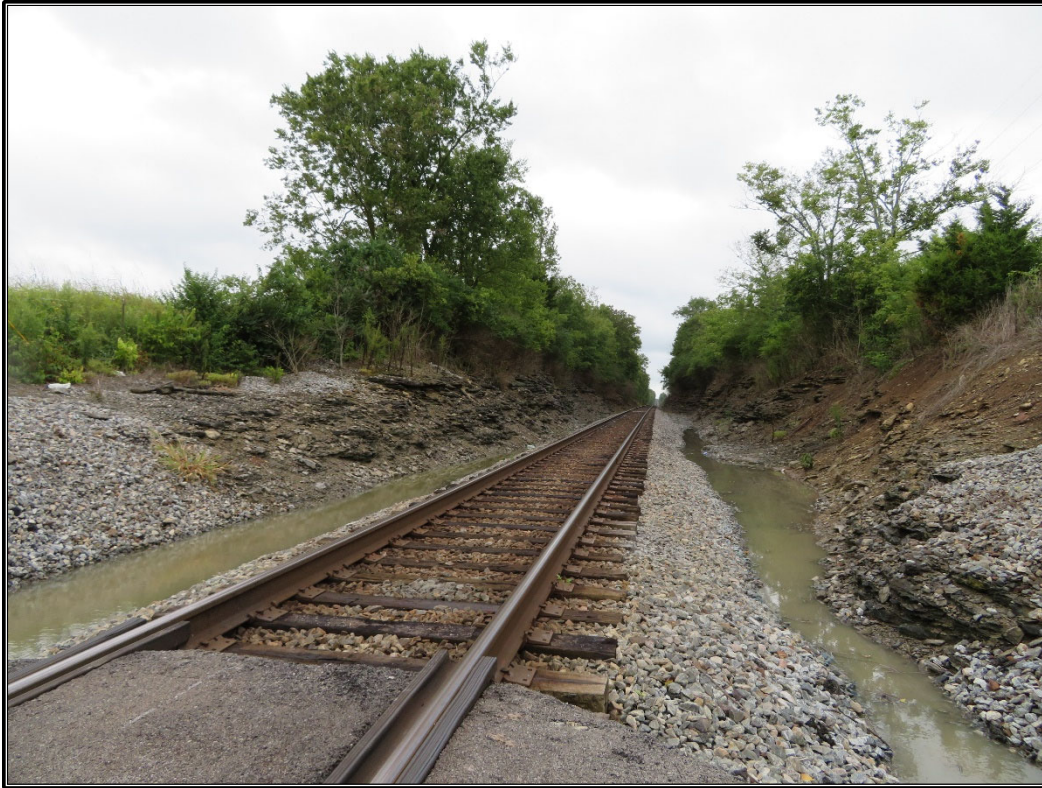
Figure 21. ME 510: Railroad leading to culvert, looking south.

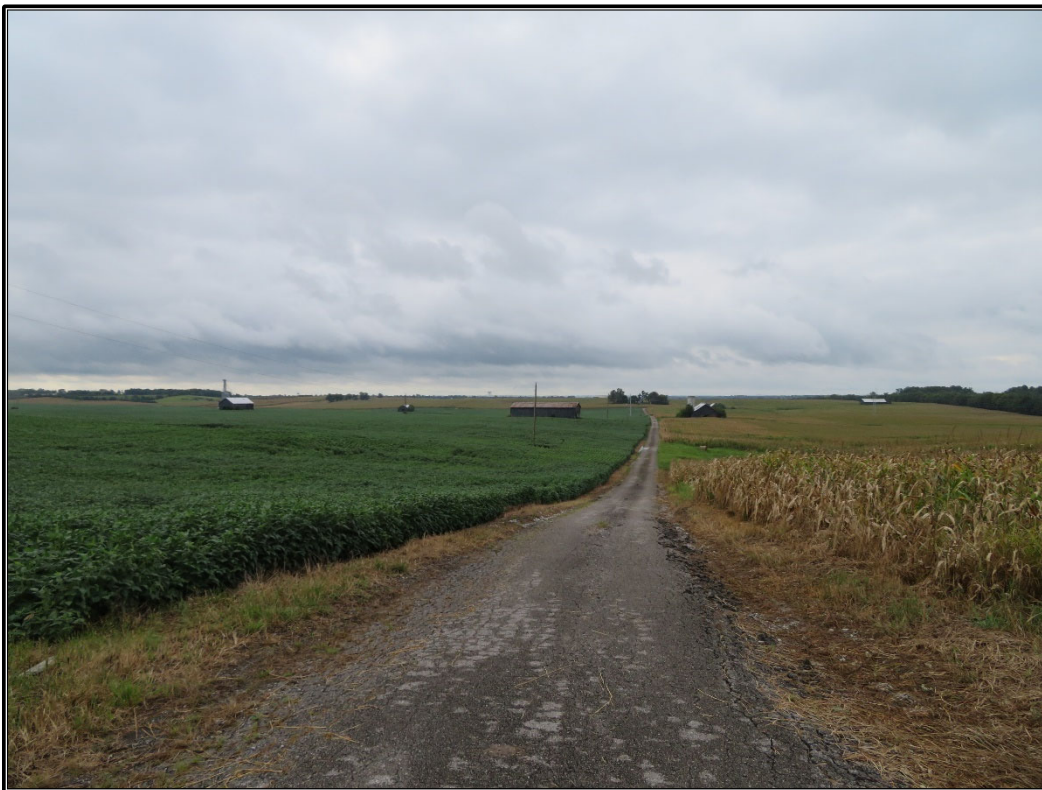
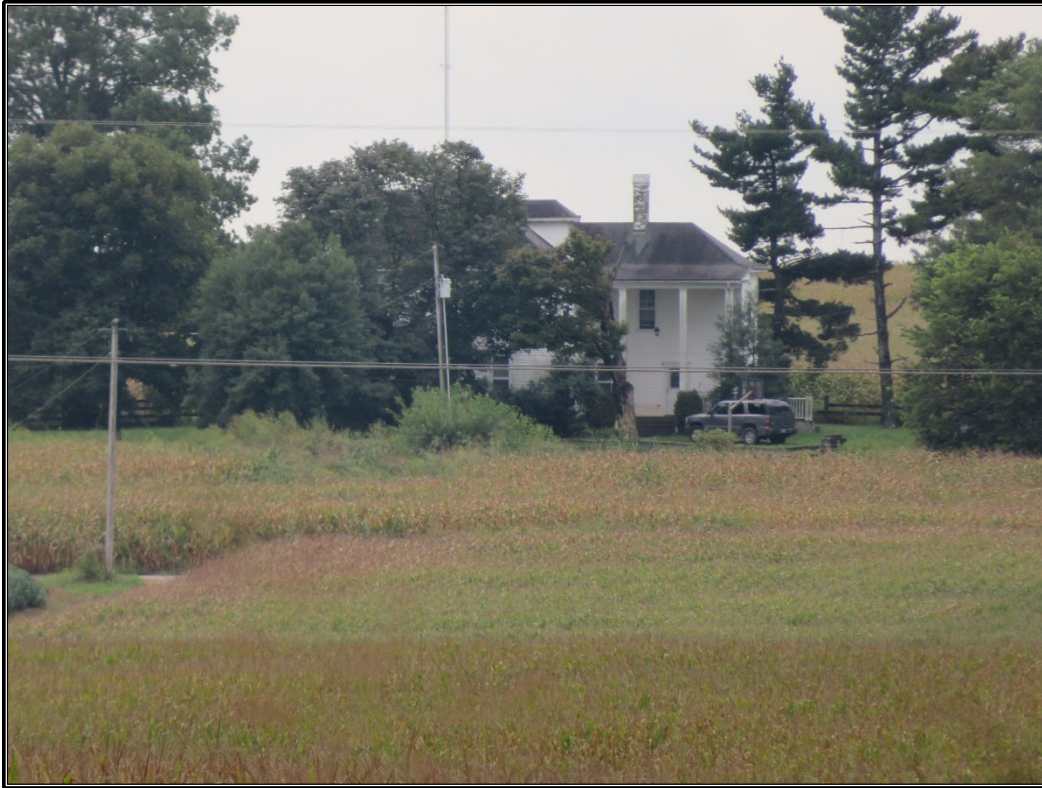
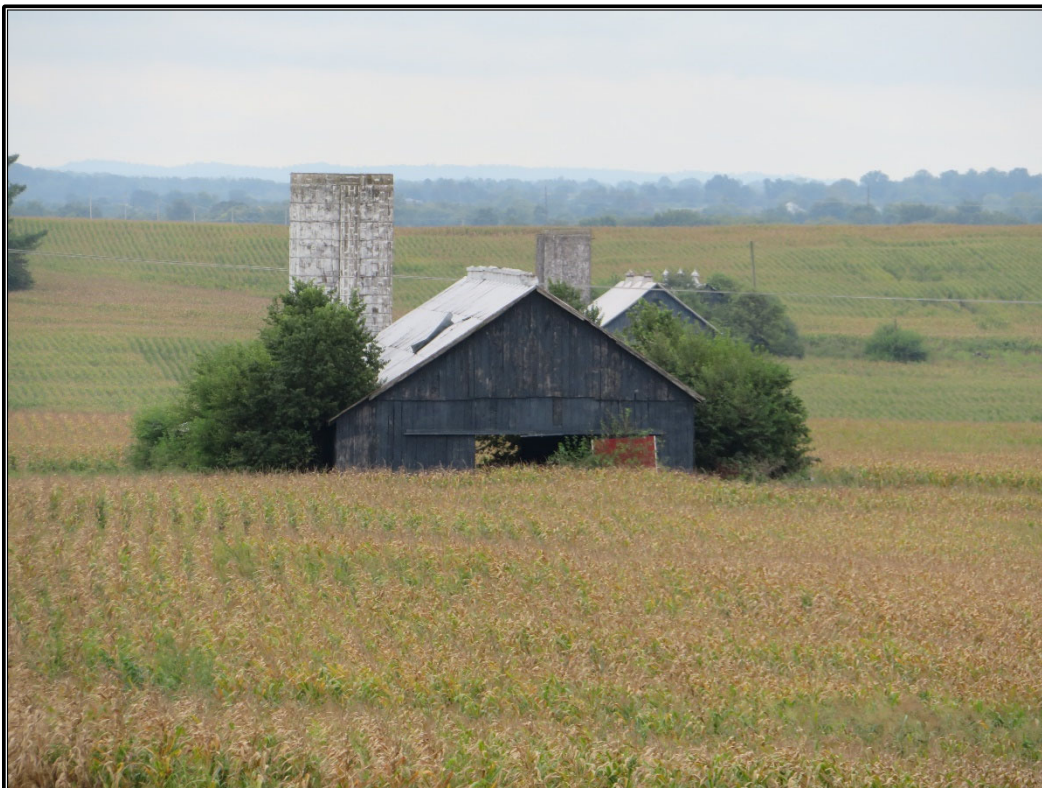
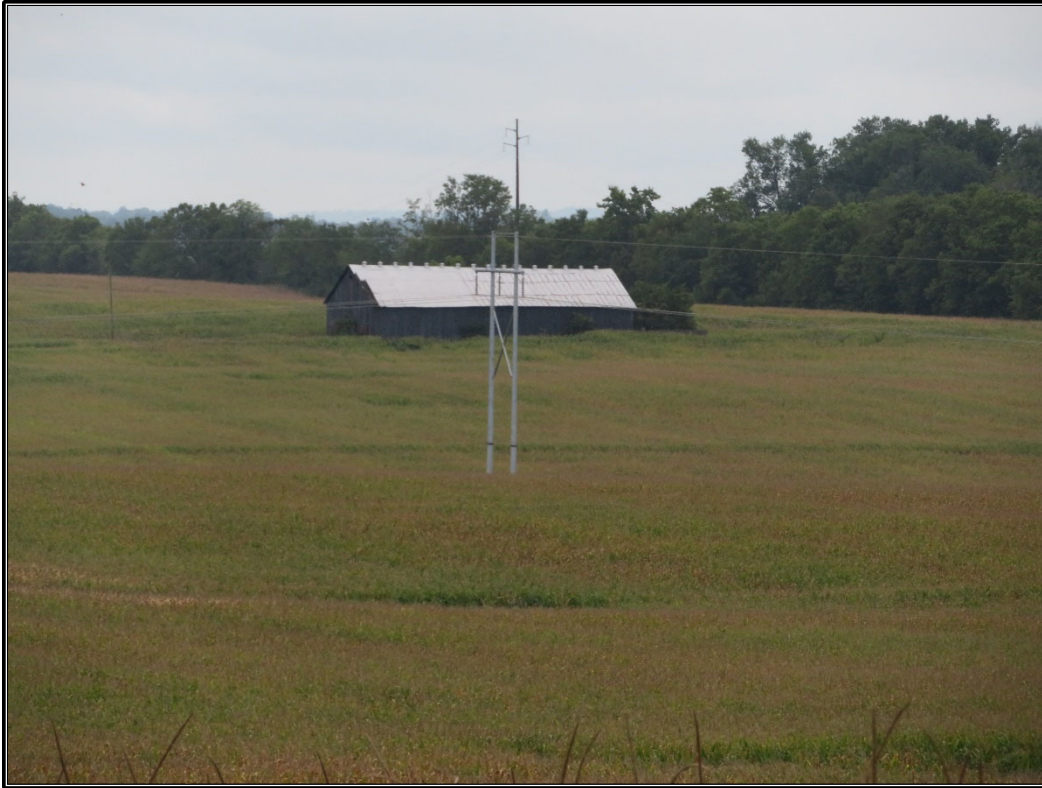
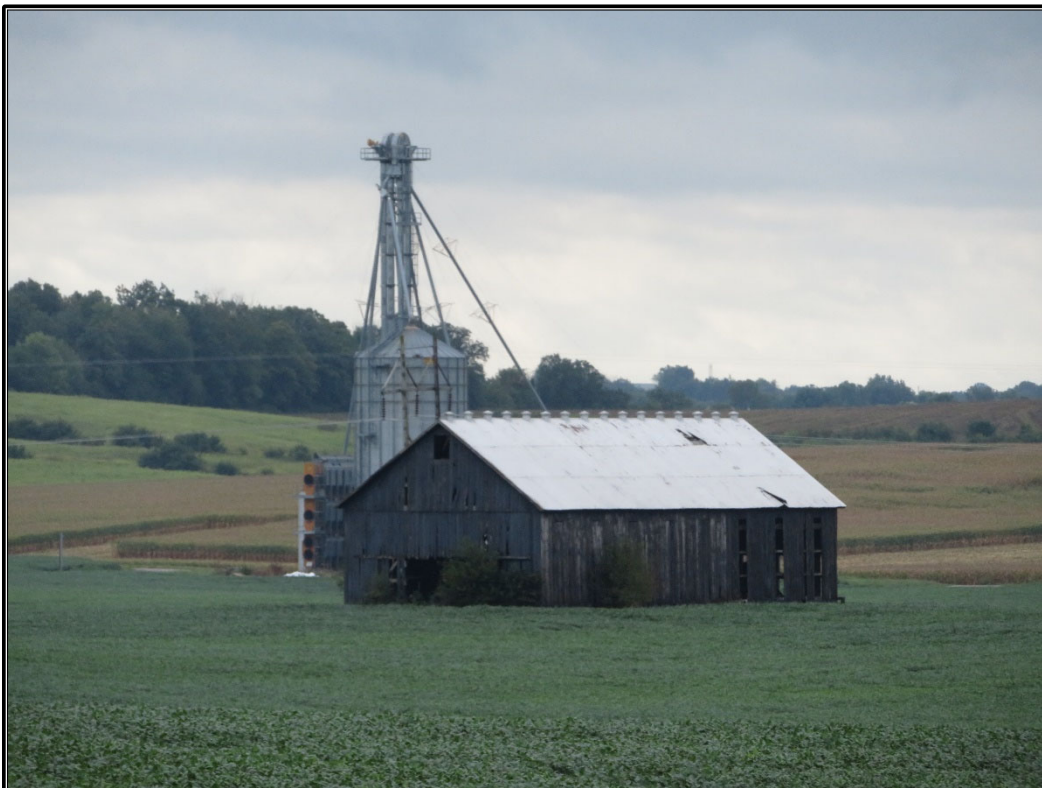
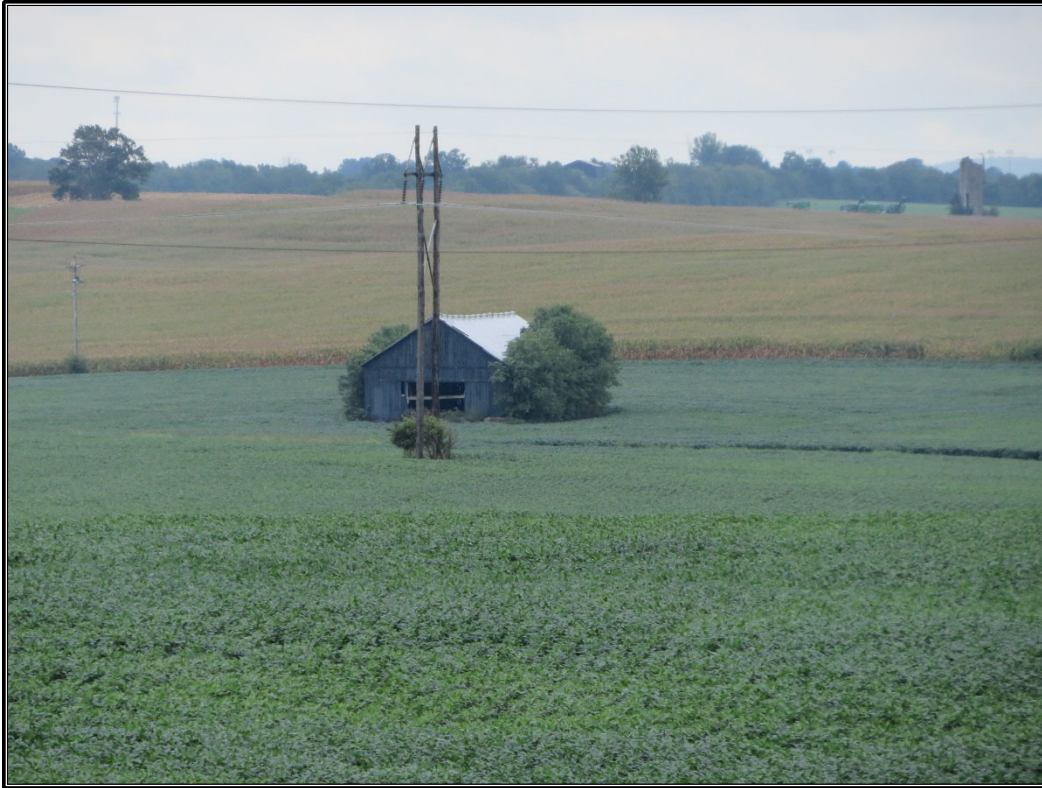
ME 511	Farmstead	1920 Louisville Road	Recommended not eligible (Martinolich and Spurlock 2012); KHC concurred. Not eligible based on CRA field observations.	According to previous survey, the property lacks architectural and historic significance. Buildings features common forms and alterations.	22–28
ME 512	Barn	Jackson Pike, east of railroad	Recommended not eligible (Martinolich and Spurlock 2012); KHC concurred. Not eligible based on CRA field observations.	Common barn form; missing materials	29

Figure 22. ME 511: Overview of large farmstead located in project area, looking south.

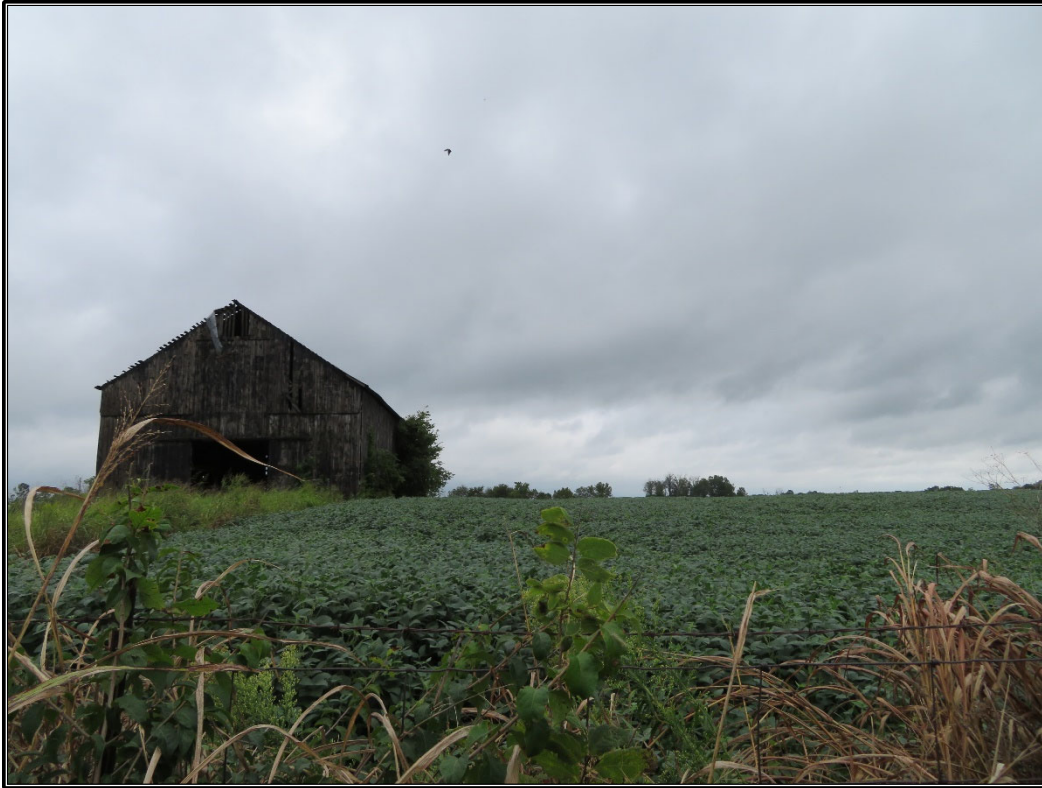
Figure 29. ME 512: Barn located in project area, looking north.

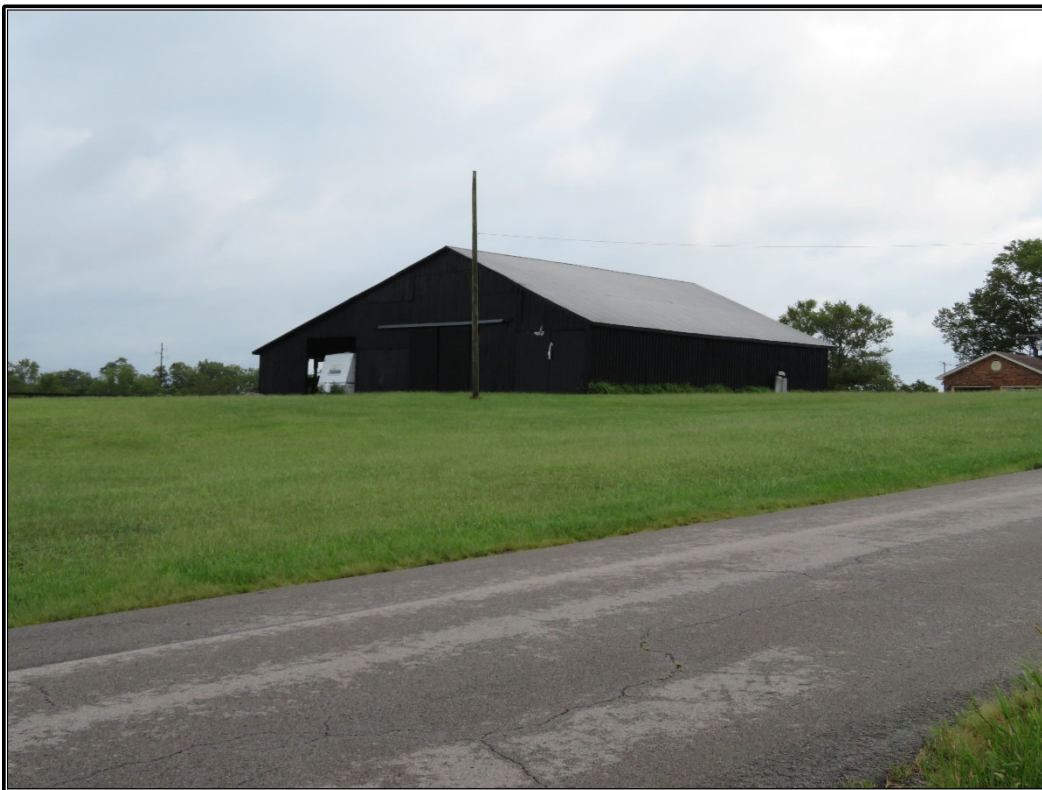
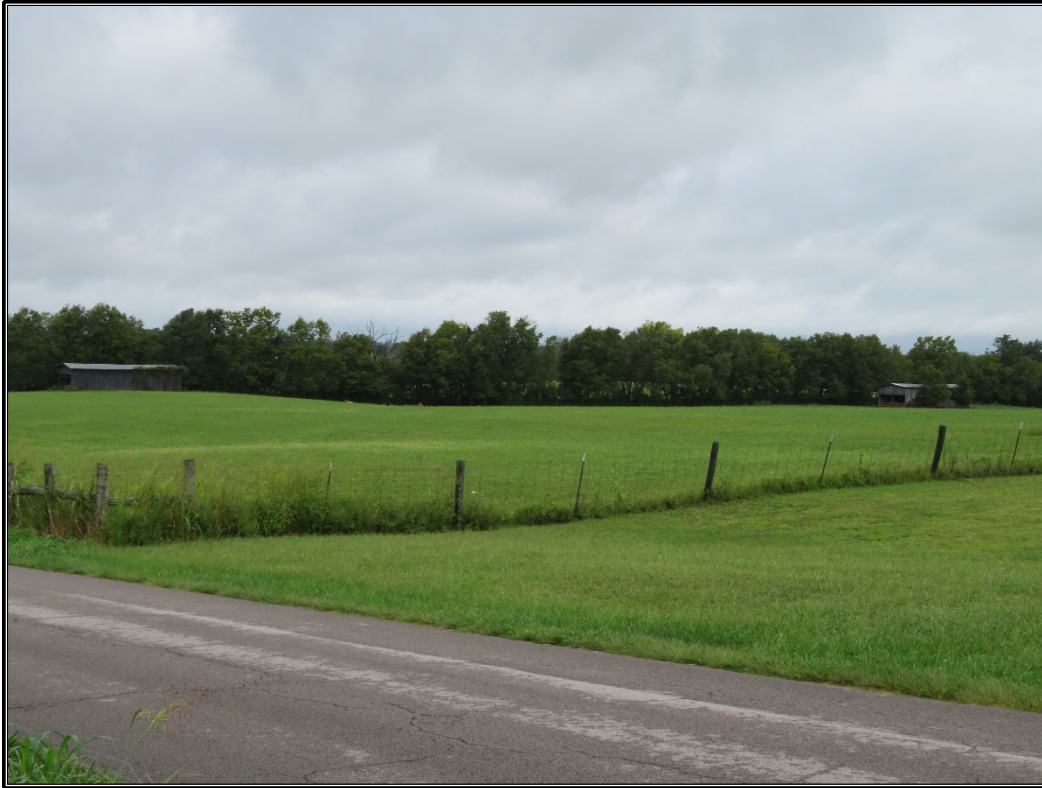
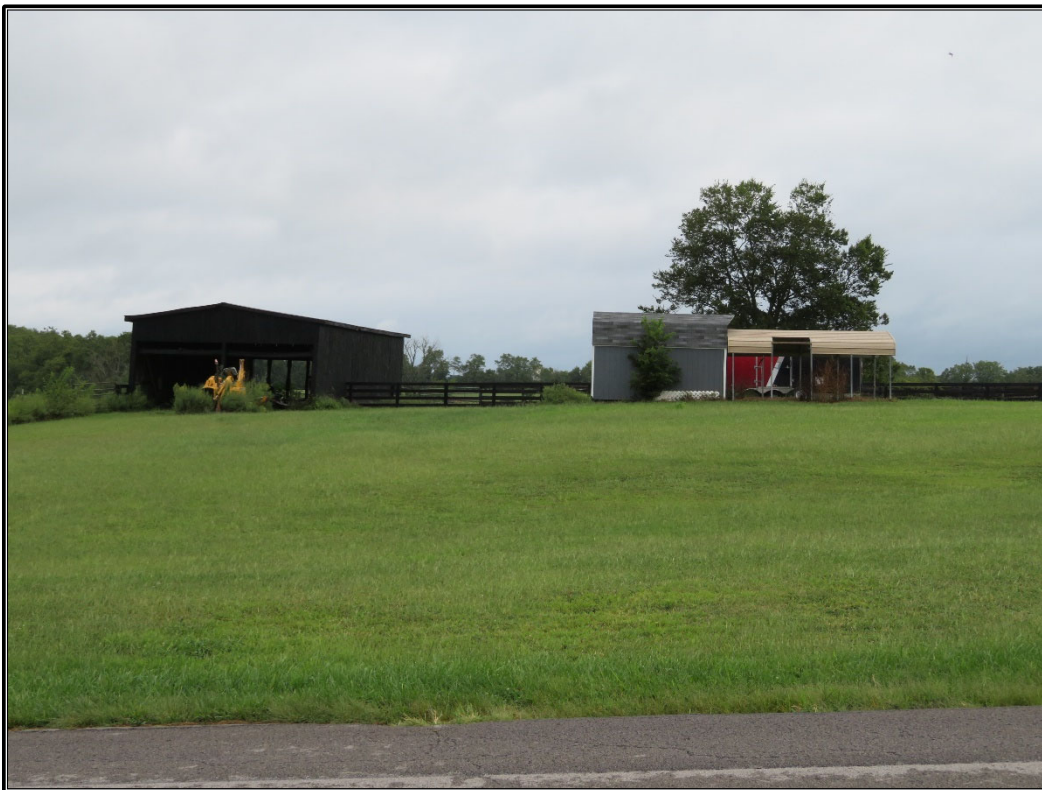
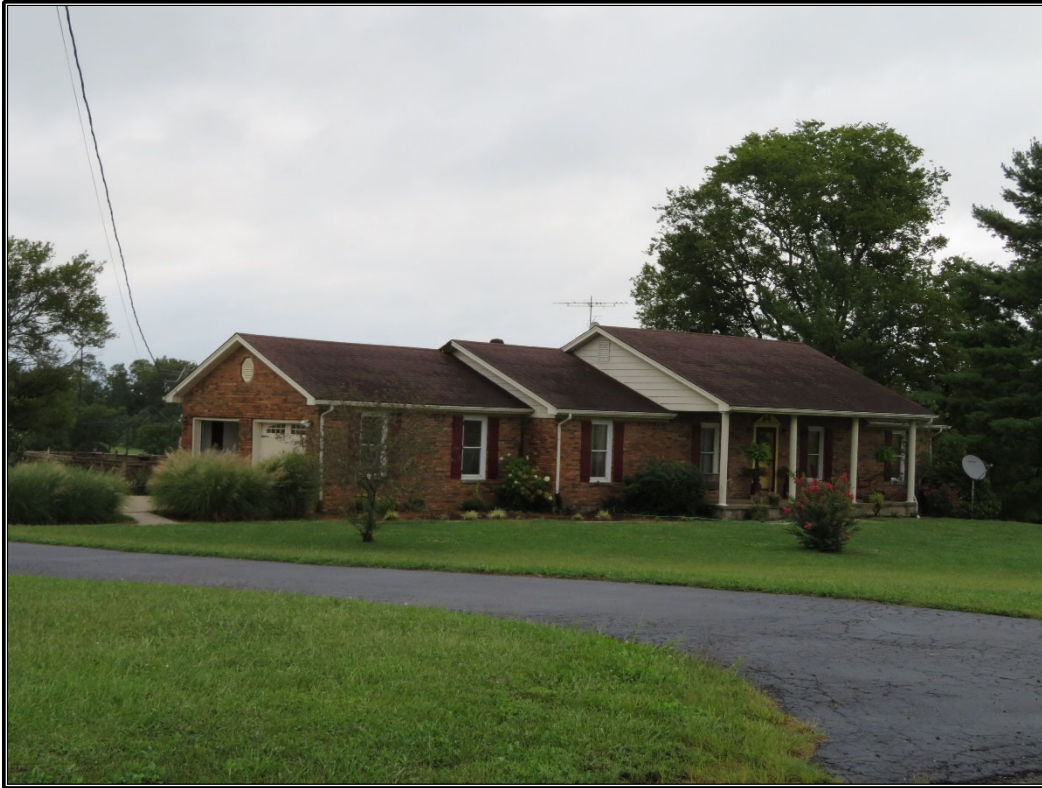
Site/Survey No.	Resource Name/Function	Address/Location	NRHP Status	Condition	Photo Figure No.
ME 513	Barns, shed, modern house	589 Jackson Pike	Recommended not eligible (Martinolich and Spurlock 2012); KHC concurred. Not eligible based on CRA field observations.	Common barn form; materials intact	30-33
ME 514	House and outbuilding	600 Jackson Pike	Recommended not eligible (Martinolich and Spurlock 2012); KHC concurred. Not eligible based on CRA field observations.	Non-extant; according to aerial photographs the buildings were demolished between 2016 and 2017.	n/a
ME 515	House, barns, and outbuildings	586 Talmage Mayo Road	Recommended not eligible (Martinolich and Spurlock 2012); KHC concurred. Not eligible based on previous recommendation and concurrence. Not visible from ROW.	According to previous survey, the house, barns, and outbuildings are undistinguished building forms that lack significant architectural features and integrity. The buildings are not visible from the ROW, but through prior report recommendation and concurrence by KHC the resource has been determined not eligible.	34

Figure 30. ME 513: Barn, looking north-northeast.

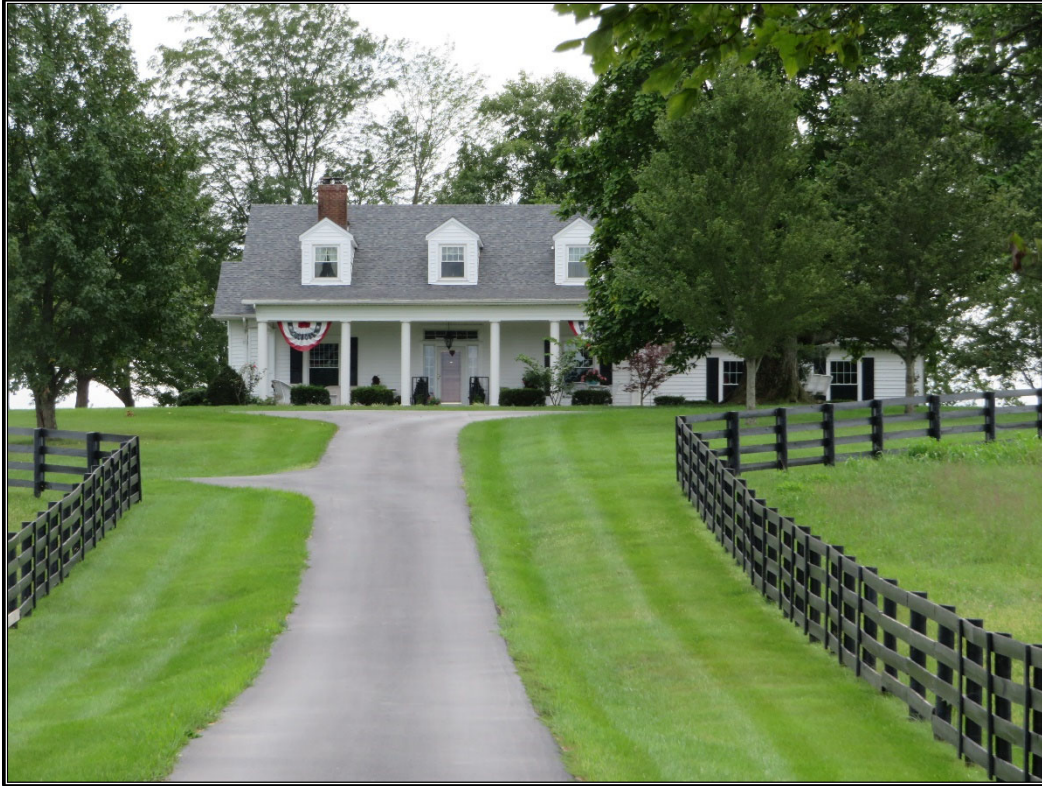
ME 520	House	532 Talmage Mayo Road	Recommended not eligible (Martinolich and Spurlock 2012); KHC concurred. Not eligible based on CRA field observations.	Common house form; alterations	35
ME 534	House, barns, and outbuildings	202 Hudson Road	Undetermined (Martinolich and Spurlock 2012); Undetermined based on CRA field observations.	According to the previous survey, this property is comprised of a house and collection of agricultural buildings that have no associations with significant events or persons. The buildings are not visible from the ROW and as such, their current condition is unknown.	36
ME 539	Steel railroad trestle bridge	Unnamed tributary of the Salt River under Norfolk Southern Railroad	Recommended not eligible (Martinolich and Spurlock 2012); KHC concurred. Not eligible based on previous recommendation and concurrence. Not visible from ROW.	According to the previous survey, the trestle is an unexceptional example of its type. It is not visible from the ROW, but through prior report recommendation and concurrence by KHC, the resource has been determined not eligible.	37

Figure 35. ME 520: House, looking south-southwest.

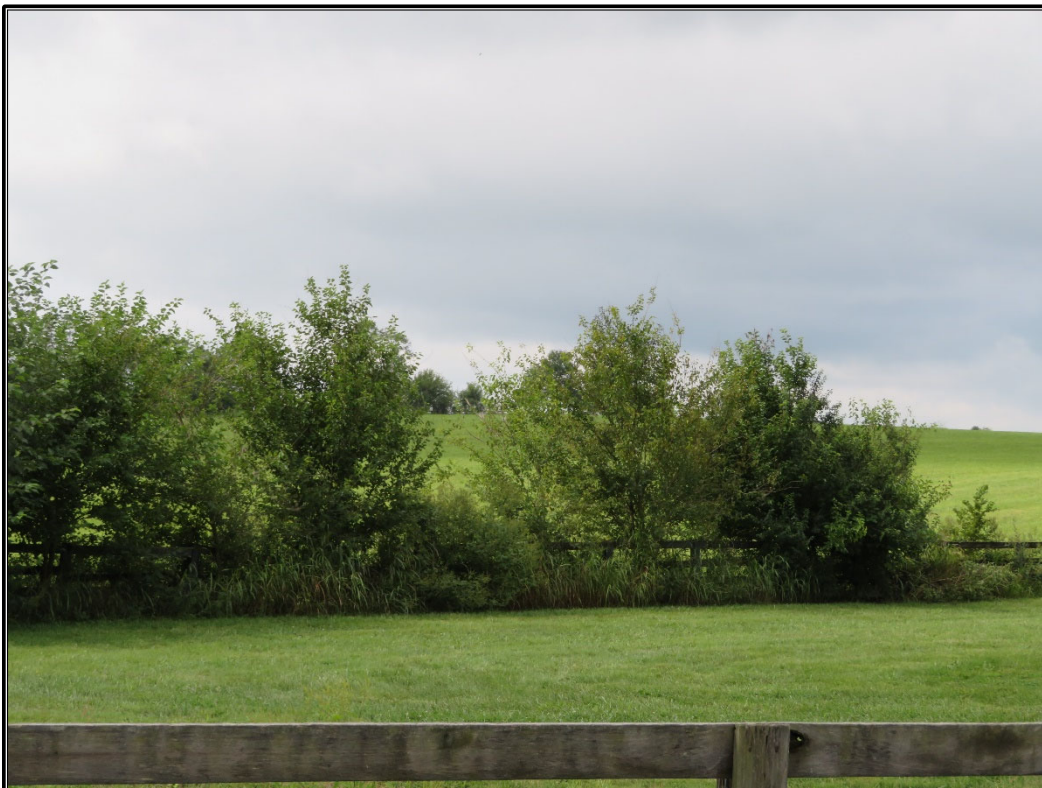
Figure 36. ME 534: View towards ME 534, looking southwest.

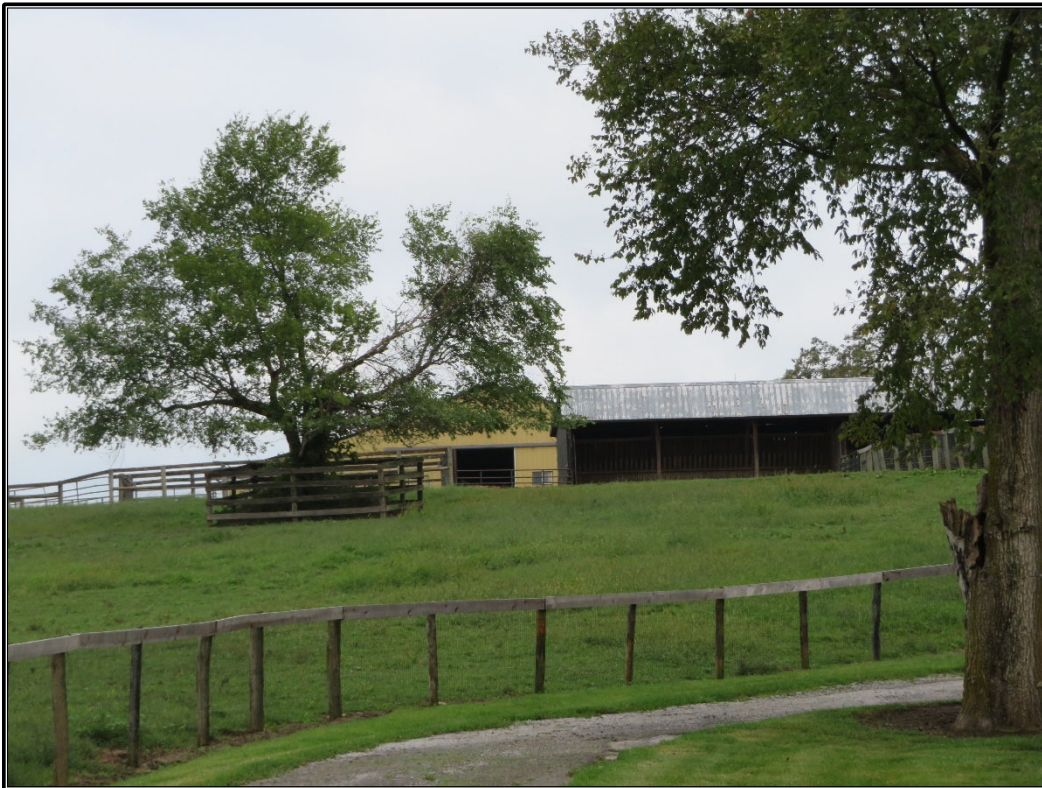
CRA 1	Barn and modern house and barns	2406 Louisville Road	Undetermined	Historic barn not visible from ROW and, as such, its current condition and potential significance is unknown.	38

Figure 38. CRA 1: View barn located behind modern outbuildings, looking west.
