Slaughters Compressor Station System Reliability Improvements

In response to the received Boardwalk Pipelines' Texas Gas Transmission Company's ('TGT') Inclement Weather Assessment, Generation Engineering was tasked with visiting the Slaughters, KY Gas Compression Station on 11/30/23 to document inclement weather system improvements.

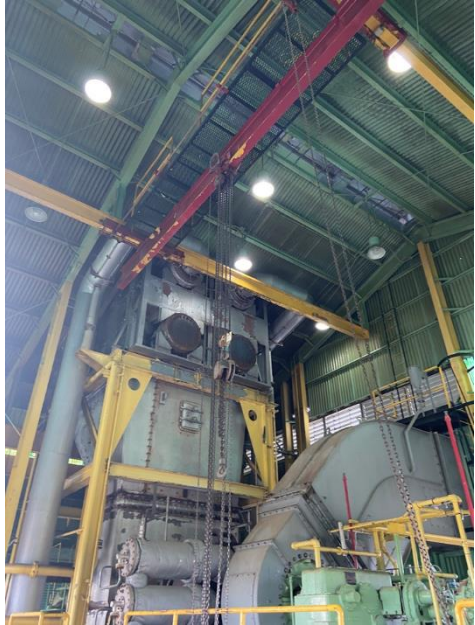
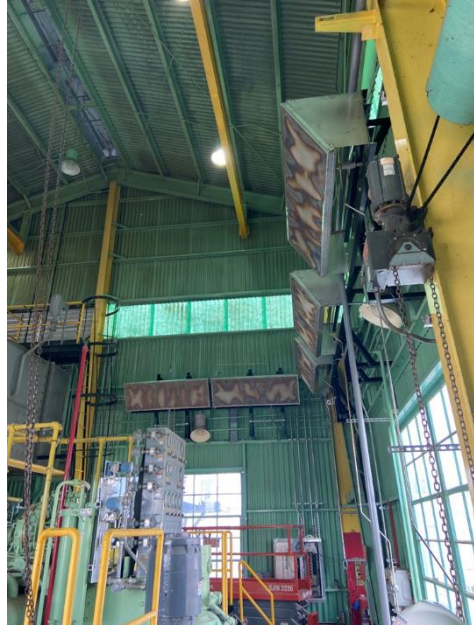
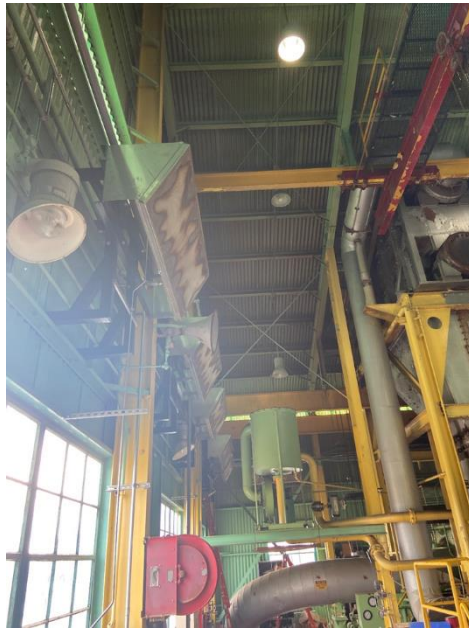
1. Building Heaters - **COMPLETE**

The building was previously heated by two small heaters, near the top of the ceiling. These two heaters have been removed and replaced with 14 catalytic heaters closer to building center.

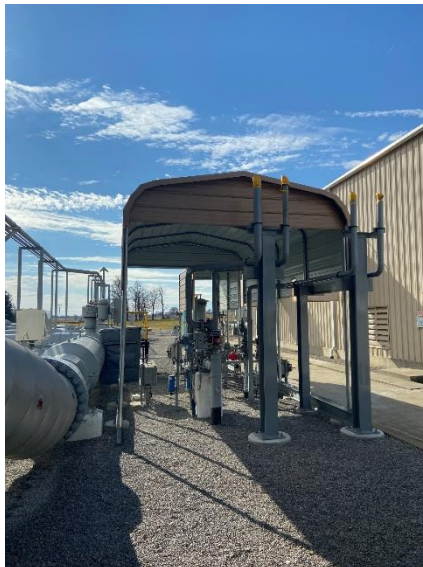
2. Fuel Run Weather Shelter – **COMPLETE**

A protective shelter was erected over the main fuel run equipment to provide protection from moisture. The sides can be covered with canvas or aluminum sheeting for further protection in the case of inclement weather.

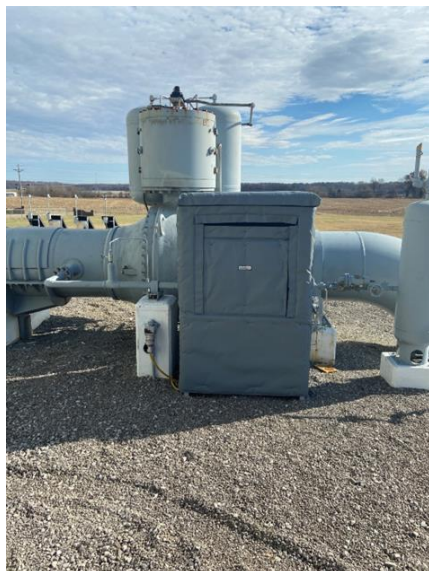
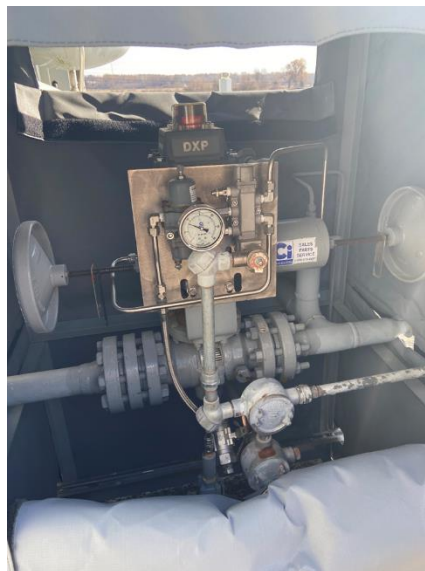
3. Turbine Loading Valve Insulated Weather Box - **COMPLETE**

An insulated protective box was constructed around this critical valve. This valve allows a small amount of fuel to pass on startup procedure prior to main fuel gas CV operation. An 8” catalytic heater is onsite and will be installed prior to year-end.

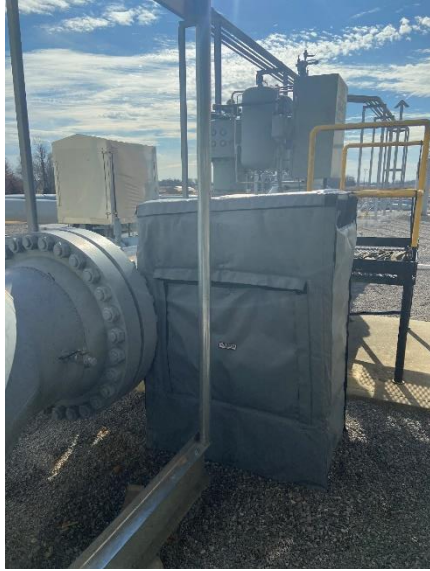
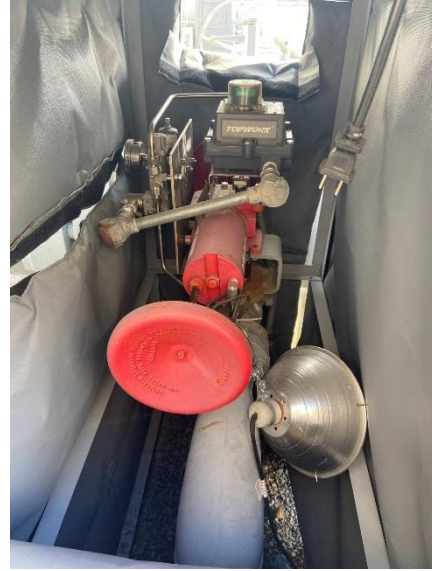
4. Turbine Vent Valve Insulated Weather Box - **COMPLETE**

An insulated protective box was constructed around this critical valve. This valve vents gas out of the fuel line in the case of shutdown. An 8" catalytic heater is onsite and will be installed prior to year-end.

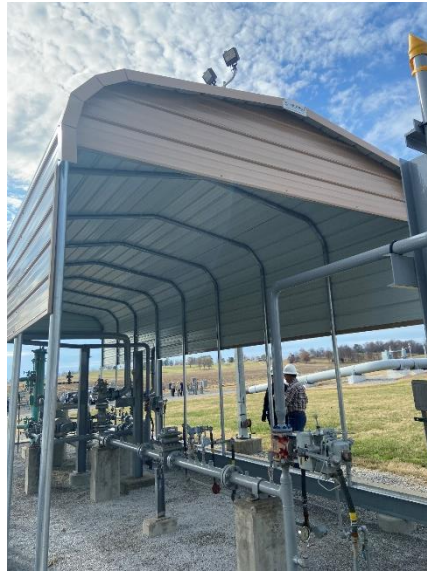
1. Fuel Run Weather Shelter - **COMPLETE**

A protective shelter was erected over the main fuel run equipment to provide protection from moisture. The sides can be covered with canvas or aluminum sheeting for further protection in the case of inclement weather.

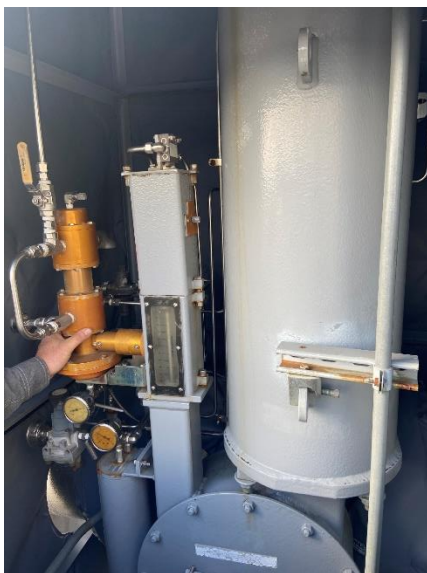
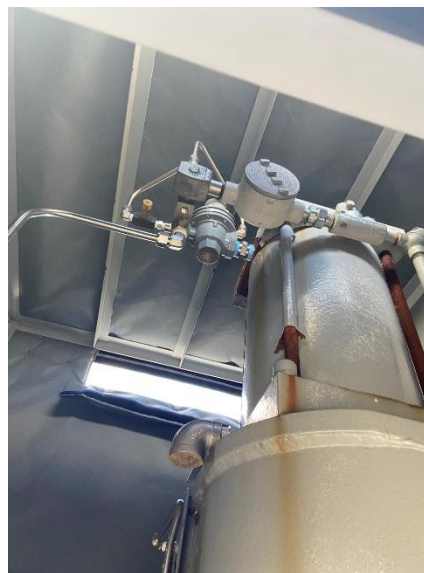
2. Turbine Anti-Surge Valve Insulated Weather Box - **COMPLETE**

As mentioned above, the Anti-Surge Valve was the valve that caused the T3 Compressor to become inoperable between 12/23/22 and 12/25/22.

To prevent surge (occurrence of backflow in the compressor system outlet, and then its sudden reversal) a valve is installed on the compressor discharge side to dump gas back to the inlet for compressor protection. The valve decreases compressor outlet pressure and increases flow through the compressor, correcting the potentially destabilizing operating point.

To start a unit, the anti-surge valve must briefly open and close for start permissives. During the reliability event, the inclement weather caused the control valve component (first photograph, in orange/gold) to fail, resulting in an opening but a refusal to close, and the unit unable to run. Once the CV issue was resolved and the valve could close, the quick dump regulator (second photograph, gray regulator) failed and valve refused to open.

An insulated protective box was constructed around this critical valve. An 8" catalytic heater is onsite and will be installed prior to year-end.

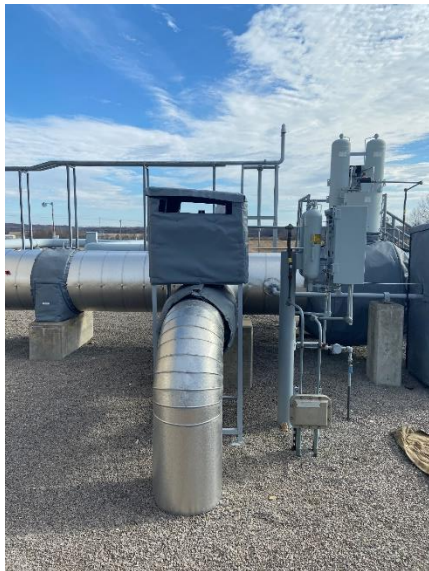
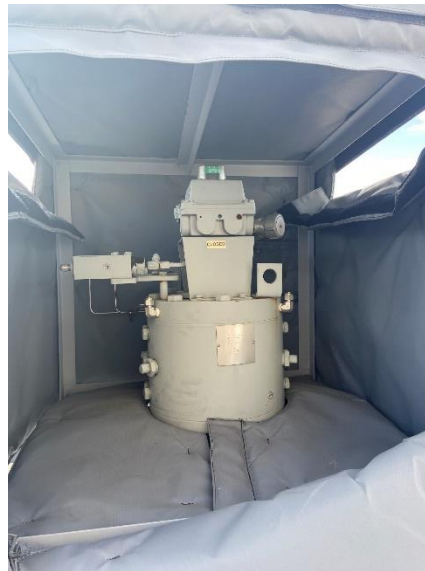
3. Turbine Hot Bypass Valve Insulated Weather Box - **COMPLETE**

An insulated protective box was constructed around this critical valve. An 8" catalytic heater is onsite and will be installed prior to year-end.

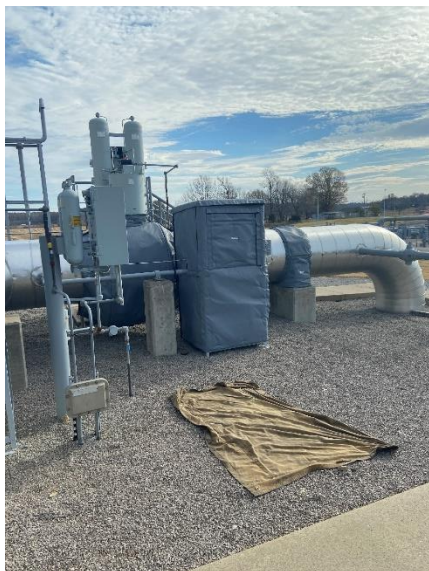
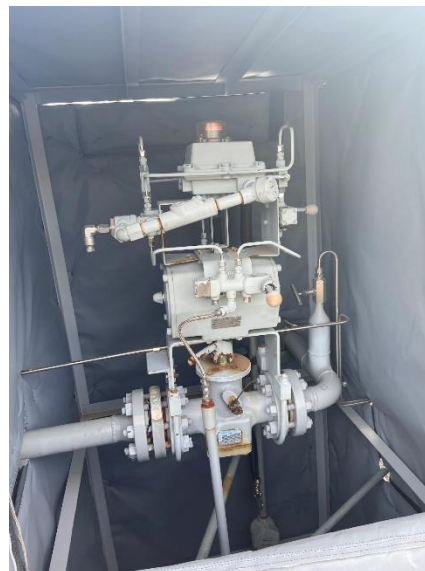
4. Turbine Loading Valve Insulated Weather Box - **COMPLETE**

An insulated protective box was constructed around this critical valve. This valve allows a small amount of fuel to pass on startup procedure prior to main fuel gas CV operation. An 8" catalytic heater is onsite and will be installed prior to year-end.

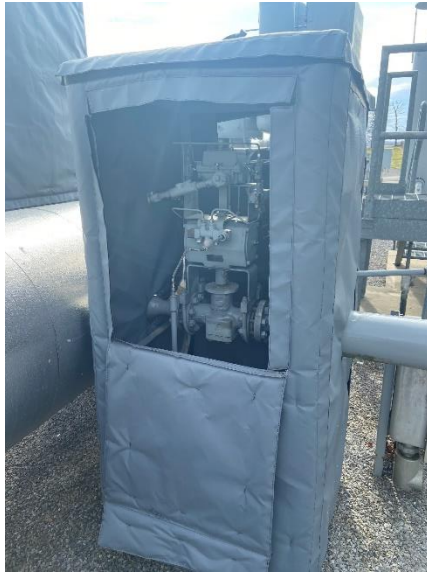
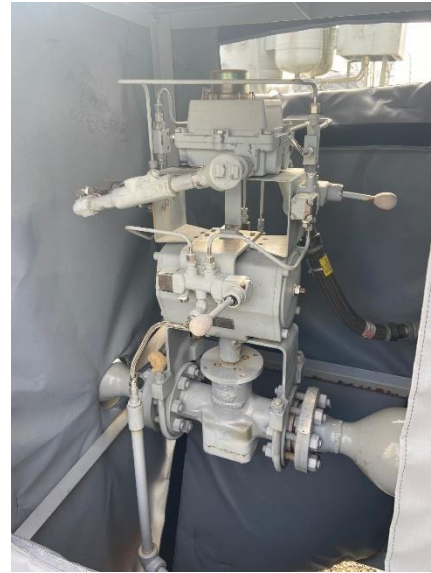
5. Turbine Vent Valve Insulated Weather Box - **COMPLETE**

An insulated protective box was constructed around this critical valve. This valve vents gas out of the fuel line in the case of shutdown. An 8" catalytic heater is onsite and will be installed prior to year-end.
