# KARST DESKTOP REVIEW

# Mantle Rock Solar

Karst Desktop Report

August 21, 2025 | Terracon Project No. 57257162

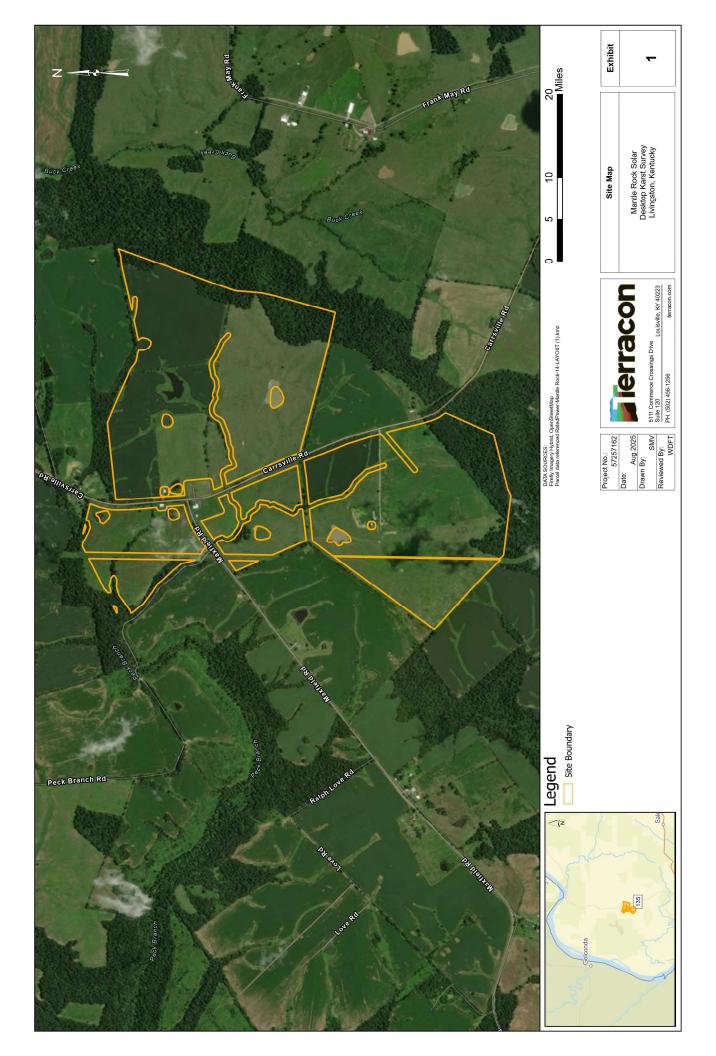
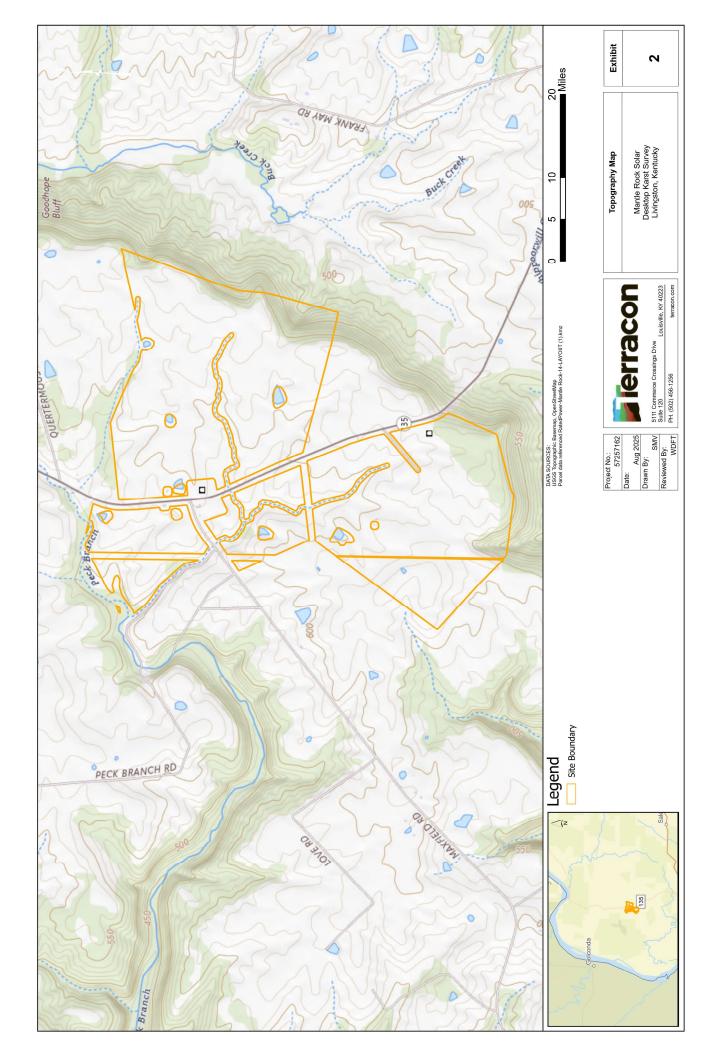
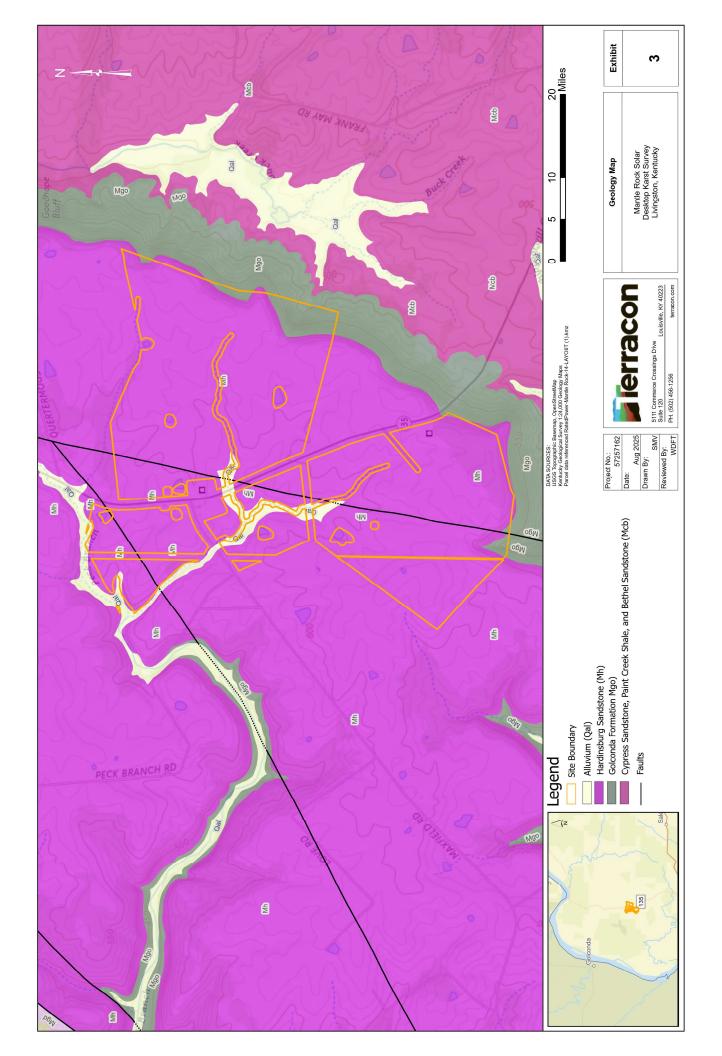
Site Map Topography Map Geology Map

A review of the LiDAR derived shaded relief map and 2-foot contour layer across the site did not identify suspect karst features (SKFs) at the site (Exhibit 1, 2, and 3). The site is predominately overlain by the Hardinsburg Sandstone, which acts as a caprock, a layer of resistant rock that overlies the more soluble Golconda Formation below. This caprock layer acts by protecting the underlying soluble rocks from erosion and influencing the development of caves, sinkholes, and other karst formations.
