# Wetland Delineation Report

Lynn Bark Energy Center

PREPARED FOR  
Lynn Bark Energy Center, LLC

DATE  
25 October 2024

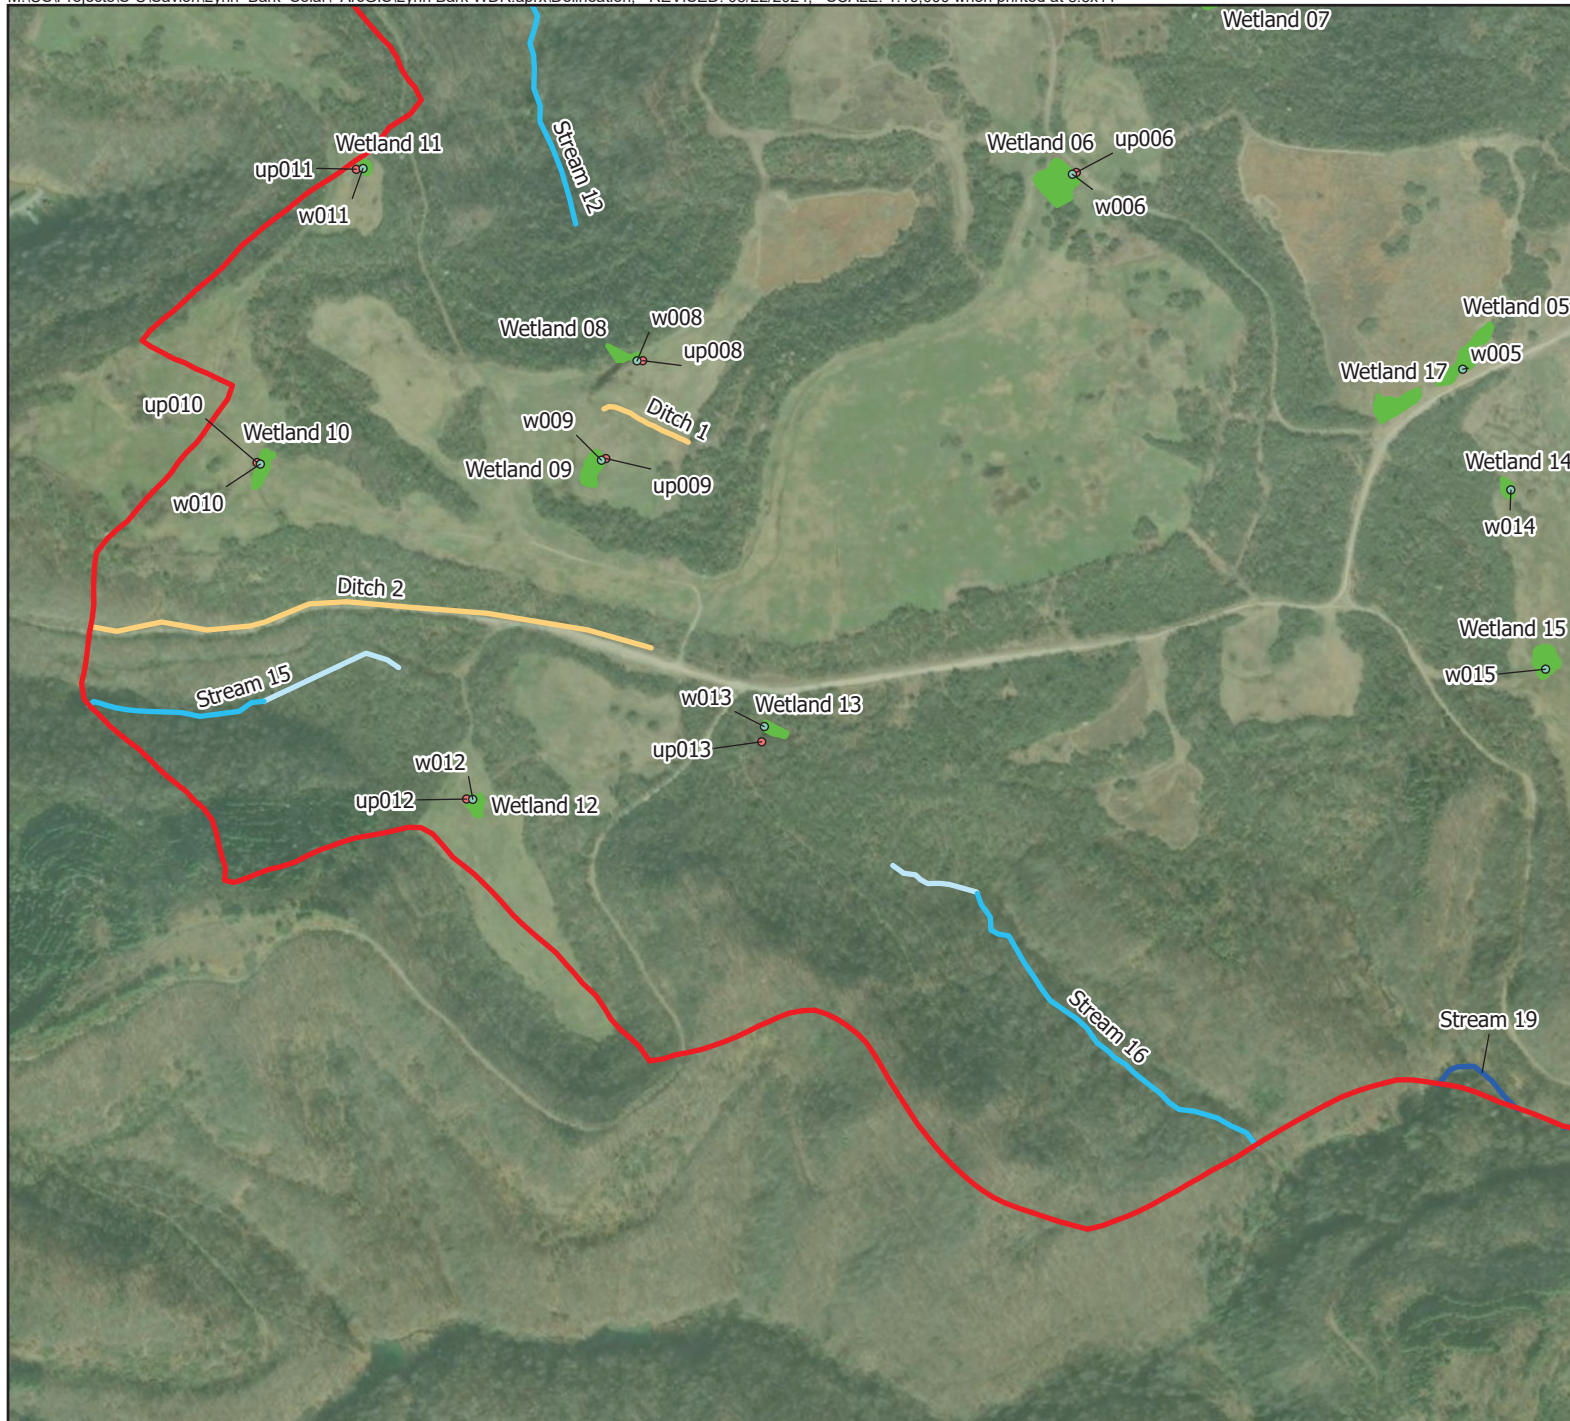
**Figure 6.3**  
**Wetland Delineation Map**  
 Lynn Bark Solar Project  
 Lynn Bark Energy Center, LLC  
 Martin County, Kentucky

- Legend**
- ▭ Project Boundary
  - ▭ PEM Wetland (2.94 acres)
  - ▬ Perennial Stream (5,086 linear feet)
  - ▬ Intermittent Stream (12,441 linear feet)
  - ▬ Ephemeral Stream (6,081 linear feet)
  - ▬ Ditch (2,884 linear feet)
  - Upland Datapoint
  - Wetland Datapoint

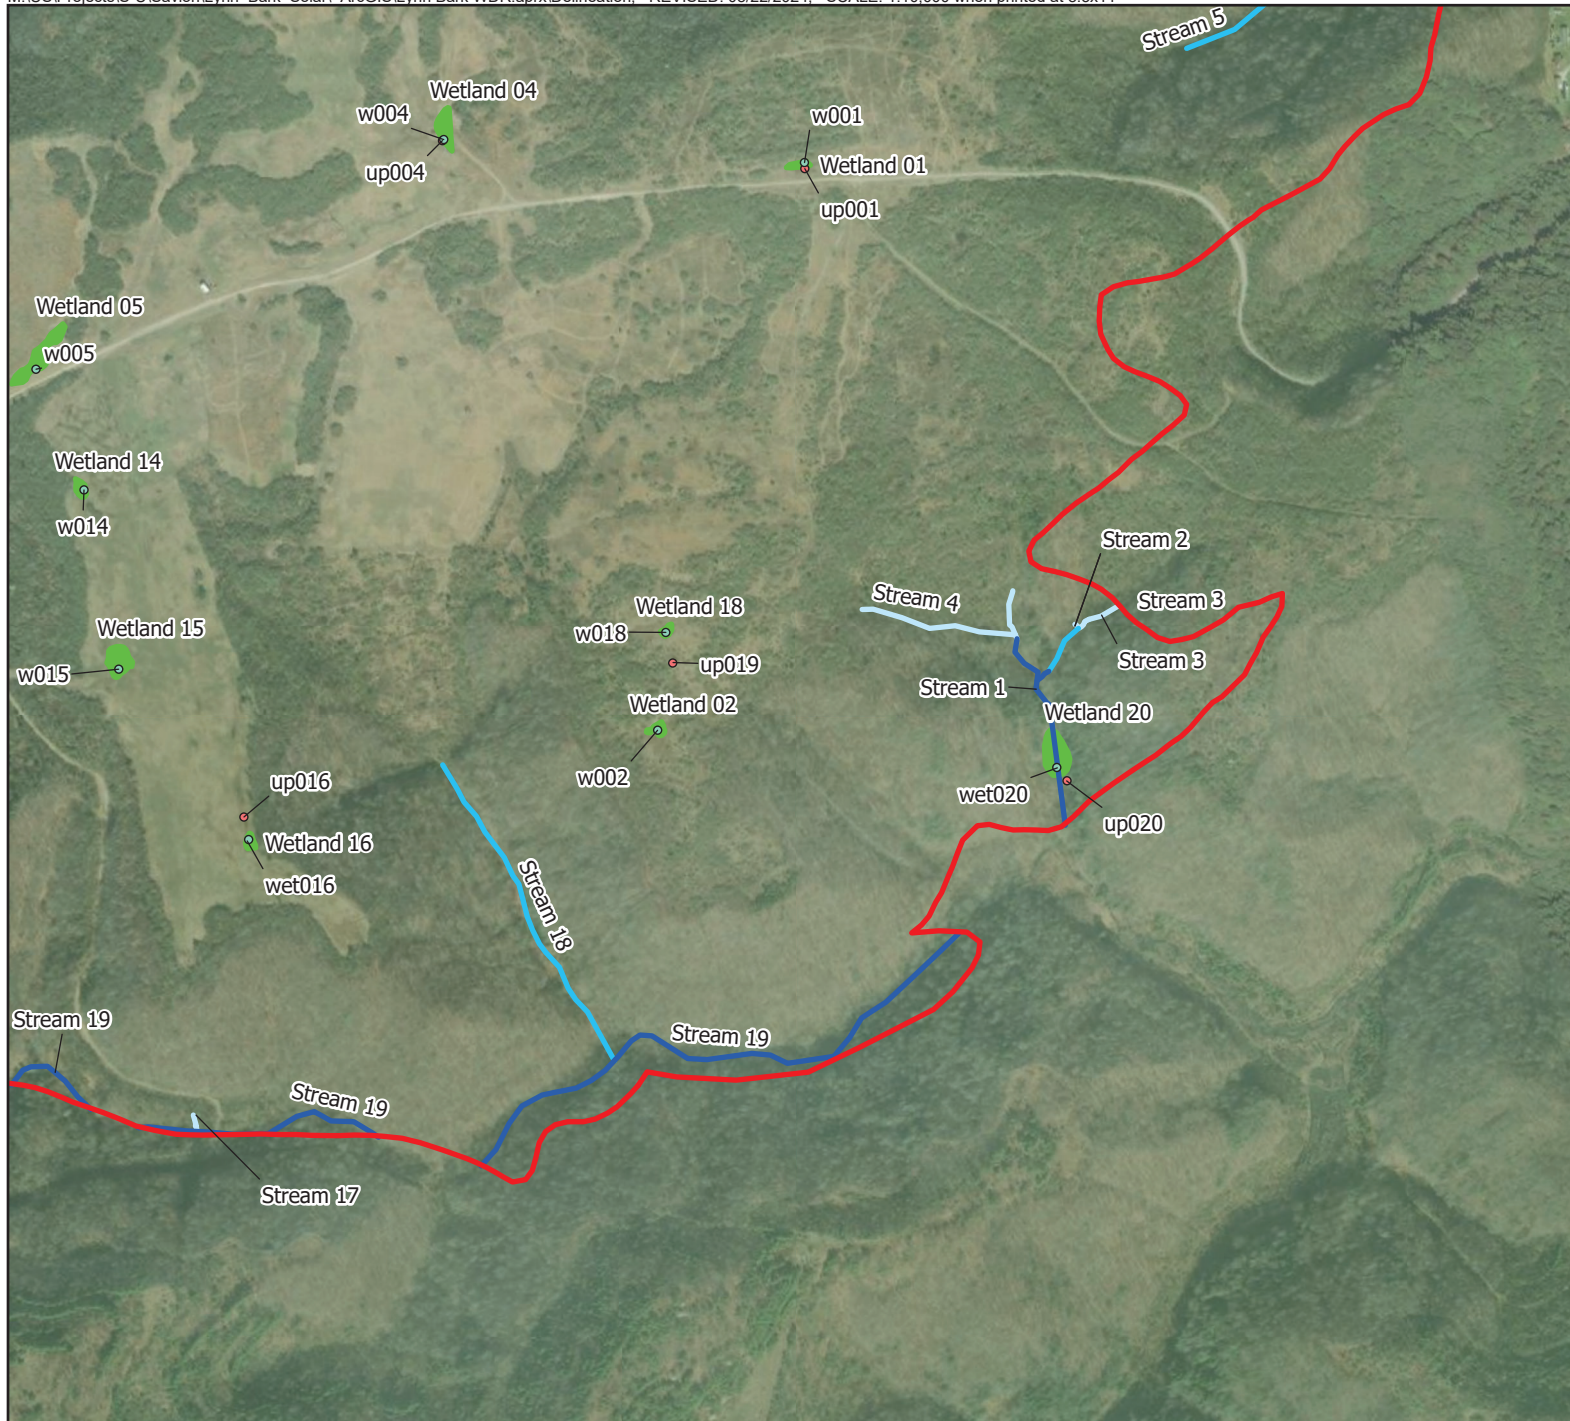
- Legend**
- ▭ Project Boundary
  - ▭ PEM Wetland (2.94 acres)
  - ▬ Perennial Stream (5,086 linear feet)
  - ▬ Intermittent Stream (12,441 linear feet)
  - ▬ Ephemeral Stream (6,081 linear feet)
  - ▬ Ditch (2,884 linear feet)
  - Upland Datapoint
  - Wetland Datapoint

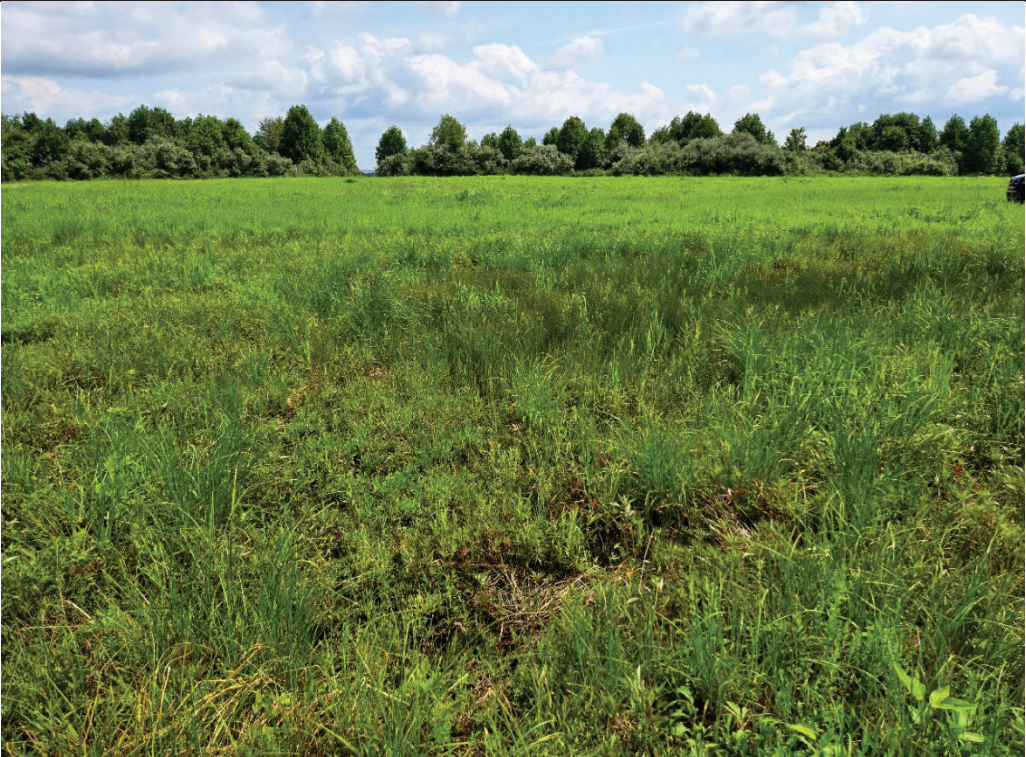
<b>PHOTO NO.</b> 3.	<b>DATE</b> 09 August 2024

<b>DIRECTION PHOTO TAKEN</b> Looking southeast		
<b>DESCRIPTION</b> Wetland 03 – Potentially Non jurisdictional

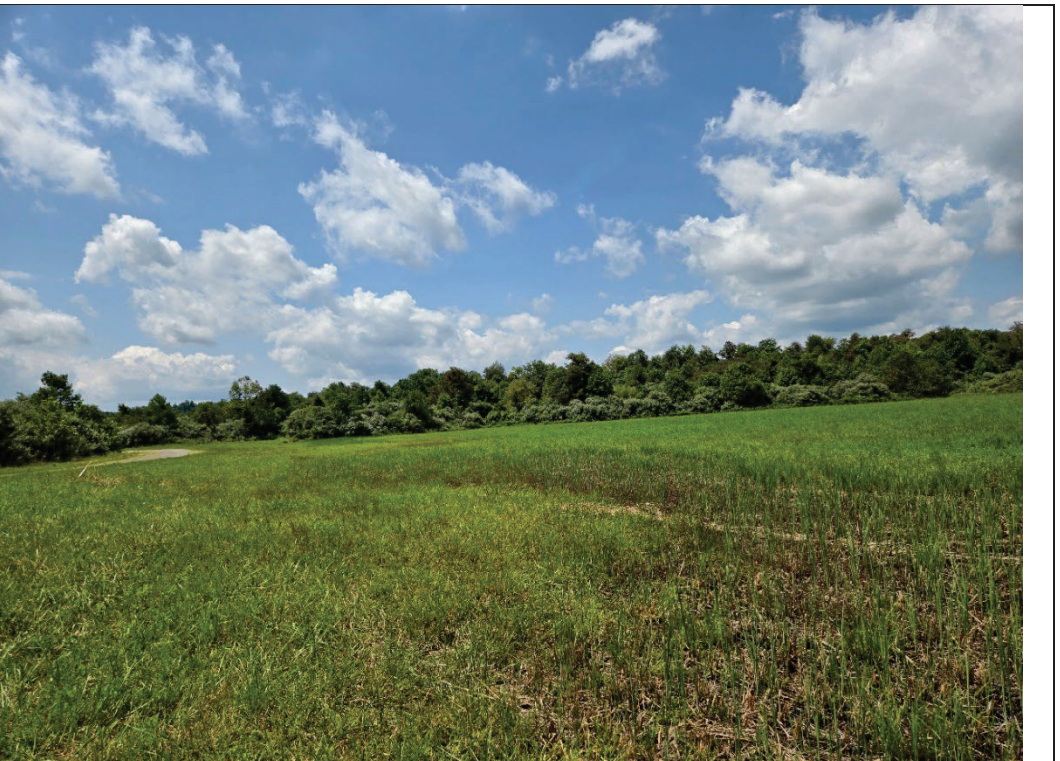
<p><b>PHOTO NO.</b> 5.</p>	<p><b>DATE</b> 09 August 2024</p>

<p><b>DIRECTION PHOTO TAKEN</b> Looking west</p>		
<p><b>DESCRIPTION</b> Wetland 05 – Potentially Non jurisdictional</p>

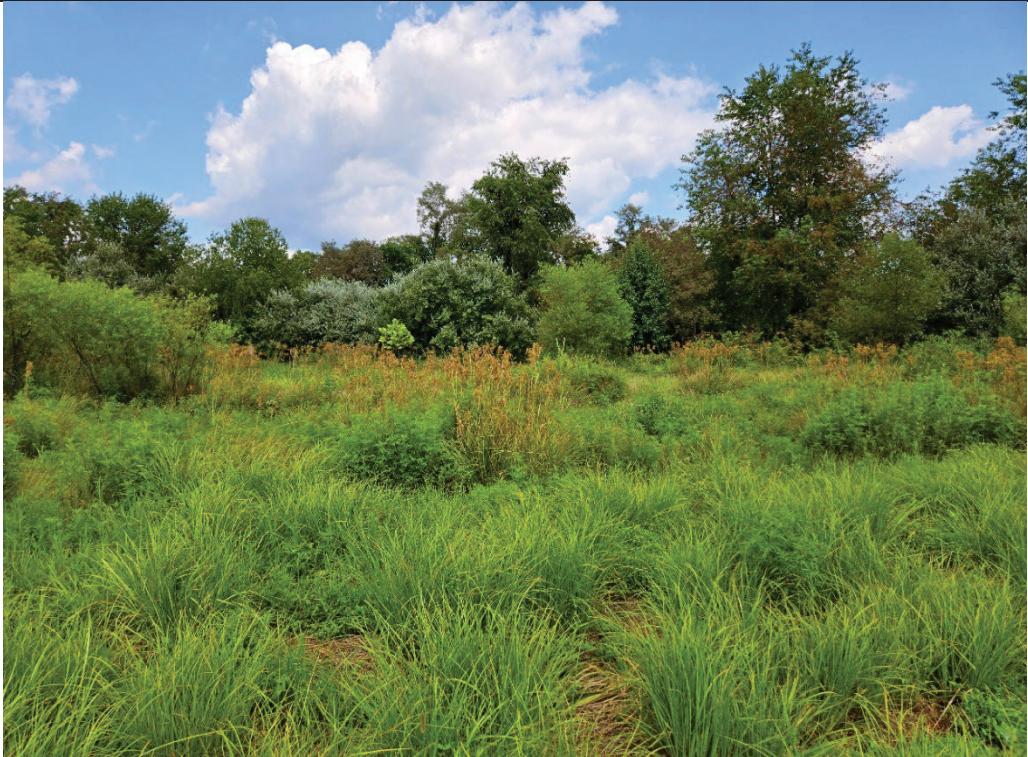
<b>PHOTO NO.</b> 7.	<b>DATE</b> 10 August 2024

<b>DIRECTION PHOTO TAKEN</b> Looking southeast		
<b>DESCRIPTION</b> Wetland 07 – Potentially Non jurisdictional

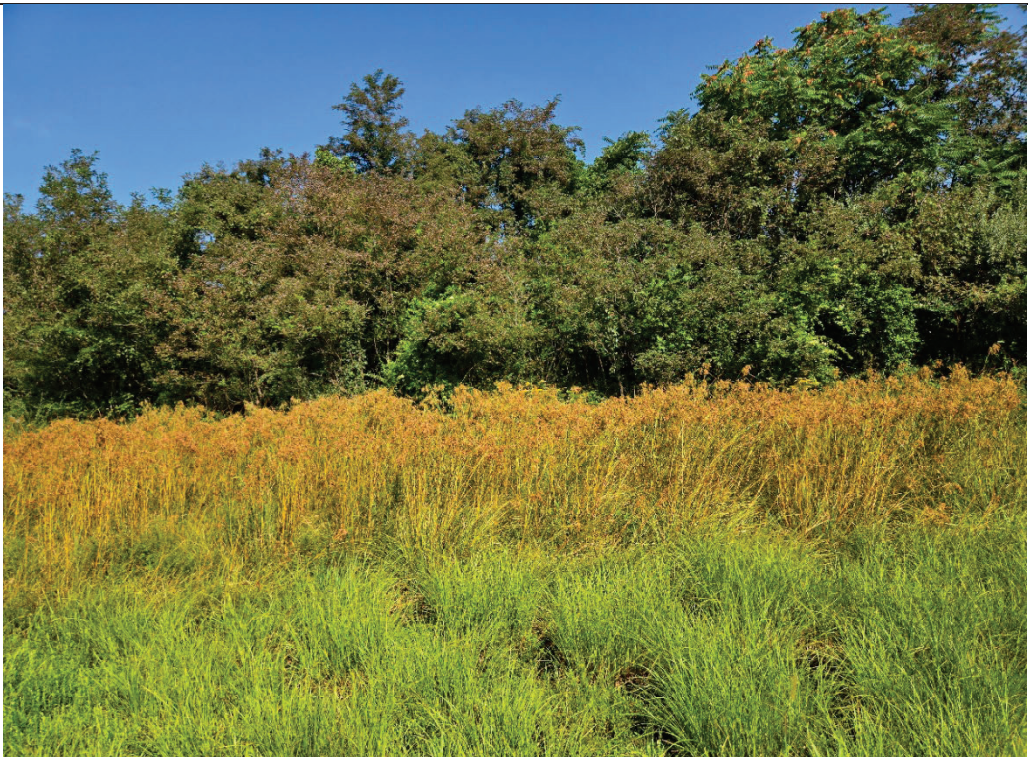
<b>PHOTO NO.</b> 8.	<b>DATE</b> 10 August 2024

<b>DIRECTION PHOTO TAKEN</b> Looking northwest		
<b>DESCRIPTION</b> Wetland 08 – Potentially Non jurisdictional

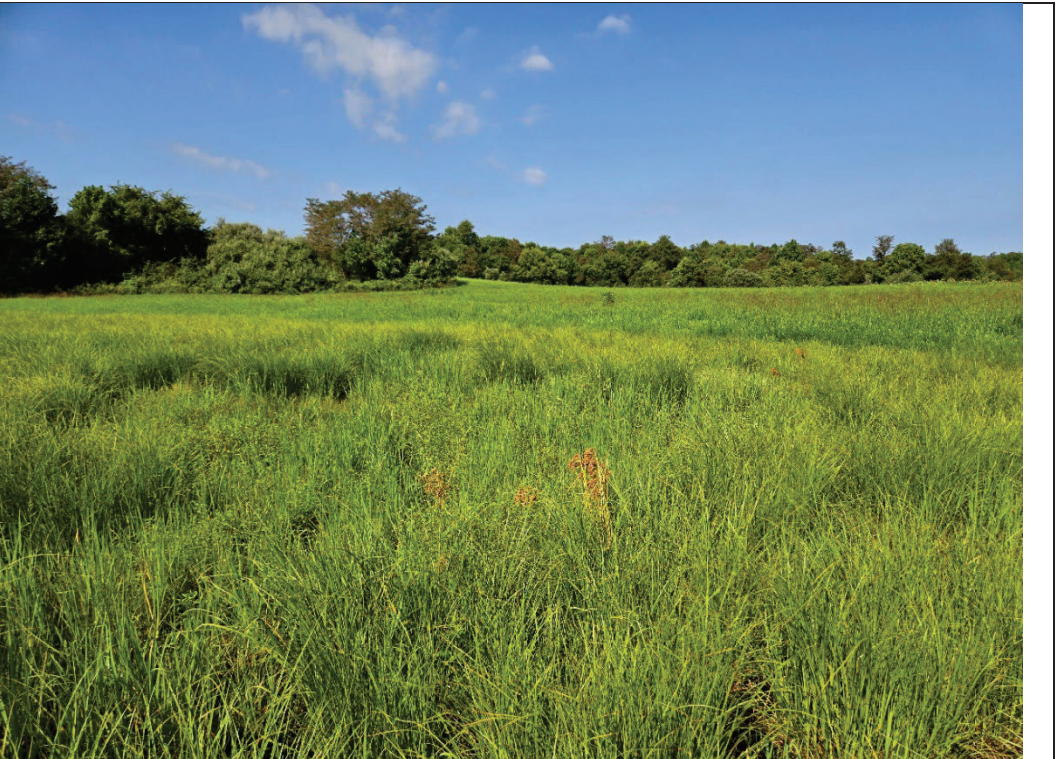
<p><b>PHOTO NO.</b> 9.</p>	<p><b>DATE</b> 10 August 2024</p>

<p><b>DIRECTION PHOTO TAKEN</b> Looking south</p>		
<p><b>DESCRIPTION</b> Wetland 09 – Potentially Non jurisdictional</p>

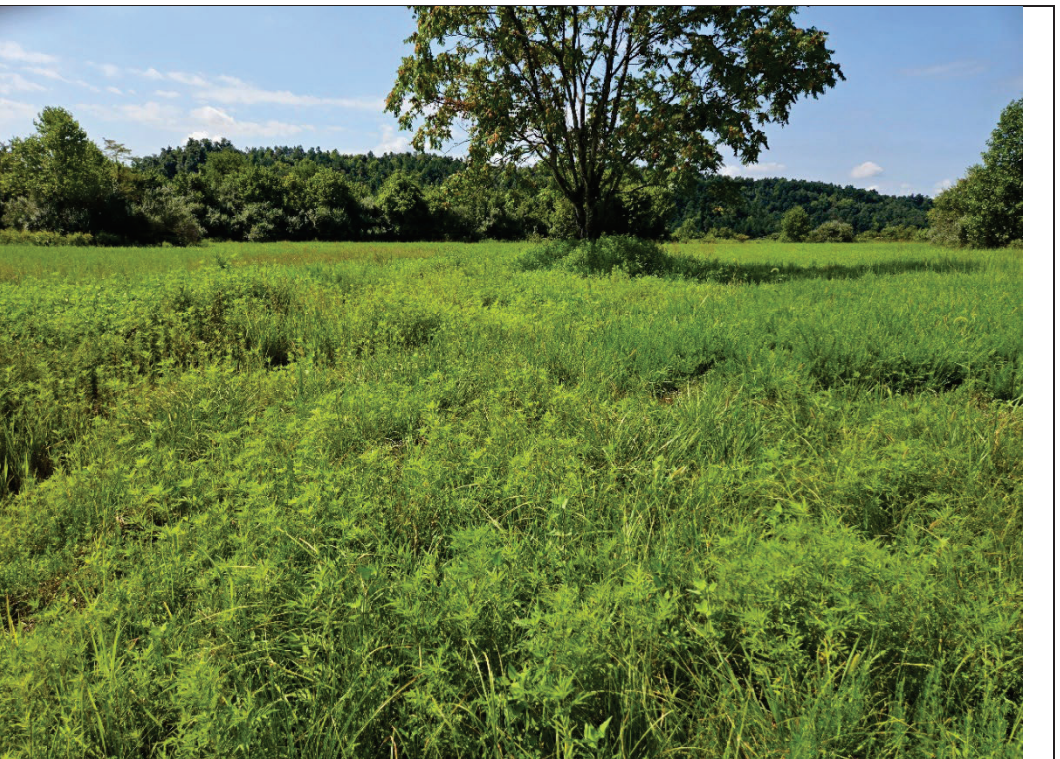
<p><b>PHOTO NO.</b> 10.</p>	<p><b>DATE</b> 10 August 2024</p>

<p><b>DIRECTION PHOTO TAKEN</b> Looking west</p>		
<p><b>DESCRIPTION</b> Wetland 10 – Potentially Non jurisdictional</p>

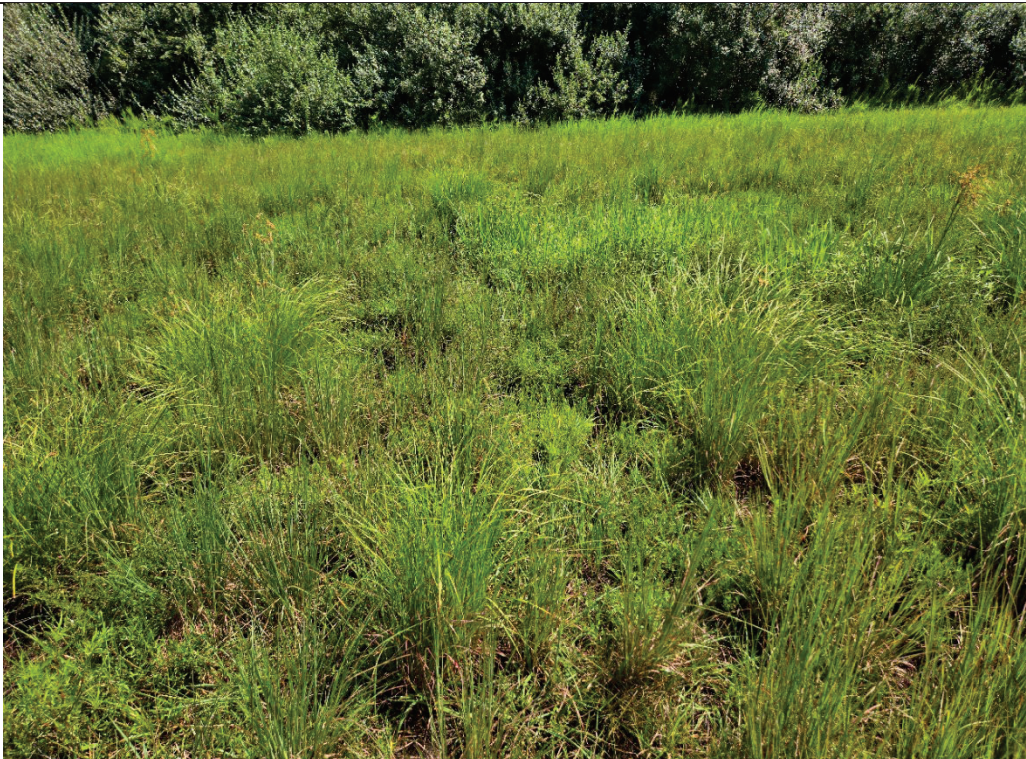
<b>PHOTO NO.</b> <b>11.</b>	<b>DATE</b> 10 August 2024

<b>DIRECTION PHOTO TAKEN</b> Looking north		
<b>DESCRIPTION</b> Wetland 11 – Potentially Non jurisdictional

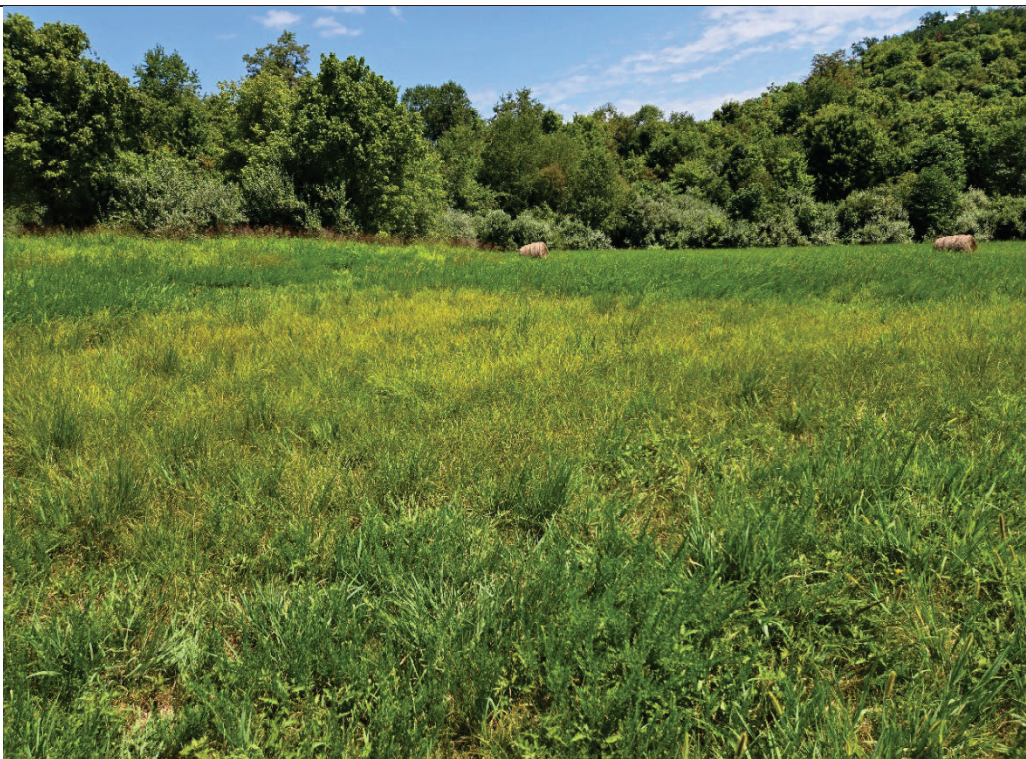
<b>PHOTO NO.</b> <b>12.</b>	<b>DATE</b> 10 August 2024

<b>DIRECTION PHOTO TAKEN</b> Looking west		
<b>DESCRIPTION</b> Wetland 12 – Potentially Non jurisdictional

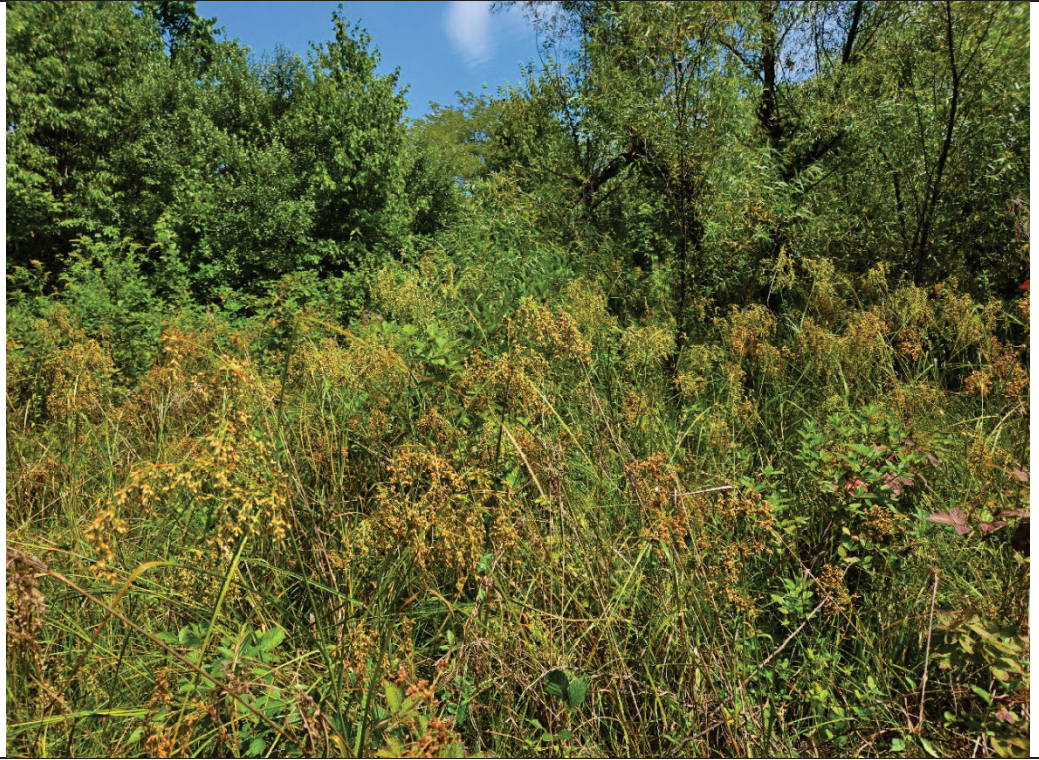
<b>PHOTO NO.</b> 13.	<b>DATE</b> 10 August 2024
<b>DIRECTION PHOTO TAKEN</b> Looking east	
<b>DESCRIPTION</b> Wetland 13 – Potentially Non jurisdictional

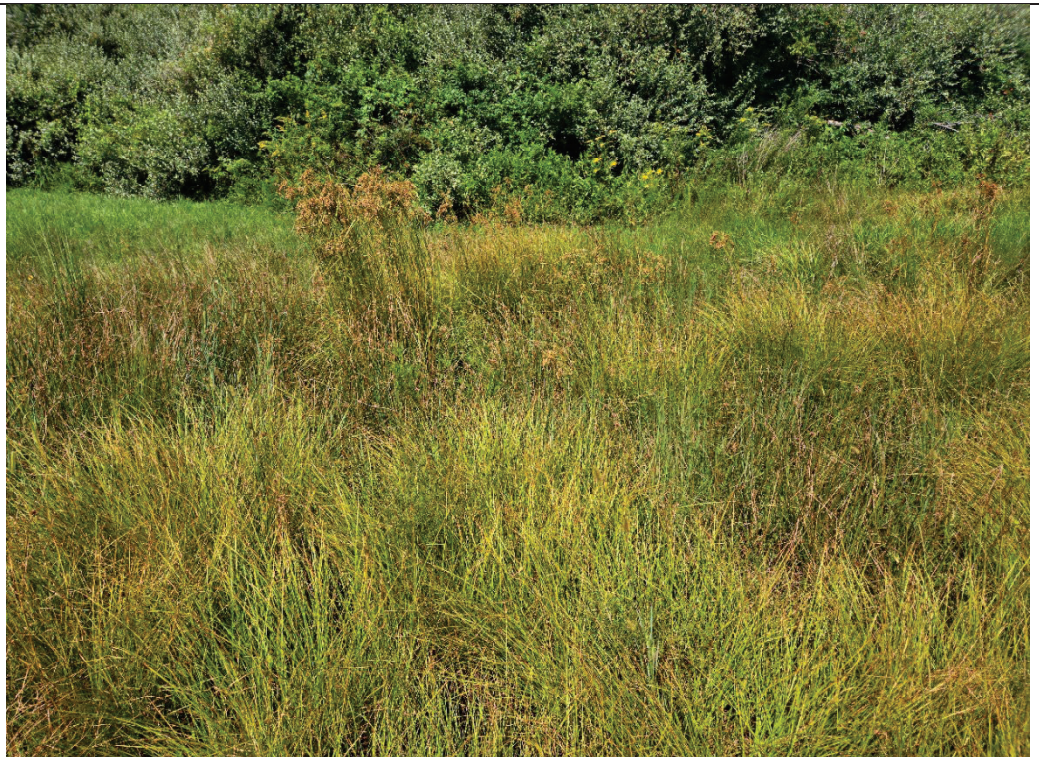
<b>PHOTO NO.</b> 14.	<b>DATE</b> 10 August 2024
<b>DIRECTION PHOTO TAKEN</b> Looking west	
<b>DESCRIPTION</b> Wetland 14 – Potentially Non jurisdictional

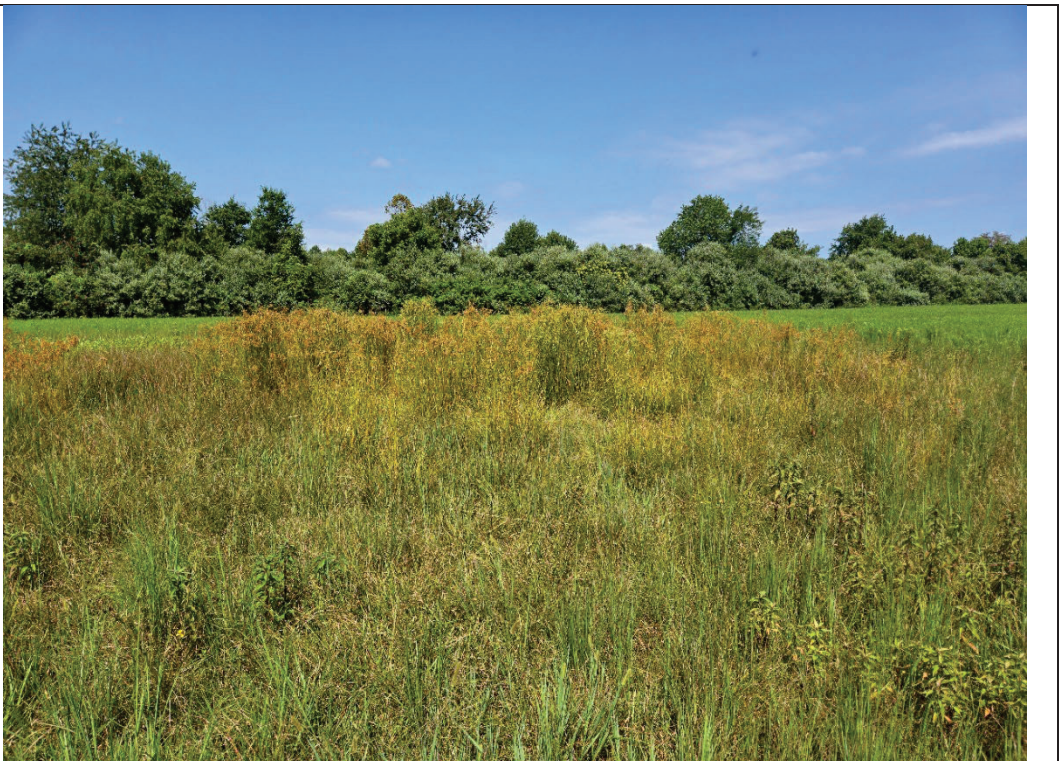
<p>PHOTO NO. <b>15.</b></p>	<p>DATE 10 August 2024</p>

<p>DIRECTION PHOTO TAKEN Looking northwest</p>		
<p>DESCRIPTION Wetland 15 – Potentially Non jurisdictional</p>

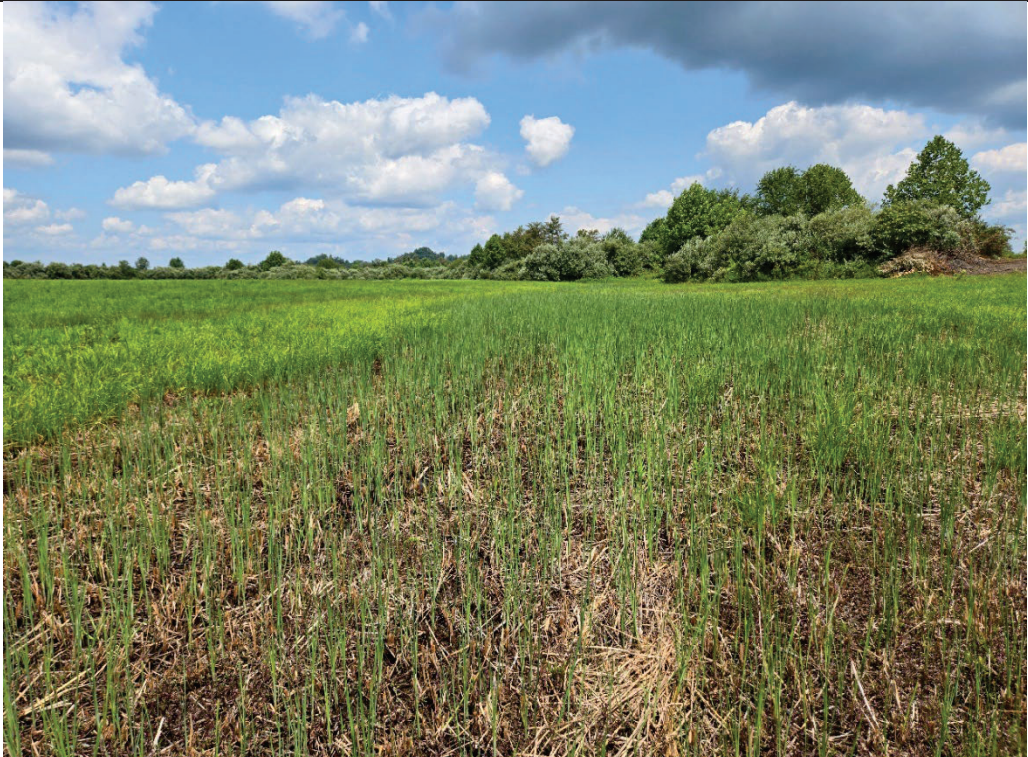
<b>PHOTO NO.</b> <b>17.</b>	<b>DATE</b> 10 August 2024

<b>DIRECTION PHOTO TAKEN</b> Looking south west		
<b>DESCRIPTION</b> Wetland 17 – Potentially Non jurisdictional

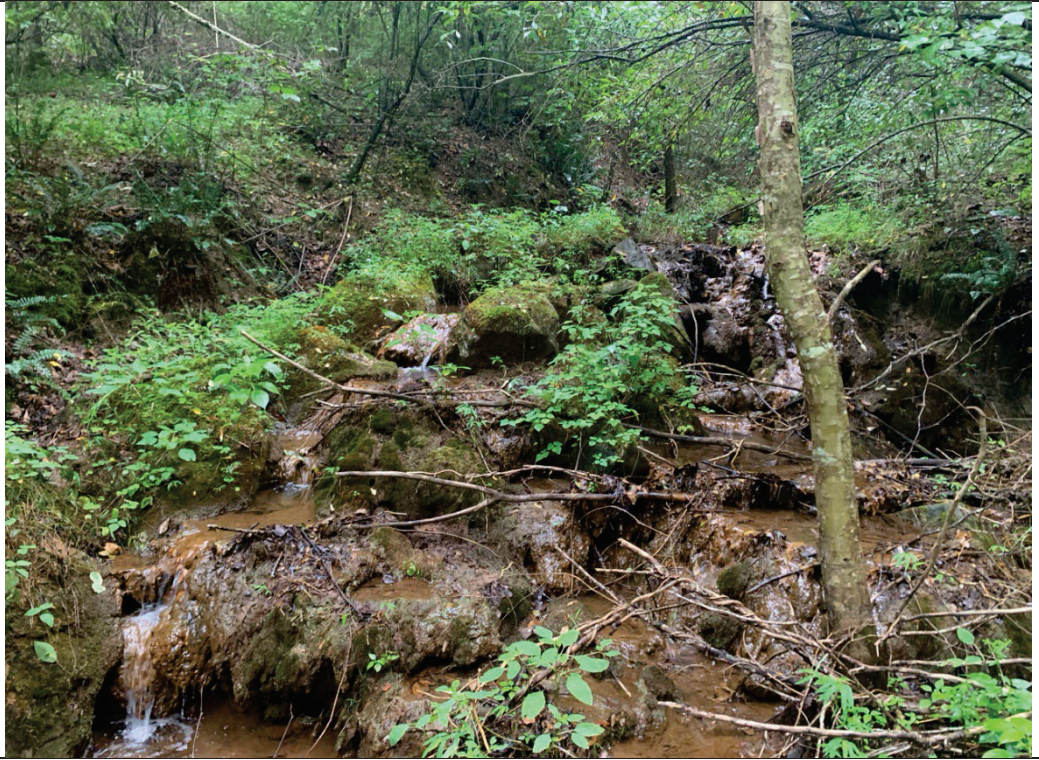
PHOTO NO. <b>21.</b>	DATE 09 August 2024
DIRECTION PHOTO TAKEN Upstream	
DESCRIPTION Stream 1 - perennial

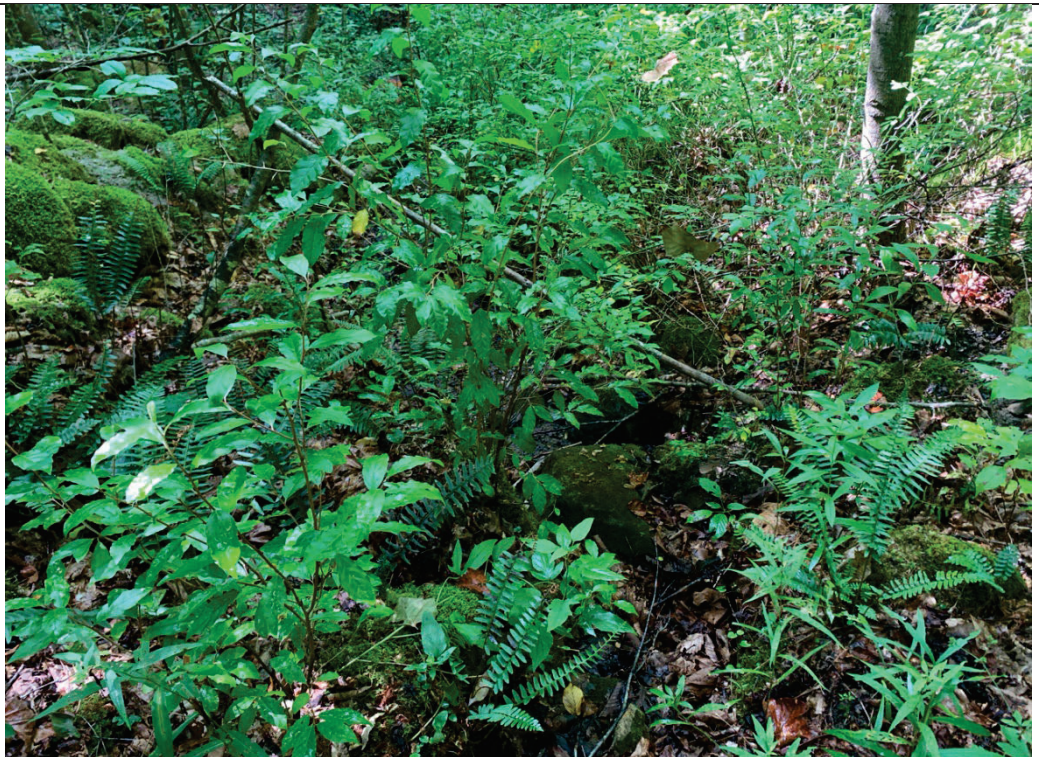
PHOTO NO. <b>22.</b>	DATE 09 August 2024
DIRECTION PHOTO TAKEN Upstream	
DESCRIPTION Stream 2 - ephemeral

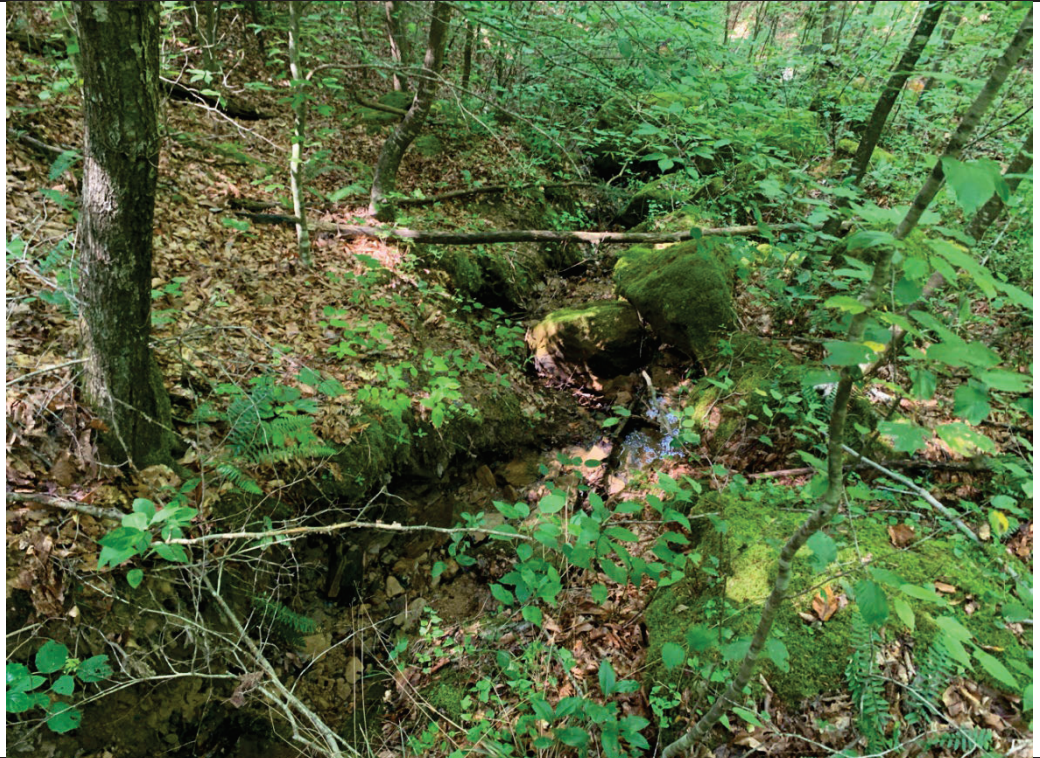
PHOTO NO. <b>23.</b>	DATE 09 August 2024
DIRECTION PHOTO TAKEN Downstream	
DESCRIPTION Stream 3 – ephemeral / intermittent conversion

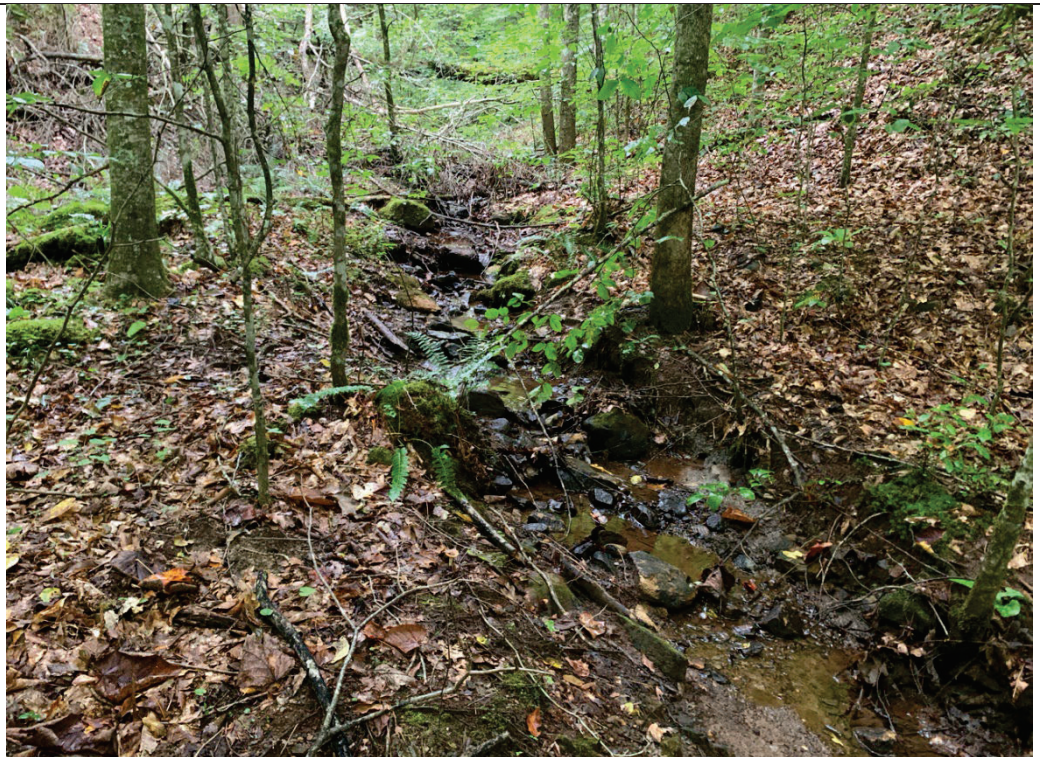
PHOTO NO. <b>24.</b>	DATE 09 August 2024
DIRECTION PHOTO TAKEN Upstream	
DESCRIPTION Stream 03 - intermittent

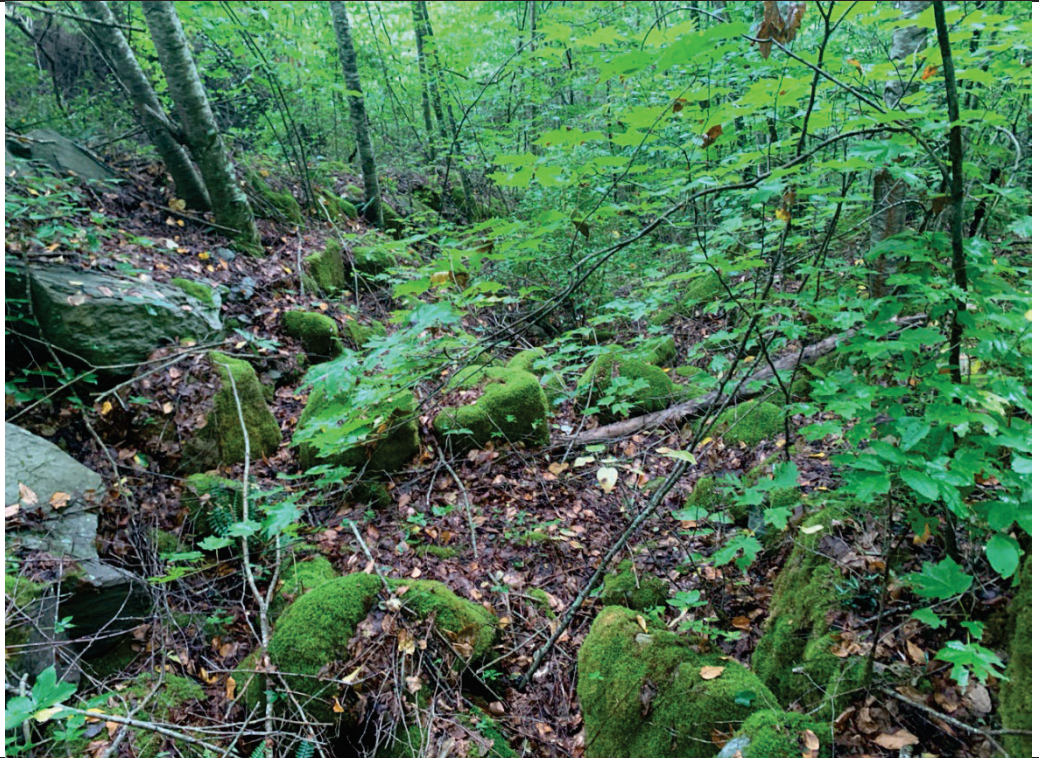
PHOTO NO. <b>25.</b>	DATE 09 August 2024
DIRECTION PHOTO TAKEN Downstream	
DESCRIPTION Stream 04 - ephemeral

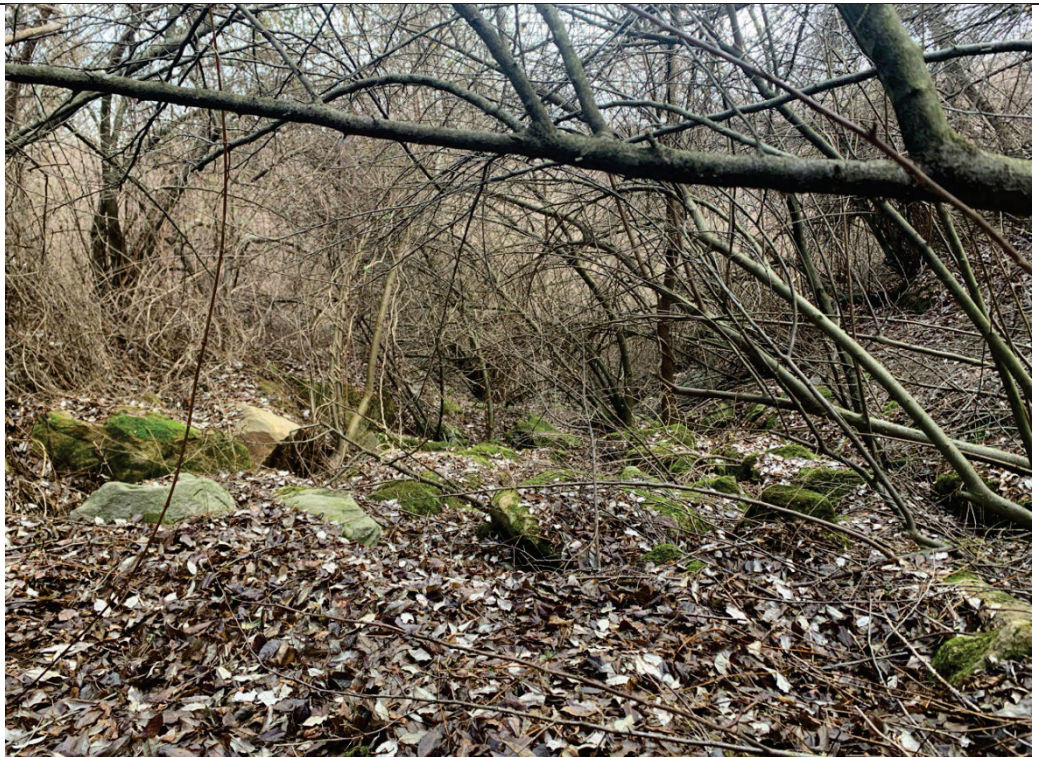
PHOTO NO. <b>26.</b>	DATE 09 August 2024
DIRECTION PHOTO TAKEN Downstream	
DESCRIPTION Stream 08 – start of ephemeral stream

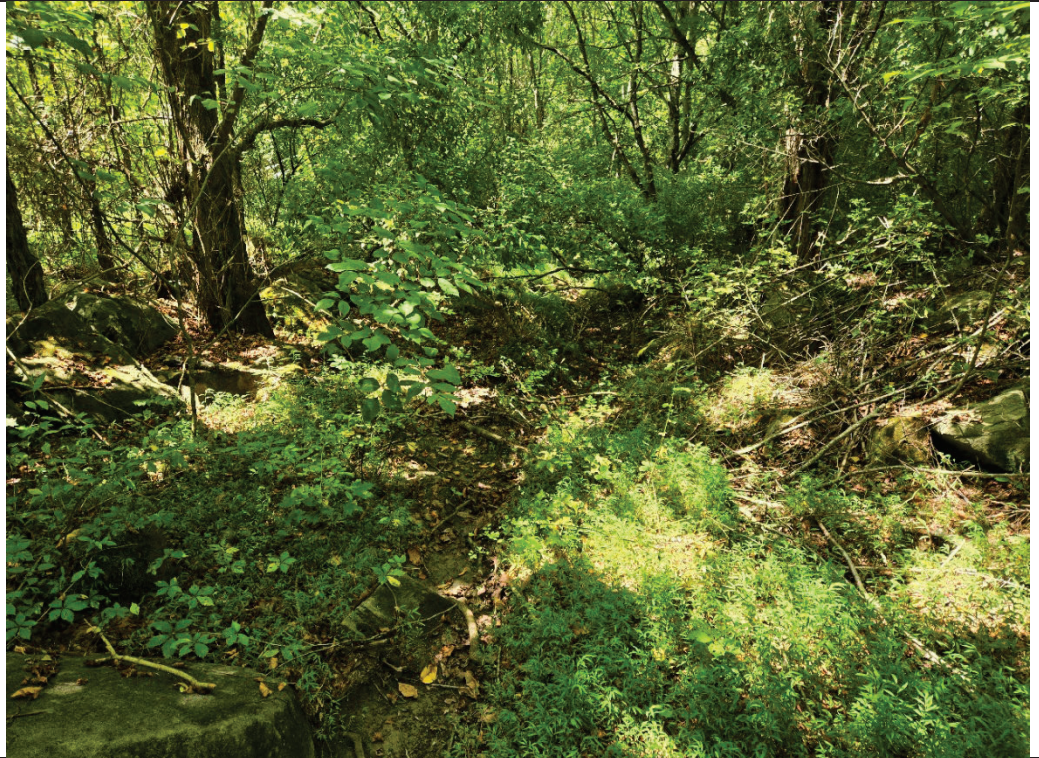
<b>PHOTO NO.</b> 27.	<b>DATE</b> 10 August 2024
<b>DIRECTION PHOTO TAKEN</b> Upstream	
<b>DESCRIPTION</b> Stream 15 - ephemeral

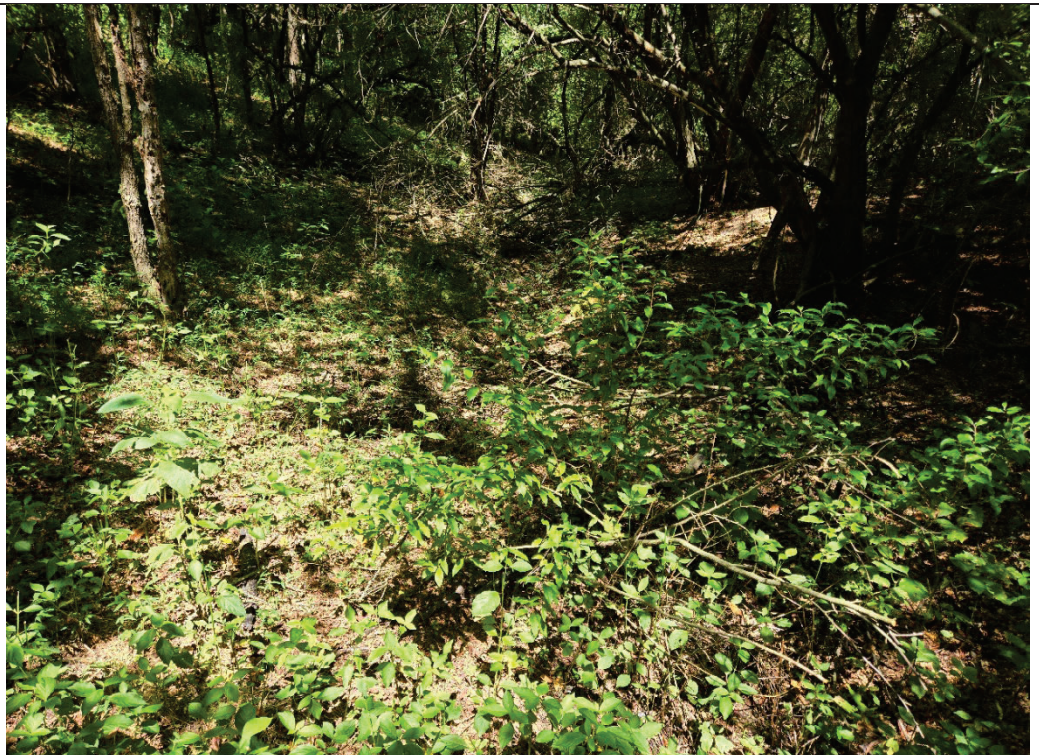
<b>PHOTO NO.</b> 28.	<b>DATE</b> 10 August 2024
<b>DIRECTION PHOTO TAKEN</b> Downstream	
<b>DESCRIPTION</b> Stream 16 - ephemeral

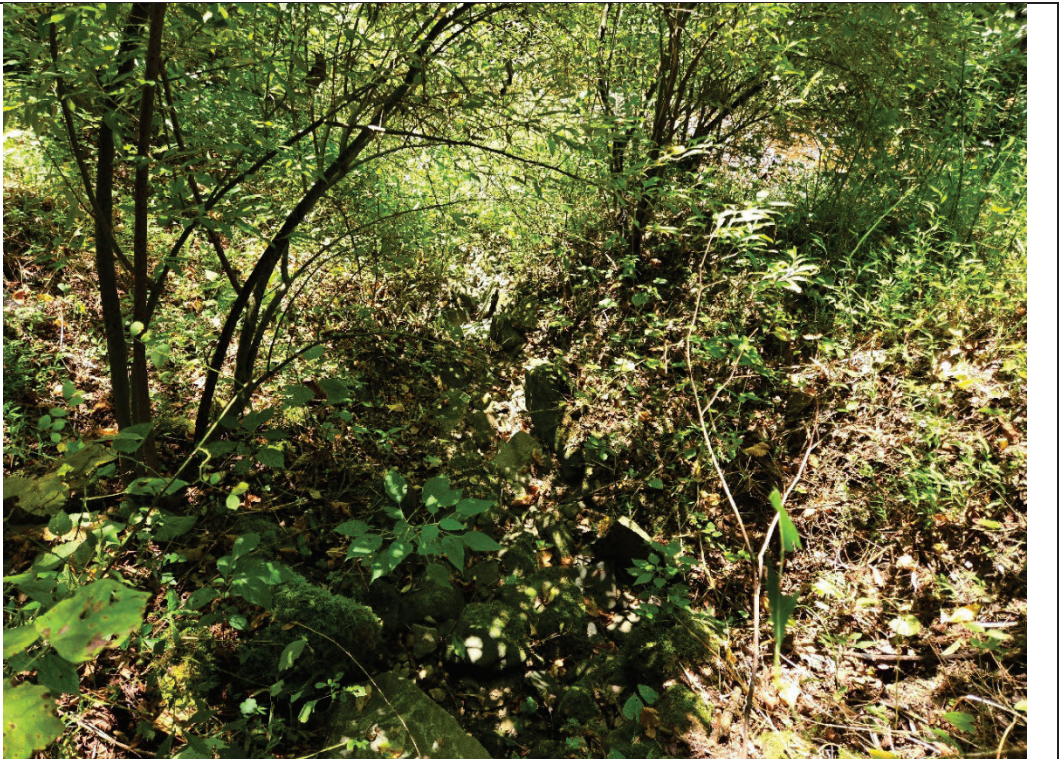
<p>PHOTO NO. <b>29.</b></p>	<p>DATE 11 August 2024</p>

<p>DIRECTION PHOTO TAKEN Downstream</p>		
<p>DESCRIPTION Stream 17 - ephemeral</p>

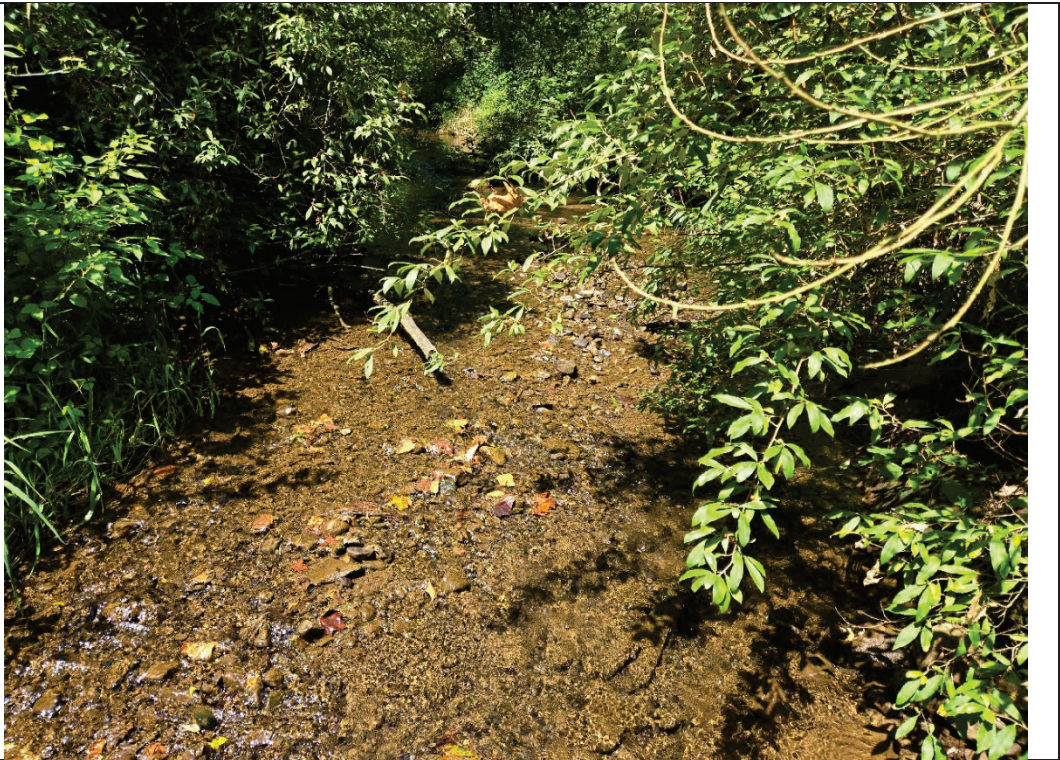
PHOTO NO. <b>31.</b>	DATE 11 August 2024
DIRECTION PHOTO TAKEN Upstream	
DESCRIPTION Stream 19 – perennial
