WETLAND DELINEATION REPORT

Clover Creek Solar Project LLC d/b/a New
Frontiers Solar Park —Breckinridge County,
Kentucky

Updated October 2024

Project Number:
235300918

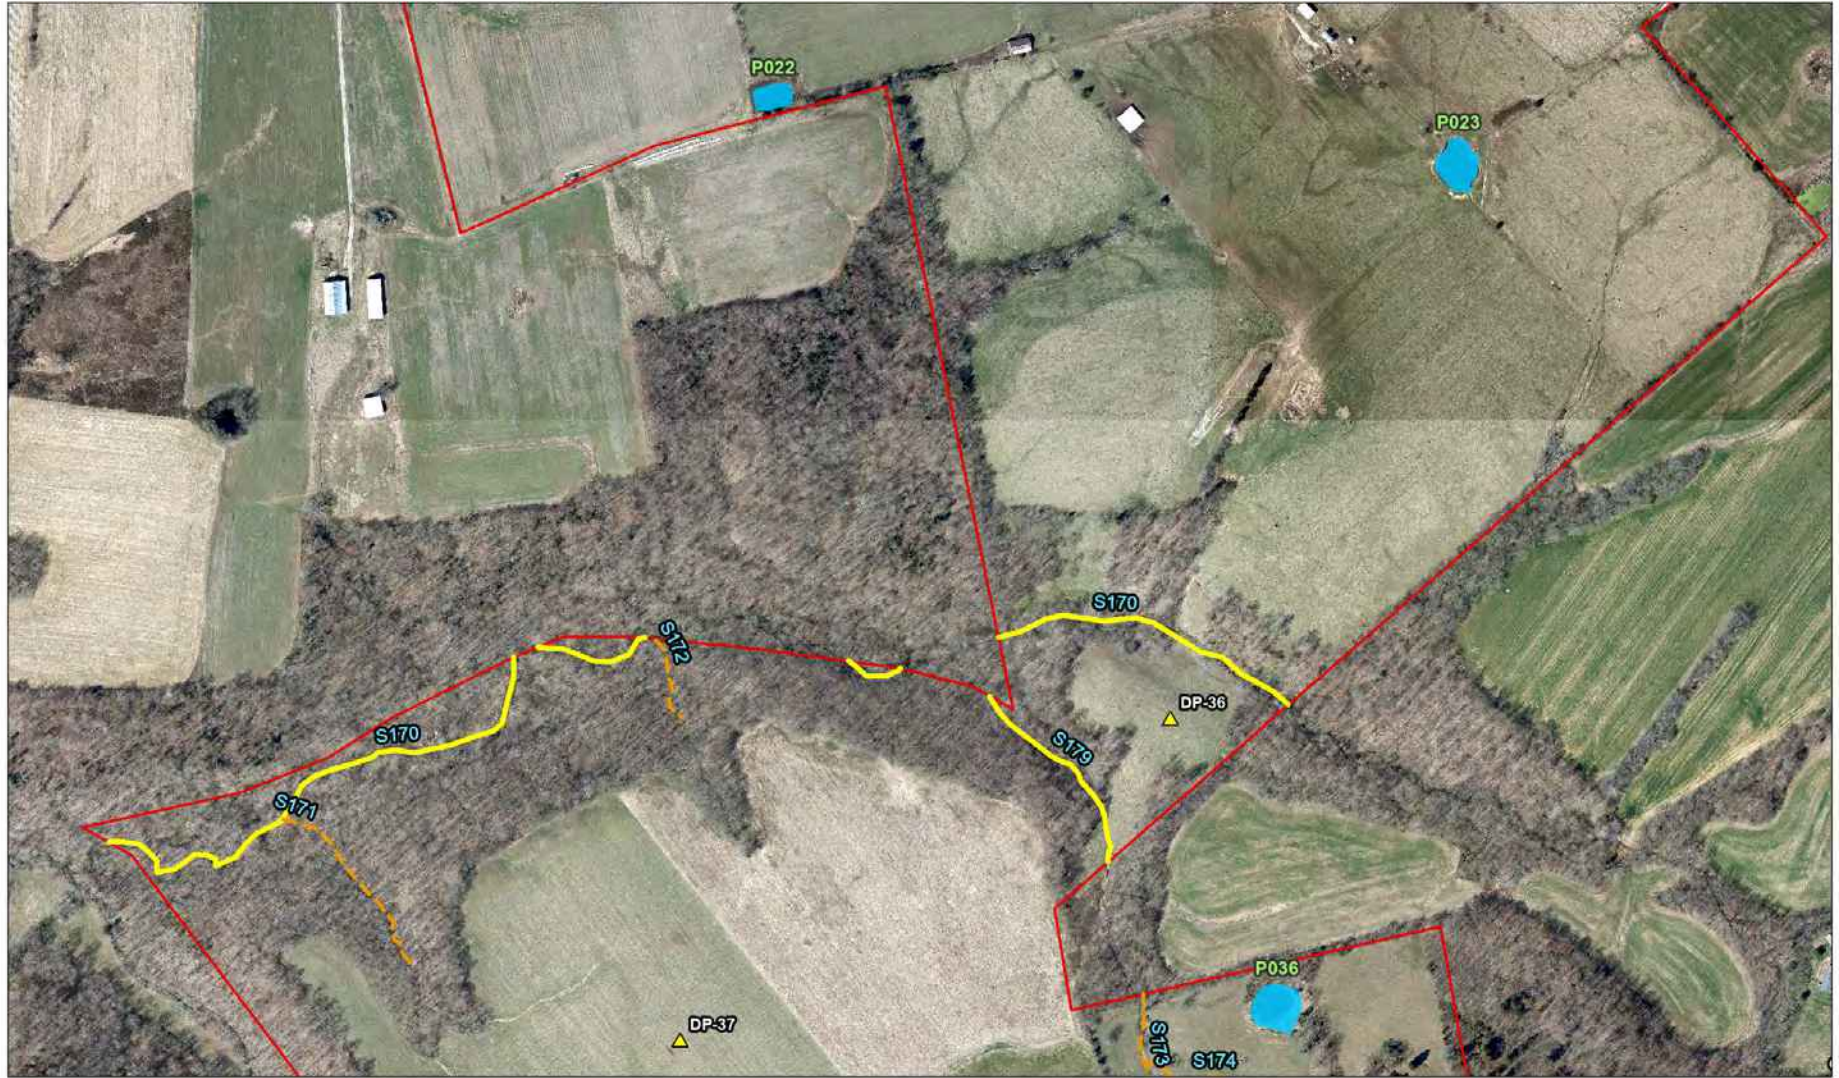
Appendix:
A
 Title:
Delineated Features

- Project Area
- Delineated Wetlands**
- PEM
- PFO
- PUB
- PSS
- Ephemeral Stream
- Intermittent Stream
- Wetland Datapoints**
- Upland
- Wetland

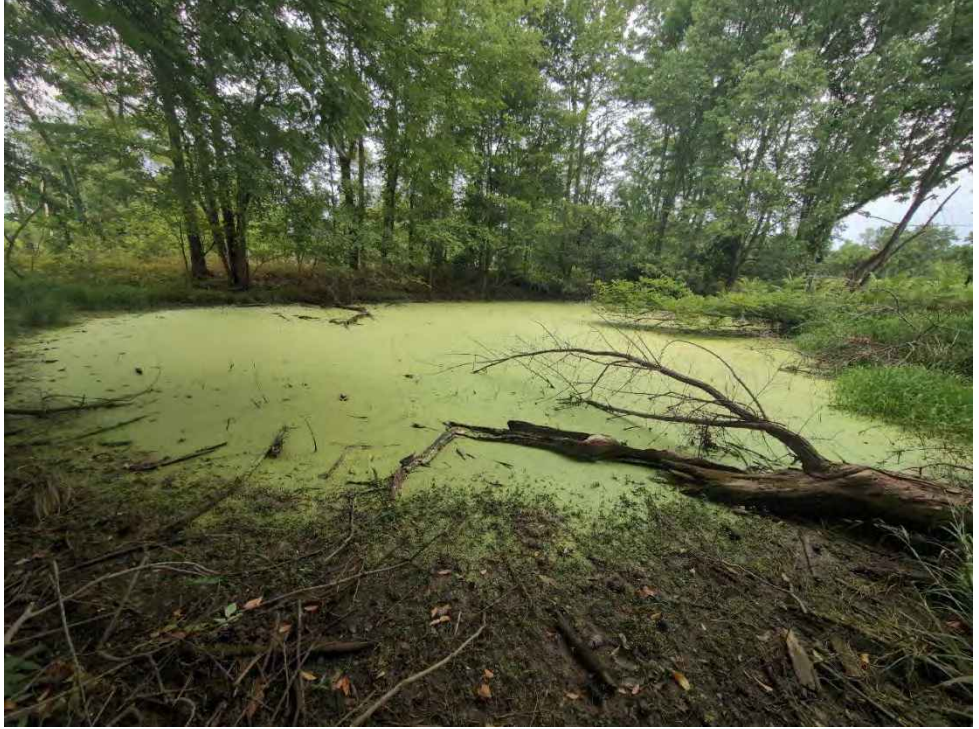
Project Name: Clover Creek Solar		County/State: Breckinridge County, Kentucky	Project No. 235300918
Photo No. 1	Date: 7/16/2024

Coordinates: 37.750704, -86.483233			
Photo Direction: N			
Description: Palustrine Unconsolidated Bottom (PUB) Pond P020

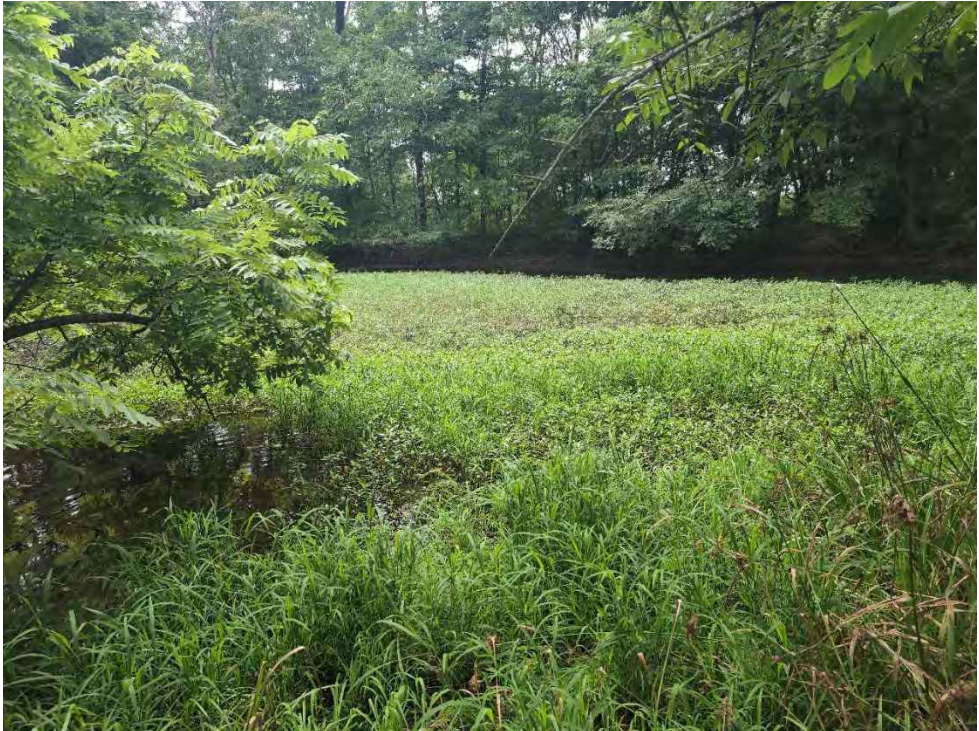
Project Name: Clover Creek Solar		County/State: Breckinridge County, Kentucky	Project No. 235300918
Photo No. 2	Date: 7/16/2024

Coordinates: 37.749276, -86.47766669			
Photo Direction: SE			
Description: Palustrine Unconsolidated Bottom (PUB) Pond P021

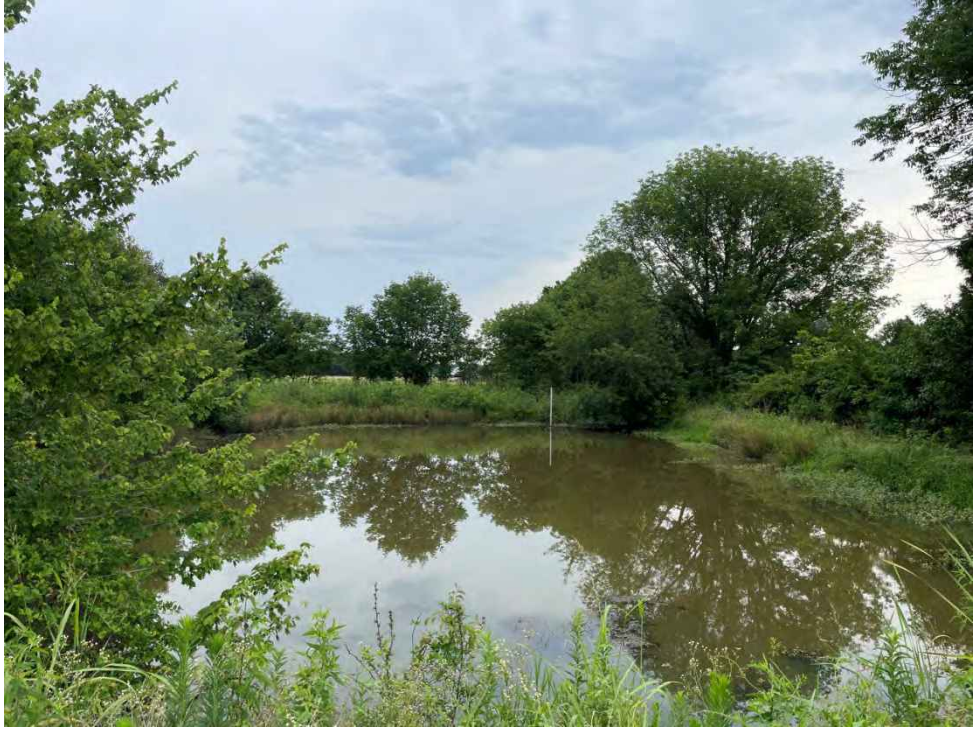
Project Name: Clover Creek Solar		County/State: Breckinridge County, Kentucky	Project No. 235300918
Photo No. 3	Date: 7/16/2024

Coordinates: 37.7458672, -86.485319			
Photo Direction: E			
Description: Palustrine Unconsolidated Bottom (PUB) Pond P022

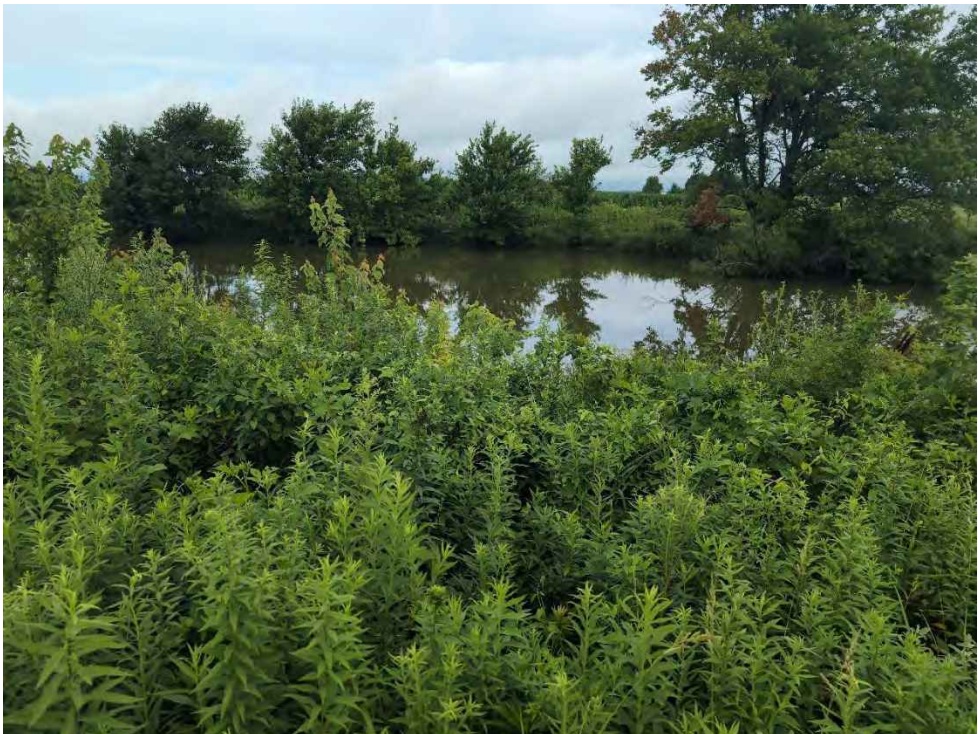
Project Name: Clover Creek Solar		County/State: Breckinridge County, Kentucky	Project No. 235300918
Photo No. 4	Date: 7/16/2024

Coordinates: 37.74533, -86.4780107			
Photo Direction: SE			
Description: Palustrine Unconsolidated Bottom (PUB) Pond P023

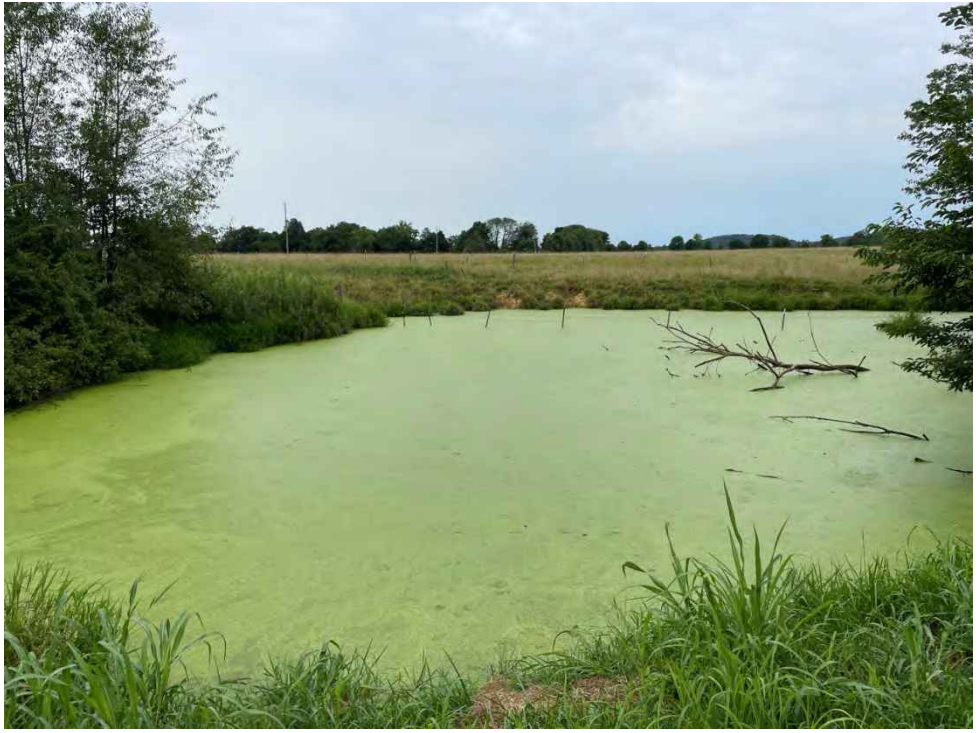
Project Name: Clover Creek Solar		County/State: Breckinridge County, Kentucky	Project No. 235300918
Photo No. 5	Date: 7/16/2024

Coordinates: 37.747285, -86.48050781			
Photo Direction: W			
Description: Palustrine Unconsolidated Bottom (PUB) Pond P024

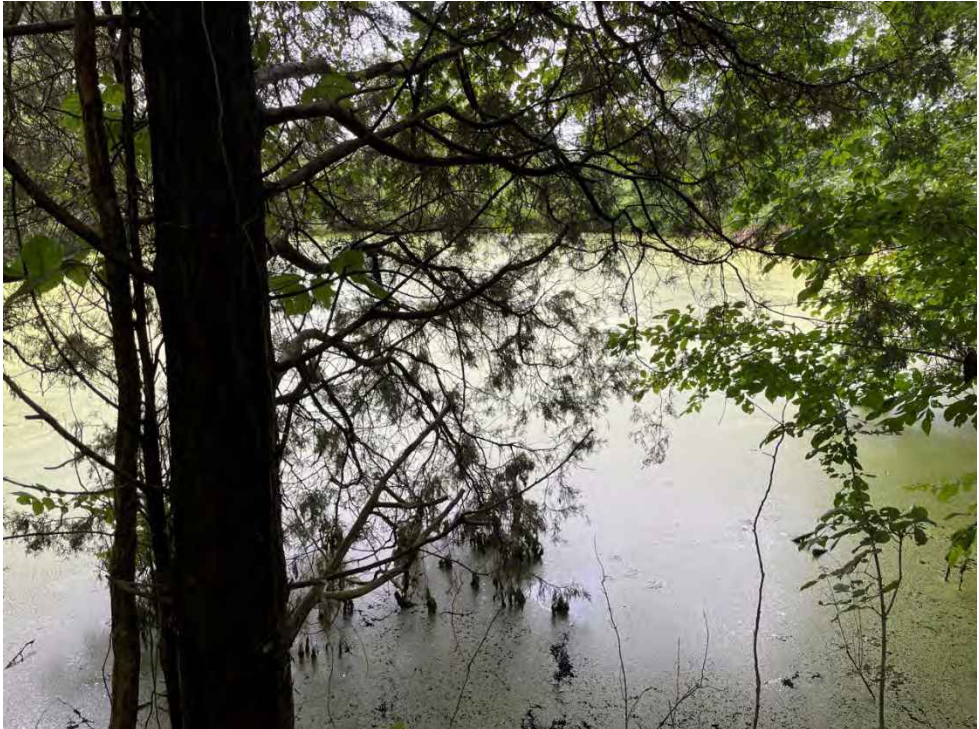
Project Name: Clover Creek Solar		County/State: Breckinridge County, Kentucky	Project No. 235300918
Photo No. 6	Date: 7/16/2024

Coordinates: 37.75085, -86.473133			
Photo Direction: NW			
Description: Palustrine Unconsolidated Bottom (PUB) Pond P025

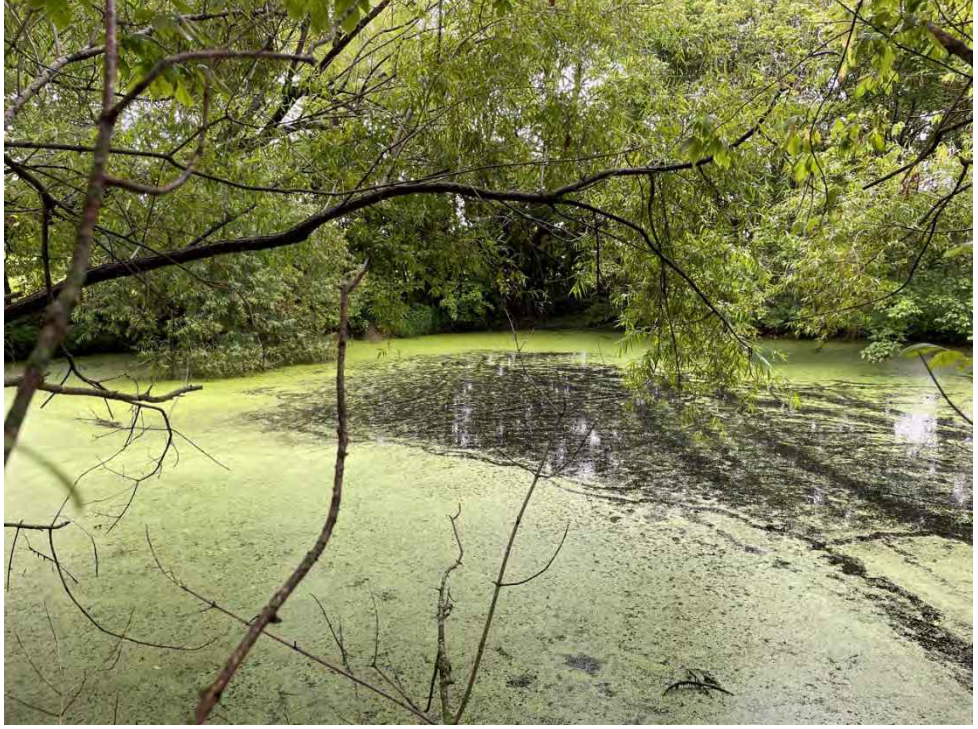
Project Name: Clover Creek Solar		County/State: Breckinridge County, Kentucky	Project No. 235300918
Photo No. 7	Date: 7/16/2024

Coordinates: 37.754107, -86.4682192			
Photo Direction: SW			
Description: Palustrine Unconsolidated Bottom (PUB) Pond P026

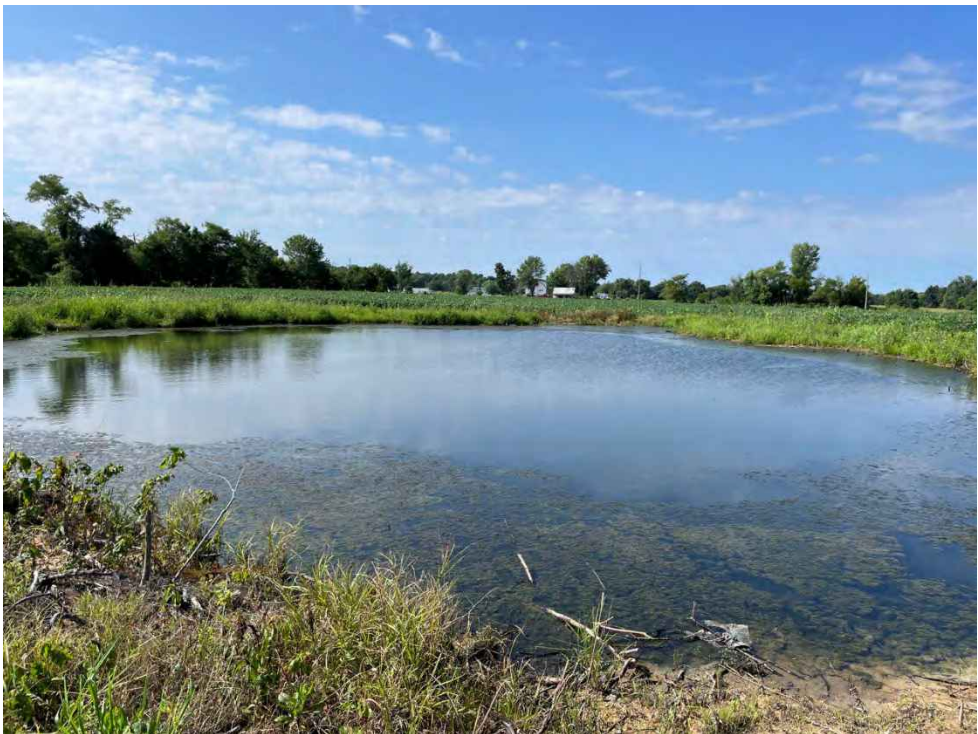
Project Name: Clover Creek Solar		County/State: Breckinridge County, Kentucky	Project No. 235300918
Photo No. 8	Date: 7/16/2024

Coordinates: 37.75590368, -86.465589			
Photo Direction: S			
Description: Palustrine Unconsolidated Bottom (PUB) Pond P027

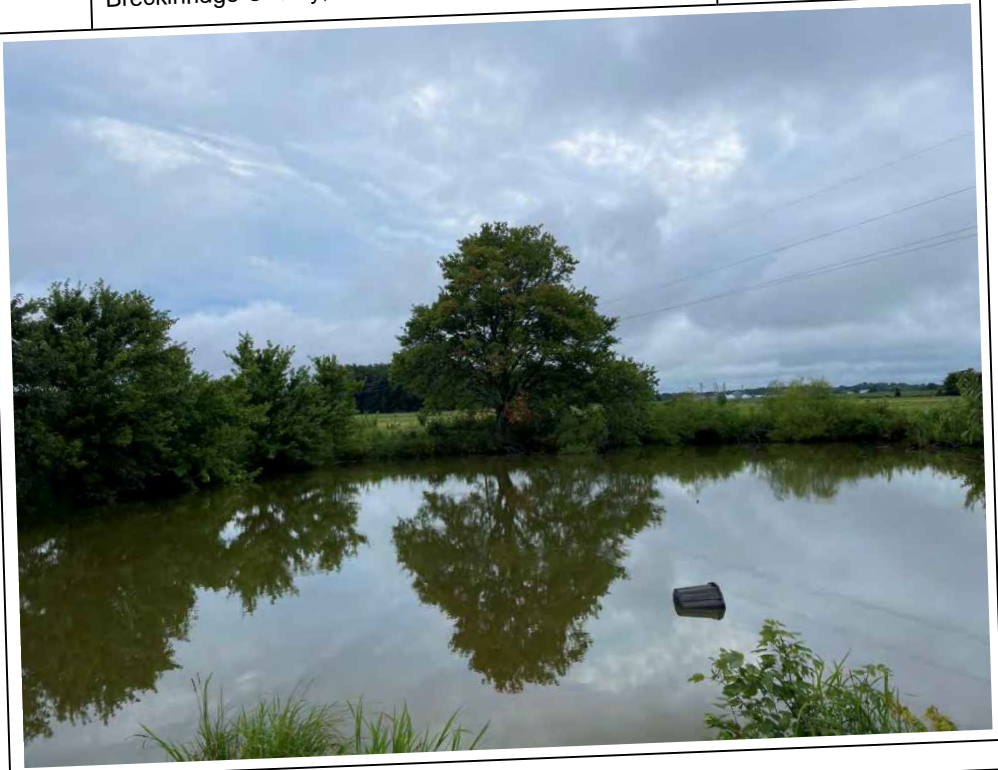
Description:
Palustrine Unconsolidated
Bottom (PUB) Pond P028

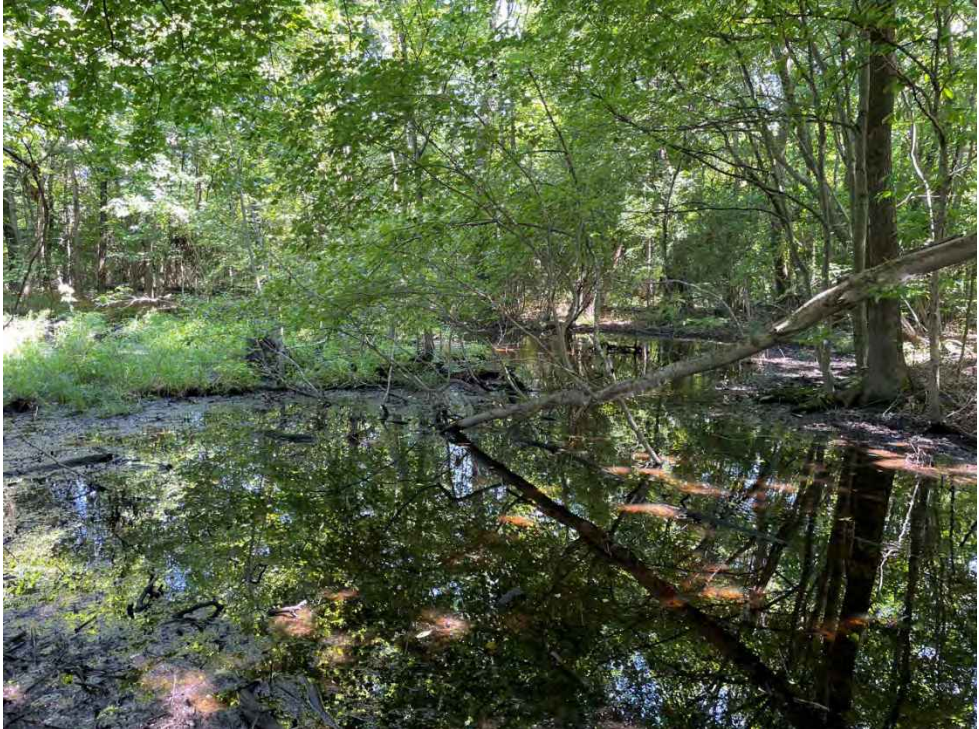
Project Name: Clover Creek Solar		County/State: Breckinridge County, Kentucky	Project No. 235300918
Photo No. 12	Date: 7/16/2024

Coordinates: 37.761211, -86.4738707			
Photo Direction: NW			
Description: Palustrine Unconsolidated Bottom (PUB) Pond P031

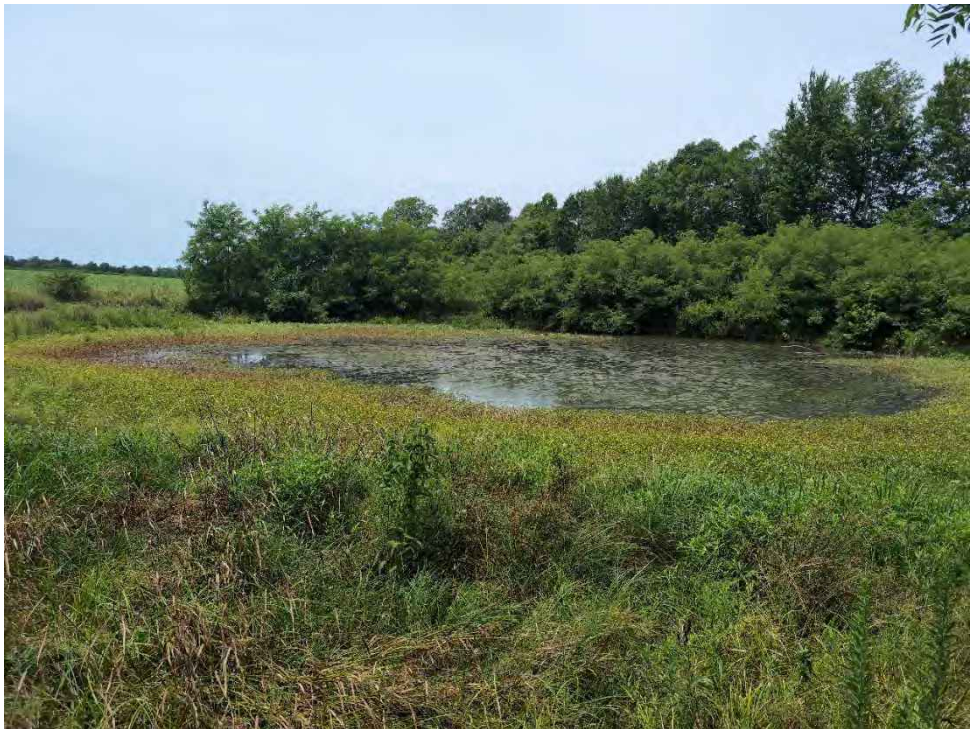
Project Name: Clover Creek Solar		County/State: Breckinridge County, Kentucky	Project No. 235300918
Photo No. 17	Date: 7/17/2024

Coordinates: 37.738191, -86.479872			
Photo Direction: W			
Description: Palustrine Unconsolidated Bottom (PUB) Pond P036

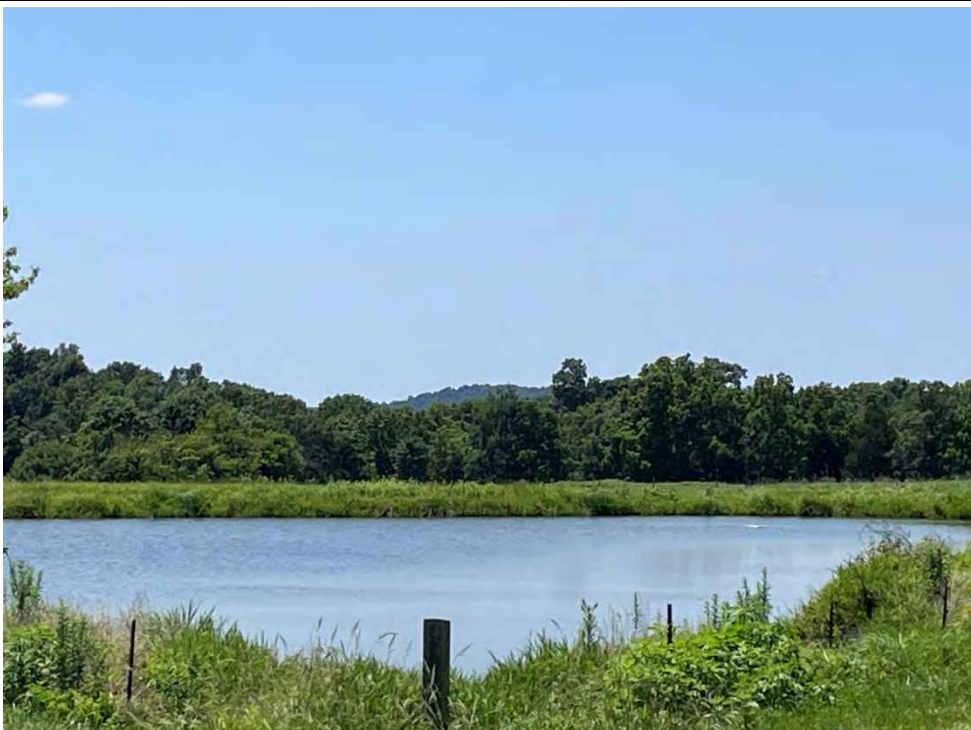
Project Name: Clover Creek Solar		County/State: Breckinridge County, Kentucky	Project No. 235300918
Photo No. 18	Date: 7/17/2024

Coordinates: 37.7689006, -86.4832974			
Photo Direction: SW			
Description: Palustrine Unconsolidated Bottom (PUB) Pond P037

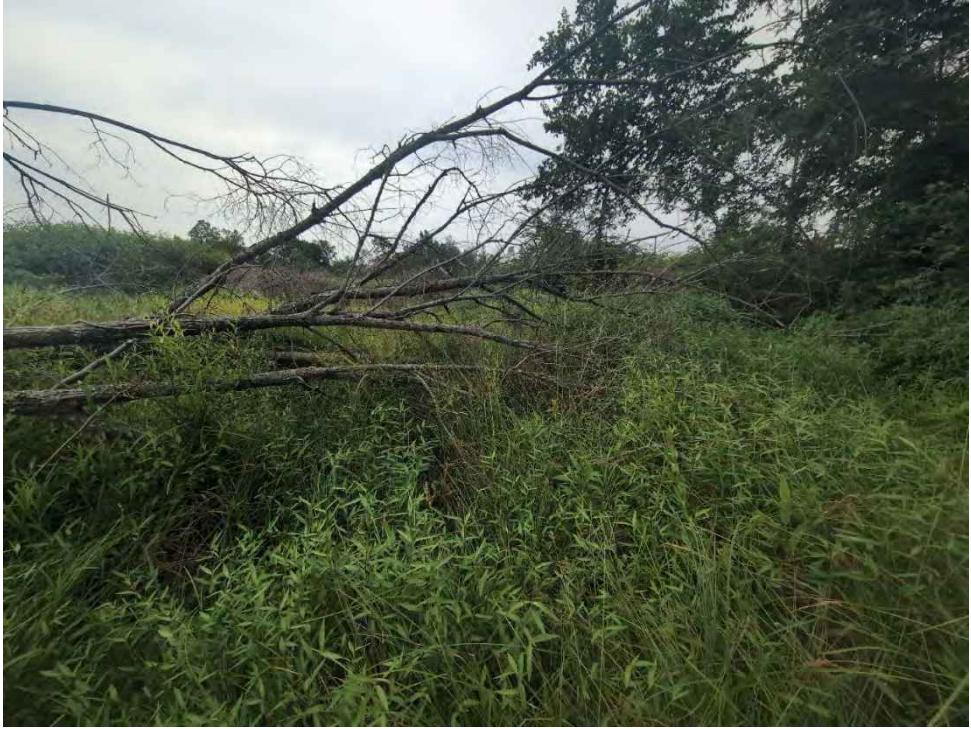
Project Name: Clover Creek Solar		County/State: Breckinridge County, Kentucky	Project No. 235300918
Photo No. 19	Date: 7/17/2024

Coordinates: 37.74974131, -86.48089			
Photo Direction: SW			
Description: Palustrine Emergent (PEM) Wetland W026 at DP-03

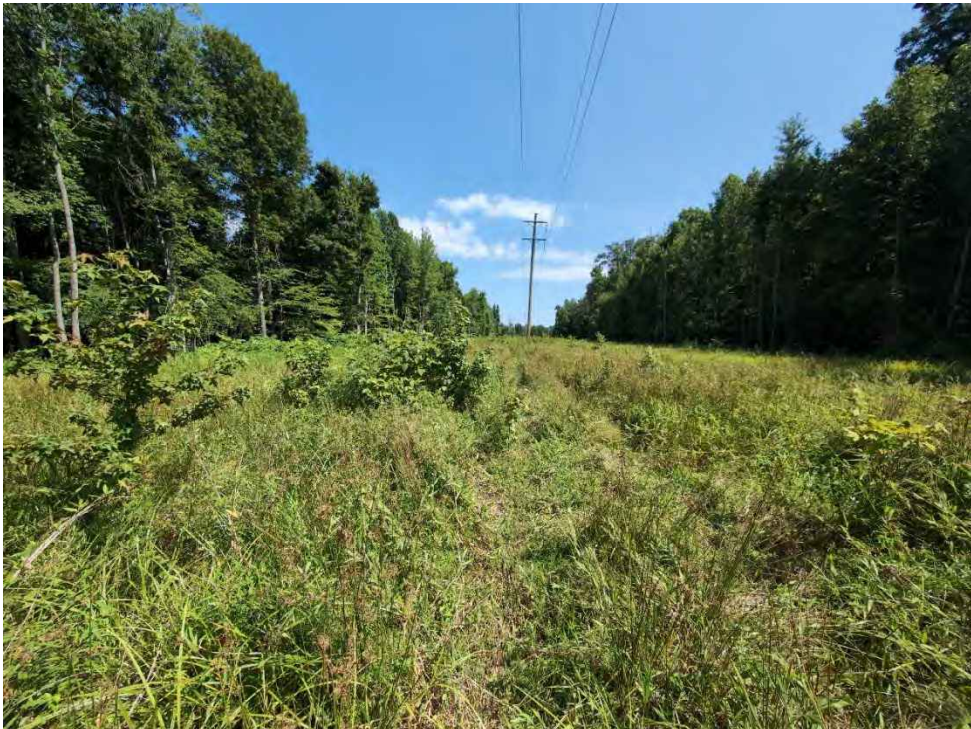
Project Name: Clover Creek Solar		County/State: Breckinridge County, Kentucky	Project No. 235300918
Photo No. 20	Date: 7/17/2024

Coordinates: 37.7609256, -86.473151			
Photo Direction: N			
Description: Palustrine Emergent (PEM) Wetland W027 at DP-12

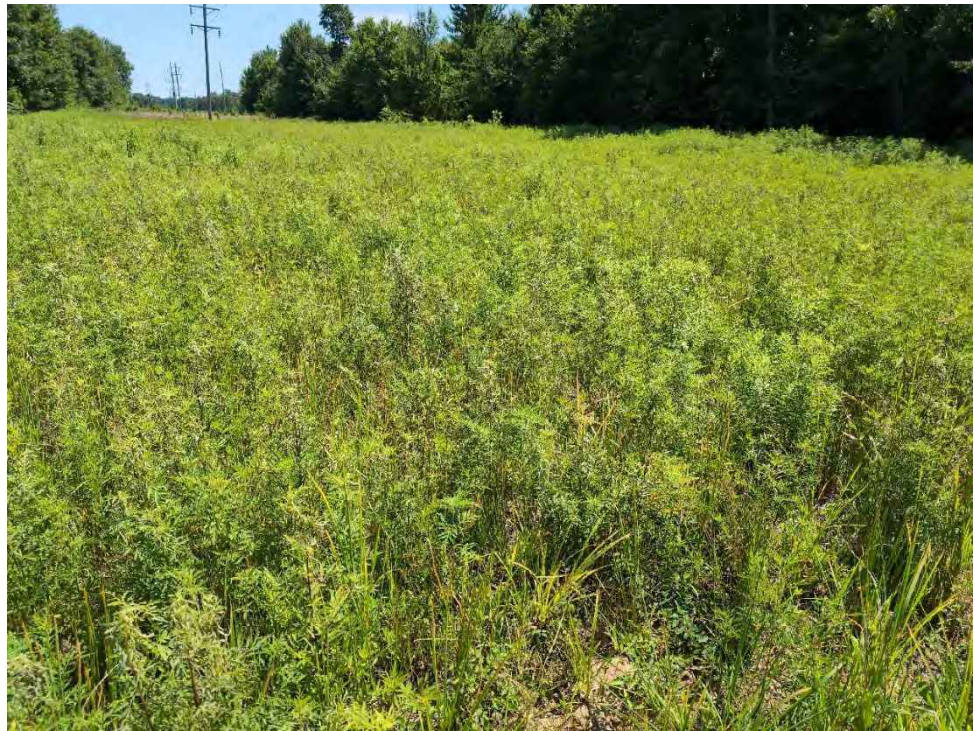
Description:
Palustrine Emergent
(PEM) Wetland W028 at
DP-14

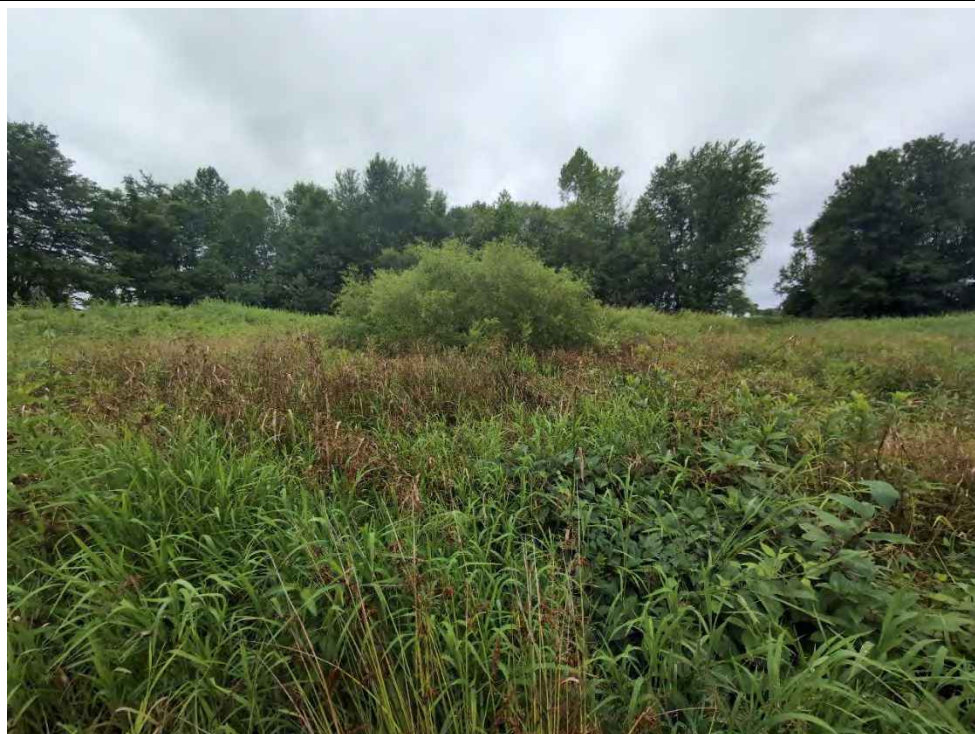
Description:
Palustrine Scrub Shrub
(PSS) Wetland W029 at
DP-22

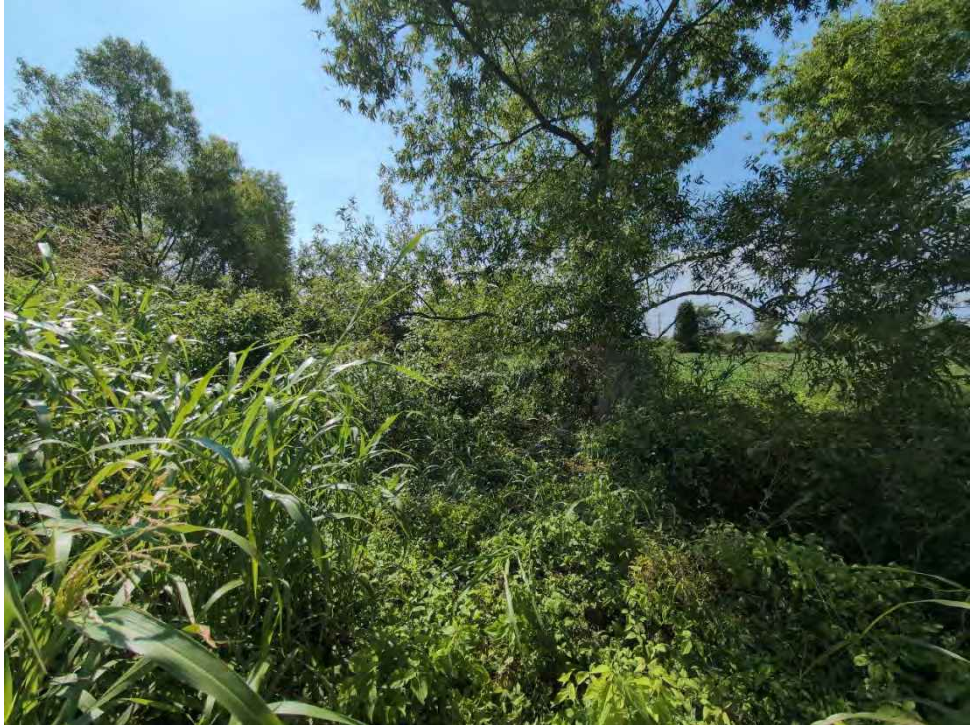
Project Name: Clover Creek Solar		County/State: Breckinridge County, Kentucky	Project No. 235300918
Photo No. 23	Date: 7/18/2024

Coordinates: 37.75780563, -86.464049			
Photo Direction: W			
Description: Palustrine Scrub Shrub (PSS) Wetland W030 at DP-09

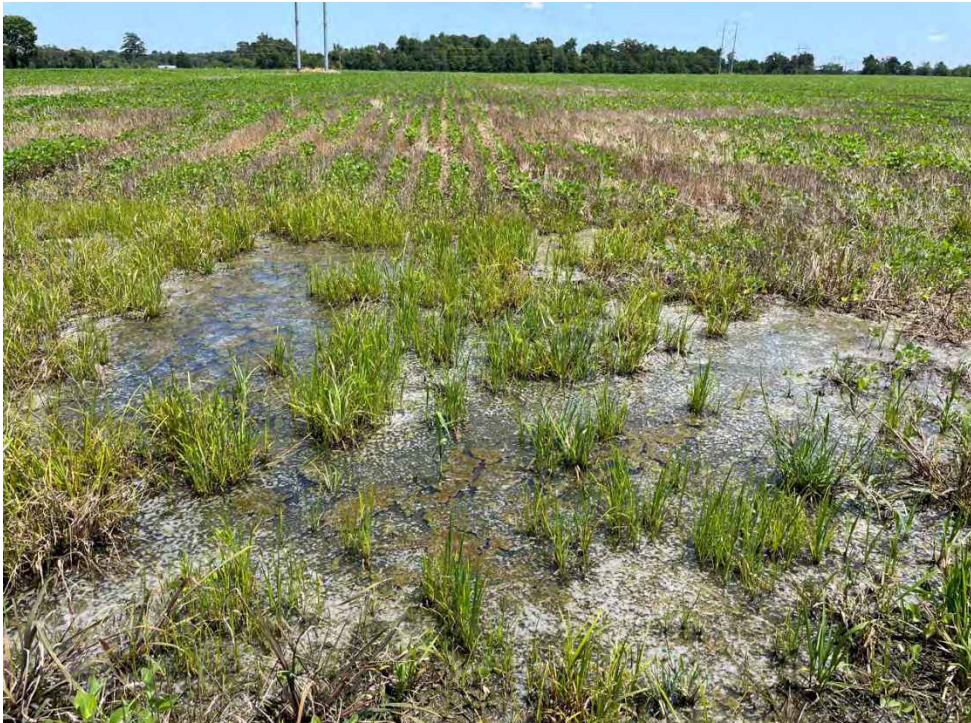
Project Name: Clover Creek Solar		County/State: Breckinridge County, Kentucky	Project No. 235300918
Photo No. 24	Date: 7/18/2024

Coordinates: 37.76821626, -86.481072			
Photo Direction: SE			
Description: Palustrine Emergent (PEM) Wetland W031 at DP-33

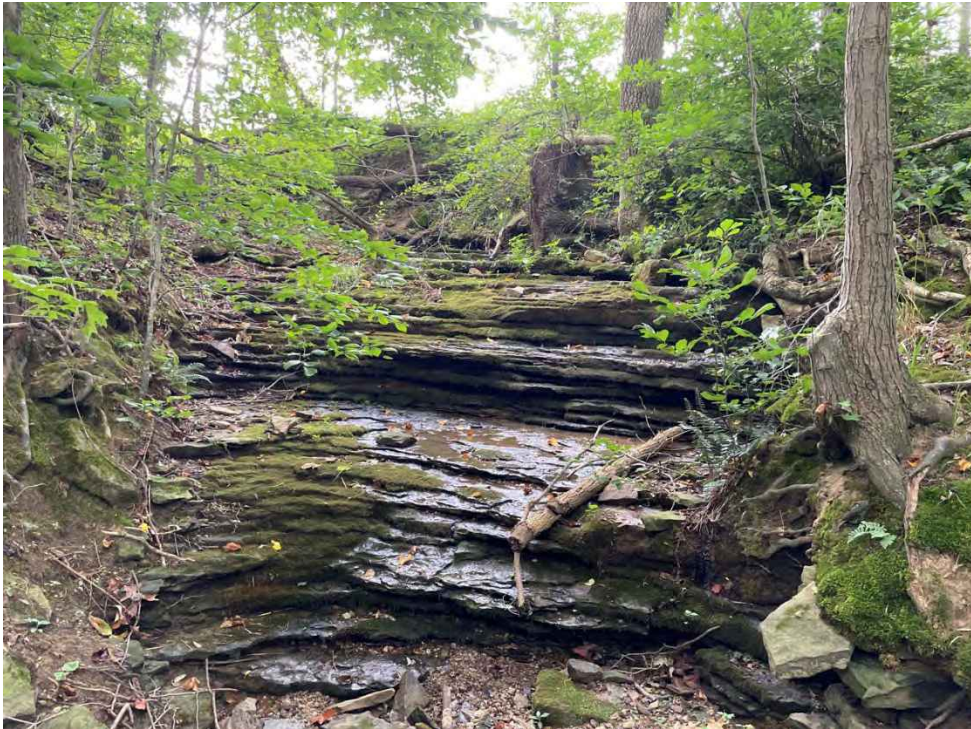
Project Name: Clover Creek Solar		County/State: Breckinridge County, Kentucky	Project No. 235300918
Photo No. 26	Date: 7/16/2024

Coordinates: 37.7474070, -86.4887315			
Photo Direction: S			
Description: Upstream view of intermittent stream S154

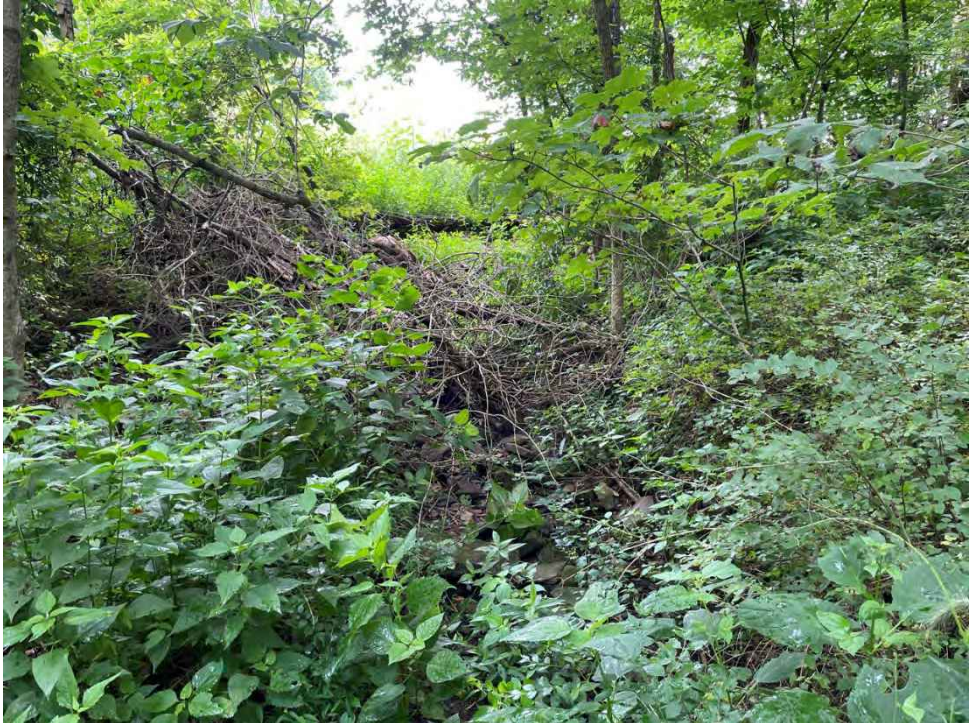
Project Name: Clover Creek Solar		County/State: Breckinridge County, Kentucky	Project No. 235300918
Photo No. 27	Date: 7/16/2024

Coordinates: 37.7495004, -86.4821361			
Photo Direction: NE			
Description: Downstream view of ephemeral stream S155

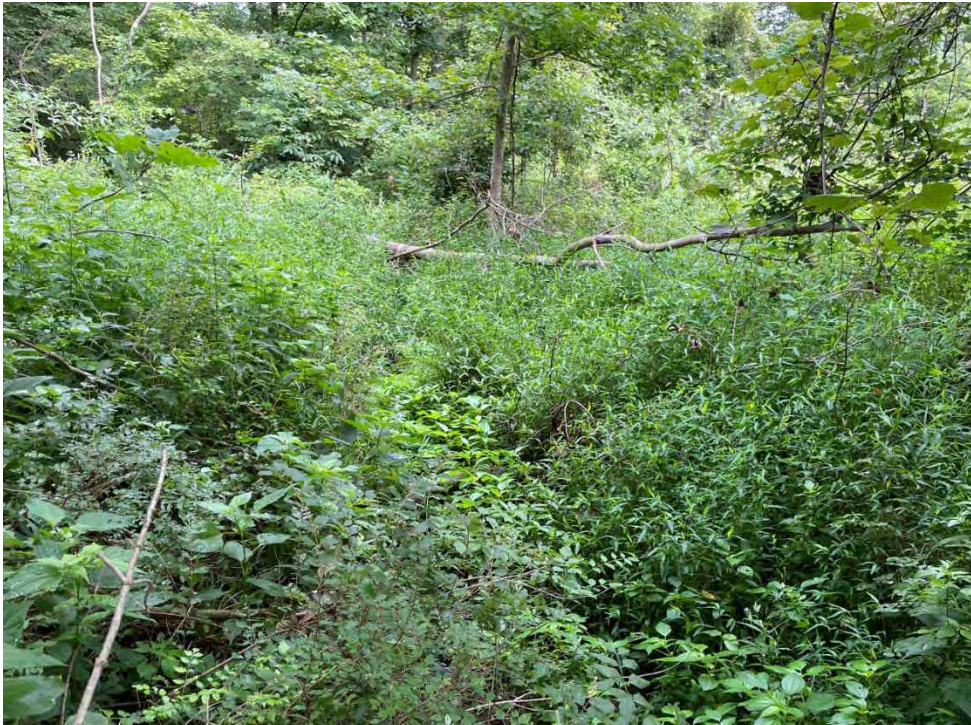
Project Name: Clover Creek Solar		County/State: Breckinridge County, Kentucky	Project No. 235300918
Photo No. 28	Date: 7/16/2024

Coordinates: 37.7480886, -86.4796199			
Photo Direction: SE			
Description: Upstream view of ephemeral stream S156

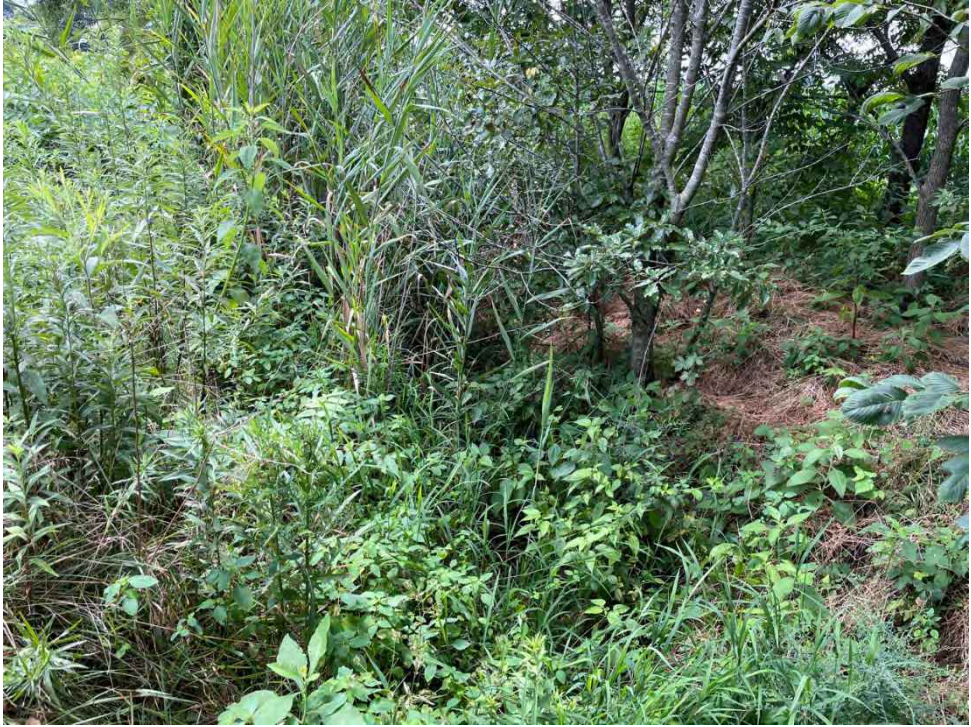
Project Name: Clover Creek Solar		County/State: Breckinridge County, Kentucky	Project No. 235300918
Photo No. 29	Date: 7/16/2024

Coordinates: 37.7491852, -86.4782486			
Photo Direction: NE			
Description: Downstream view of ephemeral stream S157

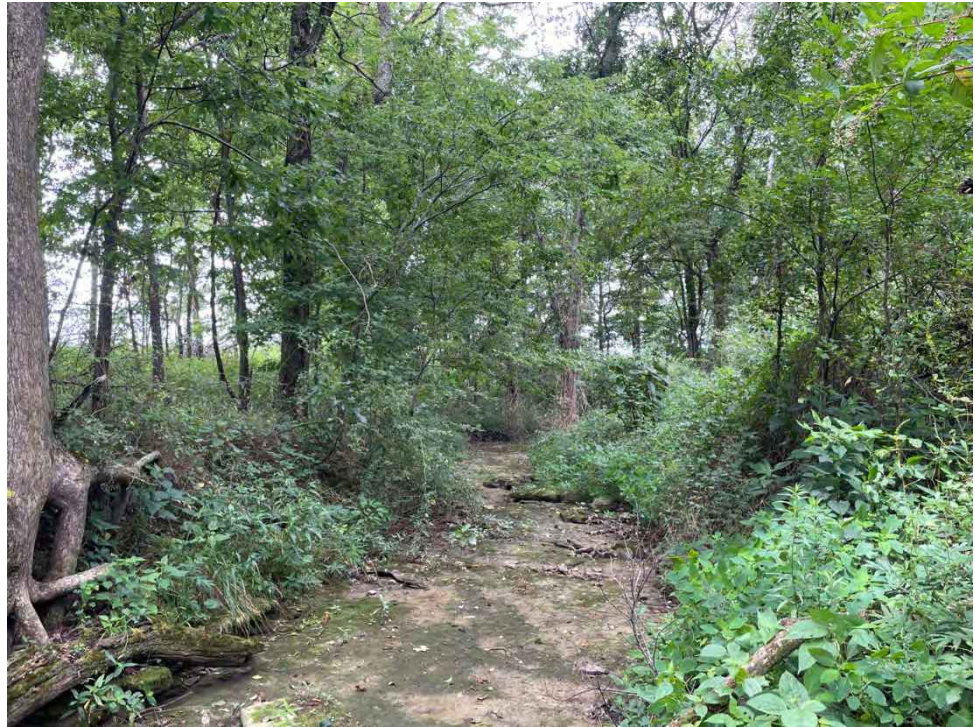
Description:
Downstream view of
intermittent stream S159.

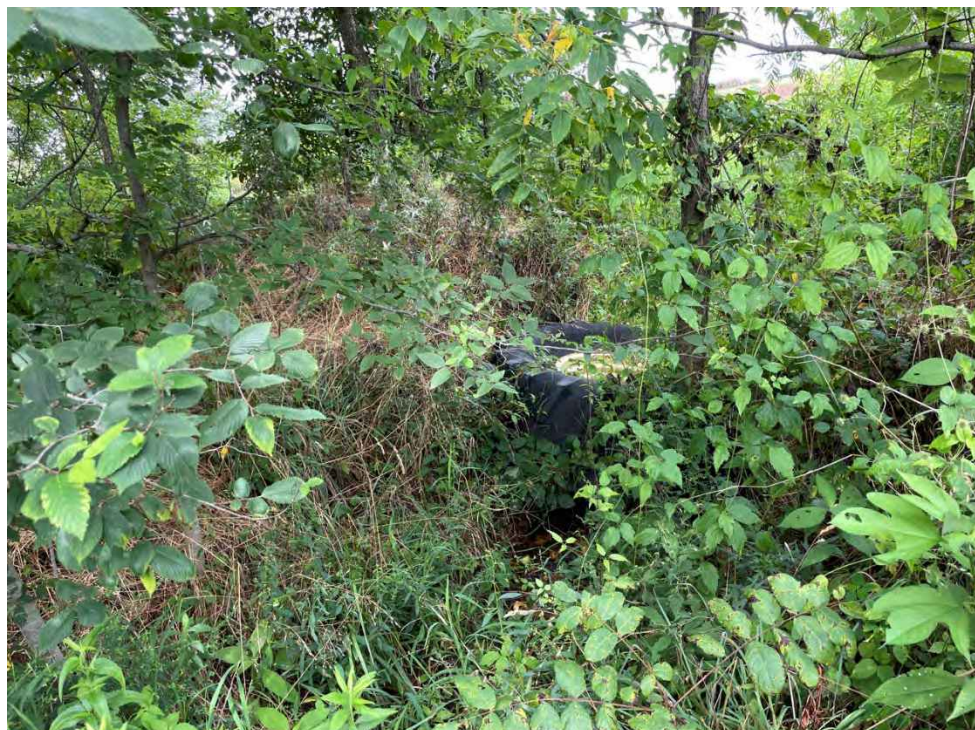
Description:
Downstream view of
ephemeral stream S160

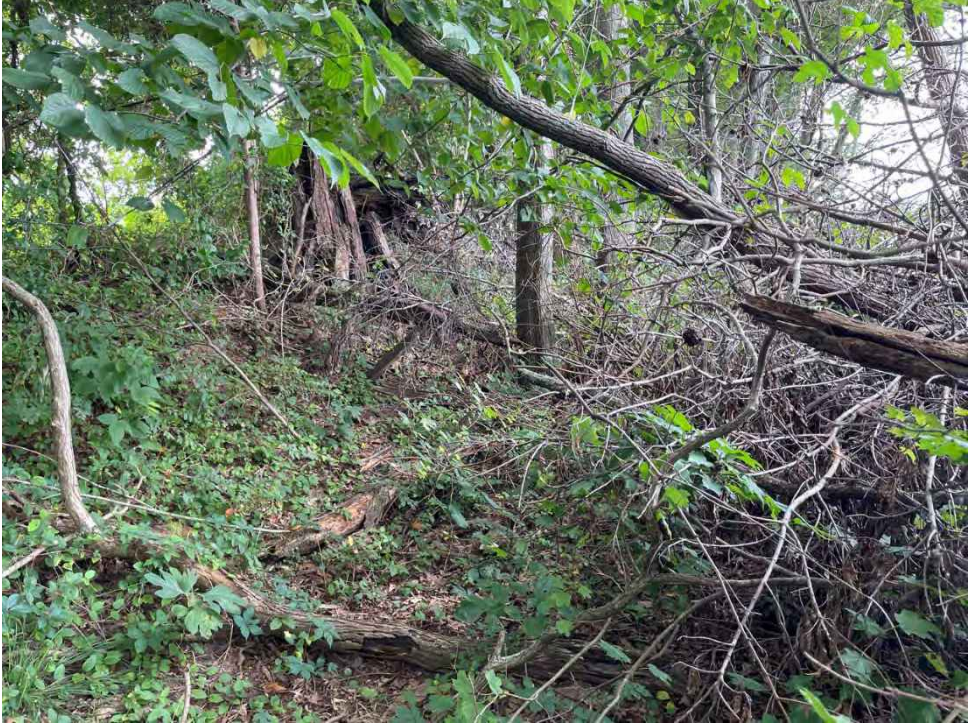
Project Name: Clover Creek Solar		County/State: Breckinridge County, Kentucky	Project No. 235300918
Photo No. 33	Date: 7/16/2024

Coordinates: 37.7481405, -86.4796385			
Photo Direction: NW			
Description: Upstream view of ephemeral stream S161

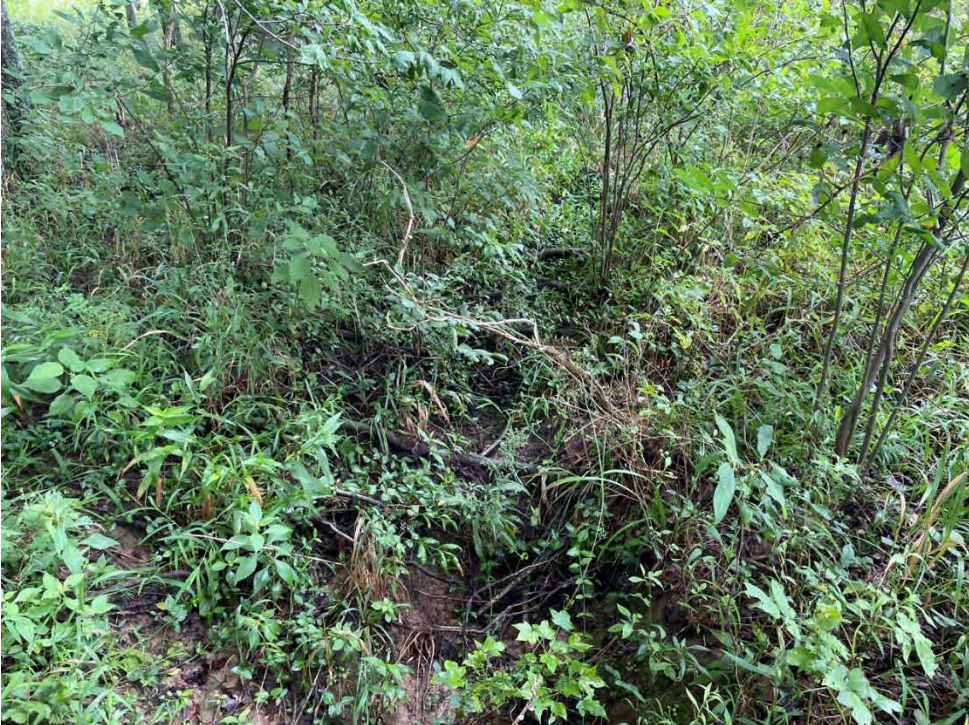
Project Name: Clover Creek Solar		County/State: Breckinridge County, Kentucky	Project No. 235300918
Photo No. 34	Date: 7/16/2024

Coordinates: 37.7506380, -86.4835622			
Photo Direction: SE			
Description: Upstream view of ephemeral stream S162

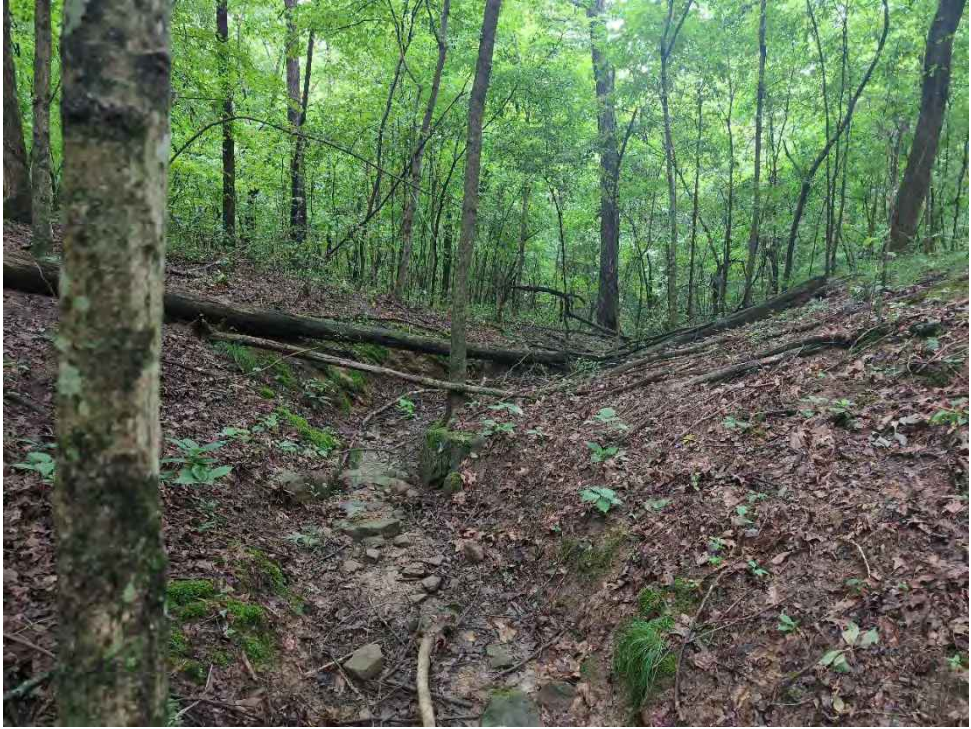
Project Name: Clover Creek Solar		County/State: Breckinridge County, Kentucky	Project No. 235300918
Photo No. 35	Date: 7/17/2024

Coordinates: 37.7436284, 86.4661250			
Photo Direction: NE			
Description: Downstream view of intermittent stream S163
