WETLAND DELINEATION REPORT

Clover Creek Solar Project LLC d/b/a New
Frontiers Solar Park —Breckinridge County,
Kentucky

Updated October 2024

Project Number:
235300918

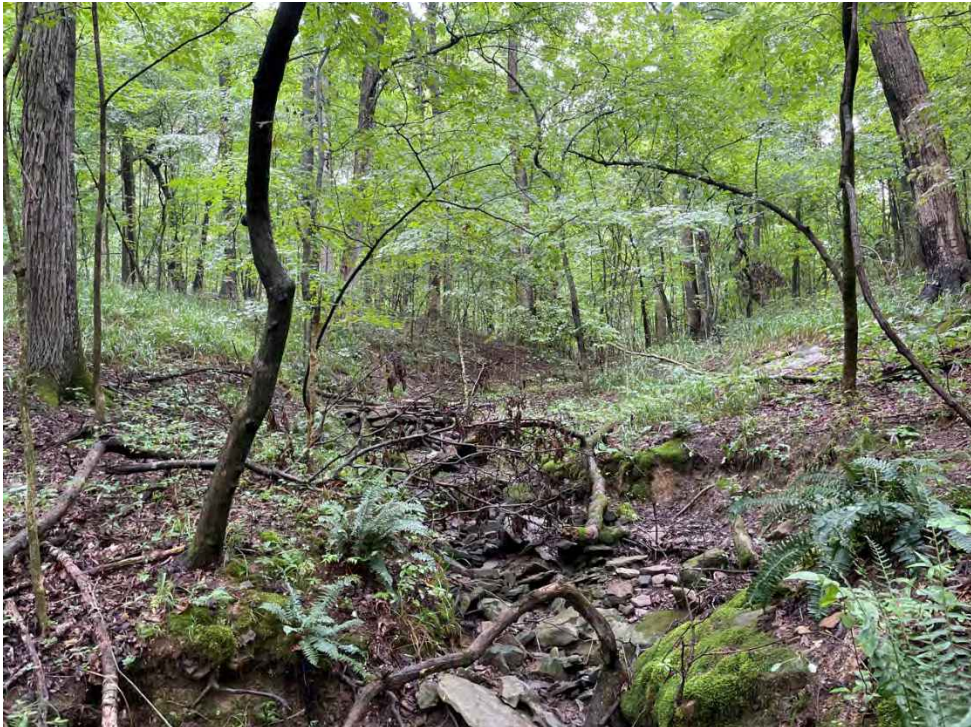
Project Name: Clover Creek Solar		County/State: Breckinridge County, Kentucky	Project No. 235300918
Photo No. 36	Date: 7/17/2024

Coordinates: 37.7430050, -86.466304			
Photo Direction: SE			
Description: Downstream view of intermittent stream S164

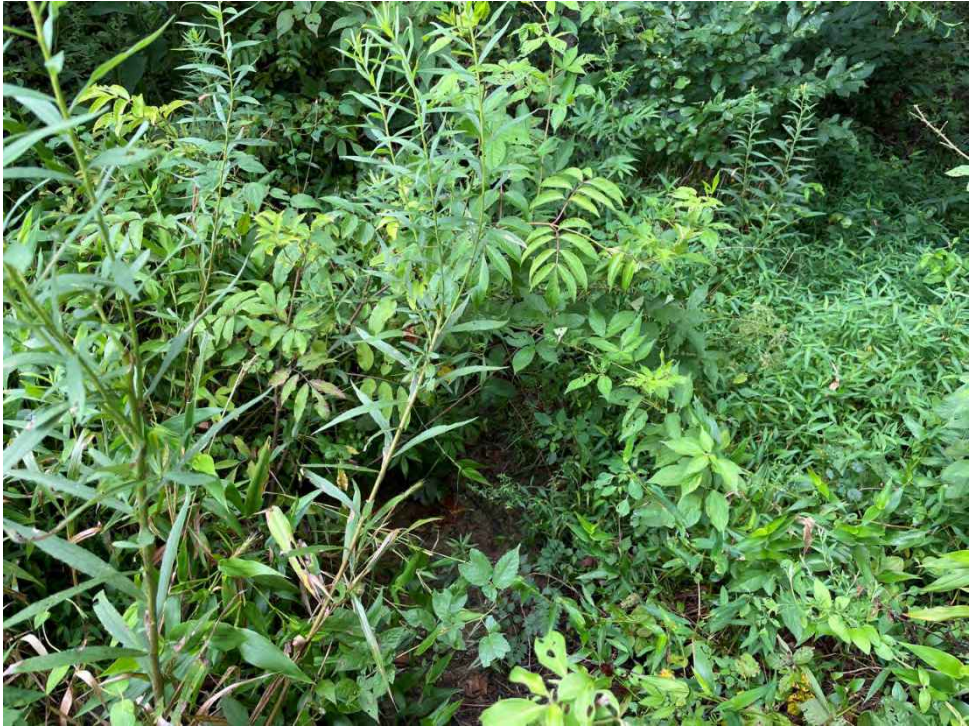
Project Name: Clover Creek Solar		County/State: Breckinridge County, Kentucky	Project No. 235300918
Photo No. 37	Date: 7/17/2024

Coordinates: 37.75780563, -86.464049			
Photo Direction: S			
Description: Downstream view of ephemeral stream S165

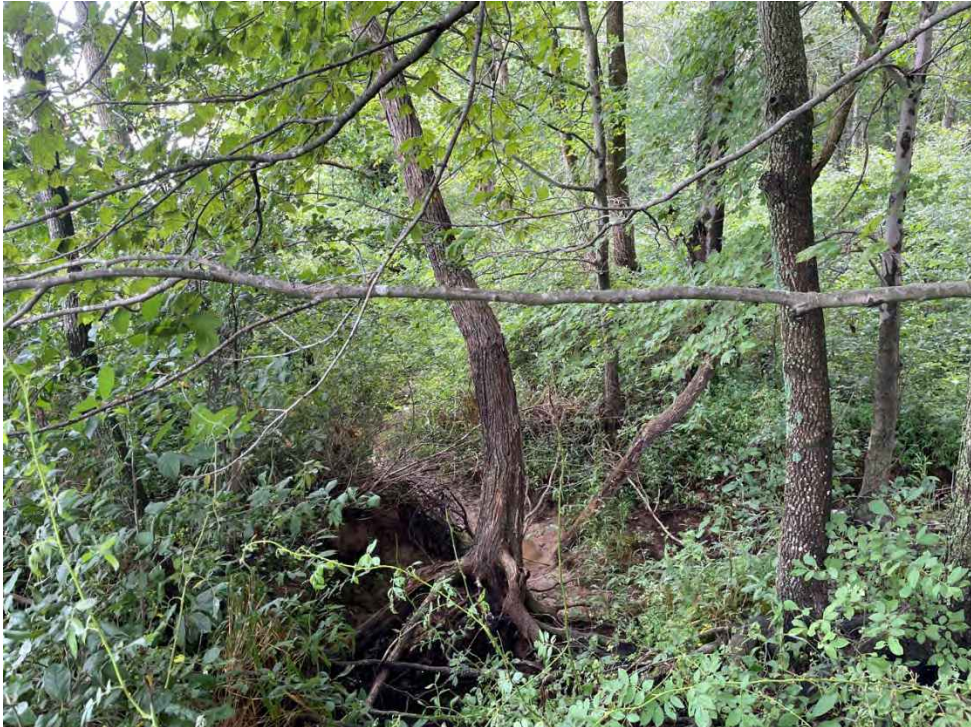
Project Name: Clover Creek Solar		County/State: Breckinridge County, Kentucky	Project No. 235300918
Photo No. 38	Date: 7/17/2024

Coordinates: 37.7513349, -86.4609997			
Photo Direction: NW			
Description: Upstream view of ephemeral stream S166

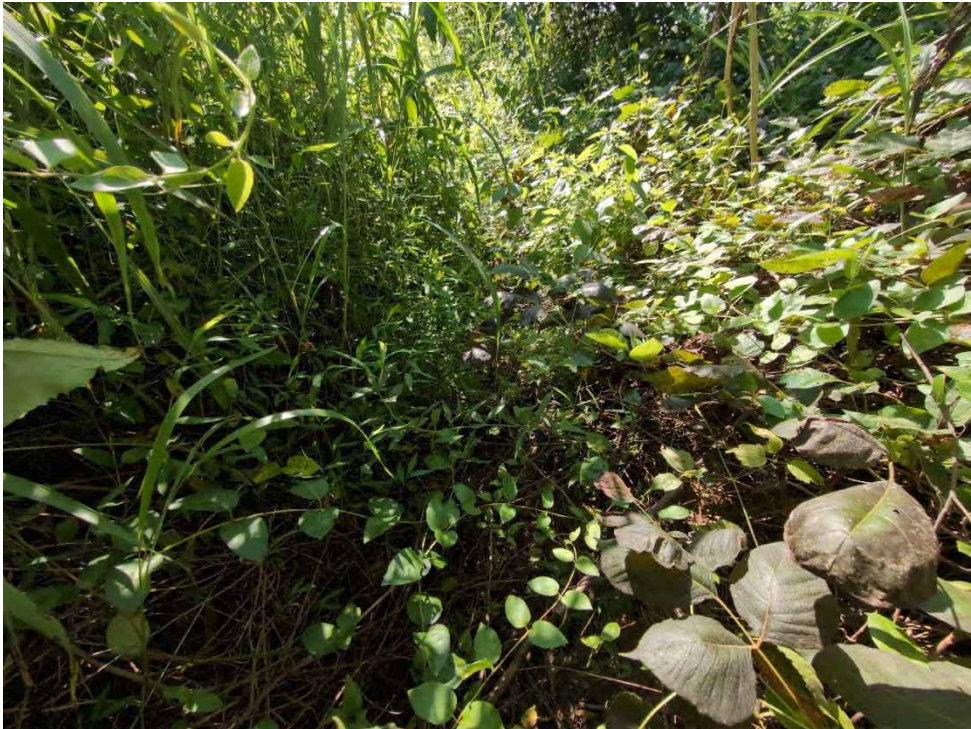
Project Name: Clover Creek Solar		County/State: Breckinridge County, Kentucky	Project No. 235300918
Photo No. 40	Date: 7/17/2024

Coordinates: 37.76821626, -86.481072			
Photo Direction: SE			
Description: Upstream view of ephemeral stream S168

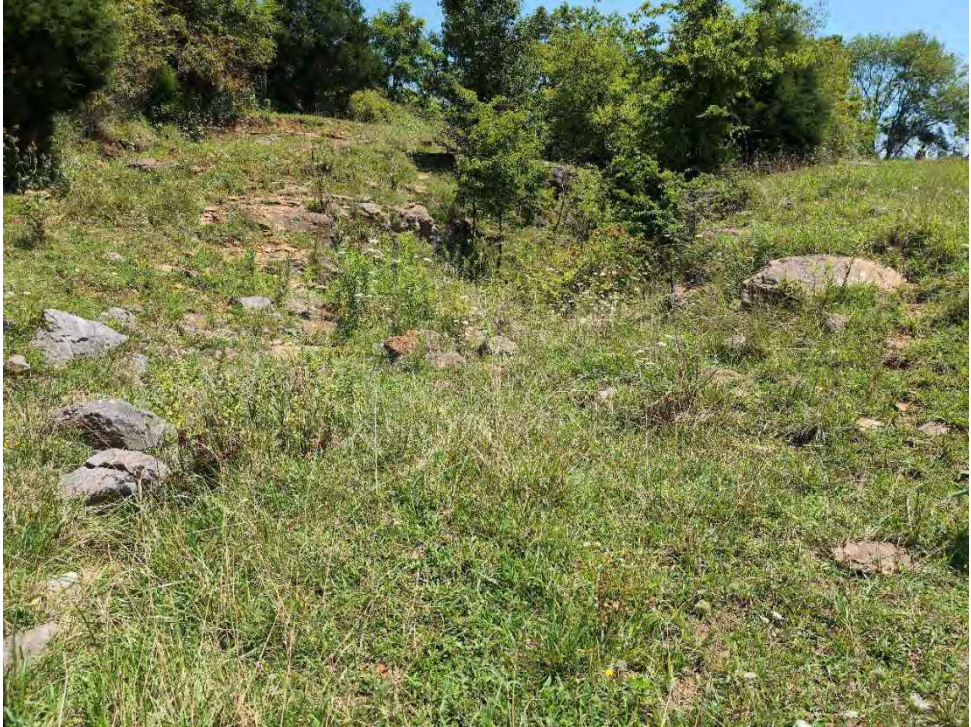
Project Name: Clover Creek Solar		County/State: Breckinridge County, Kentucky	Project No. 235300918
Photo No. 41	Date: 7/17/2024

Coordinates: 37.7626816, -86.4673921			
Photo Direction: NE			
Description: Upstream view of intermittent stream S169

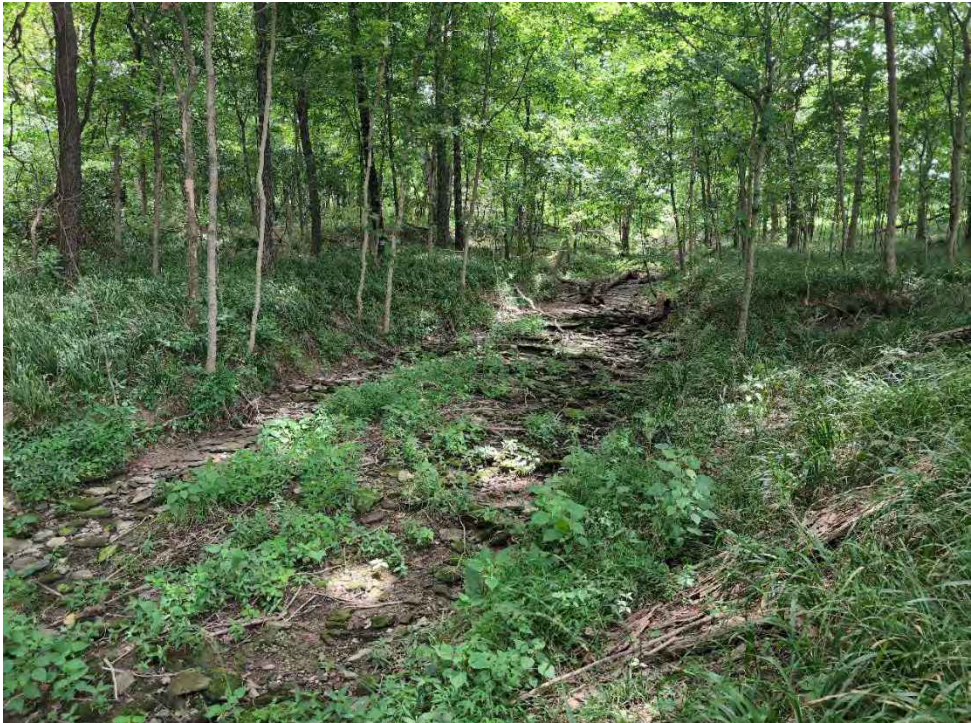
Project Name: Clover Creek Solar		County/State: Breckinridge County, Kentucky	Project No. 235300918
Photo No. 42	Date: 7/17/2024

Coordinates: 37.7414405, -86.4814579			
Photo Direction: SE			
Description: Downstream view of intermittent stream S170

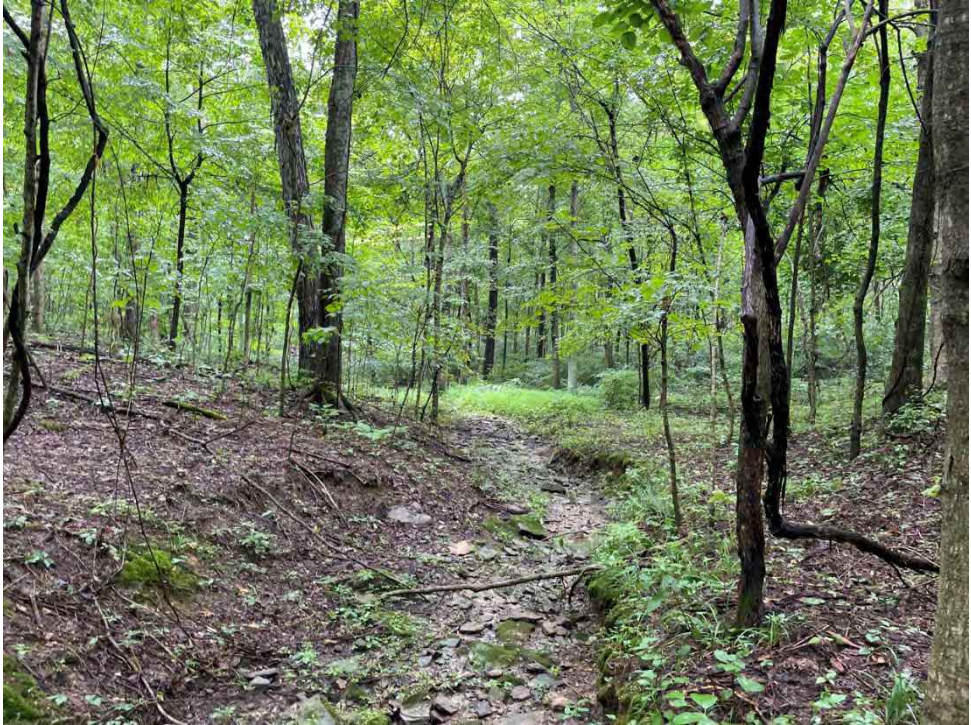
Project Name: Clover Creek Solar		County/State: Breckinridge County, Kentucky	Project No. 235300918
Photo No. 43	Date: 7/17/2024

Coordinates: 37.7394251, -86.4899636			
Photo Direction: NW			
Description: Upstream view of ephemeral stream S171

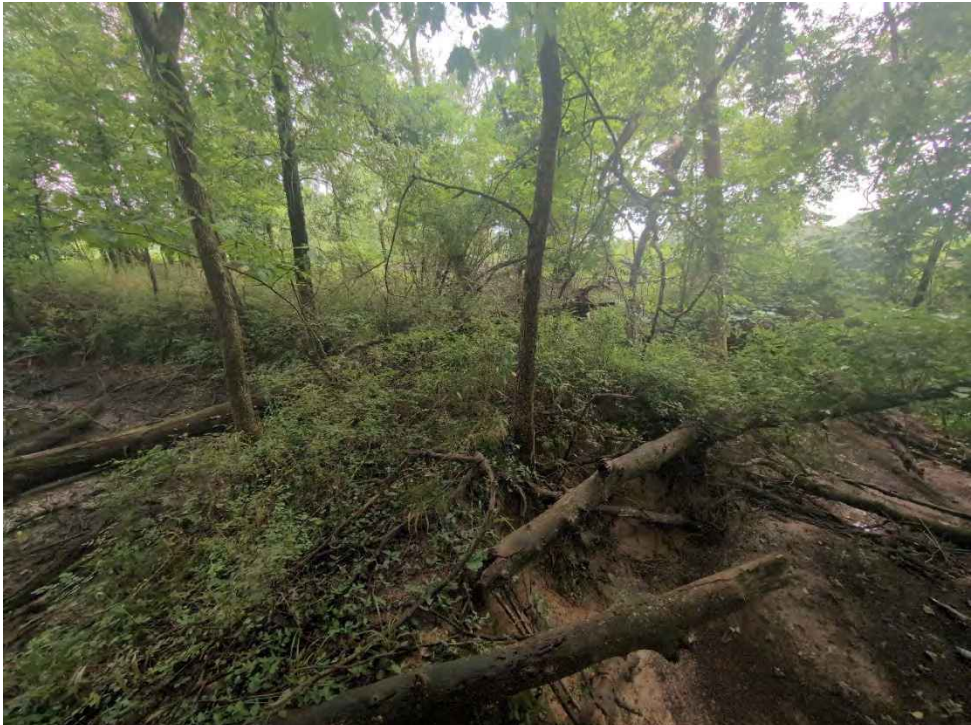
Project Name: Clover Creek Solar		County/State: Breckinridge County, Kentucky	Project No. 235300918
Photo No. 44	Date: 7/17/2024

Coordinates: 37.7411064, -86.4864226			
Photo Direction: N			
Description: Upstream view of ephemeral stream S172

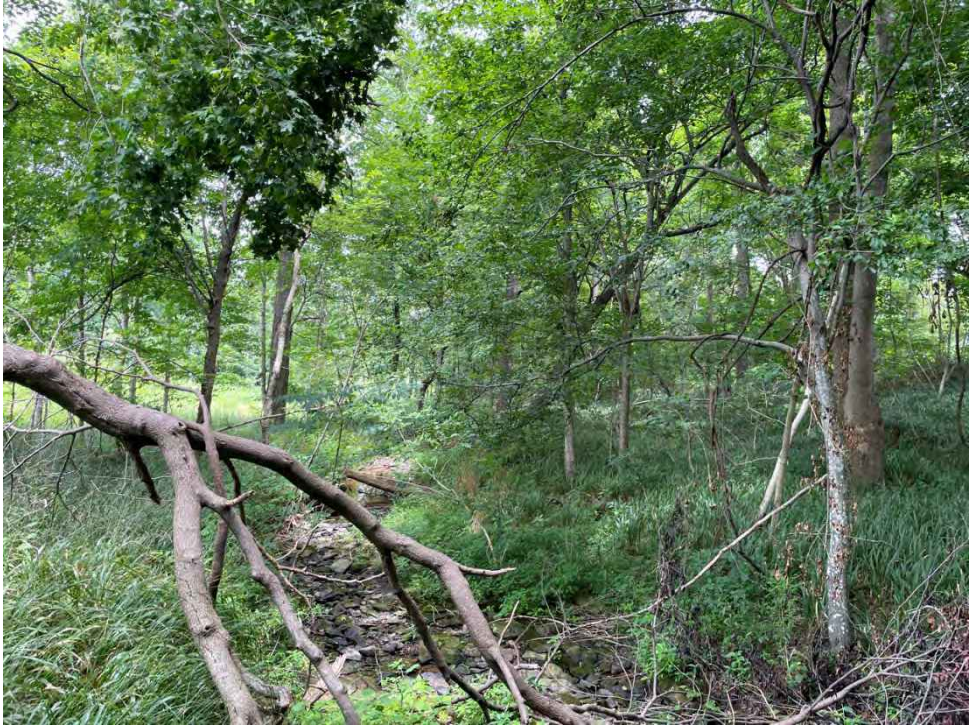
Project Name: Clover Creek Solar		County/State: Breckinridge County, Kentucky	Project No. 235300918
Photo No. 45	Date: 7/17/2024

Coordinates: 37.7374983, -86.4811865			
Photo Direction: N			
Description: Upstream view of ephemeral stream S173

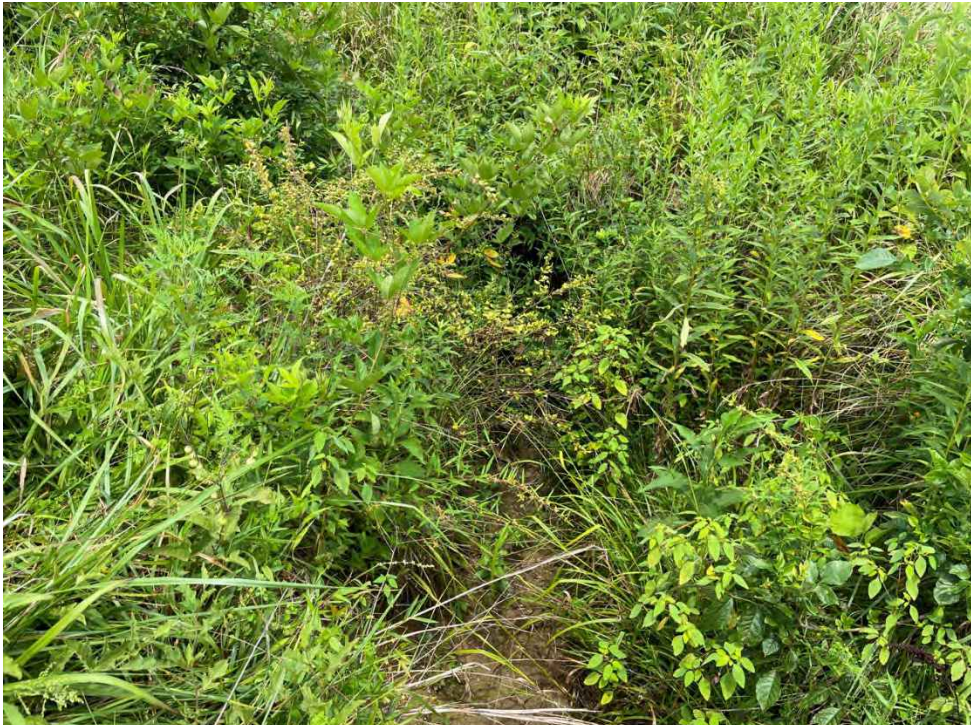
Project Name: Clover Creek Solar		County/State: Breckinridge County, Kentucky	Project No. 235300918
Photo No. 46	Date: 7/17/2024

Coordinates: 37.7375366, -86.4800918			
Photo Direction: SE			
Description: Downstream view of ephemeral stream S174

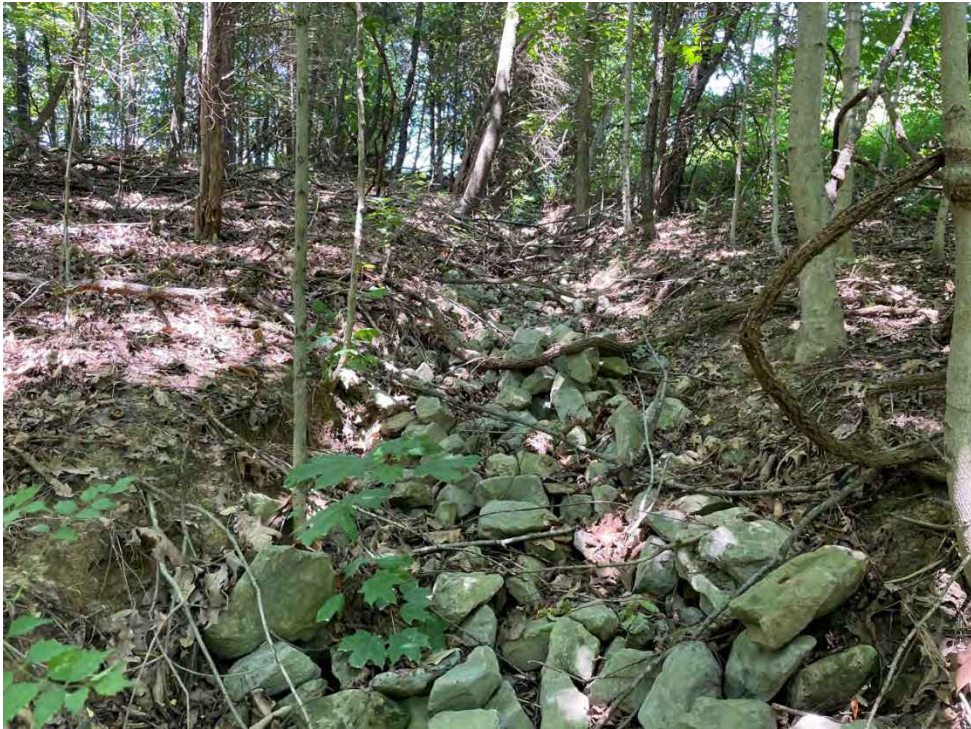
Project Name: Clover Creek Solar		County/State: Breckinridge County, Kentucky	Project No. 235300918
Photo No. 48	Date: 7/18/2024

Coordinates: 37.7728692, -86.4771514			
Photo Direction: NE			
Description: Upstream view of ephemeral stream S176

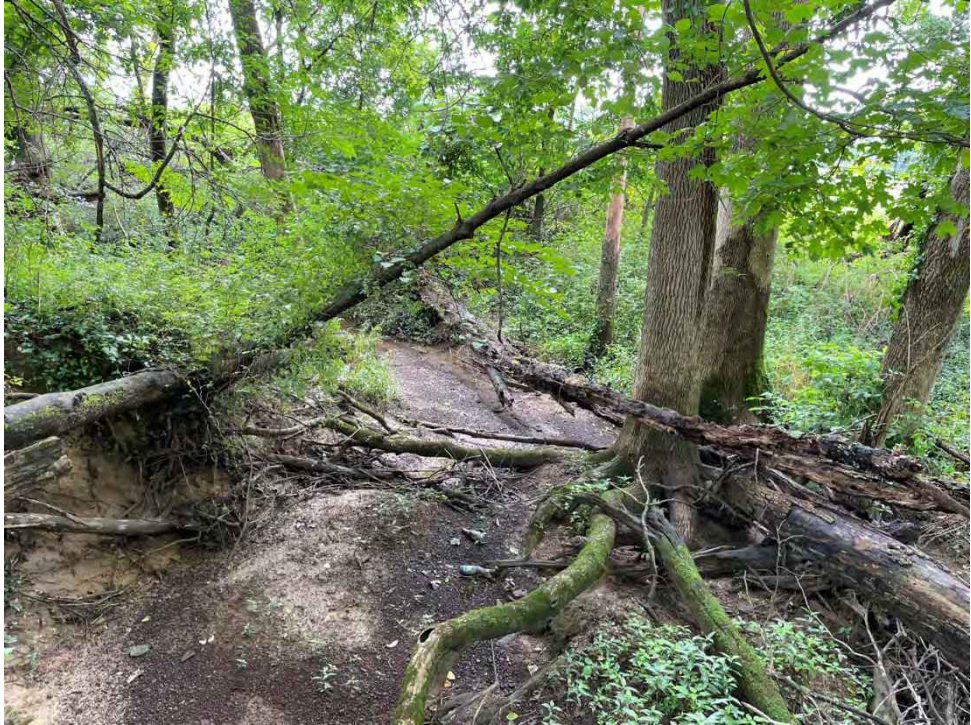
Project Name: Clover Creek Solar		County/State: Breckinridge County, Kentucky	Project No. 235300918
Photo No. 49	Date: 7/17/2024

Coordinates: 37.7516848, -86.470808			
Photo Direction: NE			
Description: Downstream view of ephemeral stream S177

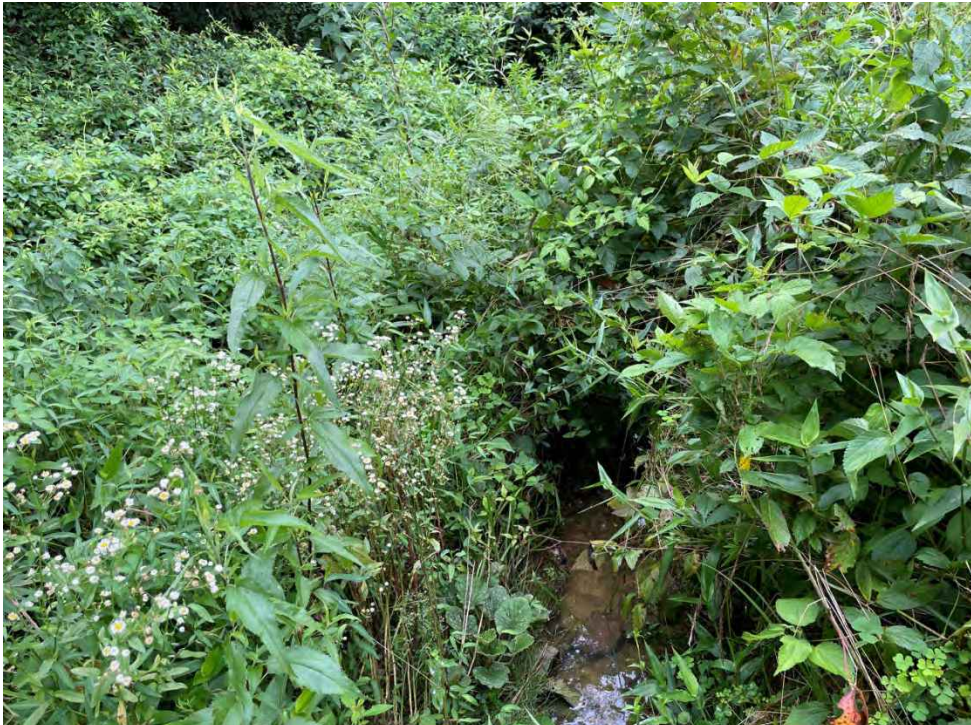
Coordinates: 37.7520280, -86.4704858			
Photo Direction: NE			
Description: Downstream view of ephemeral stream S178

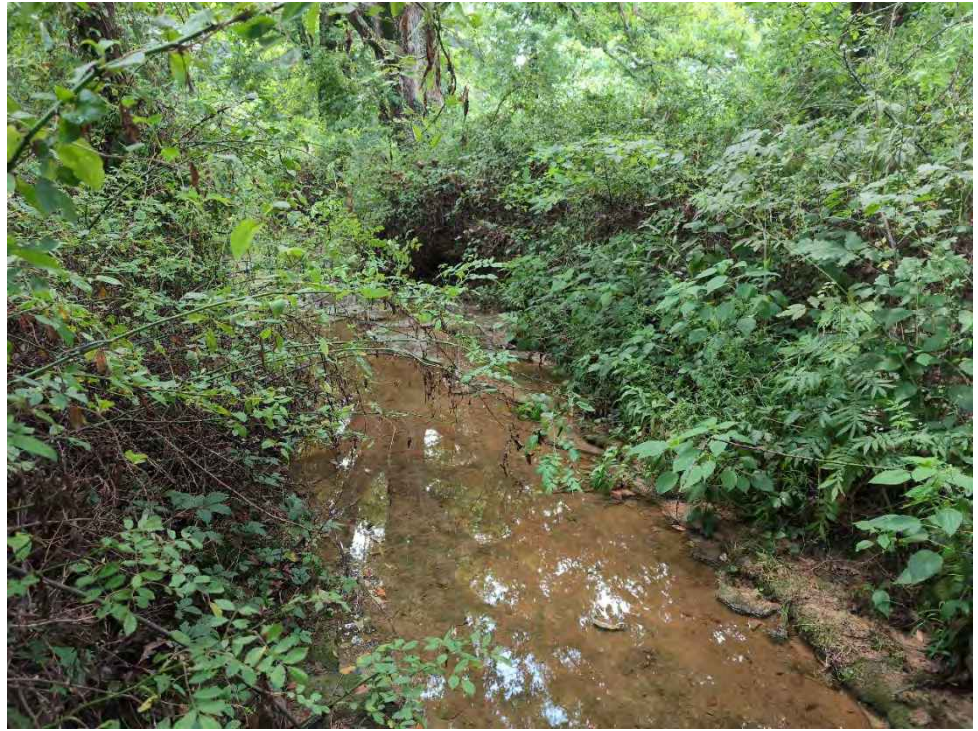
Photo Direction:
N

Description:
Upstream view of
intermittent stream S179
