Starfire Renewable Power Project

Water / Wetland Delineation Report

Re: Water/Wetland Delineation Report – Starfire Renewable Power Project

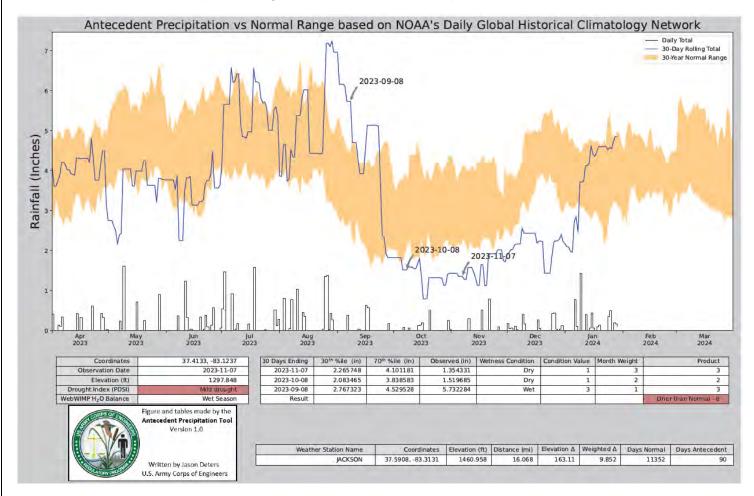
The USACE Antecedent Precipitation Tool (Deters 2023) was reviewed for the project location at the time of the field assessments to determine if recent precipitation for the area was within normal ranges. The tool rated November 7, 2023 as "Drier Than Normal - 8" and generated a drought index rating of "incipient drought." The screenshot below provides an overview of this data.

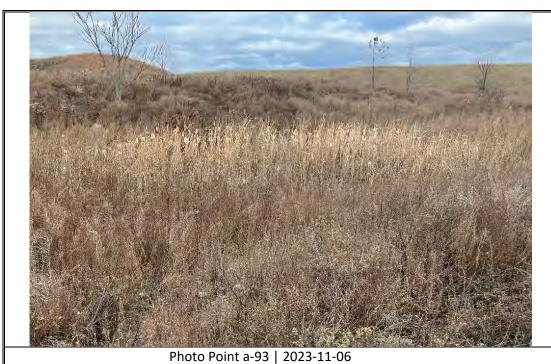
Lat. 37.406875°, Long. -83.132714° | Wetland A

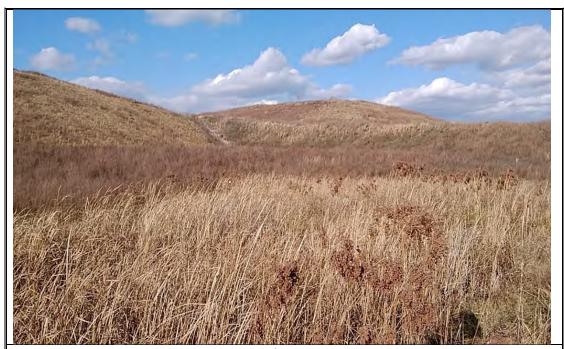
Photo Point 105 | 2023-11-07

Lat. 37.40846°, Long. -83.13296° | Isolated Wetland C

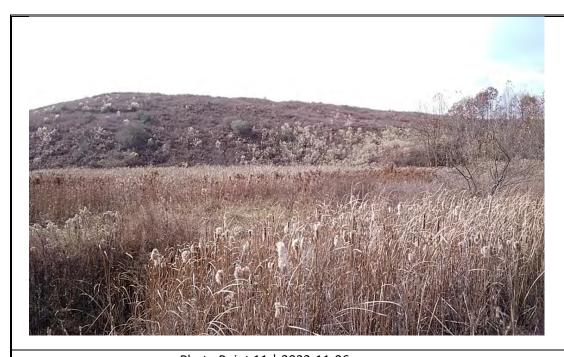
Photo Point 11 | 2023-11-06

Lat. 37.41264°, Long. -83.12733° | Isolated Wetland H, West side

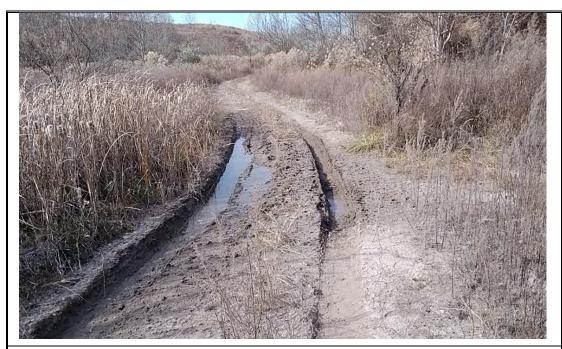
Photo Point 11 | 2023-11-06

Lat. 37.41264°, Long. -83.12733° | Isolated Wetland H, Road runs through

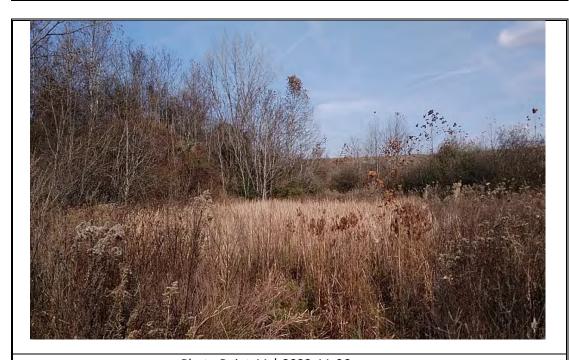
Photo Point 11 | 2023-11-06

Lat. 37.41264°, Long. -83.12733° | Isolated Wetland H, East side

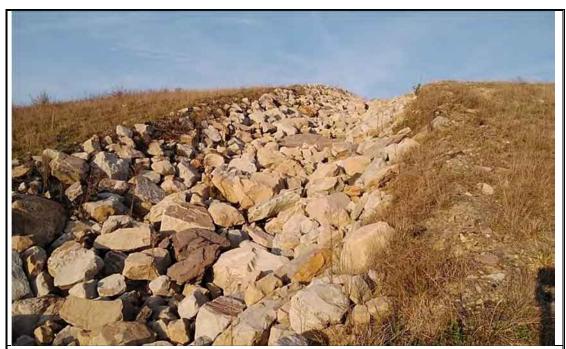
Photo Point 36 | 2023-11-06

Ditches on the site vary from narrow, shallow drainages to large, reinforced drainage channels armored with riprap and boulders. Evidence of flow was observed in only a few sections of the ditches and the flow indicators faded out without connecting to downstream defined drainages. The Kentucky Division of Water's Water Quality Certification Map Viewer Tool (KDOW 2024), which incorporates updated mapping, shows no NHD Blue Line Waters on the site with the exception of one blue line in the northern portion of the site. This line is classified by the tool as an unnamed Canal/Ditch. The line overlaps approximately 900 feet of the downstream end of a constructed ditch which is reinforced with riprap and boulders.

Lat. 37.40684°, Long. -83.11129° | Typical large reinforced ditch / drainage channel

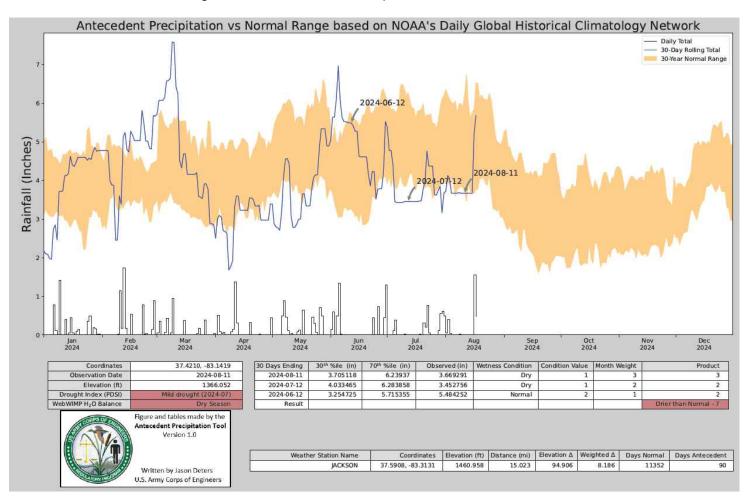
The USACE Antecedent Precipitation Tool (Deters 2023) was reviewed for the project location at the time of the field assessments to determine if recent precipitation for the area was within normal ranges. The tool rated August 12, 2024 as "Drier Than Normal – 7" and generated a drought index rating of "mild drought." The screenshot below provides an overview of this data.

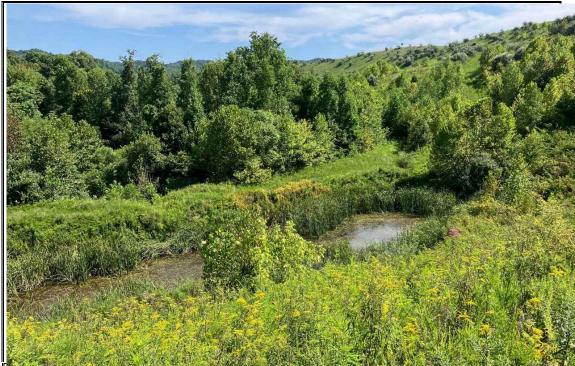
Priotograph 3: view of wetiand 1 and Pond 1 along the eastern edge of the site, racing southeast from an access road upslope of the features. August 12, 2024.

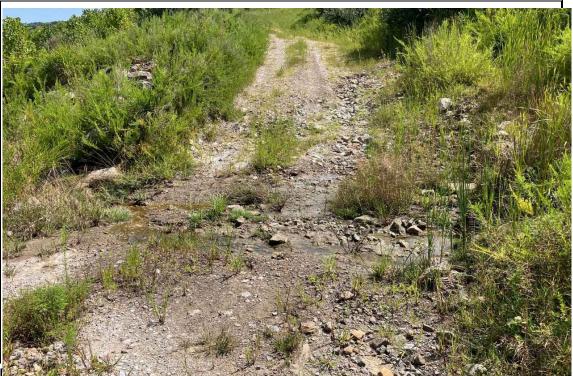
Photograph 4: Some water was observed flowing across the access road from Wetland 2 into Wetland 1, but this area does not have a defined bed and bank and was not classified as a stream. August 12, 2024.

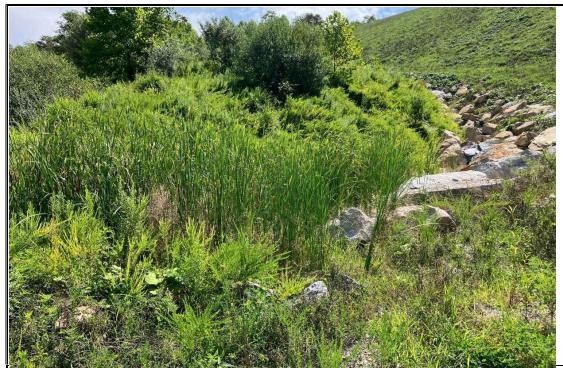
Photograph 5: View of Wetland 2, which is located below an armored drainage and above an access road upslope of Wetland 1. August 12, 2024.

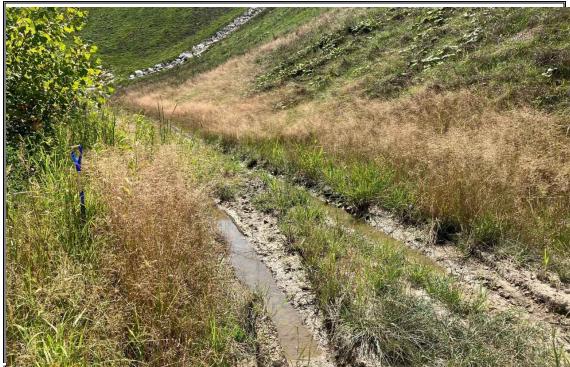
Photograph 6: View of Wetland 3, located in a low spot along an access road upslope of Wetland 1. August 12, 2024.

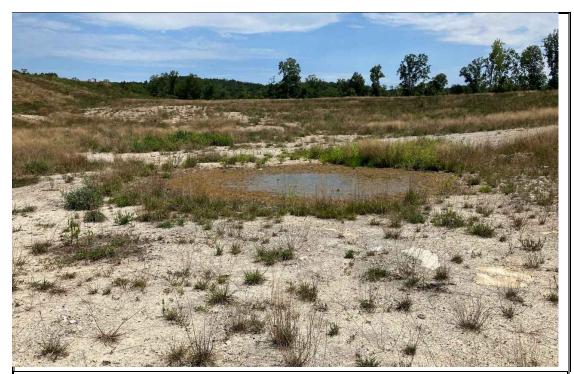
Photograph 7: View of Wetland 4, located in a low spot in the northern part of the study area. August 12, 2024.

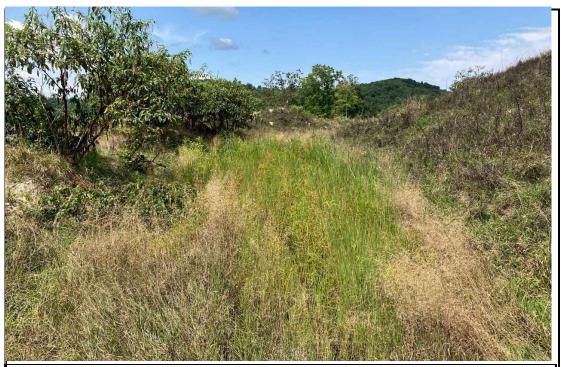
Photograph 8 View of Wetland 5, located in a low spot along an access road in the northwest part of the study area. August 12, 2024.

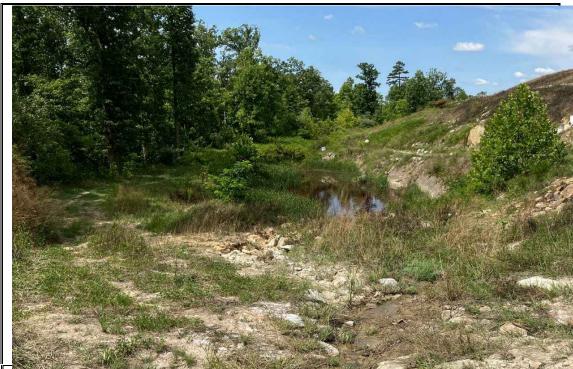
Protograph 9. view of Pond 2, which is located mostly offsite out has a small overlap in the northern part of the study area. August 12, 2024.

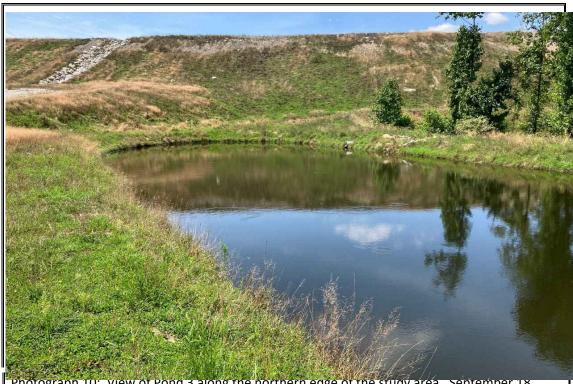
Photograph 10: View of Pond 3 along the northern edge of the study area. September 18, 2023.

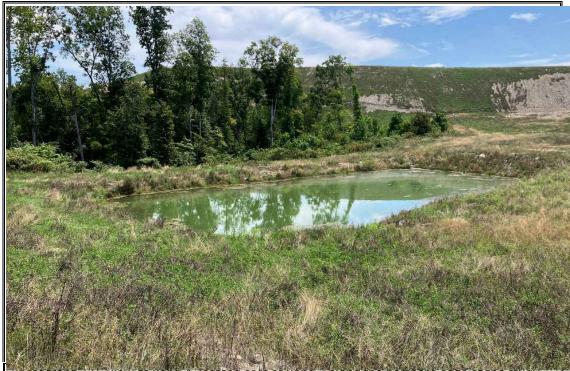
Photograph 11: View of Pond 4, located east of Pond 3 along the northern eage of the study area. August 12, 2024.

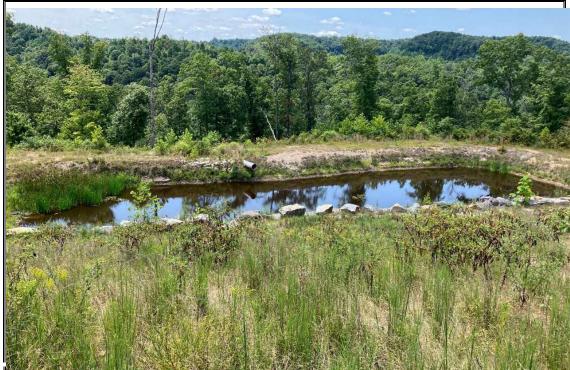
Photograph 12: View of Pond 5, which is located mostly offsite but has a small overlap in the northwestern part of the study area. August 12, 2024.
