Electronic Application Of Kentucky Power Company )  
For 1) A Certificate Of Public Convenience And )  
Necessity To Construct A Mechanical Draft Cooling )  
Tower At The Mitchell Plant 2) Approval Of Certain )  
Regulatory And Accounting Treatments, And 3) All )  
Other Required Approvals And Relief )

Case No. 2026-00001

**DIRECT TESTIMONY OF**  
**DANIEL W. PIZZINO**  
**ON BEHALF OF KENTUCKY POWER COMPANY**

### Mitchell U2 Cooling Tower DRAFT Example repair photographs February 2026

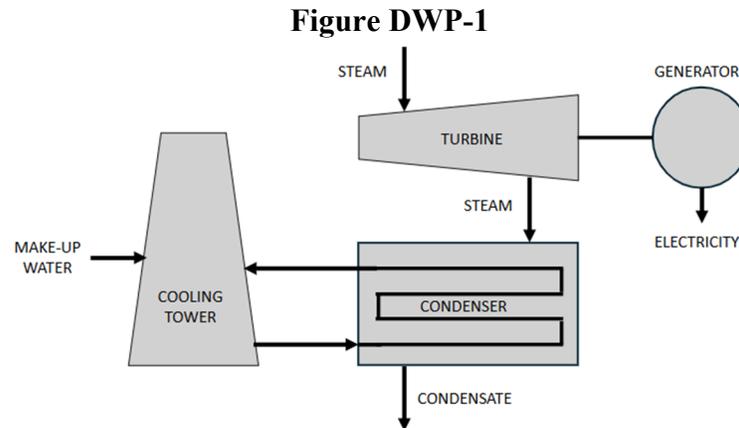
1 water into natural bodies of water. A basic layout of a closed loop water system is  
 2 shown in Figure DWP-1.

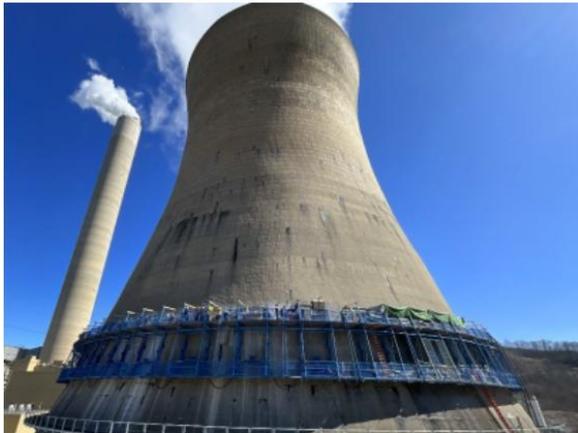
Photo 1 – Repair Working Platform

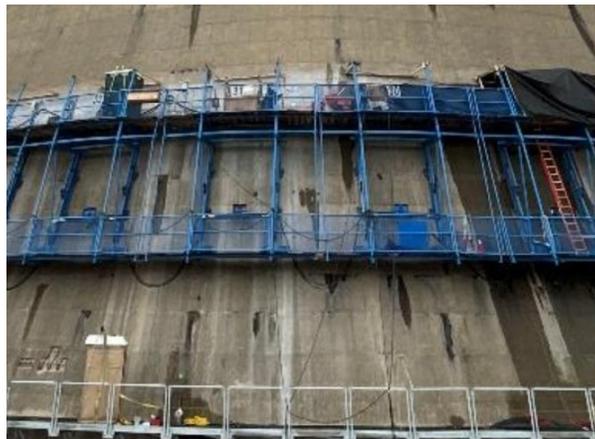
Photo 2 – Repair working platform

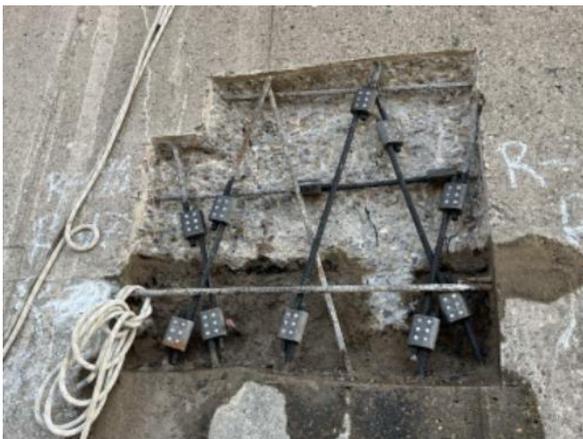
Photo 3 – Example of a partial depth concrete and rebar repair

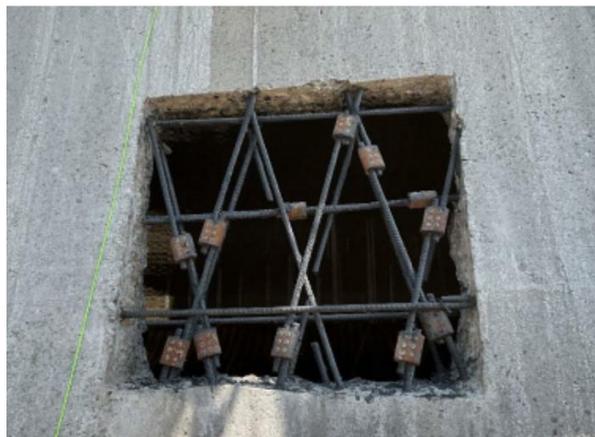
Photo 4 – Example of full depth concrete and rebar repairs

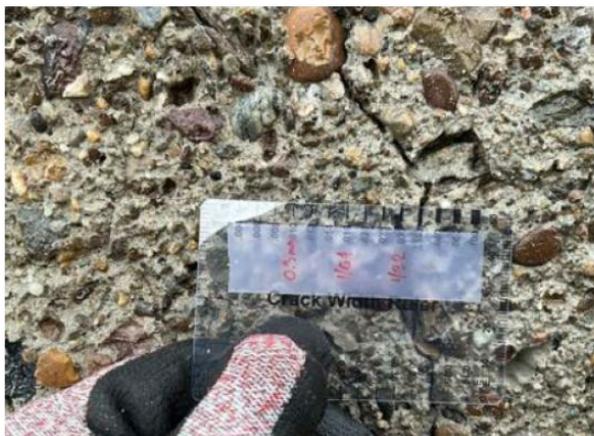
8 A. The initial observations utilized drones and binoculars to visually see the cracks. It  
9 wasn't until the scaffold was installed and the high-pressure water wash took place,  
10 that the extent of the cracking and damage was revealed. The high-pressure wash  
11 removed the outer layer of material from the surface at which point it was determined  
12 that the cracking was more extensive than the project scope.

Photo 5 – Example of crack identification after power washing surface

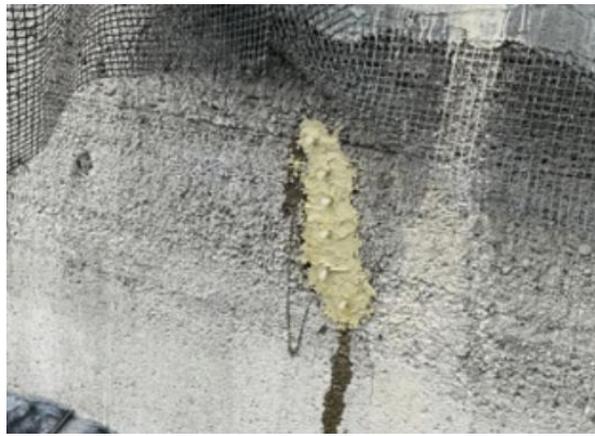
Photo 6 – Example of epoxy crack injection

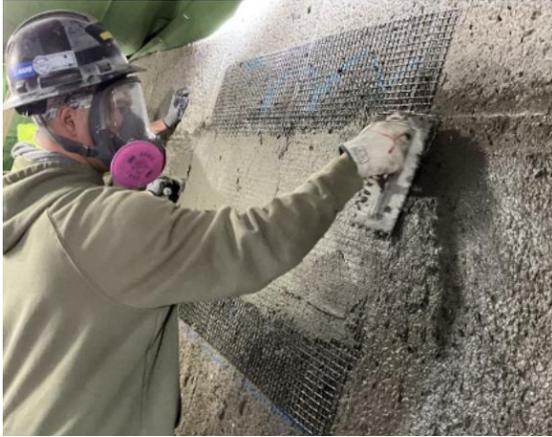
Photo 7 – Application of FRCM (Cement – Mesh – Cement)

1           To apply the FRCM, the initial layer cementitious material is applied to the  
2 shell surface. While that layer is still workable, the mesh is embedded into it, and then  
3 finishing layer of cementitious material is placed over the mesh. All these steps need  
4 to be performed at optimal weather conditions to allow adherence to the surface and  
5 proper time for the material to set. Additionally, concrete stiffening rings were to be  
6 installed in three locations to resist buckling of the overall concrete shell structure. Had  
7 the Initial Repair Project been completed as planned, the expected additional useful life  
8 of the Unit 2 Cooling Tower would have been 10 more years. Please see Exhibit DWP-  
9 2 for pictures of the process and materials used for the repairs.

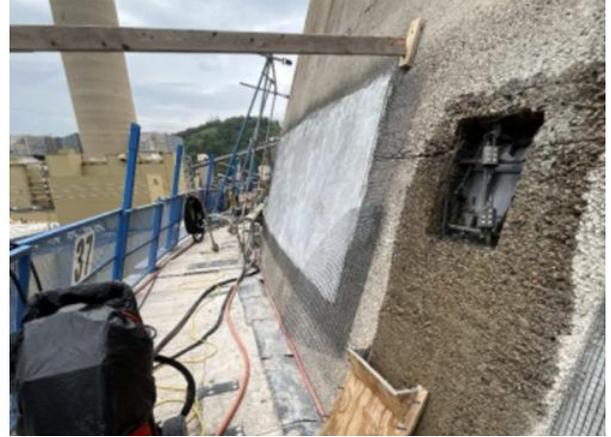
Photo 8 – Photo of completed FRCM and concrete repair in progress
