<p>Mitchell Unit 1 – Cooling Tower Concrete Shell Observation Report</p>	<p>Trip Report SES – RPT - 00269</p>	<p>Page 4 of 8</p>
<p>This document contains proprietary information of American Electric Power Service Corporation and is to be returned upon request. Its contents may not be used for other than the expressed purpose for which loaned without the written consent of American Electric Power Service Corporation.</p>

<p>Mitchell Unit#2 Cooling Tower</p>	<p>Historical Aerial Photos</p>	<p>Page 5 of 16</p>
<p>This document contains proprietary information of American Electric Power Service Corporation and is to be returned upon request. Its contents may not be used for other than the expressed purpose for which loaned without the written consent of American Electric Power Service Corporation.</p>

Analytical Evaluation of Mitchell Plant Unit #2 Cooling Tower
November 11, 2016

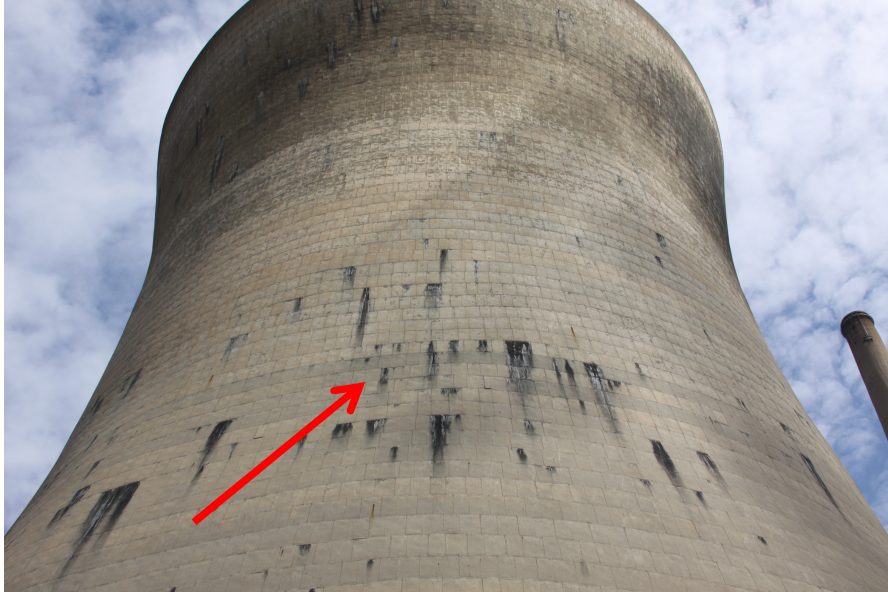
<p>Photo # 1</p>

<p>General photo of the exterior from the southwest. Arrow point to edge of dimple area.</p>	<p>Photo # 2</p>

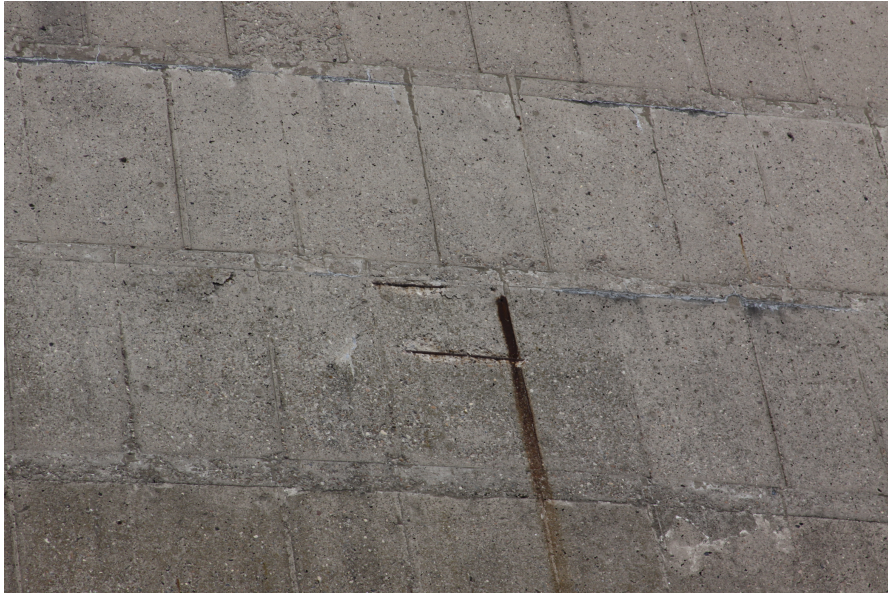
<p>General photo of horizontal steel reinforcement where the concrete cover has spalled off.</p>

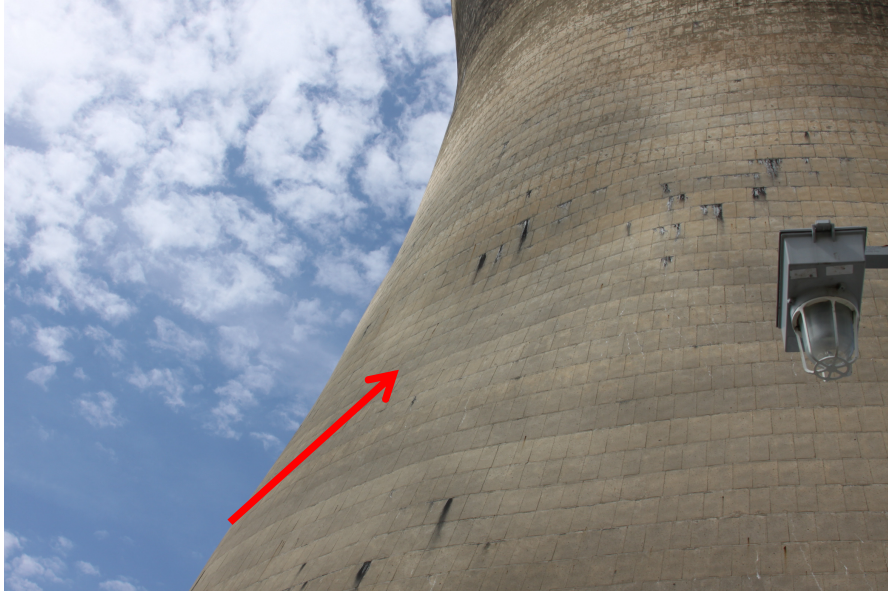
<p>Photo # 3</p>

<p>General photo of the southeast side. Arrow points to the edge of a large dimpled area.</p>	<p>Photo # 4</p>

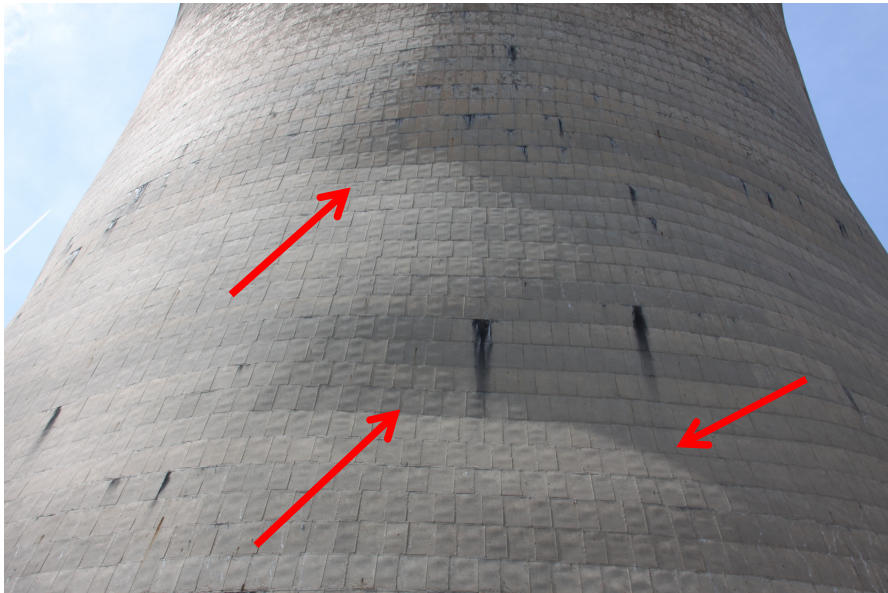
<p>General photo of the east side. Arrows point to some irregular areas.</p>

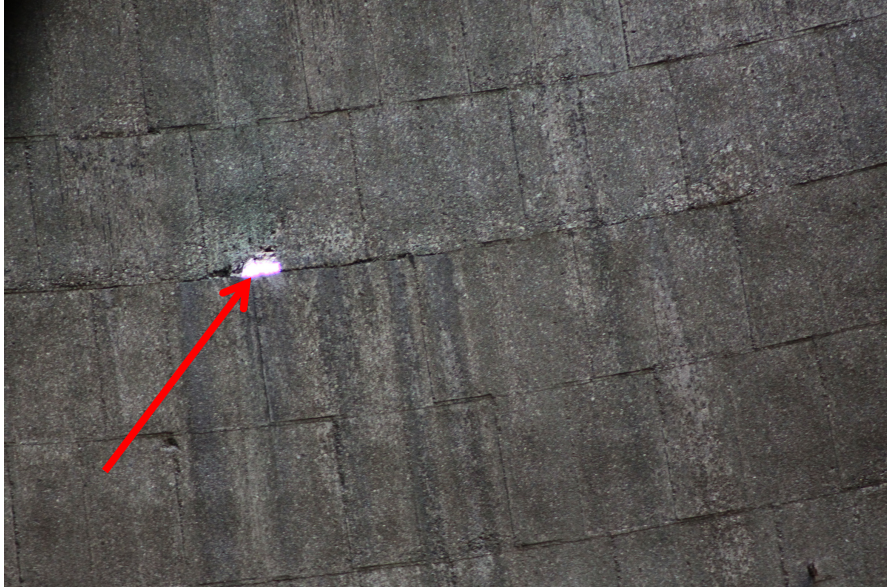
Photo # 6

General photo of a hole in the northwest area of the cooling tower shell seen from the inside looking out. The hole is below mid-height of the wall.

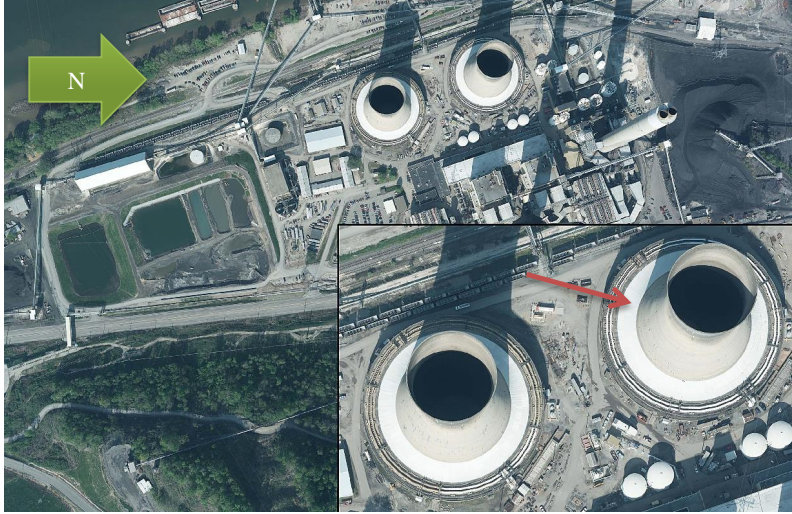
<p>Photo # 29</p>

<p>DATE: 5-7-2015</p> <p>This photo is the digital version of photo #28. It has better definition, and shows ripples or bumps on the southwest side of the tower.</p>

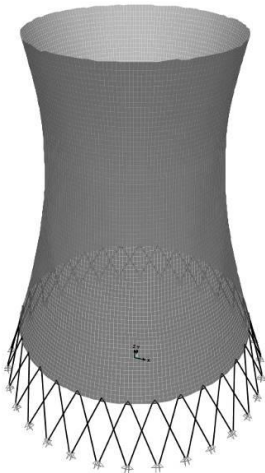
Figure 7. Existing scenario model using SAP2000

The existing condition modeling sought to recreate the existing deformed shape, provided from the 3D laser survey of the tower veil. For the analysis of this condition, the veil geometry obtained from the 3D laser survey was used as an unstressed structure and then the dead load and all subsequent loads were applied. This modelling approach produces larger dead-load and thermal deformations caused by p-delta effects. In reality the dead load and thermal loads contributed to produce the existing deformed shape. SAP2000 was utilized to perform design checks for current-code lateral load combinations and to perform linear buckling analyses, considering different load cases that could initiate global buckling. Figure 7 presents an image of the existing condition scenario model in SAP2000.
