**Re: Phase I Environmental Site Assessment  
Lynn Bark Energy Center  
East and West of South Wolf Creek Road  
Martin County, Kentucky**

# > **Phase I Environmental Site Assessment of the Lynn Bark Energy Center Martin County, Kentucky**

**Lynn Bark Energy Center  
East and West of South Wolf Creek Road  
Martin County, Kentucky**

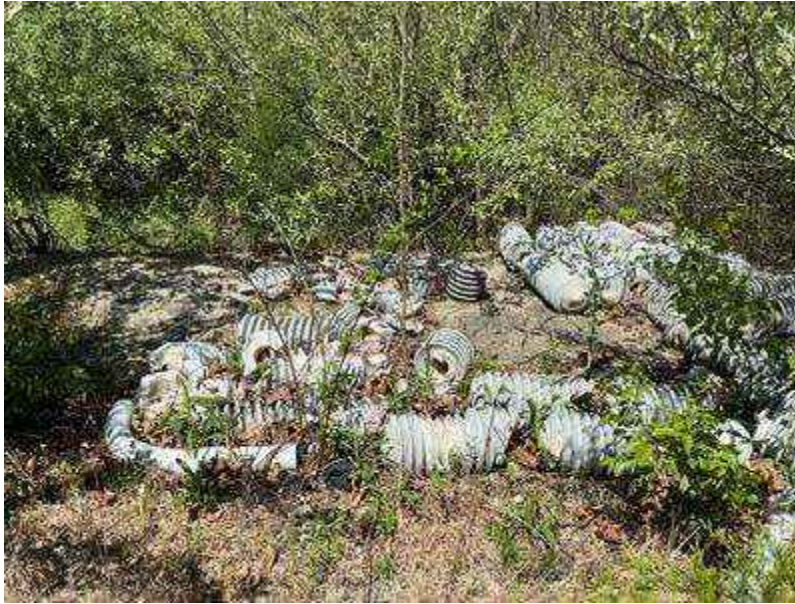
View of ceramic insulators and other discarded materials on the eastern portion of the Subject Property (Pocahontas parcel 040-00-00-020.00).

A debris pile appearing to primarily consist of ceramic insulators, an old telephone pole, and a dilapidated structure were observed on the eastern portion of the Subject Property (Pocahontas parcel 040-00-00-020.00). Refer to [Section 7.3](#) for further discussion.

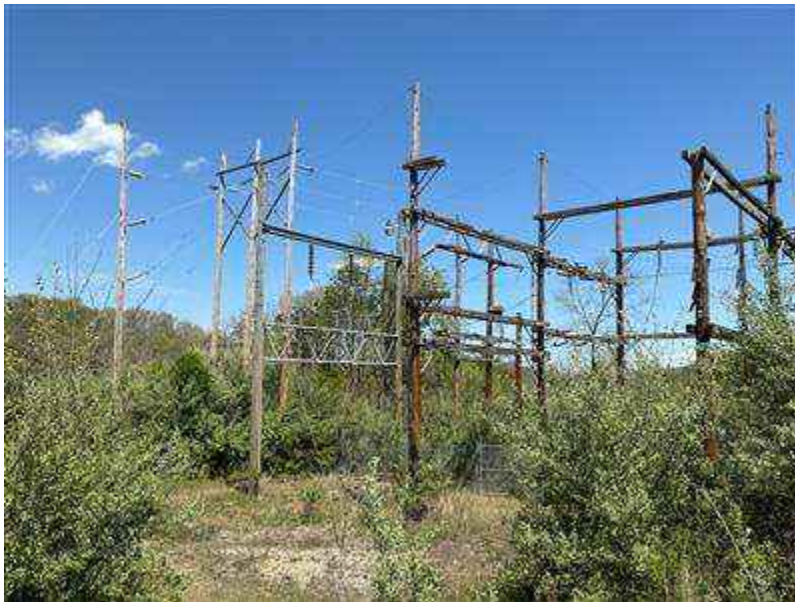
View of an abandoned/decommissioned electrical substation on the eastern portion of the Subject Property (Pocahontas parcel 040-00-00-020.00).

An electrical substation appearing to be abandoned/decommissioned was observed on the eastern portion of the Subject Property (Pocahontas parcel 040-00-00-020.00). Refer to [Section 7.3](#) for further discussion.

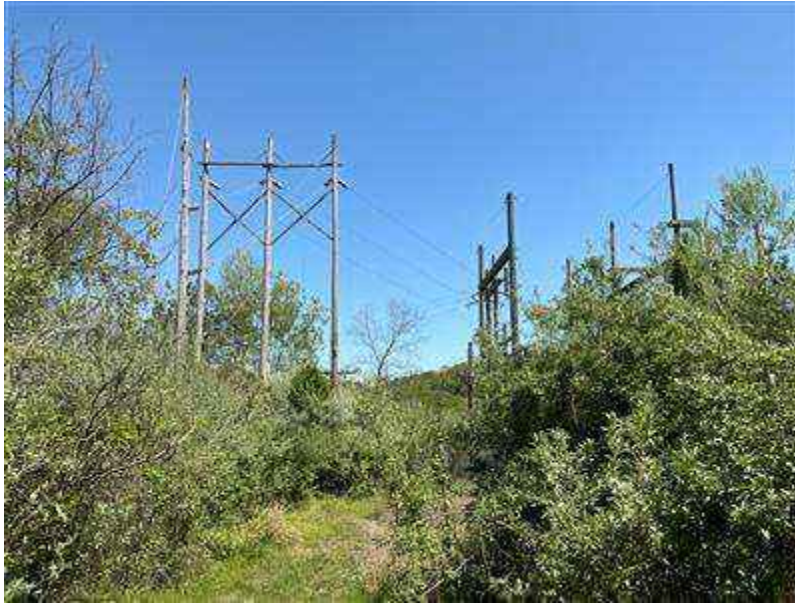
View of an abandoned/decommissioned electrical substation on the eastern portion of the Subject Property (Pocahontas parcel 040-00-00-020.00).

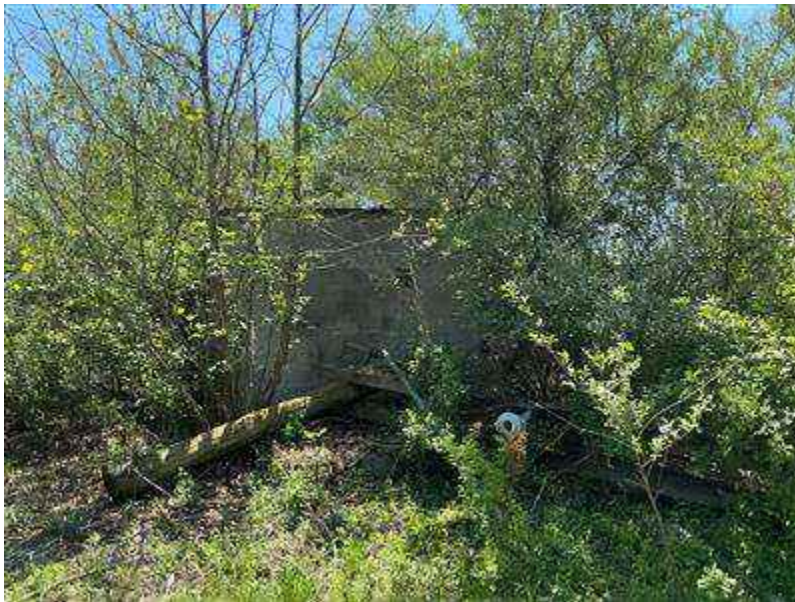
View of a dilapidated structure on the eastern portion of the Subject Property (Pocahontas parcel 040-00-00-020.00).

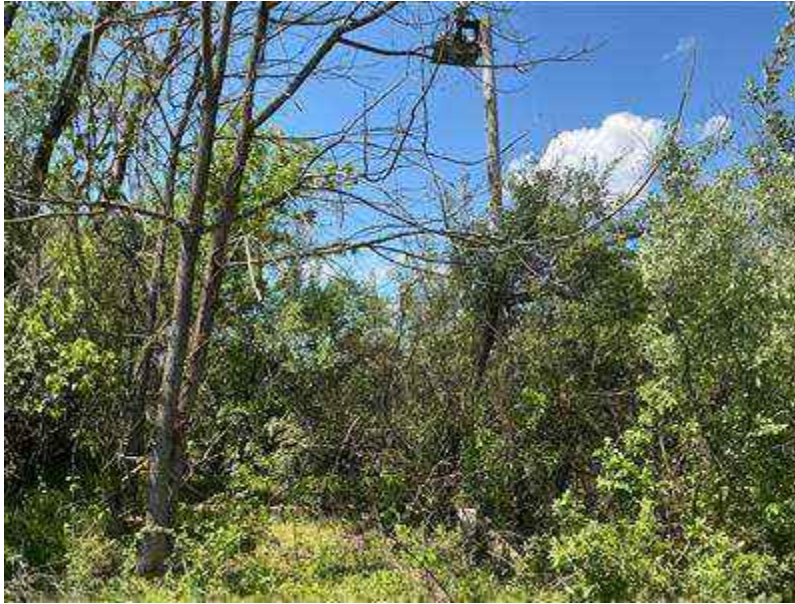
View of an old telephone pole on the eastern portion of the Subject Property (Pocahontas parcel 040-00-00-020.00).

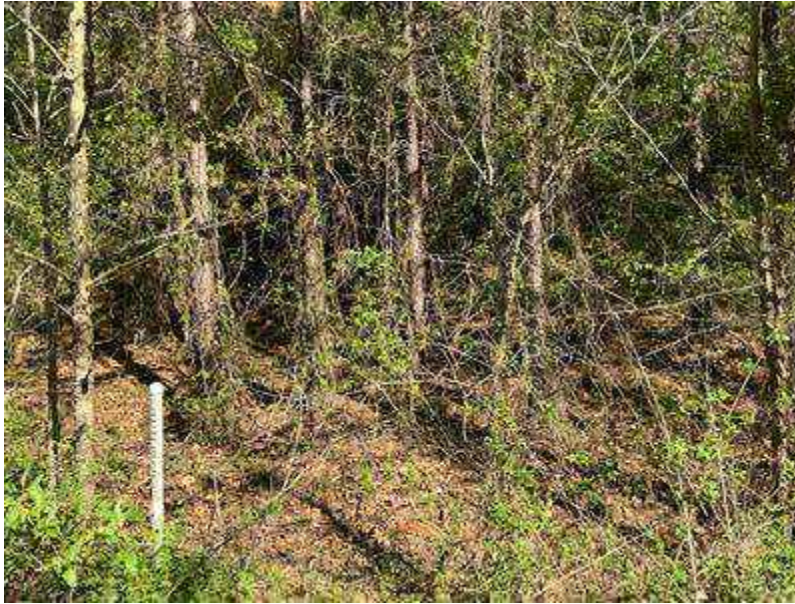
View of a gas line marker on the western portion of the Subject Property (Lexington Coal parcel 030-00-00-055.00).

A gas pipeline marker was observed on the western portion of the Subject Property (Lexington Coal parcel 030-00-00-054.00) and to the south of Pocahontas parcel 040-00-00-020.00. Refer to [Section 7.2](#) for further discussion.

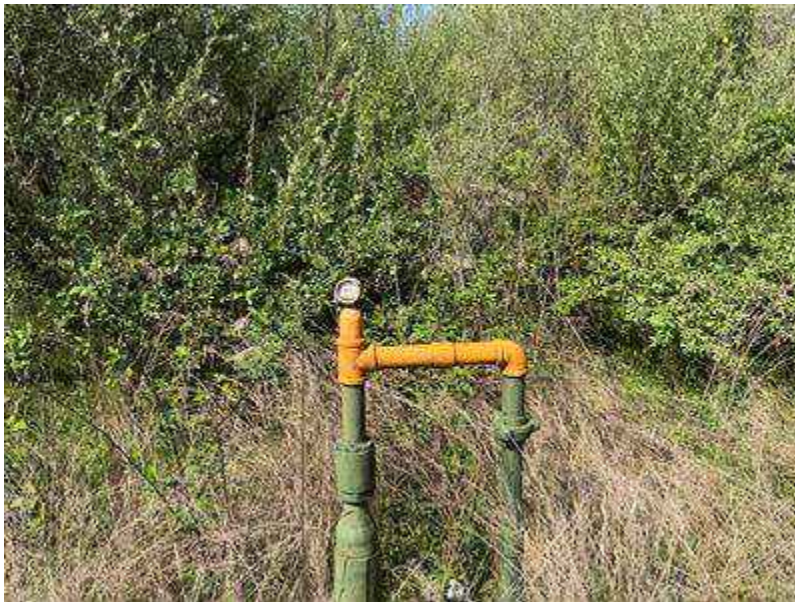
View of a gas well on the western portion of the Subject Property (Lexington Coal parcel 030-00-00-047.00).

A gas well was observed on the western portion of the Subject Property (Lexington Coal parcel 030-00-00-047.00) and to the south of Pocahontas parcel 040-00-00-020.00. Refer to [Section 7.2](#) for further discussion.

- **Oil/gas exploration (REC #1):** According to the KGS, a gas well was commenced within the western portion of the Subject Property by at least 2009 (Lexington Coal parcel 030-00-00-047.00) and three additional wells were identified within 200-feet of the Subject Property boundary. At the time of the site reconnaissance, a gas well (ID 118336) and an AST were observed on the western portion of the Subject Property (Lexington Coal parcel 030-00-00-047.00), and an oil/gas well not identified by the KGS was observed approximately 60 feet to the south of Pocahontas parcel 040-00-00-020.00. **Given the long-term presence of oil/gas exploration, infrastructure, site reconnaissance observations, the suspected presence of disposal pits, it is the EP's opinion that these findings represent a REC to the Subject Property, should these specific areas be located in areas designated for power line infrastructure.**

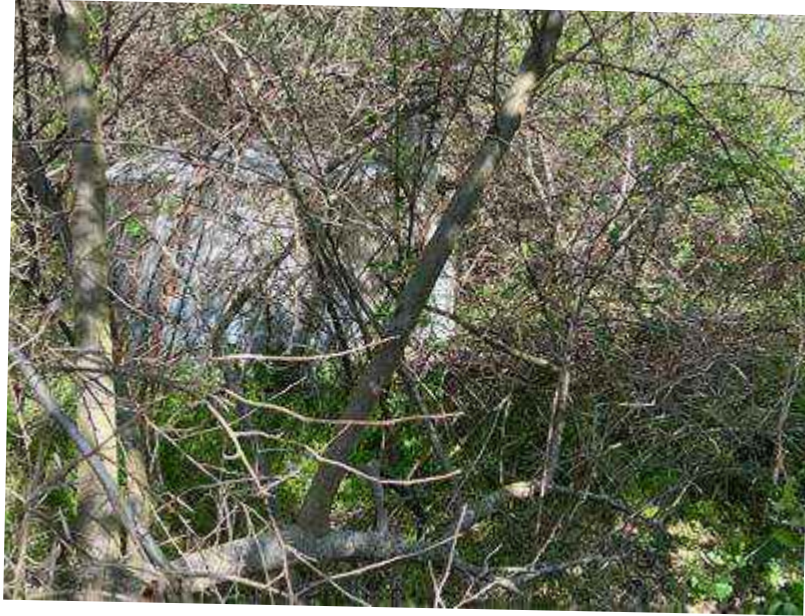
View of a partially filled 1,000-gallon AST on the western portion of the Subject Property (Lexington Coal parcel 030-00-00-047.00).

A partially filled 1,000-gallon AST was observed on the western portion of the Subject Property (Lexington Coal parcel 030-00-00-047.00). There were no observable signs of staining or stressed vegetation. Given that there was no odor detected to aid in identifying the liquid, ECT is of the opinion that the observed AST is likely partially filled with rainwater. Refer to [Section 7.3](#) for further discussion.

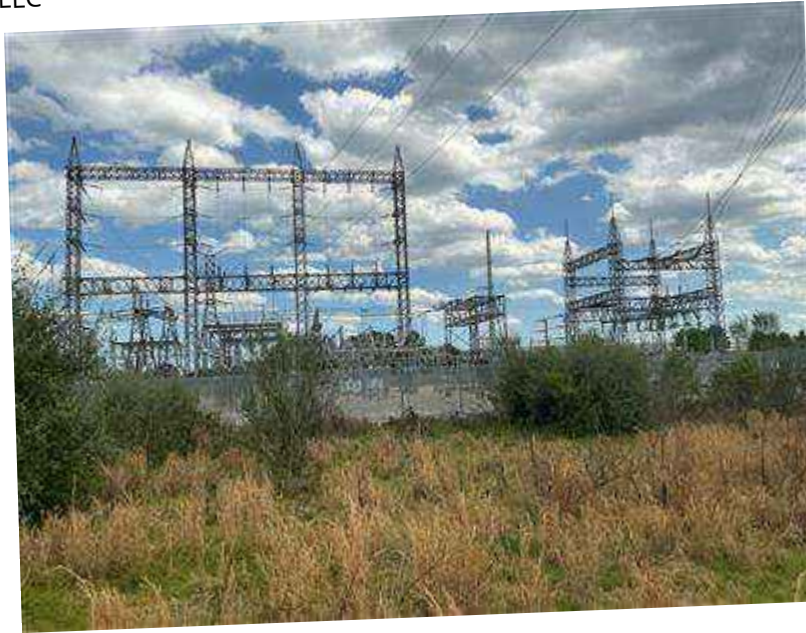
View of a Substation to the south of Pocahontas parcel 040-00-00-020.00.

An electrical substation and solar arrays were observed to the south of Pocahontas parcel 040-00-00-020.00. Given the overall distance of the electrical substation in relation to the Subject Property (approximately 390 feet), and lack of observed staining and/or stressed vegetation, it is the opinion of the EP that this finding does not represent a *REC*.

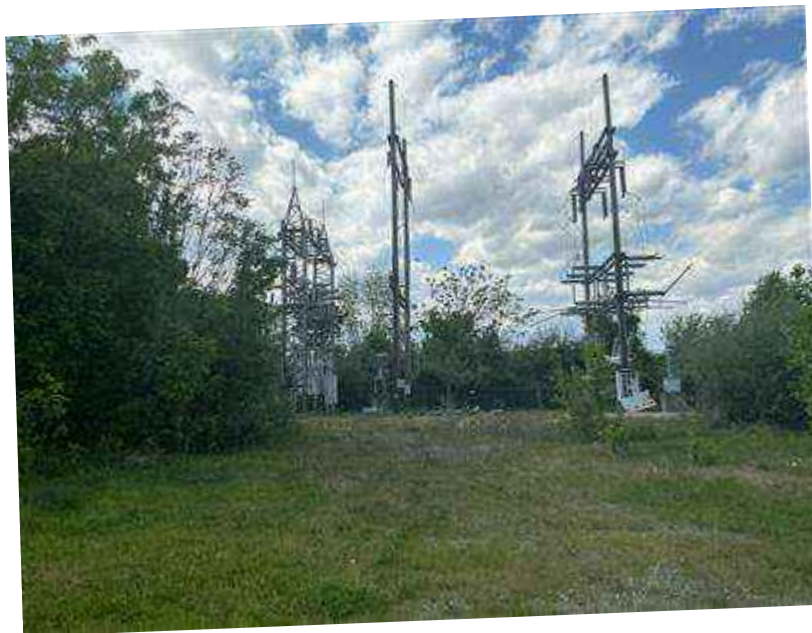
View of a substation and tote to the south of Pocahontas parcel 040-00-00-020.00.

A tote was observed to the south of Pocahontas parcel 040-00-00-020.00. Given the off-site location and lack of observed staining and/or stressed vegetation, it is the opinion of the EP that this finding does not represent a *REC*.

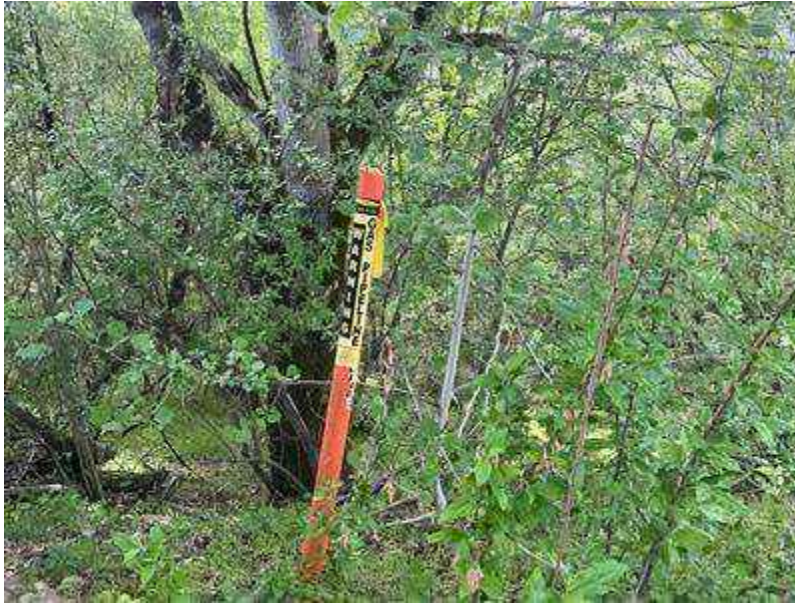
View of a gas pipeline to the south of Pocahontas parcel 040-00-00-020.00.

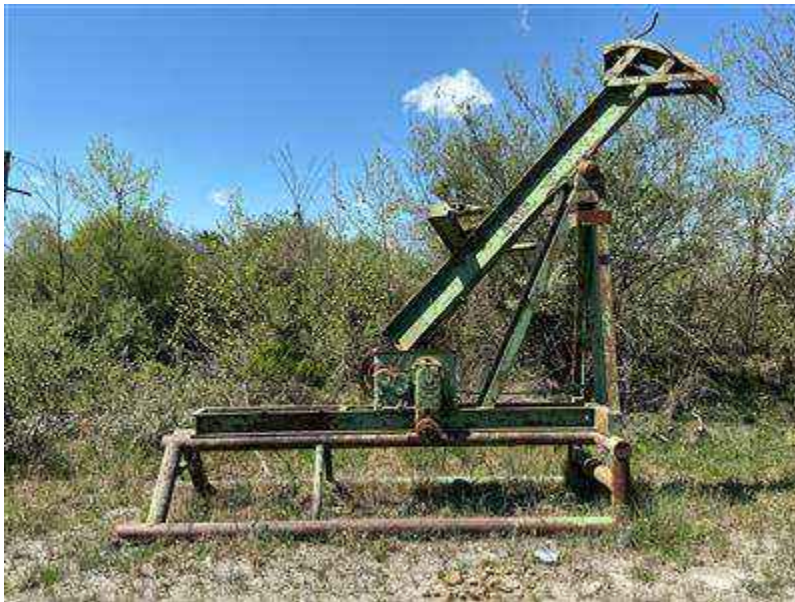
View of a gas well to the south of Pocahontas parcel 040-00-00-020.00.
