**A. There Is No Credible Evidence of Damage Resulting from the Long-Term Firing of Petroleum Coke at Station Two.**

**B. Station Two's H-1 boiler is in better condition today than when WKE took over operations in 1998.**

**DAVID FRENCH METALLURGICAL ANALYSIS 07-009**

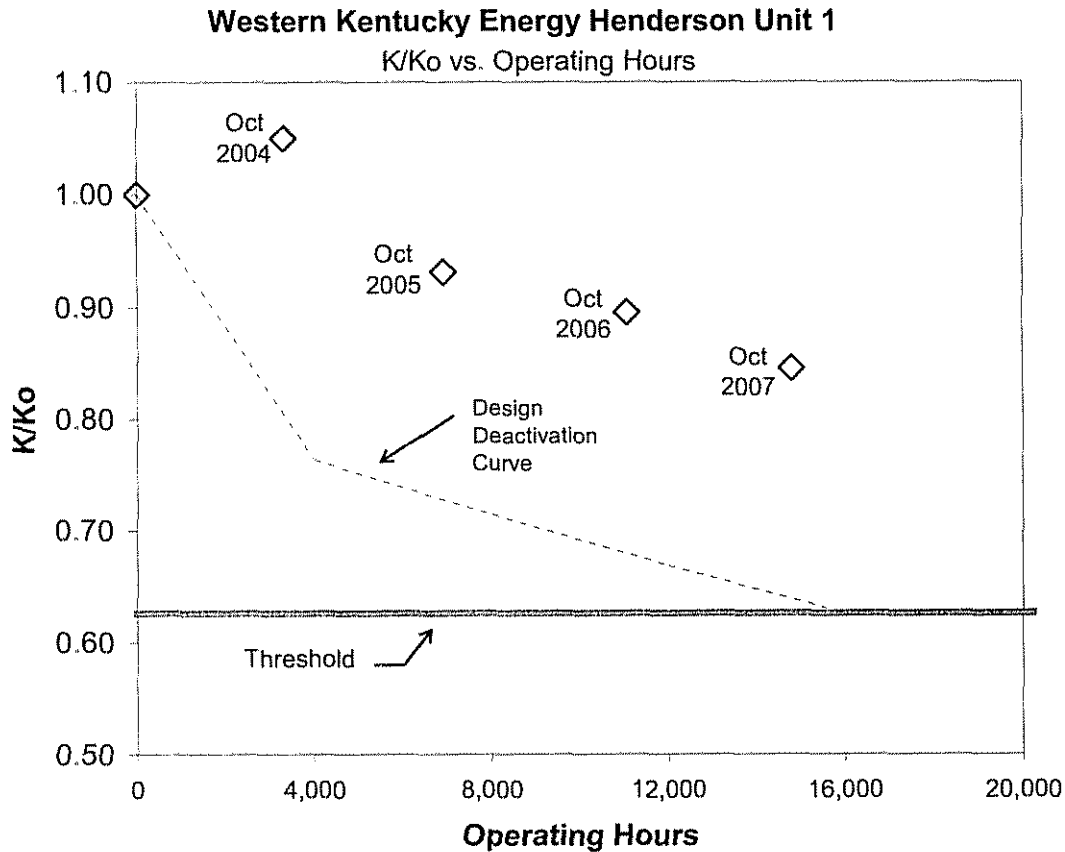
The figure below shows the trend in catalyst performance.

This audit of the Western Kentucky Energy Henderson Unit 1 SCR catalyst shows a decrease in catalytic potential of the SCR catalyst, as measured by pilot-scale testing.

Based on the results of this audit, the SCR catalyst installed in Western Kentucky Energy Henderson Unit 1 is above the performance threshold and is projected to continue to meet the design field performance requirements of 90% NO<sub>x</sub> reduction at 2 ppmvdc ammonia slip for at least the period of the guarantee life.

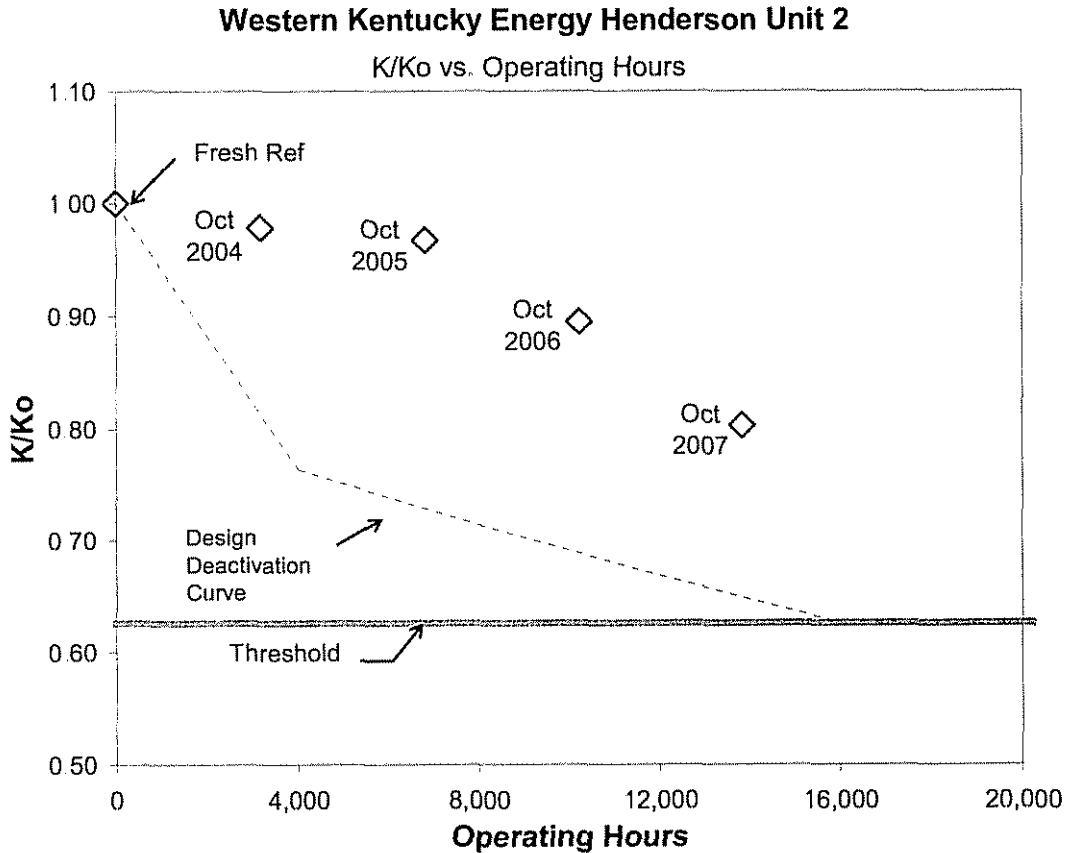
The figure below shows the trend in catalyst performance.

This audit of the Western Kentucky Energy Unit 2 SCR catalyst shows a decrease in catalytic potential of the SCR catalyst, as measured by pilot-scale testing.

Based on the results of this audit, the SCR catalyst installed in Western Kentucky Energy Unit 2 is above the performance threshold and is projected to continue to meet the design field performance requirements of 90% NO<sub>x</sub> reduction at 2 ppmvdc ammonia slip for at least the period of the guarantee life.

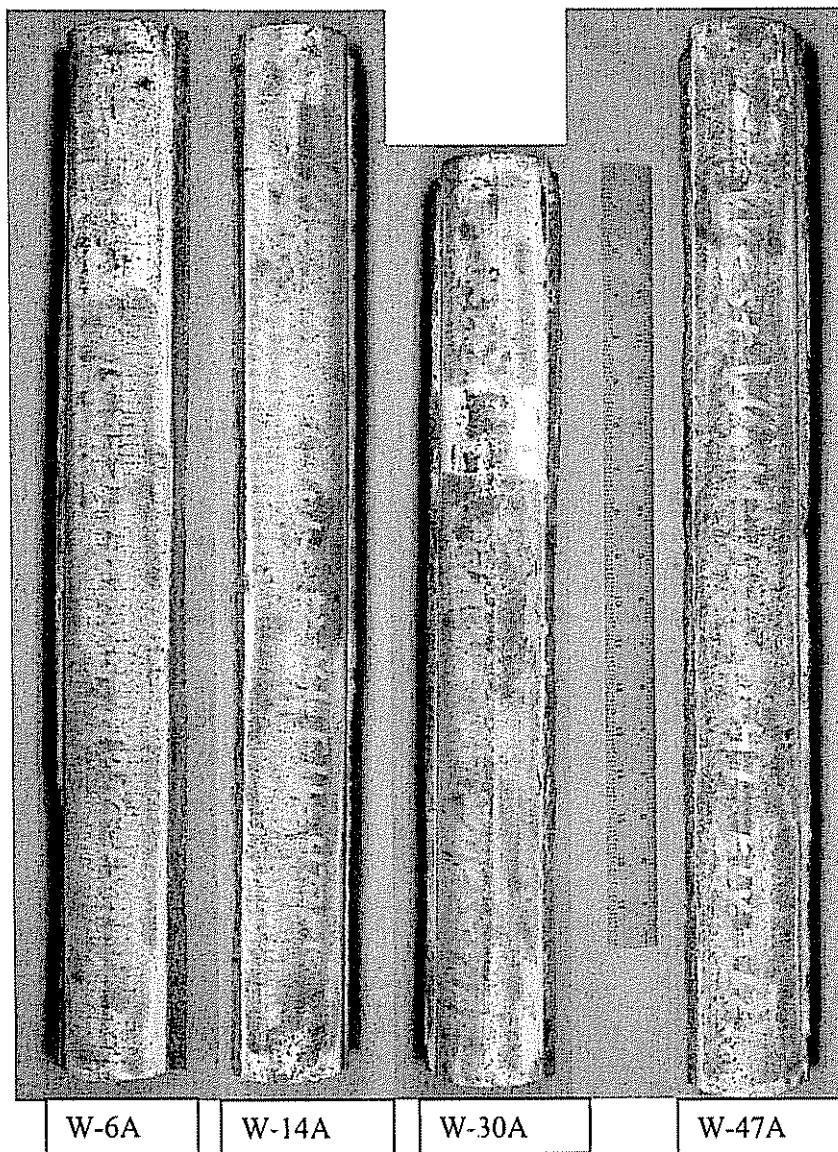
**Figure 1.** As-received tubes from the West Waterwall.

Four tube samples removed from the West Waterwall for condition assessment are shown in **Fig. 1**. The samples had some light ash on the outside but were generally clean with no evidence of damage or burning. The inside of the tubes appeared clean.

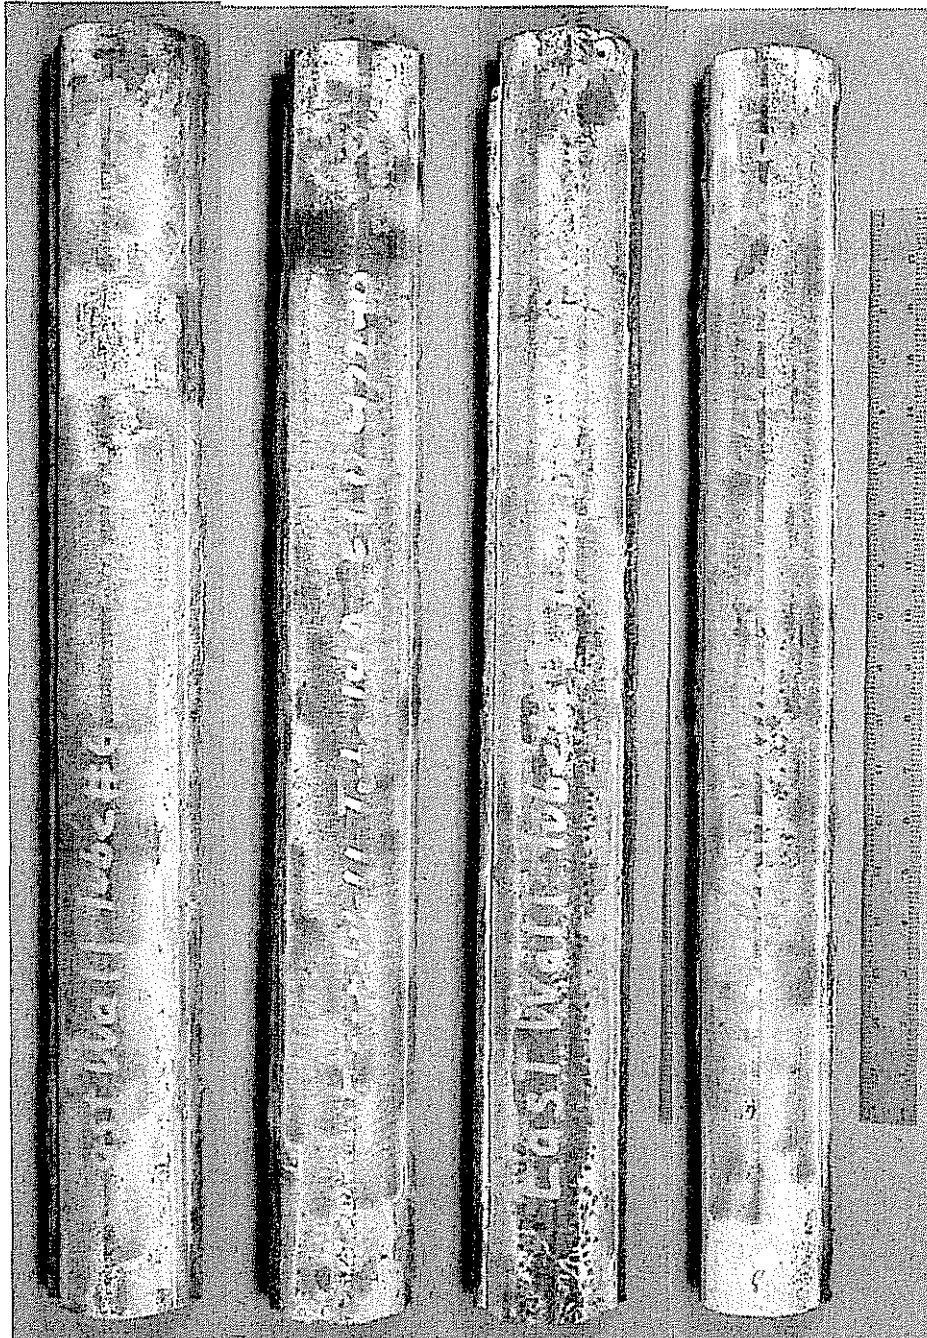
**Figure 9.** As-received tubes from East wall.

Four tube samples, removed from the East Waterwall for condition assessment are shown in **Fig. 9**. The tubes were generally clean with no evidence of damage or overheating. The inside of the tubes were clean.

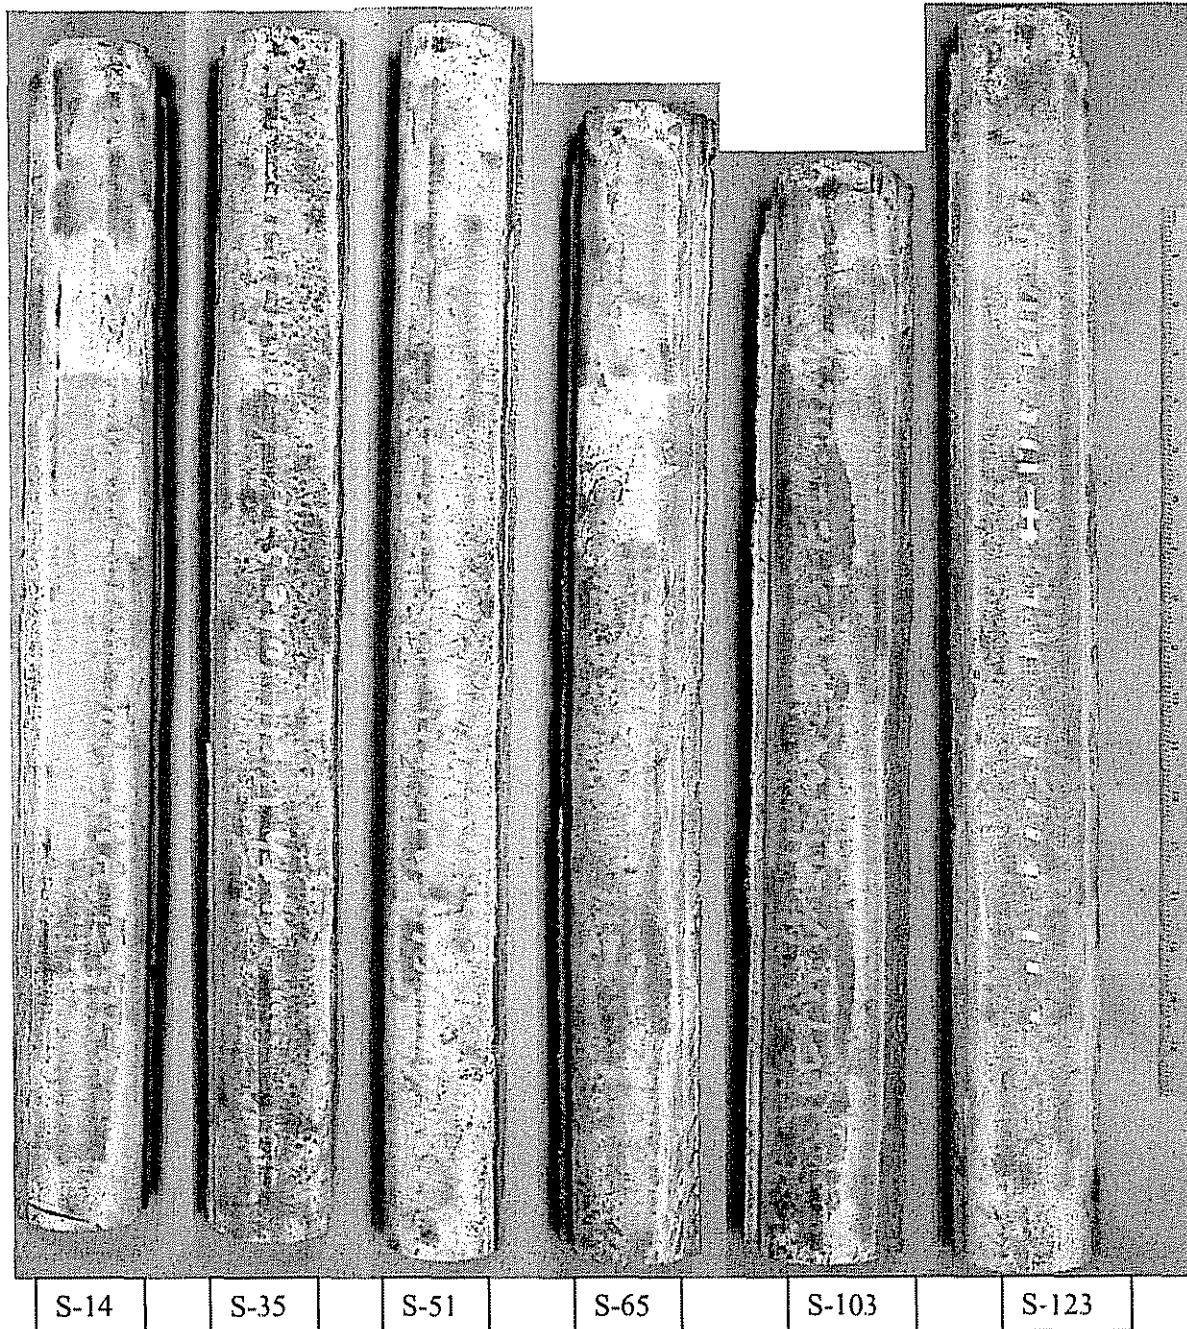
Figure 17. As-received tubes from South Waterwall.

Six tube samples, removed from the South Water Wall for condition assessment, are shown in Fig. 17. There was no visible evidence of surface damage or overheat. The inside of the tubes was clean.

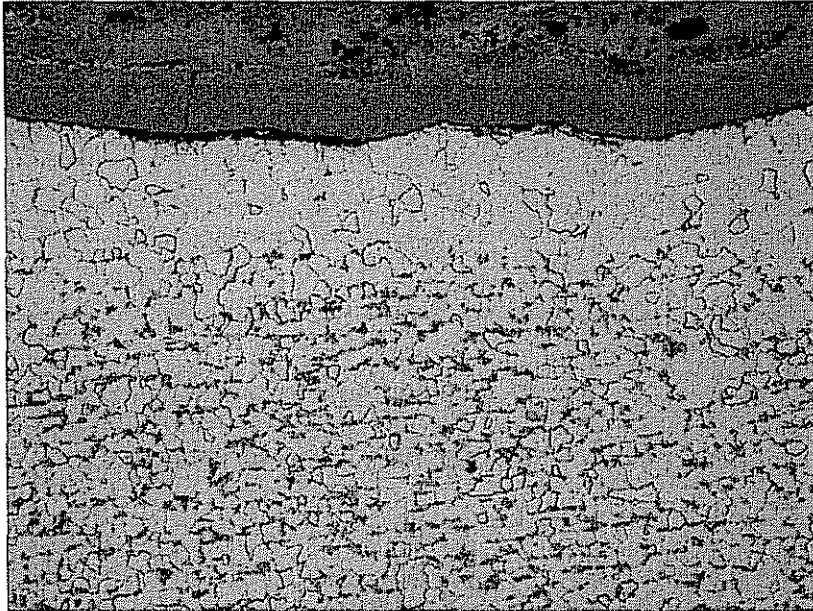
**Figure 18.** Tube S-14 hot side OD. 200x.

The cross-section at the surface of South Waterwall Tube 14, **Fig. 18**, shows a banded ferrite and pearlite microstructure, with a decarburized layer, seen in all the tubes. The decarburized layer was also observed on the ID, **Fig. 19**, and was seen on all the South Wall tubes. Some waterside pitting is also seen in **Fig. 19**.
